Access Audit Site Report

Prepared By
WT Group

San Angelo State Park
362 FM 2288
San Angelo, TX 76901
Accessibility Evaluation
Inspection Date: 10/05/2021
Inspectors: Tanya Scheibe

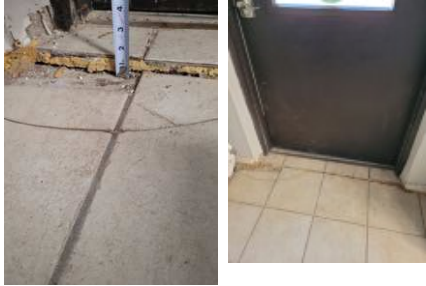
| Finding Number | Area Description | Lat/Long | Finding | As Built | Recommendation | Citation | Photos | Figure |
|---|---|---|---|---|--|---|--|---|
| 49 | Headquarters Area: Headquarters Building | [31.4545697, -100.4927865] | Thresholds, if provided at doorways, shall be 1/2 inch (13 mm) high maximum. Raised thresholds and changes in level at doorways shall comply with 302 and 303. Changes in level of 1/4 inch (6.4 mm) high maximum shall be permitted to be vertical. Changes in level between 1/4 inch (6.4 mm) high minimum and 1/2 inch (13 mm) high maximum shall be beveled with a slope not steeper than 1:2. Changes in level greater than 1/2 inch (13 mm) high shall be ramped, and shall comply with 405 or 406. | entry- change in elevation exceeds 1" | Repair, bevel or ramp CIL at doorway | 2015 ABAAS Section: 303.3, 404.2.5, 303.2, 303.4 2012 TAS Section: 303.3, 404.2.5, 303.2, 303.4 2010 ADAS Section: 303.3, 404.2.5, 303.2, 303.4 | | |

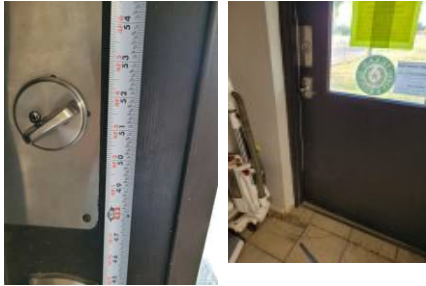
| Finding Number | Area Description | Lat/Long | Finding | As Built | Recommendation | Citation | Photos | Figure |
|---|---|---|--|---|--|---|--|---|
| 50 | Headquarters Area: Headquarters Building | [31.4545812, -100.4928026] | The door operating hardware is not accessible. Hand-activated door opening hardware, handles, pulls, latches, locks, and other operating devices on accessible doors shall have a shape that is easy to grasp with one hand and does not require tight grasping, tight pinching or twisting of the wrist to operate. Hardware shall be 34 inches minimum and 48 inches maximum above the finish floor or ground. | entry- lock at 51" | Replace hardware with lever hardware or hardware operable without a tight pinch or grasp | 2015 ABAAS Section: 404.2.7 2012 TAS Section: 404.2.7 2010 ADAS Section: 404.2.7 | | Lever Panic Bar Loop Handle Operating hardware must be centered between 34" and 48" above the floor or ground |

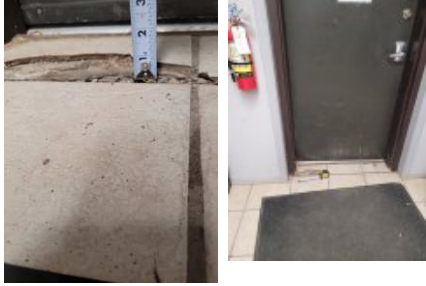
| Finding Number | Area Description | Lat/Long | Finding | As Built | Recommendation | Citation | Photos | Figure |
|---|---|---|---|--|--|---|---|---|
| 54 | Headquarters Area: Headquarters Building | [31.4545308, -100.4929072] | Thresholds, if provided at doorways, shall be 1/2 inch (13 mm) high maximum. Raised thresholds and changes in level at doorways shall comply with 302 and 303. Changes in level of 1/4 inch (6.4 mm) high maximum shall be permitted to be vertical. Changes in level between 1/4 inch (6.4 mm) high minimum and 1/2 inch (13 mm) high maximum shall be beveled with a slope not steeper than 1:2. Changes in level greater than 1/2 inch (13 mm) high shall be ramped, and shall comply with 405 or 406. | back door- approximate 1" change in level at door | Repair, bevel or ramp CIL at doorway | 2015 ABAAS Section: 303.3, 404.2.5, 303.2, 303.4 2012 TAS Section: 303.3, 404.2.5, 303.2, 303.4 2010 ADAS Section: 303.3, 404.2.5, 303.2, 303.4 | | |

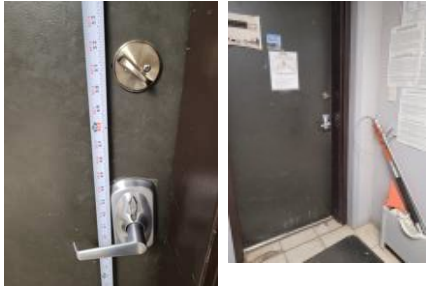
| Finding Number | Area Description | Lat/Long | Finding | As Built | Recommendation | Citation | Photos | Figure |
|---|---|---|---|--|--|---|---|---|
| 55 | Headquarters Area: Headquarters Building | [31.45454, -100.4929045] | The door operating hardware exceeds maximum height requirements. Hardware shall be 34 inches minimum and 48 inches maximum above the finish floor or ground. Hand-activated door opening hardware, handles, pulls, latches, locks, and other operating devices on accessible doors shall have a shape that is easy to grasp with one hand and does not require tight grasping, pinching or twisting of the wrist to operate. | back door- lock installed at 51" | Relocate door hardware within 34" and 48" maximum | 2015 ABAAS Section: 404.2.7 2012 TAS Section: 404.2.7 2010 ADAS Section: 404.2.7 | | |

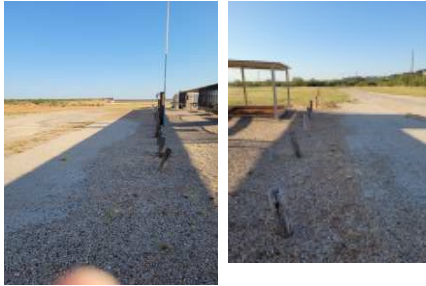
| Finding Number | Area Description | Lat/Long | Finding | As Built | Recommendation | Citation | Photos | Figure |
|---|---|---|---|---|--|--|--|---|
| 59 | RC Airplane Area: RC Airplane Area | [31.4498724, -100.5089777] | There are no accessible parking stalls. Each lot where parking is provided for the public as clients, guests or employees, shall provide accessible parking and shall be located on the shortest accessible route of travel from adjacent parking to an accessible entrance. There are a total of 15 parking stalls in the parking lot that could be reasonably associated with this facility. There should be a minimum of 1 accessible stalls with a minimum of 1 being designed as van accessible. | no marked parking, lacks accessible parking stall - approximately 15 standard, 0 accessible | Create one or more 8' accessible parking stalls, with one 5' adjacent access aisle, with proper signage and striping based on the total number of stalls | 2015 ABAAS Section: F208.2 2012 TAS Section: 208.2 2010 ADAS Section: 208.2 | | |

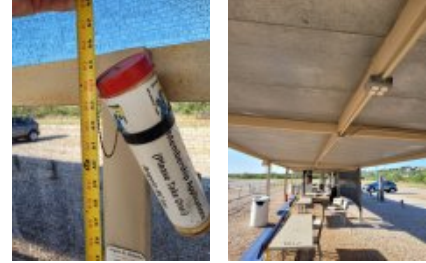
| Finding Number | Area Description | Lat/Long | Finding | As Built | Recommendation | Citation | Photos | Figure |
|---|---|---|---|---|--|--|--|---|
| 61 | RC Airplane Area: RC Airplane Area | [31.4500198, -100.5088583] | The overhead shelter extends down too close to the route of travel. Any obstruction that overhangs a route of travel must be a minimum of 80 inches above the walking surface as measured from the bottom of the obstruction. | overhead shelter is less than 80" above ground | Raise overhead shelter to min 80", or pad object to prevent hazard in overhead clearance along AR Install guardrails to warn patrons of lowered overhead clearance | 2015 ABAAS Section: 307.4 2012 TAS Section: 307.4 2010 ADAS Section: 307.4 | | |

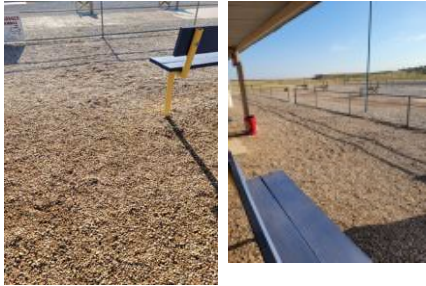
| Finding Number | Area Description | Lat/Long | Finding | As Built | Recommendation | Citation | Photos | Figure |
|---|---|---|--|---|---|---|--|---|
| 62 | RC Airplane Area: RC Airplane Area | [31.4499607, -100.5088422] | At least one accessible route shall connect accessible buildings, accessible facilities, accessible elements, and accessible spaces that are on the same site. For areas of sport activity, an accessible route is required to connect to the boundary of each area of sport activity. The size of an area of sport activity includes only the space needed to play. Where multiple sports fields or courts are provided, an accessible route is required to each field or area of sport activity. | loose gravel surface throughout participant areas | Provide an accessible route to each element within the site. | 2010 ADAS Section: 206.2.2, 206.2 | | |

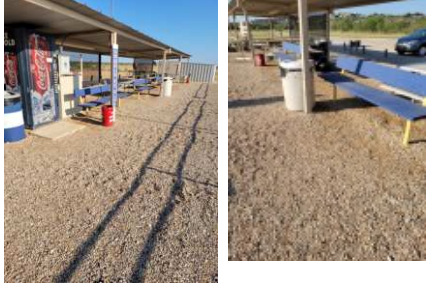
| Finding Number | Area Description | Lat/Long | Finding | As Built | Recommendation | Citation | Photos | Figure |
|---|---|---|--|---|---|---|--|---|
| 63 | RC Airplane Area: RC Airplane Area | [31.4501056, -100.5088368] | Where provided, at least one bench at each outdoor location shall comply with 1011. Where more than one bench is provided and serves the same outdoor space, feature or location, at least 20 percent of the benches shall comply with 1011. | 0 of 5 benches comply, loose surface | Provide 36" by 48" CFS adjacent to 20%, or not less than one bench. | | | |

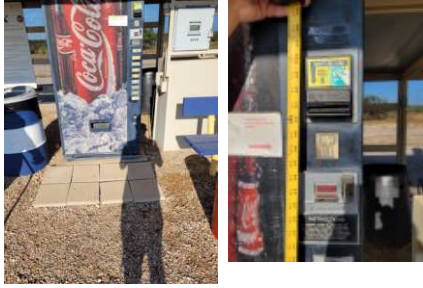
| Finding Number | Area Description | Lat/Long | Finding | As Built | Recommendation | Citation | Photos | Figure |
|---|---|---|--|---|--|---|--|---|
| 67 | RC Airplane Area: RC Airplane Area | [31.44998, -100.5089] | At least one accessible route shall connect accessible buildings, accessible facilities, accessible elements, and accessible spaces that are on the same site. For areas of sport activity, an accessible route is required to connect to the boundary of each area of sport activity. The size of an area of sport activity includes only the space needed to play. Where multiple sports fields or courts are provided, an accessible route is required to each field or area of sport activity. | lacks accessible route to vending machine, money slot 61" | Provide an accessible route to each element within the site. Work with vendor to provide accessible machine. | 2010 ADAS Section: 206.2.2, 206.2 | | |

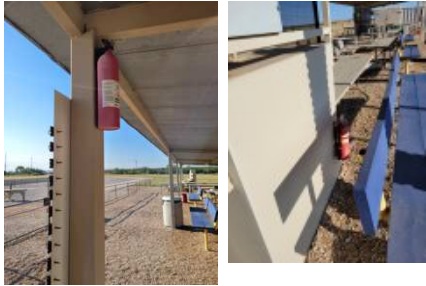
| Finding Number | Area Description | Lat/Long | Finding | As Built | Recommendation | Citation | Photos | Figure |
|---|---|---|---|--|---|--|---|---|
| 68 | RC Airplane Area: RC Airplane Area | [31.44995, -100.5089] | The fire extinguishers are positioned too high for either a side or front approach. Where a clear floor or ground space allows a parallel approach to an element and the side reach is unobstructed, the high side reach shall be 48 inches maximum and the low side reach shall be 15 inches minimum above the finish floor or ground. Where a forward reach is unobstructed, the high forward reach shall be 48 inches maximum and the low forward reach shall be 15 inches minimum above the finish floor or ground. | 2 of 3 extinguishers above 70", lower extinguisher | Remount operable parts to be in reach range of 15" min to 48" max | 2015 ABAAS Section: 308.1 2012 TAS Section: 308.1 2010 ADAS Section: 308.1 | | |

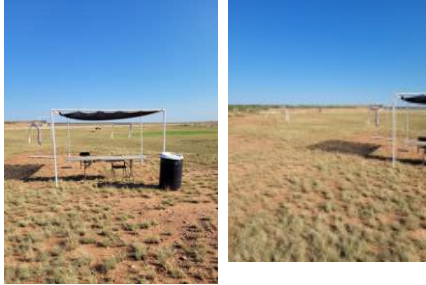
| Finding Number | Area Description | Lat/Long | Finding | As Built | Recommendation | Citation | Photos | Figure |
|---|---|---|--|--|--|---|---|---|
| 70 | RC Airplane Area: RC Airplane Area | [31.45065, -100.5087] | At least one accessible route shall connect accessible buildings, accessible facilities, accessible elements, and accessible spaces that are on the same site. For areas of sport activity, an accessible route is required to connect to the boundary of each area of sport activity. The size of an area of sport activity includes only the space needed to play. Where multiple sports fields or courts are provided, an accessible route is required to each field or area of sport activity. | lacks accessible route to quad race course | Provide an accessible route to each element within the site. | 2010 ADAS Section: 206.2.2, 206.2 | | |

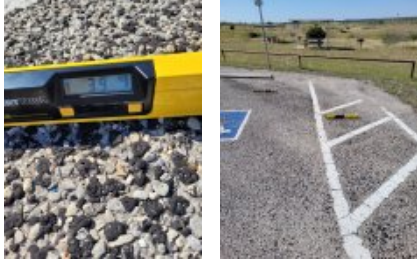
| Finding Number | Area Description | Lat/Long | Finding | As Built | Recommendation | Citation | Photos | Figure |
|---|---|---|---|---|---|---|--|---|
| 75 | Lakeview Day Use Area: Lakeview Parking | [31.4796396, -100.4826183] | The parking stall contains abrupt edges and surface irregularities over a 1/4 inch vertical. Parking spaces and access aisles serving them shall be stable, firm, and slip resistant. Access aisles shall be at the same level as the parking spaces they serve. Changes in level are not permitted and shall not be sloped steeper than 2% in any direction. | day use shelters 1-4: loose surface | Repair, bevel and ramp CIL in stalls and access aisles Resurface stalls and access aisles to eliminate gaps and cracks Resurface accessible stalls and access aisles with a firm, stable, and slip resistant material | 2015 ABAAS Section: 502.4 2012 TAS Section: 502.4 2010 ADAS Section: 502.4 | | |

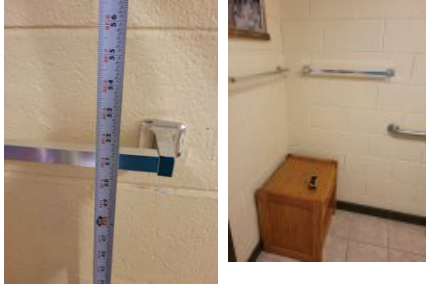
| Finding Number | Area Description | Lat/Long | Finding | As Built | Recommendation | Citation | Photos | Figure |
|---|---|---|--|---|--|--|--|--|
| 107 | Red Arroyo Camping Area: Red Arroyo Bunkhouse Restroom | [31.4677847, -100.5037782] | Where a high forward reach is over an obstruction, the clear floor space shall extend beneath the element for a distance not less than the required reach depth over the obstruction. The high forward reach shall be 48 inches (1220 mm) maximum where the reach depth is 20 inches (510 mm) maximum. Where the reach depth exceeds 20 inches (510 mm), the high forward reach shall be 44 inches (1120 mm) maximum and the reach depth shall be 25 inches (635 mm) maximum. Where a clear floor or ground space allows a parallel approach to an element and the high side reach is over an obstruction, the height of the obstruction shall be 34 inches (865 mm) maximum and the depth of the obstruction shall be 24 inches (610 mm) maximum. The high side reach shall be 48 inches (1220 mm) maximum for a reach depth of 10 inches (255 mm) maximum. Where the reach depth exceeds 10 inches (255 mm), the high side reach shall be 46 inches (1170 mm) maximum for a reach depth of 24 inches (610 mm) maximum. | restroom- towel bar 51.5" | Lower towel bar to max 48" aff to highest operable part | 2015 ABAAS Section: 308.2.1, 308.3.2 2012 TAS Section: 308.2.1, 308.3.2 2010 ADAS Section: 308.2.1, 308.3.2 | | |

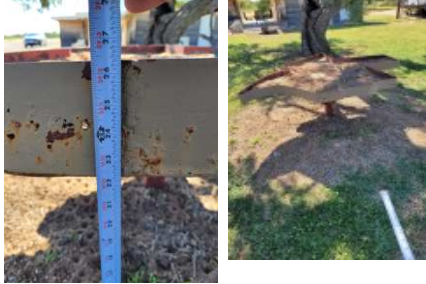
| Finding Number | Area Description | Lat/Long | Finding | As Built | Recommendation | Citation | Photos | Figure |
|---|---|---|--|---|--|---|---|---|
| 121 | Red Arroyo Camping Area: Red Arroyo Playground | [31.4680729 , -100.5035 046] | Knee clearance has not been provided at the play table. Knee clearance 24 inches high minimum, 17 inches deep minimum, and 30 inches wide minimum shall be provided. | 22.25" knee clearance | Install play table with knee clearance Raise play table to provide knee clearance min 24" high, 17" deep, and 30" wide | 2012 TAS Section: 1008.4.3 2010 ADAS Section: 1008.4.3 | | |

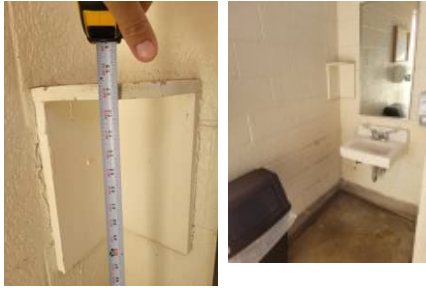
| Finding Number | Area Description | Lat/Long | Finding | As Built | Recommendation | Citation | Photos | Figure |
|---|---|---|---|---|--|--|---|---|
| 127 | Red Arroyo Camping Area: Red Arroyo RV Men's Restroom | [31.4715967, -100.5009 941] | Shelves shall be 40 inches (1015 mm) minimum and 48 inches (1220 mm) maximum above the finish floor or ground. Where shelves are provided in dressing, fitting or locker rooms without individual compartments, at least one of each type shall comply with 803.5. | shelf height 57.25" | Remount shelves to 40" - 48" aff | 2015 ABAAS Section: 308.2.1, 308.1, F222.2, 803.5 2012 TAS Section: 308.2.1, 308.1, 222.2, 803.5 2010 ADAS Section: 308.2.1, 308.1, 222.2, 803.5 | | |

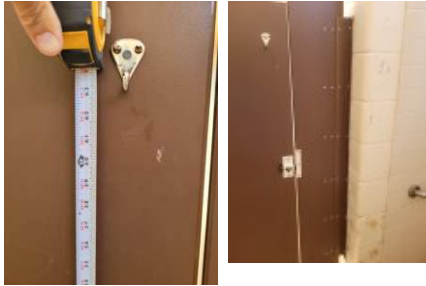
| Finding Number | Area Description | Lat/Long | Finding | As Built | Recommendation | Citation | Photos | Figure |
|---|--|---|--|---|---|--|---|---|
| 131 | Red Arroyo Camping Area: Red Arroyo RV Men's Restroom | [31.4715868, -100.5009941] | Coat hooks provided within the room shall be located within one of the reach ranges specified in 308. Shelves shall be 40 inches (1015 mm) minimum and 48 inches (1220 mm) maximum above the finish floor or ground. Where coat hooks or shelves are provided in dressing, fitting or locker rooms without individual compartments, at least one of each type shall comply with 803.5. Where coat hooks or shelves are provided in individual compartments at least one of each type complying with 803.5 shall be provided in individual compartments in dressing, fitting, or locker rooms required to comply with 222.1. | hook at 63.5" | Remount at least one hook to max 48" aff | 2015 ABAAS Section: 308.2.1, 308.1, F222.2, 803.5 2012 TAS Section: 308.2.1, 308.1, 222.2, 803.5 2010 ADAS Section: 308.2.1, 308.1, 222.2, 803.5 | | |

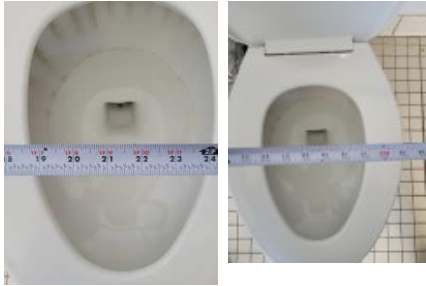
| Finding Number | Area Description | Lat/Long | Finding | As Built | Recommendation | Citation | Photos | Figure |
|---|--|---|---|---|---|--|---|---|
| 163 | Red Arroyo Camping Area: Red Arroyo Tent Men's Restroom | [31.4674141 , -100.49609 9] | The toilet is not located within the range to the side wall or partition. The centerline of the toilet shall be 17 inches minimum and 19 inches maximum side wall or partition in the ambulatory accessible toilet compartment. | centerline exceeds 20" from each wall | Remount toilet to 17" to 19" from the side wall to center line in ambulatory stalls | 2015 ABAAS Section: 604.9.1 2012 TAS Section: 604.9.1 2010 ADAS Section: 604.9.1 | | |

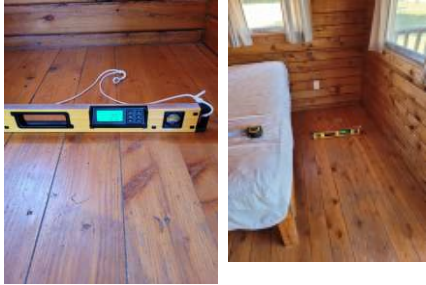
| Finding Number | Area Description | Lat/Long | Finding | As Built | Recommendation | Citation | Photos | Figure |
|---|---|---|---|--|---|--|--|---|
| 189 | Red Arroyo Camping Area: Red Arroyo Cabins - Cabin 1 | [31.4683131, -100.5044099] | The accessible route contains running slopes greater than 5 percent and cross slopes greater than 2 percent across the width of the walk and has not been constructed as a ramp (i.e. handrails, wheel guides, etc.). When the slope in the direction of travel of any walk exceeds 1 unit vertical in 20 units horizontal (5-percent slope), it must be constructed as ramp. Surface cross slopes must not exceed one unit vertical in 48 units. Horizontal (2-percent slope). | 2.5% cross slope next to main bed | Correct or repair slope to max 5% running and 2.08% cross | 2015 ABAAS Section: 403.3 2012 TAS Section: 403.3 2010 ADAS Section: 403.3 | | |

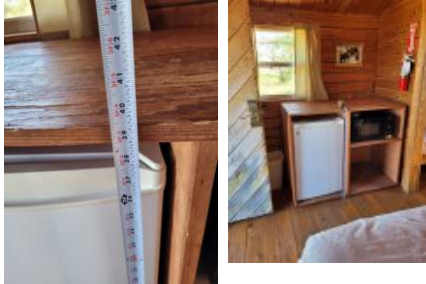
| Finding Number | Area Description | Lat/Long | Finding | As Built | Recommendation | Citation | Photos | Figure |
|---|---|---|---|--|---|--|--|---|
| 190 | Red Arroyo Camping Area: Red Arroyo Cabins - Cabin 1 | [31.4683154, -100.5044072] | The top of the work surface is not within a compliant height range. The tops of tables and counters shall be 28 inches to 34 inches from the floor or ground. | 39.5" counter | Provide tables and work surfaces at 28" to 34" aff with required knee and toe clearances | 2015 ABAAS Section: 902.3 2012 TAS Section: 902.3 2010 ADAS Section: 902.3 | | |

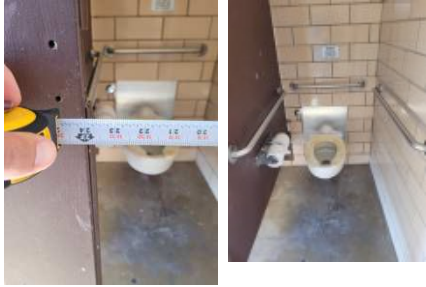
| Finding Number | Area Description | Lat/Long | Finding | As Built | Recommendation | Citation | Photos | Figure |
|---|--|---|--|---|--|---|---|---|
| 198 | Red Arroyo Camping Area: Red Arroyo Playground Men's Restroom | [31.468487, -100.5031211] | There are not enough accessible toilet compartments. The room contains zero (0) toilet compartments. A minimum of 1 must be wheelchair accessible . | lacks wheelchair accessible stall, stall most similar to ambulatory stall, stall door width 24" | Create a wheelchair accessible stall with grab bars and fixtures mounted in correct locations and at correct heights | 2015 ABAAS Section: F213.3.1 2012 TAS Section: 213.3.1 2010 ADAS Section: 213.3.1 | | |

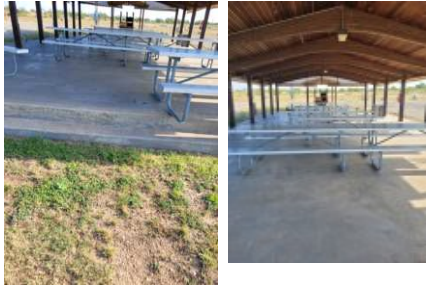
| Finding Number | Area Description | Lat/Long | Finding | As Built | Recommendation | Citation | Photos | Figure |
|---|--|---|--|---|---|--|---|---|
| 228 | Chapparral Camping Area: Chapparral Group Picnic | [31.4710448, -100.5043361] | Picnic tables shall provide at least one wheelchair space for each 24 linear feet (7320 mm) of usable table surface perimeter. Wheelchair spaces shall be 30 inches (760 mm) minimum by 48 inches (1220 mm) minimum. Wheelchair spaces shall be positioned for a forward approach to the table and provide knee and toe clearance complying with 306 under the table | 0 of 10 picnic tables are of an accessible design | Replace 20% of picnic tables with one of an accessible design as a smart practice | 2015 ABAAS Section: 1011.4.2 | | |

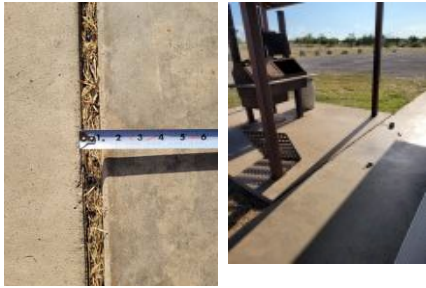
| Finding Number | Area Description | Lat/Long | Finding | As Built | Recommendation | Citation | Photos | Figure |
|---|--|---|--|---|---|--|---|---|
| 230 | Chapparral Camping Area: Chapparral Group Picnic | [31.4709875, -100.5043281] | There is a gap spaced greater than a 1/2 inch. Openings in floor or ground surfaces shall not allow passage of a sphere more than 1/2 inch diameter. Elongated openings shall be placed so that the long dimension is perpendicular to the dominant direction of travel. | 1" gap to grill access | Correct or fill gaps to be max .5". | 2015 ABAAS Section: 302.3 2012 TAS Section: 302.3 2010 ADAS Section: 302.3 | | |

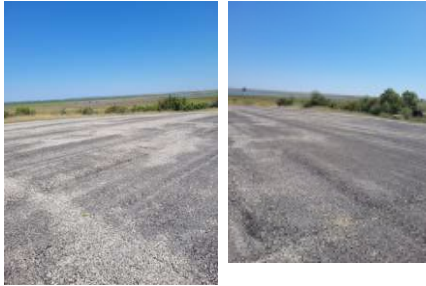
| Finding Number | Area Description | Lat/Long | Finding | As Built | Recommendation | Citation | Photos | Figure |
|---|---|---|---|--|--|---|--|---|
| 247 | Isabel Harte Multi-Use Area: Isabel Harte Campsites | [31.47926, -100.5051] | There are no accessible parking stalls. Each lot where parking is provided for the public as clients, guests or employees, shall provide accessible parking and shall be located on the shortest accessible route of travel from adjacent parking to an accessible entrance. | no marked parking stalls, no accessible parking | Create one or more 8' accessible parking stalls, with one 5' adjacent access aisle, with proper signage and striping based on the total number of stalls | 2015 ABAAS Section: F208.2 2012 TAS Section: 208.2 2010 ADAS Section: 208.2 | | |

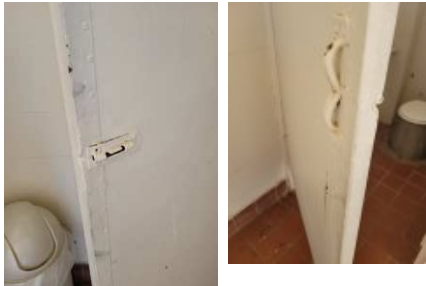
| Finding Number | Area Description | Lat/Long | Finding | As Built | Recommendation | Citation | Photos | Figure |
|---|--|---|--|---|--|---|---|---|
| 265 | Burkett Trailhead and Day Use Area: Burkett Trailhead Men's Restroom | [31.4812031 , -100.5243 239] | The door hardware is not accessible because it requires tight grasping, pinching or twisting of the wrist. | non working hardware | Replace door hardware with an operable part usable without a tight pinch or grasp | 2015 ABAAS Section: 309.4 2012 TAS Section: 309.4 2010 ADAS Section: 309.4 | | |

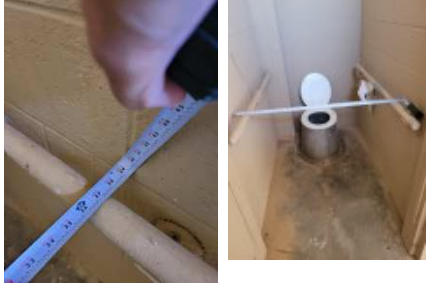
| Finding Number | Area Description | Lat/Long | Finding | As Built | Recommendation | Citation | Photos | Figure |
|---|---|---|--|--|---|---|---|---|
| 296 | River Bend Camping Area: River Bend Men's Restroom | [31.5158413, -100.5518139] | There are not enough accessible toilet compartments. The room contains 1 toilet compartments. A minimum of 1 must be wheelchair accessible . | ambulatory stall only, 39.25" width | Create a wheelchair accessible stall with grab bars and fixtures mounted in correct locations and at correct heights | 2015 ABAAS Section: F213.3.1 2012 TAS Section: 213.3.1 2010 ADAS Section: 213.3.1 | | |

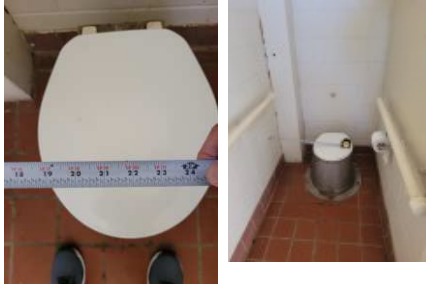
| Finding Number | Area Description | Lat/Long | Finding | As Built | Recommendation | Citation | Photos | Figure |
|---|---|---|--|--|---|--|---|---|
| 324 | North Concho Camping Area: North Concho Men's Restroom | [31.5374869 , -100.5465 621] | The toilet is not located within the range to the side wall or partition. The centerline of the toilet shall be 17 inches minimum and 19 inches maximum side wall or partition in the ambulatory accessible toilet compartment. | 22" to toilet centerline | Remount toilet to 17" to 19" from the side wall to center line in ambulatory stalls | 2015 ABAAS Section: 604.9.1 2012 TAS Section: 604.9.1 2010 ADAS Section: 604.9.1 | | |

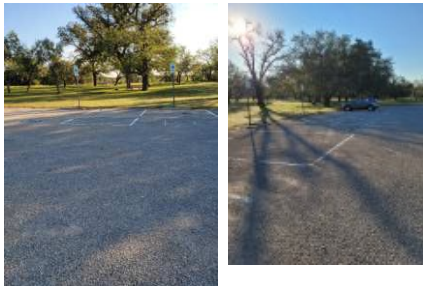
| Finding Number | Area Description | Lat/Long | Finding | As Built | Recommendation | Citation | Photos | Figure |
|---|---|---|---|--|---|---|---|---|
| 345 | North Concho Camping Area: North Concho Campsites | [31.5300307, -100.5449179] | The accessible parking is not located on the shortest accessible route to the building. Accessible parking spaces serving a particular building or facility entrance shall be located on the shortest accessible route of travel from the parking to an accessible entrance. | 2 of 2 accessible parking stalls lacks shortest accessible route from parking location | Relocate stalls to be on the shortest AR to the building entry or park features | 2015 ABAAS Section: F208.3.1 2012 TAS Section: 208.3.1 2010 ADAS Section: 208.3.1 | | |

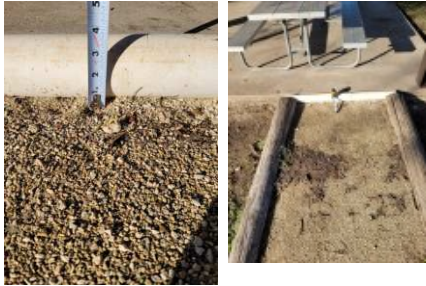
| Finding Number | Area Description | Lat/Long | Finding | As Built | Recommendation | Citation | Photos | Figure |
|---|--|---|--|--|---|---|--|---|
| 360 | North Concho Camping Area: North Concho Group Camping | [31.5308686 , -100.54527 2] | The walkway contains abrupt vertical edges and/or variations over a 1/4 inch. 1/4 inch is the maximum vertical rise. Changes in level between 1/4 inch and 1/2 inch must be beveled at 1:2 or less. Changes in level greater than 1/2 inch must be by way of a ramp. | 3.25" change in elevation at entry to shelter | Repair, bevel or ramp CIL along AR | 2012 TAS Section: 303.2, 303.3 2010 ADAS Section: 303.2, 303.3 | | |

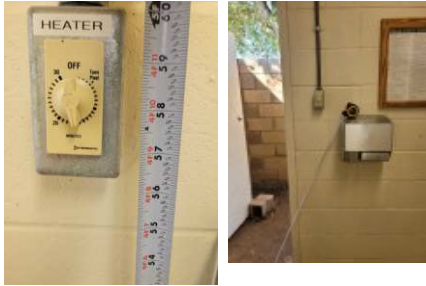
| Finding Number | Area Description | Lat/Long | Finding | As Built | Recommendation | Citation | Photos | Figure |
|---|---|---|--|---|---|---|--|--|
| 378 | Bald Eagle Camping Area: Bald Eagle North Men's Restroom | [31.5415743, -100.5542735] | Where a high forward reach is over an obstruction, the clear floor space shall extend beneath the element for a distance not less than the required reach depth over the obstruction. The high forward reach shall be 48 inches (1220 mm) maximum where the reach depth is 20 inches (510 mm) maximum. Where the reach depth exceeds 20 inches (510 mm), the high forward reach shall be 44 inches (1120 mm) maximum and the reach depth shall be 25 inches (635 mm) maximum. Where a clear floor or ground space allows a parallel approach to an element and the high side reach is over an obstruction, the height of the obstruction shall be 34 inches (865 mm) maximum and the depth of the obstruction shall be 24 inches (610 mm) maximum. The high side reach shall be 48 inches (1220 mm) maximum for a reach depth of 10 inches (255 mm) maximum. Where the reach depth exceeds 10 inches (255 mm), the high side reach shall be 46 inches (1170 mm) maximum for a reach depth of 24 inches (610 mm) maximum. | bathroom heater control mounted at 58.25" | Lower operating mechanisms in heater controls to max 48" aff to highest operable part | 2015 ABAAS Section: 308.2.1, 308.3.2 2012 TAS Section: 308.2.1, 308.3.2 2010 ADAS Section: 308.2.1, 308.3.2 | | |

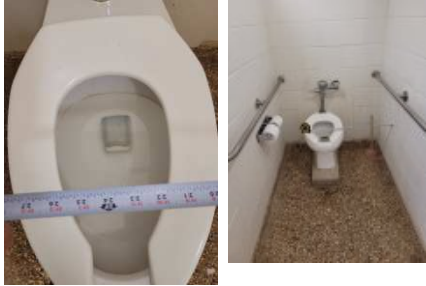
| Finding Number | Area Description | Lat/Long | Finding | As Built | Recommendation | Citation | Photos | Figure |
|---|--|---|--|--|--|---|--|---|
| 381 | Bald Eagle Camping Area: Bald Eagle North Men's Restroom | [31.5415731, -100.5542815] | The toilet is not located within the range to the side wall or partition. The centerline of the toilet shall be 17 inches minimum and 19 inches maximum side wall or partition in the ambulatory accessible toilet compartment. | toilet centerline is 23.5" from right wall | Remount toilet to 17" to 19" from the side wall to center line in ambulatory stalls | 2015 ABAAS Section: 604.9.1 2012 TAS Section: 604.9.1 2010 ADAS Section: 604.9.1 | | |

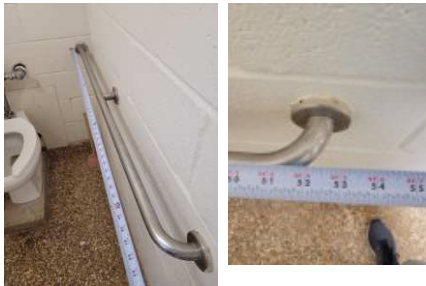
| Finding Number | Area Description | Lat/Long | Finding | As Built | Recommendation | Citation | Photos | Figure |
|---|--|---|--|--|--|---|--|---|
| 382 | Bald Eagle Camping Area: Bald Eagle North Men's Restroom | [31.5415697, -100.5542815] | The side grab bars are not in the correct location. Grab bars on the side wall must be installed so that the end closest to the rear wall is maximum 12" from the rear wall. The end furthest from the rear wall must be mounted minimum 54" from the rear wall. | grab bars extend 53" from back wall | Remount side grab bar to max 12" from the rear wall at the close end and min 54" on the far end, and 33" to 36" aff | 2015 ABAAS Section: 604.5.1 2012 TAS Section: 604.5.1 2010 ADAS Section: 604.5.1 | | |

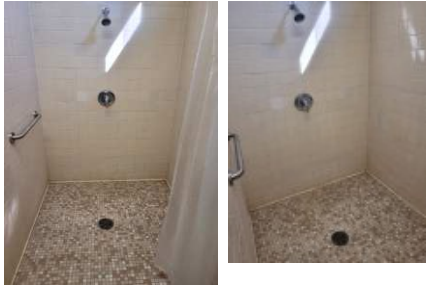
| Finding Number | Area Description | Lat/Long | Finding | As Built | Recommendation | Citation | Photos | Figure |
|---|--|---|---|---|---|--|---|---|
| 385 | Bald Eagle Camping Area: Bald Eagle North Men's Restroom | [31.5415903, -100.5542788] | There are no accessible bathing or shower facilities. Where facilities for bathing are provided for the public, clients or employees, including showers or bathtubs, at least one shower or bathtub and support facilities such as lockers, and not less than 1 percent of all facilities, shall be accessible. | shower 56" wide, lacks hand held shower wand, lacks grab bar and seat | Create an accessible shower in locker/bathing room | 2015 ABAAS Section: F213.3.6 2012 TAS Section: 213.3.6 2010 ADAS Section: 213.3.6 | | |

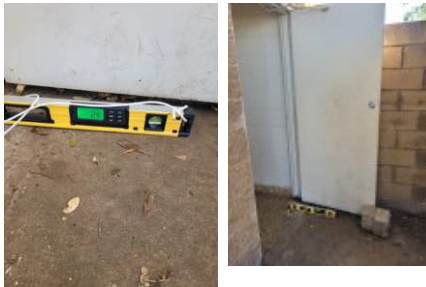
| Finding Number | Area Description | Lat/Long | Finding | As Built | Recommendation | Citation | Photos | Figure |
|---|--|---|---|---|---|--|---|---|
| 386 | Bald Eagle Camping Area: Bald Eagle North Men's Restroom | [31.5415777, -100.5542882] | Floor or ground surface within required maneuvering clearances shall comply with 302. Changes in level are not permitted. EXCEPTIONS: 1. Slopes not steeper than 1:48 shall be permitted. 2. Changes in level at thresholds complying with 404.2.5 shall be permitted. | men's- 2.4% slope at door | Correct or repair slope at doorway landing to max 2.08% in any direction for level landing. | 2015 ABAAS Section: 404.2.4.4, 404.2.4.4 EXCEPTIONS: 1, 404.2.4.4 EXCEPTIONS: 2 2012 TAS Section: 404.2.4.4, 404.2.4.4 Exception 1, 404.2.4.4 Exception 2 2010 ADAS Section: 404.2.4.4, 404.2.4.4 Exception 1, 404.2.4.4 Exception 2 | | |

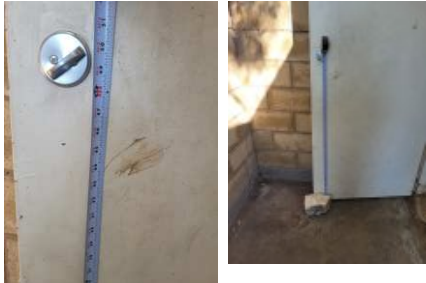
| Finding Number | Area Description | Lat/Long | Finding | As Built | Recommendation | Citation | Photos | Figure |
|---|--|---|--|--|--|--|--|--|
| 399 | Bald Eagle Camping Area: Bald Eagle North Women's Restroom | [31.5415731, -100.5543124] | The door operating hardware is not accessible. Hand-activated door opening hardware, handles, pulls, latches, locks, and other operating devices on accessible doors shall have a shape that is easy to grasp with one hand and does not require tight grasping, tight pinching or twisting of the wrist to operate. Hardware shall be 34 inches minimum and 48 inches maximum above the finish floor or ground. | women's- door lock installed at 49" and requires pinch/grasp | Replace hardware with lever hardware or hardware operable without a tight pinch or grasp and mount between 34" and 48" aff. | 2015 ABAAS Section: 404.2.7 2012 TAS Section: 404.2.7 2010 ADAS Section: 404.2.7 | | |

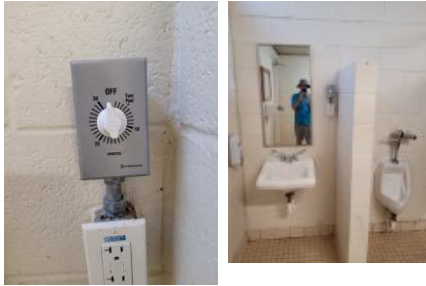
| Finding Number | Area Description | Lat/Long | Finding | As Built | Recommendation | Citation | Photos | Figure |
|---|--|---|--|---|--|--|--|--|
| 429 | Bald Eagle Camping Area: Bald Eagle Camp Men's Restroom | [31.5358981 , -100.5442 259] | The heater control is not accessible because it requires tight grasping, pinching or twisting of the wrist. | heater control requires tight pinch | Replace heater control with an operable part usable without a tight pinch or grasp | 2015 ABAAS Section: 309.4 2012 TAS Section: 309.4 2010 ADAS Section: 309.4 | | |

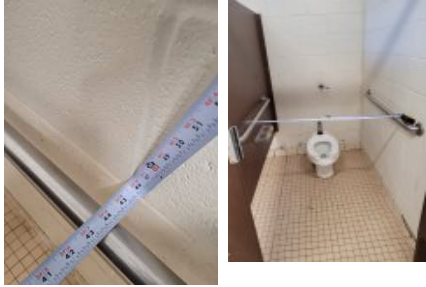
| Finding Number | Area Description | Lat/Long | Finding | As Built | Recommendation | Citation | Photos | Figure |
|---|--|---|--|---|--|--|--|--|
| 431 | Bald Eagle Camping Area: Bald Eagle Camp Men's Restroom | [31.5359118 , -100.54424 2] | The ambulatory stall is not between 35" to 37" wide and 60" deep. | ambulatory stall 46" wide | Correct ambulatory stall to be 35" to 37" wide and minimum 60" deep | 2015 ABAAS Section: 604.8.2.1 2012 TAS Section: 604.8.2.1 2010 ADAS Section: 604.8.2.1 | | |

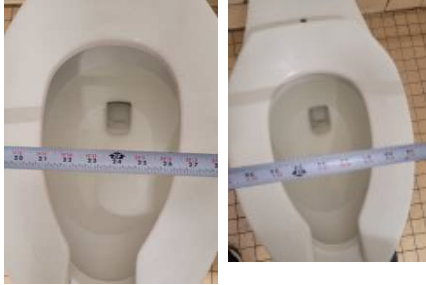
| Finding Number | Area Description | Lat/Long | Finding | As Built | Recommendation | Citation | Photos | Figure |
|---|---|---|---|---|---|---|--|---|
| 432 | Bald Eagle Camping Area: Bald Eagle Camp Men's Restroom | [31.5359027, -100.5442313] | The toilet is not located within the range to the side wall or partition. The centerline of the toilet shall be 17 inches minimum and 19 inches maximum side wall or partition in the ambulatory accessible toilet compartment. | 23.75" to centerline of toilet | Remount toilet to 17" to 19" from the side wall to center line in ambulatory stalls. | 2015 ABAAS Section: 604.9.1 2012 TAS Section: 604.9.1 2010 ADAS Section: 604.9.1 | | |

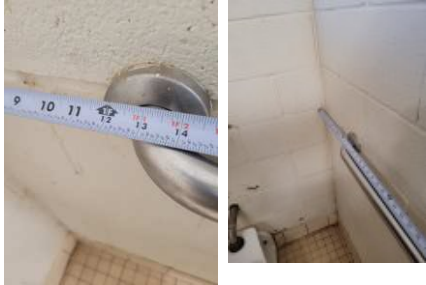
| Finding Number | Area Description | Lat/Long | Finding | As Built | Recommendation | Citation | Photos | Figure |
|---|---|---|---|---|---|---|--|---|
| 433 | Bald Eagle Camping Area: Bald Eagle Camp Men's Restroom | [31.535889, -100.544234] | The side grab bars are not in the correct location. Grab bars on the side wall must be installed so that the end closest to the rear wall is maximum 12" from the rear wall. The end furthest from the rear wall must be mounted minimum 54" from the rear wall. | grab bars mounted 13" from back wall | Remount side grab bar to max 12" from the rear wall at the close end and min 54" on the far end, and 33" to 36" aff | 2015 ABAAS Section: 604.5.1 2012 TAS Section: 604.5.1 2010 ADAS Section: 604.5.1 | | |

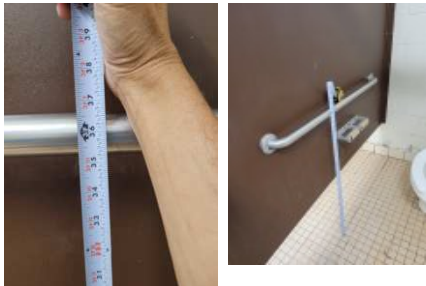
| Finding Number | Area Description | Lat/Long | Finding | As Built | Recommendation | Citation | Photos | Figure |
|---|---|---|---|---|---|---|--|---|
| 434 | Bald Eagle Camping Area: Bald Eagle Camp Men's Restroom | [31.5358981, -100.5442313] | The grab bar height and/or spacing fails. Grab bars must be mounted between 33" and 36" to the top of the gripping surface. There must be 1.5" of clearance between the grab bar and the wall. There must be a minimum of 1.5" of clearance below and minimum 12" above the grab bar to any dispenser or other obstruction. | grab bar mounted 36.75" above finished floor on left side facing toilet | Remount grab bars in accessible stall to 33" to 36" aff | 2015 ABAAS Section: 609.3, 609.4 2012 TAS Section: 609.4, 609.3 2010 ADAS Section: 609.3, 609.4 | | |

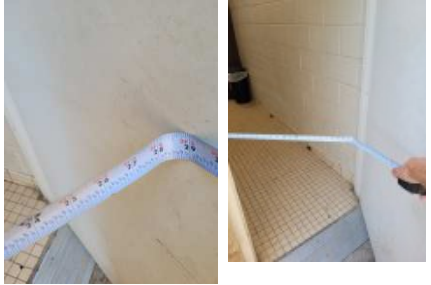
| Finding Number | Area Description | Lat/Long | Finding | As Built | Recommendation | Citation | Photos | Figure |
|---|--|---|--|--|---|---|--|--|
| 441 | Bald Eagle Camping Area: Bald Eagle Camp Men's Restroom | [31.535889, -100.5442259] | Door openings shall provide a clear width of 32 inches (815 mm) minimum. Clear openings of doorways with swinging doors shall be measured between the face of the door and the stop, with the door open 90 degrees. Openings more than 24 inches (610 mm) deep shall provide a clear opening of 36 inches (915 mm) minimum. There shall be no projections into the required clear opening width lower than 34 inches (865 mm) above the finish floor or ground. Projections into the clear opening width between 34 inches (865 mm) and 80 inches (2030 mm) above the finish floor or ground shall not exceed 4 inches (100 mm). Exterior doors are recommended to be maintained at 8.5 lbf as a smart practice. Force is to be measured at the operating hardware or 30 inches from the hinges, whichever is greater. Hand-activated door opening hardware, handles, pulls, latches, locks, and other operating devices on accessible doors shall have a shape that is easy to grasp with one hand and does not require tight grasping, tight pinching or twisting of the wrist to operate. Hardware shall be 34 inches minimum and 48 inches maximum above the finish floor or ground. | men's- door 29" wide, door will not open all the way, door lock installed at 61.5" and requires pinch, 10# | For all doors along the public circulation route, provide required maneuvering clearance on push and pull side of doors For all doors along the public circulation route, replace doors with doors having 80" overhead clearance and 32" clear width For all doors along the public circulation route, inspect, adjust, and maintain 8.5 lbf to open exterior doors as a smart practice | 2010 ADAS Section: 404.2.3, 404.2.7, 404.2.4, 404.2.11, 404.2.11 Exception | | |

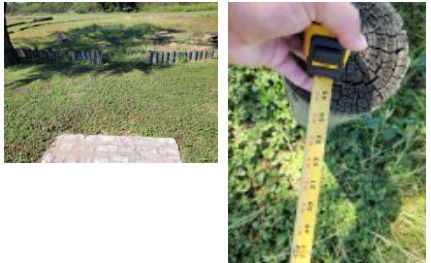
| Finding Number | Area Description | Lat/Long | Finding | As Built | Recommendation | Citation | Photos | Figure |
|---|--|---|---|--|--|--|--|---|
| 465 | Bald Eagle Camping Area: Bald Eagle Playground | [31.5338612 , -100.5457011] | As a smart practice, play area should have a minimum 60" wide entry, free of changes in level, gaps, and slope. | 54" at rockers, natural surface both, CILs at swings | Widen the designated entry to 60" width as a smart practice Repair, bevel or ramp CIL at playground entry/border | 2015 ABAAS Section: F206.1 2012 TAS Section: 206.1 2010 ADAS Section: 206.1 | | |

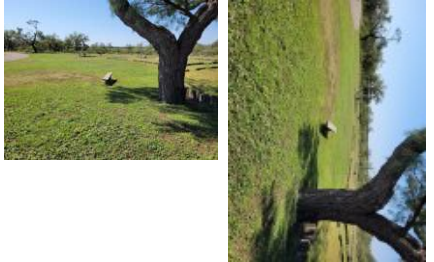
| Finding Number | Area Description | Lat/Long | Finding | As Built | Recommendation | Citation | Photos | Figure |
|---|--|---|--|---|--|---|--|---|
| 470 | Bald Eagle Camping Area: Bald Eagle Playground | [31.53387, -100.5456] | Benches shall have a 36" by 48" clear ground space (CGS) positioned near the bench with one side of the space adjoining an outdoor recreation access route (ORAR) or trail, as applicable The CGS shall not overlap with the ORAR or trail or another CGS As a smart practice, add at least one armrest and achieve height of bench seat of 17" to 19" | 0 of 3 benches at playground comply | Construct firm, stable, and slip resistant pads at least 36" by 48" adjacent to 20% of benches, and locate along an AR as a smart practice | 2015 ABAAS Section: 1011.2.1 | | |

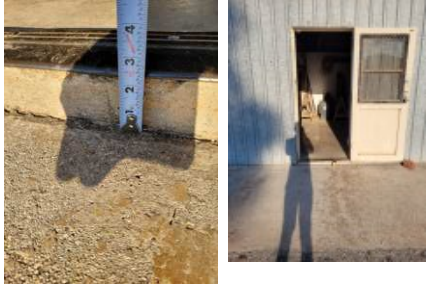
| Finding Number | Area Description | Lat/Long | Finding | As Built | Recommendation | Citation | Photos | Figure |
|---|---|---|---|--|--|---|--|--|
| 483 | Employee Spaces: Maintenance | [31.4545977, -100.4932143] | Thresholds, if provided at doorways, shall be 1/2 inch (13 mm) high maximum. Raised thresholds and changes in level at doorways shall comply with 302 and 303. Changes in level of 1/4 inch (6.4 mm) high maximum shall be permitted to be vertical. Changes in level between 1/4 inch (6.4 mm) high minimum and 1/2 inch (13 mm) high maximum shall be beveled with a slope not steeper than 1:2. Changes in level greater than 1/2 inch (13 mm) high shall be ramped, and shall comply with 405 or 406. | silver garage/workshop- 2.5" change in level | Repair, bevel or ramp CIL at doorway | 2015 ABAAS Section: 303.3, 404.2.5, 303.2, 303.4 2012 TAS Section: 303.3, 404.2.5, 303.2, 303.4 2010 ADAS Section: 303.3, 404.2.5, 303.2, 303.4 | | |

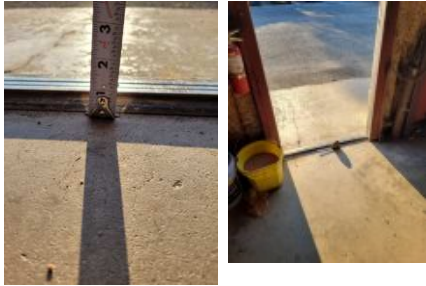
| Finding Number | Area Description | Lat/Long | Finding | As Built | Recommendation | Citation | Photos | Figure |
|---|---|---|--|--|---|--|--|--|
| 484 | Employee Spaces: Maintenance | [31.4545972, -100.4932505] | The threshold is greater than 1/2 inch high. The threshold at a doorway shall be no higher than 1/2 inch. Changes in level between 1/4 inch and 1/2 inch must be beveled at 1:2 or less. 1/4 inch is the maximum vertical rise. | silver garage/workshop-.75" threshold | For all doors along the public circulation route, replace thresholds at exterior doors with ADA thresholds | 2015 ABAAS Section: 404.2.5 2012 TAS Section: 404.2.5 2010 ADAS Section: 404.2.5 | | |

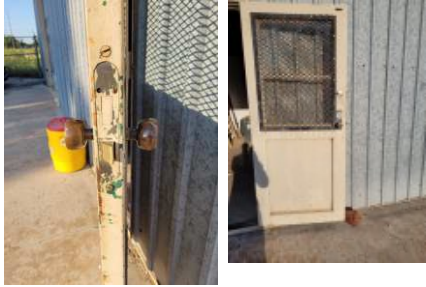
| Finding Number | Area Description | Lat/Long | Finding | As Built | Recommendation | Citation | Photos | Figure |
|---|---|---|--|--|---|--|--|--|
| 485 | Employee Spaces: Maintenance | [31.4546638, -100.4932586] | The door operating hardware is not accessible. Hand-activated door opening hardware, handles, pulls, latches, locks, and other operating devices on accessible doors shall have a shape that is easy to grasp with one hand and does not require tight grasping, tight pinching or twisting of the wrist to operate. Hardware shall be 34 inches minimum and 48 inches maximum above the finish floor or ground. | silver garage/workshop-knob hardware on door | Replace hardware with lever hardware or hardware operable without a tight pinch or grasp | 2015 ABAAS Section: 404.2.7 2012 TAS Section: 404.2.7 2010 ADAS Section: 404.2.7 | | |

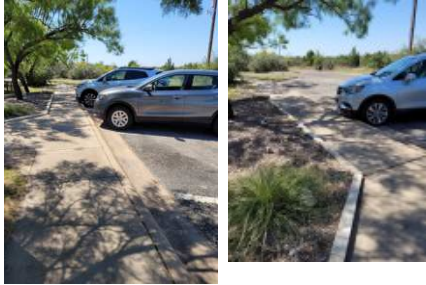
| Finding Number | Area Description | Lat/Long | Finding | As Built | Recommendation | Citation | Photos | Figure |
|---|---|---|--|---|--|---|--|--|
| 498 | South Gate Entry: Parking at South Gate Entry | [31.4640384, -100.5081301] | There are no accessible parking stalls. Each lot where parking is provided for the public as clients, guests or employees, shall provide accessible parking and shall be located on the shortest accessible route of travel from adjacent parking to an accessible entrance. There are a total of 6 parking stalls in the parking lot that could be reasonably associated with this facility. There should be a minimum of 1 accessible stalls with a minimum of 1 being designed as van accessible. | 0 of 6 parking stalls are accessible | Create one or more 8' accessible parking stalls, with one 5' adjacent access aisle, with proper signage and striping based on the total number of stalls | 2015 ABAAS Section: F208.2 2012 TAS Section: 208.2 2010 ADAS Section: 208.2 | | |

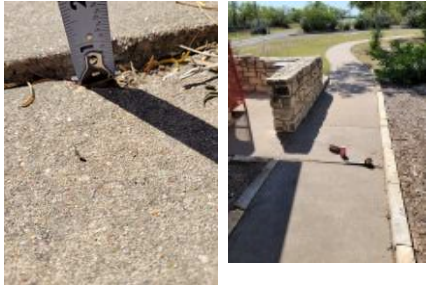
| Finding Number | Area Description | Lat/Long | Finding | As Built | Recommendation | Citation | Photos | Figure |
|---|---|---|--|---|---|--|---|---|
| 501 | South Gate Entry: Parking at South Gate Entry | [31.4639023, -100.5081113] | The walkway contains abrupt vertical edges and/or variations over a 1/4 inch. 1/4 inch is the maximum vertical rise. Changes in level between 1/4 inch and 1/2 inch must be beveled at 1:2 or less. Changes in level greater than 1/2 inch must be by way of a ramp. | 1" change in level from parking | Repair, bevel or ramp CIL along AR | 2012 TAS Section: 303.2, 303.3 2010 ADAS Section: 303.2, 303.3 | | |
