# Elephant Mt. WMA- ADA Evaluation

## WMA- Elephant Mountain, Alpine TX, ADA Evaluation

Accessibility Evaluation

Inspection Date: 06/20/2022

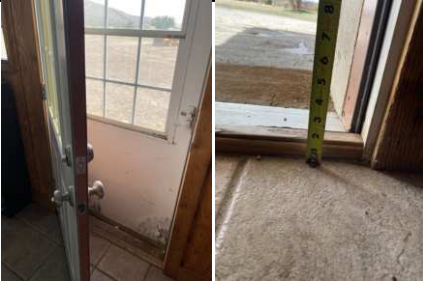
Finding Number	Area Description	Finding	As Built	Recommendation	Citation	Photos	Figure
		<p>the clear opening width between 34 inches (865 mm) and 80 inches (2030 mm) above the finish floor or ground shall not exceed 4 inches (100 mm). The threshold has a vertical change greater than 1/4 inch high. The threshold has a gap greater than 1/2 inch wide. The threshold at a doorway shall be no higher than 1/2 inch. Changes in level between 1/4 inch and 1/2 inch must be beveled at 1:2 or less. 1/4 inch is the maximum vertical rise. All interior doors must be maintained so that the operating pressure does not exceed 5 lbf to open. The sweep period for doors with closers shall be adjusted so that from an open position of 70 degrees, the door will take at least 3 seconds to move to a point 3 inches from the latch, measured to the leading edge of the door. Exterior doors are recommended to be maintained at 8.5 lbf as a smart practice. Force is to be measured at the operating hardware or 30 inches from the hinges, whichever is greater. Hand-activated door opening hardware, handles, pulls, latches, locks, and other operating devices on accessible doors shall have a shape that is easy to grasp with one hand and does not require tight grasping, tight pinching or twisting of the wrist to operate. Hardware shall be 34 inches minimum and 48 inches maximum above the finish floor or ground. The bottom 10 inches on the push side must be smooth and free of obstructions (hold open devices). Doors, gates, and side lights adjacent to doors or gates, containing one or more glazing panels that permit viewing through the panels shall have the bottom of at least one glazed panel located 43 inches (1090 mm) maximum above the finish floor. EXCEPTION: Vision lights with the lowest part more than 66 inches (1675 mm) from the finish floor or ground shall not be required to comply with 404.2.11. Egress doors shall provide a continuous and unobstructed way of egress travel from any point in a building or facility that provides an accessible route to an area of refuge, a horizontal exit, or a public way.</p>
