AE Wood IF- ADA Evaluation

IF-San Marcos TX, AE Wood ADA Evaluation

Accessibility Evaluation

Inspection Date: 12/05/2022

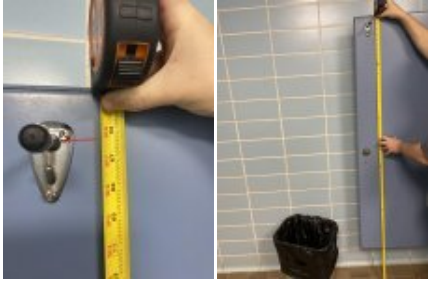
20	Structures on Property (Public) - Tour/Public Components : AE Wood/Public Restrooms (Interior) - Restroom (Men's)	The coat hook is installed greater than 48 inches above the finished floor. Where a forward reach is unobstructed, the high forward reach shall be 48 inches maximum above the finished floor.	Measures over 67"	https://www.access-board.gov/ada/#ada-308_2_1	2012 TAS Section: 308.2.1 2010 ADAS Section: 308.2.1 2015 ABAAS Section: 308.2.1

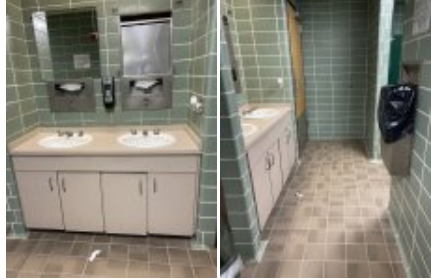
52	Structures on Property (STAFF) : AE Wood (Interior) - Restroom/Showers (Men's)	There are not enough accessible lavatories. Where lavatories are provided, at least one shall be accessible and shall not be located in a toilet compartment.	Restroom sinks are required to have front approach with knee and toe space provided. Mirror height and soap dispenser not compliant.	https://www.access-board.gov/ada/#ada-213_3_4 https://www.access-board.gov/ada/#ada-606	2012 TAS Section: 213.3.4 2010 ADAS Section: 213.3.4 2015 ABAAS Section: F213.3.4

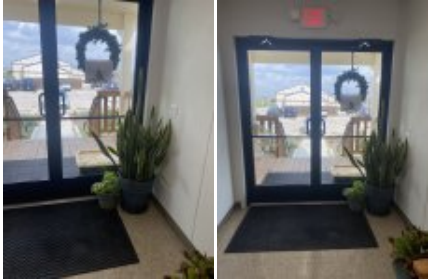
60	Structures on Property (STAFF) : TX River Studies (Interior) - Entrance/Exit Doors	The maneuvering clearance at the door is obstructed. Maneuvering clearance for doors on the push side approached from the front must be flat (2% max. slope in any direction) and have a minimum length of 48 inches in the direction of travel.	(R) side door when exiting. Obstruction prevent access.	https://www.access-board.gov/ada/#ada-404_2_4_1	2012 TAS Section: 404.2.4.1 2010 ADAS Section: 404.2.4.1 2015 ABAAS Section: 404.2.4.1
