**IF-Athens TX, TFFC ADA Evaluation**

**Accessibility Evaluation**

**Inspection Date: 11/15/2022**

**Report Date: 02/04/2024**

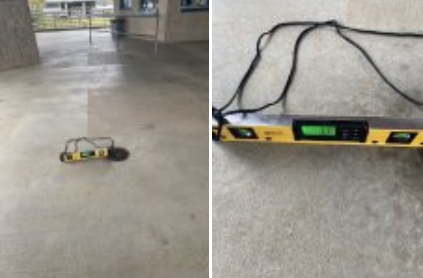
Finding Number	Area Description	Finding	As Built	Recommendation	Citation	Photos	Figure
7	Exterior of Property (Public) - Parking Lots/Walkways : Path of Travel Parking Lot to Visitors Center Admission - Exterior Walkway	The floor drain is set too low in the floor which causes a slope over 2 percent. Changes in level are not permitted in clear floor or ground spaces or surfaces of a turning spaces and shall not slope greater than 1:48.	Drain slope is 3.7% Located on accessible route to admission from parking lot.	<a href="https://www.access-board.gov/ada/#ada-303_3">https://www.access-board.gov/ada/#ada-303_3</a> <a href="https://www.access-board.gov/ada/#ada-304_2">https://www.access-board.gov/ada/#ada-304_2</a>	2012 TAS Section: 303.3, 304.2, 304.2 Exception  2010 ADAS Section: 303.3, 304.2, 304.2 Exception  2015 ABAAS Section: 303.3, 304.2, 304.2 EXCEPTION, 305.2 EXCEPTION

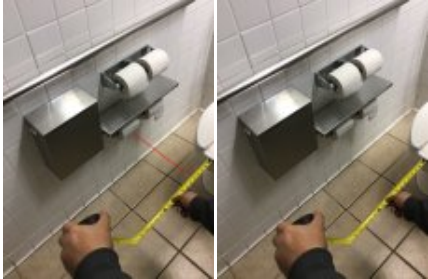
25	Structures on Property (Public) - Visitors Center : Restrooms/Water Fountains (Admission) - Restroom (Women's) Admission	The toilet paper is not installed within the compliant range in front of the toilet. Toilet paper dispensers shall be 7 inches minimum and 9 inches maximum in front of the water closet measured to the centerline of the dispenser. The outlet of the dispenser shall be 15 inches minimum and 48 inches maximum above the finish floor and shall not be located behind grab bars. Dispensers shall not be of a type that controls delivery or that does not allow continuous paper flow. There shall be a clearance of 1 1/2 inches minimum below the grab bar.	TP dispenser is less than 7" from front of toilet.	<a href="https://www.access-board.gov/ada/#ada-604_7">https://www.access-board.gov/ada/#ada-604_7</a>	2012 TAS Section: 604.7 2010 ADAS Section: 604.7 2015 ABAAS Section: 604.7

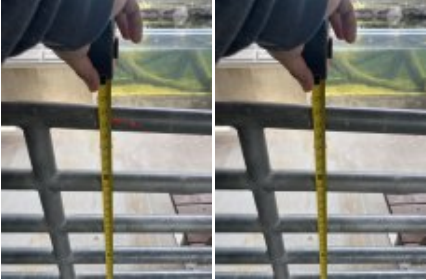
37	Structures on Property (Public) - Visitors Center : Outdoor Exhibits - Stream Pond Ramp	The handrail exceeds maximum height requirements. Handrails are measured to the top of the gripping surface and must be between 34 inches and 38 inches above the ramp surface. Handrails must extend horizontally 12 inches beyond the top and bottom of the ramp.	Handrail height is over 41" (L) side of ramp	<a href="https://www.access-board.gov/ada/#ada-505_4">https://www.access-board.gov/ada/#ada-505_4</a>	2012 TAS Section: 505.4  2010 ADAS Section: 505.4  2015 ABAAS Section: 505.4

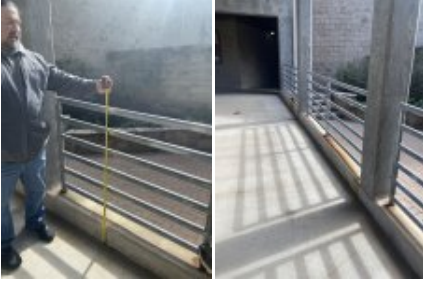
Finding Number	Area Description	Finding	As Built	Recommendation	Citation	Photos	Figure
40	Structures on Property (Public) - Visitors Center : Outdoor Exhibits - Farm Pond Ramp	The handrail exceeds maximum height requirements. Handrails are measured to the top of the gripping surface and must be between 34 inches and 38 inches above the ramp surface. Handrails must extend horizontally 12 inches beyond the top and bottom of the ramp.	Guardrails height is 44"	<a href="https://www.access-board.gov/ada/#ada-505_4">https://www.access-board.gov/ada/#ada-505_4</a>	2012 TAS Section: 505.4  2010 ADAS Section: 505.4  2015 ABAAS Section: 505.4

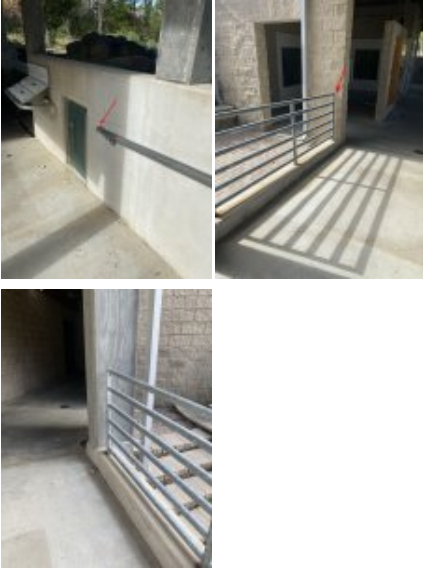
41	Structures on Property (Public) - Visitors Center : Outdoor Exhibits - Farm Pond Ramp	The handrail does not extend past the ramp. Handrails must be between 34 inches and 38 inches above the ramp surface and must extend beyond the top and bottom of the ramp run 12 inches horizontally. The 12 inches horizontal extensions must not include the radius at the top end of round handrails. Extensions shall return to a wall, guard, or the landing surface, or shall be continuous to the handrail of an adjacent ramp run.	Extensions need to be added to both sets of ramps on each end.	<a href="https://www.access-board.gov/ada/#ada-505_10_1">https://www.access-board.gov/ada/#ada-505_10_1</a>	2012 TAS Section: 505.10.1  2010 ADAS Section: 505.10.1  2015 ABAAS Section: 505.10.1

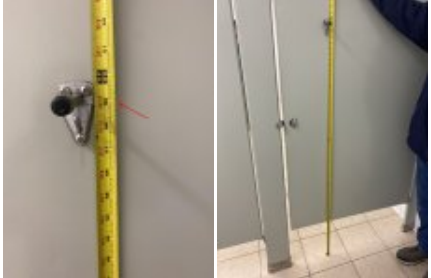
Finding Number	Area Description	Finding	As Built	Recommendation	Citation	Photos	Figure
45	Structures on Property (Public) - Visitors Center : Restrooms/Water Fountains (Gift Shop) - Restroom (Men's) Gift Shop	The coat hook is installed greater than 48 inches above the finished floor. Where a forward reach is unobstructed, the high forward reach shall be 48 inches maximum above the finished floor.	Coat height hook is 59"	<a href="https://www.access-board.gov/ada/#ada-308_2_1">https://www.access-board.gov/ada/#ada-308_2_1</a>	2012 TAS Section: 308.2.1  2010 ADAS Section: 308.2.1  2015 ABAAS Section: 308.2.1

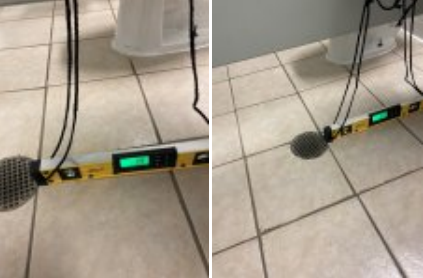
Finding Number	Area Description	Finding	As Built	Recommendation	Citation	Photos	Figure
50	Structures on Property (Public) - Visitors Center : Restrooms/Water Fountains (Gift Shop) - Restroom (Women's) Gift Shop	The floor drain is set too low in the floor which causes a slope over 2 percent. Changes in level are not permitted in clear floor or ground spaces or surfaces of a turning spaces and shall not slope greater than 1:48.	Floor drain slope is 3.9%	<a href="https://www.access-board.gov/ada/#ada-303_3">https://www.access-board.gov/ada/#ada-303_3</a> <a href="https://www.access-board.gov/ada/#ada-304_2">https://www.access-board.gov/ada/#ada-304_2</a>	2012 TAS Section: 303.3, 304.2, 304.2 Exception  2010 ADAS Section: 303.3, 304.2, 304.2 Exception  2015 ABAAS Section: 303.3, 304.2, 304.2 EXCEPTION, 305.2 EXCEPTION

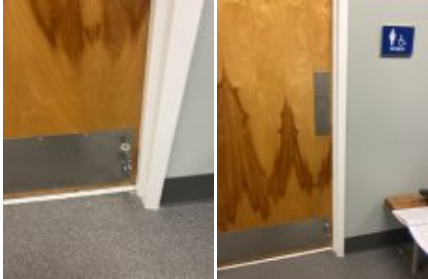
53	Structures on Property (Public) - Visitors Center : Restrooms/Water Fountains (Gift Shop) - Restroom (Women's) Gift Shop	The door has a door stop which prevents it from having a smooth surface at the bottom. Swinging door surfaces within 10 inches of the finish floor or ground measured vertically must have a smooth surface on the push side extending the full width of the door. Parts creating horizontal or vertical joints in these surfaces shall be within 1/16 inch of the same plane as the other. Cavities created by added kick plates shall be capped. This is required to allow those that use wheelchairs to use their footrests to push the door open without getting trapped or injured by the gate material. All gates, including ticket gates, shall meet all applicable specifications for doors.	Door stop		<a href="https://www.access-board.gov/ada/#ada-404_2_10">https://www.access-board.gov/ada/#ada-404_2_10</a>	2012 TAS Section: 404.2.10  2010 ADAS Section: 404.2.10  2015 ABAAS Section: 404.2.10

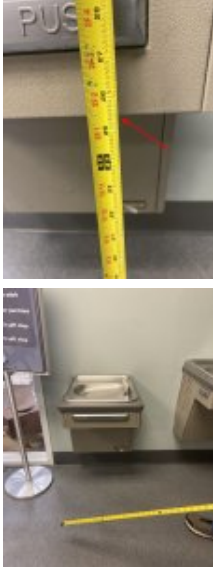
Finding Number	Area Description	Finding	As Built	Recommendation	Citation	Photos	Figure
54	Structures on Property (Public) - Visitors Center : Restrooms/Water Fountains (Gift Shop) - Water Fountain Gift Shop	There is not enough knee clearance under the drinking fountain. The drinking fountain must have a clear knee space between the bottom of the drinking fountain and the floor not less than 27 inches in height, 30 inches in width, and 8 inches in depth.	Seated water fountain height is less than 26"	<a href="https://www.access-board.gov/ada/#ada-602_2">https://www.access-board.gov/ada/#ada-602_2</a>	2012 TAS Section: 602.2 2010 ADAS Section: 602.2 2015 ABAAS Section: 602.2

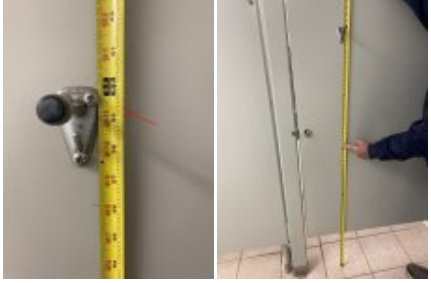
Finding Number	Area Description	Finding	As Built	Recommendation	Citation	Photos	Figure
56	Structures on Property (Public) - Visitors Center : Restrooms/Water Fountains (Overlook) - Restroom (Men's) Overlook	The coat hook is installed greater than 48 inches above the finished floor. Where a forward reach is unobstructed, the high forward reach shall be 48 inches maximum above the finished floor.	Coat hook height is over 59"	<a href="https://www.access-board.gov/ada/#ada-308_2_1">https://www.access-board.gov/ada/#ada-308_2_1</a>	2012 TAS Section: 308.2.1  2010 ADAS Section: 308.2.1  2015 ABAAS Section: 308.2.1

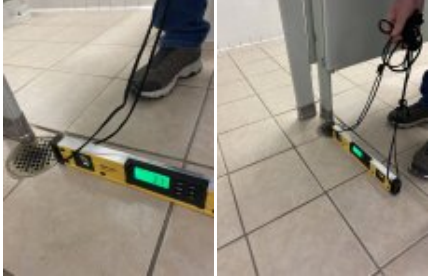
Considered Unobstructed
57	Structures on Property (Public) - Visitors Center : Restrooms/Water Fountains (Overlook) - Restroom (Men's) Overlook	The floor drain is set too low in the floor which causes a slope over 2 percent. Changes in level are not permitted in clear floor or ground spaces or surfaces of a turning spaces and shall not slope greater than 1:48.	Floor drain slope is 3.1%	<a href="https://www.access-board.gov/ada/#ada-303_3">https://www.access-board.gov/ada/#ada-303_3</a> <a href="https://www.access-board.gov/ada/#ada-304_2">https://www.access-board.gov/ada/#ada-304_2</a>	2012 TAS Section: 303.3, 304.2, 304.2 Exception  2010 ADAS Section: 303.3, 304.2, 304.2 Exception  2015 ABAAS Section: 303.3, 304.2, 304.2 EXCEPTION, 305.2 EXCEPTION

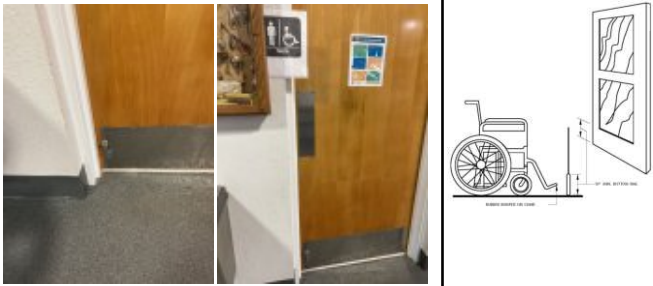
Finding Number	Area Description	Finding	As Built	Recommendation	Citation	Photos	Figure
58	Structures on Property (Public) - Visitors Center : Restrooms/Water Fountains (Overlook) - Restroom (Men's) Overlook	The door has a door stop which prevents it from having a smooth surface at the bottom. Swinging door surfaces within 10 inches of the finish floor or ground measured vertically must have a smooth surface on the push side extending the full width of the door. Parts creating horizontal or vertical joints in these surfaces shall be within 1/16 inch of the same plane as the other. Cavities created by added kick plates shall be capped. This is required to allow those that use wheelchairs to use their footrests to push the door open without getting trapped or injured by the gate material. All gates, including ticket gates, shall meet all applicable specifications for doors.	Door stop		<a href="https://www.access-board.gov/ada/#ada-404_2_10">https://www.access-board.gov/ada/#ada-404_2_10</a>	2012 TAS Section: 404.2.10  2010 ADAS Section: 404.2.10  2015 ABAAS Section: 404.2.10

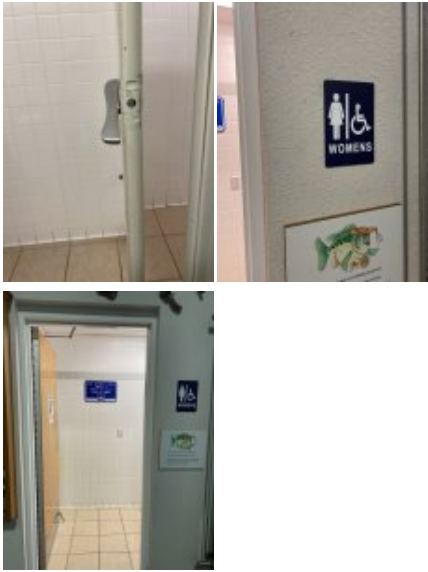
Finding Number	Area Description	Finding	As Built	Recommendation	Citation	Photos	Figure
61	Structures on Property (Public) - Visitors Center : Restrooms/Water Fountains (Overlook) - Restroom (Women's) Overlook	The water closet compartment is missing a loop handle on both sides of the door. Water closet compartments must be equipped with a door that has a loop or U-shaped handle on both sides of the door immediately below the latch. The latch must be flip-over style, sliding or other hardware not requiring the user to grasp or twist.	N/A	<a href="https://www.access-board.gov/ada/#ada-604_8_1_2">https://www.access-board.gov/ada/#ada-604_8_1_2</a>	2012 TAS Section: 604.8.1.2  2010 ADAS Section: 604.8.1.2  2015 ABAAS Section: 604.8.1.2

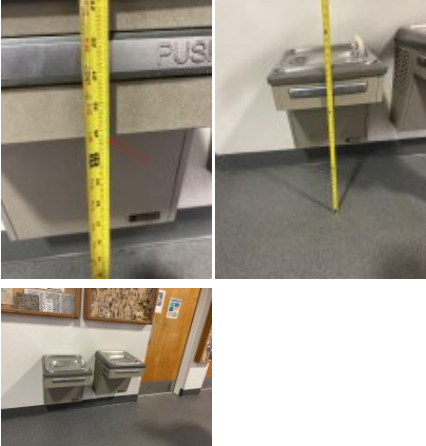
Finding Number	Area Description	Finding	As Built	Recommendation	Citation	Photos	Figure
65	Structures on Property (Public) - Visitors Center : Restrooms/Water Fountains (Overlook) - Water Fountain Overlook	There is not enough knee clearance under the drinking fountain. The drinking fountain must have a clear knee space between the bottom of the drinking fountain and the floor not less than 27 inches in height, 30 inches in width, and 8 inches in depth.	Seated water fountain height is 25"	<a href="https://www.access-board.gov/ada/#ada-602_2">https://www.access-board.gov/ada/#ada-602_2</a>	2012 TAS Section: 602.2 2010 ADAS Section: 602.2 2015 ABAAS Section: 602.2

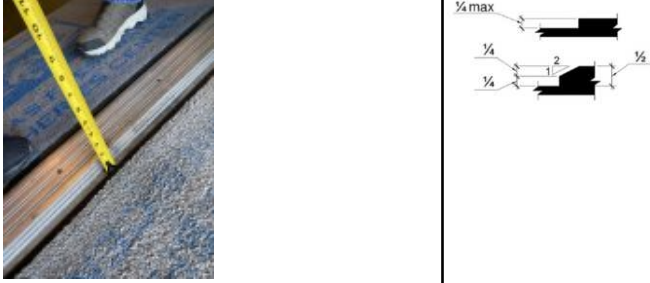
Finding Number	Area Description	Finding	As Built	Recommendation	Citation	Photos	Figure
67	Structures on Property (Public) - Conservatory Center: Entrance into Conservation Center Building - Front Entrance Doors CC Building	The threshold is greater than 1/2 inch high. The threshold at a doorway shall be no higher than 1/2 inch. Changes in level between 1/4 inch and 1/2 inch must be beveled at 1:2 or less. 1/4 inch is the maximum vertical rise.	Entrance doors into main hallway of CC building		<a href="https://www.access-board.gov/ada/#ada-404_2_5">https://www.access-board.gov/ada/#ada-404_2_5</a>	2012 TAS Section: 404.2.5  2010 ADAS Section: 404.2.5  2015 ABAAS Section: 404.2.5

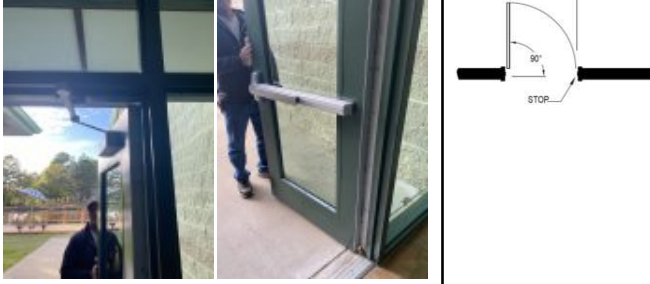
68	Structures on Property (Public) - Conservatory Center: Entrance into Conservation Center Building - Back Doors CC Building	The door does not open at least 90 degrees. Door openings shall provide a clear width of 32 inches minimum. Clear openings of doorways with swinging doors shall be measured between the face of the door and the stop, with the door open 90 degrees. There shall be no projections into the required clear opening width lower than 34 inches above the finish floor or ground. Projections into the clear opening width between 34 inches and 80 inches above the finish floor or ground shall not exceed 4 inches.	Both sets of rear entry doors do not open to 90 degrees.		<a href="https://www.access-board.gov/ada/#ada-404_2_3">https://www.access-board.gov/ada/#ada-404_2_3</a>	2012 TAS Section: 404.2.3  2010 ADAS Section: 404.2.3  2015 ABAAS Section: 404.2.3

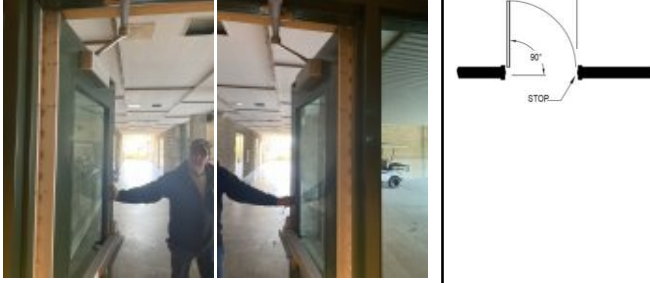
69	Structures on Property (Public) - Conservatory Center: Entrance into Conservation Center Building - Side Exit Door CC Building	The door does not open at least 90 degrees. Door openings shall provide a clear width of 32 inches minimum. Clear openings of doorways with swinging doors shall be measured between the face of the door and the stop, with the door open 90 degrees. There shall be no projections into the required clear opening width lower than 34 inches above the finish floor or ground. Projections into the clear opening width between 34 inches and 80 inches above the finish floor or ground shall not exceed 4 inches.	Both sets of side exit doors.		<a href="https://www.access-board.gov/ada/#ada-404_2_3">https://www.access-board.gov/ada/#ada-404_2_3</a>	2012 TAS Section: 404.2.3  2010 ADAS Section: 404.2.3  2015 ABAAS Section: 404.2.3

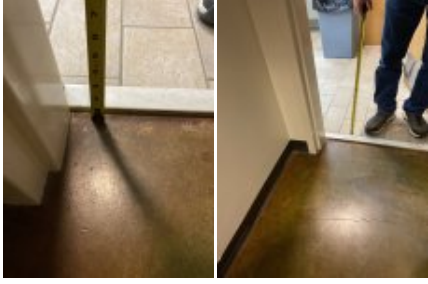
76	Structures on Property (Public) - Conservatory Center: Restrooms/Water Fountains (Conservation Center) - Restroom (Women's)	The threshold has a vertical change greater than 1/4 inch. The threshold at a doorway shall be no higher than 1/2 inch. Changes in level between 1/4 inch and 1/2 inch must be beveled at 1:2 or less. The maximum vertical rise shall be 1/4 inch.	N/A	<a href="https://www.access-board.gov/ada/#ada-404_2_5">https://www.access-board.gov/ada/#ada-404_2_5</a>	2012 TAS Section: 404.2.5  2010 ADAS Section: 404.2.5  2015 ABAAS Section: 404.2.5

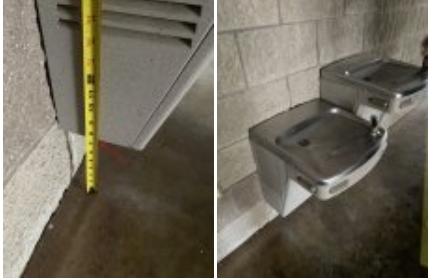
Finding Number	Area Description	Finding	As Built	Recommendation	Citation	Photos	Figure
77	Structures on Property (Public) - Conservatory Center: Restrooms/Water Fountains (Conservation Center) - Water Fountain Exterior	Toe clearance under the drinking fountain does not meet minimum height requirements. Space under an element between the finish floor or ground and 9 inches above the finish floor or ground shall be considered toe clearance. Space extending greater than 6 inches beyond the available knee clearance at 9 inches above the finish floor or ground shall not be considered toe clearance.	Water fountain mounted too low and does not allow toe height space. Space provided is less than 9"	<a href="https://www.access-board.gov/ada/#ada-306_2_1">https://www.access-board.gov/ada/#ada-306_2_1</a> <a href="https://www.access-board.gov/ada/#ada-602_2">https://www.access-board.gov/ada/#ada-602_2</a>	2012 TAS Section: 606.2, 306.2.1  2010 ADAS Section: 602.2, 306.2.1  2015 ABAAS Section: 602.2, 306.2.1

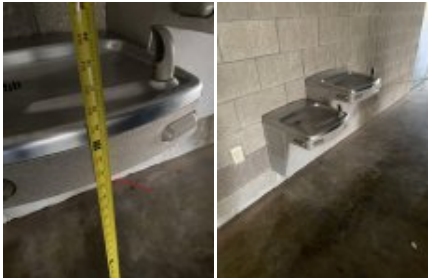
78	Structures on Property (Public) - Conservatory Center: Restrooms/Water Fountains (Conservation Center) - Water Fountain Exterior	There is not enough knee clearance under the drinking fountain. The drinking fountain must have a clear knee space between the bottom of the drinking fountain and the floor not less than 27 inches in height, 30 inches in width, and 8 inches in depth.	Seated water fountain height is 22"	<a href="https://www.access-board.gov/ada/#ada-602_2">https://www.access-board.gov/ada/#ada-602_2</a>	2012 TAS Section: 602.2  2010 ADAS Section: 602.2  2015 ABAAS Section: 602.2

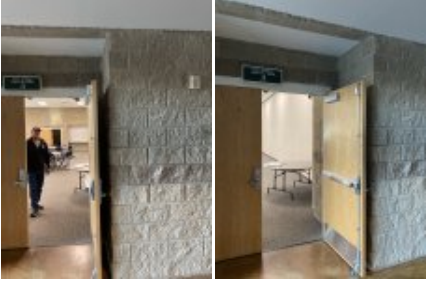
Finding Number	Area Description	Finding	As Built	Recommendation	Citation	Photos	Figure
79	Structures on Property (Public) - Conservatory Center: Interior Space of Conservation Center - Conference Room (A) CC Building	Compliant room identification signs are missing. Sign shall be located alongside the door at the latch side. Where a tactile sign is provided at double doors with one active leaf, the sign shall be located on the inactive leaf. Where a tactile sign is provided at double doors with two active leaves, the sign shall be located to the right of the right hand door. Where there is no wall space at the latch side of a single door or at the right side of double doors, signs shall be located on the nearest adjacent wall. Signs containing tactile characters shall be located so that a clear floor space of 18 inches minimum by 18 inches minimum, centered on the tactile characters, is provided beyond the arc of any door swing between the closed position and 45 degree open position. Wall signs identifying permanent rooms and spaces of a building shall be in a horizontal format and the characters raised 1/32 inch minimum and shall be sans serif uppercase characters a minimum of 5/8 inch and a maximum of 2 inches high. Contracted Grade 2 Braille shall be in a horizontal format and shall be placed a minimum of 3/8 inch and a maximum of 1/2 inch directly below the tactile characters; flush left or centered. Dots shall be 1/10 inch on center in each cell with 2/10-inch space between cells, measured from the second column of dots in the first cell to the first column of dots in the second cell. Dots shall be raised a minimum of 1/40 inch above the background. Braille dots shall be domed or rounded. Signs with raised characters or Braille shall be located 48 inches minimum above the finish floor or ground surface, measured from the baseline of the lowest tactile character and 60 inches maximum above the finish floor or ground surface, measured from the baseline of the highest tactile character.	Signs that identify a room, space or area are required to have raised characters and Braille. This requirement includes both public access areas as well as all employee areas.	Wall sign designation <a href="https://www.access-board.gov/ada/#ada-216_2">https://www.access-board.gov/ada/#ada-216_2</a> Wall signs general <a href="https://www.access-board.gov/ada/#ada-703_1">https://www.access-board.gov/ada/#ada-703_1</a> Height Above Finish Floor or Ground <a href="https://www.access-board.gov/ada/#ada-703_4_1">https://www.access-board.gov/ada/#ada-703_4_1</a> Location <a href="https://www.access-board.gov/ada/#ada-703_4_2">https://www.access-board.gov/ada/#ada-703_4_2</a>	2012 TAS Section: 216.2, 703.4.2  2010 ADAS Section: 216.2, 703.4.2  2015 ABAAS Section: F216.2, 703.4.2

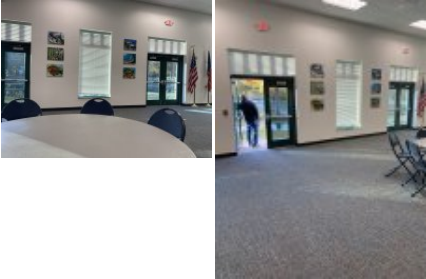
81	Structures on Property (Public) - Conservatory Center: Interior Space of Conservation Center - Exit Door Conference Room (A)	The door does not open at least 90 degrees. Door openings shall provide a clear width of 32 inches minimum. Clear openings of doorways with swinging doors shall be measured between the face of the door and the stop, with the door open 90 degrees. There shall be no projections into the required clear opening width lower than 34 inches above the finish floor or ground. Projections into the clear opening width between 34 inches and 80 inches above the finish floor or ground shall not exceed 4 inches.	None of the exit doors open 90 degrees.	<a href="https://www.access-board.gov/ada/#ada-404_2_3">https://www.access-board.gov/ada/#ada-404_2_3</a>	2012 TAS Section: 404.2.3  2010 ADAS Section: 404.2.3  2015 ABAAS Section: 404.2.3

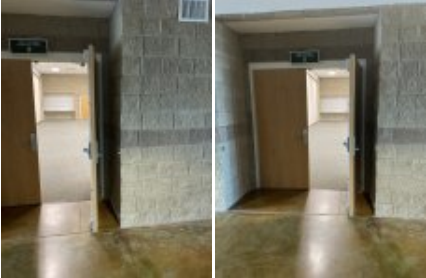
Finding Number	Area Description	Finding	As Built	Recommendation	Citation	Photos	Figure
83	Structures on Property (Public) - Conservatory Center: Interior Space of Conservation Center - Conference Room (B) CC Building	Compliant room identification signs are missing. Sign shall be located alongside the door at the latch side. Where a tactile sign is provided at double doors with one active leaf, the sign shall be located on the inactive leaf. Where a tactile sign is provided at double doors with two active leaves, the sign shall be located to the right of the right hand door. Where there is no wall space at the latch side of a single door or at the right side of double doors, signs shall be located on the nearest adjacent wall. Signs containing tactile characters shall be located so that a clear floor space of 18 inches minimum by 18 inches minimum, centered on the tactile characters, is provided beyond the arc of any door swing between the closed position and 45 degree open position. Wall signs identifying permanent rooms and spaces of a building shall be in a horizontal format and the characters raised 1/32 inch minimum and shall be sans serif uppercase characters a minimum of 5/8 inch and a maximum of 2 inches high. Contracted Grade 2 Braille shall be in a horizontal format and shall be placed a minimum of 3/8 inch and a maximum of 1/2 inch directly below the tactile characters; flush left or centered. Dots shall be 1/10 inch on center in each cell with 2/10-inch space between cells, measured from the second column of dots in the first cell to the first column of dots in the second cell. Dots shall be raised a minimum of 1/40 inch above the background. Braille dots shall be domed or rounded. Signs with raised characters or Braille shall be located 48 inches minimum above the finish floor or ground surface, measured from the baseline of the lowest tactile character and 60 inches maximum above the finish floor or ground surface, measured from the baseline of the highest tactile character.	Signs that identify a room, space or area are required to have raised characters and Braille. This requirement includes both public access areas as well as all employee areas.	Wall sign designation <a href="https://www.access-board.gov/ada/#ada-216_2">https://www.access-board.gov/ada/#ada-216_2</a> Wall signs general <a href="https://www.access-board.gov/ada/#ada-703_1">https://www.access-board.gov/ada/#ada-703_1</a> Height Above Finish Floor or Ground <a href="https://www.access-board.gov/ada/#ada-703_4_1">https://www.access-board.gov/ada/#ada-703_4_1</a> Location <a href="https://www.access-board.gov/ada/#ada-703_4_2">https://www.access-board.gov/ada/#ada-703_4_2</a>	2012 TAS Section: 216.2, 703.4.2  2010 ADAS Section: 216.2, 703.4.2  2015 ABAAS Section: F216.2, 703.4.2

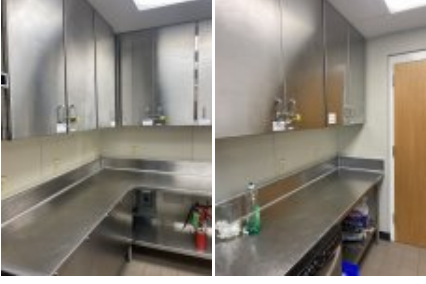
90	Structures on Property (Public) - Conservatory Center: Interior Space of Conservation Center - Conference Room Kitchen Area (Rentable/Public) CC Building	The required storage space is not within an acceptable reach range. At least 50% of the storage space must be a minimum of 15 inches and a maximum of 48 inches off the floor with an unobstructed approach. For side approach, the maximum reach range is 46 inches high over an obstruction that is a maximum of 34 inches tall and 24 inches deep.	No accessible storage space provided.	<a href="https://www.access-board.gov/ada/#ada-804_5">https://www.access-board.gov/ada/#ada-804_5</a>	2012 TAS Section: 804.5  2010 ADAS Section: 804.5  2015 ABAAS Section: 804.5

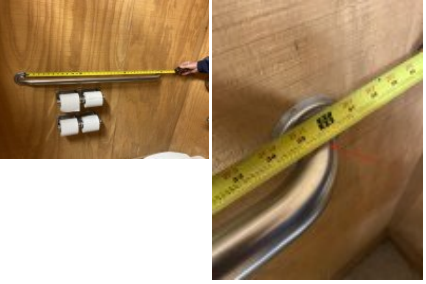
93	Structures on Property (Pubic) - Restrooms/Water Fountains (Angler Pavilion) - Restroom (Men's)	The side grab bar is not long enough. The side grab bar must extend at least 54 inches minimum beyond the rear wall and start a maximum of 12 inches from the rear wall. A 42 inch grab bar installed the maximum distance from the rear wall (12 inches) will leave the leading end 54 inches from the rear wall. Grab bars shall be installed in a horizontal position, 33 inches minimum and 36 inches maximum above the finish floor measured to the top of the gripping surface.	Side grab bar length is 36"	<a href="https://www.access-board.gov/ada/#ada-604_5_1">https://www.access-board.gov/ada/#ada-604_5_1</a>	2012 TAS Section: 604.5.1  2010 ADAS Section: 604.5.1  2015 ABAAS Section: 604.5.1

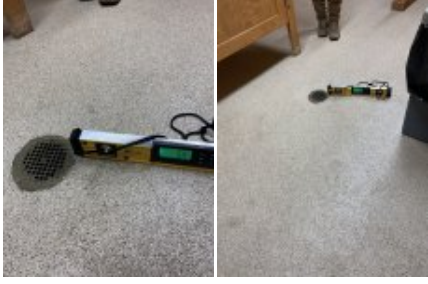
96	Structures on Property (Pubic) - Anglers Pavilion: Restrooms/Water Fountains (Angler Pavilion) - Restroom (Men's)	The floor drain is set too low in the floor which causes a slope over 2 percent. Changes in level are not permitted in clear floor or ground spaces or surfaces of a turning spaces and shall not slope greater than 1:48.	Floor drain slope is 3.4%	<a href="https://www.access-board.gov/ada/#ada-303_3">https://www.access-board.gov/ada/#ada-303_3</a> <a href="https://www.access-board.gov/ada/#ada-304_2">https://www.access-board.gov/ada/#ada-304_2</a>	2012 TAS Section: 303.3, 304.2, 304.2 Exception 2010 ADAS Section: 303.3, 304.2, 304.2 Exception 2015 ABAAS Section: 303.3, 304.2, 304.2 EXCEPTION, 305.2 EXCEPTION

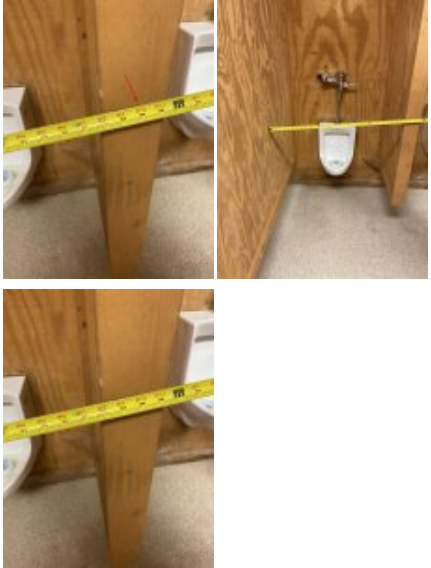
98	Structures on Property (Pubic) - Anglers Pavilion: Restrooms/Water Fountains (Angler Pavilion) - Restroom (Men's)	The urinal is located in an area that does not provide the required clear floor space for a front approach. The surrounding elements of a urinal must provide a minimum of 30 by 48 inches of clear floor space for a front approach.	If partition extends greater than 24" then 36" clear floor space must be provided. If partition extends less than 24" then 30" clear floor space is provided which would make finding compliant. Pending verification.	Measure depth of partition <a href="https://www.access-board.gov/ada/#ada-605_3">https://www.access-board.gov/ada/#ada-605_3</a>	2012 TAS Section: 605.3 2010 ADAS Section: 605.3 2015 ABAAS Section: 605.2, 605.3

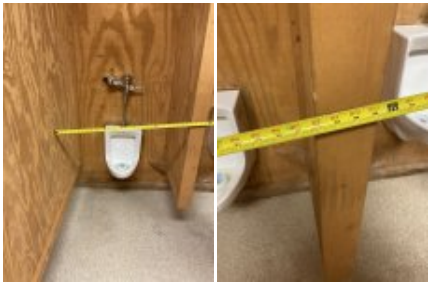
99	Structures on Property (Pubic) - Anglers Pavilion: Restrooms/Water Fountains (Angler Pavilion) - Restroom (Men's)	An accessible urinal is not provided. Where more than one urinal is provided, at least one shall be accessible.	If there is more than one urinal in a bathroom, at least one must follow accessibility guidelines. Pending verification	Min number required <a href="https://www.access-board.gov/ada/#ada-213_3_3">https://www.access-board.gov/ada/#ada-213_3_3</a> Review urinal elements <a href="https://www.access-board.gov/ada/#ada-605">https://www.access-board.gov/ada/#ada-605</a>	2010 ADAS Section: 213.3.3

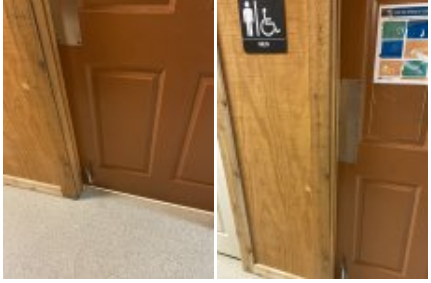
Finding Number	Area Description	Finding	As Built	Recommendation	Citation	Photos	Figure
100	Structures on Property (Pubic) - Anglers Pavilion: Restrooms/Water Fountains (Angler Pavilion) - Restroom (Men's)	The door has a door stop which prevents it from having a smooth surface at the bottom. Swinging door surfaces within 10 inches of the finish floor or ground measured vertically must have a smooth surface on the push side extending the full width of the door. Parts creating horizontal or vertical joints in these surfaces shall be within 1/16 inch of the same plane as the other. Cavities created by added kick plates shall be capped. This is required to allow those that use wheelchairs to use their footrests to push the door open without getting trapped or injured by the gate material. All gates, including ticket gates, shall meet all applicable specifications for doors.	N/A	<a href="https://www.access-board.gov/ada/#ada-404_2_10">https://www.access-board.gov/ada/#ada-404_2_10</a>	2012 TAS Section: 404.2.10  2010 ADAS Section: 404.2.10  2015 ABAAS Section: 404.2.10

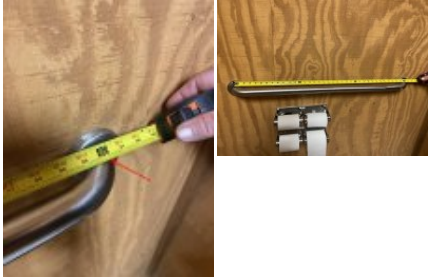
101	Structures on Property (Pubic) - Restrooms/Water Fountains (Angler Pavilion) - Restroom (Women's)	The side grab bar is not long enough. The side grab bar must extend at least 54 inches minimum beyond the rear wall and start a maximum of 12 inches from the rear wall. A 42 inch grab bar installed the maximum distance from the rear wall (12 inches) will leave the leading end 54 inches from the rear wall. Grab bars shall be installed in a horizontal position, 33 inches minimum and 36 inches maximum above the finish floor measured to the top of the gripping surface.	Side grab bar length is 36"	<a href="https://www.access-board.gov/ada/#ada-604_5_1">https://www.access-board.gov/ada/#ada-604_5_1</a>	2012 TAS Section: 604.5.1  2010 ADAS Section: 604.5.1  2015 ABAAS Section: 604.5.1

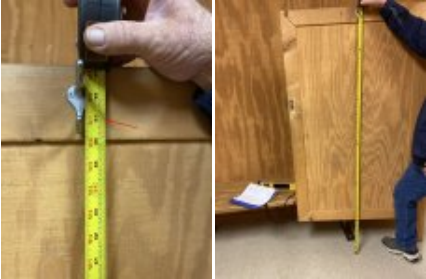
104	Structures on Property (Pubic) - Anglers Pavilion: Restrooms/Water Fountains (Angler Pavilion) - Restroom (Women's)	The coat hook is installed greater than 48 inches above the finished floor. Where a forward reach is unobstructed, the high forward reach shall be 48 inches maximum above the finished floor.	The coat hook height is 67"	<a href="https://www.access-board.gov/ada/#ada-308_2_1">https://www.access-board.gov/ada/#ada-308_2_1</a>	2012 TAS Section: 308.2.1 2010 ADAS Section: 308.2.1 2015 ABAAS Section: 308.2.1

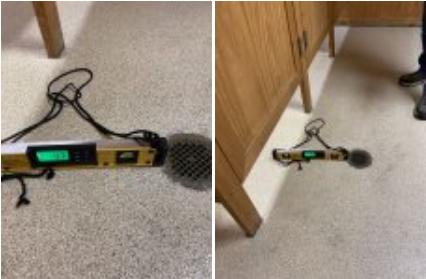
105	Structures on Property (Pubic) - Anglers Pavilion: Restrooms/Water Fountains (Angler Pavilion) - Restroom (Women's)	The floor drain is set too low in the floor which causes a slope over 2 percent. Changes in level are not permitted in clear floor or ground spaces or surfaces of a turning spaces and shall not slope greater than 1:48.	Floor drain slope is 4.7%	<a href="https://www.access-board.gov/ada/#ada-303_3">https://www.access-board.gov/ada/#ada-303_3</a> <a href="https://www.access-board.gov/ada/#ada-304_2">https://www.access-board.gov/ada/#ada-304_2</a>	2012 TAS Section: 303.3, 304.2, 304.2 Exception 2010 ADAS Section: 303.3, 304.2, 304.2 Exception 2015 ABAAS Section: 303.3, 304.2, 304.2 EXCEPTION, 305.2 EXCEPTION

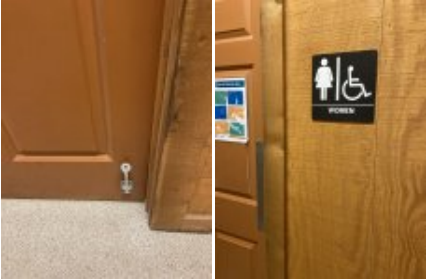
107	Structures on Property (Pubic) - Anglers Pavilion: Restrooms/Water Fountains (Angler Pavilion) - Restroom (Women's)	The door has a door stop which prevents it from having a smooth surface at the bottom. Swinging door surfaces within 10 inches of the finish floor or ground measured vertically must have a smooth surface on the push side extending the full width of the door. Parts creating horizontal or vertical joints in these surfaces shall be within 1/16 inch of the same plane as the other. Cavities created by added kick plates shall be capped. This is required to allow those that use wheelchairs to use their footrests to push the door open without getting trapped or injured by the gate material. All gates, including ticket gates, shall meet all applicable specifications for doors.	N/A	<a href="https://www.access-board.gov/ada/#ada-404_2_10">https://www.access-board.gov/ada/#ada-404_2_10</a>	2012 TAS Section: 404.2.10 2010 ADAS Section: 404.2.10 2015 ABAAS Section: 404.2.10

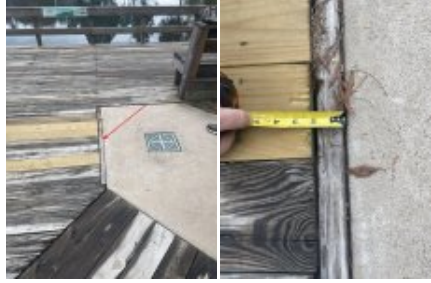
Finding Number	Area Description	Finding	As Built	Recommendation	Citation	Photos	Figure
109	Outdoor Features (Public) : Fishing Piers Near Visitors Center (3 total) - Mr. Bill's Fishing Pier & Walkways	The route contains openings greater than 1/2 inch. Openings in floor or ground surfaces shall not allow passage of a sphere more than 1/2 inch diameter. Elongated openings shall be placed so that the long dimension is perpendicular to the dominant direction of travel.	Transition from sidewalk to fishing pier has large gaps, preventing access.	<a href="https://www.access-board.gov/ada/#ada-302_3">https://www.access-board.gov/ada/#ada-302_3</a>	2012 TAS Section: 302.3 2010 ADAS Section: 302.3 2015 ABAAS Section: 302.3

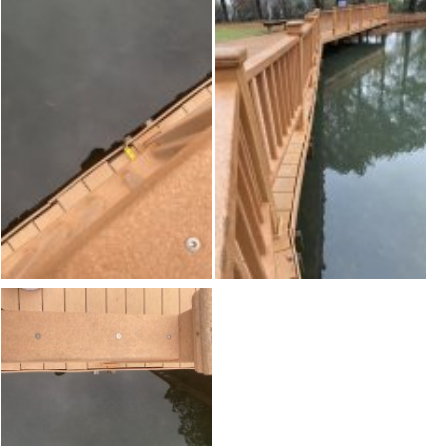
Finding Number	Area Description	Finding	As Built	Recommendation	Citation	Photos	Figure
113	Outdoor Features (Public) : Fishing Piers Near Visitors Center (3 total) - Conservation Center Fishing Pier & Walkways	The required edge protection is not provided. Where compliant railings, guards, or handrails are provided, edge protection shall also be provided. Curbs or barriers shall extend 2 inches minimum above the surface of the fishing pier or platform or The ground or deck surface shall extend 12 inches minimum beyond the inside face of the railing. Toe clearance shall be provided and shall be 30 inches wide minimum and 9 inches minimum above the ground or deck surface beyond the railing.	There is no edge protection or extended deck surface provided. Where railings, guards, or handrails are provided, edge protection must be provided and extend a minimum of 2 inches above the ground or deck surface. Edge protection is not required where a railing, guardrail, or handrail is provided, if the deck surface extends a minimum of 12 inches beyond the inside face of the railing. Fishing pier edge compliance can be satisfied 1 of 2 ways. 1- install curb barrier at 2" minimum vertical to end of deck surface. 2- extend deck surface 12" minimum beyond inside facing guard rail.	Fishing pier edge protection <a href="https://www.access-board.gov/ada/#ada-1005_3">https://www.access-board.gov/ada/#ada-1005_3</a> Curb or barrier <a href="https://www.access-board.gov/ada/#ada-1005_3_1">https://www.access-board.gov/ada/#ada-1005_3_1</a> Extended ground or floor surface <a href="https://www.access-board.gov/ada/#ada-1005_3_2">https://www.access-board.gov/ada/#ada-1005_3_2</a>	2010 ADAS Section: 1005.3.1, 1005.3.2  2015 ABAAS Section: 1005.3.1, 1005.3.2

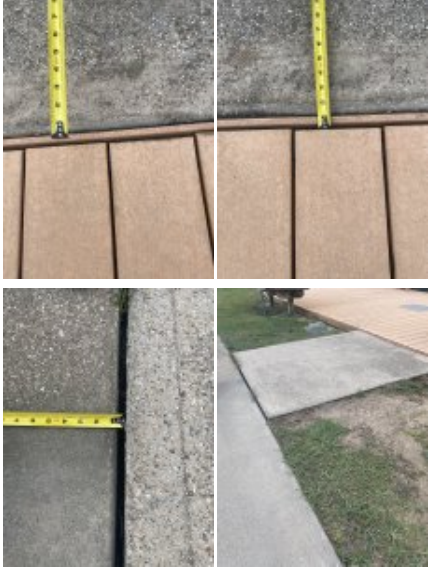
Finding Number	Area Description	Finding	As Built	Recommendation	Citation	Photos	Figure
115	Outdoor Features (Public) : Fishing Piers Near Visitors Center (3 total) - Conservation Center Fishing Pier & Walkways	The route contains openings greater than 1/2 inch. Openings in floor or ground surfaces shall not allow passage of a sphere more than 1/2 inch diameter. Elongated openings shall be placed so that the long dimension is perpendicular to the dominant direction of travel.	See previous finding for details on location.	<a href="https://www.access-board.gov/ada/#ada-302_3">https://www.access-board.gov/ada/#ada-302_3</a>	2012 TAS Section: 302.3 2010 ADAS Section: 302.3 2015 ABAAS Section: 302.3

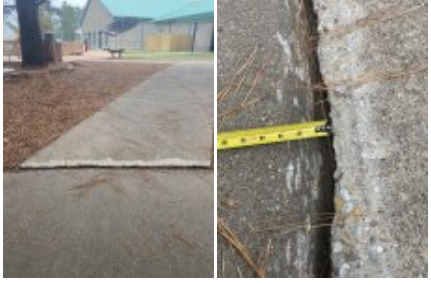
116	Outdoor Features (Public) : Fishing Piers Near Visitors Center (3 total) - Conservation Center Fishing Pier & Walkways	The route contains openings greater than 1/2 inch. Openings in floor or ground surfaces shall not allow passage of a sphere more than 1/2 inch diameter. Elongated openings shall be placed so that the long dimension is perpendicular to the dominant direction of travel.	Exterior pathway used to gain access from (L) side of CC pier has gap greater than 1/2" This gap also creates change in elevation over 1/4"	<a href="https://www.access-board.gov/ada/#ada-302_3">https://www.access-board.gov/ada/#ada-302_3</a>	2012 TAS Section: 302.3 2010 ADAS Section: 302.3 2015 ABAAS Section: 302.3

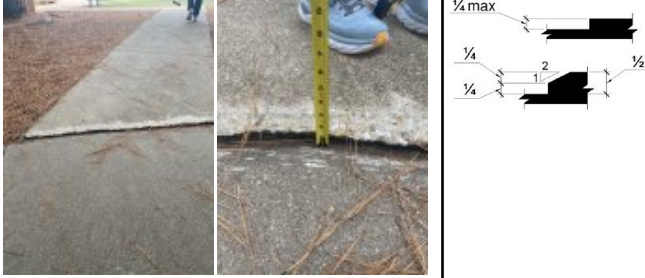
117	Outdoor Features (Public) : Fishing Piers Near Visitors Center (3 total) - Conservation Center Fishing Pier & Walkways	The walkway contains abrupt vertical edges and/or variations over 1/4 inch. 1/4 inch is the maximum vertical rise. Changes in level between 1/4 inch and 1/2 inch must be beveled at 1:2 or less. Changes in level greater than 1/2 inch must be by way of a ramp.	See previous finding for location details.	<a href="https://www.access-board.gov/ada/#ada-303_2">https://www.access-board.gov/ada/#ada-303_2</a> <a href="https://www.access-board.gov/ada/#ada-303_3">https://www.access-board.gov/ada/#ada-303_3</a>	2012 TAS Section: 303.3, 303.2 2010 ADAS Section: 303.3, 303.2 2015 ABAAS Section: 303.2, 303.3

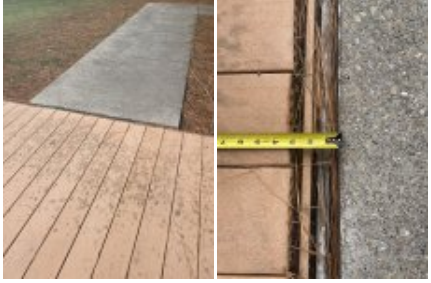
Finding Number	Area Description	Finding	As Built	Recommendation	Citation	Photos	Figure
118	Outdoor Features (Public) : Fishing Piers Near Visitors Center (3 total) - Conservation Center Fishing Pier & Walkways	The route contains openings greater than 1/2 inch. Openings in floor or ground surfaces shall not allow passage of a sphere more than 1/2 inch diameter. Elongated openings shall be placed so that the long dimension is perpendicular to the dominant direction of travel.	Exterior pathway to (L) side of CC fishing pier has gap greater than 1/2" and vertical change greater than 1/4"	<a href="https://www.access-board.gov/ada/#ada-302_3">https://www.access-board.gov/ada/#ada-302_3</a>	2012 TAS Section: 302.3 2010 ADAS Section: 302.3 2015 ABAAS Section: 302.3

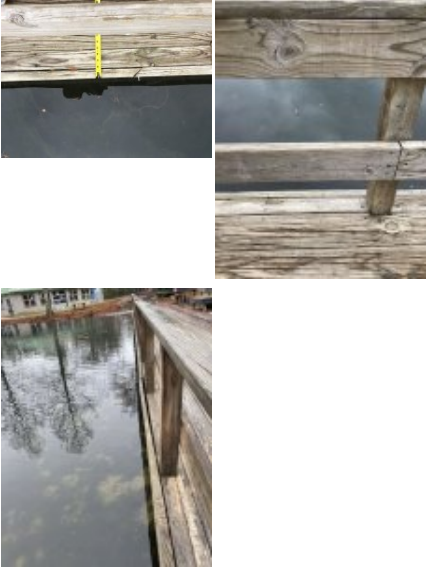
Finding Number	Area Description	Finding	As Built	Recommendation	Citation	Photos	Figure
121	Outdoor Features (Public) : Fishing Piers Near Visitors Center (3 total) - Anglers Pavilion Fishing Pier & Walkways	The required edge protection is not provided. Where compliant railings, guards, or handrails are provided, edge protection shall also be provided. Curbs or barriers shall extend 2 inches minimum above the surface of the fishing pier or platform or The ground or deck surface shall extend 12 inches minimum beyond the inside face of the railing. Toe clearance shall be provided and shall be 30 inches wide minimum and 9 inches minimum above the ground or deck surface beyond the railing.	There is no edge protection or extended deck surface provided. Where railings, guards, or handrails are provided, edge protection must be provided and extend a minimum of 2 inches above the ground or deck surface. Edge protection is not required where a railing, guardrail, or handrail is provided, if the deck surface extends a minimum of 12 inches beyond the inside face of the railing. Fishing pier edge compliance can be satisfied 1 Of 2 ways. 1- install curb barrier at 2" minimum vertical to end of deck surface. 2- extend deck surface 12" minimum beyond inside facing guard rail.	Fishing pier edge protection <a href="https://www.access-board.gov/ada/#ada-1005_3">https://www.access-board.gov/ada/#ada-1005_3</a> Curb or barrier <a href="https://www.access-board.gov/ada/#ada-1005_3_1">https://www.access-board.gov/ada/#ada-1005_3_1</a> Extended ground or floor surface <a href="https://www.access-board.gov/ada/#ada-1005_3_2">https://www.access-board.gov/ada/#ada-1005_3_2</a>	2010 ADAS Section: 1005.3.1, 1005.3.2  2015 ABAAS Section: 1005.3.1, 1005.3.2

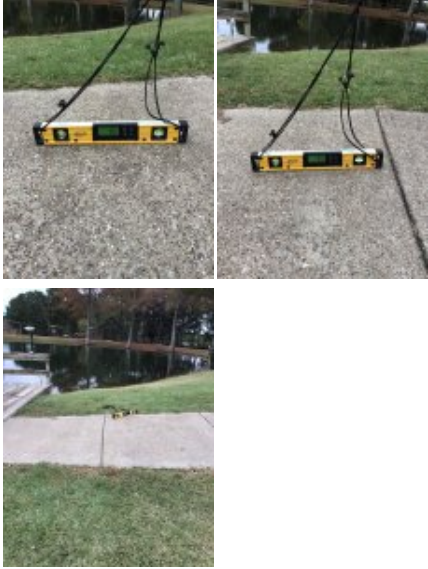
Finding Number	Area Description	Finding	As Built	Recommendation	Citation	Photos	Figure
122	Outdoor Features (Public) : Fishing Piers Near Visitors Center (3 total) - Anglers Pavilion Fishing Pier & Walkways	The accessible route on the site has running slopes greater than 5 percent and has not been constructed as a ramp (i.e. handrails, edge protection, etc.). When the slope in the direction of travel of any walk exceeds 1 unit vertical in 20 units horizontal (5-percent slope), it must be constructed as a ramp. Surface cross slopes must not exceed one unit vertical in 48 units horizontal (2-percent slope).	Running slope, (R) side of fishing pier is over 5% See additional photos for location of slope non compliance in accessible pathway or sidewalk.	<a href="https://www.access-board.gov/ada/#ada-403_3">https://www.access-board.gov/ada/#ada-403_3</a>	2012 TAS Section: 403.3 2010 ADAS Section: 403.3 2015 ABAAS Section: 403.3

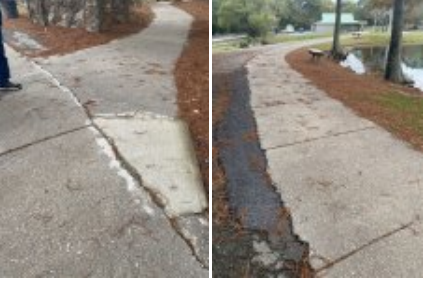
127	Outdoor Features (Public) : Fishing Piers Near Visitors Center (3 total) - Path Of Travel Around Piers	The path of contains multiple issues and is not accessible. The path of travel exceeds the maximum allowable cross and running slope requirements. It also contains changes in level and/or gaps that exceed the allowable maximum requirements. The path of travel does not meet the minimum width requirements for clearances, turning spaces, and/or passing spaces. The floor or ground surface is not firm, stable, and slip resistant.	The exterior pathway is not accessible due to running and cross slope compliance, loose debris on path, and large gaps in pathway. This section of pathway leads from Anglers Pavilion to Anglers fishing pier.	Review accessible pathway components to make accessible <a href="https://www.access-board.gov/ada/#ada-402">https://www.access-board.gov/ada/#ada-402</a> <a href="https://www.access-board.gov/ada/#ada-403_1">https://www.access-board.gov/ada/#ada-403_1</a>	2010 ADAS Section: 403.1  2015 ABAAS Section: 403.1

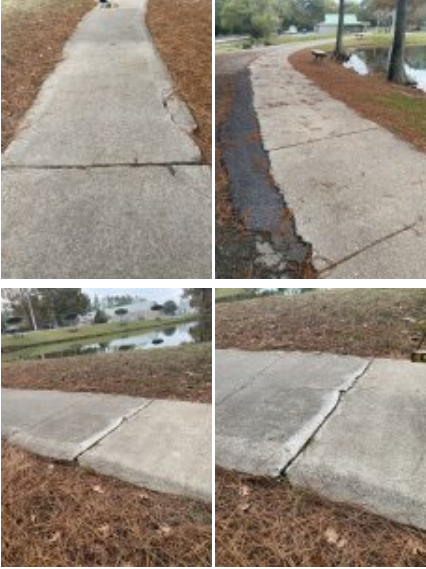
Finding Number	Area Description	Finding	As Built	Recommendation	Citation	Photos	Figure
128	Outdoor Features (Public) : Fishing Piers Near Visitors Center (3 total) - Path Of Travel Around Piers	The walking surface is obstructed. A 36 inch wide minimum walking surface is required.	Exterior pathway deterioration limits accessible space to less than 36" This section of pathway, (L) side approach, leads from Anglers Pavilion to CC fishing pier.	<a href="https://www.access-board.gov/ada/#ada-403_5_1">https://www.access-board.gov/ada/#ada-403_5_1</a>	2012 TAS Section: 403.5.1 2010 ADAS Section: 403.5.1 2015 ABAAS Section: 403.5.1

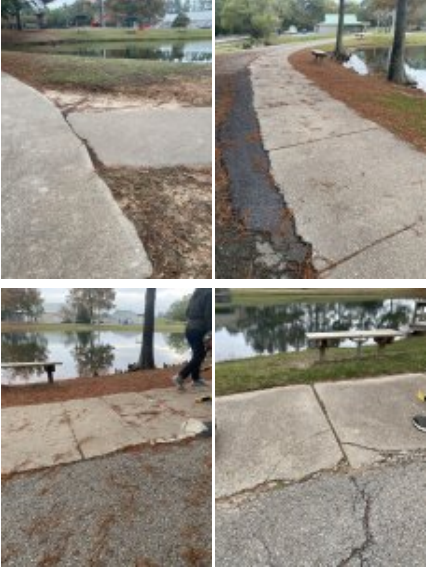
Finding Number	Area Description	Finding	As Built	Recommendation	Citation	Photos	Figure
133	Outdoor Features (Public) : Wetlands Trail - Wetlands Trail (Beginning)	The element is not accessible because there is not adequate clear floor space for an approach. The clear floor or ground space shall be 30 inches minimum by 48 inches minimum.	There is no clear floor space provided around benches to be designated as accessible. Trail bench requirements- A minimum of 36 by 48 inches of clear ground space must be provided near a bench, with one side of the clear space adjoining an ORAR or trail as applicable. This clear ground space must not overlap the ORAR, trail tread, or another clear ground space. Although there are no technical requirements for the bench itself, providing a bench with at least one armrest and back support that runs the full length of the bench is helpful.	<a href="https://www.access-board.gov/ada/#ada-305_3">https://www.access-board.gov/ada/#ada-305_3</a>	2012 TAS Section: 305.3 2010 ADAS Section: 305.3 2015 ABAAS Section: 305.3

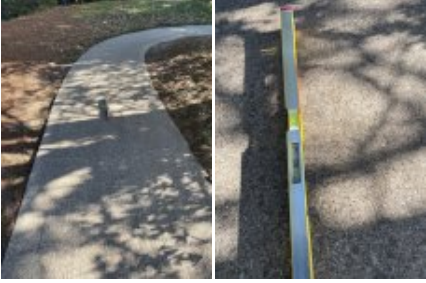
Finding Number	Area Description	Finding	As Built	Recommendation	Citation	Photos	Figure
135	Outdoor Features (Public) : Wetlands Trail - Wetlands Trail (End)	The running slope of the surface of the trail is too steep. Not more than 30 percent of the total length of a trail shall have a running slope steeper than 1:12 (8.33%).	Exterior route running slope is 8.8% This section of pathway is located near of Wetland trail and next to tram pick up/drop off	N/A - Refer to Finding	2015 ABAAS Section: 1017.7.1

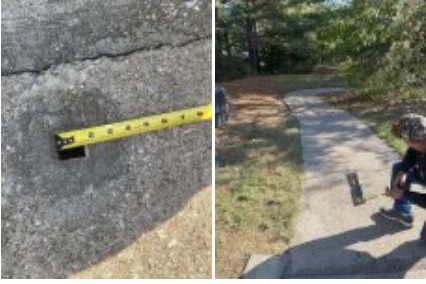
136	Outdoor Features (Public) : Wetlands Trail - Wetlands Trail (End)	There are openings in the surface of the trails, passing spaces, and resting intervals that allow the passage of a sphere more than 1/2 inch in diameter. Openings in the surface of trails, passing spaces, and resting intervals shall not allow the passage of a sphere more than 1/2 inch (13 mm) in diameter.	There is a large gap near end of Wetland trail, same area as previous finding.	N/A - Refer to Finding	2015 ABAAS Section: 1017.6

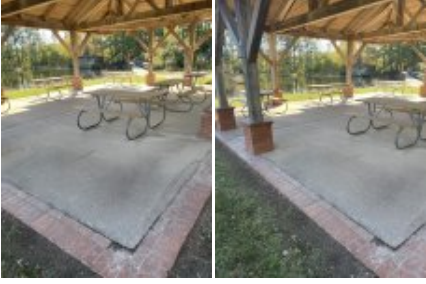
137	Outdoor Features (Public) : Fly Fishing Area - Picnic Pavilion	There are not enough picnic units with mobility features. Where picnic facilities contain more than two picnic units, at least 20 percent, but not less than two, of the picnic units shall provide mobility features.	There are no accessible picnic tables provided	Provide complaint picnic table Knee space for wheelchair seating must be at least 30 inches (760 millimeters) wide, 19 inches (485 millimeters) deep, and 27 inches (685 millimeters) high, as measured from the ground or floor to the bottom of the tabletop. Toe clearance of at least 9 inches (230 millimeters) above the ground or floor must extend at least an additional 5 inches (25 millimeters) beyond the knee clearance	2015 ABAAS Section: F245.2.2

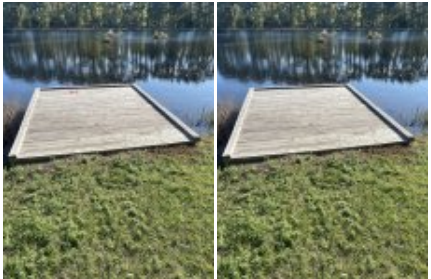
139	Outdoor Features (Public) : Fly Fishing Area - Fly Fish Pier (4 Total)	The curb or barrier does not extend 2 inches minimum above the surface. Where compliant railings, guards, or handrails are provided, edge protection shall also be provided. Curbs or barriers shall extend 2 inches minimum above the surface of the fishing pier or platform or The ground or deck surface shall extend 12 inches minimum beyond the inside face of the railing. Toe clearance shall be provided and shall be 30 inches wide minimum and 9 inches minimum above the ground or deck surface beyond the railing.	This is not required since there is no guardrail but if edge protection is provided, it needs to extend 2" min above platform surface. Needs photo verification	https://www.access-board.gov/ada/#ada-1005_3_1	2010 ADAS Section: 1005.3.1 2015 ABAAS Section: 1005.3.1

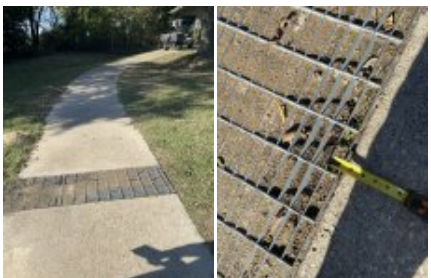
140	Outdoor Features (Public) : Fly Fishing Area - Access Route To Fly Fishing Area Restrooms	The grate openings are greater than 1/2 inch and are parallel to the direction of travel. Openings in floor or ground surfaces shall not allow passage of a sphere more than 1/2 inch diameter. Elongated openings shall be placed so that the long dimension is perpendicular to the dominant direction of travel.	Exterior route leading to restrooms, grate preventing access	https://www.access-board.gov/ada/#ada-302_3	2012 TAS Section: 302.3 2010 ADAS Section: 302.3 2015 ABAAS Section: 302.3

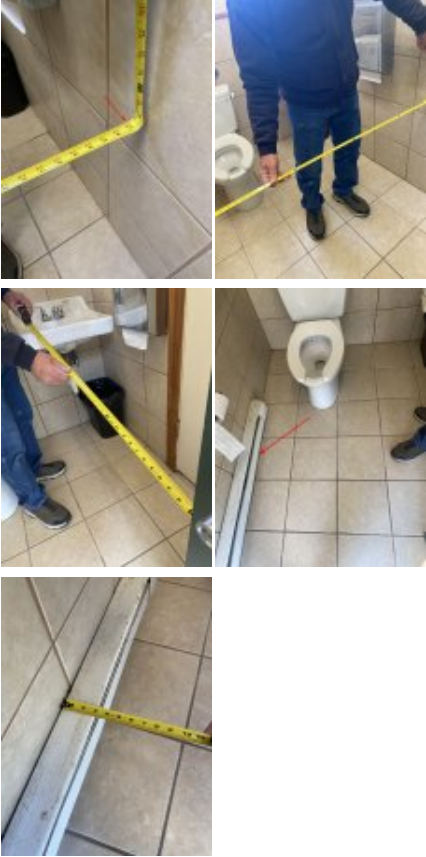
Finding Number	Area Description	Finding	As Built	Recommendation	Citation	Photos	Figure
152	Outdoor Features (Public) : Fly Fishing Area - Restroom (Men's)	There is not enough clear floor space at the water closet. Clear floor space around the water closet shall be 60 inches minimum measured perpendicular from the side wall and 56 inches minimum measured perpendicular from the rear wall. No other fixture is allowed in this space.	Compartment is not correct dimensions. Accessible length space impeded by door encroachment and width of compartment is 57" There is also an obstruction at bottom of floor which limits in usable space. See additional photos for details.	<a href="https://www.access-board.gov/ada/#ada-604_3">https://www.access-board.gov/ada/#ada-604_3</a>	2012 TAS Section: 604.3.1 2010 ADAS Section: 604.3.1 2015 ABAAS Section: 604.3.

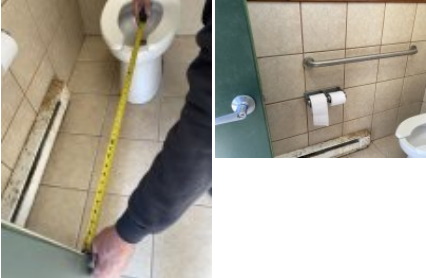
Finding Number	Area Description	Finding	As Built	Recommendation	Citation	Photos	Figure
153	Outdoor Features (Public) : Fly Fishing Area - Restroom (Men's)	The door swing encroaches more than 12 inches into the restroom turning space. Doors shall not swing into the clear floor space or clearance required for any fixture. Doors to accessible water closet compartments shall be permitted to encroach into the turning space without limitation. Other than doors to accessible water closet compartments, a door, in any position, shall be permitted to encroach into the turning space by 12 inches maximum. A clear space measured from the floor to a height of 27 inches above the floor, within the restroom, of sufficient size to inscribe a circle with a diameter not less than 60 inches in size or a "T" turning space must be provided. Changes of level are not permitted.	N/A		<a href="https://www.access-board.gov/ada/#ada-603_2_3">https://www.access-board.gov/ada/#ada-603_2_3</a>  2012 TAS Section: 603.2.3  2010 ADAS Section: 603.2.3  2015 ABAAS Section: 603.2.3

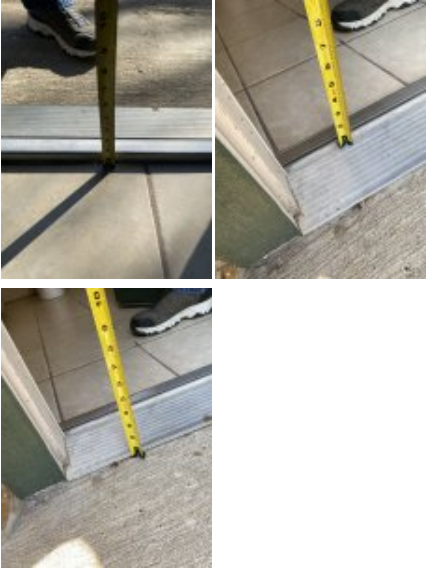
154	Outdoor Features (Public) : Fly Fishing Area - Restroom (Men's)	The threshold is greater than 1/2 inch high. The threshold at a doorway shall be no higher than 1/2 inch. Changes in level between 1/4 inch and 1/2 inch must be beveled at 1:2 or less. 1/4 inch is the maximum vertical rise.	Entry into restroom may comply with beveled requirements, verify. Exiting restroom is not compliant, threshold exceeds 1/2"		<a href="https://www.access-board.gov/ada/#ada-404_2_5">https://www.access-board.gov/ada/#ada-404_2_5</a>  2012 TAS Section: 404.2.5  2010 ADAS Section: 404.2.5  2015 ABAAS Section: 404.2.5

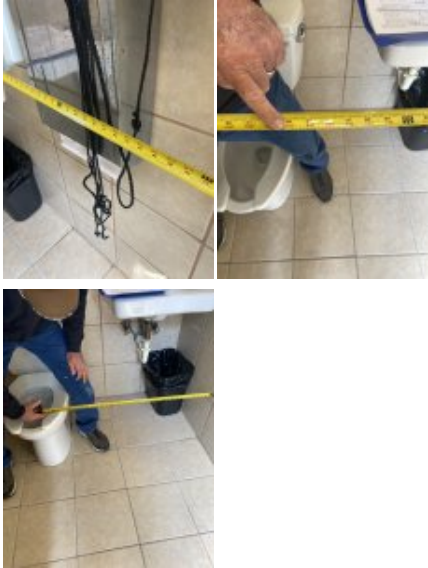
162	Outdoor Features (Public) : Fly Fishing Area - Restroom (Women's)	The lavatory's clear floor space is obstructed by the paper towel dispenser. The wall mounted soap dispenser projects (XX) from the wall and encroaches into the required 30 inches by 48 inches clear floor space. The maximum projection that a dispenser may project at this location is (XX) inches.	Paper towel dispenser location, soap dispenser, and trash can prevent access to lavatory.		<a href="https://www.access-board.gov/ada/#ada-606_2">https://www.access-board.gov/ada/#ada-606_2</a> 2012 TAS Section: 606.2 2010 ADAS Section: 606.2 2015 ABAAS Section: 606.2
