**IF-Athens TX, TFFC ADA Evaluation**

**Accessibility Evaluation**

**Inspection Date: 11/15/2022**

**Report Date: 02/04/2024**

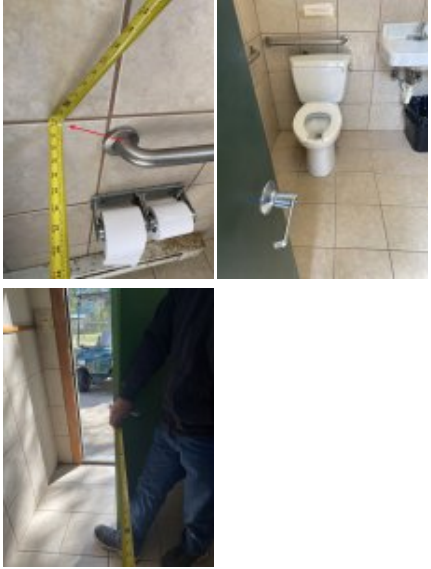
Finding Number	Area Description	Finding	As Built	Recommendation	Citation	Photos	Figure
166	Outdoor Features (Public) : Fly Fishing Area - Restroom (Women's)	There is not enough clear floor space at the water closet. Clear floor space around the water closet shall be 60 inches minimum measured perpendicular from the side wall and 56 inches minimum measured perpendicular from the rear wall. No other fixture is allowed in this space.	Compartment is not correct dimensions. Accessible length space impeded by door encroachment and width of compartment is 58"	<a href="https://www.access-board.gov/ada/#ada-604_3_1">https://www.access-board.gov/ada/#ada-604_3_1</a>	2012 TAS Section: 604.3.1 2010 ADAS Section: 604.3.1 2015 ABAAS Section: 604.3.

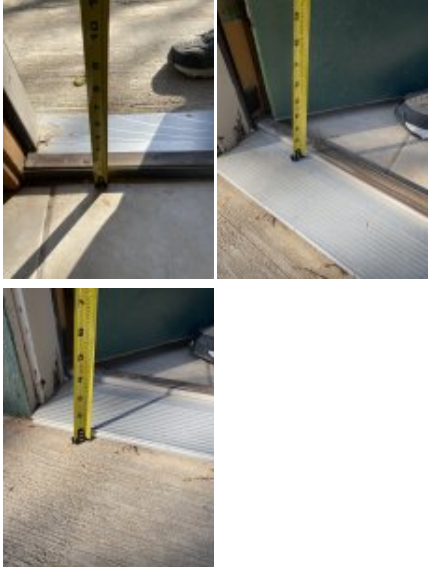
Finding Number	Area Description	Finding	As Built	Recommendation	Citation	Photos	Figure
168	Outdoor Features (Public) : Fly Fishing Area - Restroom (Women's)	The threshold is greater than 1/2 inch high. The threshold at a doorway shall be no higher than 1/2 inch. Changes in level between 1/4 inch and 1/2 inch must be beveled at 1:2 or less. 1/4 inch is the maximum vertical rise.	Entry into restroom may comply with beveled requirements, verify. Exiting restroom is not compliant, threshold exceeds 1/2"	<a href="https://www.access-board.gov/ada/#ada-404_2_5">https://www.access-board.gov/ada/#ada-404_2_5</a>	2012 TAS Section: 404.2.5 2010 ADAS Section: 404.2.5 2015 ABAAS Section: 404.2.5

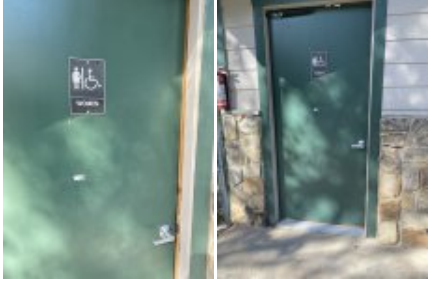
Finding Number	Area Description	Finding	As Built	Recommendation	Citation	Photos	Figure
170	Outdoor Features (Public) : Fly Fishing Area - Restroom (Women's)	The wall sign is incorrectly located. Where permanent identification signs are provided for rooms and spaces, signs shall be installed on the wall adjacent to the latch side of the door. Where there is no wall space on the latch side, including at double leaf doors, signs shall be placed on the nearest adjacent wall, preferably on the right. Mounting location shall be located so that a person may approach within 3 inches of the sign and that a clear floor space of 18 inches minimum by 18 inches minimum, centered on the tactile Characters, is provided beyond the arc of any door swing between the closed position and 45 degree open position.	Sign placement incorrect.	Height Above Finish Floor or Ground <a href="https://www.access-board.gov/ada/#ada-703_4_1">https://www.access-board.gov/ada/#ada-703_4_1</a> Location <a href="https://www.access-board.gov/ada/#ada-703_4_2">https://www.access-board.gov/ada/#ada-703_4_2</a>	2012 TAS Section: 703.4.1  2010 ADAS Section: 703.4.1  2015 ABAAS Section: 703.4.1

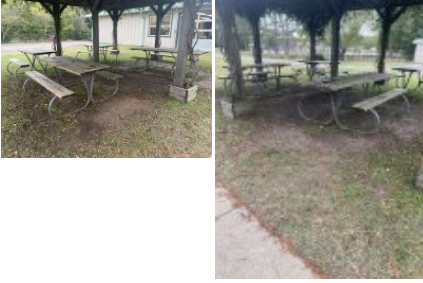
Finding Number	Area Description	Finding	As Built	Recommendation	Citation	Photos	Figure
172	Outdoor Features (Public) : Picnic Spaces Near Visitors Center - Angler Pavilion Picnic Area	The picnic unites are not adequately dispersed. Picnic units required to provide mobility features shall provide choices of picnic units comparable to, and integrated with, those available to others.	There are no compliant picnic tables at this location. Need 1 to gain compliance.	Provide compliant picnic table Knee space for wheelchair seating must be at least 30 inches wide, 19 inches deep, and 27 inches high, as measured from the ground or floor to the bottom of the tabletop. Toe clearance of at least 9 inches above the ground or floor must extend at least an additional 5 inches beyond the knee clearance.	2015 ABAAS Section: F245.2.4

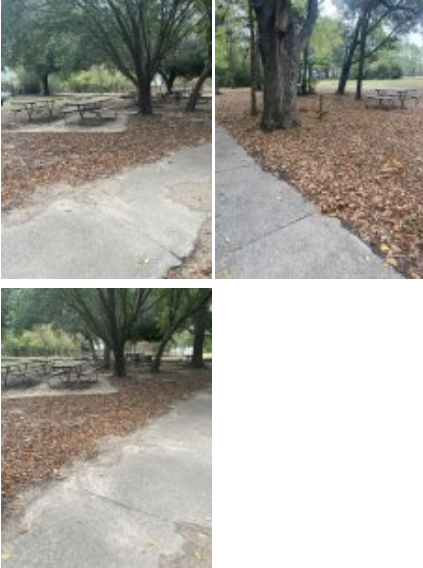
173	Outdoor Features (Public) : Picnic Spaces Near Visitors Center - School Group Area	There is no outdoor recreation access route that connects accessible elements, spaces, and facilities within the picnic unit. At least one outdoor recreation access route shall connect accessible elements, spaces, and facilities provided within picnic units with mobility features.	Ground/surface material around picnic tables is mostly compliant. Exterior pathway leading to tables non compliant.	N/A - Refer to Finding	2015 ABAAS Section: F245.4.1

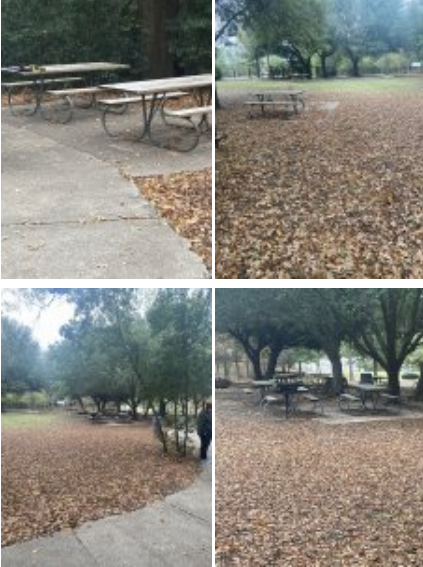
Finding Number	Area Description	Finding	As Built	Recommendation	Citation	Photos	Figure
174	Outdoor Features (Public) : Picnic Spaces Near Visitors Center - School Group Area	The picnic unites are not adequately dispersed. Picnic units required to provide mobility features shall provide choices of picnic units comparable to, and integrated with, those available to others. Provide compliant picnic table Knee space for wheelchair seating must be at least 30 inches wide, 19 inches deep, and 27 inches high, as measured from the ground or floor to the bottom of the tabletop. Toe clearance of at least 9 inches above the ground or floor must extend at least an additional 5 inches beyond the knee clearance.	Looks to be 2 accessible picnic tables with a somewhat accessible pathway and landing pad around tables. These need to be evenly dispersed around area with improved pathways.	N/A - Refer to Finding	2015 ABAAS Section: F245.2.4

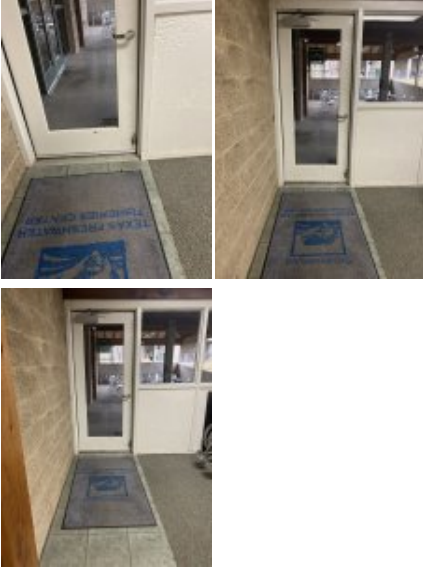
Finding Number	Area Description	Finding	As Built	Recommendation	Citation	Photos	Figure
176	Structures on Property (STAFF) - Visitor Center Top Floor: Entrance into Staff Work Area - Entrance Doors	The door has a door stop which prevents it from having a smooth surface at the bottom. Swinging door surfaces within 10 inches of the finish floor or ground measured vertically must have a smooth surface on the push side extending the full width of the door. Parts creating horizontal or vertical joints in these surfaces shall be within 1/16 inch of the same plane as the other. Cavities created by added kick plates shall be capped. This is required to allow those that use wheelchairs to use their footrests to push the door open without getting trapped or injured by the gate material. All gates, including ticket gates, shall meet all applicable specifications for doors.	Door stop	<a href="https://www.access-board.gov/ada/#ada-404_2_10">https://www.access-board.gov/ada/#ada-404_2_10</a>	2012 TAS Section: 404.2.10  2010 ADAS Section: 404.2.10  2015 ABAAS Section: 404.2.10

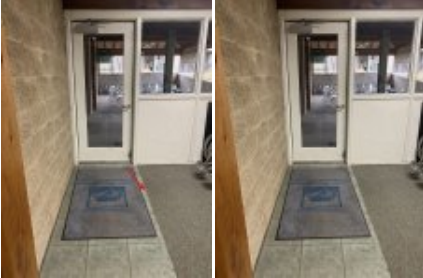
177	Structures on Property (STAFF) - Visitor Center Top Floor: Entrance into Staff Work Area - Entrance Doors	The floor mat at the door is not secured in place. If carpet or carpet tile is used on a ground or floor surface, then it shall be securely attached; have a firm cushion, pad or backing or no cushion or pad; and have a level loop, textured loop, level-cut pile or level-cut/uncut pile texture. The maximum pile height shall be 1/2 inch. Exposed edges of carpet shall be fastened to floor surfaces and have trim along the entire length of the exposed edge. Recessed doormats shall be adequately anchored to prevent interference with wheelchair traffic.	Floor Mat is not in good working condition or secured to floor. Carpet fraying and deteriorating to right of floor mat, not located on main path of travel.	<a href="https://www.access-board.gov/ada/#ada-302_2">https://www.access-board.gov/ada/#ada-302_2</a>	2012 TAS Section: 302.2  2010 ADAS Section: 302.2  2015 ABAAS Section: 302.2

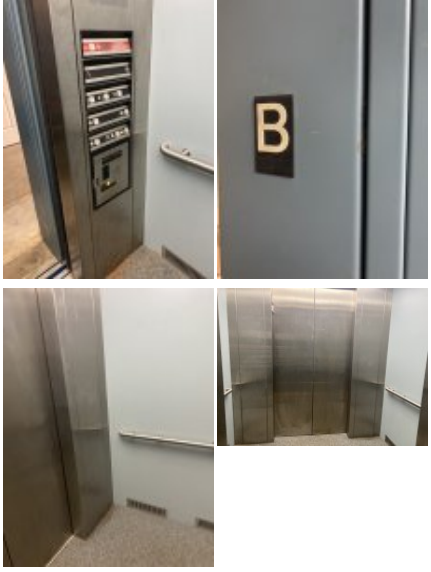
Finding Number	Area Description	Finding	As Built	Recommendation	Citation	Photos	Figure
178	Structures on Property (STAFF) - Visitor Center Top Floor: Elevator	The existing passenger elevators contain several non compliant features in accordance with ASME A17.1, (Safety Code for Elevators and Escalators). The elevator car size (XX) (length & width) (XX) is are too small, door operation, door size, door protective and reopening devices are noncompliant, hall & car calls are incorrect and/or missing, the hall lantern and door jamb markings are missing and/or incorrect. An audible signal shall sound once for the "up" direction and twice for the "down" direction or shall have verbal annunciators that say "up" or "down." Contact the elevator contractor and/or vendor to ensure compliance with ASME A17.1.	This elevator is for staff only and requires a key to use. This elevator can be used as a accommodations with TPWD personnel chaperoning participant. There are a few elements needed to gain full compliance. Emergency button location, and audio elements are non compliant.	<a href="https://www.access-board.gov/ada/#ada-407_1">https://www.access-board.gov/ada/#ada-407_1</a>	2012 TAS Section: 407.1  2010 ADAS Section: 407.1  2015 ABAAS Section: 407.1

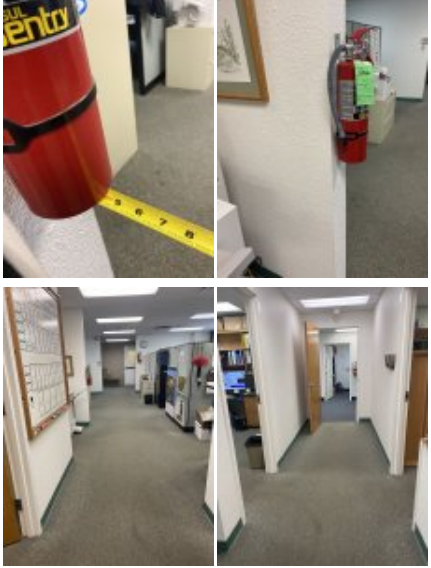
179	Structures on Property (STAFF) - Visitor Center Top Floor: Interior Hallways	The element projects more than 4 inches into the circulation path. Wall-mounted objects that have leading edges between 27 inches and 80 inches from the floor must not project more than 4 inches into the circulation path. Protruding objects that extend to the floor or within 27 inches of the floor are cane detectable and are therefore not hazardous. Where it is necessary or desirable to have objects protrude from the wall, a manner of cane detection must be provided.	This protruding object is found in staff only hallway. There are no official ADA fire extinguisher height or fire alarm ADA requirements. However, there are rules that govern the placement of all protruding objects, no matter their function, to accommodate blind and other visually impaired people Other elements of walkway are within compliance.	<a href="https://www.access-board.gov/ada/#ada-307_2">https://www.access-board.gov/ada/#ada-307_2</a>	2012 TAS Section: 307.2  2010 ADAS Section: 307.2  2015 ABAAS Section: 307.2

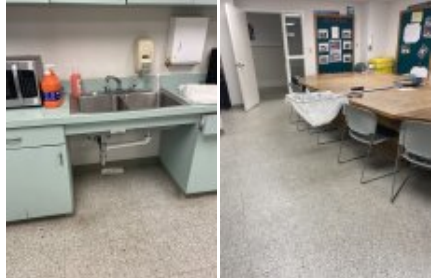
Finding Number	Area Description	Finding	As Built	Recommendation	Citation	Photos	Figure
180	Structures on Property (STAFF) - Visitor Center Bottom Floor: Conference Room/Kitchenette	The sink drain pipes are exposed. Hot water and drain pipes exposed under sinks shall be insulated or otherwise configured so as to protect against contact. There shall be no sharp or abrasive surfaces under sinks.	Pipes need to be insulated or guard provided for knee and toe clearance. Other sink elements are compliant and can be accessed via parallel approach or frontal approach.	<a href="https://www.access-board.gov/ada/#ada-606_5">https://www.access-board.gov/ada/#ada-606_5</a>	2012 TAS Section: 606.5 2010 ADAS Section: 606.5 2015 ABAAS Section: 606.5

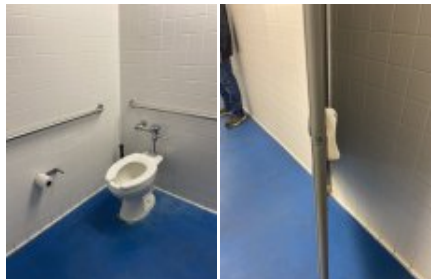
181	Structures on Property (STAFF) - Visitor Center Bottom Floor: Restrooms/Water Fountains - Restroom (Men's)	The accessible stall has been found to be in substantial compliance with accessibility codes, standards, and regulations.	Accessible stall needs a few elements for full compliance including door handles and accessible locking mechanisms.	<a href="https://www.access-board.gov/ada/#ada-604_8_1_2">https://www.access-board.gov/ada/#ada-604_8_1_2</a>	2012 TAS Section: Advisory 2010 ADAS Section: Advisory 2015 ABAAS Section: Advisory

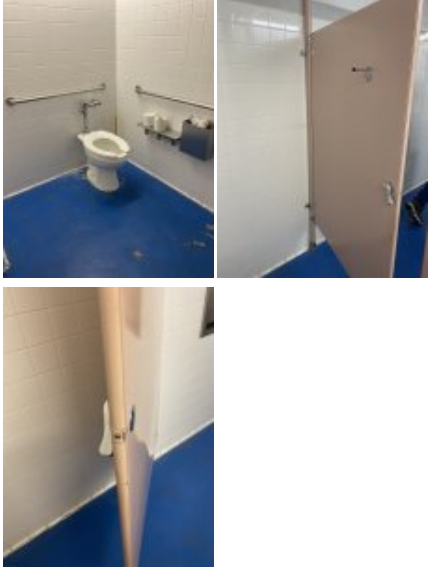
184	Structures on Property (STAFF) - Visitor Center Bottom Floor: Restrooms/Water Fountains - Restroom (Women's)	The accessible stall has been found to be in substantial compliance with accessibility codes, standards, and regulations.	Accessible stall needs a few elements for full compliance including free flowing TP dispenser, coat hook height, door handles and accessible locking mechanisms.	<a href="https://www.access-board.gov/ada/#ada-604_7">https://www.access-board.gov/ada/#ada-604_7</a> <a href="https://www.access-board.gov/ada/#ada-604_8_1_2">https://www.access-board.gov/ada/#ada-604_8_1_2</a> <a href="https://www.access-board.gov/ada/#ada-604_8_3">https://www.access-board.gov/ada/#ada-604_8_3</a>	2012 TAS Section: Advisory  2010 ADAS Section: Advisory  2015 ABAAS Section: Advisory

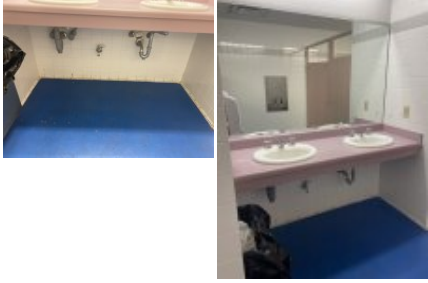
Finding Number	Area Description	Finding	As Built	Recommendation	Citation	Photos	Figure
185	Structures on Property (STAFF) - Visitor Center Bottom Floor: Restrooms/Water Fountains - Restroom (Women's)	The water and drain pipes under the lavatory are not adequately insulated. Water supply and drain pipes under lavatories and sinks shall be insulated or otherwise configured to protect against contact. There shall be no sharp or abrasive surfaces under lavatories and sinks.	N/A		<a href="https://www.access-board.gov/ada/#ada-606_5">https://www.access-board.gov/ada/#ada-606_5</a>	2012 TAS Section: 606.5 2010 ADAS Section: 606.5 2015 ABAAS Section: 606.5

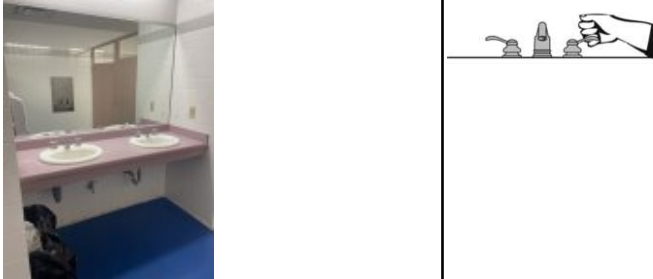
186	Structures on Property (STAFF) - Visitor Center Bottom Floor: Restrooms/Water Fountains - Restroom (Women's)	The faucet controls require twisting of the wrist. Faucet controls and operating mechanisms shall be operable with one hand and shall not require tight grasping, pinching or twisting of the wrist. The force required to activate controls shall be no greater than 5 lb. Lever-operated, push-type and electronically controlled mechanisms are examples of acceptable designs. Self-closing valves are allowed if the faucet remains open for at least 10 seconds.	N/A		<a href="https://www.access-board.gov/ada/#ada-606_4">https://www.access-board.gov/ada/#ada-606_4</a>	2012 TAS Section: 606.4 2010 ADAS Section: 606.4 2015 ABAAS Section: 606.4

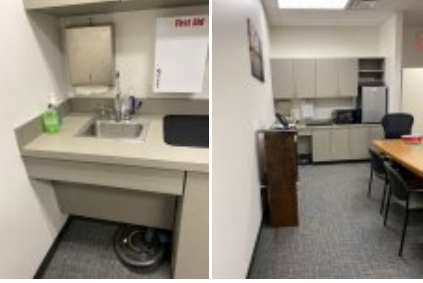
Finding Number	Area Description	Finding	As Built	Recommendation	Citation	Photos	Figure
192	Structures on Property (STAFF) - Conservatory Center : Interior Hallways of Building - Conference Room/Kitchenette	Knee and toe clearance has not been provided at the sink. The knee clearance shall be 11 inches deep minimum at 9 inches above the finish floor or ground, and 8 inches deep minimum at 27 inches above the finish floor or ground. The toe clearance is the space under the sink between the finish floor or ground and 9 inches above the finish floor 30 inches wide minimum. The toe clearance shall extend a minimum of 17 inches and a maximum of 25 inches underneath the sink.	Forward approach has obstruction in clear toe space provided. Sink is accessible once obstruction is cleared.	<a href="https://www.access-board.gov/ada/#ada-606_2">https://www.access-board.gov/ada/#ada-606_2</a>	2012 TAS Section: 606.2  2010 ADAS Section: 606.2  2015 ABAAS Section: 606.2

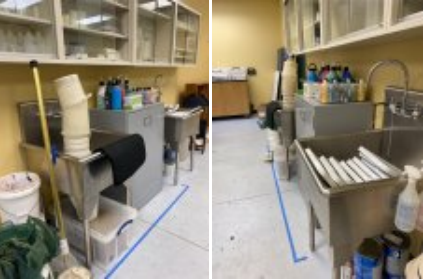
193	Structures on Property (STAFF) - Conservatory Center : Interior Hallways of Building - Classroom	There are not enough accessible lavatories. Where lavatories are provided, at least one shall be accessible and shall not be located in a toilet compartment.	Sink not required to have front approach due to function of this area. parallel approach height needs to be verified.	<a href="https://www.access-board.gov/ada/#ada-213_3_4">https://www.access-board.gov/ada/#ada-213_3_4</a>	2012 TAS Section: 213.3.4  2010 ADAS Section: 213.3.4  2015 ABAAS Section: F213.3.4

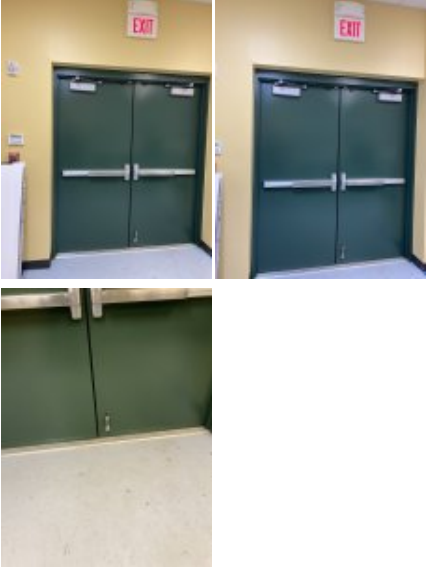
Finding Number	Area Description	Finding	As Built	Recommendation	Citation	Photos	Figure
194	Structures on Property (STAFF) - Conservatory Center : Interior Hallways of Building - Classroom	The tactile EXIT sign is missing at the door. Wall signs identifying exits shall have characters raised 1/32 inch minimum and shall be uppercase characters a minimum of 5/8 inch and a maximum of 2 inches high. Braille shall be placed directly below the tactile characters; flush left or centered. Signs shall be located a minimum of 48 inches above the floor, measured from the baseline of the lowest tactile characters and 60 inches maximum above the finish floor or ground surface, measured from the baseline of the highest tactile characters. Where a tactile sign is provided at a door, the sign shall be located on the latch side. Where a tactile sign is provided at double doors the sign shall be located to the right of the right-hand door. Where there is no wall space at the latch side of a single door or at the right side of double doors, signs shall be located on the nearest adjacent wall.	Where visual EXIT is provided, accompanying tactile EXIT sign must also be provided for same doorway. Doorway exit signs and emergency exits with emergency exit signs that are overhead or visual only, or pictograms only, must have an accompanying ADA Braille sign. Exit passages, including doors, stairs and routes, must be identified with tactile ADA signage. Signs must include braille and raised characters. Pictograms are optional.	<a href="https://www.access-board.gov/ada/#ada-216_4_1">https://www.access-board.gov/ada/#ada-216_4_1</a>	2012 TAS Section: 216.4.1  2010 ADAS Section: 216.4.1  2015 ABAAS Section: F216.4.1
