TPWD Headquarters EO- ADA Evaluation

TPWD- Austin TX, HQ & Parking ADA Evaluation

Accessibility Evaluation

Inspection Date: 07/01/2020

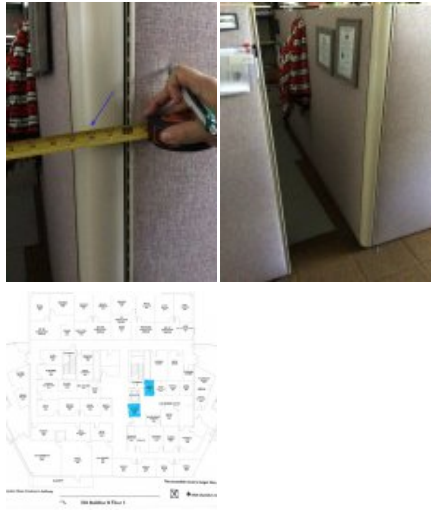
Finding Number	Area Description	Finding	As Built	Recommendation	Citation	Photos	Figure
19	Second Floor, Building B200 (STAFF): Interior spaces (B200) - Cubicle entrances	There are 2 cubicle entrances located in law enforcement area that are not compliant. The 2 cubicles located closest to elevator. **Details/locations are highlighted in blue in attached resource map. The door opening does not provide at least 32 inches between the face of the door and the opposite stop. Door openings shall provide a clear width of 32 inches minimum. Clear openings of doorways with swinging doors shall be measured between the face of the door and the stop, with the door open 90 degrees.	N/A	https://www.access-board.gov/ada/#ada-404_2_3	2012 TAS Section: 404.2.3 2010 ADAS Section: 404.2.3 2015 ABAAS Section: 404.2.3

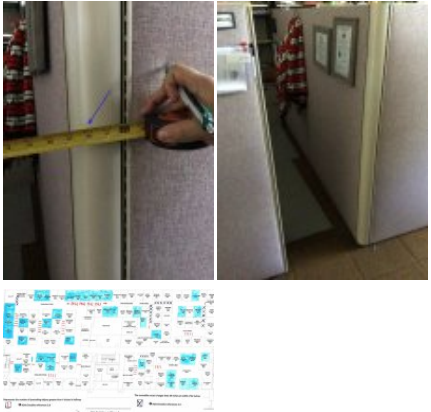
64	First Floor, Building A100 (STAFF): Interior spaces (A100) - Cubicle entrances	38 cubicle door entrances spread throughout the first floor A100. **Details/locations are highlighted in blue in attached resource map. The door opening does not provide at least 32 inches between the face of the door and the opposite stop. Door openings shall provide a clear width of 32 inches minimum. Clear openings of doorways with swinging doors shall be measured between the face of the door and the stop, with the door open 90 degrees.	N/A	https://www.access-board.gov/ada/#ada-404_2_3	2012 TAS Section: 404.2.3 2010 ADAS Section: 404.2.3 2015 ABAAS Section: 404.2.3

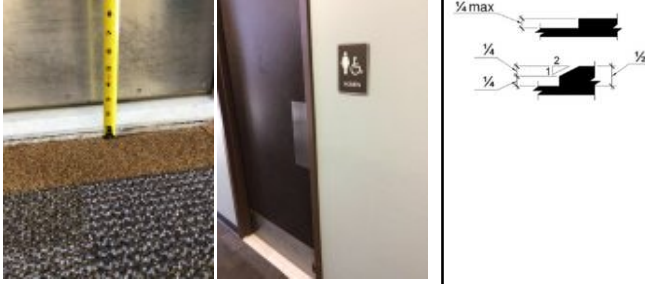
Finding Number	Area Description	Finding	As Built	Recommendation	Citation	Photos	Figure
72	Second Floor, Building A200 (STAFF): Restrooms and water fountains (A200) - Women's restroom	The threshold has a vertical change greater than 1/4 inch. The threshold at a doorway shall be no higher than 1/2 inch. Changes in level between 1/4 inch and 1/2 inch must be beveled at 1:2 or less. The maximum vertical rise shall be 1/4 inch.	threshold exceeds 1/2" max		https://www.access-board.gov/ada/#ada-404_2_5	2012 TAS Section: 404.2.5 2010 ADAS Section: 404.2.5 2015 ABAAS Section: 404.2.5

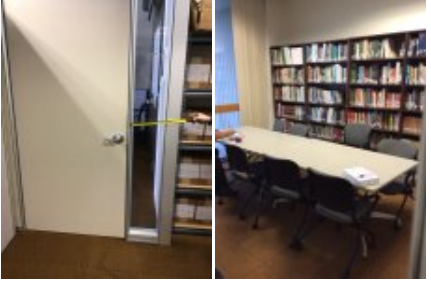
Finding Number	Area Description	Finding	As Built	Recommendation	Citation	Photos	Figure
79	Second Floor, Building A200 (STAFF): Interior spaces (A200) - Balcony Conference Room	The room identification sign is noncompliant. Multiple violations regarding sign contrast, height mount, and braille lettering. Wall signs identifying permanent rooms and spaces of a building shall be in a horizontal format and the characters raised 1/32 inch minimum and shall be sans serif uppercase characters a minimum of 5/8 inch and a maximum of 2 inches high. Characters and their background shall have a non-glare finish. Characters shall contrast with their background with either light characters on a dark background or dark characters on a light background. Signs with raised characters or Braille shall be located 48 inches minimum above the finish floor or ground surface, measured from the baseline of the lowest tactile character and 60 inches maximum above the finish floor or ground surface, measured from the baseline of the highest tactile character.	Signs that identify a room, space or area are required to have raised characters and Braille. This requirement includes both public access areas as well as all employee areas. Wall sign is not compliant, none provided	Wall sign designation https://www.access-board.gov/ada/#ada-216_2 Wall signs general https://www.access-board.gov/ada/#ada-703_1 Height Above Finish Floor or Ground https://www.access-board.gov/ada/#ada-703_4_1 Location https://www.access-board.gov/ada/#ada-703_4_2	2012 TAS Section: 216.2, 703.1 2010 ADAS Section: 216.2, 703.1 2015 ABAAS Section: F216.2, 703.1

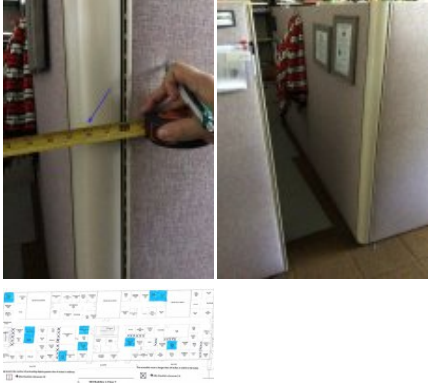
Finding Number	Area Description	Finding	As Built	Recommendation	Citation	Photos	Figure
86	Second Floor, Building A200 (STAFF): Interior spaces (A200) - Cubicle entrances	10 cubicle door entrances spread throughout the second floor. **Details/locations are highlighted in blue in attached resource map. The door opening does not provide at least 32 inches between the face of the door and the opposite stop. Door openings shall provide a clear width of 32 inches minimum. Clear openings of doorways with swinging doors shall be measured between the face of the door and the stop, with the door open 90 degrees.	N/A	**These findings only apply to TPWD personnel, and are considered a low priority until all ADA upgrades can be secured. https://www.access-board.gov/ada/#ada-404_2_3	2012 TAS Section: 404.2.3 2010 ADAS Section: 404.2.3 2015 ABAAS Section: 404.2.3

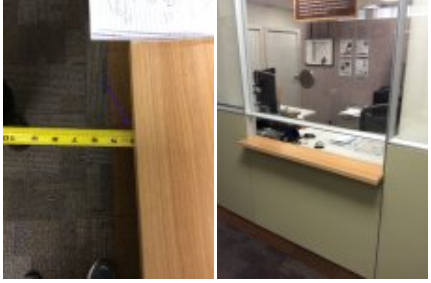
Finding Number	Area Description	Finding	As Built	Recommendation	Citation	Photos	Figure
87	First Floor, Building C100 (STAFF): Building Entrance and Lobby (C100) - Service Counter (HR - Public Element)	The counter is higher than 36 inches above the floor. A portion of the counter surface that is 30 inches long minimum and 36 inches high maximum shall be provided. Knee and toe space shall be provided under the counter. A clear floor or ground space shall be positioned for a forward approach to the counter.	Not enough space provided for parallel or front approach.	Service desks approach requirements https://www.access-board.gov/ada/#ada-904_4 Parallel approach https://www.access-board.gov/ada/#ada-904_4_1 Forward approach https://www.access-board.gov/ada/#ada-904_4_2	2012 TAS Section: 904.4.2 2010 ADAS Section: 904.4.2 2015 ABAAS Section: 904.4.2

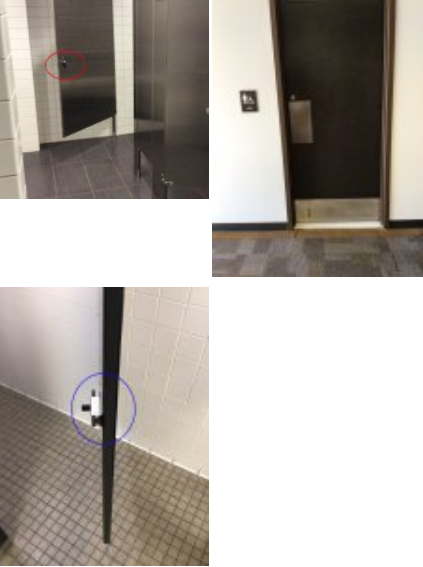
90	First Floor, Building C100 (STAFF): Restrooms and water fountains (C100) - Men's restroom (near elevator)	The water closet compartment is missing a loop handle on one side or both sides of the door. Water closet compartments must be equipped with a door that has a loop or U-shaped handle on both sides of the door immediately below the latch. The latch must be flip-over style, sliding or other hardware not requiring the user to grasp or twist.	missing	https://www.access-board.gov/ada/#ada-604_8_1_2	2012 TAS Section: 604.8.1.2 2010 ADAS Section: 604.8.1.2 2015 ABAAS Section: 604.8.1.2

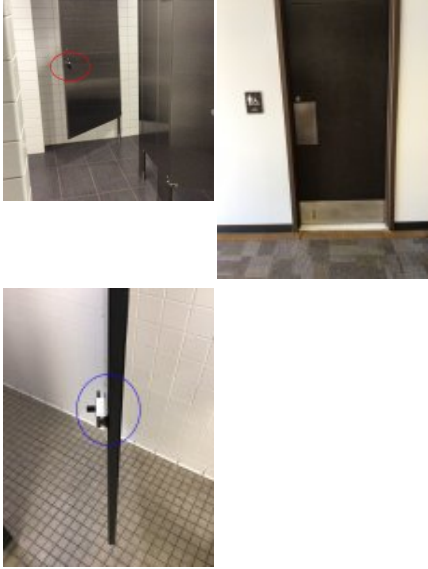
Finding Number	Area Description	Finding	As Built	Recommendation	Citation	Photos	Figure
93	First Floor, Building C100 (STAFF): Restrooms and water fountains (C100) - Men's restroom	The water closet compartment is missing a loop handle on one side or both sides of the door. Water closet compartments must be equipped with a door that has a loop or U-shaped handle on both sides of the door near the latch. The latch must be flip-over style, sliding or other hardware not requiring the user to grasp or twist.	missing	https://www.access-board.gov/ada/#ada-604_8_1_2	2012 TAS Section: 604.8.1.2 2010 ADAS Section: 604.8.1.2 2015 ABAAS Section: 604.8.1.2

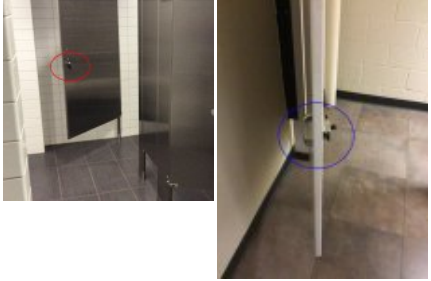
Finding Number	Area Description	Finding	As Built	Recommendation	Citation	Photos	Figure
96	First Floor, Building C100 (STAFF): Restrooms and water fountains (C100) - Women's restroom	The water closet compartment is missing a loop handle on one side or both sides of the door. Water closet compartments must be equipped with a door that has a loop or U-shaped handle on both sides of the door near the latch. The latch must be flip-over style, sliding or other hardware not requiring the user to grasp or twist.	missing	https://www.access-board.gov/ada/#ada-604_8_1_2	2012 TAS Section: 604.8.1.2 2010 ADAS Section: 604.8.1.2 2015 ABAAS Section: 604.8.1.2

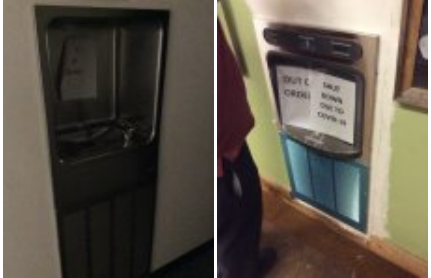
97	First Floor, Building C100 (STAFF): Restrooms and water fountains (C100) - Water Fountain	The drinking fountain is not accessible. The water fountains spread throughout C100 are not accessible due to a number of factors. **The C100 water refill stations are compliant. . Drinking fountains must be on an accessible route. An accessible route of travel is 36 inches wide minimum and provides a 30 inch by 48 inch clear floor space centered on the unit that allows a forward approach to the drinking fountain. At "hi-low" type fountains, the centerline of the 30 inch by 48 inch clear floor space must be centered on the "low" fountain. Spout outlets of drinking fountains for standing persons shall be 38 inches minimum and 43 inches maximum above the finish floor or ground. All drinking fountains shall be located completely within alcoves, positioned completely between wing walls, or otherwise positioned so as not to encroach into pedestrian ways. An alcove must not be less than 32 inches in width and 18 inches in depth. Wing walls must project out from the supporting wall at least as far as the drinking fountain.	Water fountain has been removed and water refill stations meet compliance.	Staff or public can use the water refill station located in building C100. Staff can use public water fountains located in building B100 as those are ADA compliant. These water fountains would need to be updated in order to be compliant.	2012 TAS Section: 403.5.1, 602.1 2010 ADAS Section: 403.5.1, 602.1 2015 ABAAS Section: 403.5.1, 602.1

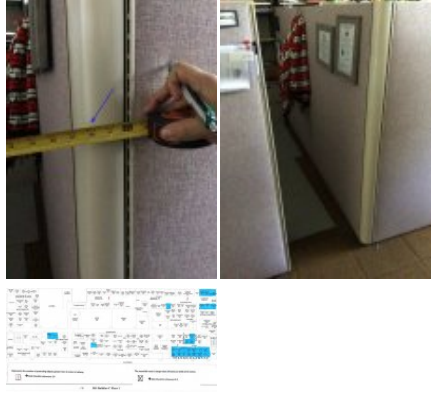
Finding Number	Area Description	Finding	As Built	Recommendation	Citation	Photos	Figure
100	First Floor, Building C100 (STAFF): Interior spaces (C100) - Cubicle entrances	27 cubicle door entrances spread throughout the C100 floor. Most infractions located AD and Landscape areas. **Details/locations are highlighted in blue in attached resource map. The door opening does not provide at least 32 inches between the face of the door and the opposite stop. Door openings shall provide a clear width of 32 inches minimum. Clear openings of doorways with swinging doors shall be measured between the face of the door and the stop, with the door open 90 degrees.	N/A	https://www.access-board.gov/ada/#ada-404_2_3	2012 TAS Section: 404.2.3 2010 ADAS Section: 404.2.3 2015 ABAAS Section: 404.2.3

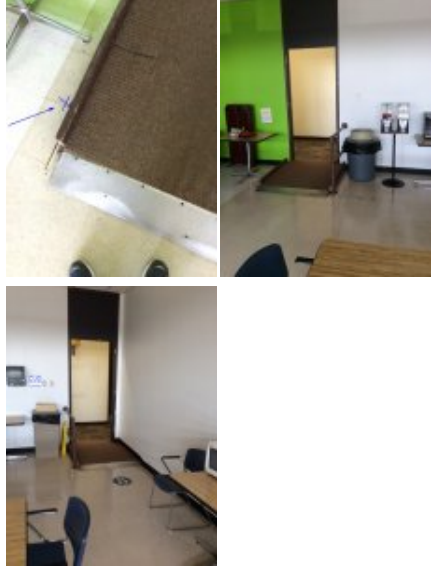
<p>Hinged Door</p>
101	First Floor, Building C100 (STAFF): Interior spaces (C100) - Cafeteria	The required edge protection is missing from the ramp run and/or ramp landing. ** Both ramps used in cafeteria. Edge protection shall be provided on each side of ramp runs and at each side of ramp landings. The floor or ground surface of the ramp run or landing shall extend 12 inches minimum beyond the inside face of a handrail or a curb or barrier shall be provided that prevents the passage of a 4 inch diameter sphere, where any portion of the sphere is within 4 inches of the finish floor or ground surface.	Edge protection and other elements of ramp are not compliant. Ramp has multiple infractions	Review ramp components to make accessible. https://www.access-board.gov/aba/#aba-405 Edge protection https://www.access-board.gov/ada/#ada-405_9 Extended ground or floor surface https://www.access-board.gov/ada/#ada-405_9_1 Curb or barrier https://www.access-board.gov/ada/#ada-405_9_2	2012 TAS Section: 405.9.1, 405.9.2, 405.9 2010 ADAS Section: 405.9.2, 405.9.1, 405.9 2015 ABAAS Section: 405.9, 405.9.1, 405.9.2

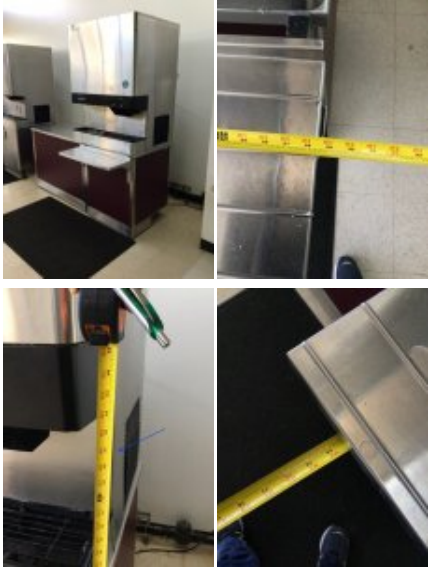
Finding Number	Area Description	Finding	As Built	Recommendation	Citation	Photos	Figure	
104	First Floor, Building C100 (STAFF): Interior spaces (C100) - Cafeteria	The ice machine used in cafeteria is not accessible due to multiple violations. **Section 904 in 2010 ADAS outlines access to service including ice machine placement and approach. The tops of tray slides shall be 28 inches minimum and 34 inches maximum above the finish floor.	N/A		https://www.access-board.gov/ada/#ada-904_5_2	2012 TAS Section: 904.5.2 2010 ADAS Section: 904.5.2 2015 ABAAS Section: 904.5.2

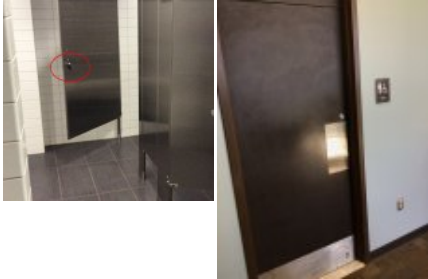
114	Second Floor, Building C200 (STAFF) : Restrooms and water fountains (C200) - Men's restroom (near elevator)	The water closet compartment is missing a loop handle on one side or both sides of the door. Water closet compartments must be equipped with a door that has a loop or U-shaped handle on both sides of the door immediately below the latch. The latch must be flip-over style, sliding or other hardware not requiring the user to grasp or twist.	N/A		https://www.access-board.gov/ada/#ada-604_8_1_2	2012 TAS Section: 604.8.1.2 2010 ADAS Section: 604.8.1.2 2015 ABAAS Section: 604.8.1.2

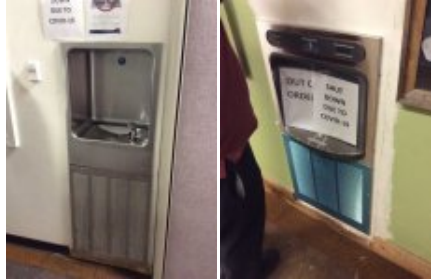
122	Second Floor, Building C200 (STAFF) : Restrooms and water fountains (C200) - Water Fountain	The drinking fountain is not accessible. The water fountains spread throughout C200 are not accessible due to a number of factors. **The water refill stations on C200 are compliant. Drinking fountains must be on an accessible route. An accessible route of travel is 36 inches wide minimum and provides a 30 inch by 48 inch clear floor space centered on the unit that allows a forward approach to the drinking fountain. At "hi-low" type fountains, the centerline of the 30 inch by 48 inch clear floor space must be centered on the "low" fountain. Spout outlets of drinking fountains for standing persons shall be 38 inches minimum and 43 inches maximum above the finish floor or ground. All drinking fountains shall be located completely within alcoves, positioned completely between wing walls, or otherwise positioned so as not to encroach into pedestrian ways. An alcove must not be less than 32 inches in width and 18 inches in depth. Wing walls must project out from the supporting wall at least as far as the drinking fountain.	Water fountain has been removed and water refill stations meet compliance.	Staff or public can use the water refill station located in building C200. Staff can use public water fountains located in building B100 as those are ADA compliant. These water fountains would need to be updated in order to be compliant.	2012 TAS Section: 403.5.1, 602.1 2010 ADAS Section: 403.5.1, 602.1 2015 ABAAS Section: 403.5.1, 602.1

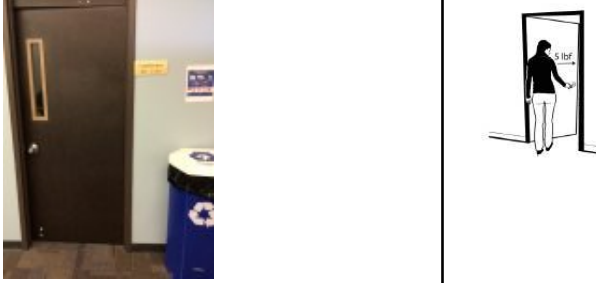
Finding Number	Area Description	Finding	As Built	Recommendation	Citation	Photos	Figure
126	Second Floor, Building C200 (STAFF) : Interior spaces (C200) - Conference Room C200	The door exceeds the maximum allowable opening force. Interior doors shall have a maximum opening force of 5 pounds. These forces do not apply to the force required to retract latch bolts or disengage other devices that hold the door or gate in a closed position.	exceed 5lbs force		https://www.access-board.gov/ada/#ada-404_2_9	2012 TAS Section: 404.2.9 2010 ADAS Section: 404.2.9 2015 ABAAS Section: 404.2.9

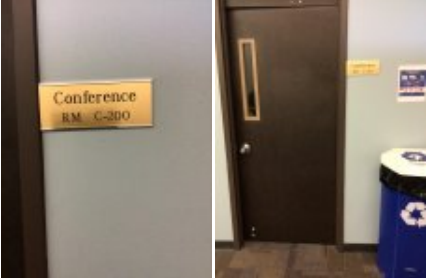
Finding Number	Area Description	Finding	As Built	Recommendation	Citation	Photos	Figure
128	Second Floor, Building C200 (STAFF) : Interior spaces (C200) - Conference Room C200	The room identification sign is noncompliant. Wall signs identifying permanent rooms and spaces of a building shall be in a horizontal format and the characters raised 1/32 inch minimum and shall be sans serif uppercase characters a minimum of 5/8 inch and a maximum of 2 inches high. Characters and their background shall have a non-glare finish. Characters shall contrast with their background with either light characters on a dark background or dark characters on a light background. Signs with raised characters or Braille shall be located 48 inches minimum above the finish floor or ground surface, measured from the baseline of the lowest tactile character and 60 inches maximum above the finish floor or ground surface, measured from the baseline of the highest tactile character.	Signs that identify a room, space or area are required to have raised characters and Braille. This requirement includes both public access areas as well as all employee areas.	Wall sign designation https://www.access-board.gov/ada/#ada-216_2 Wall signs general https://www.access-board.gov/ada/#ada-703_1	2012 TAS Section: 216.2, 703.1 2010 ADAS Section: 216.2, 703.1 2015 ABAAS Section: F216.2, 703.1

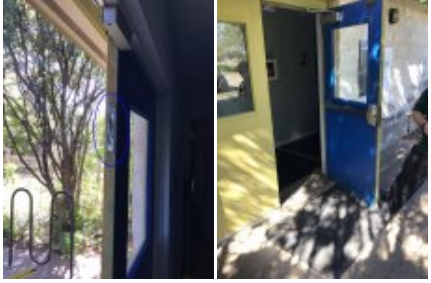
Finding Number	Area Description	Finding	As Built	Recommendation	Citation	Photos	Figure
132	First Floor, Gym (STAFF) : Building Entrance - Gym entry doors (from parking lot)	The right door is compliant, the left door is not. There are no handles on either side of left door. Door can only be opened by internal latches that are not accessible. The operating hardware requires tight grasping, pinching or twisting of the wrist to operate. Hand-activated hardware, handles, pulls, latches, locks, and other operating devices on accessible elements shall have a shape that is easy to grasp with one hand and does not require tight grasping, pinching or twisting of the wrist to operate.	double door (pictured) opening/locking mechanism is not compliant.	Make right side entrance door fully accessible or add accessible door mechanisms including handles, and entrance requirements to left door. https://www.access-board.gov/ada/#ada-309_4	2012 TAS Section: 309.4 2010 ADAS Section: 309.4 2015 ABAAS Section: 309.4

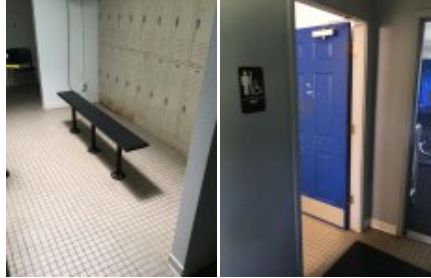
136	First Floor, Gym (STAFF) : Dressing Rooms and Water Fountains - Men's Dressing Room	The bench is not affixed to a wall or provides back support. The bench shall provide for back support or shall be affixed to a wall along its long dimension. Back support shall be 42 inches long minimum and shall extend from a point 2 inches maximum above the seat surface to a point 18 inches minimum above the seat surface. Back support shall be 2 -1/2 inches maximum from the rear edge of the seat measured horizontally.	locker room benches are required to have back support		https://www.access-board.gov/ada/#ada-903_4	2012 TAS Section: 903.4 2010 ADAS Section: 903.4 2015 ABAAS Section: 903.4

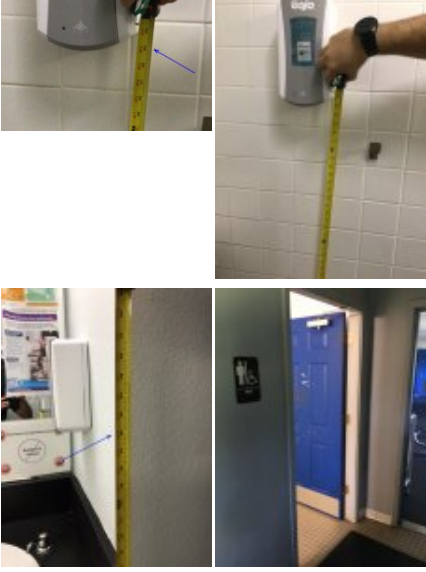
Finding Number	Area Description	Finding	As Built	Recommendation	Citation	Photos	Figure
137	First Floor, Gym (STAFF) : Dressing Rooms and Water Fountains - Men's Dressing Room	The soap dispenser's operation mechanism is too high off the floor. The soap dispenser used in men's back restroom stall. **Both soap dispensers in men's restroom. Dispensers must have all operable parts a maximum of 48 inches above the floor.	over 48"	https://www.access-board.gov/ada/#ada-308_2_1 https://www.access-board.gov/ada/#ada-308_2_2	2012 TAS Section: 308.2.1 2010 ADAS Section: 308.2.1 2015 ABAAS Section: 308.2.1

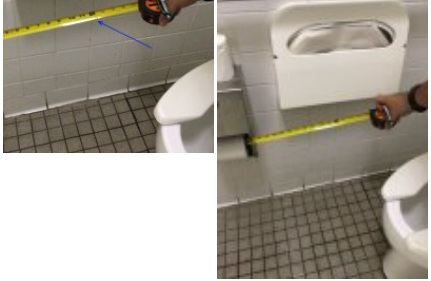
Finding Number	Area Description	Finding	As Built	Recommendation	Citation	Photos	Figure
139	First Floor, Gym (STAFF) : Dressing Rooms and Water Fountains - Men's Dressing Room	The toilet paper is not installed within the compliant range. Both toilet paper dispensers used in Men's ** Measures at 12" Toilet paper dispensers shall be 7 inches minimum and 9 inches maximum in front of the water closet measured to the centerline of the dispenser. The outlet of the dispenser shall be 15 inches minimum and 48 inches maximum above the finish floor and shall not be located behind grab bars. Dispensers shall not be of a type that controls delivery or that does not allow continuous paper flow. There shall be a clearance of 1 1/2 inches minimum below the grab bar.	TP dispenser not located in correct location	https://www.access-board.gov/ada/#ada-604_7	2012 TAS Section: 604.7 2010 ADAS Section: 604.7 2015 ABAAS Section: 604.7

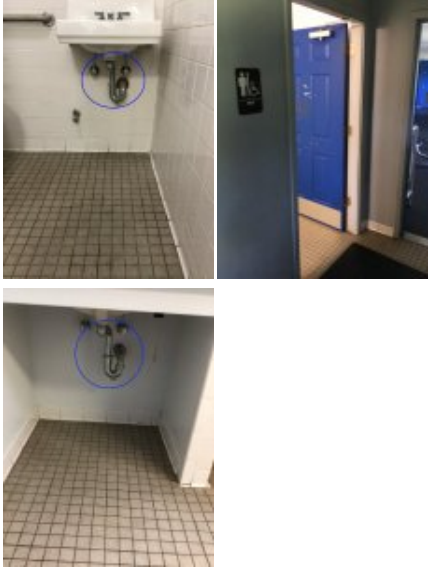
Finding Number	Area Description	Finding	As Built	Recommendation	Citation	Photos	Figure	
141	First Floor, Gym (STAFF) : Dressing Rooms and Water Fountains - Men's Dressing Room	The water and drain pipes under the lavatory are not adequately insulated. ** Both sinks in men's restroom. Water supply and drain pipes under lavatories and sinks shall be insulated or otherwise configured to protect against contact. There shall be no sharp or abrasive surfaces under lavatories and sinks.	pipes are exposed for both sinks provided.		https://www.access-board.gov/ada/#ada-606_5	2012 TAS Section: 606.5 2010 ADAS Section: 606.5 2015 ABAAS Section: 606.5

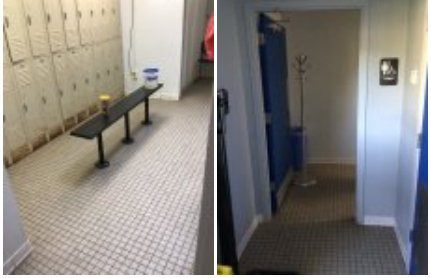
143	First Floor, Gym (STAFF) : Dressing Rooms and Water Fountains - Women's Dressing Room	The bench is not affixed to a wall or provides back support. The bench shall provide for back support or shall be affixed to a wall along its long dimension. Back support shall be 42 inches long minimum and shall extend from a point 2 inches maximum above the seat surface to a point 18 inches minimum above the seat surface. Back support shall be 2 -1/2 inches maximum from the rear edge of the seat measured horizontally.	Locker room benches are required to have back support		https://www.access-board.gov/ada/#ada-903_4	2012 TAS Section: 903.4 2010 ADAS Section: 903.4 2015 ABAAS Section: 903.4

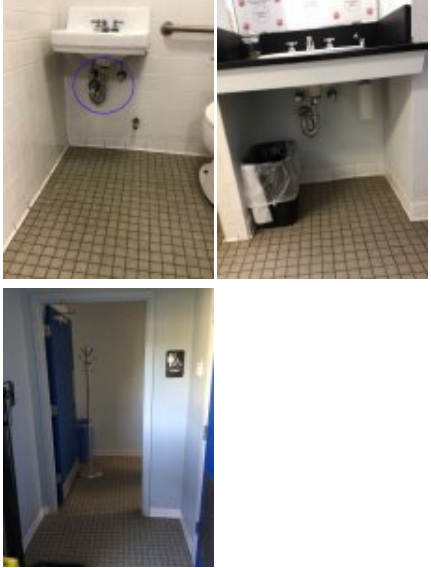
Finding Number	Area Description	Finding	As Built	Recommendation	Citation	Photos	Figure
149	First Floor, Gym (STAFF) : Dressing Rooms and Water Fountains - Women's Dressing Room	The water and drain pipes under the lavatory are not adequately insulated. Water supply and drain pipes under lavatories and sinks shall be insulated or otherwise configured to protect against contact. There shall be no sharp or abrasive surfaces under lavatories and sinks.	pipes are not insulated Both sinks in women's bathroom	https://www.access-board.gov/ada/#ada-606_5	2012 TAS Section: 606.5 2010 ADAS Section: 606.5 2015 ABAAS Section: 606.5
