Access Audit Site Reports

Atlanta State Park

Accessibility Evaluation

Inspection Date: 04/05/2022

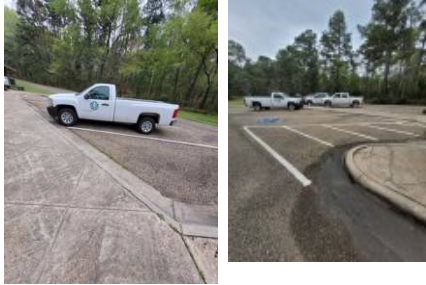
Finding Number	Area Description	Lat/Long	Finding	As Built	Recommendation	Citation	Photos	Figure
1	Headquarters Area: HQ - Parking	[33.2309548 , -94.249727 6]	Element meets all standards and requirements	Parking lot meets scoping - 8 standard spaces, 1 accessible space	None	2010 ADAS Section: N/A

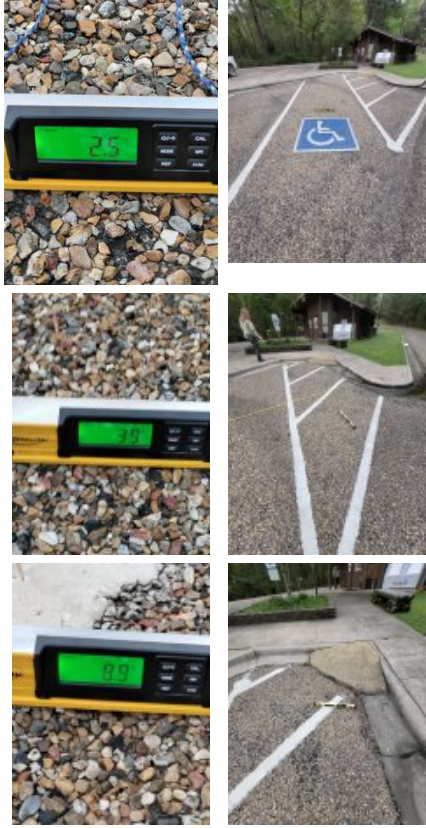
2	Headquarters Area: HQ - Parking	[33.2309167 , -94.249700 7]	The cross slopes (narrow dimension) and/or running slopes (long dimension) of the access aisle exceeds 2%. The running slope and the cross slope in an accessible parking stall and the access aisle must not exceed 2%.	2.5% slope in stall, 3.9% and 8.9% slope in access aisle	Repair or correct slope of parking space and access aisle to max 2.08% in any direction.	2015 ABAAS Section: 502.4 2012 TAS Section: 502.4 2010 ADAS Section: 502.4

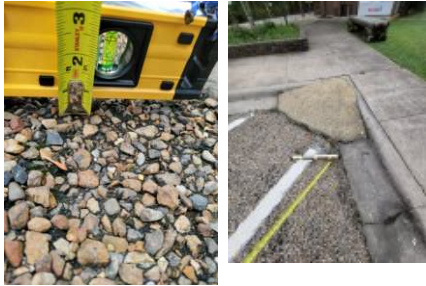
Finding Number	Area Description	Lat/Long	Finding	As Built	Recommendation	Citation	Photos	Figure
3	Headquarters Area: HQ - Parking	[33.2309234, -94.2497007]	The parking stall contains abrupt edges and surface irregularities over a 1/4 inch vertical. Parking spaces and access aisles serving them shall be stable, firm, and slip resistant. Access aisles shall be at the same level as the parking spaces they serve. Changes in level are not permitted and shall not be sloped steeper than 2% in any direction.	.75" Change in Level (CIL) along curb	Repair, bevel and ramp CIL in stalls and access aisles	2015 ABAAS Section: 502.4 2012 TAS Section: 502.4 2010 ADAS Section: 502.4

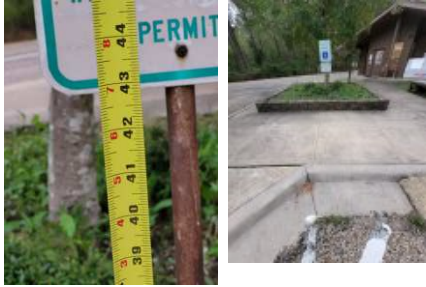
4	Headquarters Area: HQ - Parking	[33.230892, -94.2497007]	The parking sign is mounted too low. Parking space identification signs shall include the International Symbol of Accessibility complying with. Signs identifying van parking spaces shall contain the designation "van accessible." Signs shall be 60 inches minimum above the finish floor or ground surface measured to the bottom of the sign.	43" Above Grade Level (AGL) to sign bottom	Raise existing accessible parking signs so lowest end of bottom sign is min 60" above ground level (AGL) measured from the surface of the stall.	2015 ABAAS Section: 502.6 2012 TAS Section: 502.6 2010 ADAS Section: 502.6

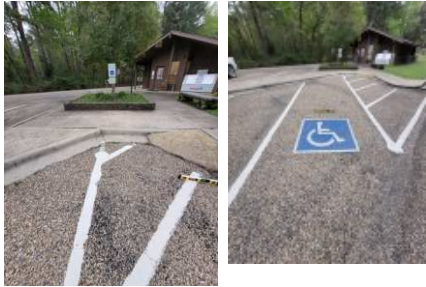
5	Headquarters Area: HQ - Parking	[33.2308606, -94.2496967]	The van stall is missing a sign identifying it as a van accessible stall. Parking space identification signs shall include the International Symbol of Accessibility. Signs identifying van parking spaces shall contain the designation "van accessible."	Space lacks van sign	Add one van parking sign to one accessible stall and assure stall and access aisle are 11' and 5' or 8' and 8'	2015 ABAAS Section: 502.6 2012 TAS Section: 502.6 2010 ADAS Section: 502.6

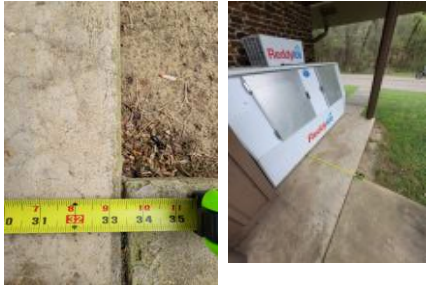
Finding Number	Area Description	Lat/Long	Finding	As Built	Recommendation	Citation	Photos	Figure
8	Headquarters Area: HQ - Exterior Accessible Route	[33.2307111 , -94.249753 3]	There is no accessible route to the ice machine At least one accessible route shall connect accessible buildings, accessible facilities, accessible elements, and accessible spaces that are on the same site.	Lacks AR to ice machine, 33.5" wide	Create an accessible route with crushed stone or other outdoor material from parking or walkway to the ice machine	2015 ABAAS Section: F206.2.2 2012 TAS Section: 206.2.2 2010 ADAS Section: 206.2.2

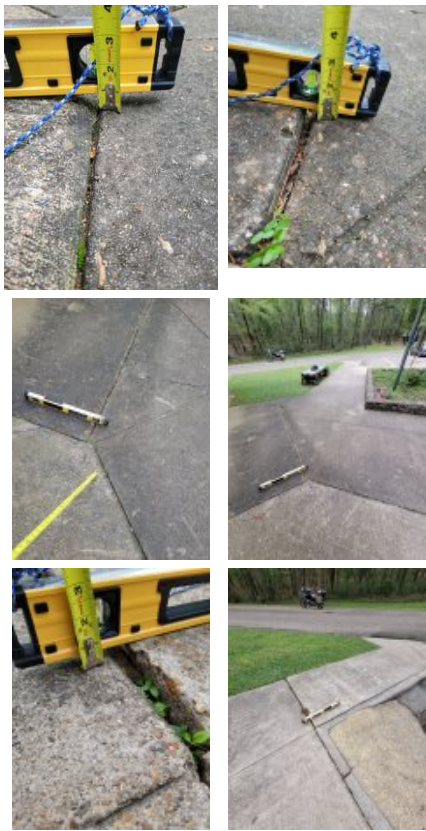
9	Headquarters Area: HQ - Exterior Accessible Route	[33.2307731 , -94.249701 5]	The walkway contains abrupt vertical edges and/or variations over a 1/4 inch. 1/4 inch is the maximum vertical rise. Changes in level between 1/4 inch and 1/2 inch must be beveled at 1:2 or less. Changes in level greater than 1/2 inch must be by way of a ramp.	.5" near apparent ramp, .75" and .5" CIL on Route from parking to entry	Repair, bevel or ramp CIL along AR.	2012 TAS Section: 303.2, 303.3 2010 ADAS Section: 303.2, 303.3

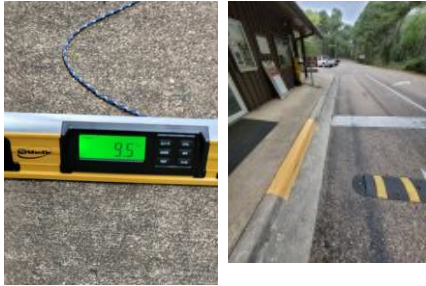
Finding Number	Area Description	Lat/Long	Finding	As Built	Recommendation	Citation	Photos	Figure
10	Headquarters Area: HQ - Exterior Accessible Route	[33.2306924 , -94.249643 8]	The accessible path of travel has cross slopes greater than 2%. Surface cross slopes shall not exceed one unit vertical in 48 units horizontal (2-percent slope). When the slope in the direction of travel of any walk exceeds 1 unit vertical in 20 units horizontal (5-percent slope), it must be constructed as a ramp.	9.5% slope at pay station on Route from drive to side entry	Correct slope to be 2.08% max. in any direction for a level clear ground space.	2015 ABAAS Section: 403.3 2012 TAS Section: 403.3 2010 ADAS Section: 403.3

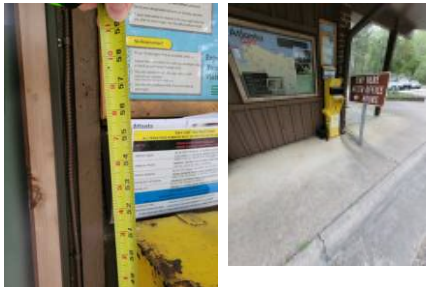
11	Headquarters Area: HQ - Exterior Accessible Route	[33.2307271 , -94.249645 1]	The operable part is positioned too high for either a side or front approach. Where a clear floor or ground space allows a parallel approach to an element and the side reach is unobstructed, the high side reach shall be 48 inches maximum and the low side reach shall be 15 inches minimum above the finish floor or ground.	55" AGL to envelopes at pay station on route from drive to side entry	Remount operable parts to be in reach range of 15" min to 48" max	2015 ABAAS Section: 308.1 2012 TAS Section: 308.1 2010 ADAS Section: 308.1

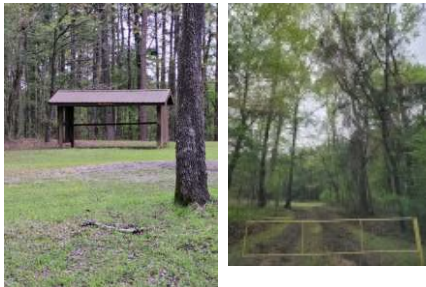
12	Headquarters Area: HQ - Public Spaces	[33.2316929 , -94.251487 1]	There is no accessible route to the fish cleaning station. At least one accessible route shall connect accessible buildings, accessible facilities, accessible elements, and accessible spaces that are on the same site.	Old fish cleaning across maintenance- no longer in use, no AR	Leave as is unused fish cleaning station. Make access corrections if reinstated.	2015 ABAAS Section: F206.2.2 2012 TAS Section: 206.2.2 2010 ADAS Section: 206.2.2

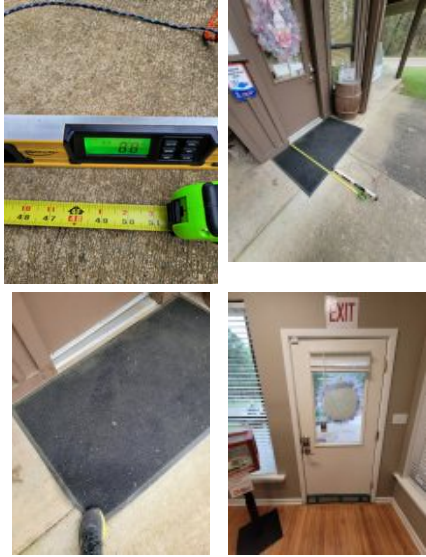
Finding Number	Area Description	Lat/Long	Finding	As Built	Recommendation	Citation	Photos	Figure
16	Headquarters Area: HQ - Public Spaces	[33.2307058 , -94.249703 4]	Minimum maneuvering clearances at doors and gates shall comply with 404.2.4. Maneuvering clearances shall extend the full width of the doorway and the required latch side or hinge side clearance. Maneuvering clearances shall have a max slope of 2.08%. Egress doors shall provide a continuous and unobstructed way of egress travel from any point in a building or facility that provides an accessible route to an area of refuge, a horizontal exit, or a public way.	8.8% slope on push side, loose mat, lacks accessible exit signage	For all doors along the public circulation route, provide required maneuvering clearance on push and pull side of doors. For all doors along the public circulation route, secure rug in door clearance to prevent trip hazard. For all doors along the public circulation route, correct slope in door clearance to max 2.08%. Provide require egress signage having Braille and raised lettering.	2010 ADAS Section: 404.2.3, 404.2.7, 404.2.4, 404.2.11, 404.2.11 Exception

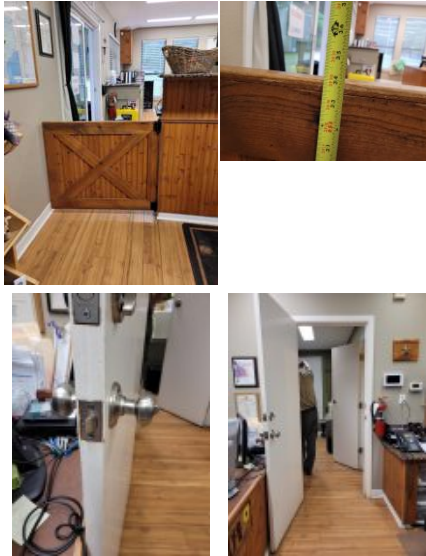
17	Headquarters Area: HQ - Employee Spaces	[33.2307069 , -94.249668 5]	Spaces and elements within employee work areas shall only be required to comply with 206.2.8, 207.1, and 215.3 and shall be designed and constructed so that individuals with disabilities can approach, enter, and exit the employee work area. Employee work areas, or portions of employee work areas, other than raised courtroom stations, that are less than 300 square feet (28 m2) and elevated 7 inches (180 mm) or more above the finish floor or ground where the elevation is essential to the function of the space shall not be required to comply with these requirements or to be on an accessible route.	employee area, half door to area from check in counter - lacks clearance on both sides; from open work space to office area - knob; sliding door - 6" clearance on interior side, loose rug not secured, 2" CIL, 15 LBF, 9% slope	For employee spaces, relocate storage, furniture, and other obstacles at doorways to provide approach, enter and exit at the employee space, replace hardware with lever hardware where indicated, provide required maneuvering clearance on push and pull side of doors, secure loose floor mat, repair, bevel, or ramp CIL at door entries to max .25", inspect, adjust, and maintain 8.5 LBF to open exterior doors as a smart practice, correct or repair slope at doorway landing to max 2.08% in any direction for level CFS	2015 ABAAS Section: F203.9 2012 TAS Section: 203.9 2010 ADAS Section: 203.9

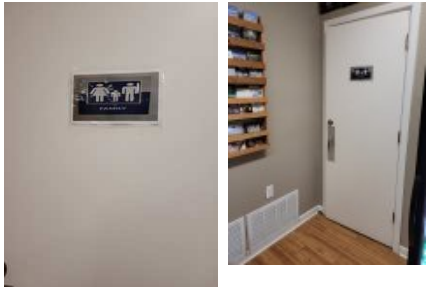
19	Headquarters Area: HQ - Family Restroom	[33.2307417 , -94.249711 5]	The restroom sign does not comply with one or more applicable requirements for the location, height, and properties of the sign.	Non compliant signage, non compliant location	Acquire and mount signage, including Braille and raised lettering mounted on wall, latch side of door, 48" to baseline of lowest character and 60" to baseline of highest character	2015 ABAAS Section: F216.2, 703.1, 703.2, 703.5, 703.6 2012 TAS Section: 216.2, 703.1, 703.2, 703.5, 703.6 2010 ADAS Section: 216.2, 703.1, 703.2, 703.5, 703.6

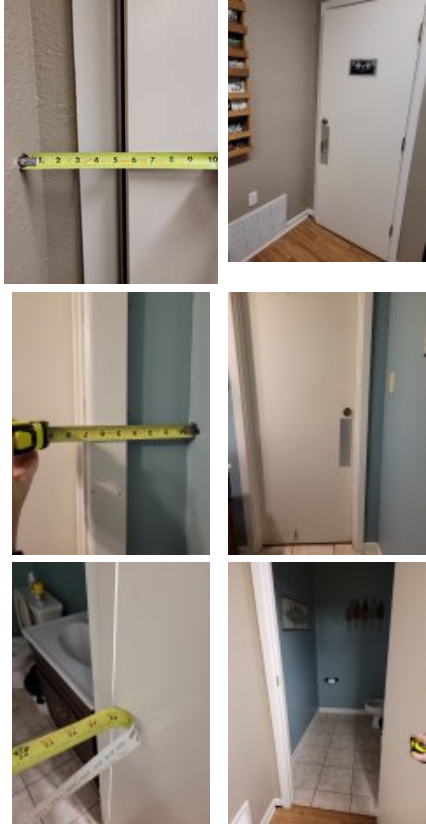
Finding Number	Area Description	Lat/Long	Finding	As Built	Recommendation	Citation	Photos	Figure
20	Headquarters Area: HQ - Family Restroom	[33.2307304 , -94.249707 4]	Minimum maneuvering clearances at doors and gates shall comply with 404.2.4. Maneuvering clearances shall extend the full width of the doorway and the required latch side or hinge side clearance. Maneuvering clearances shall have a max slope of 2.08%. Door openings shall provide a clear width of 32 inches (815 mm) minimum. Clear openings of doorways with swinging doors shall be measured between the face of the door and the stop, with the door open 90 degrees. Openings more than 24 inches (610 mm) deep shall provide a clear opening of 36 inches (915 mm) minimum. There shall be no projections into the required clear opening width lower than 34 inches (865 mm) above the finish floor or ground. Projections into the clear opening width between 34 inches (865 mm) and 80 inches (2030 mm) above the finish floor or ground shall not exceed 4 inches (100 mm).	Restroom door - 5.25" clearance on the pull side, clearance on push side 7.5", 28" width	For all doors along the public circulation route, provide required maneuvering clearance on push and pull side of doors. For all doors along the public circulation route, replace doors with doors having 80" overhead clearance and 32" clear width.	2010 ADAS Section: 404.2.3, 404.2.7, 404.2.4, 404.2.11, 404.2.11 Exception

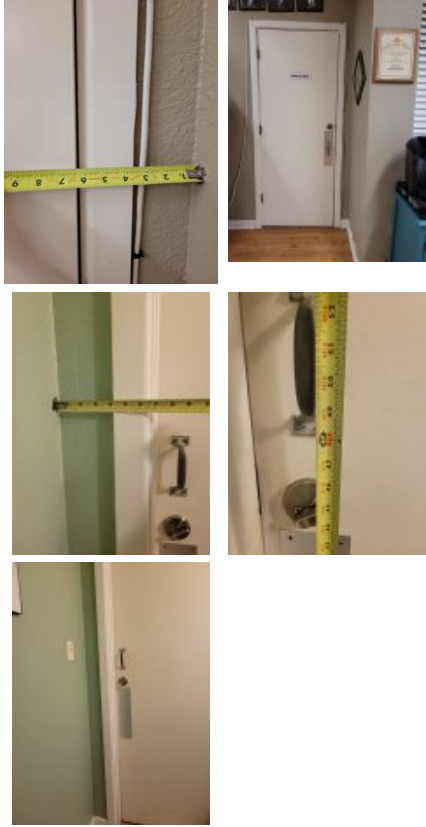
Finding Number	Area Description	Lat/Long	Finding	As Built	Recommendation	Citation	Photos	Figure
23	Headquarters Area: HQ - Employee Restroom	[33.2307215, -94.2497007]	Minimum maneuvering clearances at doors and gates shall comply with 404.2.4. Maneuvering clearances shall extend the full width of the doorway and the required latch side or hinge side clearance. Maneuvering clearances shall have a max slope of 2.08%. Relocate hardware to be 34 inches minimum and 48 inches maximum above the finish floor or ground.	6" clearance on pull, 7" clearance on push, handle 49" AFF	For all doors along the public circulation route, provide required maneuvering clearance on push and pull side of doors. Relocate hardware to be 34 inches minimum and 48 inches maximum above the finish floor or ground.	2010 ADAS Section: 404.2.3, 404.2.7, 404.2.4, 404.2.11, 404.2.11 Exception

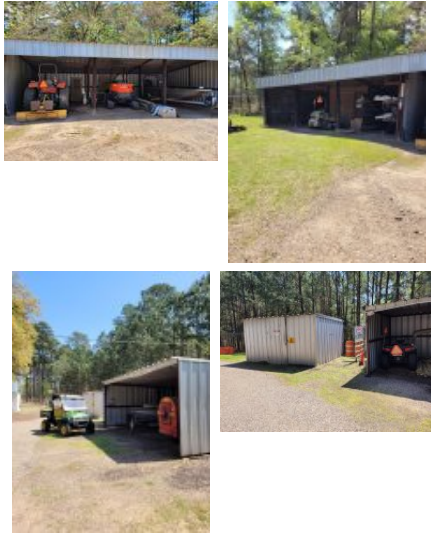
Finding Number	Area Description	Lat/Long	Finding	As Built	Recommendation	Citation	Photos	Figure
24	Employee Areas: Maintenance	[33.2338277 , -94.2498308]	There is no accessible route to the car ports. At least one accessible route shall connect accessible buildings, accessible facilities, accessible elements, and accessible spaces that are on the same site.	No accessible route (AR) to 2 of 2 exterior car ports	Create an accessible route with crushed stone or other outdoor material from parking or walkway to the car ports	2015 ABAAS Section: F206.2.2 2012 TAS Section: 206.2.2 2010 ADAS Section: 206.2.2

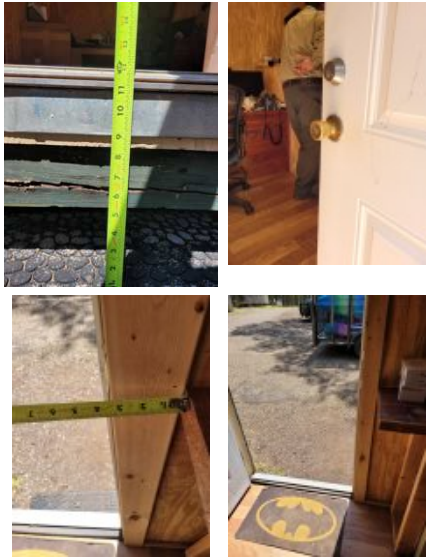
25	Employee Areas: Maintenance	[33.2336942 , -94.2497544]	Spaces and elements within employee work areas shall only be required to comply with 206.2.8, 207.1, and 215.3 and shall be designed and constructed so that individuals with disabilities can approach, enter, and exit the employee work area. Employee work areas, or portions of employee work areas, other than raised courtroom stations, that are less than 300 square feet (28 m2) and elevated 7 inches (180 mm) or more above the finish floor or ground where the elevation is essential to the function of the space shall not be required to comply with these requirements or to be on an accessible route.	Shed office at maintenance- 12"CIL, knob, clearance on pull 3.5"	For employee spaces, relocate storage, furniture, and other obstacles at doorways to provide approach, enter and exit at the employee space.	2015 ABAAS Section: F203.9 2012 TAS Section: 203.9 2010 ADAS Section: 203.9

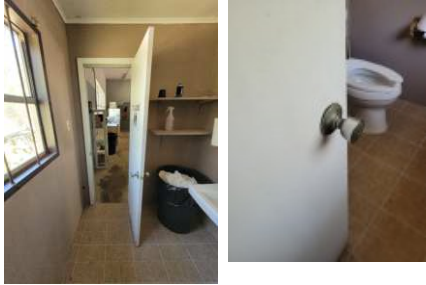
Finding Number	Area Description	Lat/Long	Finding	As Built	Recommendation	Citation	Photos	Figure
34	Employee Areas: Maintenance	[33.2338064 , -94.249840 2]	Minimum maneuvering clearances at doors and gates shall comply with 404.2.4. Maneuvering clearances shall extend the full width of the doorway and the required latch side or hinge side clearance. Maneuvering clearances shall have a max slope of 2.08%. Hand-activated door opening hardware, handles, pulls, latches, locks, and other operating devices on accessible doors shall have a shape that is easy to grasp with one hand and does not require tight grasping, tight pinching or twisting of the wrist to operate. Hardware shall be 34 inches minimum and 48 inches maximum above the finish floor or ground.	Restroom door - Lacks clearance on pull side of door, knob hardware	For all doors along the public circulation route, provide required maneuvering clearance on push and pull side of doors. For all doors along the public circulation route, replace hardware with lever hardware or hardware operable without a tight pinch or grasp.	2010 ADAS Section: 404.2.3, 404.2.7, 404.2.4, 404.2.11, 404.2.11 Exception

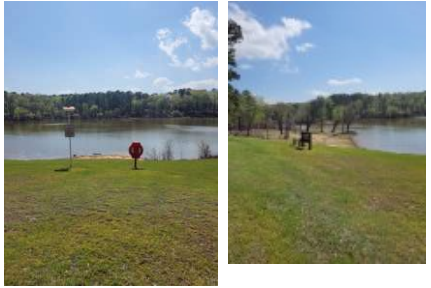
Total Number of Parking Spaces Provided in Parking Facility	Minimum Number of Required Accessible Parking Spaces	2015 ABAAS	3	2012 TAS	3	2010 ADAS	3	2015 ABAAS	3	2012 TAS	3	2010 ADAS	3	Source of Code		30' clear for each stall in parallel format per 2010		
Total Number of Parking Spaces Provided in Parking Facility	Minimum Number of Required Accessible Parking Spaces																									
2015 ABAAS	3																									
2012 TAS	3																									
2010 ADAS	3																									
2015 ABAAS	3																									
2012 TAS	3																									
2010 ADAS	3																									
Source of Code																										
30' clear for each stall in parallel format per 2010																										
38	Knights Bluff Boat Ramp Area: Boat Ramp - Swimming	[33.2340015 , -94.257083 5]	Beach access routes shall connect an entry point to the beach to the: 1. High tide level at tidal beaches; 2. Mean high water level at river beaches; or 3. Normal recreation water level at lake, pond, and reservoir beaches	No AR to swimming, no AR to safety float	Create a beach access route to normal recreational water level of a firm and stable material as a smart practice and extend to safety float.	2015 ABAAS Section: 1018.2

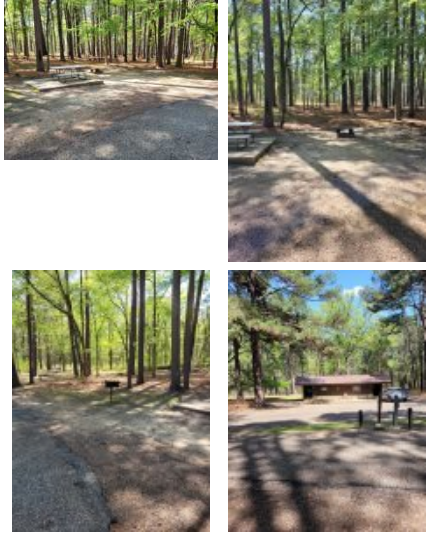
Finding Number	Area Description	Lat/Long	Finding	As Built	Recommendation	Citation	Photos	Figure
44	Knights Bluff Camping Area: Knights Bluff - Campsite	[33.2350033 , -94.254487 1]	An accessible access route is not provided between elements, spaces and the facilities provided within the accessible camping unit. At least one outdoor recreation access route shall connect accessible elements, spaces and facilities provided within camping units with mobility features.	Across from restroom, no AR to picnic area amenities	Create AR with crushed and compacted stone or similar outdoor material to camp sites and one of each type of amenity as a smart practice.	2015 ABAAS Section: F244.5.1

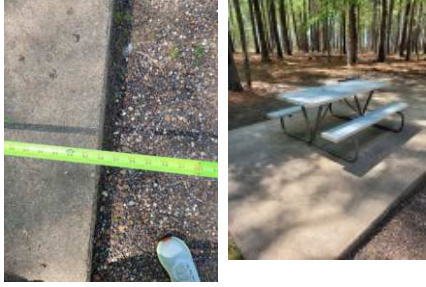
46	Knights Bluff Camping Area: Knights Bluff - Campsite	[33.2349909 , -94.254582 3]	Picnic tables are required to have clear ground space 36 inches (915 mm) on all usable sides of the table measured from the back edge of the benches.	site 22 - 26" around side of table	Provide required 36" clear ground space around all usable portions of the table as a smart practice.	2015 ABAAS Section: 1011.2.1

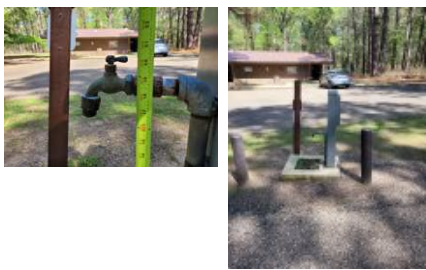
49	Knights Bluff Camping Area: Knights Bluff - Campsite	[33.2350313 , -94.254501 9]	Water spouts at water hydrants and water utility hook-ups shall be 28 inches (710 mm) minimum and 36 inches (915 mm) maximum above the ground	Site 22 - spout 20" Above Ground Level (AGL)	Remount water spouts to 28" min or 36" max above the ground as a smart practice	2015 ABAAS Section: 1011.6

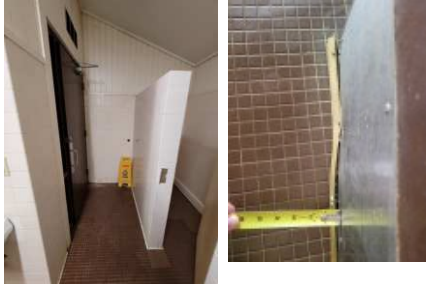
54	Knights Bluff Camping Area: Knights Bluff - Men's Restroom	[33.235121, -94.2542015]	Minimum maneuvering clearances at doors and gates shall comply with 404.2.4. Maneuvering clearances shall extend the full width of the doorway and the required latch side or hinge side clearance. Maneuvering clearances shall have a max slope of 2.08%. The bottom 10 inches on the push side must be smooth and free of obstructions (hold open devices). Opening hardware must be mounted between 30 and 44 inches above the floor or ground.	Door - Wall to shower blocks door pull clearance, door sweep broken	For all doors along the public circulation route, provide required maneuvering clearance on push and pull side of doors. For all doors along the public circulation route, provide kick plate on push side of door from floor to 10" AFF.	2010 ADAS Section: 404.2.3, 404.2.7, 404.2.4, 404.2.11, 404.2.11 Exception

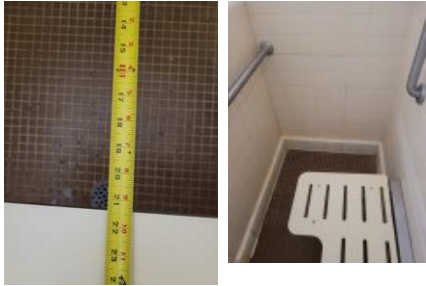
Finding Number	Area Description	Lat/Long	Finding	As Built	Recommendation	Citation	Photos	Figure
58	Knights Bluff Camping Area: Knights Bluff - Men's Restroom	[33.2351166 , -94.254185 4]	The shower seat does not have a compliant space between it and the wall. The folding seat must be mounted 17-19 inches above the floor, and have a maximum space of 1-1/2 inches between the edge of the seat and the side wall and 2-1/2 inches maximum to the seat wall.	Rear edge of seat 21.5" from wall, takes more than 5 LBF to operate	Remount shower seat to the correct location and height in the shower. Adjust seat so operating force is less than 5 LBF	2015 ABAAS Section: 610.3.2 2012 TAS Section: 610.3.2 2010 ADAS Section: 610.3.2

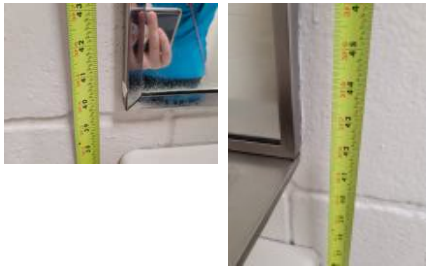
59	Knights Bluff Camping Area: Knights Bluff - Men's Restroom	[33.2350537 , -94.254153 2]	The mirror is mounted too high. Mirrors must have the bottom edge of the reflecting surface a maximum of 40 inches above the floor if above a sink or counter. Mirrors not located above lavatories or countertops shall be installed with the bottom edge of the reflecting surface 35 inches maximum above the finish floor or ground.	0 of 2 mirrors complies, bottom of left mirror surface is 40.25" AFF, right mirror is 42" AFF	Raise one mirror so top of reflective surface is min. 74" AFF (and bottom of reflecting surface is max 40" AFF)	2015 ABAAS Section: 603.3 2012 TAS Section: 603.3 2010 ADAS Section: 603.3

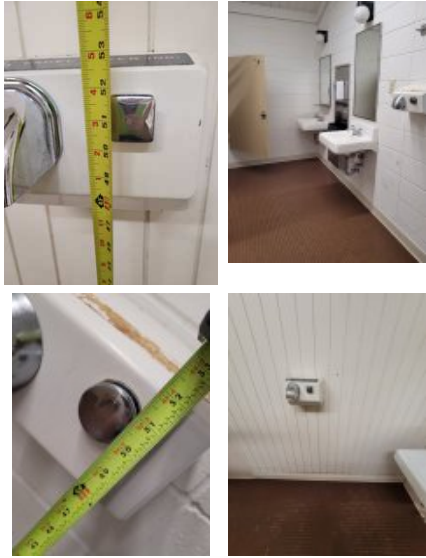
Finding Number	Area Description	Lat/Long	Finding	As Built	Recommendation	Citation	Photos	Figure
60	Knights Bluff Camping Area: Knights Bluff - Men's Restroom	[33.2350986 , -94.254131 7]	The operable part is positioned too high for either a side or front approach. Where a clear floor or ground space allows a parallel approach to an element and the side reach is unobstructed, the high side reach shall be 48 inches maximum and the low side reach shall be 15 inches minimum above the finish floor or ground. Where a forward reach is unobstructed, the high forward reach shall be 48 inches maximum and the low forward reach shall be 15 inches minimum above the finish floor or ground.	Dryer button 51" AFF	Remount operable parts to be in reach range of 15" min to 48" max. In the alternative, leave as is citing safe harbor.	2015 ABAAS Section: 308.1 2012 TAS Section: 308.1 2010 ADAS Section: 308.1

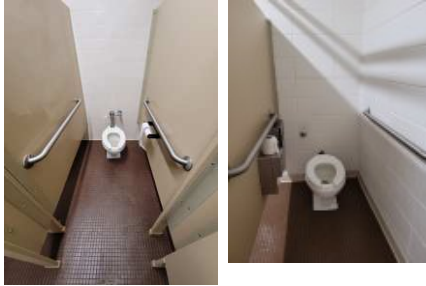
61	Knights Bluff Camping Area: Knights Bluff - Men's Restroom	[33.2350807 , -94.254206 8]	There are not enough accessible toilet compartments. The room contains toilet compartments. A minimum of 1 must be wheelchair accessible .	Lacks wheelchair accessible stall, ambulatory stall only	Create a wheelchair accessible stall with grab bars and fixtures mounted in correct locations and at correct heights.	2015 ABAAS Section: F213.3.1 2012 TAS Section: 213.3.1 2010 ADAS Section: 213.3.1

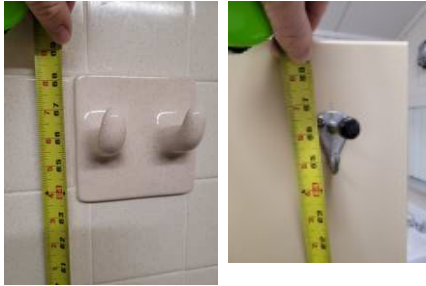
Finding Number	Area Description	Lat/Long	Finding	As Built	Recommendation	Citation	Photos	Figure
62	Knights Bluff Camping Area: Knights Bluff - Men's Restroom	[33.2350986 , -94.254196 1]	Coat hooks provided within the room shall be located within one of the reach ranges specified in 308. Where coat hooks or shelves are provided in dressing, fitting or locker rooms without individual compartments, at least one of each type shall comply with 803.5. Where coat hooks or shelves are provided in individual compartments at least one of each type complying with 803.5 shall be provided in individual compartments in dressing, fitting, or locker rooms required to comply with 222.1.	Hooks 67" and 65.25" AFF	Remount at least one hook to max 48" AFF	2015 ABAAS Section: 308.2.1, 308.1, F222.2, 803.5 2012 TAS Section: 308.2.1, 308.1, 222.2, 803.5 2010 ADAS Section: 308.2.1, 308.1, 222.2, 803.5

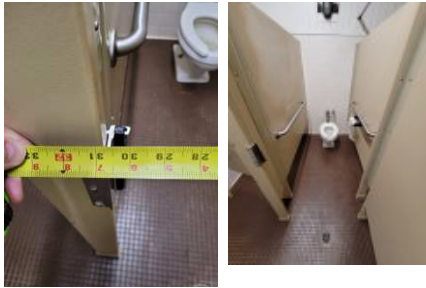
63	Knights Bluff Camping Area: Knights Bluff - Men's Restroom	[33.2351166 , -94.254217 6]	The ambulatory stall is not between 35" to 37" wide and 60" deep.	31" width	Correct ambulatory stall to be 35" to 37" wide and minimum 60" deep. In the alternative, use existing stall to create required wheelchair stall.	2015 ABAAS Section: 604.8.2.1 2012 TAS Section: 604.8.2.1 2010 ADAS Section: 604.8.2.1

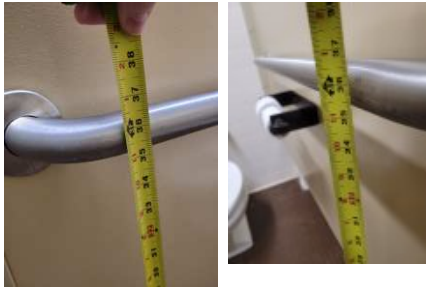
64	Knights Bluff Camping Area: Knights Bluff - Men's Restroom	[33.2351255 , -94.254185 4]	The grab bar height and/or spacing fails. Grab bars must be mounted between 33" and 36" to the top of the gripping surface. There must be 1.5" of clearance between the grab bar and the wall. There must be a minimum of 1.5" of clearance below and minimum 12" above the grab bar to any dispenser or other obstruction.	Both grab bars too high	Remount grab bars in accessible stall to 33" to 36" above the finished floor (AFF).	2015 ABAAS Section: 609.3, 609.4 2012 TAS Section: 609.4, 609.3 2010 ADAS Section: 609.3, 609.4

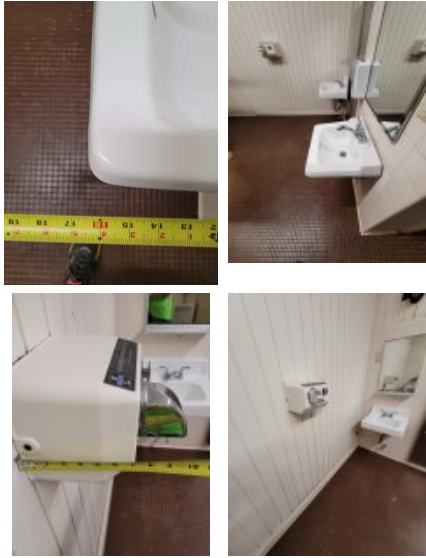
Finding Number	Area Description	Lat/Long	Finding	As Built	Recommendation	Citation	Photos	Figure
65	Knights Bluff Camping Area: Knights Bluff - Men's Restroom	[33.2351031 , -94.254196 1]	An item or items project more than 4 inches into the circulation path. Wall-mounted objects that have leading edges between 27 inches and 80 inches from the floor must not project more than 4 inches into the circulation path. Protruding objects that extend to the floor or within 27 inches of the floor are cane detectable and are therefore not hazardous. Where it is necessary or desirable to have objects protrude from the wall, a manner of cane detection must be provided.	Sink projects 16" and Dryer projects 9.5"	Relocate protruding objects or place cane detectable warning or bollard at foot of items.	2015 ABAAS Section: 307.2 2012 TAS Section: 307.2 2010 ADAS Section: 307.2

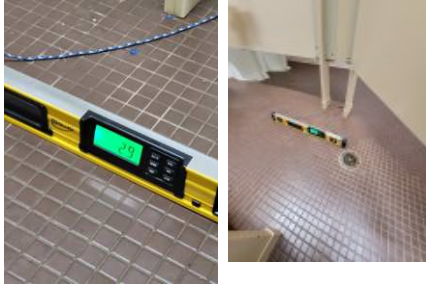
Finding Number	Area Description	Lat/Long	Finding	As Built	Recommendation	Citation	Photos	Figure
67	Knights Bluff Camping Area: Knights Bluff - Men's Restroom	[33.2350627 , -94.254174 7]	The accessible route contains running slopes greater than 5 percent and cross slopes greater than 2 percent across the width of the walk and has not been constructed as a ramp (i.e. handrails, wheel guides, etc.). When the slope in the direction of travel of any walk exceeds 1 unit vertical in 20 units horizontal (5-percent slope), it must be constructed as ramp. Surface cross slopes must not exceed one unit vertical in 48 units. Horizontal (2-percent slope).	2.9% cross slope at ambulatory stall	Correct or repair slope to max 2.08% in restroom.	2015 ABAAS Section: 403.3 2012 TAS Section: 403.3 2010 ADAS Section: 403.3

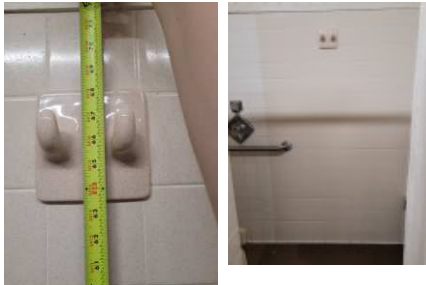
68	Knights Bluff Camping Area: Knights Bluff - Women's Restroom	[33.2351143 , -94.254193 4]	Coat hooks provided within the room shall be located within one of the reach ranges specified in 308. Where coat hooks or shelves are provided in dressing, fitting or locker rooms without individual compartments, at least one of each type shall comply with 803.5. Where coat hooks or shelves are provided in individual compartments at least one of each type complying with 803.5 shall be provided in individual compartments in dressing, fitting, or locker rooms required to comply with 222.1.	Hooks 67" AFF	Remount at least one hook to max 48" AFF	2015 ABAAS Section: 308.2.1, 308.1, F222.2, 803.5 2012 TAS Section: 308.2.1, 308.1, 222.2, 803.5 2010 ADAS Section: 308.2.1, 308.1, 222.2, 803.5

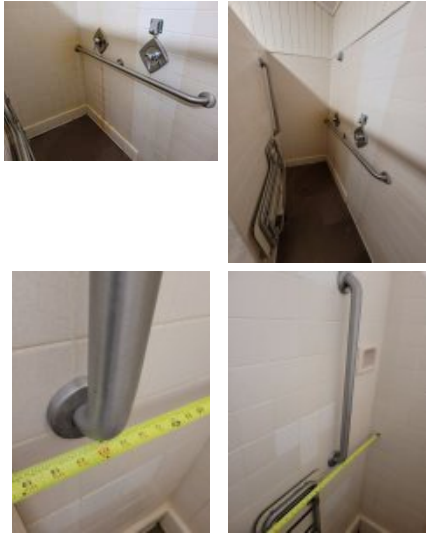
Finding Number	Area Description	Lat/Long	Finding	As Built	Recommendation	Citation	Photos	Figure
71	Knights Bluff Camping Area: Knights Bluff - Women's Restroom	[33.2351255 , -94.254174 7]	The side grab bar is missing In alternate roll-in type shower compartments, grab bars shall be provided on the back wall and the side wall farthest from the compartment entry. Grab bars shall not be provided above the seat. Grab bars shall be installed 6 inches maximum from adjacent walls.	Grab bar missing from side wall, vertical bar is 16" from side wall	Provide grab bars in the shower mounted in the correct locations for the shower type	2015 ABAAS Section: 608.3.3 2012 TAS Section: 608.3.3 2010 ADAS Section: 608.3.3

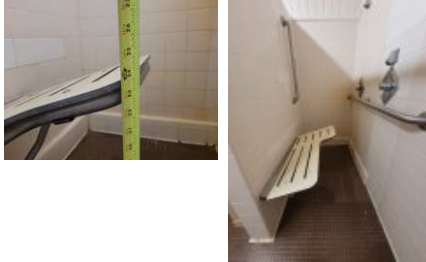
72	Knights Bluff Camping Area: Knights Bluff - Women's Restroom	[33.2350986 , -94.254153 2]	The shower seat height is noncompliant. A seat in a standard roll-in shower compartment shall be a folding type, shall be installed on the side wall adjacent to the controls, and shall extend from the back wall to a point within 3 inches of the compartment entry. A seat in an alternate roll-in type shower compartment shall be a folding type, shall be installed on the front wall opposite the back wall, and shall extend from the adjacent side wall to a point within 3 inches of the compartment entry. The top of the seat shall be 17 inches minimum and 19 inches maximum above the bathroom finish floor.	Seat is broken so edge is 24"	Remount shower seat to the correct location and height in the shower	2015 ABAAS Section: 610.3 2012 TAS Section: 610.3 2010 ADAS Section: 610.3

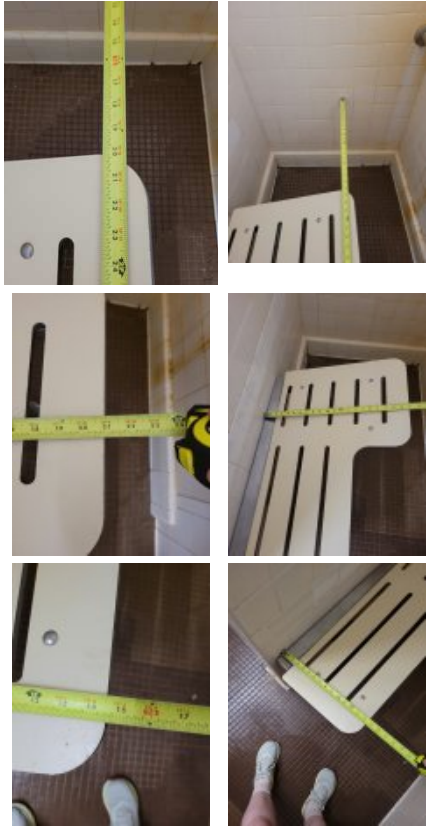
Finding Number	Area Description	Lat/Long	Finding	As Built	Recommendation	Citation	Photos	Figure
73	Knights Bluff Camping Area: Knights Bluff - Women's Restroom	[33.2350807 , -94.254196 1]	The shower seat does not have a compliant space between it and the wall. The folding seat must be mounted 17-19 inches above the floor, and have a maximum space of 1-1/2 inches between the edge of the seat and the side wall and 2-1/2 inches maximum to the seat wall.	20" to side wall, thick part of L is 21", thin part is 13.5"	Remount shower seat to the correct location and height in the shower.	2015 ABAAS Section: 610.3.2 2012 TAS Section: 610.3.2 2010 ADAS Section: 610.3.2

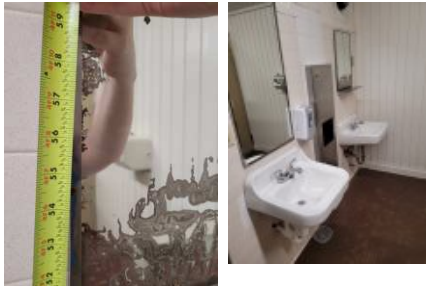
74	Knights Bluff Camping Area: Knights Bluff - Women's Restroom	[33.2351704 , -94.254217 6]	The mirror is mounted too high. Mirrors must have the bottom edge of the reflecting surface a maximum of 40 inches above the floor if above a sink or counter. Mirrors not located above lavatories or countertops shall be installed with the bottom edge of the reflecting surface 35 inches maximum above the finish floor or ground.	1 of 2 mirrors complies; higher mirror surface is 55" AFF	Leave as is second mirror, first one complies	2015 ABAAS Section: 603.3 2012 TAS Section: 603.3 2010 ADAS Section: 603.3

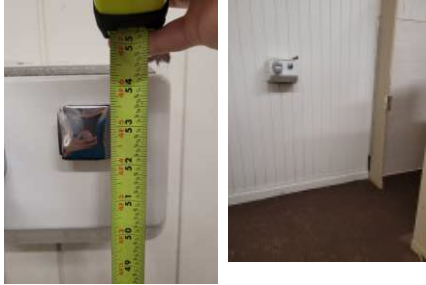
Finding Number	Area Description	Lat/Long	Finding	As Built	Recommendation	Citation	Photos	Figure
75	Knights Bluff Camping Area: Knights Bluff - Women's Restroom	[33.2351255 , -94.254196 1]	The operable part is positioned too high for either a side or front approach. Where a clear floor or ground space allows a parallel approach to an element and the side reach is unobstructed, the high side reach shall be 48 inches maximum and the low side reach shall be 15 inches minimum above the finish floor or ground. Where a forward reach is unobstructed, the high forward reach shall be 48 inches maximum and the low forward reach shall be 15 inches minimum above the finish floor or ground.	Dryer button 52.25" AFF	Remount operable parts to be in reach range of 15" min to 48" max. In the alternative, leave as is citing safe harbor.	2015 ABAAS Section: 308.1 2012 TAS Section: 308.1 2010 ADAS Section: 308.1

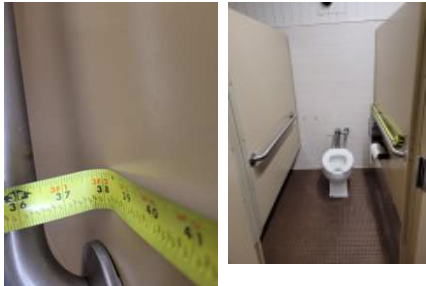
77	Knights Bluff Camping Area: Knights Bluff - Women's Restroom	[33.2351255 , -94.254185 4]	The ambulatory stall is not between 35" to 37" wide and 60" deep.	stall 38" wide	Correct ambulatory stall to be 35" to 37" wide and minimum 60" deep. In the alternative, use existing stall to create required wheelchair stall.	2015 ABAAS Section: 604.8.2.1 2012 TAS Section: 604.8.2.1 2010 ADAS Section: 604.8.2.1

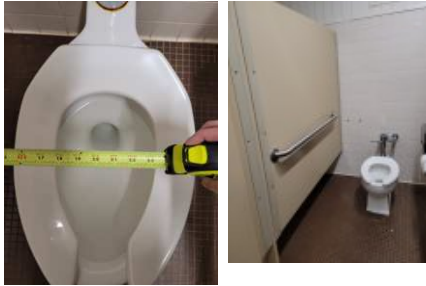
Finding Number	Area Description	Lat/Long	Finding	As Built	Recommendation	Citation	Photos	Figure
78	Knights Bluff Camping Area: Knights Bluff - Women's Restroom	[33.2351345, -94.2541854]	The toilet is not located within the range to the side wall or partition. The centerline of the toilet shall be 17 inches minimum and 19 inches maximum side wall or partition in the ambulatory accessible toilet compartment.	20.1" from flusher side	Remount toilet to 17" to 19" from the side wall to center line in ambulatory stalls or 16" to 18" in the new wheelchair stall.	2015 ABAAS Section: 604.9.1 2012 TAS Section: 604.9.1 2010 ADAS Section: 604.9.1

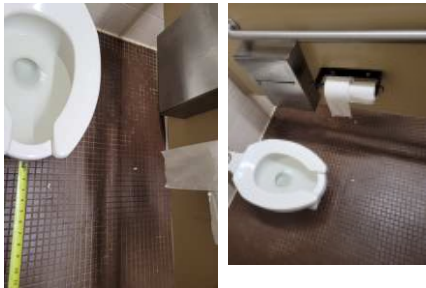
80	Knights Bluff Camping Area: Knights Bluff - Women's Restroom	[33.2351704, -94.2541317]	The toilet paper is not installed within the compliant range in front of the toilet. Toilet paper dispensers shall be 7 inches minimum and 9 inches maximum in front of the water closet measured to the centerline of the dispenser. The outlet of the dispenser shall be 15 inches minimum and 48 inches maximum above the finish floor and shall not be located behind grab bars. Dispensers shall not be of a type that controls delivery or that does not allow continuous paper flow. There shall be a clearance of 1 1/2 inches minimum below the grab bar.	Toilet paper too close to front of toilet	Remount toilet paper dispenser max 7" to 9" from front of toilet, 15" to 48" AFF and min 12" above or 1.5" below grab bar	2015 ABAAS Section: 604.7 2012 TAS Section: 604.7 2010 ADAS Section: 604.7

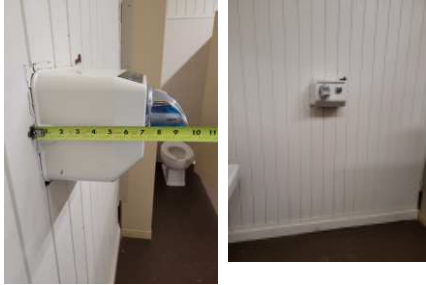
Finding Number	Area Description	Lat/Long	Finding	As Built	Recommendation	Citation	Photos	Figure
81	Knights Bluff Camping Area: Knights Bluff - Women's Restroom	[33.235139, -94.25418]	An item or items project more than 4 inches into the circulation path. Wall-mounted objects that have leading edges between 27 inches and 80 inches from the floor must not project more than 4 inches into the circulation path. Protruding objects that extend to the floor or within 27 inches of the floor are cane detectable and are therefore not hazardous. Where it is necessary or desirable to have objects protrude from the wall, a manner of cane detection must be provided.	Dryer projects 9.5"	Relocate protruding objects or place cane detectable warning or bollard at foot of item	2015 ABAAS Section: 307.2 2012 TAS Section: 307.2 2010 ADAS Section: 307.2

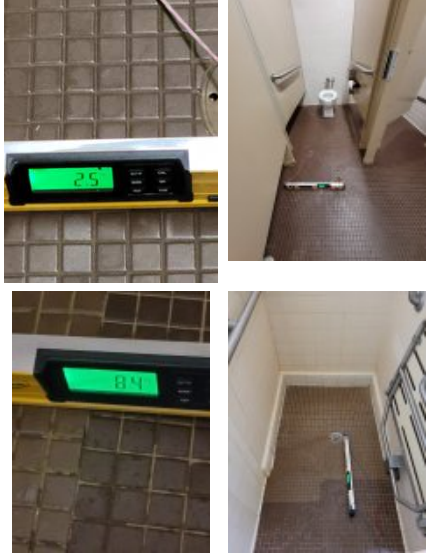
82	Knights Bluff Camping Area: Knights Bluff - Women's Restroom	[33.2351345, -94.2542176]	The accessible route contains running slopes greater than 5 percent and cross slopes greater than 2 percent across the width of the walk and has not been constructed as a ramp (i.e. handrails, wheel guides, etc.). When the slope in the direction of travel of any walk exceeds 1 unit vertical in 20 units horizontal (5-percent slope), it must be constructed as ramp. Surface cross slopes must not exceed one unit vertical in 48 units. Horizontal (2-percent slope).	2.5% cross slope at ambulatory stall, 8.4% running slope at shower	Correct or repair slope to max 2.08% in restroom.	2015 ABAAS Section: 403.3 2012 TAS Section: 403.3 2010 ADAS Section: 403.3

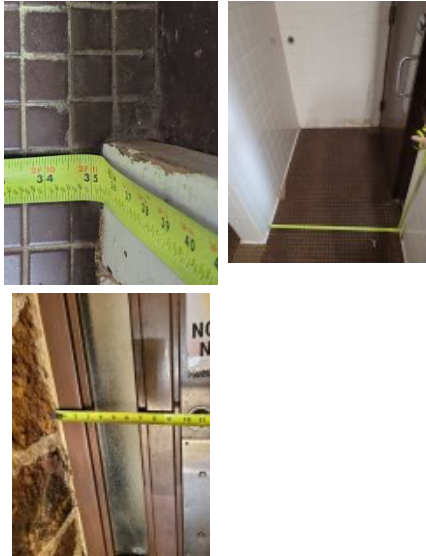
Finding Number	Area Description	Lat/Long	Finding	As Built	Recommendation	Citation	Photos	Figure
83	Knights Bluff Camping Area: Knights Bluff - Women's Restroom	[33.2351076 , -94.254196 1]	<p>Minimum maneuvering clearances at doors and gates shall comply with 404.2.4. Maneuvering clearances shall extend the full width of the doorway and the required latch side or hinge side clearance. Maneuvering clearances shall have a max slope of 2.08%. Door openings shall provide a clear width of 32 inches (815 mm) minimum. Clear openings of doorways with swinging doors shall be measured between the face of the door and the stop, with the door open 90 degrees. Openings more than 24 inches (610 mm) deep shall provide a clear opening of 36 inches (915 mm) minimum. There shall be no projections into the required clear opening width lower than 34 inches (865 mm) above the finish floor or ground. Projections into the clear opening width between 34 inches (865 mm) and 80 inches (2030 mm) above the finish floor or ground shall not exceed 4 inches (100 mm). The threshold has a vertical change greater than 1/4 inch high. The threshold has a gap greater than 1/2 inch wide. The threshold at a doorway shall be no higher than 1/2 inch. Changes in level between 1/4 inch and 1/2 inch must be beveled at 1:2 or less. 1/4 inch is the maximum vertical rise. All interior doors must be maintained so that the operating pressure does not exceed 5 lb. force to open. The sweep period for doors with closers shall be adjusted so that from an open position of 70 degrees, the door will take at least 3 seconds to move to a point 3 inches from the latch, measured to the leading edge of the door. Exterior doors are recommended to be maintained at 8.5 lbf as a smart practice. Force is to be measured at the operating hardware or 30 inches from the hinges, whichever is greater. Hand-activated door opening hardware, handles, pulls, latches, locks, and other operating devices on accessible doors shall have a shape that is easy to grasp with one hand and does not require tight grasping, tight</p>	Door - 35" back to wall on pull side, clearance on push 9.5" to wall	For all doors along the public circulation route, provide required maneuvering clearance on push and pull side of doors.	2010 ADAS Section: 404.2.3, 404.2.7, 404.2.4, 404.2.11, 404.2.11 Exception

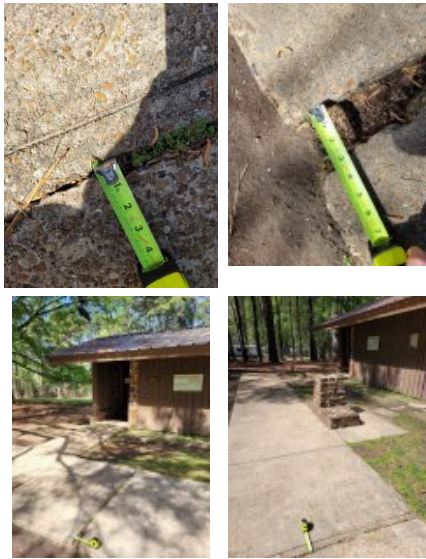
Finding Number	Area Description	Lat/Long	Finding	As Built	Recommendation	Citation	Photos	Figure
			pinching or twisting of the wrist to operate. Hardware shall be 34 inches minimum and 48 inches maximum above the finish floor or ground. The bottom 10 inches on the push side must be smooth and free of obstructions (hold open devices). Opening hardware must be mounted between 30 and 44 inches above the floor or ground. Doors, gates, and side lights adjacent to doors or gates, containing one or more glazing panels that permit viewing through the panels shall have the bottom of at least one glazed panel located 43 inches (1090 mm) maximum above the finish floor. EXCEPTION: Vision lights with the lowest part more than 66 inches (1675 mm) from the finish floor or ground shall not be required to comply with 404.2.11.					
84	Knights Bluff Camping Area: Knights Bluff - Women's Restroom	[33.2351345 , -94.254196 1]	There is a gap spaced greater than a 1/2 inch. Openings in floor or ground surfaces shall not allow passage of a sphere more than 1/2 inch diameter. Elongated openings shall be placed so that the long dimension is perpendicular to the dominant direction of travel.	1" gap on way to men's from parking, 3" front of men's	Correct or fill gaps to be max .5"	2015 ABAAS Section: 302.3 2012 TAS Section: 302.3 2010 ADAS Section: 302.3

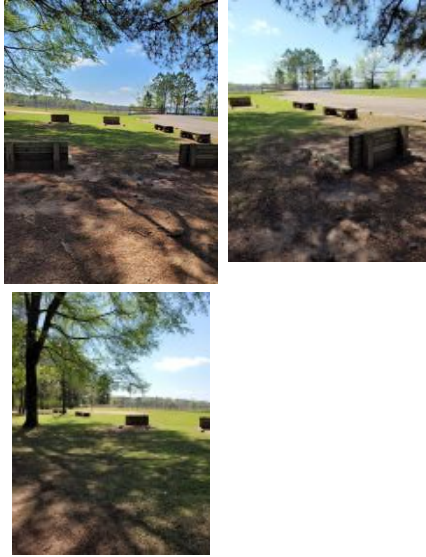
Finding Number	Area Description	Lat/Long	Finding	As Built	Recommendation	Citation	Photos	Figure
85	Day Use Area: Day Use - Volleyball	[33.2371626 , -94.255816 2]	There is no accessible route to the site elements At least one accessible route shall connect accessible buildings, accessible facilities, accessible elements, and accessible spaces that are on the same site.	No AR to 2 of 2 horseshoes, no AR to volleyball, no AR to 4 of 4 benches	Create an accessible route with crushed stone or other outdoor material from parking or walkway to one of each of the site elements	2015 ABAAS Section: F206.2.2 2012 TAS Section: 206.2.2 2010 ADAS Section: 206.2.2

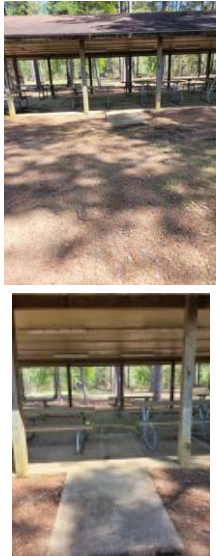
Finding Number	Area Description	Lat/Long	Finding	As Built	Recommendation	Citation	Photos	Figure
87	Day Use Area: Day Use - Group Picnic Pavilion	[33.23045, -94.24969]	Picnic facilities shall provide outdoor recreation access routes complying with 1016 in accordance with F245.4 and 245.4 of IAC	No route to shelter, 33" width at entry due to table placement	Create ORAR with crushed and compacted stone or similar outdoor material from parking or sidewalk to shelter or picnic area Relocate picnic table to provide 36" min clear entry to shelter	2015 ABAAS Section: F245.4

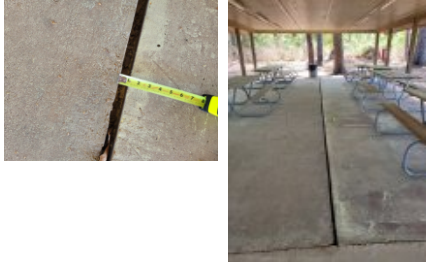
88	Day Use Area: Day Use - Group Picnic Pavilion	[33.2373712, -94.255324]	Openings in floor or ground surfaces shall not allow passage of a sphere more than 1/2 inch (13 mm) diameter except as allowed in 407.4.3, 409.4.3, 410.4, 810.5.3 and 810.10. Elongated openings shall be placed so that the long dimension is perpendicular to the dominant direction of travel. Floor or ground surface within required maneuvering clearances shall comply with 302. Changes in level are not permitted.	1" gap down middle	Correct or fill gap in doorway to max .5" as a smart practice.	2010 ADAAS Section: 302.3, 404.2.4.4

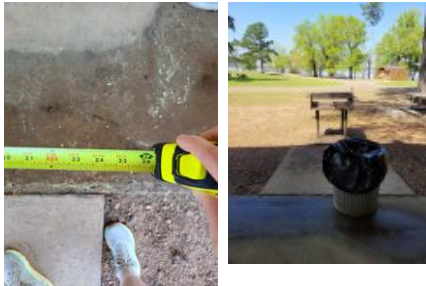
89	Day Use Area: Day Use - Group Picnic Pavilion	[33.2373679, -94.2553253]	Where picnic facilities contain two or fewer picnic units, each picnic unit shall provide mobility features complying with F245.2.	34" width to grill due to trash can	Relocate trash can to provide 36" clear wide route.	2015 ABAAS Section: F245.2.1

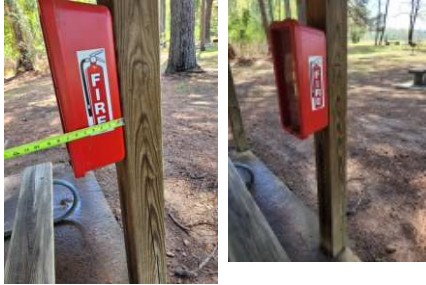
Finding Number	Area Description	Lat/Long	Finding	As Built	Recommendation	Citation	Photos	Figure																																				
90	Day Use Area: Day Use - Group Picnic Pavilion	[33.2373667 , -94.2553065]	Objects project more than 4 inches into the circulation path. Wall-mounted objects that have leading edges between 27 inches and 80 inches from the floor must not project more than 4 inches into the circulation path. Protruding objects that extend to the floor or within 27 inches of the floor are cane detectable and are therefore not hazardous. Where it is necessary or desirable to have objects protrude from the wall, a manner of cane detection must be provided.	Fire extinguisher projects 7"	Relocate object to not protrude into the circulation path.	2015 ABAAS Section: 307.2 2012 TAS Section: 307.2 2010 ADAS Section: 307.2

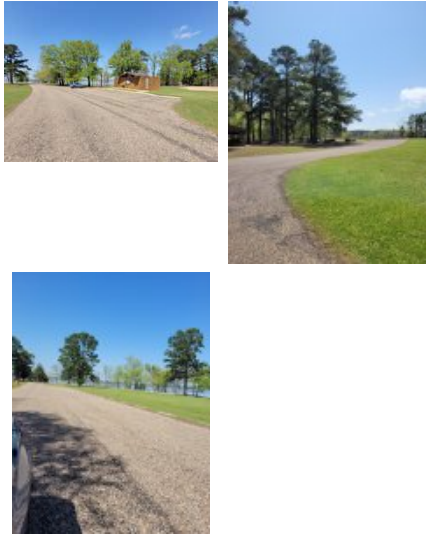
91	Day Use Area: Day Use - Parking and Exterior Accessible Route	[33.2373555 , -94.2553334]	There are no or not enough accessible parking stalls. Each lot where parking is provided for the public as clients, guests or employees, shall provide accessible parking and shall be located on the shortest accessible route of travel from adjacent parking to an accessible entrance. There are a total of (42) parking stalls in the parking lot that could be reasonably associated with this facility. There should be a minimum of (3) accessible stalls with a minimum of (1) being designed as van accessible.	Day use restroom building - 10 accessible, 0 of 14 at pavilion accessible, parking across restroom - 0 of 18 accessible	Create two 8' accessible parking stalls, with one 5' adjacent access aisle, with proper signage and striping based on the total number of stalls. Create one 8' accessible van parking stalls, with one 8' adjacent access aisle, with proper signage and striping based on the total number of stalls.	2015 ABAAS Section: F208.2 2012 TAS Section: 208.2 2010 ADAS Section: 208.2

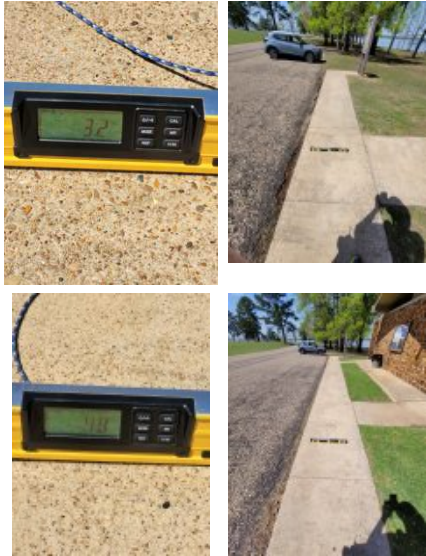
Finding Number	Area Description	Lat/Long	Finding	As Built	Recommendation	Citation	Photos	Figure
92	Day Use Area: Day Use - Parking and Exterior Accessible Route	[33.2378902 , -94.255307 3]	The accessible path of travel has cross slopes greater than 2%. Surface cross slopes shall not exceed one unit vertical in 48 units horizontal (2-percent slope). When the slope in the direction of travel of any walk exceeds 1 unit vertical in 20 units horizontal (5-percent slope), it must be constructed as a ramp.	3.2% slope at women's restroom, 4.8% slope at men's restroom route intersection	Correct or repair sidewalk cross slope along AR to max 2.08%	2015 ABAAS Section: 403.3 2012 TAS Section: 403.3 2010 ADAS Section: 403.3

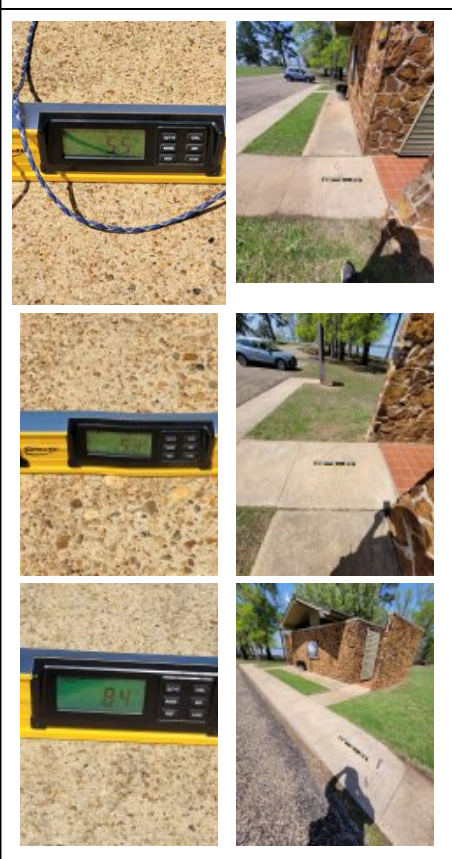
Finding Number	Area Description	Lat/Long	Finding	As Built	Recommendation	Citation	Photos	Figure
93	Day Use Area: Day Use - Parking and Exterior Accessible Route	[33.237888, -94.255296 6]	The running slope of walking surfaces shall not be steeper than 1:20.	8.4% slope from parking to route, 5.5% slope toward men's restroom, 5.9% slope toward women's restroom	Correct running slope along the AR to max 5%	2015 ABAAS Section: 403.3 2012 TAS Section: 403.3 2010 ADAS Section: 403.3

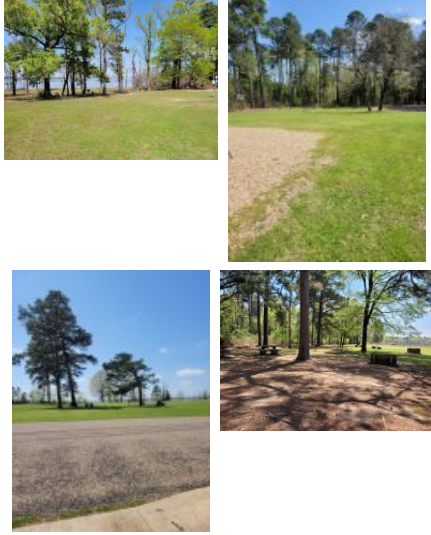
Finding Number	Area Description	Lat/Long	Finding	As Built	Recommendation	Citation	Photos	Figure
94	Day Use Area: Day Use - Picnic Area	[33.2372299 , -94.255499 7]	The surface of outdoor recreation access routes, passing spaces, and resting intervals shall be firm and stable	No route to 11 of 11 grills, 4 of 4 spouts, 24 of 24 picnic tables at day use; 0 of accessible design	Repair or replace surface or ORAR to be firm and stable as a smart practice. Provide route to 3 grills and tables. Replace 5 tables with ones of an accessible design.	2015 ABAAS Section: 1016. 2

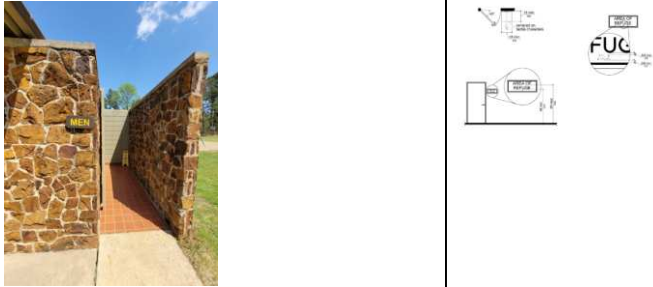
95	Day Use Area: Day Use - Men's Restroom	[33.2379108 , -94.255250 2]	The restroom sign does not comply with one or more applicable requirements for the location, height, and properties of the sign.	Restroom lacks accessible signage	Acquire and mount signage, including Braille, raised lettering and access symbol mounted on wall, latch side of gate, 48" to baseline of lowest character and 60" to baseline of highest character	2015 ABAAS Section: F216.2, 703.1, 703.2, 703.5, 703.6 2012 TAS Section: 216.2, 703.1, 703.2, 703.5, 703.6 2010 ADAS Section: 216.2, 703.1, 703.2, 703.5, 703.6
