Access Audit Site Reports

Atlanta State Park

Accessibility Evaluation

Inspection Date: 04/05/2022

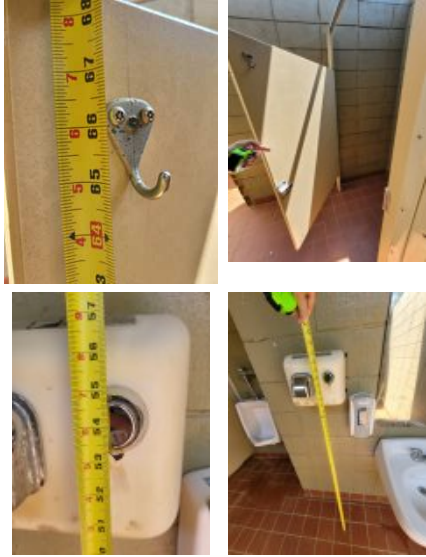
Finding Number	Area Description	Lat/Long	Finding	As Built	Recommendation	Citation	Photos	Figure
98	Day Use Area: Day Use - Men's Restroom	[33.2379085 , -94.255247 5]	The operable part is positioned too high for either a side or front approach. Where a clear floor or ground space allows a parallel approach to an element and the side reach is unobstructed, the high side reach shall be 48 inches maximum and the low side reach shall be 15 inches minimum above the finish floor or ground. Where a forward reach is unobstructed, the high forward reach shall be 48 inches maximum and the low forward reach shall be 15 inches minimum above the finish floor or ground.	65" AFF to hook, 54" AFF to dryer button	Lower hook to 48" max. Leave as is dryer citing safe harbor.	2015 ABAAS Section: 308.1 2012 TAS Section: 308.1 2010 ADAS Section: 308.1

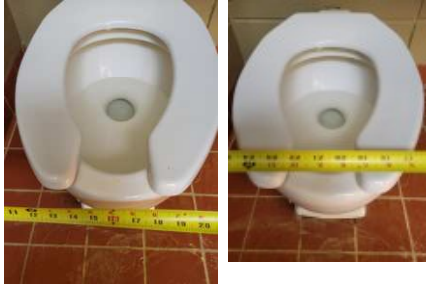
Finding Number	Area Description	Lat/Long	Finding	As Built	Recommendation	Citation	Photos	Figure
100	Day Use Area: Day Use - Men's Restroom	[33.2379388 , -94.2552368]	The toilet is not located within the range to the side wall or partition. The centerline of the toilet shall be 17 inches minimum and 19 inches maximum side wall or partition in the ambulatory accessible toilet compartment.	toilet center line - 16.5" to left side, 20.5" to right side	Remount toilet to 17" to 19" from the side wall to center line in ambulatory stalls or 16" to 18" in new wheelchair stall.	2015 ABAAS Section: 604.9.1 2012 TAS Section: 604.9.1 2010 ADAS Section: 604.9.1

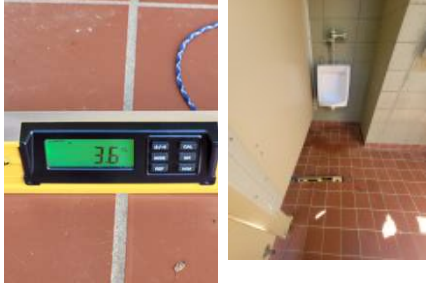
104	Day Use Area: Day Use - Men's Restroom	[33.2379253 , -94.255269]	The accessible route contains running slopes greater than 5 percent and cross slopes greater than 2 percent across the width of the walk and has not been constructed as a ramp (i.e. handrails, wheel guides, etc.). When the slope in the direction of travel of any walk exceeds 1 unit vertical in 20 units horizontal (5-percent slope), it must be constructed as ramp. Surface cross slopes must not exceed one unit vertical in 48 units. Horizontal (2-percent slope).	3.6% cross slope at hand dryer	Correct or repair slope to max 2.08% in restroom.	2015 ABAAS Section: 403.3 2012 TAS Section: 403.3 2010 ADAS Section: 403.3

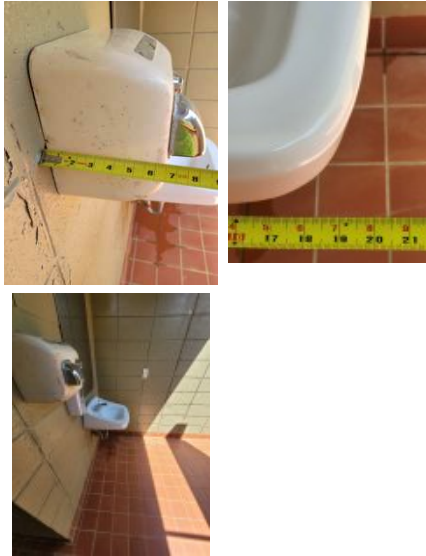
Finding Number	Area Description	Lat/Long	Finding	As Built	Recommendation	Citation	Photos	Figure
105	Day Use Area: Day Use - Men's Restroom	[33.2379052 , -94.255244 9]	An item or items project more than 4 inches into the circulation path. Wall-mounted objects that have leading edges between 27 inches and 80 inches from the floor must not project more than 4 inches into the circulation path. Protruding objects that extend to the floor or within 27 inches of the floor are cane detectable and are therefore not hazardous. Where it is necessary or desirable to have objects protrude from the wall, a manner of cane detection must be provided.	Sink projects 20" and Dryer projects 9.5"	Relocate protruding objects or place cane detectable warning or bollard at foot of items.	2015 ABAAS Section: 307.2 2012 TAS Section: 307.2 2010 ADAS Section: 307.2

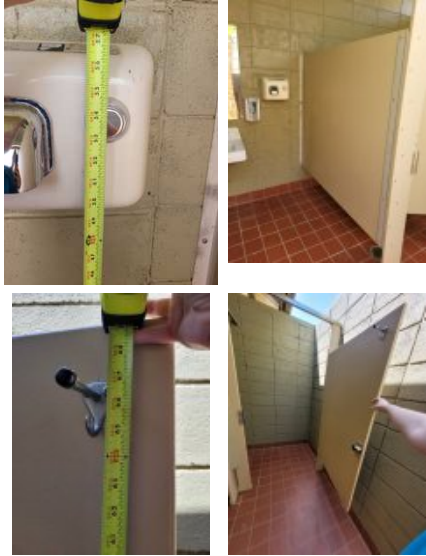
108	Day Use Area: Day Use - Women's Restroom	[33.2379164 , -94.255263 6]	The operable part is positioned too high for either a side or front approach. Where a clear floor or ground space allows a parallel approach to an element and the side reach is unobstructed, the high side reach shall be 48 inches maximum and the low side reach shall be 15 inches minimum above the finish floor or ground. Where a forward reach is unobstructed, the high forward reach shall be 48 inches maximum and the low forward reach shall be 15 inches minimum above the finish floor or ground.	Dryer button 53" AFF, hook in stall 65" AFF	Lower hook to 48" max. Leave as is dryer citing safe harbor.	2015 ABAAS Section: 308.1 2012 TAS Section: 308.1 2010 ADAS Section: 308.1

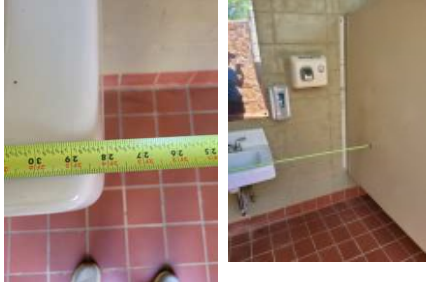
109	Day Use Area: Day Use - Women's Restroom	[33.2378962 , -94.255244 9]	The operable part is not accessible because there is not adequate clear floor space for either a forward or side approach. The clear floor or ground space shall be 30 inches minimum by 48 inches minimum.	28" width at hand soap and hand dryer	Provide required 30" by 48" CFS at operable parts	2015 ABAAS Section: 305.3 2012 TAS Section: 305.3 2010 ADAS Section: 305.3

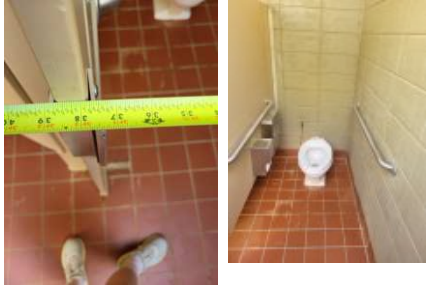
111	Day Use Area: Day Use - Women's Restroom	[33.2379152 , -94.255242 2]	The ambulatory stall is not between 35" to 37" wide and 60" deep.	ambulatory stall 37.5" wide	Correct ambulatory stall to be 35" to 37" wide and minimum 60" deep. In the alternative, use existing stall to create required wheelchair stall.	2015 ABAAS Section: 604.8.2.1 2012 TAS Section: 604.8.2.1 2010 ADAS Section: 604.8.2.1

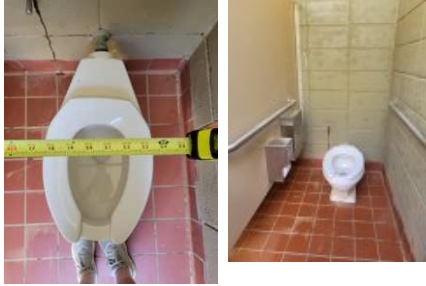
112	Day Use Area: Day Use - Women's Restroom	[33.237913, -94.255239 5]	The toilet is not located within the range to the side wall or partition. The centerline of the toilet shall be 17 inches minimum and 19 inches maximum side wall or partition in the ambulatory accessible toilet compartment.	toilet center line 20.5" from partition side	Remount toilet to 17" to 19" from the side wall to center line in ambulatory stalls or 16" to 18" in new wheelchair accessible stall.	2015 ABAAS Section: 604.9.1 2012 TAS Section: 604.9.1 2010 ADAS Section: 604.9.1

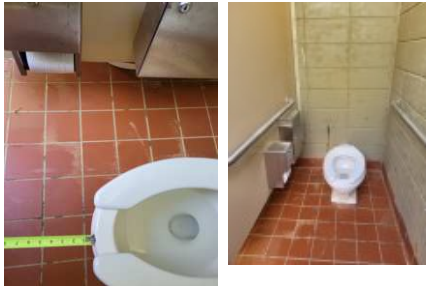
114	Day Use Area: Day Use - Women's Restroom	[33.2379096 , -94.255247 5]	The toilet paper is not installed within the compliant range in front of the toilet. Toilet paper dispensers shall be 7 inches minimum and 9 inches maximum in front of the water closet measured to the centerline of the dispenser. The outlet of the dispenser shall be 15 inches minimum and 48 inches maximum above the finish floor and shall not be located behind grab bars. Dispensers shall not be of a type that controls delivery or that does not allow continuous paper flow. There shall be a clearance of 1 1/2 inches minimum below the grab bar.	Toilet paper too close to front of toilet	Remount toilet paper dispenser max 7" to 9" from front of toilet, 15" to 48" aff and min 12" above or 1.5" below grab bar	2015 ABAAS Section: 604.7 2012 TAS Section: 604.7 2010 ADAS Section: 604.7

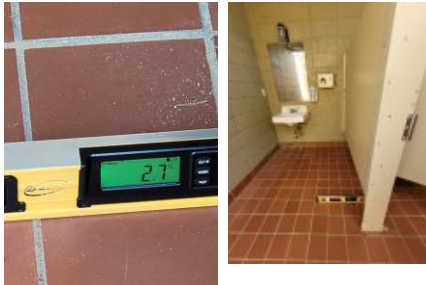
115	Day Use Area: Day Use - Women's Restroom	[33.2379063 , -94.255238 1]	The accessible route contains running slopes greater than 5 percent and cross slopes greater than 2 percent across the width of the walk and has not been constructed as a ramp (i.e. handrails, wheel guides, etc.). When the slope in the direction of travel of any walk exceeds 1 unit vertical in 20 units horizontal (5-percent slope), it must be constructed as ramp. Surface cross slopes must not exceed one unit vertical in 48 units. Horizontal (2-percent slope).	2.7% cross slope at hand dryer	Correct or repair slope to max 2.08% in restroom.	2015 ABAAS Section: 403.3 2012 TAS Section: 403.3 2010 ADAS Section: 403.3

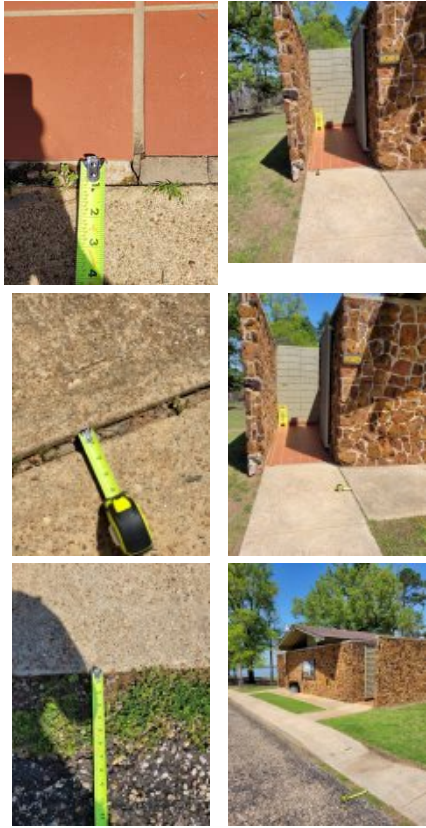
Finding Number	Area Description	Lat/Long	Finding	As Built	Recommendation	Citation	Photos	Figure
116	Day Use Area: Day Use - Women's Restroom	[33.2378805 , -94.255231 4]	There is a gap spaced greater than a 1/2 inch. Openings in floor or ground surfaces shall not allow passage of a sphere more than 1/2 inch diameter. Elongated openings shall be placed so that the long dimension is perpendicular to the dominant direction of travel.	1" gap at entry to women's, 1" at corner of women's, 7.5" gap at entry to restroom from parking lot	Correct or fill gaps to be max .5"	2015 ABAAS Section: 302.3 2012 TAS Section: 302.3 2010 ADAS Section: 302.3

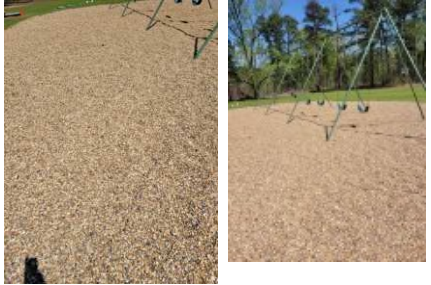
Finding Number	Area Description	Lat/Long	Finding	As Built	Recommendation	Citation	Photos	Figure
118	Day Use Area: Day Use - Playground and Beach Access	[33.2378513 , -94.255092]	There is no accessible route within the play area At least one accessible route shall connect accessible buildings, accessible facilities, accessible elements, and accessible spaces that are on the same site.	Swing area surface is pea gravel	Replace surface at swings with one that is firm and stable.	2015 ABAAS Section: F206.2.2 2012 TAS Section: 206.2.2 2010 ADAS Section: 206.2.2

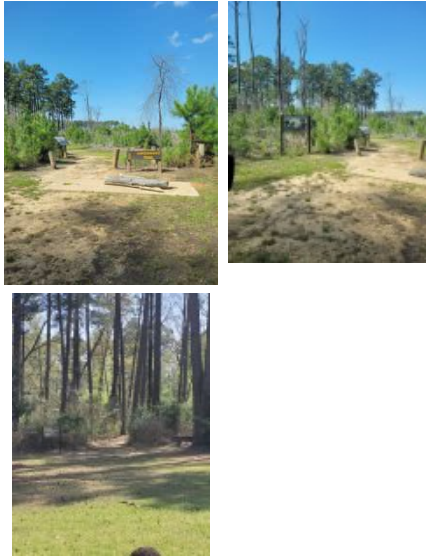
Finding Number	Area Description	Lat/Long	Finding	As Built	Recommendation	Citation	Photos	Figure
122	Trails: Arrowhead Trailhead	[33.23246, -94.24445]	The surface of outdoor recreation access routes, passing spaces, and resting intervals shall be firm and stable	Arrowhead and Hickory Hollow trailheads lacks firm and stable surface	Repair or replace surface of ORAR to be firm and stable as a smart practice.	2015 ABAAS Section: 1016.2

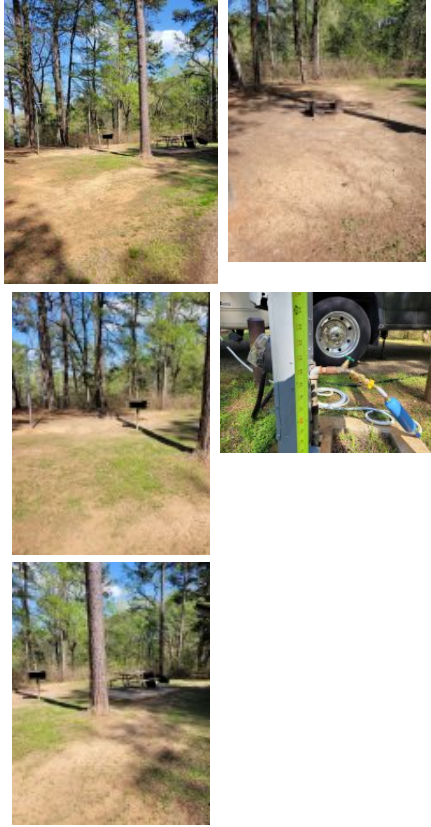
Finding Number	Area Description	Lat/Long	Finding	As Built	Recommendation	Citation	Photos	Figure
123	Wilkins Creek Camping Area: Wilkins Creek - Campsite 41 (Sample)	[33.2300372 , -94.235978 5]	Camping facilities shall provide camping units with mobility features complying with F244.2 in accordance with Table F244.2. Where a camping facility provides different types of camping units, Table F244.2 shall apply to each type of camping unit provided. Total Number of Camping Units Provided in Camping Facility Minimum Number of Camping Units with Mobility Features Required 1 1 2 to 25 2 26 to 50 3 51 to 75 4 76 to 100 5 101 to 150 7 151 to 200 8 201 and over 8, plus 2 percent of the number over 200	0 accessible camp sites, 19 standard camp sites; sample site lack accessible table, grill or fire ring; not route to site or amenities; water spigot low at 21"	Create the required number of accessible camp sites per table F244.2 as a smart practice.	2015 ABAAS Section: F244.2

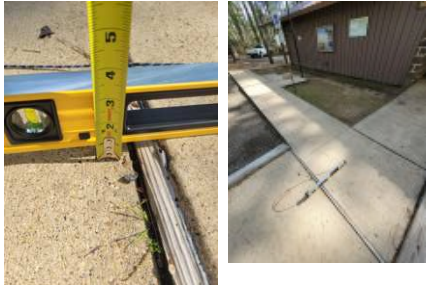
Finding Number	Area Description	Lat/Long	Finding	As Built	Recommendation	Citation	Photos	Figure
130	Wilkins Creek Camping Area: Wilkins Creek - Parking and Exterior Accessible Route at Restrooms	[33.2297949 , -94.236059]	The walkway contains abrupt vertical edges and/or variations over a 1/4 inch. 1/4 inch is the maximum vertical rise. Changes in level between 1/4 inch and 1/2 inch must be beveled at 1:2 or less. Changes in level greater than 1/2 inch must be by way of a ramp.	1" at apparent ramp	Repair, bevel or ramp CIL along the route.	2012 TAS Section: 303.2, 303.3 2010 ADAS Section: 303.2, 303.3

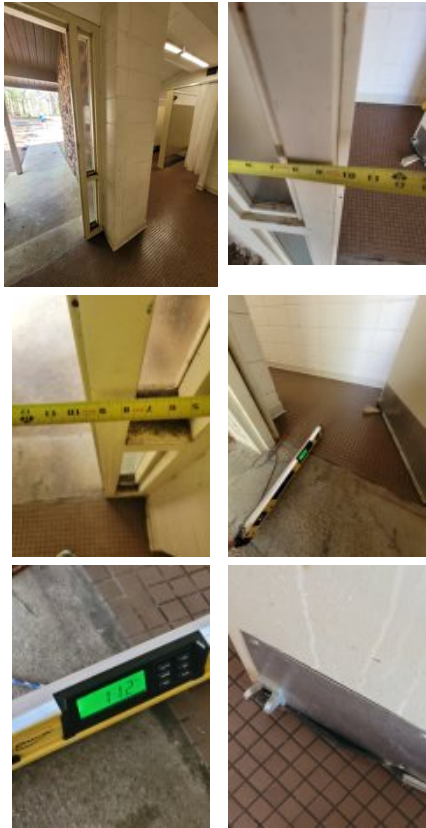
131	Wilkins Creek Camping Area: Wilkins Creek - Men's Restroom	[33.2297635 , -94.2361247]	Minimum maneuvering clearances at doors and gates shall comply with 404.2.4. Maneuvering clearances shall extend the full width of the doorway and the required latch side or hinge side clearance. Maneuvering clearances shall have a max slope of 2.08%. Exterior doors are recommended to be maintained at 8.5 lbf as a smart practice. Force is to be measured at the operating hardware or 30 inches from the hinges, whichever is greater. The bottom 10 inches on the push side must be smooth and free of obstructions (hold open devices). Opening hardware must be mounted between 30 and 44 inches above the floor or ground.	Door - wall blocks pull side clearance, 11.2% slope in door clearance, 22# push, hold open device on push side, broke sweep	For all doors along the public circulation route, provide required maneuvering clearance on push and pull side of doors. For all doors along the public circulation route, inspect, adjust, and maintain 8.5 lbf to open exterior doors as a smart practice. For all doors along the public circulation route, provide kick plate on push side of door from floor to 10" AFF.	2010 ADAS Section: 404.2.3, 404.2.7, 404.2.4, 404.2.11, 404.2.11 Exception

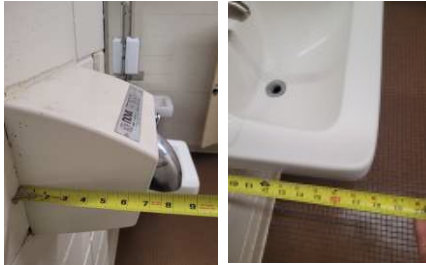
Finding Number	Area Description	Lat/Long	Finding	As Built	Recommendation	Citation	Photos	Figure
138	Wilkins Creek Camping Area: Wilkins Creek - Men's Restroom	[33.2297668 , -94.2361234]	An item or items project more than 4 inches into the circulation path. Wall-mounted objects that have leading edges between 27 inches and 80 inches from the floor must not project more than 4 inches into the circulation path. Protruding objects that extend to the floor or within 27 inches of the floor are cane detectable and are therefore not hazardous. Where it is necessary or desirable to have objects protrude from the wall, a manner of cane detection must be provided.	Dryer projects 8.5", sink projects 18"	Relocate protruding objects or place cane detectable warning or bollard at foot of items.	2015 ABAAS Section: 307.2 2012 TAS Section: 307.2 2010 ADAS Section: 307.2

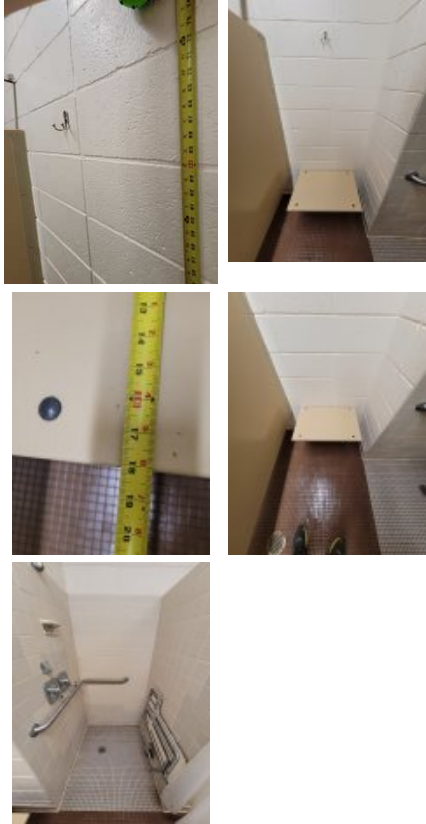
Finding Number	Area Description	Lat/Long	Finding	As Built	Recommendation	Citation	Photos	Figure
140	Wilkins Creek Camping Area: Wilkins Creek - Men's Restroom	[33.2297657 , -94.236120 7]	Where a high forward reach is over an obstruction, the clear floor space shall extend beneath the element for a distance not less than the required reach depth over the obstruction. The high forward reach shall be 48 inches (1220 mm) maximum where the reach depth is 20 inches (510 mm) maximum. Where the reach depth exceeds 20 inches (510 mm), the high forward reach shall be 44 inches (1120 mm) maximum and the reach depth shall be 25 inches (635 mm) maximum. Where a clear floor or ground space allows a parallel approach to an element and the high side reach is over an obstruction, the height of the obstruction shall be 34 inches (865 mm) maximum and the depth of the obstruction shall be 24 inches (610 mm) maximum. The high side reach shall be 48 inches (1220 mm) maximum for a reach depth of 10 inches (255 mm) maximum. Where the reach depth exceeds 10 inches (255 mm), the high side reach shall be 46 inches (1170 mm) maximum for a reach depth of 24 inches (610 mm) maximum.	Hook 67" AFF over a bench	Lower hook to max 46" above the finished floor (AFF) for a side reach over a bench	2015 ABAAS Section: 308.2.1, 308.3.2 2012 TAS Section: 308.2.1, 308.3.2 2010 ADAS Section: 308.2.1, 308.3.2

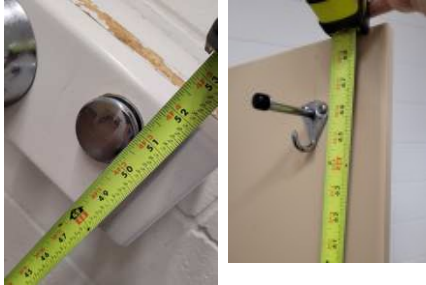
147	Wilkins Creek Camping Area: Wilkins Creek - Women's Restroom	[33.2297635 , -94.2361127]	The operable part is positioned too high for either a side or front approach. Where a clear floor or ground space allows a parallel approach to an element and the side reach is unobstructed, the high side reach shall be 48 inches maximum and the low side reach shall be 15 inches minimum above the finish floor or ground. Where a forward reach is unobstructed, the high forward reach shall be 48 inches maximum and the low forward reach shall be 15 inches minimum above the finish floor or ground.	Hand dryer 50" AFF, hook in stall 65" AFF	Lower hook to 48" max. Leave as is hand dryer citing safe harbor.	2015 ABAAS Section: 308.1 2012 TAS Section: 308.1 2010 ADAS Section: 308.1

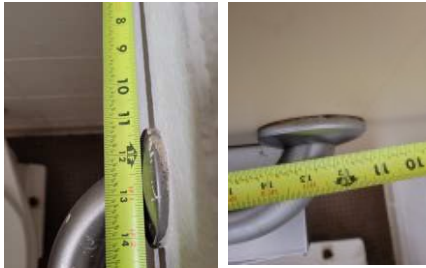
150	Wilkins Creek Camping Area: Wilkins Creek - Women's Restroom	[33.2297635 , -94.2361247]	The side grab bars are not in the correct location. Grab bars on the side wall must be installed so that the end closest to the rear wall is maximum 12" from the rear wall. The end furthest from the rear wall must be mounted minimum 54" from the rear wall.	Both mounted 12.5" from rear wall	Remount side grab bar to max 12" from the rear wall at the close end and min 54" on the far end, and 33" to 36" AFF	2015 ABAAS Section: 604.5.1 2012 TAS Section: 604.5.1 2010 ADAS Section: 604.5.1

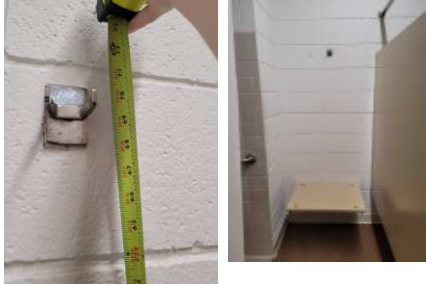
Finding Number	Area Description	Lat/Long	Finding	As Built	Recommendation	Citation	Photos	Figure
154	Wilkins Creek Camping Area: Wilkins Creek - Women's Restroom	[33.2297679 , -94.2361274]	Coat hooks provided within the room shall be located within one of the reach ranges specified in 308. Shelves shall be 40 inches (1015 mm) minimum and 48 inches (1220 mm) maximum above the finish floor or ground. Where coat hooks or shelves are provided in dressing, fitting or locker rooms without individual compartments, at least one of each type shall comply with 803.5. Where coat hooks or shelves are provided in individual compartments at least one of each type complying with 803.5 shall be provided in individual compartments in dressing, fitting, or locker rooms required to comply with 222.1.	Hook 70" AFF	Remount at least one hook to max 48" AFF.	2015 ABAAS Section: 308.2.1, 308.1, F222.2, 803.5 2012 TAS Section: 308.2.1, 308.1, 222.2, 803.5 2010 ADAS Section: 308.2.1, 308.1, 222.2, 803.5

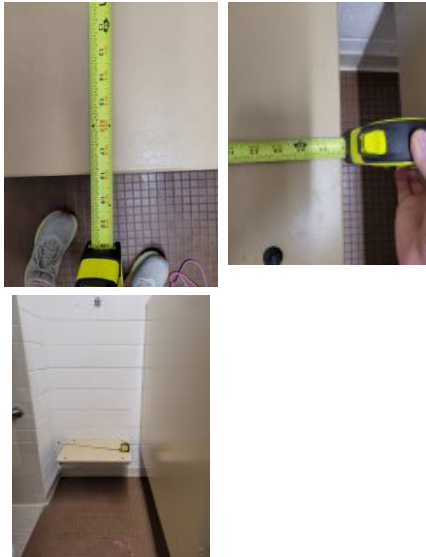
155	Wilkins Creek Camping Area: Wilkins Creek - Women's Restroom	[33.2297691 , -94.2361234]	The bench is not deep enough or long enough or is missing. Benches shall be provided having seats that are 42 inches long minimum and 20 inches deep minimum and 24 inches deep maximum. The bench shall provide for back support or shall be affixed to a wall. Back support shall be 42 inches (1065 mm) long minimum and shall extend from a point 2 inches (51 mm) maximum above the seat surface to a point 18 inches (455 mm) minimum above the seat surface. Back support shall be 2½ inches (64 mm) maximum from the rear edge of the seat measured horizontally. The top of the bench seat surface shall be 17 inches (430 mm) minimum and 19 inches (485 mm) maximum above the finish floor or ground. Clear floor or ground space complying with 305 shall be provided and shall be positioned at the end of the bench seat and parallel to the short axis of the bench	bench dimensions fail - 18" x 26"	Replace bench in dressing area with one having a seat depth of 20" to 24" deep, 42" long, affixed to the wall or having a back and mounted 17" to 19" aff and provide required clear floor space on the short axis of the bench.	2012 TAS Section: 903.4, 903.2, 903.3, 903.5 2010 ADAS Section: 903.4, 903.2, 903.3, 903.5

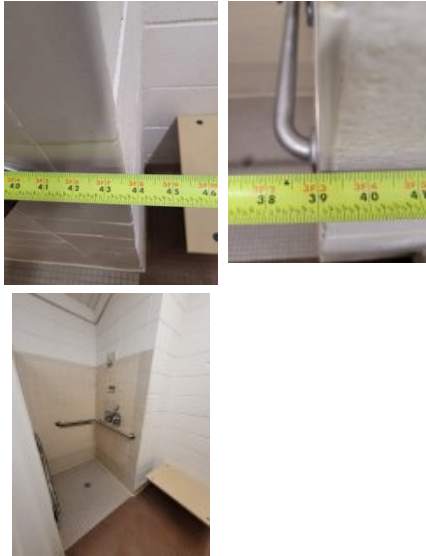
Finding Number	Area Description	Lat/Long	Finding	As Built	Recommendation	Citation	Photos	Figure
156	Wilkins Creek Camping Area: Wilkins Creek - Women's Restroom	[33.2297679 , -94.236134 1]	Transfer type shower compartments shall be 36 inches (915 mm) by 36 inches (915 mm) clear inside dimensions measured at the center points of opposing sides and shall have a 36 inch (915 mm) wide minimum entry on the face of the shower compartment. Clearance of 36 inches (915 mm) wide minimum by 48 inches (1220 mm) long minimum measured from the control wall shall be provided.	shower dimension - 43.5" depth by 39" width	Reduce transfer shower to compliant 36" by 36" clear inside dimension	2015 ABAAS Section: 608.2.1 2012 TAS Section: 608.2.1 2010 ADAS Section: 608.2.1

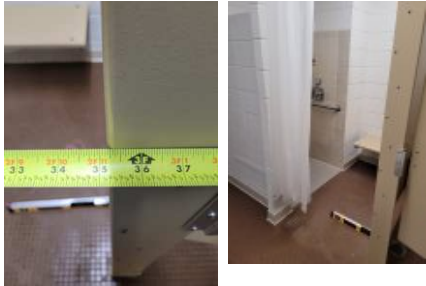
<p><small>Note: Inside finished dimensions measured at the center points of opposing sides.</small></p>
157	Wilkins Creek Camping Area: Wilkins Creek - Women's Restroom	[33.2297702 , -94.236126 1]	Transfer type shower compartments shall be 36 inches (915 mm) by 36 inches (915 mm) clear inside dimensions measured at the center points of opposing sides and shall have a 36 inch (915 mm) wide minimum entry on the face of the shower compartment. Clearance of 36 inches (915 mm) wide minimum by 48 inches (1220 mm) long minimum measured from the control wall shall be provided.	35.5" width at entry	Provide appropriate CFS on the exterior of the transfer shower.	2015 ABAAS Section: 608.2.1 2012 TAS Section: 608.2.1 2010 ADAS Section: 608.2.1

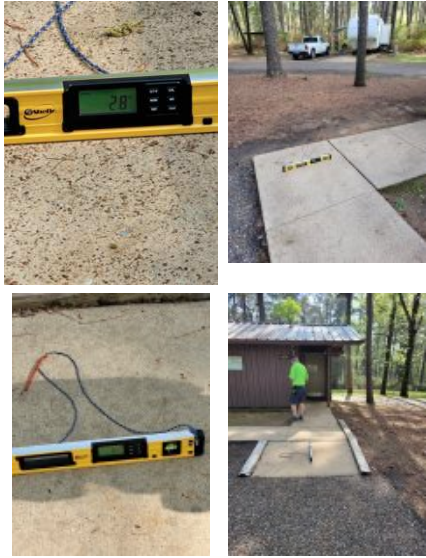
Finding Number	Area Description	Lat/Long	Finding	As Built	Recommendation	Citation	Photos	Figure
162	Wilkins Creek Camping Area: Wilkins Creek - Women's Restroom	[33.2297702 , -94.236126 1]	The running slope of walking surfaces shall not be steeper than 1:20. The cross slope of turning spaces shall not be steeper than 1:48.	2.8% cross slope at turn to women's restroom 8.4% slope at curb ramp in front of men's restroom	Leave as is curb ramp slope citing construction tolerance. Correct cross slope at turning space along the AR to max. 2.08%	2015 ABAAS Section: 403.3 2012 TAS Section: 403.3 2010 ADAS Section: 403.3

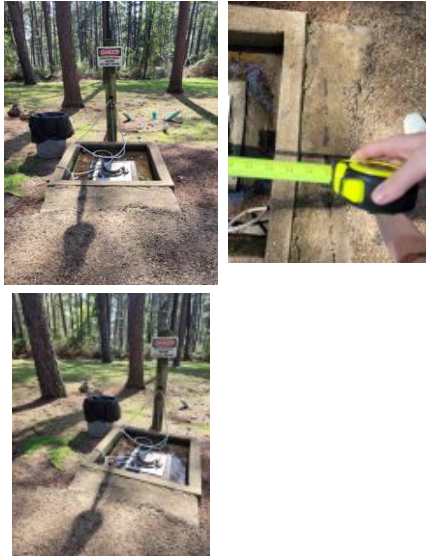
163	Wilkins Creek Camping Area: WC - Dump Station	[33.2297186 , -94.236175 7]	The element is not accessible because the operable parts are not within the required reach range. Operable parts on accessible elements, accessible routes, and in accessible rooms and spaces shall comply with requirements for operable parts. The requirements include complying with a clear floor space, reach range, and operation.	No CFS or AR to spigot, reach 55" AGL	Provide a firm and stable route to the spigot Create a level CGS at spigot; max 2.08% slope in any direction Lower water spout to 28" to 36" above the ground	2015 ABAAS Section: F205.1 2012 TAS Section: 205.1 2010 ADAS Section: 205.1

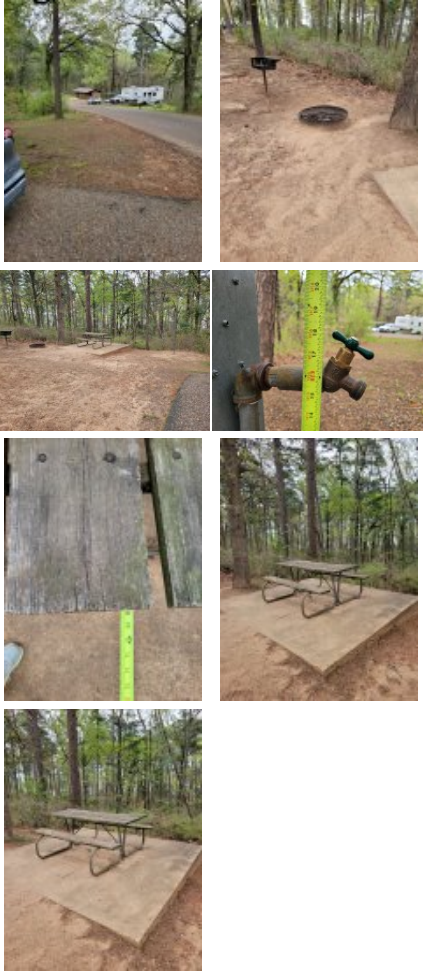
Finding Number	Area Description	Lat/Long	Finding	As Built	Recommendation	Citation	Photos	Figure
165	White Oak Camping Area: White Oak - Campsite #44 - Sample	[33.2350919 , -94.234640 1]	Camping facilities shall provide camping units with mobility features complying with F244.2 in accordance with Table F244.2. Where a camping facility provides different types of camping units, Table F244.2 shall apply to each type of camping unit provided. Total Number of Camping Units Provided in Camping Facility Minimum Number of Camping Units with Mobility Features Required 1 1 2 to 25 2 26 to 50 3 51 to 75 4 76 to 100 5 101 to 150 7 151 to 200 8 201 and over 8, plus 2 percent of the number over 200	0 accessible campsites, 16 standard campsites; sample site 44 - no route to amenities; lacks accessible features - table, fire ring, water spigot	Create the required number of accessible camp sites per table F244.2 as a smart practice	2015 ABAAS Section: F244.2

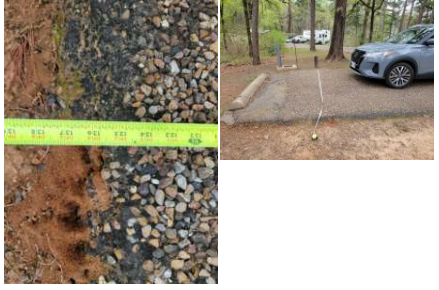
Finding Number	Area Description	Lat/Long	Finding	As Built	Recommendation	Citation	Photos	Figure
166	White Oak Camping Area: White Oak - Campsite #44 - Sample	[33.2343369 , -94.2350116]	Parking spaces and pull-up spaces for recreational vehicles shall be 20 feet (6100 mm) wide minimum. EXCEPTION: Where two adjacent parking spaces are provided for recreational vehicles, one parking space shall be permitted to be 16 feet (4880 mm) wide minimum.	parking at site - 11' 3" wide stall	Correct RV parking space to be 20' wide minimum; or 16' for two adjacent spaces as a smart practice at new accessible camping sites.	2015 ABAAS Section: 1012.2, 1012.2 EXCEPTION

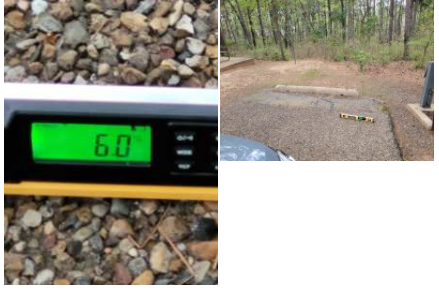
167	White Oak Camping Area: White Oak - Campsite #44 - Sample	[33.2344256 , -94.2349808]	The surface of parking spaces and pull-up spaces shall be firm and stable. The slope of the surface of parking spaces and pull-up spaces shall not be steeper than 1:48 in any direction. EXCEPTION: Where the surface is other than asphalt, concrete, or boards, slopes not steeper than 1:20 shall be permitted when necessary for drainage.	6% slope in parking stall	Correct surface of parking spaces to be firm and stable with slopes max of 2.08% or 5% for surfaces other than concrete, asphalt or boards as a smart practice at 2 new accessible campsites.	2015 ABAAS Section: 1012.4, 1012.5, 1012.5 EXCEPTION

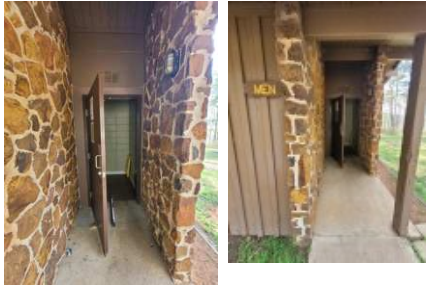
Finding Number	Area Description	Lat/Long	Finding	As Built	Recommendation	Citation	Photos	Figure
171	White Oak Camping Area: White Oak - Men's Restroom	[33.2341272 , -94.235278 5]	The restroom sign does not comply with one or more applicable requirements for the location, height, and properties of the sign.	Lacks accessible signage, no ISA	Acquire and mount signage, including Braille, raised lettering and access symbol mounted on wall, latch side of door, 48" to baseline of lowest character and 60" to baseline of highest character	2015 ABAAS Section: F216.2, 703.1, 703.2, 703.5, 703.6 2012 TAS Section: 216.2, 703.1, 703.2, 703.5, 703.6 2010 ADAS Section: 216.2, 703.1, 703.2, 703.5, 703.6

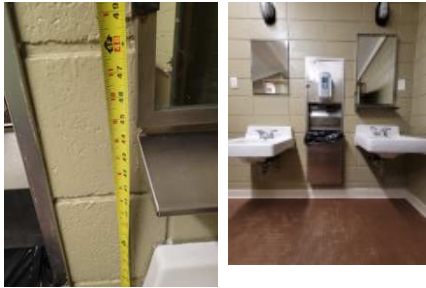
172	White Oak Camping Area: White Oak - Men's Restroom	[33.2341047 , -94.235275 8]	The mirror is mounted too high. Mirrors must have the bottom edge of the reflecting surface a maximum of 40 inches above the floor if above a sink or counter. Mirrors not located above lavatories or countertops shall be installed with the bottom edge of the reflecting surface 35 inches maximum above the finish floor or ground.	45.4" AFF to mirror bottom	Lower mirror so reflective surface is max 40" AFF	2015 ABAAS Section: 603.3 2012 TAS Section: 603.3 2010 ADAS Section: 603.3

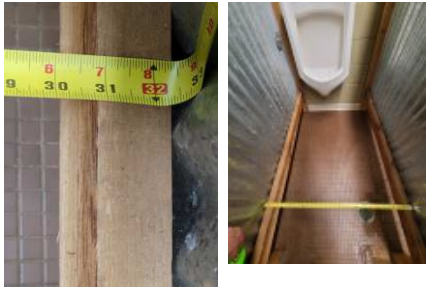
173	White Oak Camping Area: White Oak - Men's Restroom	[33.2340913 , -94.235262 4]	The urinal is located in an area that does not provide the required clear floor space for a front approach. The surrounding elements of a recessed urinal must provide a minimum of 36 by 48 inches of clear floor space for a front approach.	30.75" width to urinal (over 24" deep recess), sink ok	Relocate privacy wall at urinal to provide 36" CFS	2015 ABAAS Section: 605.2 2012 TAS Section: 605.2 2010 ADAS Section: 605.2

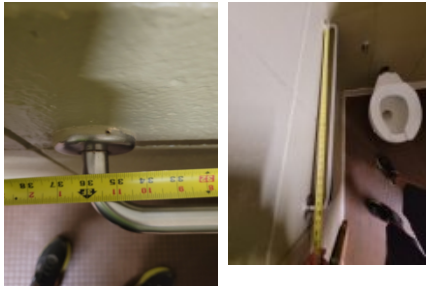
180	White Oak Camping Area: White Oak - Men's Restroom	[33.2340969 , -94.235277 1]	Grab bars shall comply with 609. A side-wall grab bar complying with 604.5.1 shall be provided on both sides of the compartment. The space between the wall and the grab bar shall be 1½ inches (38 mm). The space between the grab bar and projecting objects below and at the ends shall be 1½ inches (38 mm) minimum. The space between the grab bar and projecting objects above shall be 12 inches (305 mm) minimum. Grab bars shall be installed in a horizontal position, 33 inches (840 mm) minimum and 36 inches (915 mm) maximum above the finish floor measured to the top of the gripping surface, except that at water closets for children's use complying with 604.9, grab bars shall be installed in a horizontal position 18 inches (455 mm) minimum and 27 inches (685 mm) max	36" long grab bar	Replace side grab bars with a 42" long grab bar, mounted max 12" from the rear wall at the close end and min 54" on the far end and 33" to 36" AFF	2015 ABAAS Section: 604.8.2.3, 609.3, 609.4 2012 TAS Section: 609.4, 609.3, 604.8.2.3 2010 ADAS Section: 609.3, 609.4, 604.8.2.3

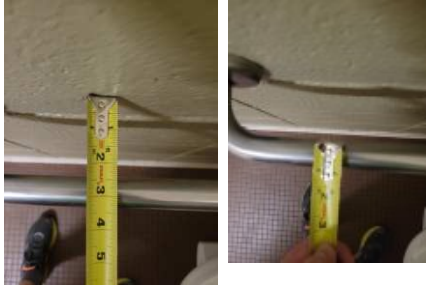
182	White Oak Camping Area: White Oak - Men's Restroom	[33.2340958 , -94.235270 4]	The grab bar height and/or spacing fails. Grab bars must be mounted between 33" and 36" to the top of the gripping surface. There must be 1.5" of clearance between the grab bar and the wall. There must be a minimum of 1.5" of clearance below and minimum 12" above the grab bar to any dispenser or other obstruction.	Both bars 2.5" gap, bars only 1" diameter.	Replace grab bars in accessible stall with ones having a max gap of 1.5" and mounted to 33" to 36" above the finished floor (AFF). Cost included in previous finding	2015 ABAAS Section: 609.3, 609.4 2012 TAS Section: 609.4, 609.3 2010 ADAS Section: 609.3, 609.4

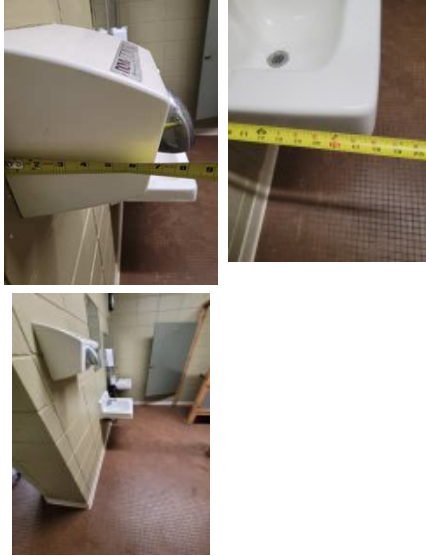
183	White Oak Camping Area: White Oak - Men's Restroom	[33.234107, -94.235254 4]	An item or items project more than 4 inches into the circulation path. Wall-mounted objects that have leading edges between 27 inches and 80 inches from the floor must not project more than 4 inches into the circulation path. Protruding objects that extend to the floor or within 27 inches of the floor are cane detectable and are therefore not hazardous. Where it is necessary or desirable to have objects protrude from the wall, a manner of cane detection must be provided.	Dryer 8" and sink 18" projections	Relocate protruding objects or place cane detectable warning or bollard at foot of items.	2015 ABAAS Section: 307.2 2012 TAS Section: 307.2 2010 ADAS Section: 307.2

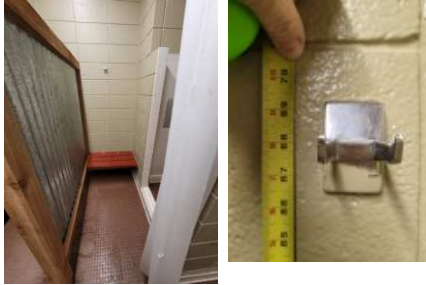
Finding Number	Area Description	Lat/Long	Finding	As Built	Recommendation	Citation	Photos	Figure
184	White Oak Camping Area: White Oak - Men's Restroom	[33.2341025, -94.2352919]	Coat hooks provided within the room shall be located within one of the reach ranges specified in 308. Shelves shall be 40 inches (1015 mm) minimum and 48 inches (1220 mm) maximum above the finish floor or ground. Where coat hooks or shelves are provided in dressing, fitting or locker rooms without individual compartments, at least one of each type shall comply with 803.5. Where coat hooks or shelves are provided in individual compartments at least one of each type complying with 803.5 shall be provided in individual compartments in dressing, fitting, or locker rooms required to comply with 222.1.	Hook obstructed over bench, 68" AFF	Install at least one hook at max 48" AFF	2015 ABAAS Section: 308.2.1, 308.1, F222.2, 803.5 2012 TAS Section: 308.2.1, 308.1, 222.2, 803.5 2010 ADAS Section: 308.2.1, 308.1, 222.2, 803.5

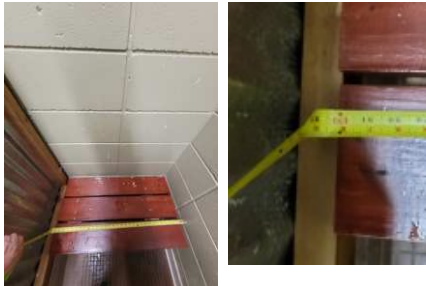
185	White Oak Camping Area: White Oak - Men's Restroom	[33.234107, -94.2352919]	The bench is not deep enough or long enough or is missing. Benches shall be provided having seats that are 42 inches long minimum and 20 inches deep minimum and 24 inches deep maximum. The bench shall provide for back support or shall be affixed to a wall. Back support shall be 42 inches (1065 mm) long minimum and shall extend from a point 2 inches (51 mm) maximum above the seat surface to a point 18 inches (455 mm) minimum above the seat surface. Back support shall be 2½ inches (64 mm) maximum from the rear edge of the seat measured horizontally. The top of the bench seat surface shall be 17 inches (430 mm) minimum and 19 inches (485 mm) maximum above the finish floor or ground. Clear floor or ground space complying with 305 shall be provided and shall be positioned at the end of the bench seat and parallel to the short axis of the bench	32" wide bench	Replace bench in dressing area with one having a seat depth of 20" to 24" deep, 42" long, affixed to the wall or having a back and mounted 17" to 19" aff and provide required clear floor space on the short axis of the bench.	2012 TAS Section: 903.4, 903.2, 903.3, 903.5 2010 ADAS Section: 903.4, 903.2, 903.3, 903.5

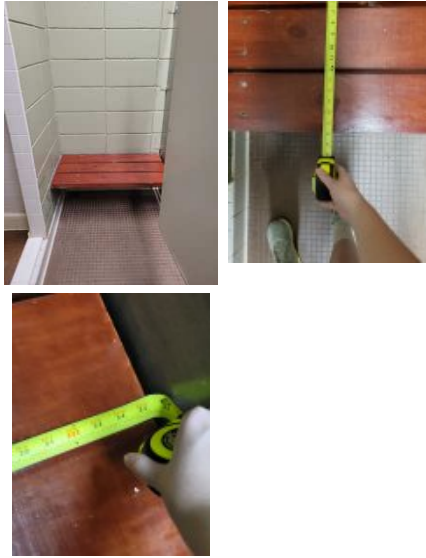
Finding Number	Area Description	Lat/Long	Finding	As Built	Recommendation	Citation	Photos	Figure
188	White Oak Camping Area: White Oak - Women's Restroom	[33.2341003 , -94.235274 5]	The bench is not deep enough or long enough or is missing. Benches shall be provided having seats that are 42 inches long minimum and 20 inches deep minimum and 24 inches deep maximum. The bench shall provide for back support or shall be affixed to a wall. Back support shall be 42 inches (1065 mm) long minimum and shall extend from a point 2 inches (51 mm) maximum above the seat surface to a point 18 inches (455 mm) minimum above the seat surface. Back support shall be 2½ inches (64 mm) maximum from the rear edge of the seat measured horizontally. The top of the bench seat surface shall be 17 inches (430 mm) minimum and 19 inches (485 mm) maximum above the finish floor or ground. Clear floor or ground space complying with 305 shall be provided and shall be positioned at the end of the bench seat and parallel to the short axis of the bench	18" x 36" bench	Replace bench in dressing area with one having a seat depth of 20" to 24" deep, 42" long, affixed to the wall or having a back and mounted 17" to 19" aff and provide required clear floor space on the short axis of the bench.	2012 TAS Section: 903.4, 903.2, 903.3, 903.5 2010 ADAS Section: 903.4, 903.2, 903.3, 903.5

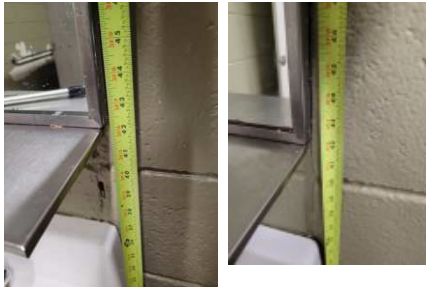
191	White Oak Camping Area: White Oak - Women's Restroom	[33.2341305 , -94.2352798]	The mirror is mounted too high. Mirrors must have the bottom edge of the reflecting surface a maximum of 40 inches above the floor if above a sink or counter. Mirrors not located above lavatories or countertops shall be installed with the bottom edge of the reflecting surface 35 inches maximum above the finish floor or ground.	Both mirrors at 42" AFF	Lower at least one mirror so reflective surface is max 40" AFF	2015 ABAAS Section: 603.3 2012 TAS Section: 603.3 2010 ADAS Section: 603.3

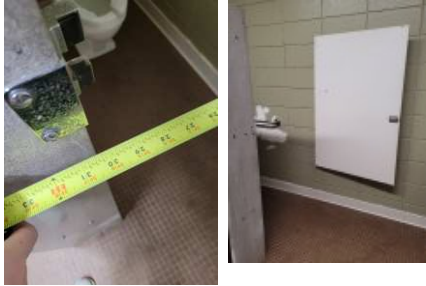
196	White Oak Camping Area: White Oak - Women's Restroom	[33.2341182, -94.235273 1]	The stall door fails to comply with all of the door requirements. The stall door must be a minimum of 32" wide and have compliant hardware on both sides. The stall door must be self-closing.	30.5" width, not self closing	Widen stall doors to 32" when opened to 90 degrees Adjust stall door to be self-closing Ensure stall hardware has hardware operable without a tight pinch or grasp on both sides of the stall door	2015 ABAAS Section: 404.2.3, 404.2.7, 604.8.2.2 2012 TAS Section: 404.2.3, 404.2.7, 604.8.2.2 2010 ADAS Section: 404.2.3, 404.2.7, 604.8.2.2

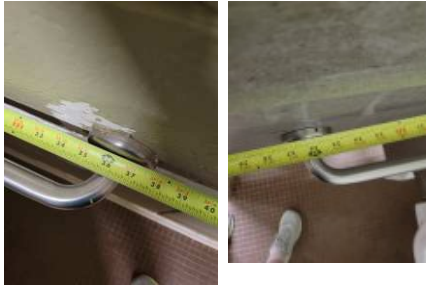
Finding Number	Area Description	Lat/Long	Finding	As Built	Recommendation	Citation	Photos	Figure
197	White Oak Camping Area: White Oak - Women's Restroom	[33.2341137 , -94.235273 1]	Grab bars shall comply with 609. A side-wall grab bar complying with 604.5.1 shall be provided on both sides of the compartment. The space between the wall and the grab bar shall be 1½ inches (38 mm). The space between the grab bar and projecting objects below and at the ends shall be 1½ inches (38 mm) minimum. The space between the grab bar and projecting objects above shall be 12 inches (305 mm) minimum. Grab bars shall be installed in a horizontal position, 33 inches (840 mm) minimum and 36 inches (915 mm) maximum above the finish floor measured to the top of the gripping surface, except that at water closets for children's use complying with 604.9, grab bars shall be installed in a horizontal position 18 inches (455 mm) minimum and 27 inches (685 mm) max	36" long grab bars	Replace side grab bars with a 42" long grab bar, mounted max 12" from the rear wall at the close end and min 54" on the far end and 33" to 36" AFF	2015 ABAAS Section: 604.8.2.3, 609.3, 609.4 2012 TAS Section: 609.4, 609.3, 604.8.2.3 2010 ADAS Section: 609.3, 609.4, 604.8.2.3

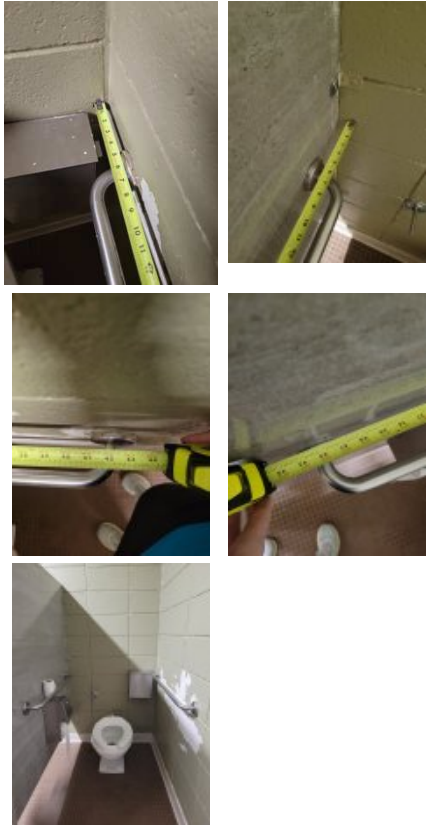
Finding Number	Area Description	Lat/Long	Finding	As Built	Recommendation	Citation	Photos	Figure
198	White Oak Camping Area: White Oak - Women's Restroom	[33.2341238 , -94.2352704]	The side grab bars are not in the correct location. Grab bars on the side wall must be installed so that the end closest to the rear wall is maximum 12" from the rear wall. The end furthest from the rear wall must be mounted minimum 54" from the rear wall.	36" grab bars mounted 6" from rear wall and extends 42" to end	Cost and recommendation included in previous finding	2015 ABAAS Section: 604.5.1 2012 TAS Section: 604.5.1 2010 ADAS Section: 604.5.1

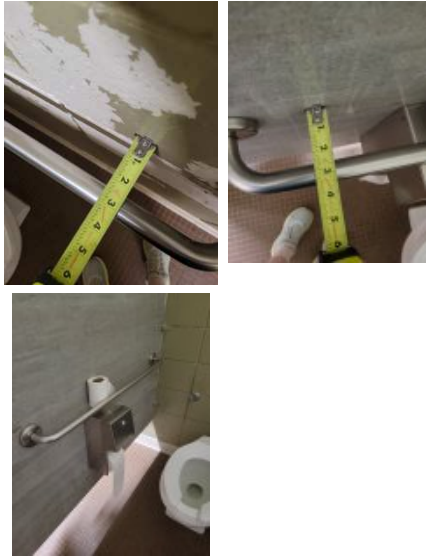
Finding Number	Area Description	Lat/Long	Finding	As Built	Recommendation	Citation	Photos	Figure
199	White Oak Camping Area: White Oak - Women's Restroom	[33.2341272 , -94.235278 5]	The grab bar height and/or spacing fails. Grab bars must be mounted between 33" and 36" to the top of the gripping surface. There must be 1.5" of clearance between the grab bar and the wall. There must be a minimum of 1.5" of clearance below and minimum 12" above the grab bar to any dispenser or other obstruction.	Toilet paper on top, 3" grip clearance	Remove loose toilet paper from grab bar. Assure new grab bars have a max gap of 1.5" between grip surface and wall.	2015 ABAAS Section: 609.3, 609.4 2012 TAS Section: 609.4, 609.3 2010 ADAS Section: 609.3, 609.4

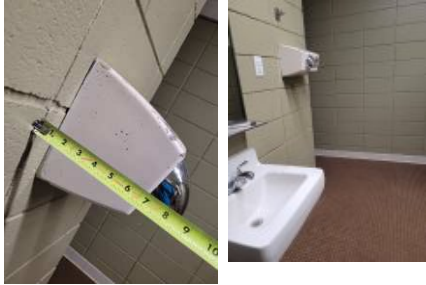
Finding Number	Area Description	Lat/Long	Finding	As Built	Recommendation	Citation	Photos	Figure
201	White Oak Camping Area: White Oak - Women's Restroom	[33.2341317 , -94.235286 5]	An item or items project more than 4 inches into the circulation path. Wall-mounted objects that have leading edges between 27 inches and 80 inches from the floor must not project more than 4 inches into the circulation path. Protruding objects that extend to the floor or within 27 inches of the floor are cane detectable and are therefore not hazardous. Where it is necessary or desirable to have objects protrude from the wall, a manner of cane detection must be provided.	Hand dryer projects 8"	Relocate protruding objects or place cane detectable warning or bollard at foot of item	2015 ABAAS Section: 307.2 2012 TAS Section: 307.2 2010 ADAS Section: 307.2

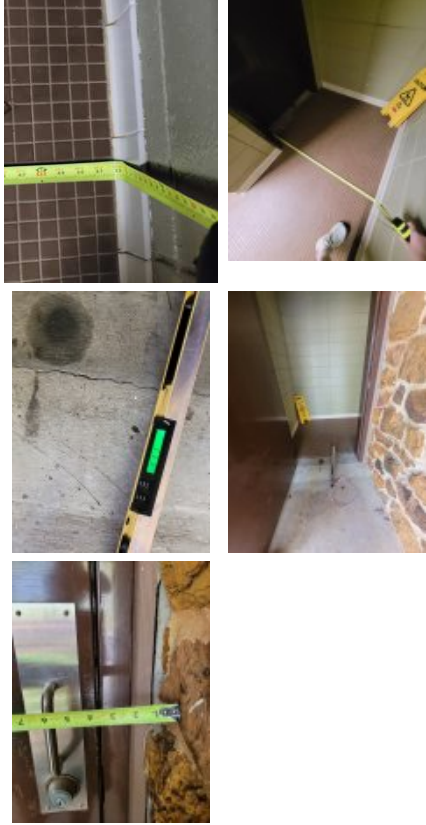
202	White Oak Camping Area: White Oak - Women's Restroom	[33.2340935 , -94.235262 4]	Minimum maneuvering clearances at doors and gates shall comply with 404.2.4. Maneuvering clearances shall extend the full width of the doorway and the required latch side or hinge side clearance. Maneuvering clearances shall have a max slope of 2.08%. Exterior doors are recommended to be maintained at 8.5 LBF as a smart practice. Force is to be measured at the operating hardware or 30 inches from the hinges, whichever is greater.	Door - On push side, latch approach 52" back, 13# push, 11.1% slope, clearance on pull 3.5" due to rock wall	For all doors along the public circulation route, provide required maneuvering clearance on push and pull side of doors. For all doors along the public circulation route, correct slope in door clearance to max 2.08%. For all doors along the public circulation route, inspect, adjust, and maintain 8.5 LBF to open exterior doors as a smart practice.	2010 ADAS Section: 404.2.3, 404.2.7, 404.2.4, 404.2.11, 404.2.11 Exception
