# Access Audit Site Report

**Buescher State Park**

**Accessibility Evaluation**

**Inspection Date: 11/11/2021**

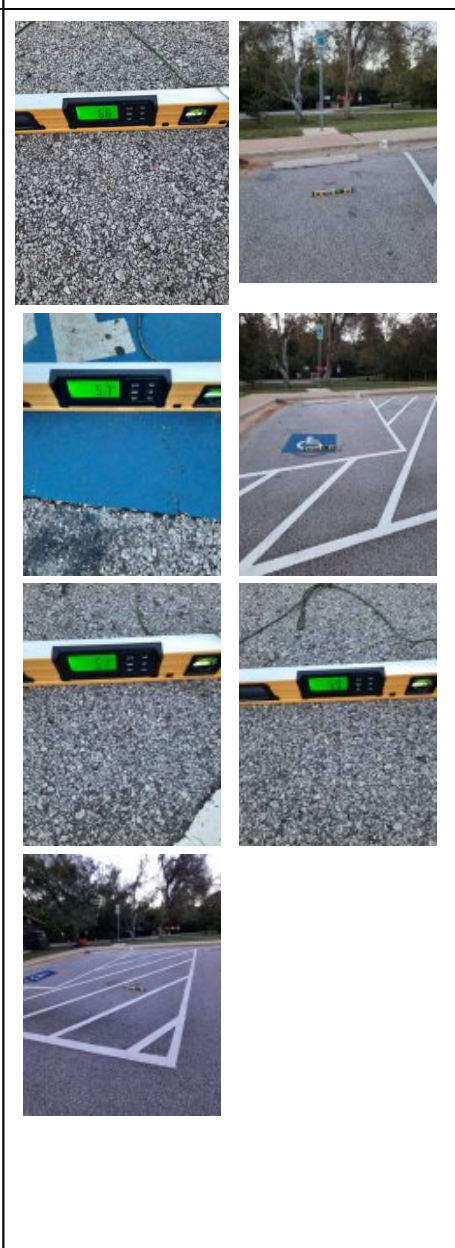
Finding Number	Area Description	Lat/Long	Finding	As Built	Recommendation	Citation	Photos	Figure
1	Headquarters: Headquarters Parking	[30.0392552 , -97.158250 6]	The cross slopes (narrow dimension) and/or running slopes (long dimension) of the access aisle exceeds 2%. The running slope and the cross slope in an accessible parking stall and the access aisle must not exceed 2%.	Slopes of 6.6% at head and 5.7% at foot of stall, and 5.1% at head and 5.9% at foot of access aisle	Repair or correct slope of parking space and access aisle to max 2.08% in any direction.	2015 ABAAS Section: 502.4  2012 TAS Section: 502.4  2010 ADAS Section: 502.4

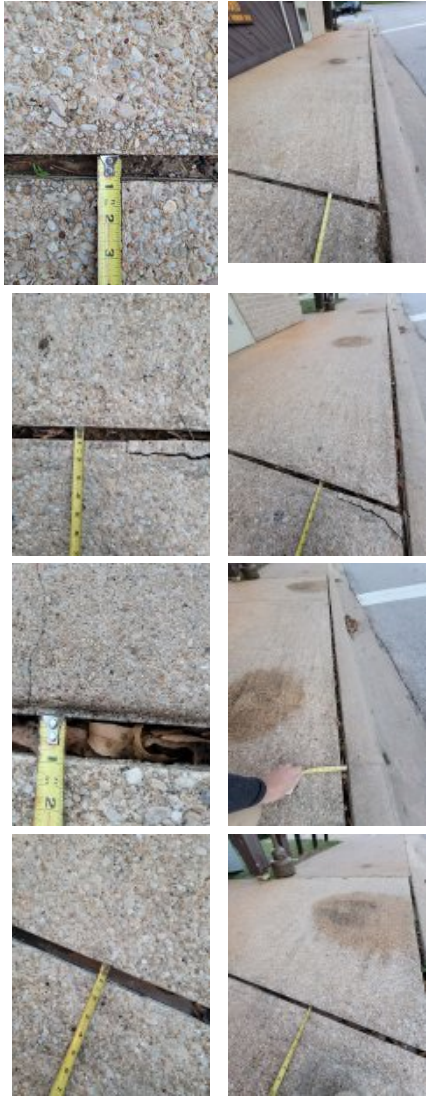
Finding Number	Area Description	Lat/Long	Finding	As Built	Recommendation	Citation	Photos	Figure
2	Headquarters: Headquarters Parking	[30.0392217 , -97.158257 2]	There is a gap spaced greater than a 1/2 inch. Openings in floor or ground surfaces shall not allow passage of a sphere more than 1/2 inch diameter. Elongated openings shall be placed so that the long dimension is perpendicular to the dominant direction of travel.	Multiple gaps between 1" and 2" on walkway	Correct or fill gaps to be max .5"	2015 ABAAS Section: 302.3  2012 TAS Section: 302.3  2010 ADAS Section: 302.3

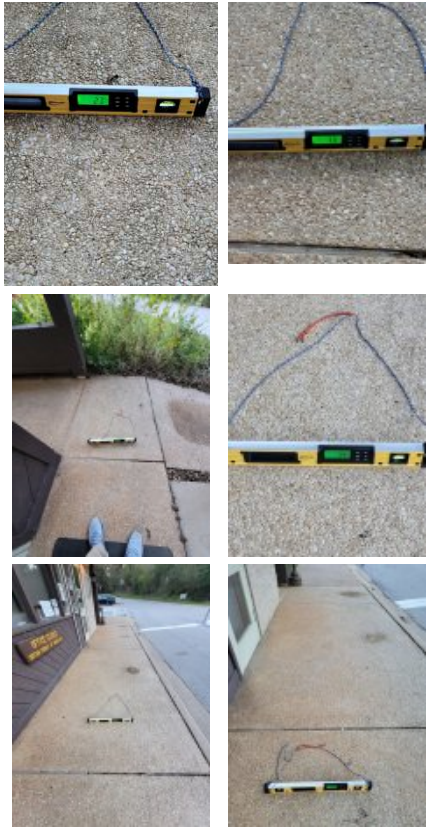
3	Headquarters: Headquarters Parking	[30.0392554 , -97.158290 8]	The running slope of walking surfaces shall not be steeper than 1:20. The cross slope of walking surfaces shall not be steeper than 1:48.	Cross slopes of 2.3%, 3%, 3.1%, and 3.4%, and running slopes of 9%, 6.5%, and 5.7%	Correct running slopes to max 5% and cross to max 2.08%.	2012 TAS Section: 403.3  2010 ADAS Section: 403.3

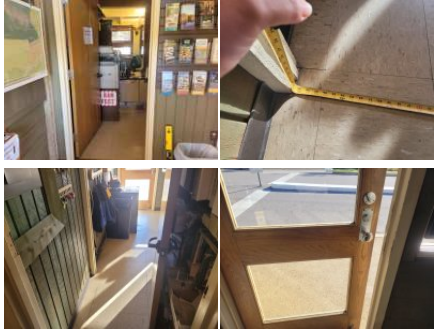
Finding Number	Area Description	Lat/Long	Finding	As Built	Recommendation	Citation	Photos	Figure
7	Headquarters: Headquarters Building	[30.0391414 , -97.1582855]	Minimum maneuvering clearances at doors and gates shall comply with 404.2.4. Maneuvering clearances shall extend the full width of the doorway and the required latch side or hinge side clearance. Door openings shall provide a clear width of 32 inches (815 mm) minimum. Clear openings of doorways with swinging doors shall be measured between the face of the door and the stop, with the door open 90 degrees. Openings more than 24 inches (610 mm) deep shall provide a clear opening of 36 inches (915 mm) minimum. There shall be no projections into the required clear opening width lower than 34 inches (865 mm) above the finish floor or ground. Projections into the clear opening width between 34 inches (865 mm) and 80 inches (2030 mm) above the finish floor or ground shall not exceed 4 inches (100 mm). Hand-activated door opening hardware, handles, pulls, latches, locks, and other operating devices on accessible doors shall have a shape that is easy to grasp with one hand and does not require tight grasping, tight pinching or twisting of the wrist to operate. Hardware shall be 34 inches minimum and 48 inches maximum above the finish floor or ground.	Office door - cabinet pull side; reception door - wall pull side, recessed, 29.5" wide; reception exit door - knobs	For all doors along the public circulation route, provide required maneuvering clearance on push and pull side of doors For all doors along the public circulation route, replace doors with doors having 80" overhead clearance and 32" clear width For all doors along the public circulation route, replace hardware with lever hardware or hardware operable without a tight pinch or grasp Widen doors to 36" for recessed doors	2010 ADAS Section: 404.2.3, 404.2.7, 404.2.4, 404.2.11, 404.2.11 Exception

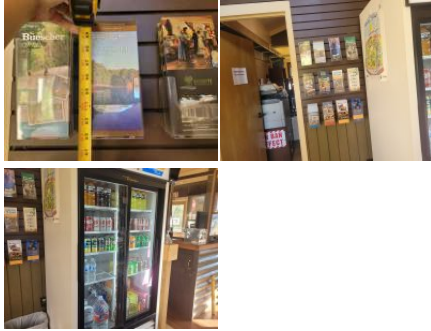
12	Headquarters: Headquarters Building	[30.0391182, -97.158289 5]	The top row of brochures and some rows in the beverage refrigerator are positioned too high for either a side or front approach. Where a clear floor or ground space allows a parallel approach to an element and the side reach is unobstructed, the high side reach shall be 48 inches maximum and the low side reach shall be 15 inches minimum above the finish floor or ground. Where a forward reach is unobstructed, the high forward reach shall be 48 inches maximum and the low forward reach shall be 15 inches minimum above the finish floor or ground.	Top row of brochure racks 62" aff and some rows in beverage refrigerator exceed reach range	Remount operable parts to be in reach range of 15" min to 48" max	2015 ABAAS Section: 308.1  2012 TAS Section: 308.1  2010 ADAS Section: 308.1

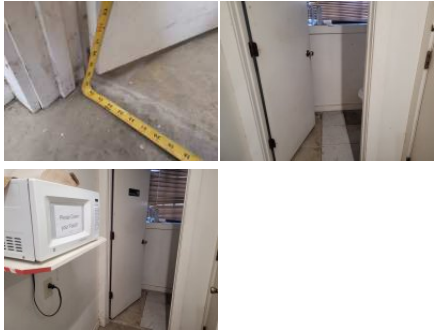
Finding Number	Area Description	Lat/Long	Finding	As Built	Recommendation	Citation	Photos	Figure
27	Employee Spaces: Maintenance Building	[30.044166, -97.1579006]	Minimum maneuvering clearances at doors and gates shall comply with 404.2.4. Maneuvering clearances shall extend the full width of the doorway and the required latch side or hinge side clearance. Door openings shall provide a clear width of 32 inches (815 mm) minimum. Clear openings of doorways with swinging doors shall be measured between the face of the door and the stop, with the door open 90 degrees. Openings more than 24 inches (610 mm) deep shall provide a clear opening of 36 inches (915 mm) minimum. There shall be no projections into the required clear opening width lower than 34 inches (865 mm) above the finish floor or ground. Projections into the clear opening width between 34 inches (865 mm) and 80 inches (2030 mm) above the finish floor or ground shall not exceed 4 inches (100 mm). Hand-activated door opening hardware, handles, pulls, latches, locks, and other operating devices on accessible doors shall have a shape that is easy to grasp with one hand and does not require tight grasping, tight pinching or twisting of the wrist to operate. Hardware shall be 34 inches minimum and 48 inches maximum above the finish floor or ground.	Restroom door - Lacks maneuvering clearance on push and pull sides, 28" wide, knobs	For all doors along the public circulation route, provide required maneuvering clearance on push and pull side of doors For all doors along the public circulation route, replace doors with doors having 80" overhead clearance and 32" clear width For all doors along the public circulation route, replace hardware with lever hardware or hardware operable without a tight pinch or grasp	2010 ADAS Section: 404.2.3, 404.2.7, 404.2.4, 404.2.11, 404.2.11 Exception

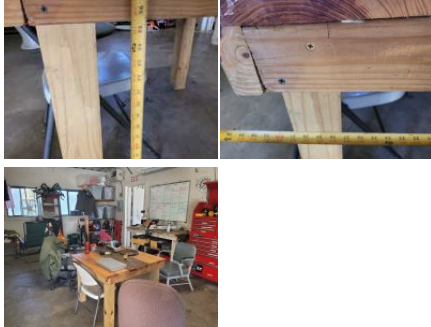
31	Employee Spaces: Maintenance Building	[30.0441799, -97.1578952]	The top of the work surface is not within a compliant height range. The tops of tables and counters shall be 28 inches to 34 inches from the floor or ground.	Small work table lacks knee clearance	Provide tables and work surfaces at 28" to 34" aff with required knee and toe clearances	2015 ABAAS Section: 902.3 2012 TAS Section: 902.3 2010 ADAS Section: 902.3

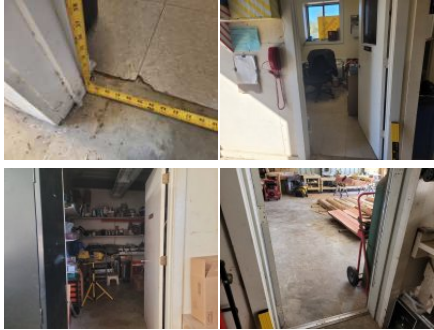
Finding Number	Area Description	Lat/Long	Finding	As Built	Recommendation	Citation	Photos	Figure
32	Employee Spaces: Maintenance Building	[30.0441846 , -97.157897 9]	Minimum maneuvering clearances at doors and gates shall comply with 404.2.4. Maneuvering clearances shall extend the full width of the doorway and the required latch side or hinge side clearance. Door openings shall provide a clear width of 32 inches (815 mm) minimum. Clear openings of doorways with swinging doors shall be measured between the face of the door and the stop, with the door open 90 degrees. Openings more than 24 inches (610 mm) deep shall provide a clear opening of 36 inches (915 mm) minimum. There shall be no projections into the required clear opening width lower than 34 inches (865 mm) above the finish floor or ground. Projections into the clear opening width between 34 inches (865 mm) and 80 inches (2030 mm) above the finish floor or ground shall not exceed 4 inches (100 mm). Hand-activated door opening hardware, handles, pulls, latches, locks, and other operating devices on accessible doors shall have a shape that is easy to grasp with one hand and does not require tight grasping, tight pinching or twisting of the wrist to operate. Hardware shall be 34 inches minimum and 48 inches maximum above the finish floor or ground.	Office door - garbage can and cabinet pull side, 30" wide, knobs; rear storage door - storage pull side, knobs; bay door - tank pull side	For all doors along the public circulation route, provide required maneuvering clearance on push and pull side of doors For all doors along the public circulation route, replace doors with doors having 80" overhead clearance and 32" clear width For all doors along the public circulation route, replace hardware with lever hardware or hardware operable without a tight pinch or grasp	2010 ADAS Section: 404.2.3, 404.2.7, 404.2.4, 404.2.11, 404.2.11 Exception

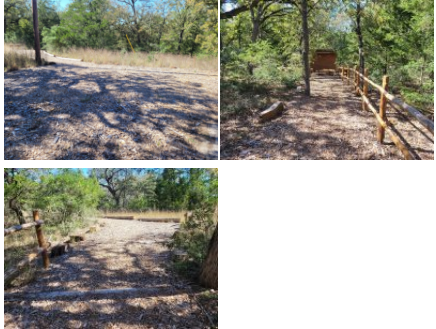
Finding Number	Area Description	Lat/Long	Finding	As Built	Recommendation	Citation	Photos	Figure
39	Park Sites: Amphitheater	[30.0481516 , -97.160122 1]	There is no accessible route to the amphitheater. At least one accessible route shall connect accessible buildings, accessible facilities, accessible elements, and accessible spaces that are on the same site.	Lacks accessible route to amphitheater	Create an accessible route with crushed stone or other outdoor material from parking or walkway to the amphitheater	2015 ABAAS Section: F206.2.2  2012 TAS Section: 206.2.2  2010 ADAS Section: 206.2.2

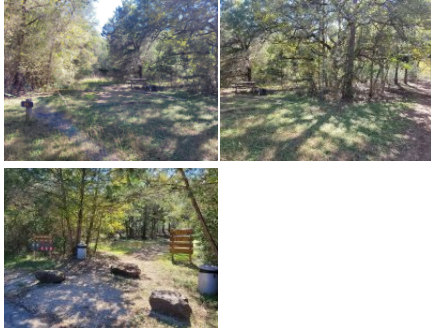
53	Walk-in Campsites: Walk-in Campsites	[30.048768, -97.161091]	Camping facilities shall provide camping units with mobility features complying with F244.2 in accordance with Table F244.2. Where a camping facility provides different types of camping units, Table F244.2 shall apply to each type of camping unit provided. Total Number of Camping Units Provided in Camping Facility Minimum Number of Camping Units with Mobility Features Required 1 1 2 to 25 2 26 to 50 3 51 to 75 4 76 to 100 5 101 to 150 7 151 to 200 8 201 and over 8, plus 2 percent of the number over 200	Lacks camping units with mobility features (11 standard, 0 accessible campsites)	Create the required number of accessible camp sites per table F244.2 as a smart practice	2015 ABAAS Section: F244.2

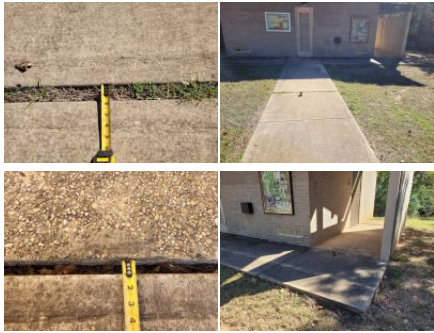
59	Cozy Circle Camping Area: Cozy Circle Camping Area Restroom Parking	[30.0471616 , -97.159847 4]	There is a gap spaced greater than a 1/2 inch. Openings in floor or ground surfaces shall not allow passage of a sphere more than 1/2 inch diameter. Elongated openings shall be placed so that the long dimension is perpendicular to the dominant direction of travel.	Gap of 1.5" on main walkway and 1" near men's restroom	Correct or fill gaps to be max .5"	2015 ABAAS Section: 302.3  2012 TAS Section: 302.3  2010 ADAS Section: 302.3

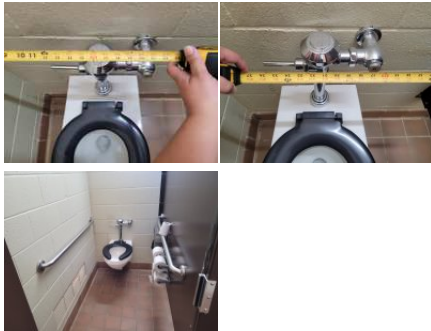
77	Cozy Circle Camping Area: Cozy Circle Camping Area Women's Restroom	[30.0471321 , -97.159837 1]	The toilet is not located within the range to the side wall or partition. The centerline of the toilet shall be 17 inches minimum and 19 inches maximum side wall or partition in the ambulatory accessible toilet compartment.	Centerline of the toilet is 21.25" from the partition and 16.25" from the side wall	Remount toilet to 17" to 19" from the side wall to center line in ambulatory stalls	2015 ABAAS Section: 604.9.1  2012 TAS Section: 604.9.1  2010 ADAS Section: 604.9.1

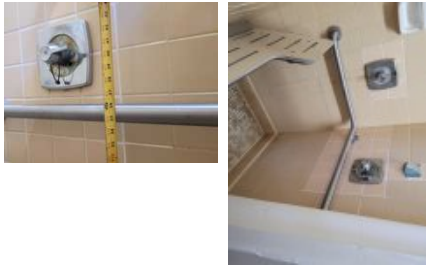
89	Cozy Circle Camping Area: Cozy Circle Camping Area Women's Showers	[30.0471356 , -97.1598184]	Grab bars shall be installed in a horizontal position, 33 inches (840 mm) minimum and 36 inches (915 mm) maximum above the finish floor measured to the top of the gripping surface	Gripping surfaces of grab bars are 36.25" aff	Remount shower grab bar to 33" min and 36" max aff	2015 ABAAS Section: 609.3 Exception, 609.4  2012 TAS Section: 609.4, 609.3 Exception  2010 ADAS Section: 609.4, 609.3 Exception

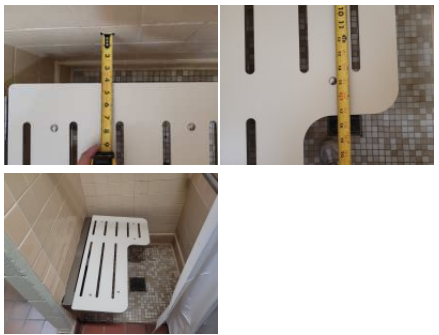
Finding Number	Area Description	Lat/Long	Finding	As Built	Recommendation	Citation	Photos	Figure
91	Cozy Circle Camping Area: Cozy Circle Camping Area Women's Showers	[30.0471239 , -97.1598264]	The shower seat does not have a compliant space between it and the wall. The folding seat must be mounted 17-19 inches above the floor, and have a maximum space of 1-1/2 inches between the edge of the seat and the side wall and 2-1/2 inches maximum to the seat wall.	The shower seat lacks required dimensions and spacing between it and the wall	Remount shower seat to the correct location and height in the shower	2015 ABAAS Section: 610.3.2  2012 TAS Section: 610.3.2  2010 ADAS Section: 610.3.2

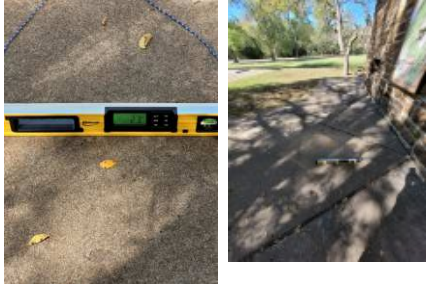
Finding Number	Area Description	Lat/Long	Finding	As Built	Recommendation	Citation	Photos	Figure
101	Lakeview Camping Area: Lakeview Camping Area Restroom Exterior Accessible Route	[30.0484543 , -97.1618719]	The accessible route of travel on the accessible route contains cross slopes greater than 2%. Cross slopes shall not exceed one unit vertical in 48 units horizontal (2-percent slope).	Cross slope of 2.3% on walkway	Correct or repair cross slope along AR to max 2.08%	2015 ABAAS Section: 403.3  2012 TAS Section: 403.3  2010 ADAS Section: 403.3

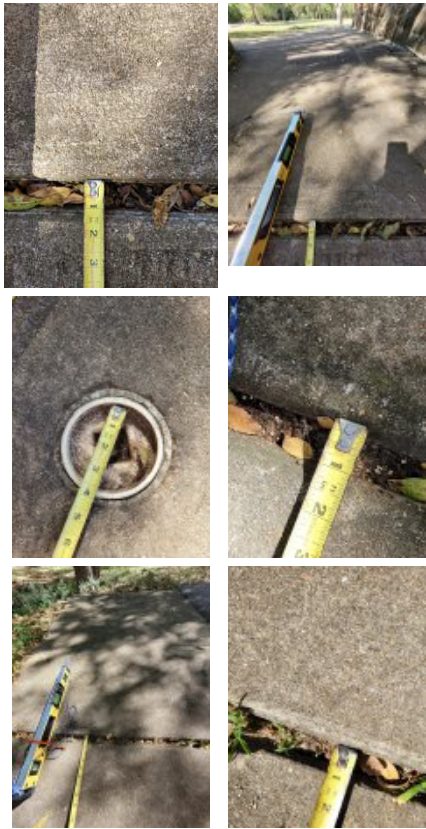
102	Lakeview Camping Area: Lakeview Camping Area Restroom Exterior Accessible Route	[30.0485007 , -97.1617593]	There is a gap spaced greater than a 1/2 inch. Openings in floor or ground surfaces shall not allow passage of a sphere more than 1/2 inch diameter. Elongated openings shall be placed so that the long dimension is perpendicular to the dominant direction of travel.	Multiple gaps (6) greater than .5"	Correct or fill gaps to be max .5"	2015 ABAAS Section: 302.3  2012 TAS Section: 302.3  2010 ADAS Section: 302.3

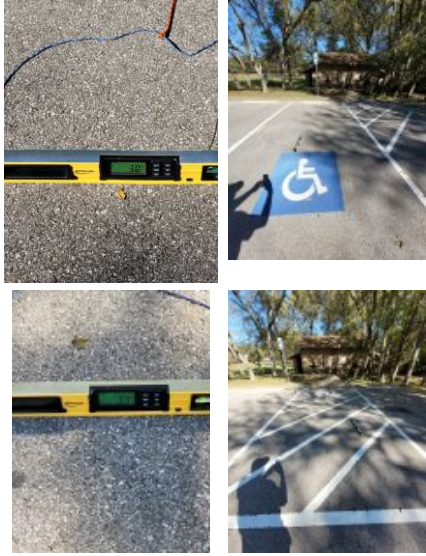
103	Lakeview Camping Area: Lakeview Camping Area Restroom Exterior Accessible Route	[30.0484578 , -97.1618689]	The cross slopes (narrow dimension) and/or running slopes (long dimension) of the access aisle exceeds 2%. The running slope and the cross slope in an accessible parking stall and the access aisle must not exceed 2%.	Slopes of 3% in stall and 3.4% in access aisle	Repair or correct slope of parking space and access aisle to max 2.08% in any direction.	2015 ABAAS Section: 502.4  2012 TAS Section: 502.4  2010 ADAS Section: 502.4

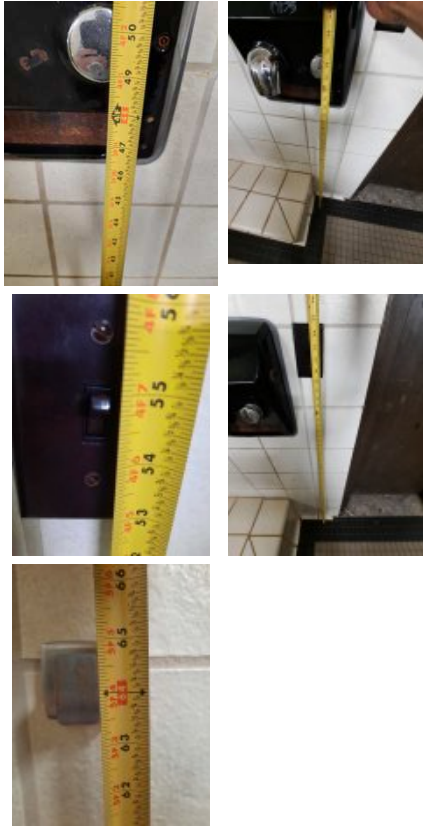
108	Lakeview Camping Area: Lakeview Camping Area Men's Restroom	[30.0483367 , -97.161652 8]	Where a high forward reach is over an obstruction, the clear floor space shall extend beneath the element for a distance not less than the required reach depth over the obstruction. The high forward reach shall be 48 inches (1220 mm) maximum where the reach depth is 20 inches (510 mm) maximum. Where the reach depth exceeds 20 inches (510 mm), the high forward reach shall be 44 inches (1120 mm) maximum and the reach depth shall be 25 inches (635 mm) maximum. Where a clear floor or ground space allows a parallel approach to an element and the high side reach is over an obstruction, the height of the obstruction shall be 34 inches (865 mm) maximum and the depth of the obstruction shall be 24 inches (610 mm) maximum. The high side reach shall be 48 inches (1220 mm) maximum for a reach depth of 10 inches (255 mm) maximum. Where the reach depth exceeds 10 inches (255 mm), the high side reach shall be 46 inches (1170 mm) maximum for a reach depth of 24 inches (610 mm) maximum.	Hand dryer 49.5" aff, light switch 55" aff, and coat hook 65" aff	Lower coat hook and light switch to max 48" aff to highest operable part Lower hand dryer to max 46" aff for a side reach over bench	2015 ABAAS Section: 308.2.1, 308.3.2  2012 TAS Section: 308.2.1, 308.3.2  2010 ADAS Section: 308.2.1, 308.3.2

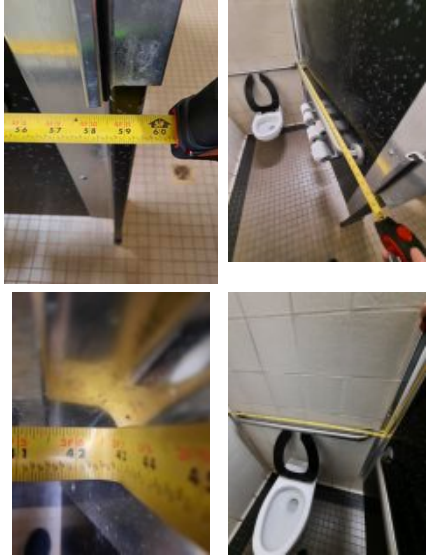
Finding Number	Area Description	Lat/Long	Finding	As Built	Recommendation	Citation	Photos	Figure
109	Lakeview Camping Area: Lakeview Camping Area Men's Restroom	[30.0483127 , -97.1616503]	There are not enough accessible toilet compartments. The room contains several toilet compartments. A minimum of 1 must be wheelchair accessible .	stall is 42.5" wide x 58.5" deep, will not meet requirements for wheelchair or ambulatory stalls	Create a wheelchair accessible stall with grab bars and fixtures mounted in correct locations and at correct heights	2015 ABAAS Section: F213.3.1  2012 TAS Section: 213.3.1  2010 ADAS Section: 213.3.1

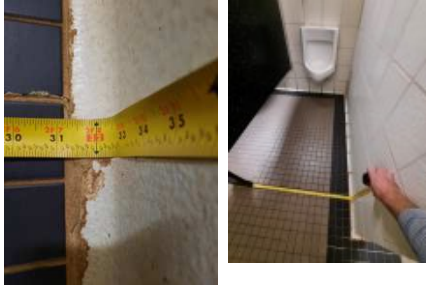
110	Lakeview Camping Area: Lakeview Camping Area Men's Restroom	[30.0483266 , -97.1616557]	The route of travel at this location does not provide a minimum width of 36 inches. The clear width shall be permitted to be reduced to 32 inches minimum for a length of 24 inches maximum provided that reduced width segments are separated by segments that are 48 inches long minimum and 36 inches wide minimum.	33" between urinal partition and wall	Relocate privacy wall at urinal to provide 36" route of travel	2015 ABAAS Section: 403.5.1  2012 TAS Section: 403.5.1  2010 ADAS Section: 403.5.1

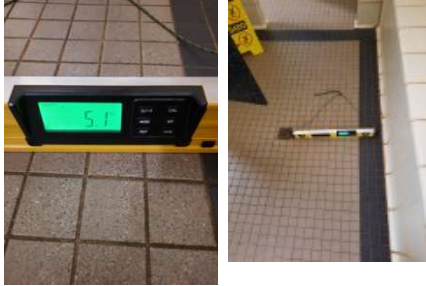
111	Lakeview Camping Area: Lakeview Camping Area Men's Restroom	[30.0483266 , -97.1616543]	The accessible route contains running slopes greater than 5 percent and cross slopes greater than 2 percent across the width of the walk and has not been constructed as a ramp (i.e. handrails, wheel guides, etc.). When the slope in the direction of travel of any walk exceeds 1 unit vertical in 20 units horizontal (5-percent slope), it must be constructed as ramp. Surface cross slopes must not exceed one unit vertical in 48 units. Horizontal (2-percent slope).	Cross slope of 5.1% near floor drain near shower area	Correct or repair slope to max 5% running and 2.08% cross	2015 ABAAS Section: 403.3  2012 TAS Section: 403.3  2010 ADAS Section: 403.3

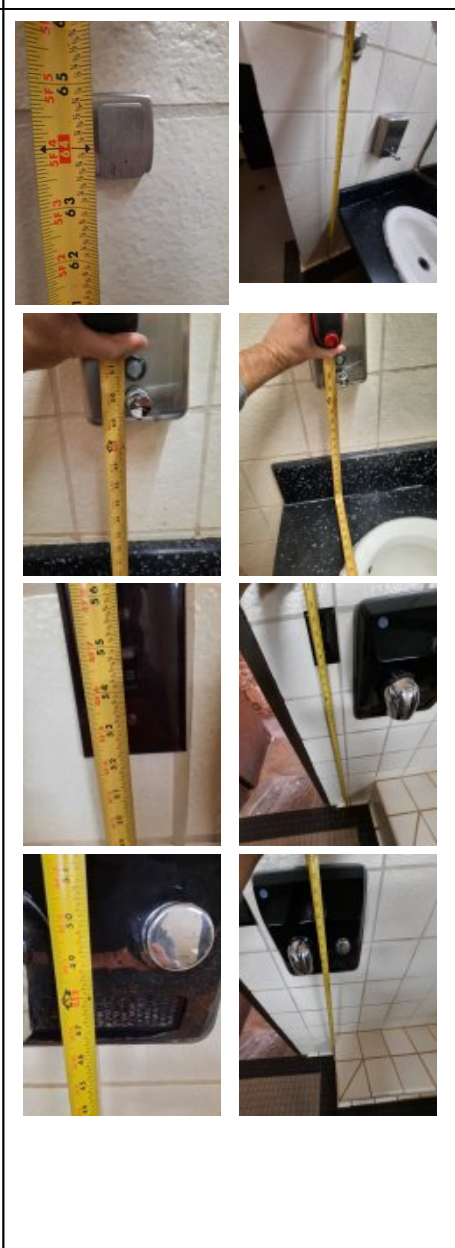
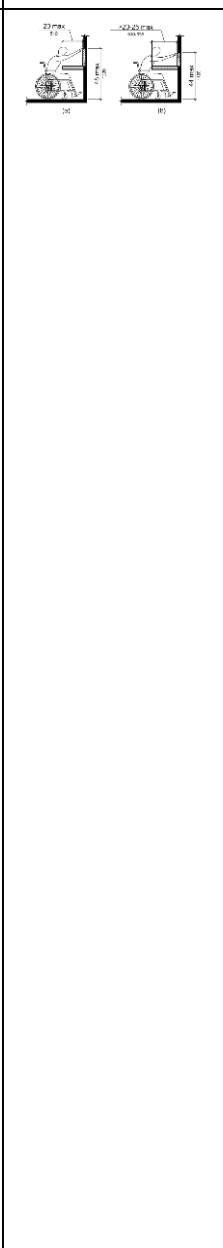
Finding Number	Area Description	Lat/Long	Finding	As Built	Recommendation	Citation	Photos	Figure
118	Lakeview Camping Area: Lakeview Camping Area Women's Restroom	[30.0483289 , -97.161661]	Where a high forward reach is over an obstruction, the clear floor space shall extend beneath the element for a distance not less than the required reach depth over the obstruction. The high forward reach shall be 48 inches (1220 mm) maximum where the reach depth is 20 inches (510 mm) maximum. Where the reach depth exceeds 20 inches (510 mm), the high forward reach shall be 44 inches (1120 mm) maximum and the reach depth shall be 25 inches (635 mm) maximum. Where a clear floor or ground space allows a parallel approach to an element and the high side reach is over an obstruction, the height of the obstruction shall be 34 inches (865 mm) maximum and the depth of the obstruction shall be 24 inches (610 mm) maximum. The high side reach shall be 48 inches (1220 mm) maximum for a reach depth of 10 inches (255 mm) maximum. Where the reach depth exceeds 10 inches (255 mm), the high side reach shall be 46 inches (1170 mm) maximum for a reach depth of 24 inches (610 mm) maximum.	Coat hook 64.5" aff, soap dispenser 50" aff, light switch 55" aff, and hand dryer 50" aff	Lower operating mechanisms to max 48" above the finished floor (AFF) to highest operable part. Lower soap dispenser to max 44" above the finished floor (AFF) for a forward reach over counter. Lower hand dryer to max 46" above the finished floor (AFF) for a side reach over counter.	2015 ABAAS Section: 308.2.1, 308.3.2  2012 TAS Section: 308.2.1, 308.3.2  2010 ADAS Section: 308.2.1, 308.3.2

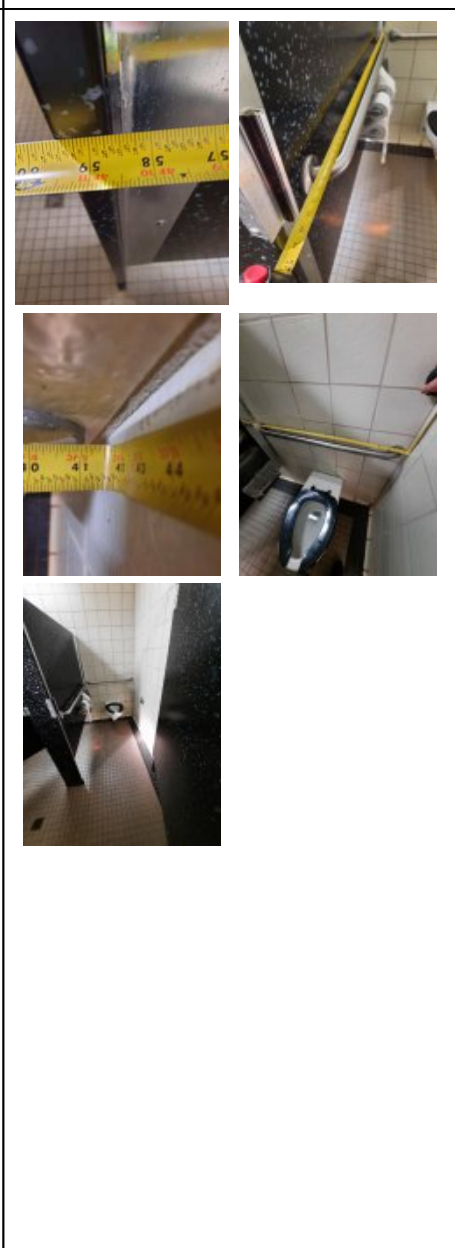
Finding Number	Area Description	Lat/Long	Finding	As Built	Recommendation	Citation	Photos	Figure
119	Lakeview Camping Area: Lakeview Camping Area Women's Restroom	[30.0483254 , -97.1616584]	There are not enough accessible toilet compartments. The room contains several toilet compartments. A minimum of 1 must be wheelchair accessible .	stall is 41.5" wide x 58.5" deep, will not meet requirements for wheelchair stall or ambulatory stall	Create a wheelchair accessible stall with grab bars and fixtures mounted in correct locations and at correct heights	2015 ABAAS Section: F213.3.1  2012 TAS Section: 213.3.1  2010 ADAS Section: 213.3.1

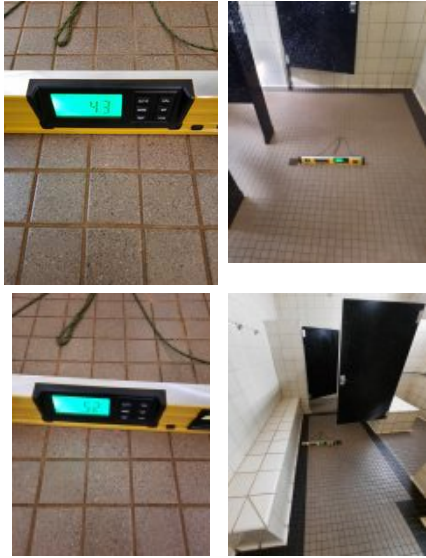
Finding Number	Area Description	Lat/Long	Finding	As Built	Recommendation	Citation	Photos	Figure
120	Lakeview Camping Area: Lakeview Camping Area Women's Restroom	[30.0483266 , -97.161658 4]	The accessible route contains running slopes greater than 5 percent and cross slopes greater than 2 percent across the width of the walk and has not been constructed as a ramp (i.e. handrails, wheel guides, etc.). When the slope in the direction of travel of any walk exceeds 1 unit vertical in 20 units horizontal (5-percent slope), it must be constructed as ramp. Surface cross slopes must not exceed one unit vertical in 48 units. Horizontal (2-percent slope).	Cross slopes of 4.3% near stall floor drain and 5.2% at floor drain near shower area	Correct or repair slope to max 5% running and 2.08% cross	2015 ABAAS Section: 403.3  2012 TAS Section: 403.3  2010 ADAS Section: 403.3

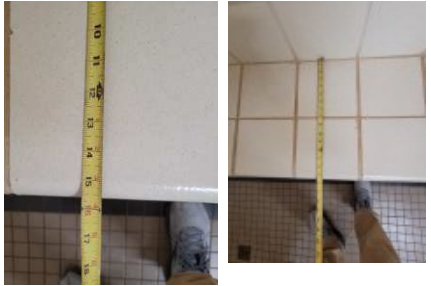
Finding Number	Area Description	Lat/Long	Finding	As Built	Recommendation	Citation	Photos	Figure
122	Lakeview Camping Area: Lakeview Camping Area Men's Shower	[30.0483336 , -97.1616584]	The bench is not deep enough or long enough or is missing. Benches shall be provided having seats that are 42 inches long minimum and 20 inches deep minimum and 24 inches deep maximum. The bench shall provide for back support or shall be affixed to a wall. Back support shall be 42 inches (1065 mm) long minimum and shall extend from a point 2 inches (51 mm) maximum above the seat surface to a point 18 inches (455 mm) minimum above the seat surface. Back support shall be 2½ inches (64 mm) maximum from the rear edge of the seat measured horizontally. The top of the bench seat surface shall be 17 inches (430 mm) minimum and 19 inches (485 mm) maximum above the finish floor or ground.	bench 16" deep	Replace bench in dressing area with one having a seat depth of 20" to 24" deep, 42" long, affixed to the wall or having a back and mounted 17" to 19" aff	2012 TAS Section: 903.4, 903.2, 903.3, 903.5  2010 ADAS Section: 903.4, 903.2, 903.3, 903.5

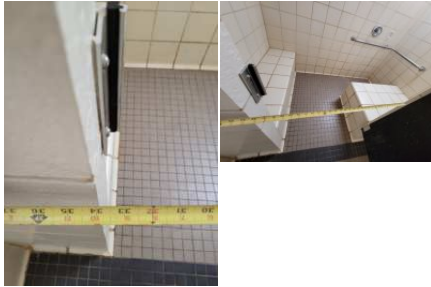
123	Lakeview Camping Area: Lakeview Camping Area Men's Shower	[30.0483289 , -97.1616557]	Transfer type shower compartments shall be 36 inches (915 mm) by 36 inches (915 mm) clear inside dimensions measured at the center points of opposing sides and shall have a 36 inch (915 mm) wide minimum entry on the face of the shower compartment. Clearance of 36 inches (915 mm) wide minimum by 48 inches (1220 mm) long minimum measured from the control wall shall be provided.	34" wide CFS	Provide appropriate CFS on the exterior of the transfer shower	2015 ABAAS Section: 608.2.1  2012 TAS Section: 608.2.1  2010 ADAS Section: 608.2.1

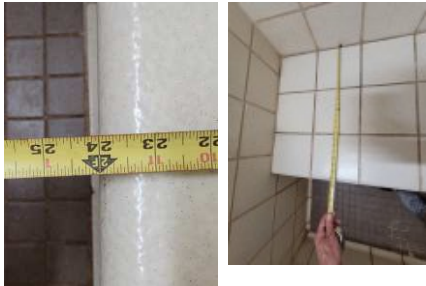
126	Lakeview Camping Area: Lakeview Camping Area Men's Shower	[30.0483266 , -97.1616584]	Where a seat is provided in a standard roll-in shower compartment, it shall be a folding type, shall be installed on the side wall adjacent to the controls, and shall extend from the back wall to a point within 3 inches (75 mm) of the compartment entry. Where a seat is provided in an alternate roll-in type shower compartment, it shall be a folding type, shall be installed on the front wall opposite the back wall, and shall extend from the adjacent side wall to a point within 3 inches (75 mm) of the compartment entry. In transfer-type showers, the seat shall extend from the back wall to a point within 3 inches (75 mm) of the compartment entry. The top of the seat shall be 17 inches (430 mm) minimum and 19 inches (485 mm) maximum above the bathroom finish floor. Seats shall comply with 610.3.1 or 610.3.2.	seat 24" deep	Provide the correct seat based on shower type.	2015 ABAAS Section: 610.3  2012 TAS Section: 610.3  2010 ADAS Section: 610.3

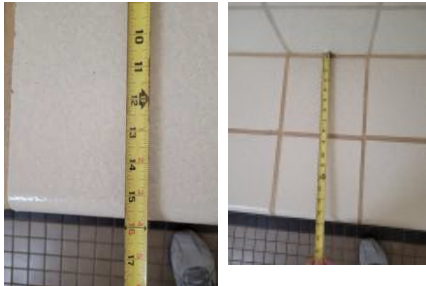
128	Lakeview Camping Area: Lakeview Camping Area Women's Shower	[30.0483266 , -97.161657]	The bench is not deep enough or long enough or is missing. Benches shall be provided having seats that are 42 inches long minimum and 20 inches deep minimum and 24 inches deep maximum. The bench shall provide for back support or shall be affixed to a wall. Back support shall be 42 inches (1065 mm) long minimum and shall extend from a point 2 inches (51 mm) maximum above the seat surface to a point 18 inches (455 mm) minimum above the seat surface. Back support shall be 2½ inches (64 mm) maximum from the rear edge of the seat measured horizontally. The top of the bench seat surface shall be 17 inches (430 mm) minimum and 19 inches (485 mm) maximum above the finish floor or ground. Clear floor or ground space complying with 305 shall be provided and shall be positioned at the end of the bench seat and parallel to the short axis of the bench	bench 16" deep	Replace bench in dressing area with one having a seat depth of 20" to 24" deep, 42" long, affixed to the wall or having a back and mounted 17" to 19" AFF and provide required clear floor space on the short axis of the bench.	2012 TAS Section: 903.4, 903.2, 903.3, 903.5  2010 ADAS Section: 903.4, 903.2, 903.3, 903.5

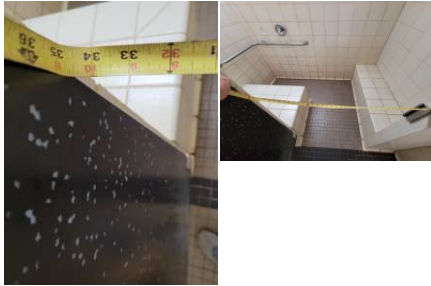
Finding Number	Area Description	Lat/Long	Finding	As Built	Recommendation	Citation	Photos	Figure
129	Lakeview Camping Area: Lakeview Camping Area Women's Shower	[30.0483266 , -97.161657]	Transfer type shower compartments shall be 36 inches (915 mm) by 36 inches (915 mm) clear inside dimensions measured at the center points of opposing sides and shall have a 36 inch (915 mm) wide minimum entry on the face of the shower compartment. Clearance of 36 inches (915 mm) wide minimum by 48 inches (1220 mm) long minimum measured from the control wall shall be provided.	34.5" wide CFS	Provide appropriate CFS on the exterior of the transfer shower	2015 ABAAS Section: 608.2.1  2012 TAS Section: 608.2.1  2010 ADAS Section: 608.2.1

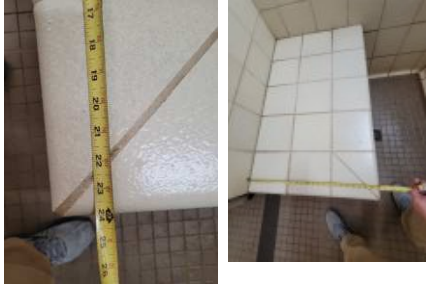
Finding Number	Area Description	Lat/Long	Finding	As Built	Recommendation	Citation	Photos	Figure
132	Lakeview Camping Area: Lakeview Camping Area Women's Shower	[30.0483243 , -97.161657]	Where a seat is provided in a standard roll-in shower compartment, it shall be a folding type, shall be installed on the side wall adjacent to the controls, and shall extend from the back wall to a point within 3 inches (75 mm) of the compartment entry. Where a seat is provided in an alternate roll-in type shower compartment, it shall be a folding type, shall be installed on the front wall opposite the back wall, and shall extend from the adjacent side wall to a point within 3 inches (75 mm) of the compartment entry. In transfer-type showers, the seat shall extend from the back wall to a point within 3 inches (75 mm) of the compartment entry. The top of the seat shall be 17 inches (430 mm) minimum and 19 inches (485 mm) maximum above the bathroom finish floor. Seats shall comply with 610.3.1 or 610.3.2.	seat dimensions fail, 24" deep	Provide the correct seat based on shower type.	2015 ABAAS Section: 610.3  2012 TAS Section: 610.3  2010 ADAS Section: 610.3

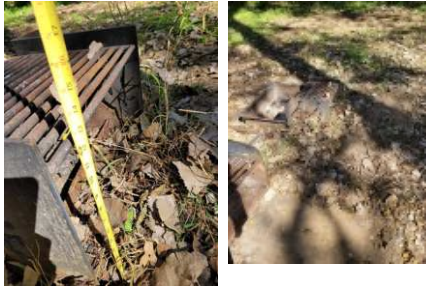
134	Lakeview Camping Area: Lakeview Camping Area Accessible Site 52	[30.0483104 , -97.161548 4]	Where provided, cooking surfaces shall be 15 inches (380 mm) minimum and 34 inches (865 mm) maximum above the ground	Cooking surface of low grill/fire ring 13" at highest setting	Raise or lower cooking surface to be 15" min to 34" max above the ground; in the alternative, replace with a compliant surface as a smart practice	2015 ABAAS Section: 1011.5.2

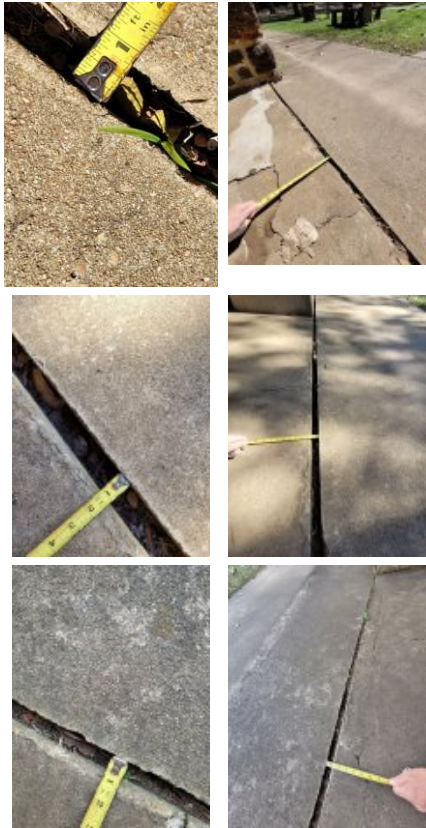
136	Lakeview Camping Area: Lakeview Camping Area Group Picnic Pavilion	[30.0481362 , -97.162133 1]	There is a gap spaced greater than a 1/2 inch. Openings in floor or ground surfaces shall not allow passage of a sphere more than 1/2 inch diameter. Elongated openings shall be placed so that the long dimension is perpendicular to the dominant direction of travel.	Gaps of .75", 1", and .5" along both sides of shelter floor	Correct or fill gaps to be max .5".	2015 ABAAS Section: 302.3  2012 TAS Section: 302.3  2010 ADAS Section: 302.3

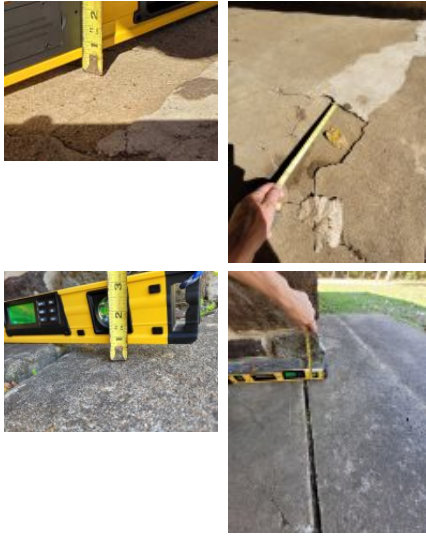
Finding Number	Area Description	Lat/Long	Finding	As Built	Recommendation	Citation	Photos	Figure
137	Lakeview Camping Area: Lakeview Camping Area Group Picnic Pavilion	[30.0481409 , -97.1621385]	The walkway contains abrupt vertical edges and/or variations over a 1/4 inch. 1/4 inch is the maximum vertical rise. Changes in level between 1/4 inch and 1/2 inch must be beveled at 1:2 or less. Changes in level greater than 1/2 inch must be by way of a ramp.	CILs of .5" and .5"	Repair, bevel or ramp CIL along AR	2012 TAS Section: 303.2, 303.3  2010 ADAS Section: 303.2, 303.3

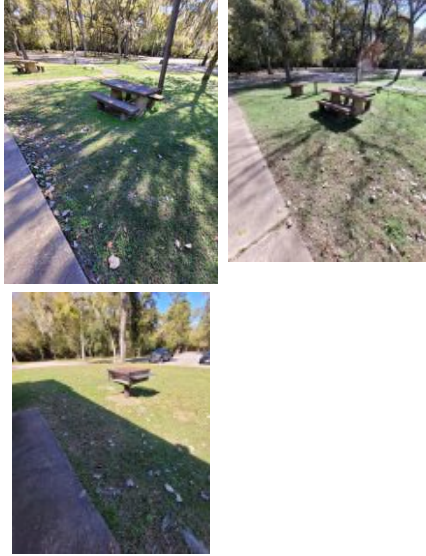
138	Lakeview Camping Area: Lakeview Camping Area Group Picnic Pavilion	[30.048055, -97.1620312]	Where picnic facilities contain two or fewer picnic units, each picnic unit shall provide mobility features complying with F245.2.	Lacks accessible route to picnic tables (2), grill, and water spout	Create an ORAR to shelter or picnic area and provide accessible features as a smart practice.	2015 ABAAS Section: F245.2.1

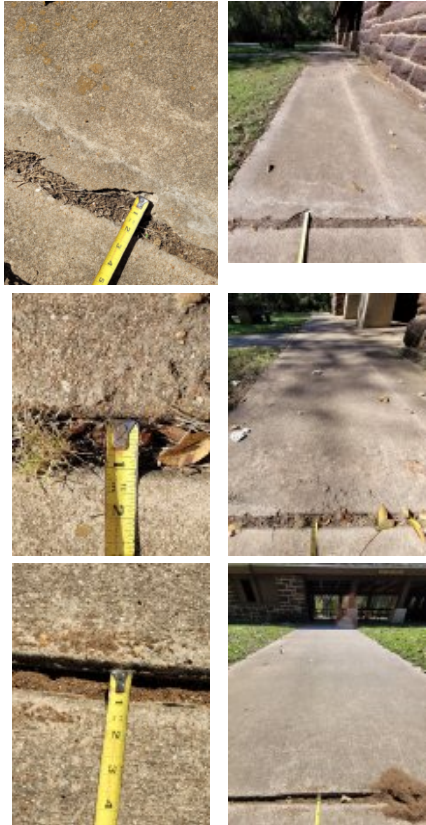
Finding Number	Area Description	Lat/Long	Finding	As Built	Recommendation	Citation	Photos	Figure
139	Lakeview Camping Area: Lakeview Camping Area Group Picnic Pavilion	[30.0482437 , -97.1621297]	There is a gap spaced greater than a 1/2 inch. Openings in floor or ground surfaces shall not allow passage of a sphere more than 1/2 inch diameter. Elongated openings shall be placed so that the long dimension is perpendicular to the dominant direction of travel.	Multiple gaps (3) between 1" and 2"	Correct or fill gaps to be max .5"	2015 ABAAS Section: 302.3  2012 TAS Section: 302.3  2010 ADAS Section: 302.3

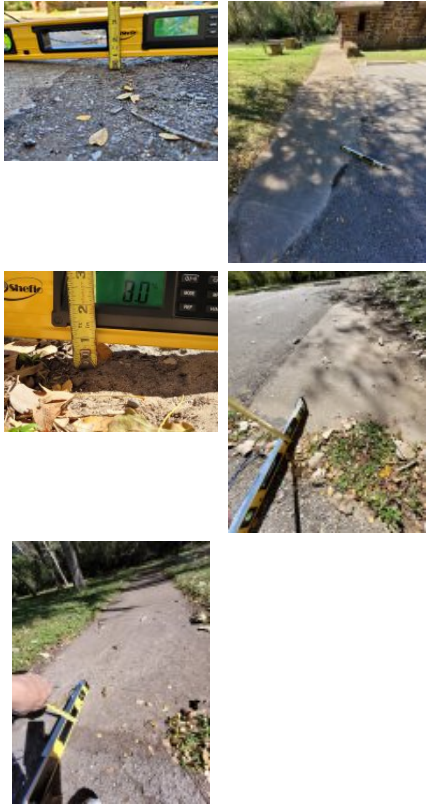
Finding Number	Area Description	Lat/Long	Finding	As Built	Recommendation	Citation	Photos	Figure
140	Lakeview Camping Area: Lakeview Camping Area Group Picnic Pavilion	[30.0482088 , -97.162128 4]	The walkway contains abrupt vertical edges and/or variations over a 1/4 inch. 1/4 inch is the maximum vertical rise. Changes in level between 1/4 inch and 1/2 inch must be beveled at 1:2 or less. Changes in level greater than 1/2 inch must be by way of a ramp.	CILs of .5", .75", and 1"	Repair, bevel or ramp CIL along AR	2012 TAS Section: 303.2, 303.3  2010 ADAS Section: 303.2, 303.3

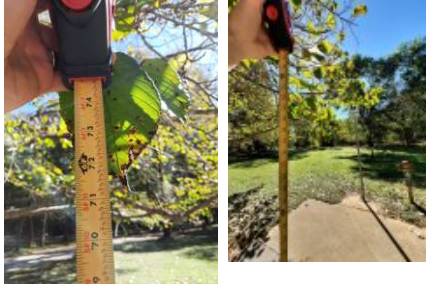
Finding Number	Area Description	Lat/Long	Finding	As Built	Recommendation	Citation	Photos	Figure
142	Lakeview Camping Area: Lakeview Camping Area Group Picnic Pavilion Parking	[30.0475314 , -97.161901 1]	The vehicle route to the accessible parking contains vertical clearances less than 98 inches. A minimum vertical clearance of 98 inches must be provided at accessible parking spaces and along at least one vehicle access route to such spaces from site entrances and exits.	1 of 2 accessible parking spaces lacks 98" of vertical clearance	Maintain overhead clearance to provide minimum 98" at van stalls	2015 ABAAS Section: 502.5  2012 TAS Section: 502.5  2010 ADAS Section: 502.5

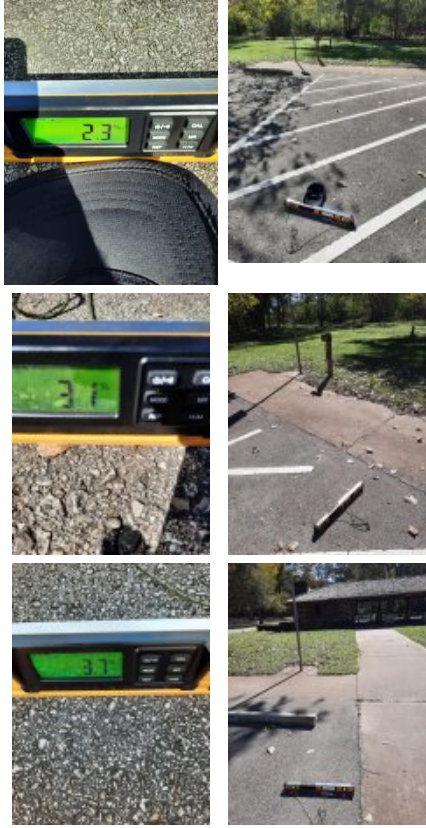
143	Lakeview Camping Area: Lakeview Camping Area Group Picnic Pavilion Parking	[30.0483266 , -97.162095 6]	The cross slopes (narrow dimension) and/or running slopes (long dimension) of the access aisle exceeds 2%. The running slope and the cross slope in an accessible parking stall and the access aisle must not exceed 2%.	Slopes of 2.3% at foot and 3.1% at head of access aisle near campsite 47, slopes of 3.7% at head of stall and 2.3% at foot and 3.8% at head of access aisle of accessible parking space near pavilion	Repair or correct slope of parking space and access aisle to max 2.08% in any direction.	2015 ABAAS Section: 502.4  2012 TAS Section: 502.4  2010 ADAS Section: 502.4

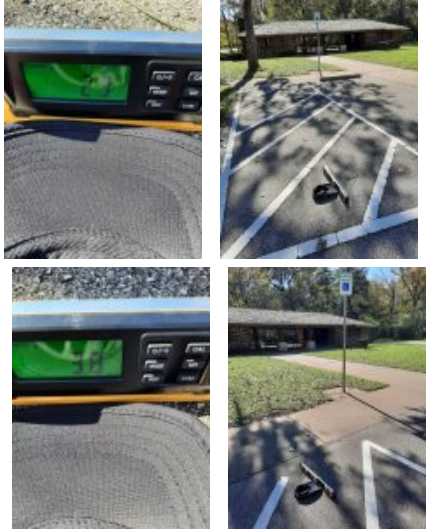
144	Lakeview Camping Area: Lakeview Camping Area Group Picnic Pavilion Parking	[30.0483347 , -97.162117]	The parking stall contains abrupt edges and surface irregularities over a 1/4 inch vertical. Parking spaces and access aisles serving them shall be stable, firm, and slip resistant. Access aisles shall be at the same level as the parking spaces they serve. Changes in level are not permitted and shall not be sloped steeper than 2% in any direction.	Multiple gaps (approximately 25) ranging from .5" to 2.5" in access aisle of accessible parking space near the pavilion due to deterioration of paint/stripping	Resurface stalls and access aisles to eliminate gaps and cracks	2015 ABAAS Section: 502.4  2012 TAS Section: 502.4  2010 ADAS Section: 502.4

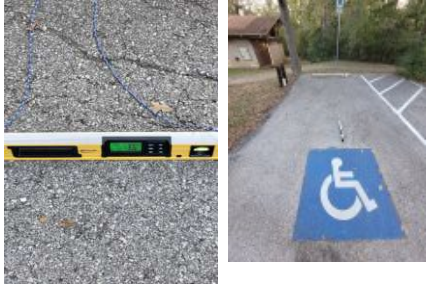
Finding Number	Area Description	Lat/Long	Finding	As Built	Recommendation	Citation	Photos	Figure
145	Oak Haven Camping Area: Oak Haven Camping Area Restroom Parking	[30.0441033 , -97.162070 1]	The cross slopes (narrow dimension) and/or running slopes (long dimension) of the access aisle exceeds 2%. The running slope and the cross slope in an accessible parking stall and the access aisle must not exceed 2%.	Slope of 3.6% in stall	Repair or correct slope of parking space and access aisle to max 2.08% in any direction	2015 ABAAS Section: 502.4  2012 TAS Section: 502.4  2010 ADAS Section: 502.4

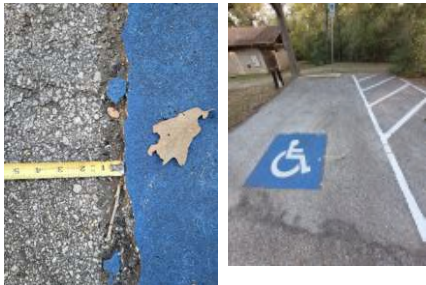
146	Oak Haven Camping Area: Oak Haven Camping Area Restroom Parking	[30.0441021 , -97.162062]	The parking stall contains abrupt edges and surface irregularities over a 1/4 inch vertical. Parking spaces and access aisles serving them shall be stable, firm, and slip resistant. Access aisles shall be at the same level as the parking spaces they serve. Changes in level are not permitted and shall not be sloped steeper than 2% in any direction.	Gap of 1"	Repair, bevel and ramp CIL in stalls and access aisles	2015 ABAAS Section: 502.4  2012 TAS Section: 502.4  2010 ADAS Section: 502.4

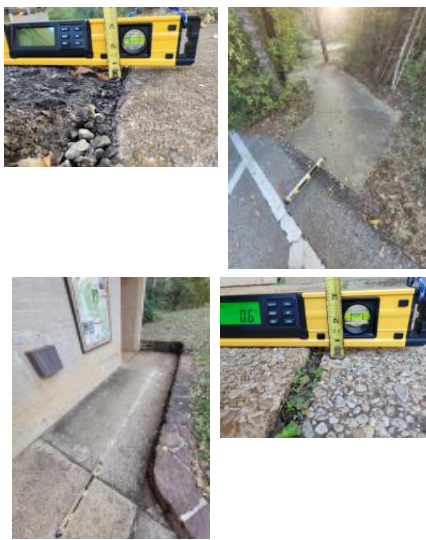
147	Oak Haven Camping Area: Oak Haven Camping Area Restroom Parking	[30.0440344 , -97.162049 3]	The walkway contains abrupt vertical edges and/or variations over a 1/4 inch. 1/4 inch is the maximum vertical rise. Changes in level between 1/4 inch and 1/2 inch must be beveled at 1:2 or less. Changes in level greater than 1/2 inch must be by way of a ramp.	CILs of .5" and .75"	Repair, bevel or ramp CIL along AR	2012 TAS Section: 303.2, 303.3  2010 ADAS Section: 303.2, 303.3

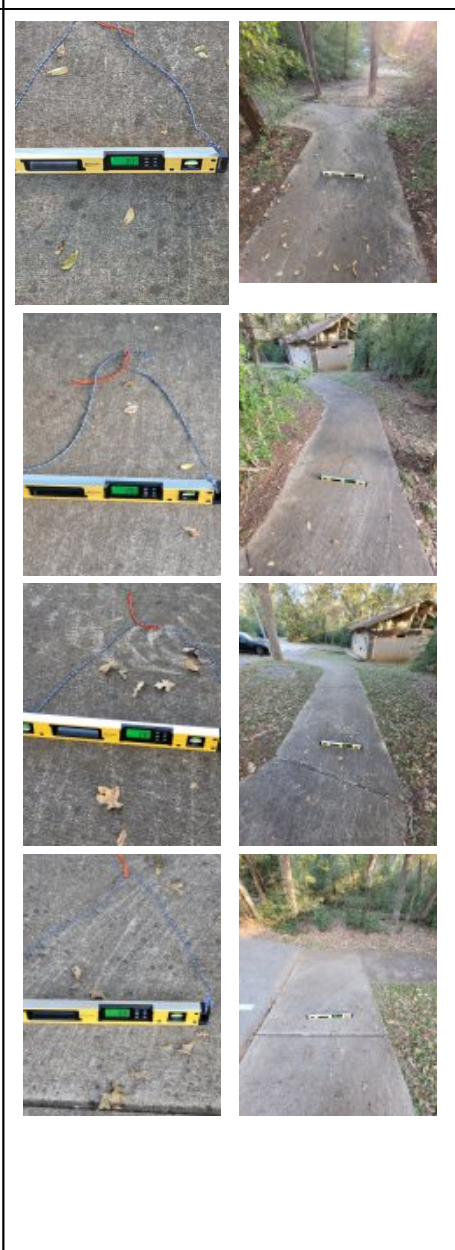
Finding Number	Area Description	Lat/Long	Finding	As Built	Recommendation	Citation	Photos	Figure
148	Oak Haven Camping Area: Oak Haven Camping Area Restroom Parking	[30.0440715 , -97.161913 8]	The running slope of walking surfaces shall not be steeper than 1:20. The cross slope of walking surfaces shall not be steeper than 1:48.	Running slope of 7.2%, and cross slopes of 2.5%, 2.9%, 3.1%, 3.3%, 3.5%, and 5.1%	Correct running slopes to max 5% and cross to max 2.08%.	2012 TAS Section: 403.3  2010 ADAS Section: 403.3

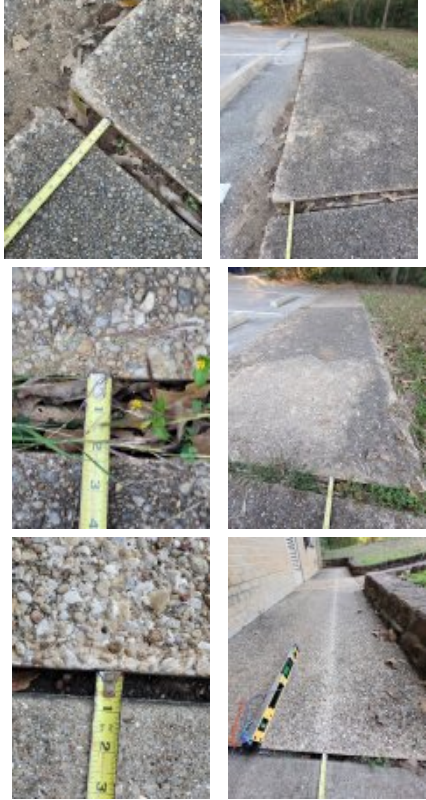
Finding Number	Area Description	Lat/Long	Finding	As Built	Recommendation	Citation	Photos	Figure
149	Oak Haven Camping Area: Oak Haven Camping Area Restroom Parking	[30.0440611 , -97.161935 3]	There is a gap spaced greater than a 1/2 inch. Openings in floor or ground surfaces shall not allow passage of a sphere more than 1/2 inch diameter. Elongated openings shall be placed so that the long dimension is perpendicular to the dominant direction of travel.	Gaps of .75", 1", 2", and 2.25"	Correct or fill gaps to be max .5"	2015 ABAAS Section: 302.3  2012 TAS Section: 302.3  2010 ADAS Section: 302.3

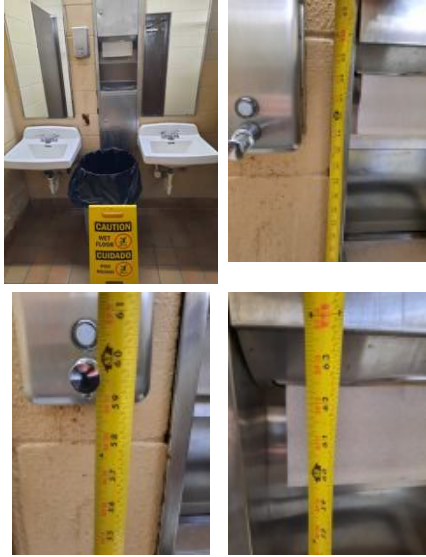
Finding Number	Area Description	Lat/Long	Finding	As Built	Recommendation	Citation	Photos	Figure
151	Oak Haven Camping Area: Oak Haven Camping Area Men's Restroom	[30.0441242 , -97.161936]	Where a high forward reach is over an obstruction, the clear floor space shall extend beneath the element for a distance not less than the required reach depth over the obstruction. The high forward reach shall be 48 inches (1220 mm) maximum where the reach depth is 20 inches (510 mm) maximum. Where the reach depth exceeds 20 inches (510 mm), the high forward reach shall be 44 inches (1120 mm) maximum and the reach depth shall be 25 inches (635 mm) maximum. Where a clear floor or ground space allows a parallel approach to an element and the high side reach is over an obstruction, the height of the obstruction shall be 34 inches (865 mm) maximum and the depth of the obstruction shall be 24 inches (610 mm) maximum. The high side reach shall be 48 inches (1220 mm) maximum for a reach depth of 10 inches (255 mm) maximum. Where the reach depth exceeds 10 inches (255 mm), the high side reach shall be 46 inches (1170 mm) maximum for a reach depth of 24 inches (610 mm) maximum.	Soap dispenser 59.5" aff and paper towel dispenser 62.5" aff	Lower operable parts to max 44" above the finished floor (AFF) for a forward reach over sink.	2015 ABAAS Section: 308.2.1, 308.3.2  2012 TAS Section: 308.2.1, 308.3.2  2010 ADAS Section: 308.2.1, 308.3.2

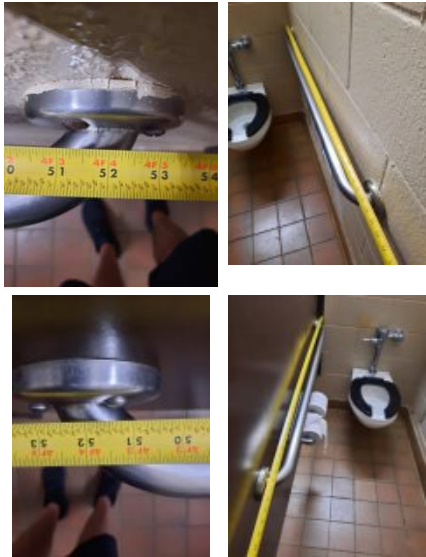
Finding Number	Area Description	Lat/Long	Finding	As Built	Recommendation	Citation	Photos	Figure
153	Oak Haven Camping Area: Oak Haven Camping Area Men's Restroom	[30.0441195 , -97.161923 9]	The stall door fails to comply with all of the door requirements. The stall door must be a minimum of 32" wide and have compliant hardware on both sides. The stall door must be self-closing.	Lacks self-closing door	Adjust stall door to be self-closing	2015 ABAAS Section: 404.2.3, 404.2.7, 604.8.2.2  2012 TAS Section: 404.2.3, 404.2.7, 604.8.2.2  2010 ADAS Section: 404.2.3, 404.2.7, 604.8.2.2		
154	Oak Haven Camping Area: Oak Haven Camping Area Men's Restroom	[30.0441172 , -97.161922 6]	The side grab bars are not in the correct location. Grab bars on the side wall must be installed so that the end closest to the rear wall is maximum 12" from the rear wall. The end furthest from the rear wall must be mounted minimum 54" from the rear wall.	Side grab bars end less than 54" from rear wall	Remount side grab bar to max 12" from the rear wall at the close end and min 54" on the far end, and 33" to 36" aff	2015 ABAAS Section: 604.5.1  2012 TAS Section: 604.5.1  2010 ADAS Section: 604.5.1

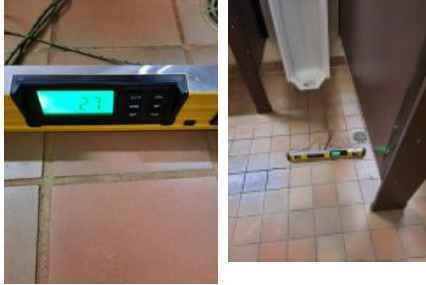
Finding Number	Area Description	Lat/Long	Finding	As Built	Recommendation	Citation	Photos	Figure
155	Oak Haven Camping Area: Oak Haven Camping Area Men's Restroom	[30.0441172 , -97.161925 2]	The accessible route contains running slopes greater than 5 percent and cross slopes greater than 2 percent across the width of the walk and has not been constructed as a ramp (i.e. handrails, wheel guides, etc.). When the slope in the direction of travel of any walk exceeds 1 unit vertical in 20 units horizontal (5-percent slope), it must be constructed as ramp. Surface cross slopes must not exceed one unit vertical in 48 units. Horizontal (2-percent slope).	Cross slope of 2.7% near floor drain near urinal	Correct or repair slope to max 5% running and 2.08% cross	2015 ABAAS Section: 403.3  2012 TAS Section: 403.3  2010 ADAS Section: 403.3

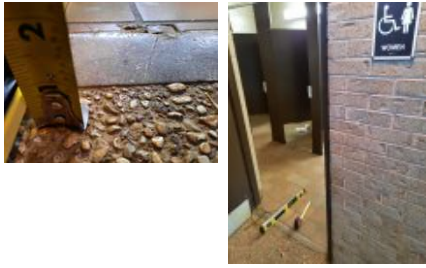
157	Oak Haven Camping Area: Oak Haven Camping Area Women's Restroom	[30.0441242 , -97.161929 3]	Thresholds, if provided at doorways, shall be 1/2 inch (13 mm) high maximum. Raised thresholds and changes in level at doorways shall comply with 302 and 303. Changes in level of 1/4 inch (6.4 mm) high maximum shall be permitted to be vertical. Changes in level between 1/4 inch (6.4 mm) high minimum and 1/2 inch (13 mm) high maximum shall be beveled with a slope not steeper than 1:2. Changes in level greater than 1/2 inch (13 mm) high shall be ramped, and shall comply with 405 or 406.	CIL of .5" at the doorway	Repair, bevel or ramp CIL at doorway	2015 ABAAS Section: 303.3, 404.2.5, 303.2, 303.4  2012 TAS Section: 303.3, 404.2.5, 303.2, 303.4  2010 ADAS Section: 303.3, 404.2.5, 303.2, 303.4
