# Access Audit Site Report

**Buescher State Park**

**Accessibility Evaluation**

**Inspection Date: 11/11/2021**

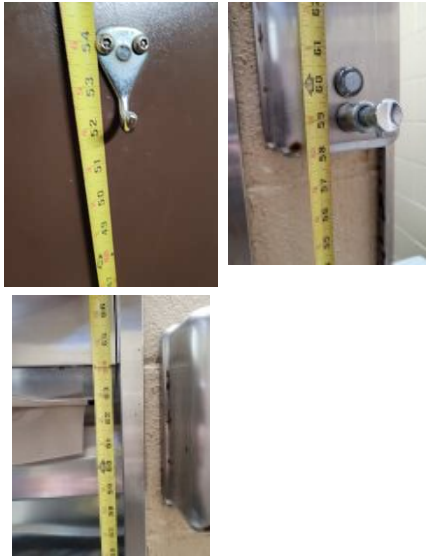
159	Oak Haven Camping Area: Oak Haven Camping Area Women's Restroom	[30.0441195 , -97.161929 3]	Where a high forward reach is over an obstruction, the clear floor space shall extend beneath the element for a distance not less than the required reach depth over the obstruction. The high forward reach shall be 48 inches (1220 mm) maximum where the reach depth is 20 inches (510 mm) maximum. Where the reach depth exceeds 20 inches (510 mm), the high forward reach shall be 44 inches (1120 mm) maximum and the reach depth shall be 25 inches (635 mm) maximum. Where a clear floor or ground space allows a parallel approach to an element and the high side reach is over an obstruction, the height of the obstruction shall be 34 inches (865 mm) maximum and the depth of the obstruction shall be 24 inches (610 mm) maximum. The high side reach shall be 48 inches (1220 mm) maximum for a reach depth of 10 inches (255 mm) maximum. Where the reach depth exceeds 10 inches (255 mm), the high side reach shall be 46 inches (1170 mm) maximum for a reach depth of 24 inches (610 mm) maximum.	Coat hook 52" aff, soap dispenser 59" aff, and paper towel dispenser 63" aff	Lower operating mechanisms to max 48" above the finished floor (AFF) to highest operable part. Lower operable parts to max 44" above the finished floor (AFF) for a forward reach over sink.	2015 ABAAS Section: 308.2.1, 308.3.2  2012 TAS Section: 308.2.1, 308.3.2  2010 ADAS Section: 308.2.1, 308.3.2

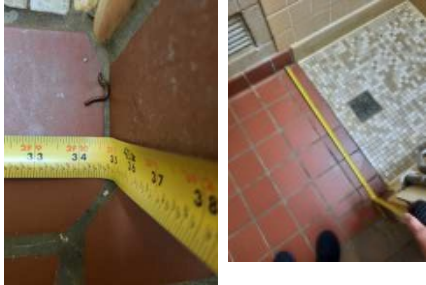
165	Oak Haven Camping Area: Oak Haven Camping Area Men's Shower	[30.0441195 , -97.161934 6]	Transfer type shower compartments shall be 36 inches (915 mm) by 36 inches (915 mm) clear inside dimensions measured at the center points of opposing sides and shall have a 36 inch (915 mm) wide minimum entry on the face of the shower compartment. Clearance of 36 inches (915 mm) wide minimum by 48 inches (1220 mm) long minimum measured from the control wall shall be provided.	transfer shower 34.75" wide	Enlarge transfer shower to compliant 36" by 36" clear inside dimension	2015 ABAAS Section: 608.2.1  2012 TAS Section: 608.2.1  2010 ADAS Section: 608.2.1

<small>Note: make transfer shower a minimum at the center points of opposing sides</small>

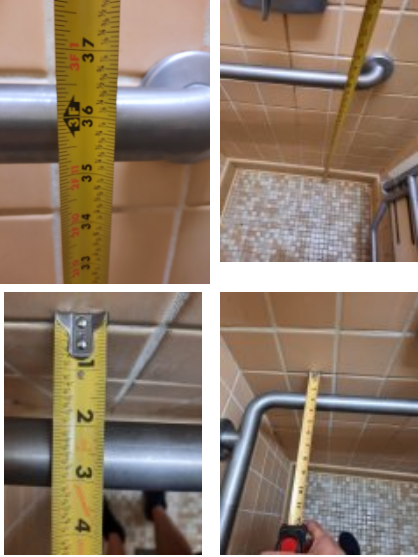
Finding Number	Area Description	Lat/Long	Finding	As Built	Recommendation	Citation	Photos	Figure
168	Oak Haven Camping Area: Oak Haven Camping Area Men's Shower	[30.0441242 , -97.161922 6]	Grab bars shall be installed in a horizontal position, 33 inches (840 mm) minimum and 36 inches (915 mm) maximum above the finish floor measured to the top of the gripping surface. The space between the wall and the grab bar shall be 1½ inches (38 mm). The space between the grab bar and projecting objects below and at the ends shall be 1½ inches (38 mm) minimum. The space between the grab bar and projecting objects above shall be 12 inches (305 mm) minimum. EXCEPTION: The space between the grab bars and shower controls, shower fittings, and other grab bars above shall be permitted to be 1½ inches (38 mm) minimum.	Gripping surfaces of grab bars are 36.5" aff and bars exceed 1.5" between bars and walls	Remount shower grab bar to 33" min and 36" max aff providing 1.5" gap between bar and wall	2015 ABAAS Section: 609.3 Exception, 609.4  2012 TAS Section: 609.4, 609.3 Exception  2010 ADAS Section: 609.4, 609.3 Exception

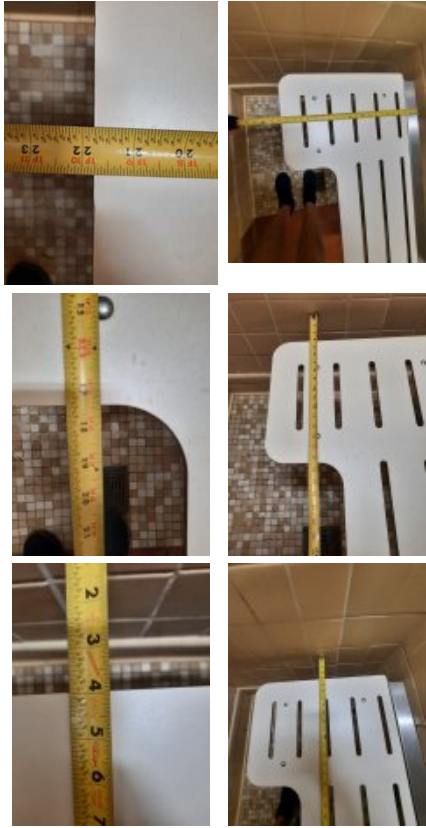
Finding Number	Area Description	Lat/Long	Finding	As Built	Recommendation	Citation	Photos	Figure
169	Oak Haven Camping Area: Oak Haven Camping Area Men's Shower	[30.0441207 , -97.161927 9]	The shower seat does not have a compliant space between it and the wall. The folding seat must be mounted 17-19 inches above the floor, and have a maximum space of 1-1/2 inches between the edge of the seat and the side wall and 2-1/2 inches maximum to the seat wall.	The shower seat lacks required dimensions and spacing between it and the wall	Remount shower seat to the correct location and height in the shower	2015 ABAAS Section: 610.3.2  2012 TAS Section: 610.3.2  2010 ADAS Section: 610.3.2

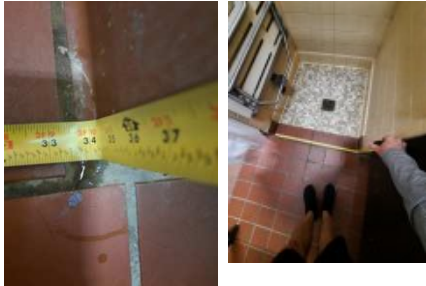
170	Oak Haven Camping Area: Oak Haven Camping Area Women's Shower	[30.0441207 , -97.161917 2]	Transfer type shower compartments shall be 36 inches (915 mm) by 36 inches (915 mm) clear inside dimensions measured at the center points of opposing sides and shall have a 36 inch (915 mm) wide minimum entry on the face of the shower compartment. Clearance of 36 inches (915 mm) wide minimum by 48 inches (1220 mm) long minimum measured from the control wall shall be provided.	transfer shower 34.25" wide	Enlarge transfer shower to compliant 36" by 36" clear inside dimension	2015 ABAAS Section: 608.2.1  2012 TAS Section: 608.2.1  2010 ADAS Section: 608.2.1

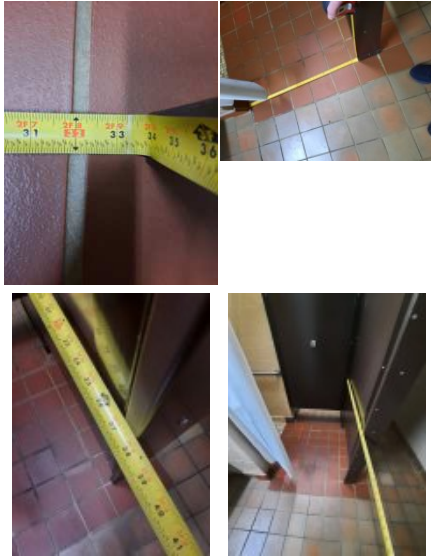
Finding Number	Area Description	Lat/Long	Finding	As Built	Recommendation	Citation	Photos	Figure
171	Oak Haven Camping Area: Oak Haven Camping Area Women's Shower	[30.0441312 , -97.161915 9]	Transfer type shower compartments shall be 36 inches (915 mm) by 36 inches (915 mm) clear inside dimensions measured at the center points of opposing sides and shall have a 36 inch (915 mm) wide minimum entry on the face of the shower compartment. Clearance of 36 inches (915 mm) wide minimum by 48 inches (1220 mm) long minimum measured from the control wall shall be provided.	Lacks clear floor space on the exterior of the transfer shower due to dimensions of exterior area	Provide appropriate CFS on the exterior of the transfer shower	2015 ABAAS Section: 608.2.1  2012 TAS Section: 608.2.1  2010 ADAS Section: 608.2.1

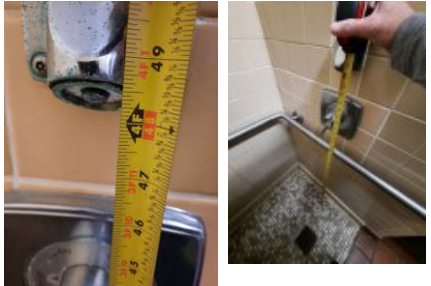
172	Oak Haven Camping Area: Oak Haven Camping Area Women's Shower	[30.0441172 , -97.161911 8]	There is no hand held sprayer unit. The sprayer unit must have a 59 inches hose and be mounted 48 inches maximum to the top of mounting bracket off the floor. The shower spray unit shall have an on/off control with a non-positive shutoff. If an adjustable-height shower head on a vertical bar is used, the bar shall be installed so as not to obstruct the use of grab bars.	Lacks handheld shower head and fixed shower head 48.5" aff	Replace shower control with a compliant lever control with a shower head on a 59" hose and usable as hand held; in the alternative, remount fixed shower head to max 48" aff	2015 ABAAS Section: 608.6  2012 TAS Section: 608.6  2010 ADAS Section: 608.6

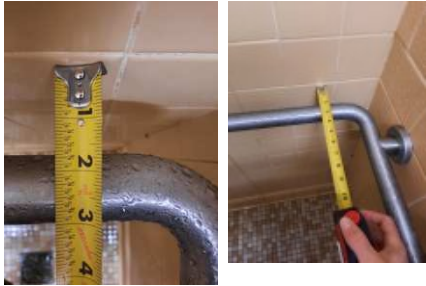
Finding Number	Area Description	Lat/Long	Finding	As Built	Recommendation	Citation	Photos	Figure
173	Oak Haven Camping Area: Oak Haven Camping Area Women's Shower	[30.0441103, -97.1619266]	The space between the wall and the grab bar shall be 1½ inches (38 mm). The space between the grab bar and projecting objects below and at the ends shall be 1½ inches (38 mm) minimum. The space between the grab bar and projecting objects above shall be 12 inches (305 mm) minimum. EXCEPTION: The space between the grab bars and shower controls, shower fittings, and other grab bars above shall be permitted to be 1½ inches (38 mm) minimum.	Grab bars exceed 1.5" between bars and walls	Replace grab bars with ones providing 1.5" gap between bar and wall and mount so no objects interfere within 1.5" below and 12" above bar.	2010 ADAS Section: 609.3, 609.3 Exception

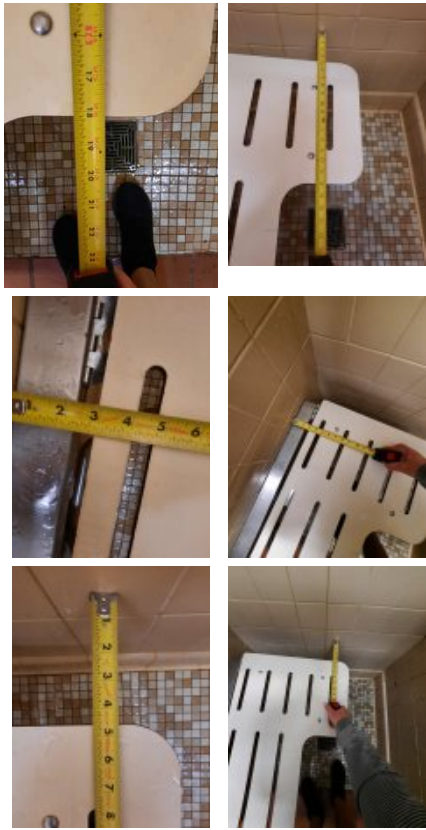
174	Oak Haven Camping Area: Oak Haven Camping Area Women's Shower	[30.044123, -97.1619293]	The shower seat does not have a compliant space between it and the wall. The folding seat must be mounted 17-19 inches above the floor, and have a maximum space of 1-1/2 inches between the edge of the seat and the side wall and 2-1/2 inches maximum to the seat wall.	The shower seat lacks required dimensions and spacing between it and the wall	Remount shower seat to the correct location and height in the shower	2015 ABAAS Section: 610.3.2  2012 TAS Section: 610.3.2  2010 ADAS Section: 610.3.2

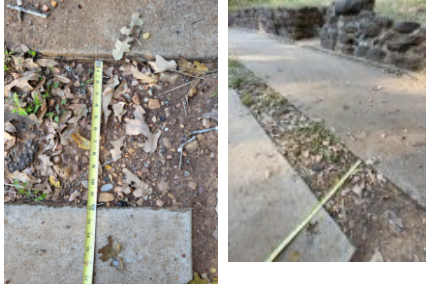
Finding Number	Area Description	Lat/Long	Finding	As Built	Recommendation	Citation	Photos	Figure
175	Oak Haven Camping Area: Oak Haven Camping Area Accessible Site 31	[30.0438897 , -97.161738 8]	The surface of the outdoor recreation access route, passing spaces, and/or resting intervals are not firm and stable. The surface of outdoor recreation access route, passing spaces, and resting intervals shall be firm and stable, having a width of 36", max gaps of .5" and tread obstacles of .5" or less.	Gap of 12" between parking pad and accessible route	Correct surface of ORAR to be firm and stable, a min 36" wide and having gaps and changes in level of max .5"	2015 ABAAS Section: 1016.2

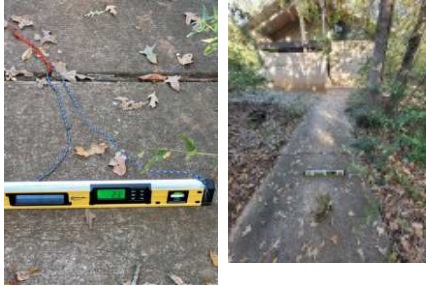
176	Oak Haven Camping Area: Oak Haven Camping Area Accessible Site 31	[30.043899 , -97.161793 8]	The cross slope shall not be steeper than 1:48. EXCEPTION: Where the surface is other than concrete, asphalt, or boards, cross slopes not steeper than 1:20 shall be permitted when necessary for drainage.	Cross slope of 2.3% on walkway	Correct or repair ORAR cross slope to max 2.08% or 5% for surfaces other than concrete, asphalt or board as a smart practices	2015 ABAAS Section: 1016.7.2, 1016.7.2 EXCEPTION

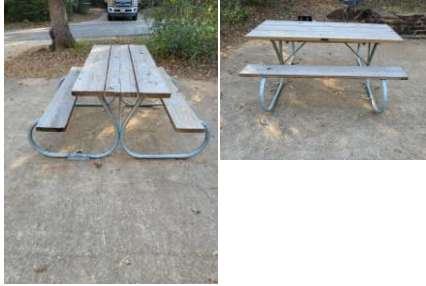
177	Oak Haven Camping Area: Oak Haven Camping Area Accessible Site 31	[30.0439013 , -97.161818]	Picnic tables shall provide at least one wheelchair space for each 24 linear feet (7320 mm) of usable table surface perimeter. Wheelchair spaces shall be 30 inches (760 mm) minimum by 48 inches (1220 mm) minimum. Wheelchair spaces shall be positioned for a forward approach to the table and provide knee and toe clearance complying with 306 under the table	Lacks picnic table of accessible design	Replace picnic table with one of an accessible design as a smart practice	2015 ABAAS Section: 1011.4.2

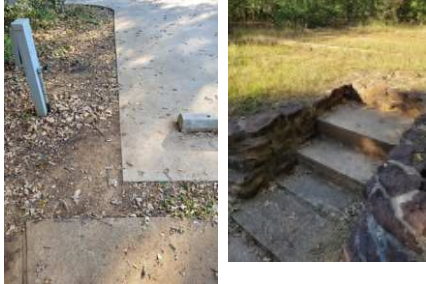
178	Oak Haven Camping Area: Oak Haven Camping Area Accessible Site 31	[30.0439059 , -97.161822]	There is no accessible route to the water spout and tent pad. At least one accessible route shall connect accessible buildings, accessible facilities, accessible elements, and accessible spaces that are on the same site.	Lacks accessible route to tent pad (stairs and grass surface) and water spout	Create an accessible route with crushed stone or other outdoor material from parking or walkway to the water spout and tent pad	2015 ABAAS Section: F206.2.2  2012 TAS Section: 206.2.2  2010 ADAS Section: 206.2.2

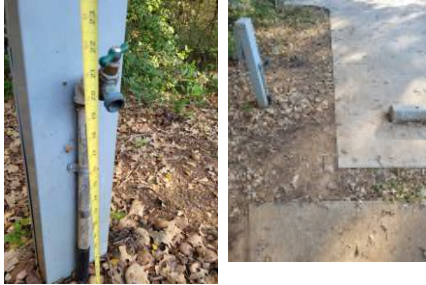
Finding Number	Area Description	Lat/Long	Finding	As Built	Recommendation	Citation	Photos	Figure
179	Oak Haven Camping Area: Oak Haven Camping Area Accessible Site 31	[30.0439001 , -97.161816 6]	Water spouts at water hydrants and water utility hook-ups shall be 28 inches (710 mm) minimum and 36 inches (915 mm) maximum above the ground	Water spout 19.5" above ground level	Remount water spouts to 28" min or 36" max above the ground as a smart practice	2015 ABAAS Section: 1011.6

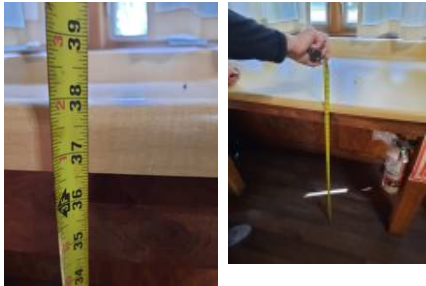
181	Oak Haven Camping Area: Oak Haven Camping Area Mini Cabin 1 MC1	[30.044996, -97.161615 4]	The top of the work surface is not within a compliant height range. The tops of tables and counters shall be 28 inches to 34 inches from the floor or ground.	Work surface 38" aff	Provide tables and work surfaces at 28" to 34" aff with required knee and toe clearances	2015 ABAAS Section: 902.3  2012 TAS Section: 902.3  2010 ADAS Section: 902.3

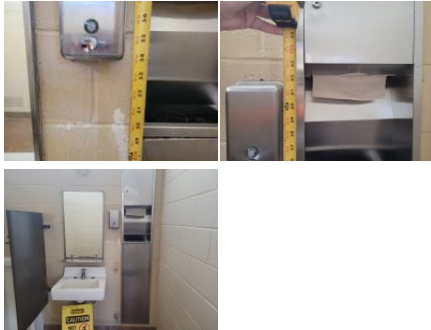
Finding Number	Area Description	Lat/Long	Finding	As Built	Recommendation	Citation	Photos	Figure
192	Day Use Area: Day Use Area Men's Restroom	[30.0440754 , -97.158804 5]	Where a high forward reach is over an obstruction, the clear floor space shall extend beneath the element for a distance not less than the required reach depth over the obstruction. The high forward reach shall be 48 inches (1220 mm) maximum where the reach depth is 20 inches (510 mm) maximum. Where the reach depth exceeds 20 inches (510 mm), the high forward reach shall be 44 inches (1120 mm) maximum and the reach depth shall be 25 inches (635 mm) maximum. Where a clear floor or ground space allows a parallel approach to an element and the high side reach is over an obstruction, the height of the obstruction shall be 34 inches (865 mm) maximum and the depth of the obstruction shall be 24 inches (610 mm) maximum. The high side reach shall be 48 inches (1220 mm) maximum for a reach depth of 10 inches (255 mm) maximum. Where the reach depth exceeds 10 inches (255 mm), the high side reach shall be 46 inches (1170 mm) maximum for a reach depth of 24 inches (610 mm) maximum.	Soap dispenser 54.5" aff and paper towel dispenser 62" aff	Lower operable parts to max 44" above the finished floor (AFF) for a forward reach over counter.	2015 ABAAS Section: 308.2.1, 308.3.2  2012 TAS Section: 308.2.1, 308.3.2  2010 ADAS Section: 308.2.1, 308.3.2

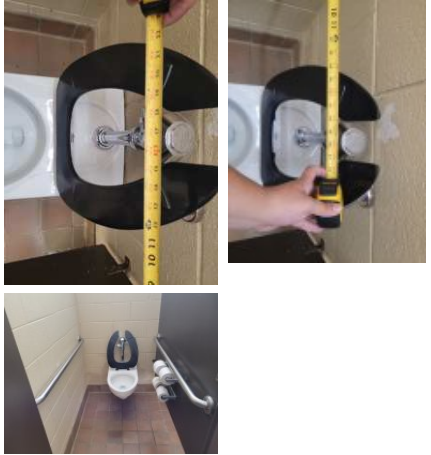
195	Day Use Area: Day Use Area Men's Restroom	[30.0440661 , -97.158797 8]	The toilet is not located within the range to the side wall or partition. The centerline of the toilet shall be 17 inches minimum and 19 inches maximum side wall or partition in the ambulatory accessible toilet compartment.	Centerline of the toilet is 16.5" from the partition and 19.75" from the side wall	Remount toilet to 17" to 19" from the side wall to center line in ambulatory stalls	2015 ABAAS Section: 604.9.1  2012 TAS Section: 604.9.1  2010 ADAS Section: 604.9.1

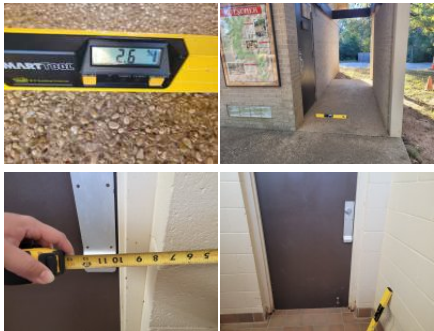
200	Day Use Area: Day Use Area Men's Restroom	[30.0440698 , -97.158799 3]	Minimum maneuvering clearances at doors and gates shall comply with 404.2.4. Maneuvering clearances shall extend the full width of the doorway and the required latch side or hinge side clearance.	men's- 10" to wall pull side and slope of 2.6% on landing	For all doors along the public circulation route, provide required maneuvering clearance on push and pull side of doors For all doors along the public circulation route, correct or repair slope at doorway landing to max 2.08% in any direction for level maneuvering clearance	2010 ADAS Section: 404.2.3, 404.2.7, 404.2.4, 404.2.11, 404.2.11 Exception

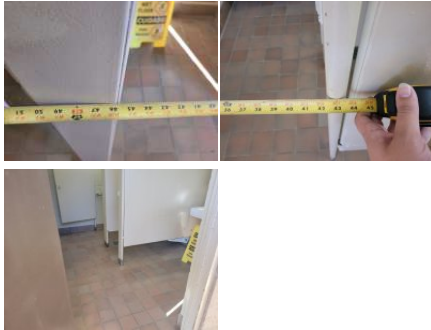
211	Day Use Area: Day Use Area Women's Restroom	[30.0440592 , -97.158799 1]	There is insufficient turning space within this room or space. The space required for a wheelchair to make a 180-degree turn is a clear space of 60 inches in diameter or a T-shaped space.	Lacks sufficient turning space within this room or space	Renovate restroom to provide 60" turning space	2015 ABAAS Section: 304.3.1, 304.3.2  2012 TAS Section: 304.3.1, 304.3.2  2010 ADAS Section: 304.3.1, 304.3.2

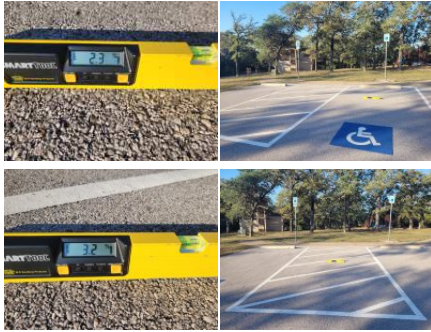
212	Day Use Area: Day Use Area Parking (along Park Road 1E)	[30.0442484 , -97.158588 6]	The cross slopes (narrow dimension) and/or running slopes (long dimension) of the access aisle exceeds 2%. The running slope and the cross slope in an accessible parking stall and the access aisle must not exceed 2%.	Slopes of 2.3% in right stall and 3.2% in access aisle	Repair or correct slope of parking space and access aisle to max 2.08% in any direction.	2015 ABAAS Section: 502.4  2012 TAS Section: 502.4  2010 ADAS Section: 502.4

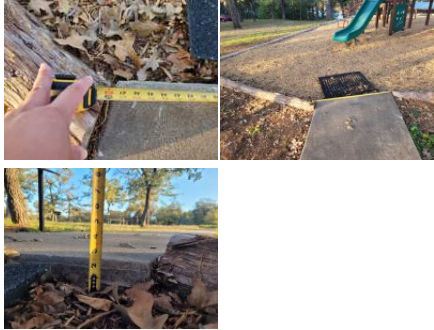
Finding Number	Area Description	Lat/Long	Finding	As Built	Recommendation	Citation	Photos	Figure
213	Day Use Area: Day Use Area Playground	[30.0442496 , -97.158898 4]	As a smart practice, play area should have a minimum 60" wide entry, free of changes in level, gaps, and slope.	Designated entry 48" wide and has a CIL of 2.5"	Widen the designated entry to 60" width as a smart practice Repair, bevel or ramp CIL at playground entry/border	2015 ABAAS Section: F206.1  2012 TAS Section: 206.1  2010 ADAS Section: 206.1

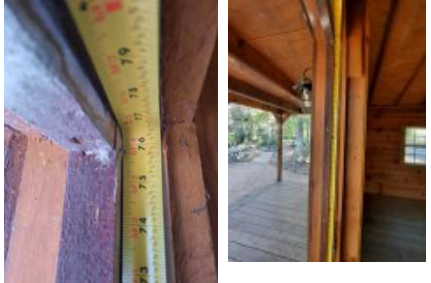
219	Day Use Area: Day Use Area Accessible Screen Shelter 4	[30.0437318 , -97.158976 1]	Vertical clearance shall be 80 inches (2030 mm) high minimum. Guardrails or other barriers shall be provided where the vertical clearance is less than 80 inches (2030 mm) high. The leading edge of such guardrail or barrier shall be located 27 inches (685 mm) maximum above the finish floor or ground. EXCEPTION: Door closers and door stops shall be permitted to be 78 inches (1980 mm) minimum above the finish floor or ground.	Door lacks 76.5" aff	Replace doors with doors having 80" overhead clearance	2015 ABAAS Section: 307.4, 307.4 EXCEPTION  2012 TAS Section: 307.4, 307.4 Exception  2010 ADAS Section: 307.4, 307.4 Exception

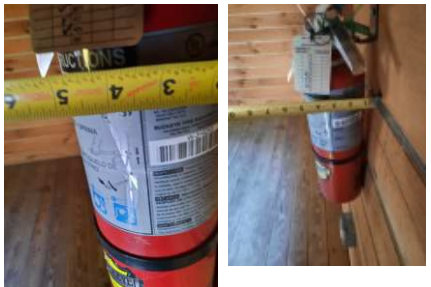
220	Day Use Area: Day Use Area Accessible Screen Shelter 4	[30.0437411 , -97.158965 4]	The fire extinguisher projects more than 4 inches into the circulation path. Wall-mounted objects that have leading edges between 27 inches and 80 inches from the floor must not project more than 4 inches into the circulation path. Protruding objects that extend to the floor or within 27 inches of the floor are cane detectable and are therefore not hazardous. Where it is necessary or desirable to have objects protrude from the wall, a manner of cane detection must be provided.	Fire extinguisher protrudes 5"	Relocate protruding objects or place cane detectable warning or bollard at foot of item	2015 ABAAS Section: 307.2  2012 TAS Section: 307.2  2010 ADAS Section: 307.2

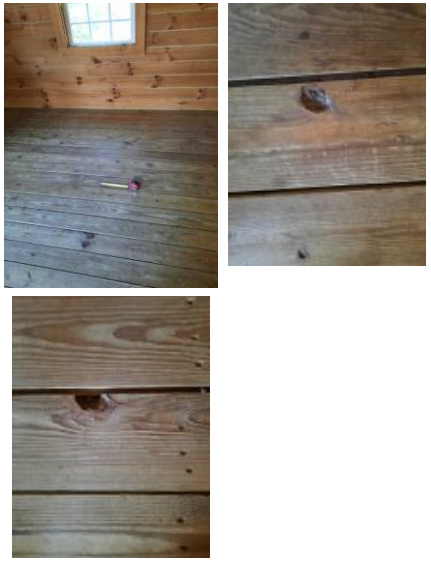
222	Day Use Area: Day Use Area Accessible Screen Shelter 4	[30.0437411 , -97.158957 4]	Openings in floor or ground surfaces shall not allow passage of a sphere more than 1/2 inch (13 mm) diameter except as allowed in 407.4.3, 409.4.3, 410.4, 810.5.3 and 810.10. Elongated openings shall be placed so that the long dimension is perpendicular to the dominant direction of travel.	Multiple gaps (approximately 8) ranging from .5" to 1.5"	Fill and maintain gaps to max .5"	2015 ABAAS Section: 302.3  2012 TAS Section: 302.3  2010 ADAS Section: 302.3

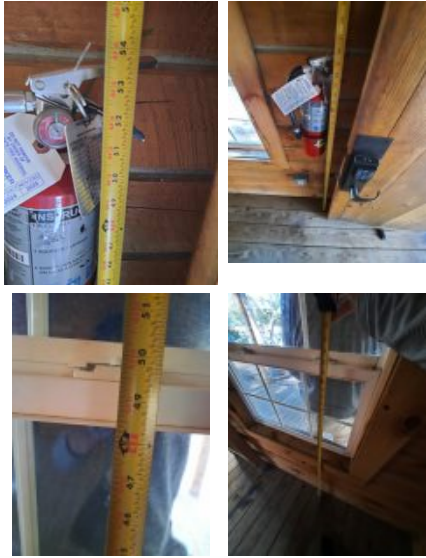
Finding Number	Area Description	Lat/Long	Finding	As Built	Recommendation	Citation	Photos	Figure
223	Day Use Area: Day Use Area Accessible Screen Shelter 4	[30.0437388 , -97.158972 1]	The fire extinguisher and 6 of 6 window locks are positioned too high for either a side or front approach. Where a clear floor or ground space allows a parallel approach to an element and the side reach is unobstructed, the high side reach shall be 48 inches maximum and the low side reach shall be 15 inches minimum above the finish floor or ground. Where a forward reach is unobstructed, the high forward reach shall be 48 inches maximum and the low forward reach shall be 15 inches minimum above the finish floor or ground.	Fire extinguisher 53.5" aff and 6 of 6 window locks exceed reach range	Remount operable parts to be in reach range of 15" min to 48" max	2015 ABAAS Section: 308.1  2012 TAS Section: 308.1  2010 ADAS Section: 308.1

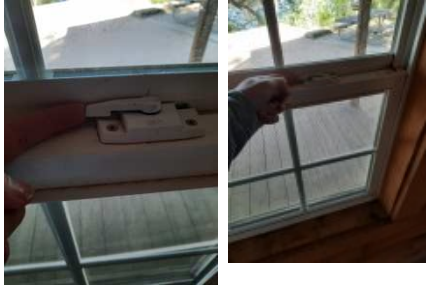
224	Day Use Area: Day Use Area Accessible Screen Shelter 4	[30.0437364 , -97.158964 1]	4 of 6 window locks are not accessible because they require tight grasping, pinching or twisting of the wrist.	4 of 6 window locks require tight grasping, pinching, or twisting of the wrist	Replace window locks with an operable part usable without a tight pinch or grasp	2015 ABAAS Section: 309.4  2012 TAS Section: 309.4  2010 ADAS Section: 309.4

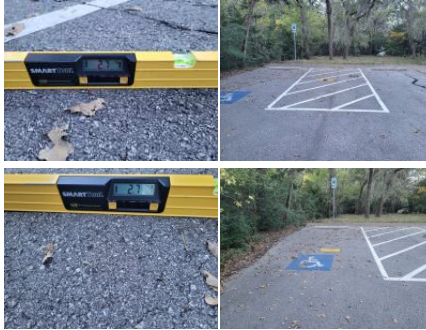
225	Day Use Area: Day Use Area Accessible Screen Shelter 4	[30.0437411 , -97.158962 7]	The cross slopes (narrow dimension) and/or running slopes (long dimension) of the access aisle exceeds 2%. The running slope and the cross slope in an accessible parking stall and the access aisle must not exceed 2%.	Slopes of 2.7% in access aisle and 2.7% in stall	Resurface stalls and access aisles to eliminate slopes	2015 ABAAS Section: 502.4  2012 TAS Section: 502.4  2010 ADAS Section: 502.4

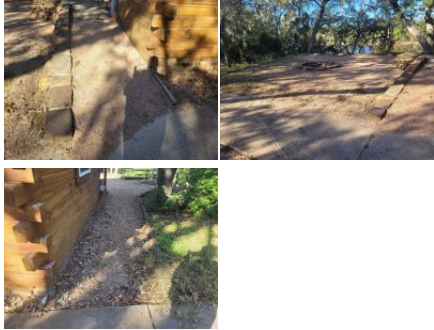
Finding Number	Area Description	Lat/Long	Finding	As Built	Recommendation	Citation	Photos	Figure
226	Day Use Area: Day Use Area Accessible Screen Shelter 4	[30.0437411 , -97.158962 7]	The surface of the outdoor recreation access route, passing spaces, and/or resting intervals are not firm and stable. The surface of outdoor recreation access route, passing spaces, and resting intervals shall be firm and stable, having a width of 36", max gaps of .5" and tread obstacles of .5" or less.	Walkway lacks firm and stable surface, loose surface, not well compacted, and displaces easily	Correct surface of ORAR to be firm and stable, a min 36" wide and having gaps and changes in level of max .5"	2015 ABAAS Section: 1016.2

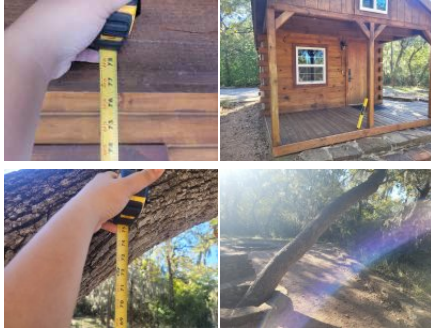
232	Day Use Area: Day Use Area Accessible Screen Shelter 4	[30.0437396 , -97.158963 7]	The shelter porch beams and tree branch extend down too close to the route of travel. Any obstruction that overhangs a route of travel must be a minimum of 80 inches above the walking surface as measured from the bottom of the obstruction.	Shelter porch beams 77.5" aff and tree branch 72" agl - alternate route to access table area provided	Raise shelter porch beams to min 80", or pad object to prevent hazard in overhead clearance Leave as is tree blocking route and provide alternate route to camp amenities as a smart practice	2015 ABAAS Section: 307.3  2012 TAS Section: 307.3  2010 ADAS Section: 307.3

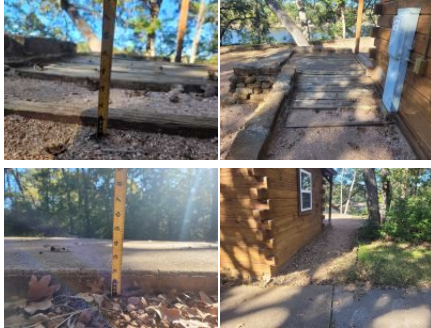
233	Day Use Area: Day Use Area Accessible Screen Shelter 4	[30.04374, -97.158972 9]	The walkway contains abrupt vertical edges and/or variations over a 1/4 inch. 1/4 inch is the maximum vertical rise. Changes in level between 1/4 inch and 1/2 inch must be beveled at 1:2 or less. Changes in level greater than 1/2 inch must be by way of a ramp.	Multiple CILs of 1" to access shelter from ramped surface and CIL of 2" from sidewalk to surface on table side	Repair, bevel or ramp CIL along AR	2012 TAS Section: 303.2, 303.3  2010 ADAS Section: 303.2, 303.3

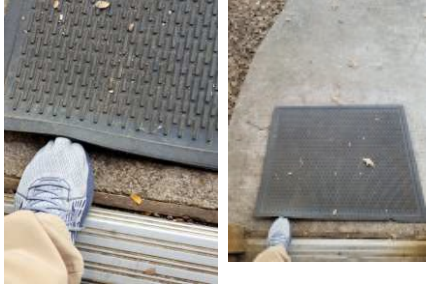
235	Day Use Area: Day Use Area Accessible Screen Shelter 1	[30.0450297 , -97.159552 8]	The doormat is not secured in place at the entry door. If carpet or carpet tile is used on a ground or floor surface, then it shall be securely attached; have a firm cushion, pad or backing or no cushion or pad; and have a level loop, textured loop, level-cut pile or level-cut/uncut pile texture. The maximum pile height shall be 1/2 inch. Exposed edges of carpet shall be fastened to floor surfaces and have trim along the entire length of the exposed edge. Recessed doormats shall be adequately anchored to prevent interference with wheelchair traffic.	Lacks secure floor mat	Remove or secure mat at door to prevent trip hazard	2015 ABAAS Section: 302.2  2012 TAS Section: 302.2  2010 ADAS Section: 302.2

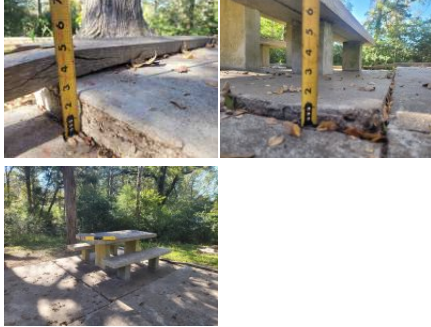
236	Day Use Area: Day Use Area Accessible Screen Shelter 1	[30.0450413 , -97.159562 2]	The surface of the outdoor recreation access route, passing spaces, and/or resting intervals are not firm and stable. The surface of outdoor recreation access route, passing spaces, and resting intervals shall be firm and stable, having a width of 36", max gaps of .5" and tread obstacles of .5" or less.	CILs of 2.5" and 1" at concrete table	Correct surface of ORAR to be firm and stable, a min 36" wide and having gaps and changes in level of max .5"	2015 ABAAS Section: 1016.2

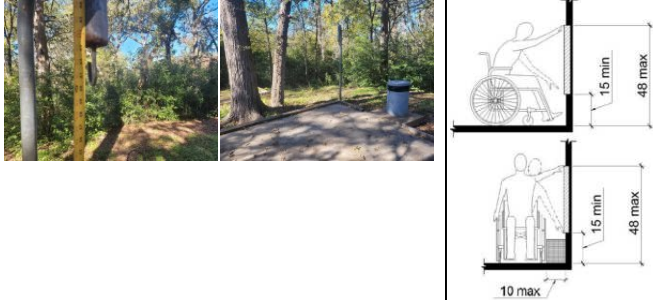
245	Day Use Area: Day Use Area Accessible Screen Shelter 1	[30.0450363 , -97.159558 4]	The lantern hook is positioned too high for either a side or front approach. Where a clear floor or ground space allows a parallel approach to an element and the side reach is unobstructed, the high side reach shall be 48 inches maximum and the low side reach shall be 15 inches minimum above the finish floor or ground. Where a forward reach is unobstructed, the high forward reach shall be 48 inches maximum and the low forward reach shall be 15 inches minimum above the finish floor or ground.	Lanterns hook 60" agl	Remount operable parts to be in reach range of 15" min to 48" max	2015 ABAAS Section: 308.1  2012 TAS Section: 308.1  2010 ADAS Section: 308.1

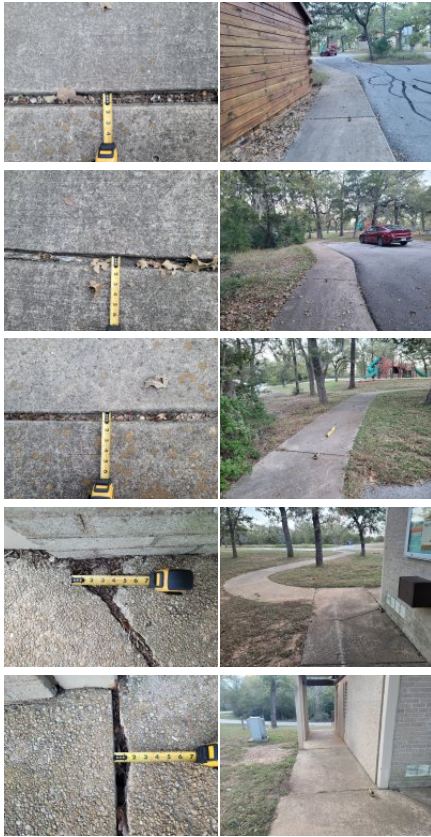
247	Day Use Area: Day Use Area Central Picnic Areas	[30.04373, -97.159]	There is a gap spaced greater than a 1/2 inch. Openings in floor or ground surfaces shall not allow passage of a sphere more than 1/2 inch diameter. Elongated openings shall be placed so that the long dimension is perpendicular to the dominant direction of travel.	Gaps of 1" near shelter 4, 1.25", two 1" gaps between shelter and restrooms, gap up to 5" at restroom, and 1.5" at women's restroom	Correct or fill gaps to be max .5"	2015 ABAAS Section: 302.3  2012 TAS Section: 302.3  2010 ADAS Section: 302.3

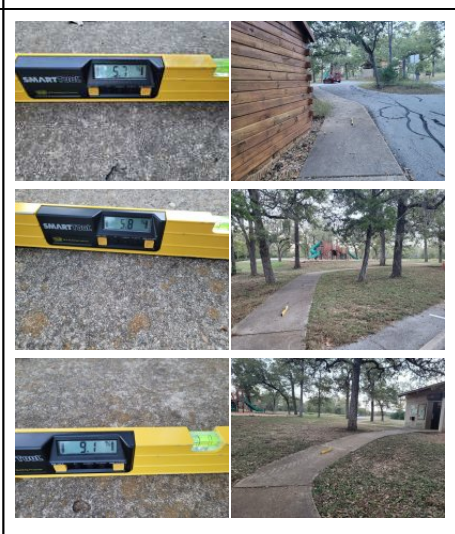
Finding Number	Area Description	Lat/Long	Finding	As Built	Recommendation	Citation	Photos	Figure
248	Day Use Area: Day Use Area Central Picnic Areas	[30.04374, -97.15895]	The running slope of walking surfaces shall not be steeper than 1:20.	Running slopes of 5.7% near shelter 4, and 5.8% and 9.1% on walkway to restroom from shelter	Correct running slope along the AR to max 5%	2015 ABAAS Section: 403.3  2012 TAS Section: 403.3  2010 ADAS Section: 403.3

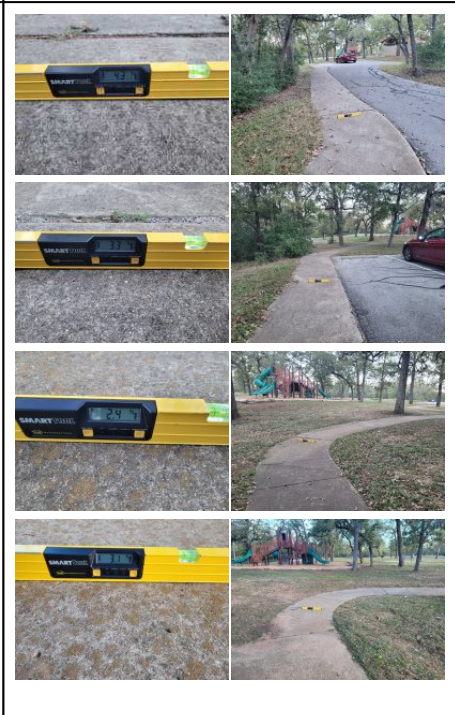
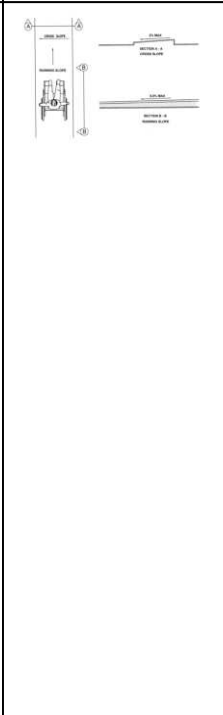
249	Day Use Area: Day Use Area Central Picnic Areas	[30.04378, -97.15896]	The accessible route of travel on the accessible route contains cross slopes greater than 2%. Cross slopes shall not exceed one unit vertical in 48 units horizontal (2-percent slope).	Cross slopes of 4.3% near shelter 4, 3.3%, 2.4% at curve, and 3.1% at curve	Correct or repair cross slope along AR to max 2.08%	2015 ABAAS Section: 403.3  2012 TAS Section: 403.3  2010 ADAS Section: 403.3

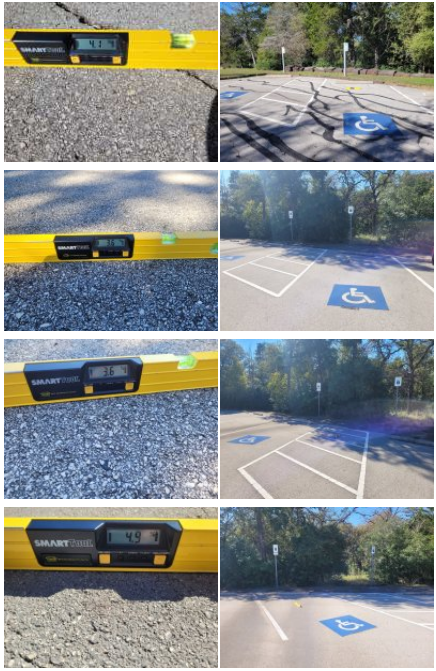
255	Day Use Area: Day Use Area North Loop Parking	[30.0458934 , -97.159890 8]	The cross slopes (narrow dimension) and/or running slopes (long dimension) of the access aisle exceeds 2%. The running slope and the cross slope in an accessible parking stall and the access aisle must not exceed 2%.	Group Rec Hall parking - Slope of 4.1% in right stall in lot near building, slopes of 3.6% in right stall, 3.6% in access aisle, and 4.9% in left stall in side lot	Resurface stalls and access aisles to eliminate slopes	2015 ABAAS Section: 502.4  2012 TAS Section: 502.4  2010 ADAS Section: 502.4

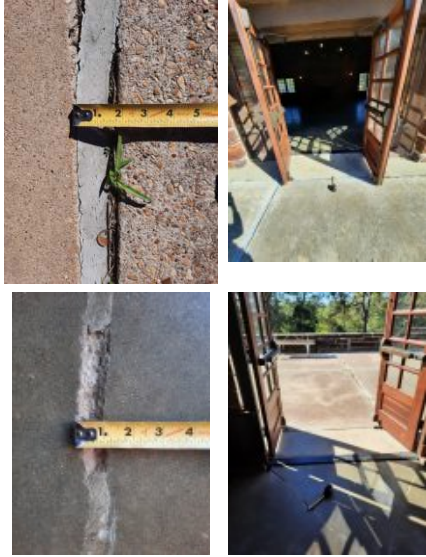
Finding Number	Area Description	Lat/Long	Finding	As Built	Recommendation	Citation	Photos	Figure
258	Day Use Area: Day Use Area Group Recreation Hall	[30.0455277 , -97.160043 7]	Floor or ground surface within required maneuvering clearances shall comply with 302. Changes in level are not permitted. Openings in floor or ground surfaces shall not allow passage of a sphere more than 1/2 inch (13 mm) diameter except as allowed in 407.4.3, 409.4.3, 410.4, 810.5.3 and 810.10. Elongated openings shall be placed so that the long dimension is perpendicular to the dominant direction of travel.	Main room doors, patio side - Lacks maneuvering clearance gaps of 2"	For all doors along the public circulation route, fill and maintain gaps at doorways to max .5"	2015 ABAAS Section: 302.1, 302.2, 302.3, 302.1 EXCEPTION S: 1, 404.2.4.4, 404.2.4.4 EX CEPTIONS: 1, 404.2.4.4 E XCEPTIONS: 2  2012 TAS Section: 302.1, 302.1 Exception 1, 302.3, 404.2.4.4, 404.2.4.4 Exception 1, 404.2.4.4 Exception 2, 302.2  2010 ADAS Section: 302.3, 302.1, 302.2, 404.2.4.4

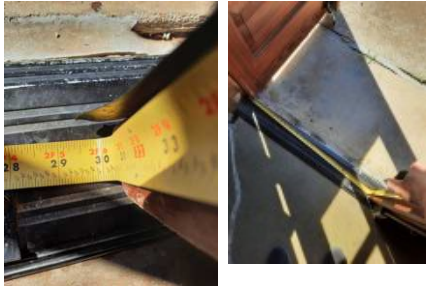
259	Day Use Area: Day Use Area Group Recreation Hall	[30.0455359 , -97.160059 8]	The door opening does not provide at least 32 inches between the face of the door and the opposite stop. Door openings shall provide a clear width of 32 inches minimum. Clear openings of doorways with swinging doors shall be measured between the face of the door and the stop, with the door open 90 degrees. There shall be no projections into the required clear opening width lower than 34 inches above the finish floor or ground. Projections into the clear opening width between 34 inches and 80 inches above the finish floor or ground shall not exceed 4 inches.	Main room doors, patio side - 30.25" wide	Replace door with one having 32" clear width	2015 ABAAS Section: 404.2.3  2012 TAS Section: 404.2.3  2010 ADAS Section: 404.2.3

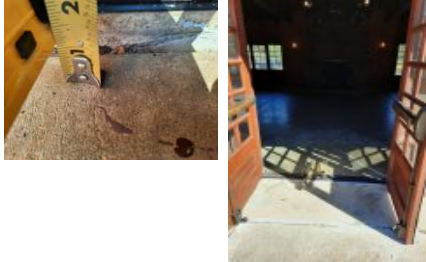
Finding Number	Area Description	Lat/Long	Finding	As Built	Recommendation	Citation	Photos	Figure
260	Day Use Area: Day Use Area Group Recreation Hall	[30.0455405 , -97.160027 6]	Changes in level of ¼ inch (6.4 mm) high maximum shall be permitted to be vertical Changes in level between ¼ inch (6.4 mm) high minimum and ½ inch (13 mm) high maximum shall be beveled with a slope not steeper than 1:2. Changes in level greater than ½ inch (13 mm) high shall be ramped, and shall comply with 405 or 406.	Main room doors, patio side - CIL of 1"	Repair, bevel or ramp CIL at doorway	2015 ABAAS Section: 303.3, 404.2.5, 303.2, 303.4  2012 TAS Section: 303.3, 404.2.5, 303.2, 303.4  2010 ADAS Section: 303.3, 404.2.5, 303.2, 303.4

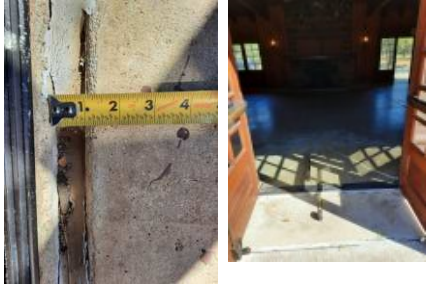
Finding Number	Area Description	Lat/Long	Finding	As Built	Recommendation	Citation	Photos	Figure
261	Day Use Area: Day Use Area Group Recreation Hall	[30.0455382 , -97.160039 6]	Floor or ground surface within required maneuvering clearances shall comply with 302. Changes in level are not permitted. Openings in floor or ground surfaces shall not allow passage of a sphere more than 1/2 inch (13 mm) diameter except as allowed in 407.4.3, 409.4.3, 410.4, 810.5.3 and 810.10. Elongated openings shall be placed so that the long dimension is perpendicular to the dominant direction of travel.	Main room doors, patio side - gap of 1" at the doorway	For all doors along the public circulation route, fill and maintain gaps at doorways to max .5"	2015 ABAAS Section: 302.1, 302.2, 302.3, 302.1 EXCEPTION S: 1, 404.2.4.4, 404.2.4.4 EX CEPTIONS: 1, 404.2.4.4 E XCEPTIONS: 2  2012 TAS Section: 302.1, 302.1 Exception 1, 302.3, 404.2.4.4, 404.2.4.4 Exception 1, 404.2.4.4 Exception 2, 302.2  2010 ADAS Section: 302.3, 302.1, 302.2, 404.2.4.4

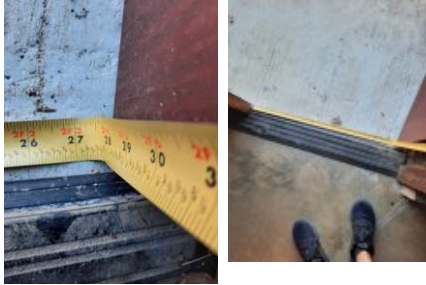
Finding Number	Area Description	Lat/Long	Finding	As Built	Recommendation	Citation	Photos	Figure
263	Day Use Area: Day Use Area Group Recreation Hall	[30.0455324 , -97.160042 3]	The door opening does not provide at least 32 inches between the face of the door and the opposite stop. Door openings shall provide a clear width of 32 inches minimum. Clear openings of doorways with swinging doors shall be measured between the face of the door and the stop, with the door open 90 degrees. There shall be no projections into the required clear opening width lower than 34 inches above the finish floor or ground. Projections into the clear opening width between 34 inches and 80 inches above the finish floor or ground shall not exceed 4 inches.	Main room doors, parking lot side - 27.75" wide	Replace door with one having 32" clear width	2015 ABAAS Section: 404.2.3  2012 TAS Section: 404.2.3  2010 ADAS Section: 404.2.3

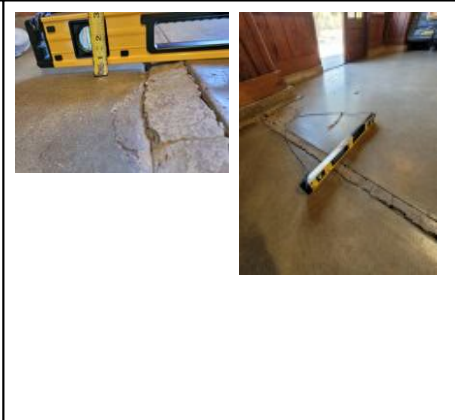
266	Day Use Area: Day Use Area Group Recreation Hall	[30.04553, -97.160035 6]	There is a change in level greater than 1/4 inch. 1/4 inch is the maximum vertical rise. Changes in level between 1/4 inch and 1/2 inch must be beveled at 1:2 or less. Changes in level greater than 1/2 inch must be by way of a ramp.	main room- CIL of .5" at floor joint	Repair, bevel or ramp CIL along AR to max .25"	2015 ABAAS Section: 303.3  2012 TAS Section: 303.3  2010 ADAS Section: 303.3

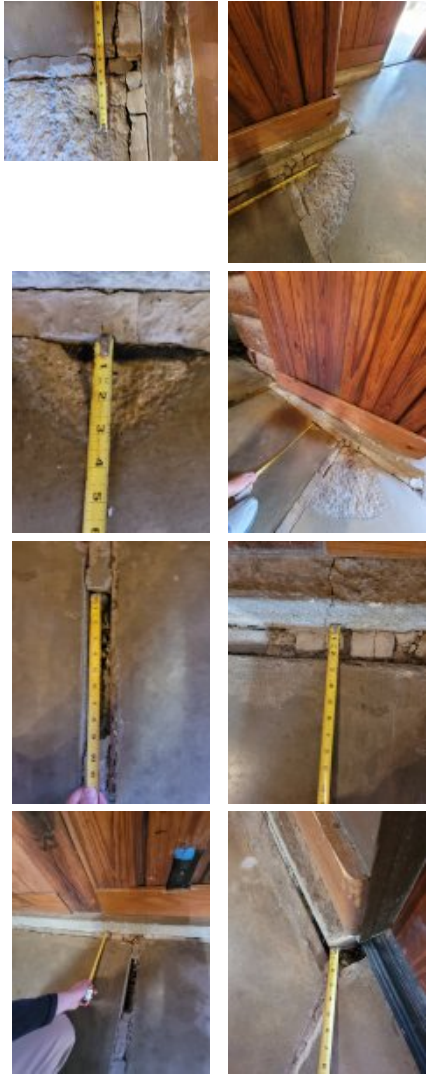
Finding Number	Area Description	Lat/Long	Finding	As Built	Recommendation	Citation	Photos	Figure
267	Day Use Area: Day Use Area Group Recreation Hall	[30.0455382 , -97.160038 3]	Openings in floor or ground surfaces shall not allow passage of a sphere more than 1/2 inch (13 mm) diameter except as allowed in 407.4.3, 409.4.3, 410.4, 810.5.3 and 810.10. Elongated openings shall be placed so that the long dimension is perpendicular to the dominant direction of travel.	main room- multiple gaps (8) of 2", 3", and 6"	Fill and maintain gaps to max .5"	2015 ABAAS Section: 302.3  2012 TAS Section: 302.3  2010 ADAS Section: 302.3

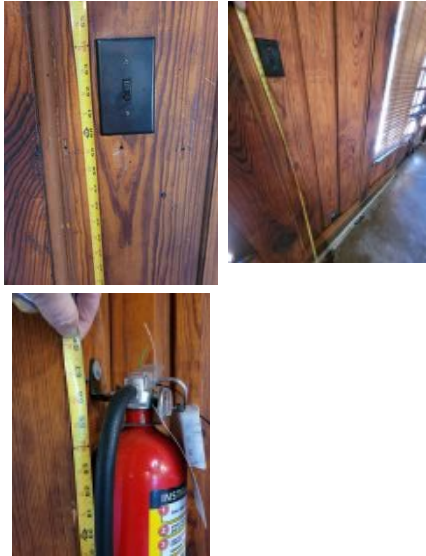
Finding Number	Area Description	Lat/Long	Finding	As Built	Recommendation	Citation	Photos	Figure
268	Day Use Area: Day Use Area Group Recreation Hall	[30.0455428 , -97.160047 7]	The elements are positioned too high for either a side or front approach. Where a clear floor or ground space allows a parallel approach to an element and the side reach is unobstructed, the high side reach shall be 48 inches maximum and the low side reach shall be 15 inches minimum above the finish floor or ground. Where a forward reach is unobstructed, the high forward reach shall be 48 inches maximum and the low forward reach shall be 15 inches minimum above the finish floor or ground.	main room- light switch 62" aff and fire extinguisher 66" aff	Remount operable parts to be in reach range of 15" min to 48" max	2015 ABAAS Section: 308.1  2012 TAS Section: 308.1  2010 ADAS Section: 308.1

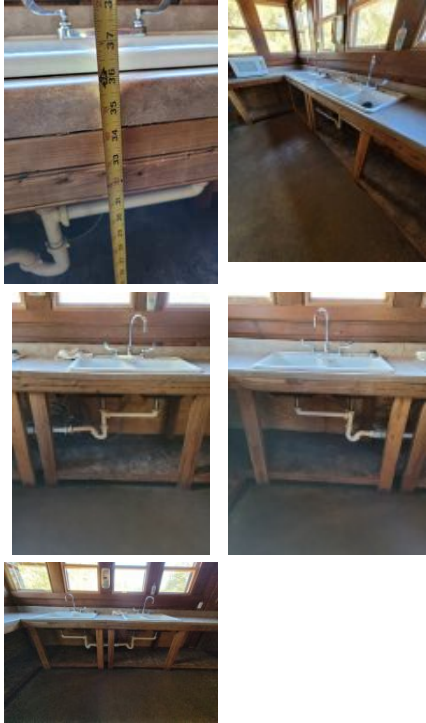
Finding Number	Area Description	Lat/Long	Finding	As Built	Recommendation	Citation	Photos	Figure
269	Day Use Area: Day Use Area Group Recreation Hall	[30.0455498 , -97.1600517]	The sink is not accessible. A clear floor space at least 30 inches by 48 shall be provided in front of a sink to allow forward approach. -The clear floor space shall be on an accessible route and shall extend a maximum of 19 inches underneath the sink. -Sinks shall be mounted with the counter or rim no higher than 34 inches above the finish floor. -Knee clearance at least 27 inches high, 30 inches wide and 19 inches deep shall be provided. -Hot water and drain pipes exposed under sinks shall be insulated or otherwise configured so as to protect against contact. There shall be no sharp or abrasive surfaces under sinks.	kitchen- sink rims 36" aff, lack 8" deep knee clearance, and lack insulated pipes	Replace sink with model that allows CFS and knee clearance 30" wide and 27" high while rim height is max 34" aff Insulate exposed pipes under one sink	<p>2015 ABAAS Section: 606.2, 606.2 EXCEPTION S: 1, 606.2 EXCEPTIONS: 4, 606.2 EXCEPTIONS: 5, 606.2 EXCEPTIONS: 6, 606.2 EXCEPTIONS: 7, 606.3, 606.4, 606.5</p> <p>2012 TAS Section: 606.2, 606.2 Exception 1, 606.2 Exception 4, 606.2 Exception 5, 606.2 Exception 6, 606.2 Exception 7, 606.3, 606.4, 606.5</p> <p>2010 ADAS Section: 606.2, 606.2 Exception 1, 606.2 Exception 4, 606.2 Exception 5, 606.2 Exception 6, 606.2 Exception 7, 606.3, 606.4, 606.5</p>

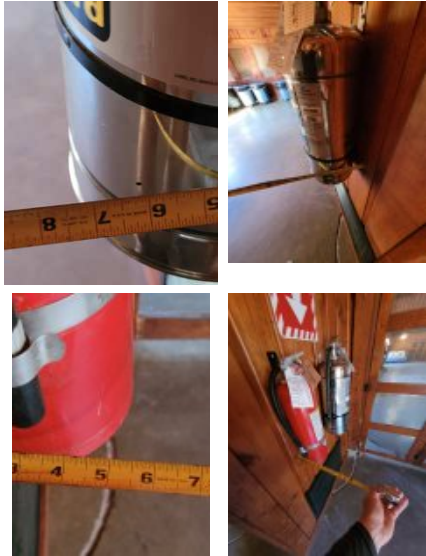
Finding Number	Area Description	Lat/Long	Finding	As Built	Recommendation	Citation	Photos	Figure
270	Day Use Area: Day Use Area Group Recreation Hall	[30.0455359 , -97.160038 3]	The fire extinguishers project more than 4 inches into the circulation path. Wall-mounted objects that have leading edges between 27 inches and 80 inches from the floor must not project more than 4 inches into the circulation path. Protruding objects that extend to the floor or within 27 inches of the floor are cane detectable and are therefore not hazardous. Where it is necessary or desirable to have objects protrude from the wall, a manner of cane detection must be provided.	kitchen- two fire extinguishers protrude 6" and 7"	Relocate protruding objects or place cane detectable warning or bollard at foot of item For deficit, leave as is, employee work area pursuant to 2010 Standards 106.5 Defined Terms, until an employee with a disability works here	2015 ABAAS Section: 307.2  2012 TAS Section: 307.2  2010 ADAS Section: 307.2

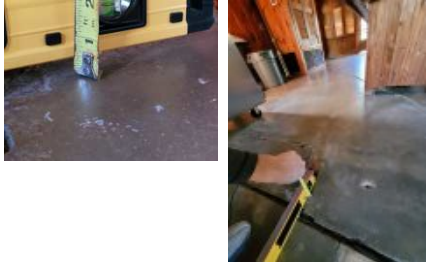
271	Day Use Area: Day Use Area Group Recreation Hall	[30.0455382 , -97.160035 6]	There is a change in level greater than 1/4 inch. 1/4 inch is the maximum vertical rise. Changes in level between 1/4 inch and 1/2 inch must be beveled at 1:2 or less. Changes in level greater than 1/2 inch must be by way of a ramp.	kitchen- CIL of .5" at floor joint	Repair, bevel or ramp CIL along AR to max .25"	2015 ABAAS Section: 303.3  2012 TAS Section: 303.3  2010 ADAS Section: 303.3

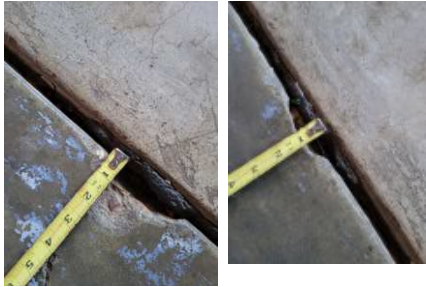
272	Day Use Area: Day Use Area Group Recreation Hall	[30.0455266 , -97.160038 3]	Openings in floor or ground surfaces shall not allow passage of a sphere more than 1/2 inch (13 mm) diameter except as allowed in 407.4.3, 409.4.3, 410.4, 810.5.3 and 810.10. Elongated openings shall be placed so that the long dimension is perpendicular to the dominant direction of travel.	kitchen- multiple gaps (6) between .5" and 2"	Fill and maintain gaps to max .5"	2015 ABAAS Section: 302.3  2012 TAS Section: 302.3  2010 ADAS Section: 302.3

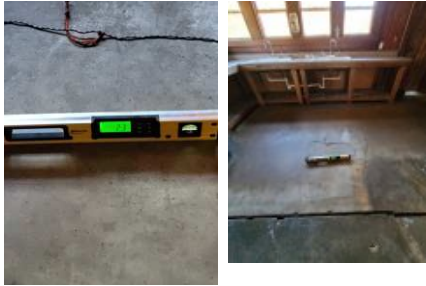
Finding Number	Area Description	Lat/Long	Finding	As Built	Recommendation	Citation	Photos	Figure
273	Day Use Area: Day Use Area Group Recreation Hall	[30.0455312 , -97.160049]	The accessible path of travel contains cross slopes greater than 2%. Surface cross slopes shall not exceed one unit vertical in 48 units horizontal (2-percent slope). When the slope in the direction of travel of any walk exceeds 1 unit vertical in 20 units horizontal (5-percent slope), it must be constructed as ramp.	kitchen- slope of 2.3% near sinks	Correct or repair cross slope of AR to max 2.08%	2015 ABAAS Section: F206.2.4, 403.3  2012 TAS Section: 206.2.4, 403.3  2010 ADAS Section: 206.2.4, 403.3

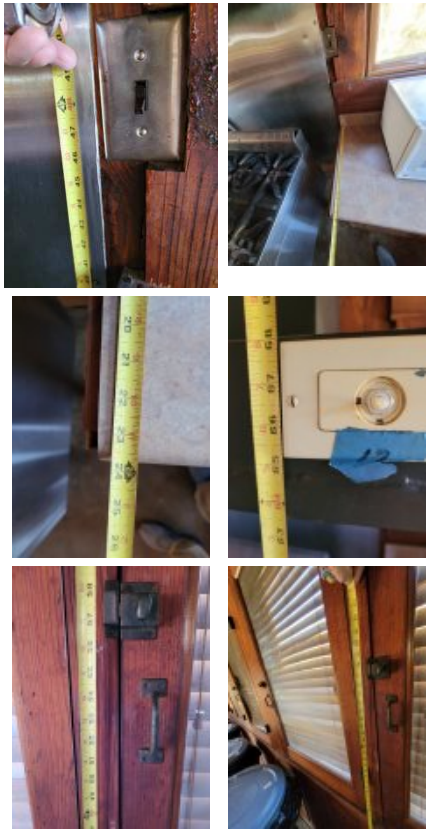
274	Day Use Area: Day Use Area Group Recreation Hall	[30.045515, -97.160030 3]	The switch near cooking range, hood switch, window handle, and window latch are positioned too high for either a side or front approach. Where a high forward reach is over an obstruction, the clear floor space is over an obstruction, the clear floor space shall extend beneath the element for a distance not less than the required reach depth over the obstruction. The high forward reach shall be 48 inches (1220 mm) maximum where the reach depth is 20 inches (510 mm) maximum. Where the reach depth exceeds 20 inches (510 mm), the high forward reach shall be 44 inches (1120 mm) maximum and the reach depth shall be 25 inches (635 mm) maximum. Where a clear floor or ground space allows a parallel approach to an element and the side reach is unobstructed, the high side reach shall be 48 inches maximum and the low side reach shall be 15 inches minimum above the finish floor or ground. Where a forward reach is unobstructed, the high forward reach shall be 48 inches maximum and the low forward reach shall be 15 inches minimum above the finish floor or ground.	kitchen- switch near cooking range 48" aff - obstructed by 24" deep surface, hood switch 66.5" aff, window handle 53" aff, and window latch 57.5" aff	Lower operating mechanisms of hood switch, window handle, and window latch to max 48" aff to highest operable part Lower switch near cooking range to max 44" aff for a forward reach over counter	2015 ABAAS Section: 308.2.1, 308.3.2  2012 TAS Section: 308.2.1, 308.3.2  2010 ADAS Section: 308.2.1, 308.3.2

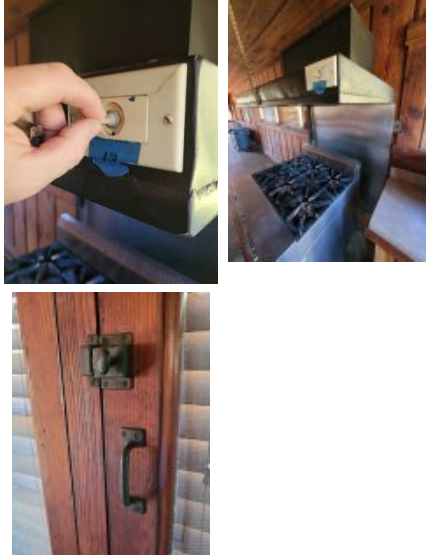
Finding Number	Area Description	Lat/Long	Finding	As Built	Recommendation	Citation	Photos	Figure
275	Day Use Area: Day Use Area Group Recreation Hall	[30.0455359 , -97.160032 9]	The switch is not accessible because it requires tight grasping, pinching or twisting of the wrist.	kitchen- hood switch and window latch require tight grasping, pinching, or twisting of the wrist	Replace hood switch and window latch with an operable part usable without a tight pinch or grasp	2015 ABAAS Section: 309.4  2012 TAS Section: 309.4  2010 ADAS Section: 309.4

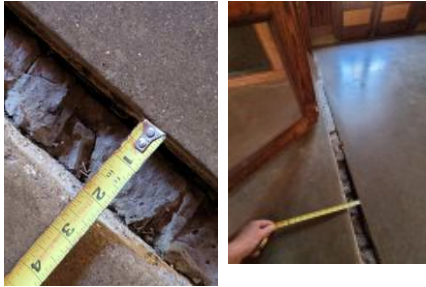
276	Day Use Area: Day Use Area Group Recreation Hall	[30.04553, -97.160038 3]	Openings in floor or ground surfaces shall not allow passage of a sphere more than 1/2 inch (13 mm) diameter except as allowed in 407.4.3, 409.4.3, 410.4, 810.5.3 and 810.10. Elongated openings shall be placed so that the long dimension is perpendicular to the dominant direction of travel.	Gap of 2.5" at doorway	Fill and maintain gaps to max .5"	2015 ABAAS Section: 302.3  2012 TAS Section: 302.3  2010 ADAS Section: 302.3

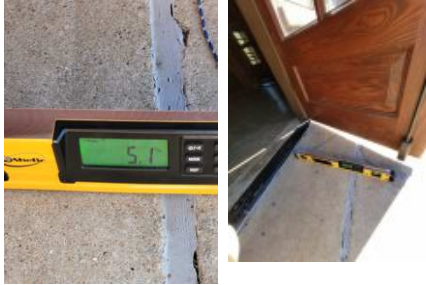
Finding Number	Area Description	Lat/Long	Finding	As Built	Recommendation	Citation	Photos	Figure
279	Day Use Area: Day Use Area Group Recreation Hall	[30.0455312 , -97.160041]	Floor or ground surface within required maneuvering clearances shall comply with 302. Changes in level are not permitted. EXCEPTIONS: 1. Slopes not steeper than 1:48 shall be permitted. 2. Changes in level at thresholds complying with 404.2.5 shall be permitted.	Kitchen exterior door to patio - Slope of 5.1% on pull side landing	Correct or repair slope at doorway landing to max 2.08% in any direction for level	2015 ABAAS Section: 404.2.4.4, 404.2.4.4 EX CEPTIONS: 1, 404.2.4.4 E XCEPTIONS: 2  2012 TAS Section: 404.2.4.4, 404.2.4.4 Exception 1, 404.2.4.4 Exception 2  2010 ADAS Section: 404.2.4.4, 404.2.4.4 Exception 1, 404.2.4.4 Exception 2

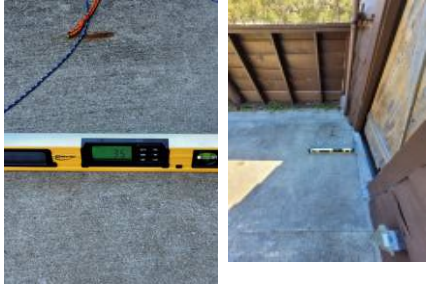
Finding Number	Area Description	Lat/Long	Finding	As Built	Recommendation	Citation	Photos	Figure
283	Day Use Area: Day Use Area Group Recreation Hall	[30.0455359 , -97.160049]	Floor or ground surface within required maneuvering clearances shall comply with 302. Changes in level are not permitted. EXCEPTIONS: 1. Slopes not steeper than 1:48 shall be permitted. 2. Changes in level at thresholds complying with 404.2.5 shall be permitted.	Kitchen side door to fenced area - Slope of 3.5% on push side landing	Correct or repair slope at doorway landing to max 2.08% in any direction for level	2015 ABAAS Section: 404.2.4.4, 404.2.4.4 EX CEPTIONS: 1, 404.2.4.4 E XCEPTIONS: 2  2012 TAS Section: 404.2.4.4, 404.2.4.4 Exception 1, 404.2.4.4 Exception 2  2010 ADAS Section: 404.2.4.4, 404.2.4.4 Exception 1, 404.2.4.4 Exception 2

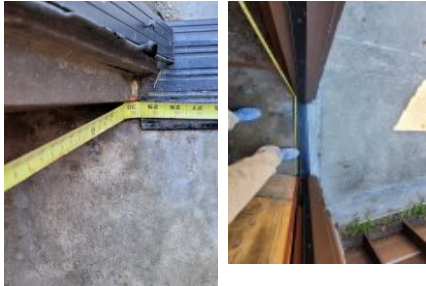
284	Day Use Area: Day Use Area Group Recreation Hall	[30.0455359 , -97.160032 9]	The door opening does not provide at least 32 inches between the face of the door and the opposite stop. Door openings shall provide a clear width of 32 inches minimum. Clear openings of doorways with swinging doors shall be measured between the face of the door and the stop, with the door open 90 degrees. There shall be no projections into the required clear opening width lower than 34 inches above the finish floor or ground. Projections into the clear opening width between 34 inches and 80 inches above the finish floor or ground shall not exceed 4 inches.	Kitchen side door to fenced area - 30" clear width	Replace door with one having 32" clear width	2015 ABAAS Section: 404.2.3  2012 TAS Section: 404.2.3  2010 ADAS Section: 404.2.3
