# Access Audit Site Report

**Buescher State Park**

**Accessibility Evaluation**

**Inspection Date: 11/11/2021**

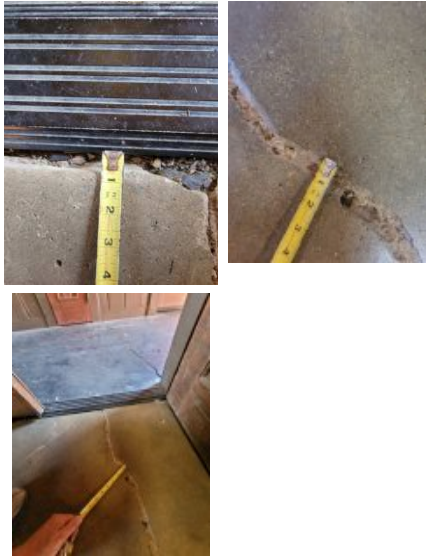
Finding Number	Area Description	Lat/Long	Finding	As Built	Recommendation	Citation	Photos	Figure
285	Day Use Area: Day Use Area Group Recreation Hall	[30.0455312 , -97.160035 6]	Floor or ground surface within required maneuvering clearances shall comply with 302. Changes in level are not permitted. Openings in floor or ground surfaces shall not allow passage of a sphere more than 1/2 inch (13 mm) diameter except as allowed in 407.4.3, 409.4.3, 410.4, 810.5.3 and 810.10. Elongated openings shall be placed so that the long dimension is perpendicular to the dominant direction of travel.	Main room exterior doors, bathroom side -Gaps of .75" and 1" on pull side landing	For all doors along the public circulation route, fill and maintain gaps at doorways to max .5"	2015 ABAAS Section: 302.1, 302.2, 302.3, 302.1 EXCEPTION S: 1, 404.2.4.4, 404.2.4.4 EX CEPTIONS: 1, 404.2.4.4 E XCEPTIONS: 2  2012 TAS Section: 302.1, 302.1 Exception 1, 302.3, 404.2.4.4, 404.2.4.4 Exception 1, 404.2.4.4 Exception 2, 302.2  2010 ADAS Section: 302.3, 302.1, 302.2, 404.2.4.4

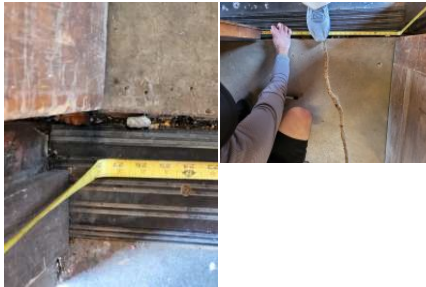
286	Day Use Area: Day Use Area Group Recreation Hall	[30.0455382 , -97.160032 9]	The door opening does not provide at least 32 inches between the face of the door and the opposite stop. Door openings shall provide a clear width of 32 inches minimum. Clear openings of doorways with swinging doors shall be measured between the face of the door and the stop, with the door open 90 degrees. There shall be no projections into the required clear opening width lower than 34 inches above the finish floor or ground. Projections into the clear opening width between 34 inches and 80 inches above the finish floor or ground shall not exceed 4 inches.	Main room exterior doors, bathroom side - 28" clear width	Replace door with one having 32" clear width	2015 ABAAS Section: 404.2.3  2012 TAS Section: 404.2.3  2010 ADAS Section: 404.2.3

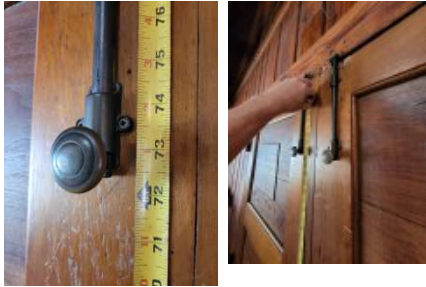
288	Day Use Area: Day Use Area Group Recreation Hall	[30.0455312 , -97.160024 9]	The door throw bolt is positioned too high for either a side or front approach. Where a clear floor or ground space allows a parallel approach to an element and the side reach is unobstructed, the high side reach shall be 48 inches maximum and the low side reach shall be 15 inches minimum above the finish floor or ground. Where a forward reach is unobstructed, the high forward reach shall be 48 inches maximum and the low forward reach shall be 15 inches minimum above the finish floor or ground.	Double doors from main room - door throw bolt at 72.75" aff	Remount operable parts to be in reach range of 15" min to 48" max	2015 ABAAS Section: 308.1  2012 TAS Section: 308.1  2010 ADAS Section: 308.1

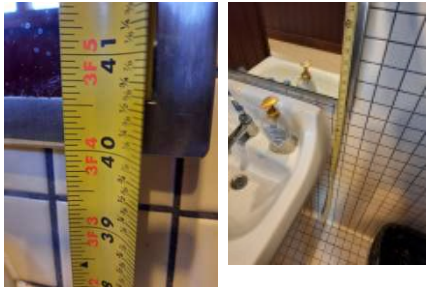
295	Day Use Area: Day Use Area Group Recreation Hall Men's Restroom	[30.0455289 , -97.160035 6]	The mirror is mounted too high. Mirrors must have the bottom edge of the reflecting surface a maximum of 40 inches above the floor if above a sink or counter. Mirrors not located above lavatories or countertops shall be installed with the bottom edge of the reflecting surface 35 inches maximum above the finish floor or ground.	Bottom edge of reflecting surface of mirror is 40.5" aff	Lower mirror so reflective surface is max 40" aff	2015 ABAAS Section: 603.3  2012 TAS Section: 603.3  2010 ADAS Section: 603.3

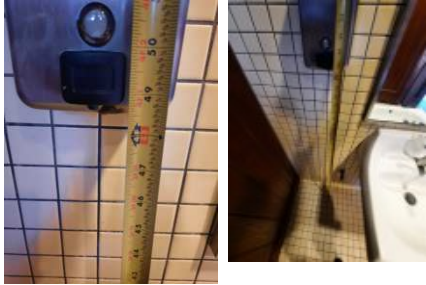
Finding Number	Area Description	Lat/Long	Finding	As Built	Recommendation	Citation	Photos	Figure
296	Day Use Area: Day Use Area Group Recreation Hall Men's Restroom	[30.0455347 , -97.160043 7]	Where a high forward reach is over an obstruction, the clear floor space shall extend beneath the element for a distance not less than the required reach depth over the obstruction. The high forward reach shall be 48 inches (1220 mm) maximum where the reach depth is 20 inches (510 mm) maximum. Where the reach depth exceeds 20 inches (510 mm), the high forward reach shall be 44 inches (1120 mm) maximum and the reach depth shall be 25 inches (635 mm) maximum. Where a clear floor or ground space allows a parallel approach to an element and the high side reach is over an obstruction, the height of the obstruction shall be 34 inches (865 mm) maximum and the depth of the obstruction shall be 24 inches (610 mm) maximum. The high side reach shall be 48 inches (1220 mm) maximum for a reach depth of 10 inches (255 mm) maximum. Where the reach depth exceeds 10 inches (255 mm), the high side reach shall be 46 inches (1170 mm) maximum for a reach depth of 24 inches (610 mm) maximum.	Soap dispenser 48.75" aff	Lower soap dispenser to max 44" above the finished floor (AFF) for a forward reach over counter.	2015 ABAAS Section: 308.2.1, 308.3.2  2012 TAS Section: 308.2.1, 308.3.2  2010 ADAS Section: 308.2.1, 308.3.2

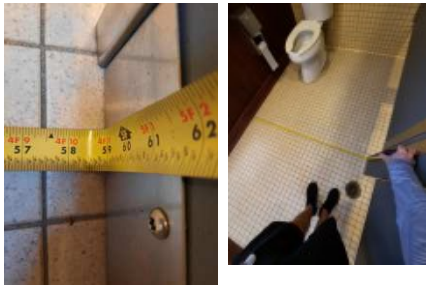
297	Day Use Area: Day Use Area Group Recreation Hall Men's Restroom	[30.0455359 , -97.160038 3]	The dimensions of the toilet stall do not comply. Wheelchair accessible compartments shall be 60 inches wide and 59 inches deep minimum for floor mounted water closets measured perpendicular to the rear wall. Door shall not swing into the minimum clear floor space required for the toilet.	Accessible stall is 59" wide	Widen accessible stalls to min. 60" clear width, 59" depth	2015 ABAAS Section: 604.8.1.1  2012 TAS Section: 604.3.2  2010 ADAS Section: 604.3.2

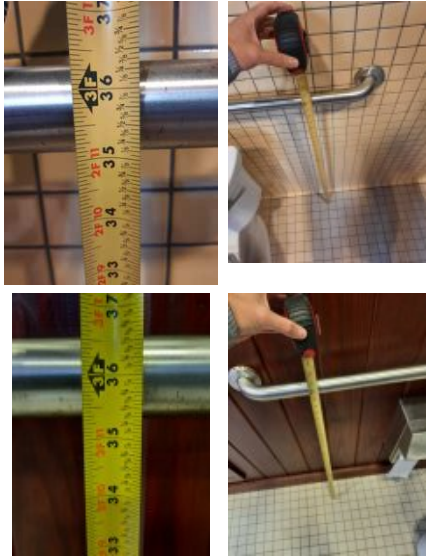
Finding Number	Area Description	Lat/Long	Finding	As Built	Recommendation	Citation	Photos	Figure
298	Day Use Area: Day Use Area Group Recreation Hall Men's Restroom	[30.0455405 , -97.160043 7]	The grab bar height and/or spacing fails. Grab bars must be mounted between 33" and 36" to the top of the gripping surface. There must be 1.5" of clearance between the grab bar and the wall. There must be a minimum of 1.5" of clearance below and minimum 12" above the grab bar to any dispenser or other obstruction.	Gripping surfaces of grab bars are 36.25" aff and 36.5" aff	Remount grab bars in accessible stall to 33" to 36" aff	2015 ABAAS Section: 609.3, 609.4  2012 TAS Section: 609.4, 609.3  2010 ADAS Section: 609.3, 609.4

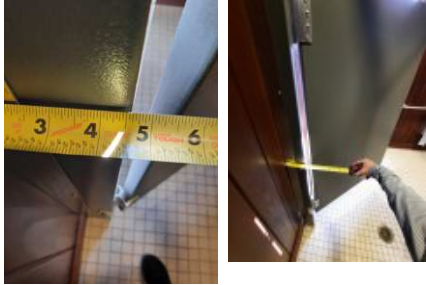
Finding Number	Area Description	Lat/Long	Finding	As Built	Recommendation	Citation	Photos	Figure
300	Day Use Area: Day Use Area Group Recreation Hall Men's Restroom	[30.0455219 , -97.160032 9]	The compartment door is located too far from the partition or wall. The door shall be located in front of the clear space and diagonal to the water closet. Where located in the front partition, the door opening shall be 4 inches maximum from the side wall or partition farthest from the water closet. Where located in the side wall or partition, the door opening shall be 4 inches maximum from the front partition. Toilet compartment doors shall not swing into the minimum required compartment area.	Stall door 4.5" from partition	Rehang stall door to be max 4" from adjacent stall partition and on the stall wall farthest from the toilet	2015 ABAAS Section: 604.8.1.2  2012 TAS Section: 604.8.1.2  2010 ADAS Section: 604.8.1.2

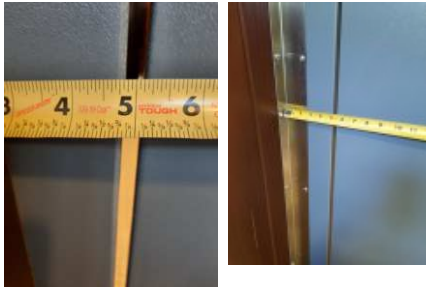
311	Day Use Area: Day Use Area Group Recreation Hall Women's Restroom	[30.0455242 , -97.160046 4]	The compartment door is located too far from the partition or wall. The door shall be located in front of the clear space and diagonal to the water closet. Where located in the front partition, the door opening shall be 4 inches maximum from the side wall or partition farthest from the water closet. Where located in the side wall or partition, the door opening shall be 4 inches maximum from the front partition. Toilet compartment doors shall not swing into the minimum required compartment area.	Stall door 4.75" from partition	Rehang stall door to be max 4" from adjacent stall partition and on the stall wall farthest from the toilet	2015 ABAAS Section: 604.8.1.2  2012 TAS Section: 604.8.1.2  2010 ADAS Section: 604.8.1.2
