Access Audit Site Report

Daingerfield State Park

Accessibility Evaluation

Inspection Date: 04/07/2022

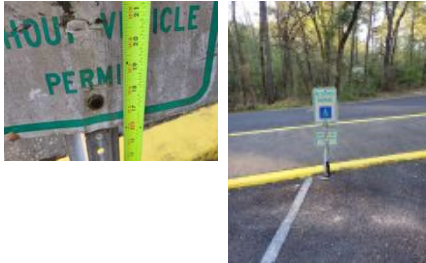
Finding Number	Area Description	Lat/Long	Finding	As Built	Recommendation	Citation	Photos	Figure
4	Headquarters Area: HQ Parking	[33.0128854 , -94.6907004]	The parking sign is mounted too low. Parking space identification signs shall include the International Symbol of Accessibility complying with. Signs identifying van parking spaces shall contain the designation "van accessible." Signs shall be 60 inches minimum above the finish floor or ground surface measured to the bottom of the sign.	Parking sign-18" AGL	Raise existing accessible parking signs so lowest end of bottom sign is min 60" above ground level (AGL) measured from the surface of the stall.	2015 ABAAS Section: 502.6 2012 TAS Section: 502.6 2010 ADAS Section: 502.6

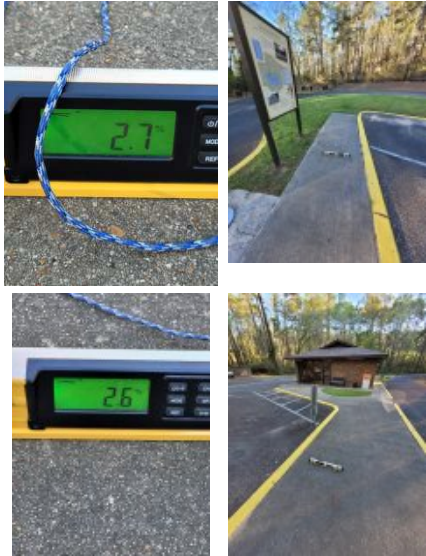
5	Headquarters Area: HQ Public Spaces	[33.0128735 , -94.6907002], [33.0128161 , -94.6907753]	The accessible route of travel contains cross slopes greater than 2%. Cross slopes shall not exceed one unit vertical in 48 units horizontal (2-percent slope).	2.7% slope in sign CFS, 2.6% slope near parking access aisle	Correct or repair cross slope along AR to max 2.08%.	2015 ABAAS Section: 403.3 2012 TAS Section: 403.3 2010 ADAS Section: 403.3

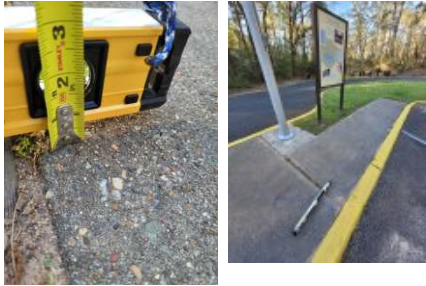
Finding Number	Area Description	Lat/Long	Finding	As Built	Recommendation	Citation	Photos	Figure
6	Headquarters Area: HQ Public Spaces	[33.012824, -94.690755 2]	The walkway contains abrupt vertical edges and/or variations over a 1/4 inch. 1/4 inch is the maximum vertical rise. Changes in level between 1/4 inch and 1/2 inch must be beveled at 1:2 or less. Changes in level greater than 1/2 inch must be by way of a ramp.	.5" CIL in route near sign CFS	Repair, bevel or ramp CIL along AR.	2012 TAS Section: 303.2, 303.3 2010 ADAS Section: 303.2, 303.3

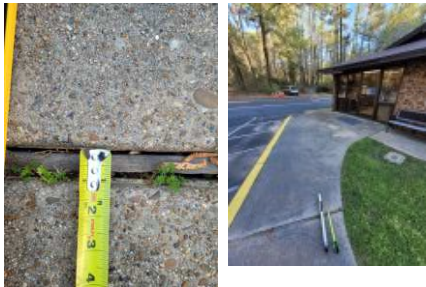
7	Headquarters Area: HQ Public Spaces	[33.0129443, -94.690686 8]	There is a gap spaced greater than a 1/2 inch. Openings in floor or ground surfaces shall not allow passage of a sphere more than 1/2 inch diameter. Elongated openings shall be placed so that the long dimension is perpendicular to the dominant direction of travel.	1" gap in route between access aisle and HQ entry	Correct or fill gaps to be max .5"	2015 ABAAS Section: 302.3 2012 TAS Section: 302.3 2010 ADAS Section: 302.3

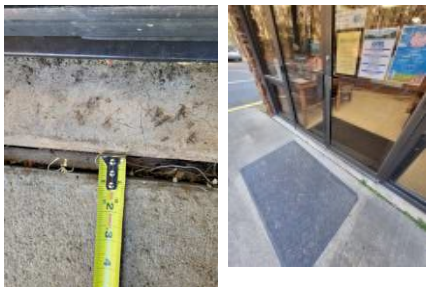
8	Headquarters Area: HQ Public Spaces	[33.0129506, -94.690657 4]	There is a gap spaced greater than a 1/2 inch. Openings in floor or ground surfaces shall not allow passage of a sphere more than 1/2 inch diameter. Elongated openings shall be placed so that the long dimension is perpendicular to the dominant direction of travel.	1" gap in front of door	Correct or fill gaps to be max .5"	2015 ABAAS Section: 302.3 2012 TAS Section: 302.3 2010 ADAS Section: 302.3

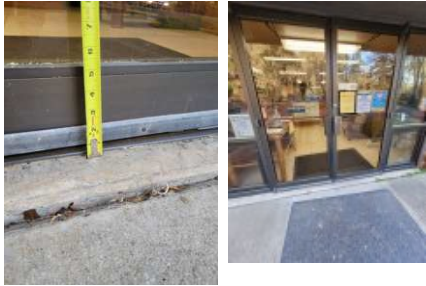
Finding Number	Area Description	Lat/Long	Finding	As Built	Recommendation	Citation	Photos	Figure
10	Headquarters Area: HQ Public Spaces	[33.0129641, -94.6906427]	The sweep period for doors with closers shall be adjusted so that from an open position of 70 degrees, the door will take at least 3 seconds to move to a point 3 inches from the latch, measured to the leading edge of the door. Exterior doors are recommended to be maintained at 8.5 lbf as a smart practice. Force is to be measured at the operating hardware or 30 inches from the hinges, whichever is greater. The bottom 10 inches on the push side must be smooth and free of obstructions (hold open devices). Opening hardware must be mounted between 30 and 44 inches above the floor or ground.	main entry door- 10 lbf, closes fast, 5.5" to glass at door bottom	For all doors along the public circulation route, inspect, adjust, and maintain closing speed on door closers. For all doors along the public circulation route, inspect, adjust, and maintain 8.5 lbf to open exterior doors as a smart practice. For all doors along the public circulation route, provide kick plate on push side of door from floor to 10" AFF.	2010 ADAS Section: 404.2.3, 404.2.7, 404.2.4, 404.2.11, 404.2.11 Exception

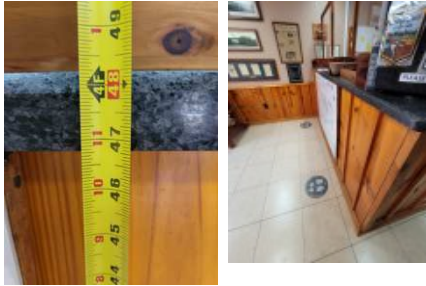
12	Headquarters Area: HQ Public Spaces	[33.0129754, -94.6906306]	The transaction counter is too high. A portion of the counter surface that is 36 inches long minimum and 36 inches high maximum above the finish floor shall be provided. Knee and toe space must be provided for a forward approach. A 30 inch by 48 inch clear floor space on an accessible route must be provided for either a forward or parallel approach.	48" AFF to top of service counter	Lower 36" wide segment of service counter to max 36" AFF	2015 ABAAS Section: 904.4.2, 904.4.1 2012 TAS Section: 904.4.1, 904.4.2 2010 ADAS Section: 904.4.2, 904.4.1

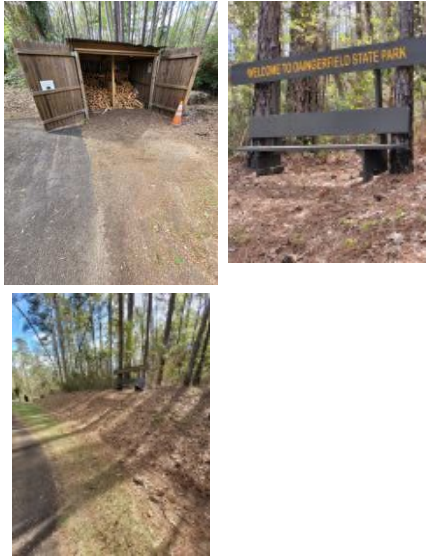
Finding Number	Area Description	Lat/Long	Finding	As Built	Recommendation	Citation	Photos	Figure
13	Headquarters Area: HQ Public Spaces	[33.01321, -94.69081]	There is no accessible route to the site elements. At least one accessible route shall connect accessible buildings, accessible facilities, accessible elements, and accessible spaces that are on the same site.	Wood box lacks AR, 15'; bench lacks AR, 30' up hill	Create an accessible route with crushed stone or other outdoor material from parking or walkway to the site elements	2015 ABAAS Section: F206.2.2 2012 TAS Section: 206.2.2 2010 ADAS Section: 206.2.2

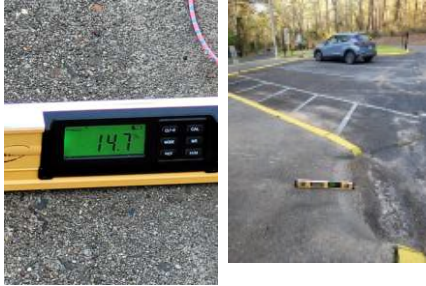
14	Headquarters Area: HQ Public Spaces	[33.0129709, -94.6907097]	The curb ramp slope exceeds the maximum running slope (Parallel to the direction of travel) allowable of 8.33%. Curb ramps should have the least possible slope but in no case more than 8.3% (1:12).	14.7% slope at curb ramp by accessible parking	Correct curb ramp running slope to max 8.33%	2015 ABAAS Section: 406.1 2012 TAS Section: 406.1 2010 ADAS Section: 406.1

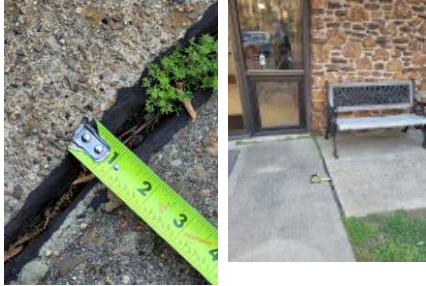
15	Headquarters Area: HQ Public Spaces	[33.0129484, -94.6906521]	There is a gap spaced greater than a 1/2 inch. Openings in floor or ground surfaces shall not allow passage of a sphere more than 1/2 inch diameter. Elongated openings shall be placed so that the long dimension is perpendicular to the dominant direction of travel.	1" gap at bench by entry	Correct or fill gaps to be max .5"	2015 ABAAS Section: 302.3 2012 TAS Section: 302.3 2010 ADAS Section: 302.3

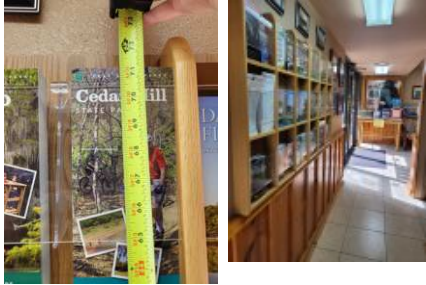
Finding Number	Area Description	Lat/Long	Finding	As Built	Recommendation	Citation	Photos	Figure
16	Headquarters Area: HQ Public Spaces	[33.0129832 , -94.690622 6]	The operable part is positioned too high for either a side or front approach. Where a clear floor or ground space allows a parallel approach to an element and the side reach is unobstructed, the high side reach shall be 48 inches maximum and the low side reach shall be 15 inches minimum above the finish floor or ground. Where a forward reach is unobstructed, the high forward reach shall be 48 inches maximum and the low forward reach shall be 15 inches minimum above the finish floor or ground.	70.5" AFF to brochures in hallway	Remount operable parts to be in reach range of 15" min to 48" max	2015 ABAAS Section: 308.1 2012 TAS Section: 308.1 2010 ADAS Section: 308.1

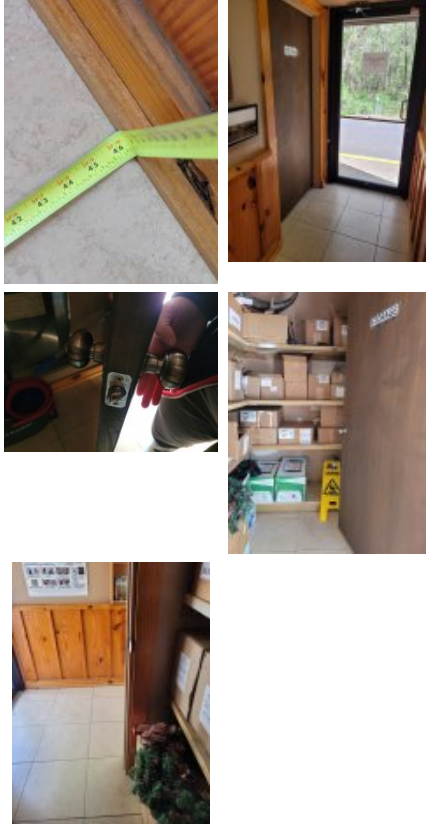
17	Headquarters Area: HQ Employee Spaces	[33.0129832 , -94.690627 9]	Spaces and elements within employee work areas shall only be required to comply with 206.2.8, 207.1, and 215.3 and shall be designed and constructed so that individuals with disabilities can approach, enter, and exit the employee work area. Employee work areas, or portions of employee work areas, other than raised courtroom stations, that are less than 300 square feet (28 m2) and elevated 7 inches (180 mm) or more above the finish floor or ground where the elevation is essential to the function of the space shall not be required to comply with these requirements or to be on an accessible route.	Storage, latch approach - 46.25" back MC on push, doesn't open 90 degrees due to storage, MC on pull reduced by storage	For employee spaces, relocate storage, furniture, and other obstacles at doorways to provide approach, enter and exit at the employee space.	2015 ABAAS Section: F203.9 2012 TAS Section: 203.9 2010 ADAS Section: 203.9

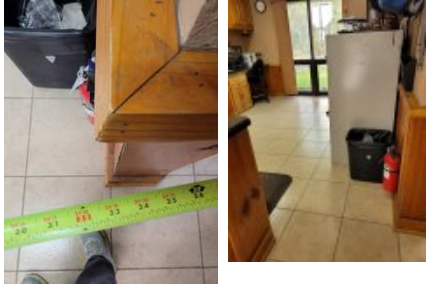
19	Headquarters Area: HQ Employee Spaces	[33.0129844, -94.6906266]	Employee Work Areas. Common use circulation paths within employee work areas shall comply with 402. EXCEPTIONS: 1. Common use circulation paths located within employee work areas that are less than 1000 square feet (93 m2) and defined by permanently installed partitions, counters, casework, or furnishings shall not be required to comply with 402. 2. Common use circulation paths located within employee work areas that are an integral component of work area equipment shall not be required to comply with 402. 3. Common use circulation paths located within exterior employee work areas that are fully exposed to the weather shall not be required to comply with 402.	33" width behind front desk	Make corrections for compliant circulation path.	2015 ABAAS Section: F206.2.8, F206.2.8.1, F206.2.8.2 2012 TAS Section: 206.2.8, 206.2.8 Exception 1, 206.2.8 Exception 2, 206.2.8 Exception 3, 206.2.8 Advisory 1, 206.2.8 Advisory 2 2010 ADAS Section: 206.2.8, 206.2.8 Exception 1, 206.2.8 Exception 2, 206.2.8 Exception 3

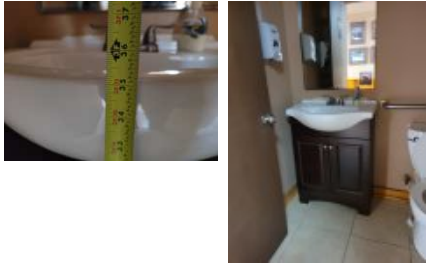
Finding Number	Area Description	Lat/Long	Finding	As Built	Recommendation	Citation	Photos	Figure
22	Headquarters Area: HQ Restroom	[33.0129742 , -94.690633 3]	The top rim of the sink is too high. All lavatories/sinks that are designated to be accessible shall be a minimum 17 inches in horizontal depth and mounted with the rim or counter edge no higher than 34 inches above the finished floor.	35.25" to rim	Lower sinks to max 34" above the finished floor (AFF) to front of rim. Replacement sink cost included in previous finding	2015 ABAAS Section: 606.3 2012 TAS Section: 606.3 2010 ADAS Section: 606.3

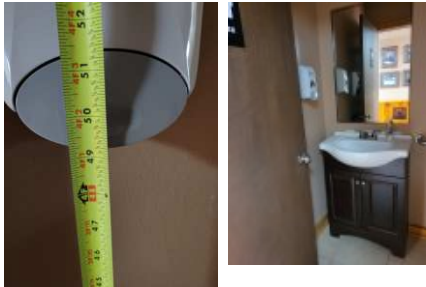
23	Headquarters Area: HQ Restroom	[33.0129776 , -94.690629 3]	Where a high forward reach is over an obstruction, the clear floor space shall extend beneath the element for a distance not less than the required reach depth over the obstruction. The high forward reach shall be 48 inches (1220 mm) maximum where the reach depth is 20 inches (510 mm) maximum. Where the reach depth exceeds 20 inches (510 mm), the high forward reach shall be 44 inches (1120 mm) maximum and the reach depth shall be 25 inches (635 mm) maximum. Where a clear floor or ground space allows a parallel approach to an element and the high side reach is over an obstruction, the height of the obstruction shall be 34 inches (865 mm) maximum and the depth of the obstruction shall be 24 inches (610 mm) maximum. The high side reach shall be 48 inches (1220 mm) maximum for a reach depth of 10 inches (255 mm) maximum. Where the reach depth exceeds 10 inches (255 mm), the high side reach shall be 46 inches (1170 mm) maximum for a reach depth of 24 inches (610 mm) maximum.	49.25" AFF to soap dispenser	Lower operating mechanisms to max 48" above the finished floor (AFF) to highest operable part.	2015 ABAAS Section: 308.2.1, 308.3.2 2012 TAS Section: 308.2.1, 308.3.2 2010 ADAS Section: 308.2.1, 308.3.2

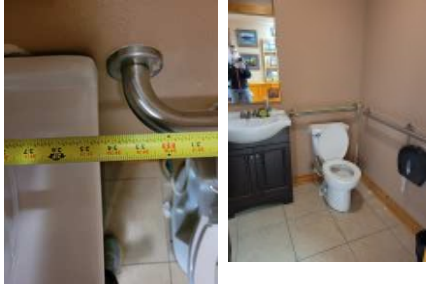
Finding Number	Area Description	Lat/Long	Finding	As Built	Recommendation	Citation	Photos	Figure
24	Headquarters Area: HQ Restroom	[33.0129799 , -94.6906306]	The required 56 inches by 60 inches clear floor space for the water closet has been obstructed. The clear floor space around the water closet shall be 60 inches minimum measured perpendicular from the side wall and 56 inches minimum measured perpendicular from the rear wall.	35" to sink	Relocate sink to provide required 60" clearance around toilet	2015 ABAAS Section: 604.3. 2012 TAS Section: 604.3.1 2010 ADAS Section: 604.3.1

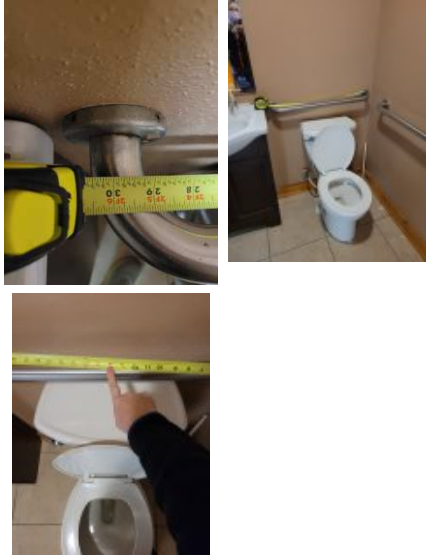
26	Headquarters Area: HQ Restroom	[33.0129742 , -94.6906333]	The rear grab bar is not 36" long or is not mounted in the correct location. The rear grab bar must be a minimum of 36" long and extend from the toilet centerline a minimum 12" towards the wall side and a minimum 24" towards the open side of the toilet. Grab bars shall be installed in a horizontal position, 33 inches minimum and 36 inches maximum above the finish floor measured to the top of the gripping surface and the space between the grab bar and the top of the tank shall be 1-1/2 inches minimum.	30" grab bar	Replace rear grab bar with one 36" long, mounted behind the toilet, 12" to the wall side of center and 24" to the open side and 33" to 36" AFF	2015 ABAAS Section: 604.5.2 2012 TAS Section: 604.5.2 2010 ADAS Section: 604.5.2

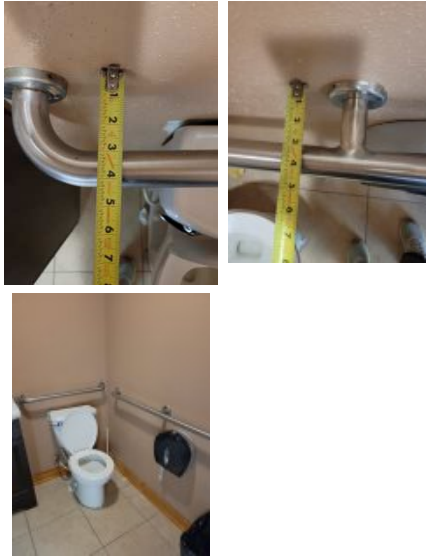
Finding Number	Area Description	Lat/Long	Finding	As Built	Recommendation	Citation	Photos	Figure
27	Headquarters Area: HQ Restroom	[33.0129765 , -94.690636]	The grab bar height and/or spacing fails. Grab bars must be mounted between 33" and 36" to the top of the gripping surface. There must be 1.5" of clearance between the grab bar and the wall. There must be a minimum of 1.5" of clearance below and minimum 12" above the grab bar to any dispenser or other obstruction.	3" clearance	Remount grab bars in accessible stall to 33" to 36" above the finished floor (AFF) with 1.5" max. between wall and grab bar	2015 ABAAS Section: 609.3, 609.4 2012 TAS Section: 609.4, 609.3 2010 ADAS Section: 609.3, 609.4

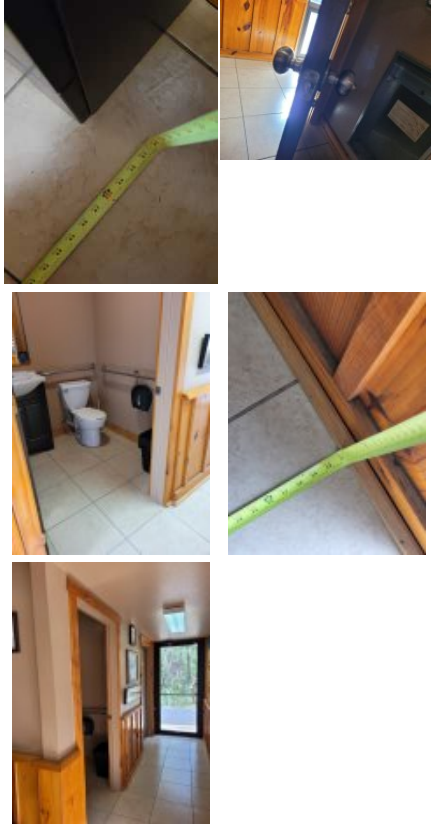
Finding Number	Area Description	Lat/Long	Finding	As Built	Recommendation	Citation	Photos	Figure
28	Headquarters Area: HQ Restroom	[33.0129866 , -94.690614 5]	Minimum maneuvering clearances at doors and gates shall comply with 404.2.4. Maneuvering clearances shall extend the full width of the doorway and the required latch side or hinge side clearance. Maneuvering clearances shall have a max slope of 2.08%. Hand-activated door opening hardware, handles, pulls, latches, locks, and other operating devices on accessible doors shall have a shape that is easy to grasp with one hand and does not require tight grasping, tight pinching or twisting of the wrist to operate. Hardware shall be 34 inches minimum and 48 inches maximum above the finish floor or ground.	restroom- 50" maneuvering clearance on back pull side due to sink, knob, push side latch approach - 41" back	For all doors along the public circulation route, provide required maneuvering clearance on push and pull side of doors. For all doors along the public circulation route, replace hardware with lever hardware or hardware operable without a tight pinch or grasp.	2010 ADAS Section: 404.2.3, 404.2.7, 404.2.4, 404.2.11, 404.2.11 Exception

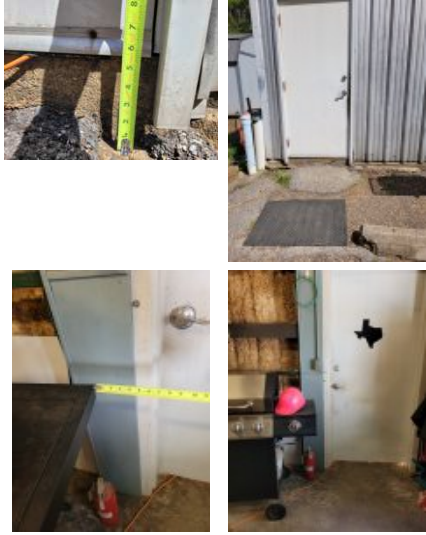
Finding Number	Area Description	Lat/Long	Finding	As Built	Recommendation	Citation	Photos	Figure
29	Employee Areas: Maintenance	[33.0131227 , -94.697403 2]	Spaces and elements within employee work areas shall only be required to comply with 206.2.8, 207.1, and 215.3 and shall be designed and constructed so that individuals with disabilities can approach, enter, and exit the employee work area. Employee work areas, or portions of employee work areas, other than raised courtroom stations, that are less than 300 square feet (28 m2) and elevated 7 inches (180 mm) or more above the finish floor or ground where the elevation is essential to the function of the space shall not be required to comply with these requirements or to be on an accessible route.	5.5" CIL at main entry, 7" MC on push due to grill	For employee spaces, relocate storage, furniture, and other obstacles at doorways to provide approach, enter and exit at the employee space.	2015 ABAAS Section: F203.9 2012 TAS Section: 203.9 2010 ADAS Section: 203.9

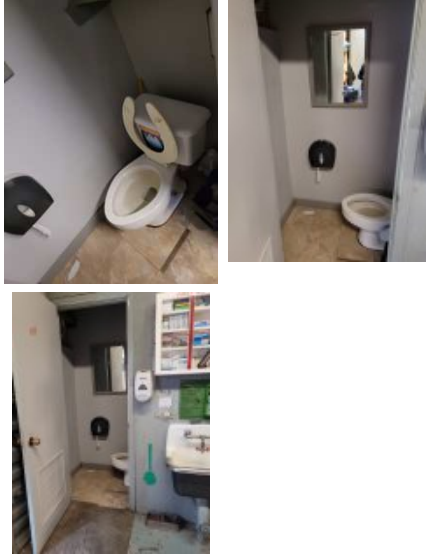
30	Employee Areas: Maintenance	[33.0130844 , -94.697424 7]	There are not enough accessible toilet compartments. The room contains toilet compartments. A minimum of 1 must be wheelchair accessible .	Non compliant restroom, lacks directional sign to accessible restroom	Restroom not accessible, acquire and mount signage directing patrons to nearest accessible restroom	2015 ABAAS Section: F213.3.1 2012 TAS Section: 213.3.1 2010 ADAS Section: 213.3.1

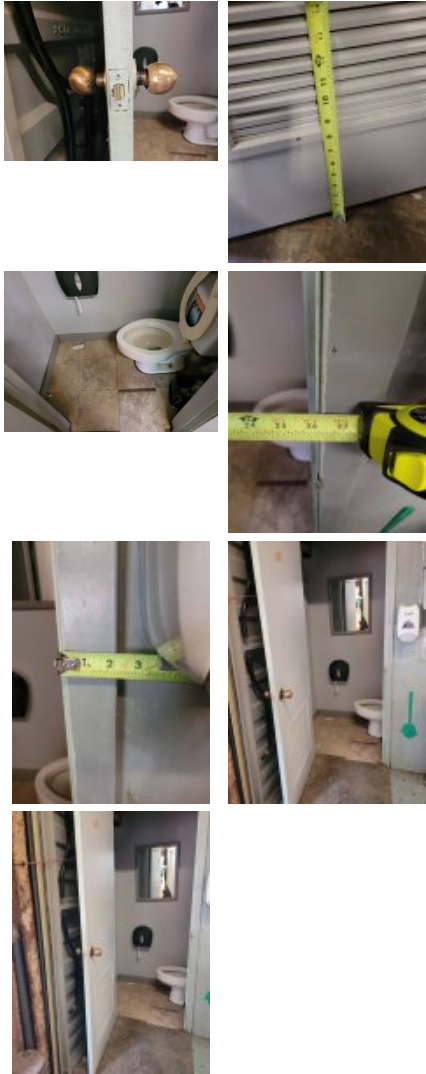
Finding Number	Area Description	Lat/Long	Finding	As Built	Recommendation	Citation	Photos	Figure
31	Employee Areas: Maintenance	[33.0130777 , -94.697424 7]	<p>Minimum maneuvering clearances at doors and gates shall comply with 404.2.4. Maneuvering clearances shall extend the full width of the doorway and the required latch side or hinge side clearance. Maneuvering clearances shall have a max slope of 2.08%. Door openings shall provide a clear width of 32 inches (815 mm) minimum. Clear openings of doorways with swinging doors shall be measured between the face of the door and the stop, with the door open 90 degrees. Openings more than 24 inches (610 mm) deep shall provide a clear opening of 36 inches (915 mm) minimum. There shall be no projections into the required clear opening width lower than 34 inches (865 mm) above the finish floor or ground. Projections into the clear opening width between 34 inches (865 mm) and 80 inches (2030 mm) above the finish floor or ground shall not exceed 4 inches (100 mm). Hand-activated door opening hardware, handles, pulls, latches, locks, and other operating devices on accessible doors shall have a shape that is easy to grasp with one hand and does not require tight grasping, tight pinching or twisting of the wrist to operate. Hardware shall be 34 inches minimum and 48 inches maximum above the finish floor or ground. The bottom 10 inches on the push side must be smooth and free of obstructions (hold open devices). Opening hardware must be mounted between 30 and 44 inches above the floor or ground.</p>	Restroom door - knob, 8.5" to grate, no MC on push, 26" width, 3.5" MC on pull, door won't open 90 due to tables behind door	<p>For all doors along the public circulation route, provide required maneuvering clearance on push and pull side of doors. For all doors along the public circulation route, replace doors with doors having 80" overhead clearance and 32" clear width. For all doors along the public circulation route, replace hardware with lever hardware or hardware operable without a tight pinch or grasp. For all doors along the public circulation route, provide kick plate on push side of door from floor to 10" AFF.</p>	2010 ADAS Section: 404.2.3, 404.2.7, 404.2.4, 404.2.11, 404.2.11 Exception

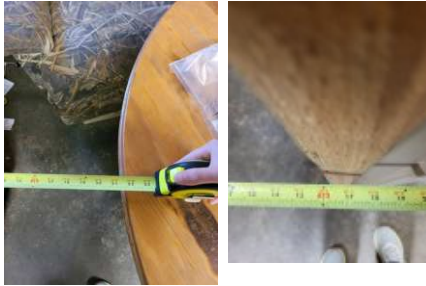
Finding Number	Area Description	Lat/Long	Finding	As Built	Recommendation	Citation	Photos	Figure
37	Employee Areas: Maintenance	[33.0130754 , -94.697419 3]	The route of travel at this location does not provide a minimum width of 36 inches. The clear width shall be permitted to be reduced to 32 inches minimum for a length of 24 inches maximum provided that reduced width segments are separated by segments that are 48 inches long minimum and 36 inches wide minimum.	break room- 21" around table, 16" around table	Replace table and remove storage to widen AR to compliant 36" clear width	2015 ABAAS Section: 403.5.1 2012 TAS Section: 403.5.1 2010 ADAS Section: 403.5.1

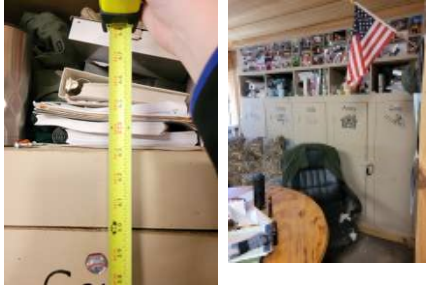
39	Employee Areas: Maintenance	[33.0130732 , -94.697422]	The operable part is positioned too high for either a side or front approach. Where a clear floor or ground space allows a parallel approach to an element and the side reach is unobstructed, the high side reach shall be 48 inches maximum and the low side reach shall be 15 inches minimum above the finish floor or ground. Where a forward reach is unobstructed, the high forward reach shall be 48 inches maximum and the low forward reach shall be 15 inches minimum above the finish floor or ground.	break room- 63" AFF to shelves	Remount operable parts to be in reach range of 15" min to 48" max	2015 ABAAS Section: 308.1 2012 TAS Section: 308.1 2010 ADAS Section: 308.1

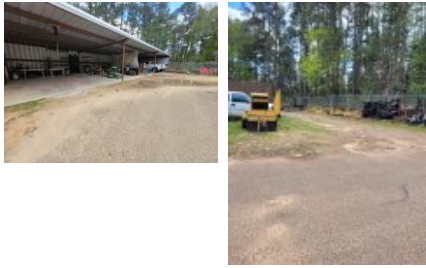
41	Employee Areas: Maintenance	[33.0130743 , -94.697422]	Spaces and elements within employee work areas shall only be required to comply with 206.2.8, 207.1, and 215.3 and shall be designed and constructed so that individuals with disabilities can approach, enter, and exit the employee work area. Employee work areas, or portions of employee work areas, other than raised courtroom stations, that are less than 300 square feet (28 m2) and elevated 7 inches (180 mm) or more above the finish floor or ground where the elevation is essential to the function of the space shall not be required to comply with these requirements or to be on an accessible route.	No AR to carport, no AR to yard storage	Create AR with crushed and compacted stone or similar outdoor material from parking or sidewalk to the building	2015 ABAAS Section: F203.9 2012 TAS Section: 203.9 2010 ADAS Section: 203.9

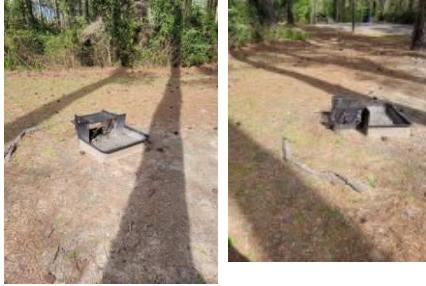
45	Big Pine Camping Area: Big Pine - Sample Campsite	[33.0091877 , -94.693337]	48 inches (1220 mm) by 48 inches (1220 mm) on all usable sides of the fire ring, grill, fireplace, and woodstove Center the space on each usable side of the grill, fireplace, and woodstove	Non compliant surface, root in the CFS for cooking	Provide required 48" clear ground space centered along usable side of fire ring, grill, fireplace, or woodstove as a smart practice Raise fire building surface to 9" min	2015 ABAAS Section: 1011.2

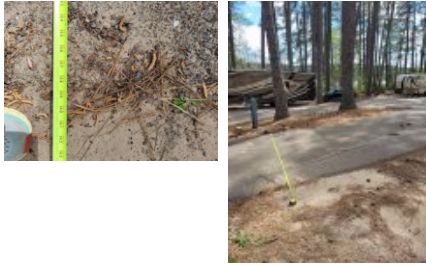
Finding Number	Area Description	Lat/Long	Finding	As Built	Recommendation	Citation	Photos	Figure
47	Big Pine Camping Area: Big Pine - Sample Campsite	[33.0091697 , -94.693306 1]	Camping facilities shall provide camping units with mobility features complying with F244.2 in accordance with Table F244.2. Where a camping facility provides different types of camping units, Table F244.2 shall apply to each type of camping unit provided. Total Number of Camping Units Provided in Camping Facility Minimum Number of Camping Units with Mobility Features Required 1 1 2 to 25 2 26 to 50 3 51 to 75 4 76 to 100 5 101 to 150 7 151 to 200 8 201 and over 8, plus 2 percent of the number over 200	0 accessible campsites, 10 total premium full hook up sites	Create the required number of accessible camp sites per table F244.2 as a smart practice	2015 ABAAS Section: F244.2		
48	Big Pine Camping Area: Big Pine - Sample Campsite	[33.0091641 , -94.693341]	Parking spaces and pull-up spaces for recreational vehicles shall be 20 feet (6100 mm) wide minimum. EXCEPTION: Where two adjacent parking spaces are provided for recreational vehicles, one parking space shall be permitted to be 16 feet (4880 mm) wide minimum.	13'8" wide parking space	Correct RV parking space to be 20' wide minimum; or 16' for two adjacent spaces as a smart practice.	2015 ABAAS Section: 1012.2, 1012.2 EXCEPTION

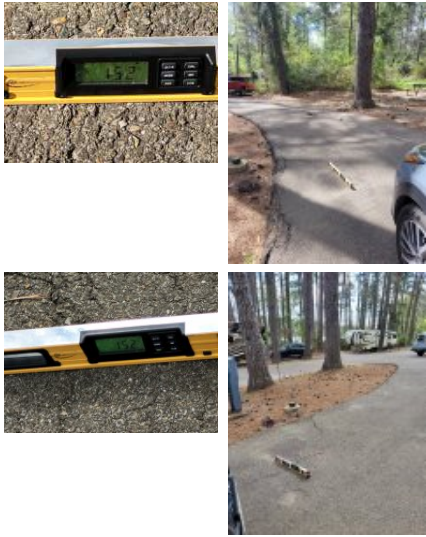
49	Big Pine Camping Area: Big Pine - Sample Campsite	[33.0091944 , -94.693320 9]	The surface of parking spaces and pull-up spaces shall be firm and stable. The slope of the surface of parking spaces and pull-up spaces shall not be steeper than 1:48 in any direction. EXCEPTION: Where the surface is other than asphalt, concrete, or boards, slopes not steeper than 1:20 shall be permitted when necessary for drainage.	Slopes:15.2%, 15.2%	Correct surface of parking spaces to be firm and stable with slopes max of 2.08% or 5% for surfaces other than concrete, asphalt or boards as a smart practice.	2015 ABAAS Section: 1012.4, 1012.5, 1012.5 EXCEPTION

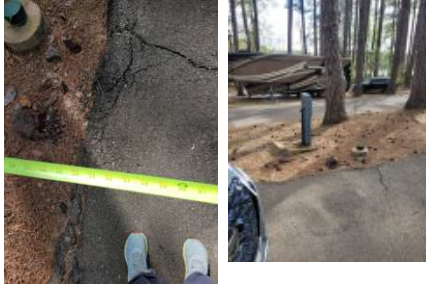
Finding Number	Area Description	Lat/Long	Finding	As Built	Recommendation	Citation	Photos	Figure
50	Big Pine Camping Area: Big Pine - Sample Campsite	[33.0091933 , -94.6932994]	30 inches (760 mm) by 60 inches (1525 mm) with the long side of the space adjoining or overlapping an accessible parking space or pull-up space for recreational vehicles. Locate the space so that the hook-ups are at the rear center of the space. Bollards or other barriers shall not obstruct the clear ground space in front of the hook-ups	54" reach over due to non compliant surface	Provide required 30" by 60" clear ground space with hook ups at the rear of the space as a smart practice	2015 ABAAS Section: 1011.2

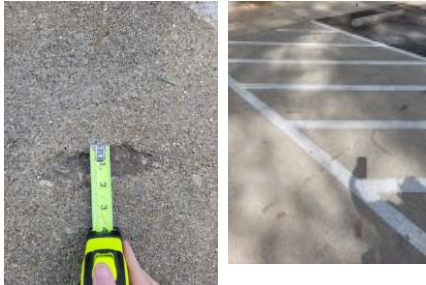
51	Big Pine Camping Area: Big Pine - Parking	[33.0091225 , -94.6929078]	Element meets all standards and requirements	8 standard parking spaces, 1 accessible parking space	None	2010 ADAS Section: N/A		
52	Big Pine Camping Area: Big Pine - Parking	[33.0091258 , -94.6928542]	The parking stall contains abrupt edges and surface irregularities over a 1/4 inch vertical. Parking spaces and access aisles serving them shall be stable, firm, and slip resistant. Access aisles shall be at the same level as the parking spaces they serve. Changes in level are not permitted and shall not be sloped steeper than 2% in any direction.	1.5" gap, deterioration	Repair, bevel and ramp CIL in stalls and access aisles	2015 ABAAS Section: 502.4 2012 TAS Section: 502.4 2010 ADAS Section: 502.4

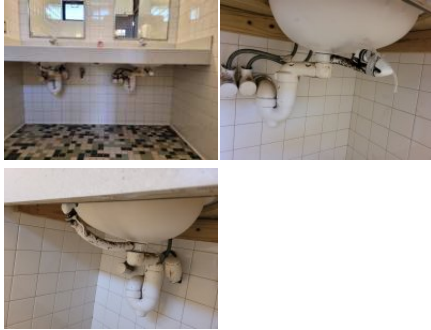
Finding Number	Area Description	Lat/Long	Finding	As Built	Recommendation	Citation	Photos	Figure
54	Big Pine Camping Area: Big Pine - Men's Restroom	[33.00938, -94.69294]	The water and drain pipes under the lavatory are not adequately insulated. Water supply and drain pipes under lavatories and sinks shall be insulated or otherwise configured to protect against contact. There shall be no sharp or abrasive surfaces under lavatories and sinks.	Not in knee clearance but hazardous pipe	Insulate exposed pipes under one sink.	2015 ABAAS Section: 606.5 2012 TAS Section: 606.5 2010 ADAS Section: 606.5

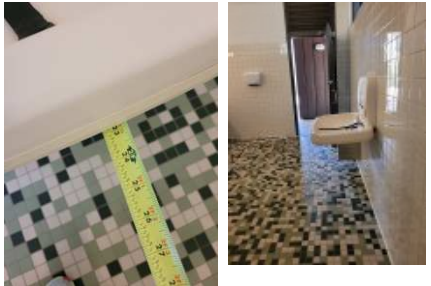
55	Big Pine Camping Area: Big Pine - Men's Restroom	[33.00938, -94.69294]	The baby changing table is not compliant. Baby changing tables are work surfaces. If fixed or built-in baby changing tables are provided, at least 5%, but not less than one, must comply with TAS 902 based TAS 226.1. Baby changing tables cannot violate the protruding object requirements in either an open or closed position since either position is a potential hazard for persons with visual impairments. Baby changing tables are not prohibited from being located in wheelchair accessible toilet compartments; however, the minimum space required for the compartment cannot be obstructed by the baby changing table in either an open or closed position. The clear floor space required for a baby changing table may overlap the water closet clearance since baby changing tables are considered convenience "fixtures" based on Advisory 604.8.1.1. The overlap is applicable only to the clear floor space and not to actual table itself. Baby changing tables must be dispersed throughout a space, however, an additional baby changing table is not required in a common use area of a toilet or bathing room when the only baby changing table is located in a toilet compartment.	baby changing table projects 23" when open.	Remount baby changing table so that operable parts are max 48" and the changing surface in the open position is max 34" and does not project into AR.	2012 TAS Section: 226.1, 902.3, 604.3.2, 204.1, 226.1 Advisory, 226.2, 307.1, 604.8.1.1 Advisory, 902.1, 902.1 Advisory, 902.2

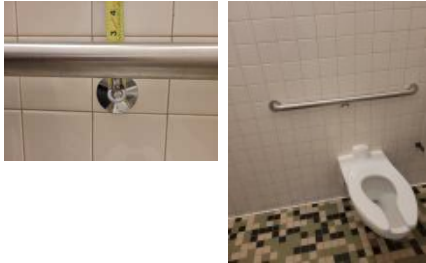
Finding Number	Area Description	Lat/Long	Finding	As Built	Recommendation	Citation	Photos	Figure
59	Big Pine Camping Area: Big Pine - Men's Restroom	[33.00938, -94.69294]	The grab bar height and/or spacing fails. Grab bars must be mounted between 33" and 36" to the top of the gripping surface. There must be 1.5" of clearance between the grab bar and the wall. There must be a minimum of 1.5" of clearance below and minimum 12" above the grab bar to any dispenser or other obstruction.	Flush button .5" below grab bar	Remount grab bars in accessible stall to 33" to 36" above the finished floor (AFF) and Remount toilet flush button 15" to 48" above the finished floor (AFF) and min 12" above or 1.5" below grab bar.	2015 ABAAS Section: 609.3, 609.4 2012 TAS Section: 609.4, 609.3 2010 ADAS Section: 609.3, 609.4

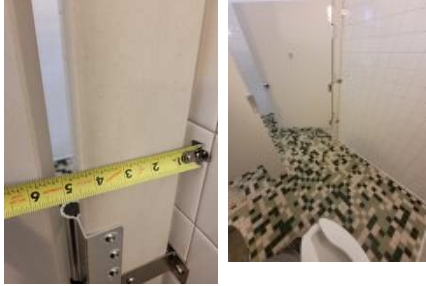
61	Big Pine Camping Area: Big Pine - Men's Restroom	[33.00938, -94.69294]	The compartment door is located too far from the partition or wall. The door shall be located in front of the clear space and diagonal to the water closet. Where located in the front partition, the door opening shall be 4 inches maximum from the side wall or partition farthest from the water closet. Where located in the side wall or partition, the door opening shall be 4 inches maximum from the front partition. Toilet compartment doors shall not swing into the minimum required compartment area.	4.5" partition width	Rehang stall door to be max 4" from adjacent stall partition and on the stall wall farthest from the toilet	2015 ABAAS Section: 604.8.1.2 2012 TAS Section: 604.8.1.2 2010 ADAS Section: 604.8.1.2

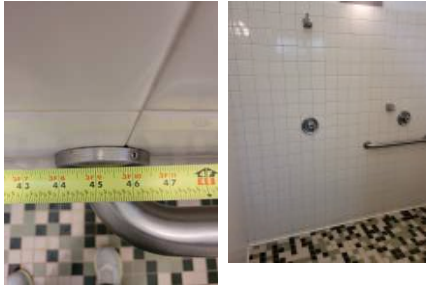
Finding Number	Area Description	Lat/Long	Finding	As Built	Recommendation	Citation	Photos	Figure
65	Big Pine Camping Area: Big Pine - Men's Restroom	[33.00938, -94.69294]	The grab bar does not extend as required along the back of the shower In alternate roll-in type shower compartments, grab bars shall be provided on the back wall and the side wall farthest from the compartment entry. Grab bars shall not be provided above the seat. Grab bars shall be installed 6 inches maximum from adjacent walls.	45" from wall on one side	Provide grab bars in the shower mounted in the correct locations for the shower type	2015 ABAAS Section: 608.3.3 2012 TAS Section: 608.3.3 2010 ADAS Section: 608.3.3

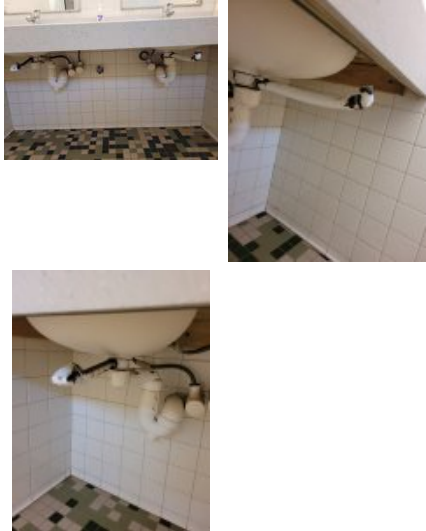
Finding Number	Area Description	Lat/Long	Finding	As Built	Recommendation	Citation	Photos	Figure
71	Big Pine Camping Area: Big Pine - Women's Restroom	[33.00938, -94.69294]	The water and drain pipes under the lavatory are not adequately insulated. Water supply and drain pipes under lavatories and sinks shall be insulated or otherwise configured to protect against contact. There shall be no sharp or abrasive surfaces under lavatories and sinks.	Both sinks have pipes that could be hazardous sticking out (doesn't disrupt the knee, lowest part at 28" AFF)	Insulate exposed pipes under both sinks.	2015 ABAAS Section: 606.5 2012 TAS Section: 606.5 2010 ADAS Section: 606.5

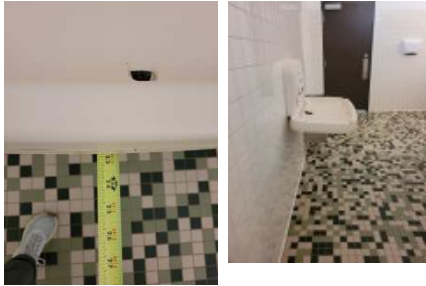
Finding Number	Area Description	Lat/Long	Finding	As Built	Recommendation	Citation	Photos	Figure
72	Big Pine Camping Area: Big Pine - Women's Restroom	[33.00938, -94.69294]	The baby changing table is not compliant. Baby changing tables are work surfaces. If fixed or built-in baby changing tables are provided, at least 5%, but not less than one, must comply with TAS 902 based TAS 226.1. Baby changing tables cannot violate the protruding object requirements in either an open or closed position since either position is a potential hazard for persons with visual impairments. Baby changing tables are not prohibited from being located in wheelchair accessible toilet compartments; however, the minimum space required for the compartment cannot be obstructed by the baby changing table in either an open or closed position. The clear floor space required for a baby changing table may overlap the water closet clearance since baby changing tables are considered convenience "fixtures" based on Advisory 604.8.1.1. The overlap is applicable only to the clear floor space and not to actual table itself. Baby changing tables must be dispersed throughout a space, however, an additional baby changing table is not required in a common use area of a toilet or bathing room when the only baby changing table is located in a toilet compartment.	Baby changing table projects 23" when open	Relocate baby changing table to eliminate protrusion when in the open position.	2012 TAS Section: 226.1, 902.3, 604.3.2, 204.1, 226.1 Advisory, 226.2, 307.1, 604.8.1.1 Advisory, 902.1, 902.1 Advisory, 902.2

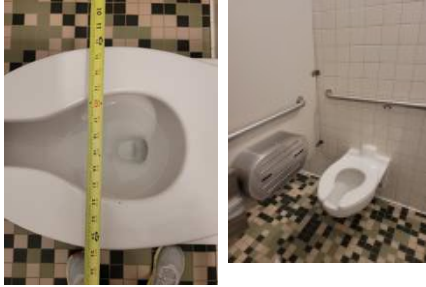
73	Big Pine Camping Area: Big Pine - Women's Restroom	[33.00938, -94.69294]	The toilet is not located within the range allowed from the side wall or partition. The centerline of the toilet must be 16 to 18 inches from the side wall.	18.75" to centerline of toilet	Remount toilets to 16" to 18" from the side wall to centerline	2015 ABAAS Section: 604.2 2012 TAS Section: 604.2 2010 ADAS Section: 604.2

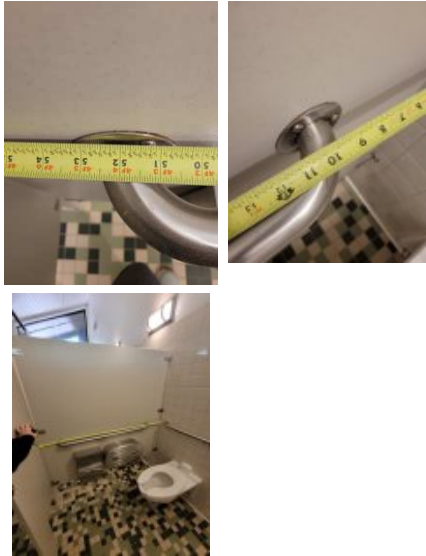
Finding Number	Area Description	Lat/Long	Finding	As Built	Recommendation	Citation	Photos	Figure
74	Big Pine Camping Area: Big Pine - Women's Restroom	[33.00938, -94.69294]	The side grab bars are not in the correct location. Grab bars on the side wall must be installed so that the end closest to the rear wall is maximum 12" from the rear wall. The end furthest from the rear wall must be mounted minimum 54" from the rear wall.	Grab bar mounted 10" from rear wall, extends 52" to grab bar end	Remount side grab bar to max 12" from the rear wall at the close end and min 54" on the far end, and 33" to 36" aff.	2015 ABAAS Section: 604.5.1 2012 TAS Section: 604.5.1 2010 ADAS Section: 604.5.1

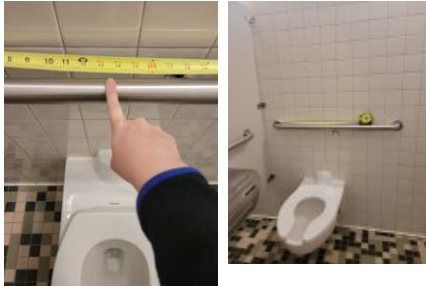
75	Big Pine Camping Area: Big Pine - Women's Restroom	[33.00938, -94.69294]	The rear grab bar is not 36" long or is not mounted in the correct location. The rear grab bar must be a minimum of 36" long and extend from the toilet centerline a minimum 12" towards the wall side and a minimum 24" towards the open side of the toilet. Grab bars shall be installed in a horizontal position, 33 inches minimum and 36 inches maximum above the finish floor measured to the top of the gripping surface and the space between the grab bar and the top of the tank shall be 1-1/2 inches minimum.	Grab bar 13.5" to centerline of toilet, lacks 24" to open side	Remount rear grab bar to behind the toilet, 12" to the wall side of center and 24" to the open side and 33" to 36" AFF	2015 ABAAS Section: 604.5.2 2012 TAS Section: 604.5.2 2010 ADAS Section: 604.5.2

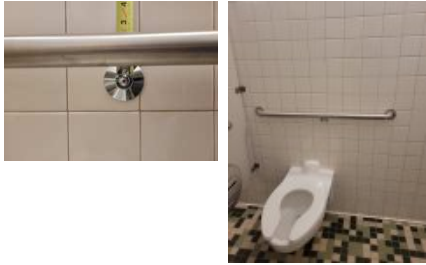
Finding Number	Area Description	Lat/Long	Finding	As Built	Recommendation	Citation	Photos	Figure
76	Big Pine Camping Area: Big Pine - Women's Restroom	[33.00938, -94.69294]	The grab bar height and/or spacing fails. Grab bars must be mounted between 33" and 36" to the top of the gripping surface. There must be 1.5" of clearance between the grab bar and the wall. There must be a minimum of 1.5" of clearance below and minimum 12" above the grab bar to any dispenser or other obstruction.	Flush button .5" below rear grab bar	Remount flush control 15" to 48" above the finished floor (AFF) and min 12" above or 1.5" below grab bar.	2015 ABAAS Section: 609.3, 609.4 2012 TAS Section: 609.4, 609.3 2010 ADAS Section: 609.3, 609.4

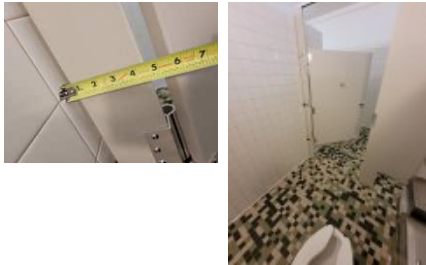
78	Big Pine Camping Area: Big Pine - Women's Restroom	[33.00938, -94.69294]	The compartment door is located too far from the partition or wall. The door shall be located in front of the clear space and diagonal to the water closet. Where located in the front partition, the door opening shall be 4 inches maximum from the side wall or partition farthest from the water closet. Where located in the side wall or partition, the door opening shall be 4 inches maximum from the front partition. Toilet compartment doors shall not swing into the minimum required compartment area.	4.5" from partition	Rehang stall door to be max 4" from adjacent stall partition and on the stall wall farthest from the toilet	2015 ABAAS Section: 604.8.1.2 2012 TAS Section: 604.8.1.2 2010 ADAS Section: 604.8.1.2

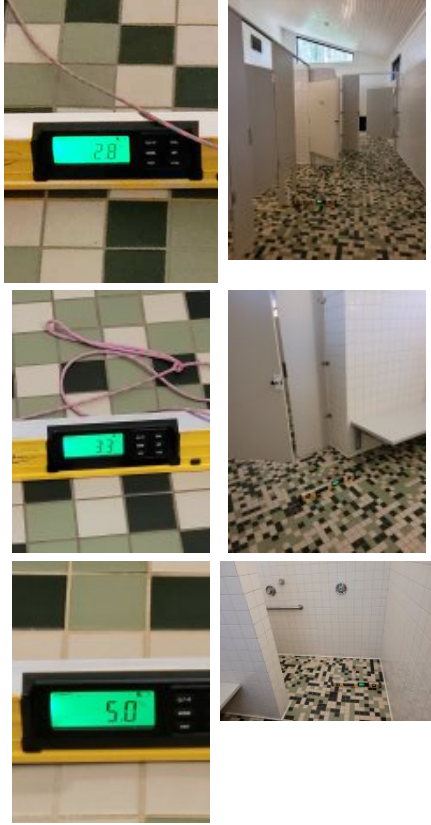
80	Big Pine Camping Area: Big Pine - Women's Restroom	[33.00938, -94.69294]	The accessible route contains running slopes greater than 5 percent and cross slopes greater than 2 percent across the width of the walk and has not been constructed as a ramp (i.e. handrails, wheel guides, etc.). When the slope in the direction of travel of any walk exceeds 1 unit vertical in 20 units horizontal (5-percent slope), it must be constructed as ramp. Surface cross slopes must not exceed one unit vertical in 48 units. Horizontal (2-percent slope).	2.8% cross slope in front of stall, 3.3% cross slope in shower stall by bench, 5% cross in shower	Correct or repair slope to max 2.08% in restroom.	2015 ABAAS Section: 403.3 2012 TAS Section: 403.3 2010 ADAS Section: 403.3

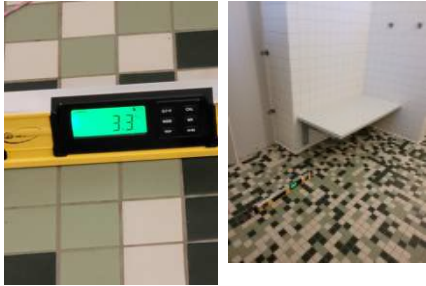
Finding Number	Area Description	Lat/Long	Finding	As Built	Recommendation	Citation	Photos	Figure
81	Big Pine Camping Area: Big Pine - Women's Restroom	[33.00938, -94.69294]	The 30 inches minimum by 48 inches minimum clear floor space required at the operable part is not flat (2% or 1:48 maximum slope) in all directions. Changes in level are not permitted at required clear floor or ground space except that slopes not steeper than 1:48 shall be permitted.	3.3% slope in CFS	Correct or repair slope in CFS to max 2.08%. Cost included in previous finding	2015 ABAAS Section: 305.2 2012 TAS Section: 305.2 2010 ADAS Section: 305.2

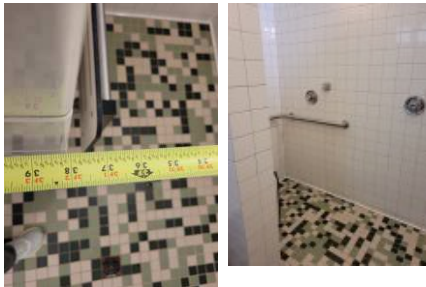
82	Big Pine Camping Area: Big Pine - Women's Restroom	[33.00938, -94.69294]	Alternate roll-in type shower compartments shall be 36 inches (915 mm) wide and 60 inches (1525 mm) deep minimum clear inside dimensions measured at center points of opposing sides. A 36 inch (915 mm) wide minimum entry shall be provided at one end of the long side of the compartment.	shower 38" width	Correct shower stall, if feasible, to compliant dimensions for an alternate roll in shower of 36" deep by 60" wide with a 36" opening on the long dimension	2015 ABAAS Section: 608.2.3 2012 TAS Section: 608.2.3 2010 ADAS Section: 608.2.3

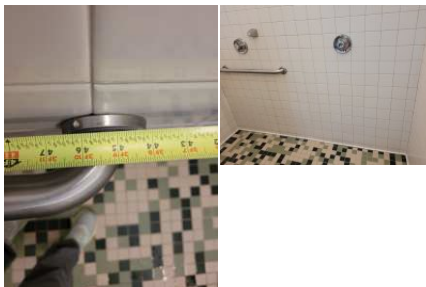
83	Big Pine Camping Area: Big Pine - Women's Restroom	[33.00938, -94.69294]	The grab bar does not extend as required along back of shower In alternate roll-in type shower compartments, grab bars shall be provided on the back wall and the side wall farthest from the compartment entry. Grab bars shall not be provided above the seat. Grab bars shall be installed 6 inches maximum from adjacent walls.	45" from wall on open side	Provide grab bars in the shower mounted in the correct locations for the shower type	2015 ABAAS Section: 608.3.3 2012 TAS Section: 608.3.3 2010 ADAS Section: 608.3.3

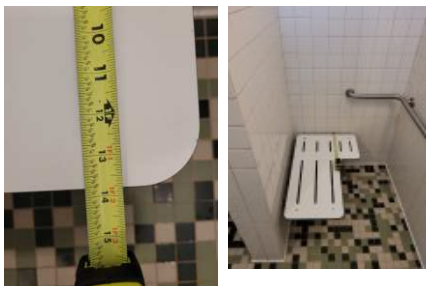
84	Big Pine Camping Area: Big Pine - Women's Restroom	[33.00938, -94.69294]	The shower seat does not have a compliant space between it and the wall. The folding seat must be mounted 17-19 inches above the floor, and have a maximum space of 1-1/2 inches between the edge of the seat and the side wall and 2-1/2 inches maximum to the seat wall.	13.75" from side wall to wide part of L	Remount shower seat to the correct location and height in the shower.	2015 ABAAS Section: 610.3.2 2012 TAS Section: 610.3.2 2010 ADAS Section: 610.3.2

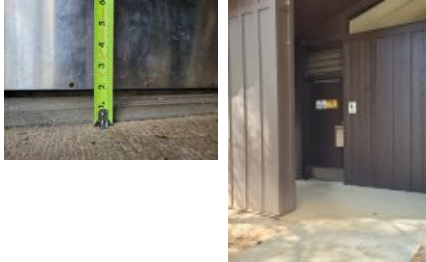
Finding Number	Area Description	Lat/Long	Finding	As Built	Recommendation	Citation	Photos	Figure
85	Big Pine Camping Area: Big Pine - Women's Restroom	[33.00938, -94.69294]	The threshold at a doorway shall be no higher than 1/2 inch. Changes in level between 1/4 inch and 1/2 inch must be beveled at 1:2 or less. 1/4 inch is the maximum vertical rise. Exterior doors are recommended to be maintained at 8.5 lbf as a smart practice. Force is to be measured at the operating hardware or 30 inches from the hinges, whichever is greater.	women's- 13 lbf push, 1" threshold	For all doors along the public circulation route, provide beveled threshold. For all doors along the public circulation route, inspect, adjust, and maintain 8.5 lbf to open exterior doors as a smart practice.	2010 ADAS Section: 404.2.3, 404.2.7, 404.2.4, 404.2.11, 404.2.11 Exception

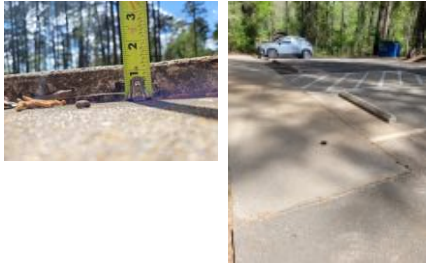
86	Big Pine Camping Area: Big Pine - Women's Restroom	[33.00938, -94.69294]	The walkway contains abrupt vertical edges and/or variations over a 1/4 inch. 1/4 inch is the maximum vertical rise. Changes in level between 1/4 inch and 1/2 inch must be beveled at 1:2 or less. Changes in level greater than 1/2 inch must be by way of a ramp.	1.25" CIL on driver side of accessible stall	Repair, bevel or ramp CIL along AR.	2012 TAS Section: 303.2, 303.3 2010 ADAS Section: 303.2, 303.3

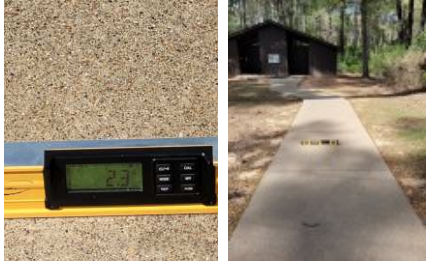
87	Big Pine Camping Area: Big Pine - Women's Restroom	[33.00938, -94.69294]	The accessible route of travel contains cross slopes greater than 2%. Cross slopes shall not exceed one unit vertical in 48 units horizontal (2-percent slope).	2.3% slope in route	Correct or repair cross slope along AR to max 2.08%.	2015 ABAAS Section: 403.3 2012 TAS Section: 403.3 2010 ADAS Section: 403.3

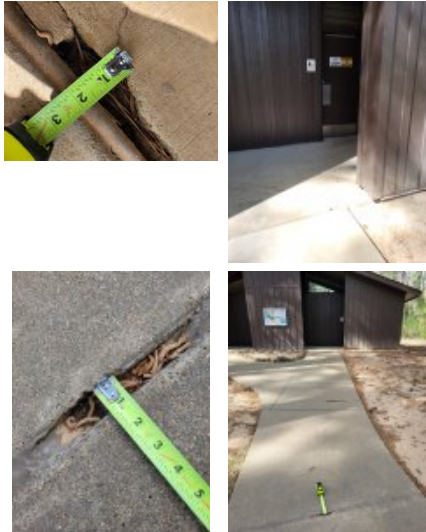
Finding Number	Area Description	Lat/Long	Finding	As Built	Recommendation	Citation	Photos	Figure
88	Big Pine Camping Area: Big Pine - Women's Restroom	[33.00938, -94.69294]	There is a gap spaced greater than a 1/2 inch. Openings in floor or ground surfaces shall not allow passage of a sphere more than 1/2 inch diameter. Elongated openings shall be placed so that the long dimension is perpendicular to the dominant direction of travel.	1.5" gap at women's restroom, 1" gap at fork	Correct or fill gaps to be max .5"	2015 ABAAS Section: 302.3 2012 TAS Section: 302.3 2010 ADAS Section: 302.3

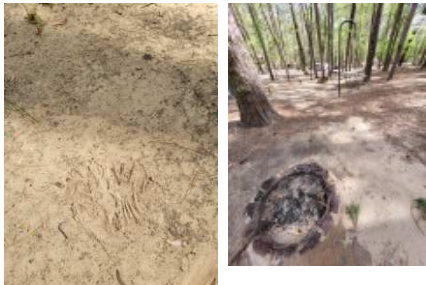
90	Dogwood Camping Area: Dogwood - Sample Campsite	[33.0064559 , -94.691843]	The surface of the outdoor recreation access route, passing spaces, and/or resting intervals are not firm and stable. The surface of outdoor recreation access route, passing spaces, and resting intervals shall be firm and stable, having a width of 36", max gaps of .5" and tread obstacles of .5" or less.	Lacks firm and stable surface	Correct surface of ORAR to be firm and stable, a min 36" wide and having gaps and changes in level of max .5". Cost included in previous finding	2015 ABAAS Section: 1016.2

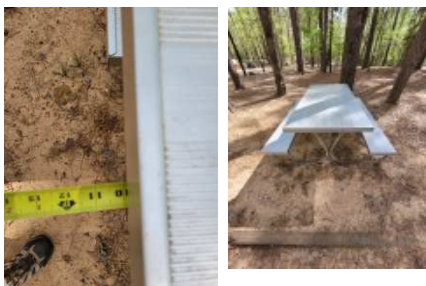
91	Dogwood Camping Area: Dogwood - Sample Campsite	[33.0064537 , -94.691834 9]	Picnic tables shall provide at least one wheelchair space for each 24 linear feet (7320 mm) of usable table surface perimeter. Wheelchair spaces shall be 30 inches (760 mm) minimum by 48 inches (1220 mm) minimum. Wheelchair spaces shall be positioned for a forward approach to the table and provide knee and toe clearance complying with 306 under the table	Lacks knee and toe space, 10" deep to supports	Replace picnic table with one of an accessible design as a smart practice	2015 ABAAS Section: 1011.4.2

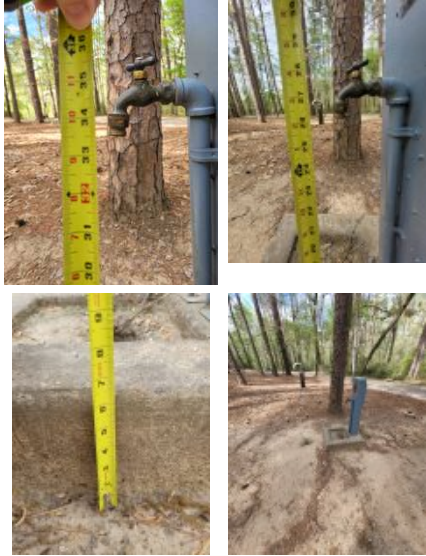
94	Dogwood Camping Area: Dogwood - Sample Campsite	[33.0064537 , -94.691841 6]	Water spouts at water hydrants and water utility hook-ups shall be 28 inches (710 mm) minimum and 36 inches (915 mm) maximum above the ground	34" AGL, 26.5" AGL to pad	Remount water spouts to 28" min or 36" max above the ground as a smart practice	2015 ABAAS Section: 1011.6

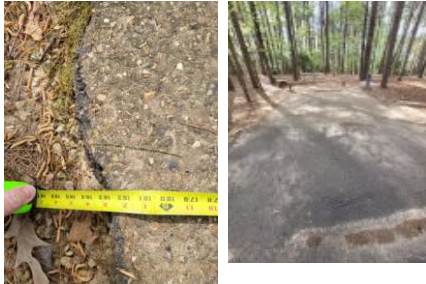
96	Dogwood Camping Area: Dogwood - Sample Campsite	[33.0064526 , -94.691844 3]	Parking spaces and pull-up spaces for recreational vehicles shall be 20 feet (6100 mm) wide minimum. EXCEPTION: Where two adjacent parking spaces are provided for recreational vehicles, one parking space shall be permitted to be 16 feet (4880 mm) wide minimum.	15.5' wide	Correct RV parking space to be 20' wide minimum; or 16' for two adjacent spaces as a smart practice.	2015 ABAAS Section: 1012.2, 1012.2 EXCEPTION

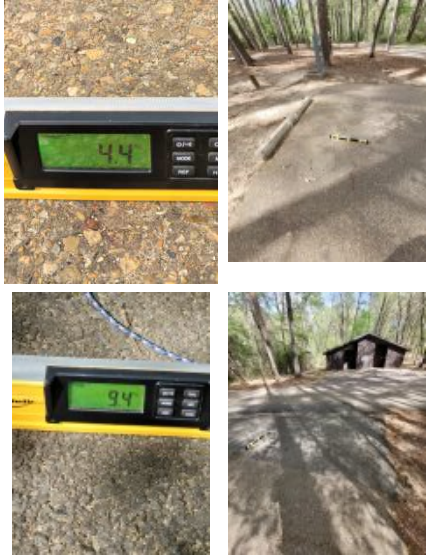
Finding Number	Area Description	Lat/Long	Finding	As Built	Recommendation	Citation	Photos	Figure
97	Dogwood Camping Area: Dogwood - Sample Campsite	[33.0064526 , -94.6918416]	The surface of parking spaces and pull-up spaces shall be firm and stable. The slope of the surface of parking spaces and pull-up spaces shall not be steeper than 1:48 in any direction.	4.4% running slope at top of space, 9.4% at bottom of stall	Correct surface of parking spaces to be firm and stable with slopes max of 2.08%	2015 ABAAS Section: 1012.4, 1012.5, 1012.5 EXCEPTION

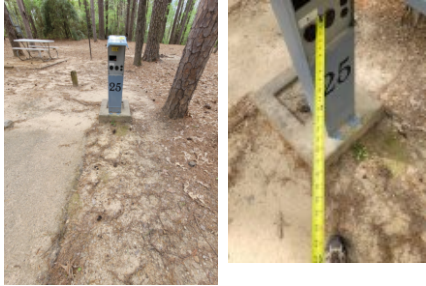
98	Dogwood Camping Area: Dogwood - Sample Campsite	[33.0064492 , -94.6918416]	30 inches (760 mm) by 60 inches (1525 mm) with the long side of the space adjoining or overlapping an accessible parking space or pull-up space for recreational vehicles Locate the space so that the hook-ups are at the rear center of the space. Bollards or other barriers shall not obstruct the clear ground space in front of the hook-ups	Lacks AR, exceeds 20" side/forward reach range	Provide required 30" by 60" clear ground space with hook ups at the rear of the space as a smart practice	2015 ABAAS Section: 1011.2

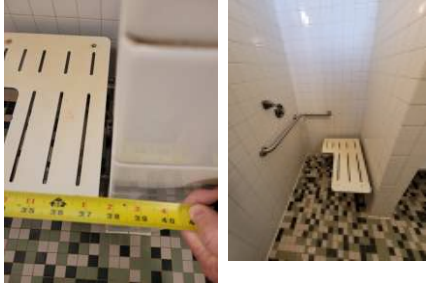
Finding Number	Area Description	Lat/Long	Finding	As Built	Recommendation	Citation	Photos	Figure
100	Dogwood Camping Area: Dogwood - Parking	[33.00636, -94.69165]	Element meets all standards and requirements	Exterior accessible route from parking to restrooms complies	None	2010 ADAS Section: N/A		
101	Dogwood Camping Area: Dogwood - Men's Restroom	[33.006366, -94.691458 1]	It is recommended that exterior doors be maintained so that the operating pressure does not exceed 8.5 lb. force to open.	men's- 10 lbf	For all doors along the public circulation route, inspect, adjust, and maintain 8.5 lbf to open exterior doors as a smart practice	2012 TAS Section: 404.2.9, 404.2.9 Advisory, 404.2.8.1 2010 ADAS Section: 404.2.9, 404.2.8.1		
102	Dogwood Camping Area: Dogwood - Men's Restroom	[33.0063513, -94.691454 1]	Alternate roll-in type shower compartments shall be 36 inches (915 mm) wide and 60 inches (1525 mm) deep minimum clear inside dimensions measured at center points of opposing sides. A 36 inch (915 mm) wide minimum entry shall be provided at one end of the long side of the compartment.	37.75" shower depth	Correct shower stall, if feasible, to compliant dimensions for an alternate roll in shower of 36" deep by 60" wide with a 36" opening on the long dimension	2015 ABAAS Section: 608.2.3 2012 TAS Section: 608.2.3 2010 ADAS Section: 608.2.3
