Access Audit Site Report

Daingerfield State Park

Accessibility Evaluation

Inspection Date: 04/07/2022

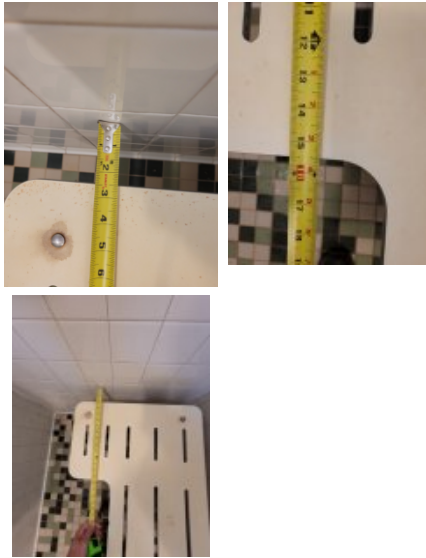
Finding Number	Area Description	Lat/Long	Finding	As Built	Recommendation	Citation	Photos	Figure
104	Dogwood Camping Area: Dogwood - Men's Restroom	[33.0063468 , -94.69145]	The force required to operate the element exceeds the maximum. The force required to activate operable parts is 5 pounds maximum.	controls exceed 8 lbf	Adjust operating mechanism to be usable with 5 LBF or less	2015 ABAAS Section: 309.4 2012 TAS Section: 309.4 2010 ADAS Section: 309.4		
105	Dogwood Camping Area: Dogwood - Men's Restroom	[33.0063513 , -94.6914675]	The shower seat does not have a compliant space between it and the wall. The folding seat must be mounted 17-19 inches above the floor, and have a maximum space of 1-1/2 inches between the edge of the seat and the side wall and 2-1/2 inches maximum to the seat wall.	2.5" rear L, 15" from wall	Remount shower seat to the correct location and height in the shower.	2015 ABAAS Section: 610.3.2 2012 TAS Section: 610.3.2 2010 ADAS Section: 610.3.2

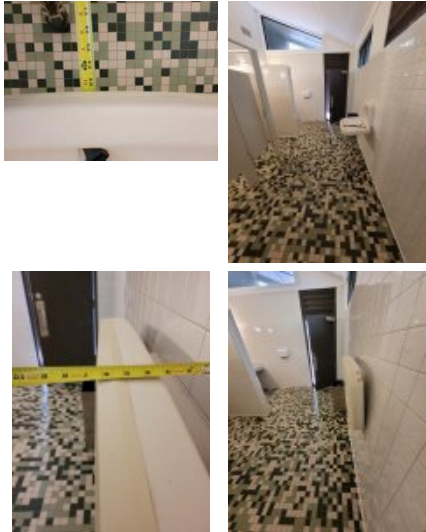
Finding Number	Area Description	Lat/Long	Finding	As Built	Recommendation	Citation	Photos	Figure
108	Dogwood Camping Area: Dogwood - Men's Restroom	[33.00633, -94.691451 4]	The baby changing table is not compliant. Baby changing tables are work surfaces. If fixed or built-in baby changing tables are provided, at least 5%, but not less than one, must comply with TAS 902 based TAS 226.1. Baby changing tables cannot violate the protruding object requirements in either an open or closed position since either position is a potential hazard for persons with visual impairments. Baby changing tables are not prohibited from being located in wheelchair accessible toilet compartments; however, the minimum space required for the compartment cannot be obstructed by the baby changing table in either an open or closed position. The clear floor space required for a baby changing table may overlap the water closet clearance since baby changing tables are considered convenience "fixtures" based on Advisory 604.8.1.1. The overlap is applicable only to the clear floor space and not to actual table itself. Baby changing tables must be dispersed throughout a space, however, an additional baby changing table is not required in a common use area of a toilet or bathing room when the only baby changing table is located in a toilet compartment.	Baby changing table protrudes 23" in open position, 6.5" in closed position	Relocate baby changing table to eliminate protrusion both in the closed and open positions.	2012 TAS Section: 226.1, 902.3, 604.3.2, 204.1, 226.1 Advisory, 226.2, 307.1, 604.8.1.1 Advisory, 902.1, 902.1 Advisory, 902.2

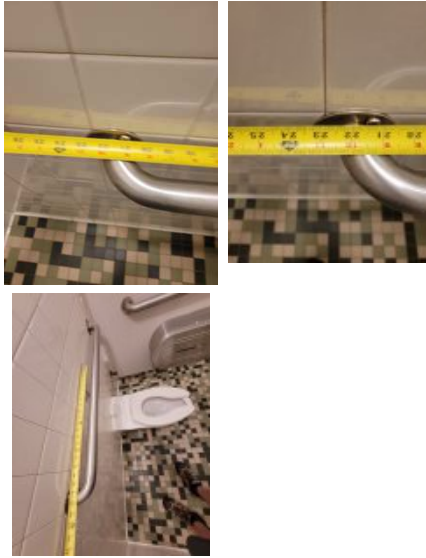
Finding Number	Area Description	Lat/Long	Finding	As Built	Recommendation	Citation	Photos	Figure
110	Dogwood Camping Area: Dogwood - Men's Restroom	[33.0063345 , -94.691456 7]	The rear grab bar is not 36" long or is not mounted in the correct location. The rear grab bar must be a minimum of 36" long and extend from the toilet centerline a minimum 12" towards the wall side and a minimum 24" towards the open side of the toilet. Grab bars shall be installed in a horizontal position, 33 inches minimum and 36 inches maximum above the finish floor measured to the top of the gripping surface and the space between the grab bar and the top of the tank shall be 1-1/2 inches minimum.	rear bar 22" to open side	Remount rear grab bar to behind the toilet, 12" to the wall side of center and 24" to the open side and 33" to 36" AFF	2015 ABAAS Section: 604.5.2 2012 TAS Section: 604.5.2 2010 ADAS Section: 604.5.2

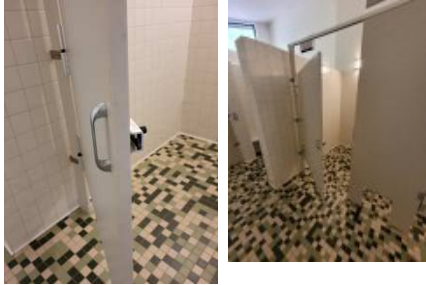
Finding Number	Area Description	Lat/Long	Finding	As Built	Recommendation	Citation	Photos	Figure
113	Dogwood Camping Area: Dogwood - Men's Restroom	[33.0063322 , -94.691459 4]	The stall door fails to comply with some of the door requirements. The stall door must have compliant hardware on both sides. The stall door must be self-closing.	Stall door lacks auto close	Adjust stall door to be self-closing	2015 ABAAS Section: 404.2.3, 404.2.7, 604.8.2.2 2012 TAS Section: 404.2.3, 404.2.7, 604.8.2.2 2010 ADAS Section: 404.2.3, 404.2.7, 604.8.2.2

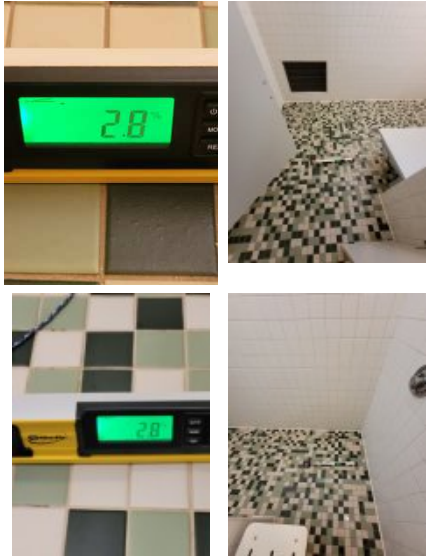
Finding Number	Area Description	Lat/Long	Finding	As Built	Recommendation	Citation	Photos	Figure
116	Dogwood Camping Area: Dogwood - Men's Restroom	[33.0063277 , -94.691459 4]	The accessible route contains running slopes greater than 5 percent and cross slopes greater than 2 percent across the width of the walk and has not been constructed as a ramp (i.e. handrails, wheel guides, etc.). When the slope in the direction of travel of any walk exceeds 1 unit vertical in 20 units horizontal (5-percent slope), it must be constructed as ramp. Surface cross slopes must not exceed one unit vertical in 48 units. Horizontal (2-percent slope).	2.8% slope at bench CFS/floor drain at shower, 2.8% slope at shower drain	Correct or repair slope to max 2.08% in restroom.	2015 ABAAS Section: 403.3 2012 TAS Section: 403.3 2010 ADAS Section: 403.3

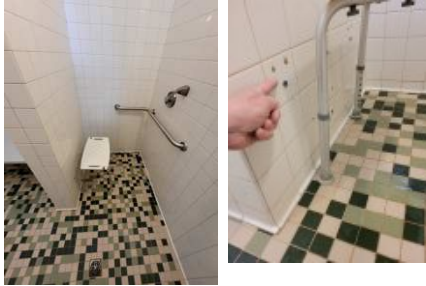
120	Dogwood Camping Area: Dogwood - Women's Restroom	[33.00633, -94.6914701]	The operable parts of controls are incorrectly installed. In alternate roll-in type shower compartments, the controls, faucets, and shower spray unit shall be located above the grab bar, but no higher than 48 inches (1220 mm) above the shower floor. Where a seat is provided, the controls, faucets, and shower spray unit shall be located on the side wall adjacent to the seat 27 inches (685 mm) maximum from the side wall behind the seat or shall be located on the back wall opposite the seat 15 inches (380 mm) maximum, left or right, of the centerline of the seat. Where a seat is not provided, the controls, faucets, and shower spray unit shall be installed on the side wall farthest from the compartment entry.	controls on wrong wall without permanent seat	Remount shower controls to the correct location in the alternate shower based on whether or not the shower includes a seat	2015 ABAAS Section: 608.5.3 2012 TAS Section: 608.5.3 2010 ADAS Section: 608.5.3

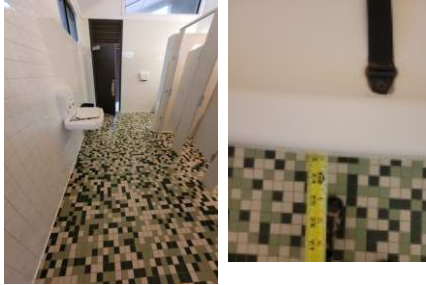
Finding Number	Area Description	Lat/Long	Finding	As Built	Recommendation	Citation	Photos	Figure
124	Dogwood Camping Area: Dogwood - Women's Restroom	[33.0063322 , -94.691472 8]	The baby changing table is not compliant. Baby changing tables are work surfaces. If fixed or built-in baby changing tables are provided, at least 5%, but not less than one, must comply with TAS 902 based TAS 226.1. Baby changing tables cannot violate the protruding object requirements in either an open or closed position since either position is a potential hazard for persons with visual impairments. Baby changing tables are not prohibited from being located in wheelchair accessible toilet compartments; however, the minimum space required for the compartment cannot be obstructed by the baby changing table in either an open or closed position. The clear floor space required for a baby changing table may overlap the water closet clearance since baby changing tables are considered convenience "fixtures" based on Advisory 604.8.1.1. The overlap is applicable only to the clear floor space and not to actual table itself. Baby changing tables must be dispersed throughout a space, however, an additional baby changing table is not required in a common use area of a toilet or bathing room when the only baby changing table is located in a toilet compartment.	Baby changing table protrudes 23" into route	Relocate baby changing table to eliminate protrusion when in the open position.	2012 TAS Section: 226.1, 902.3, 604.3.2, 204.1, 226.1 Advisory, 226.2, 307.1, 604.8.1.1 Advisory, 902.1, 902.1 Advisory, 902.2

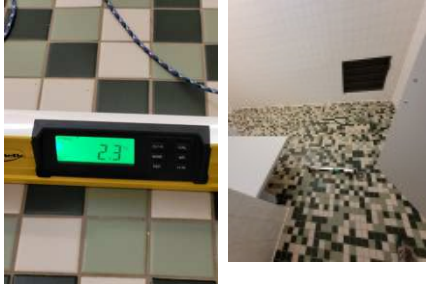
Finding Number	Area Description	Lat/Long	Finding	As Built	Recommendation	Citation	Photos	Figure
126	Dogwood Camping Area: Dogwood - Women's Restroom	[33.0063322 , -94.691451 4]	The accessible route contains running slopes greater than 5 percent and cross slopes greater than 2 percent across the width of the walk and has not been constructed as a ramp (i.e. handrails, wheel guides, etc.). When the slope in the direction of travel of any walk exceeds 1 unit vertical in 20 units horizontal (5-percent slope), it must be constructed as ramp. Surface cross slopes must not exceed one unit vertical in 48 units. Horizontal (2-percent slope).	2.3% slope at bench CFS/floor drain at accessible shower	Correct or repair slope to max 2.08% in restroom.	2015 ABAAS Section: 403.3 2012 TAS Section: 403.3 2010 ADAS Section: 403.3

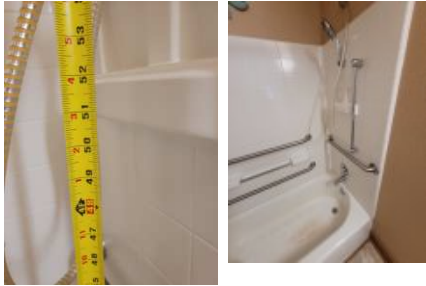
Finding Number	Area Description	Lat/Long	Finding	As Built	Recommendation	Citation	Photos	Figure
128	Cabins: Cabin - Cabin 3	[33.0091607 , -94.696479 2]	The operable part is positioned too high for either a side or front approach. Where a clear floor or ground space allows a parallel approach to an element and the side reach is unobstructed, the high side reach shall be 48 inches maximum and the low side reach shall be 15 inches minimum above the finish floor or ground. Where a forward reach is unobstructed, the high forward reach shall be 48 inches maximum and the low forward reach shall be 15 inches minimum above the finish floor or ground.	Cabin 3- 52" AFF to soap dish	Install soap dish to be in reach range of 15" min to 48" max	2015 ABAAS Section: 308.1 2012 TAS Section: 308.1 2010 ADAS Section: 308.1

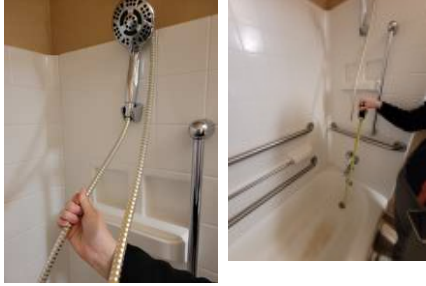
129	Cabins: Cabin - Cabin 3	[33.0091843 , -94.696481 9]	The hand held sprayer unit is mounted too high. The sprayer unit must have a 59 inches hose and be mounted 48 inches maximum to the top of mounting bracket off the floor. The shower spray unit shall have an on/off control with a non-positive shutoff. If an adjustable-height shower head on a vertical bar is used, the bar shall be installed so as not to obstruct the use of grab bars.	shower spray mount too high	Lower shower controls to max 48" aff	2015 ABAAS Section: 608.6 2012 TAS Section: 608.6 2010 ADAS Section: 608.6

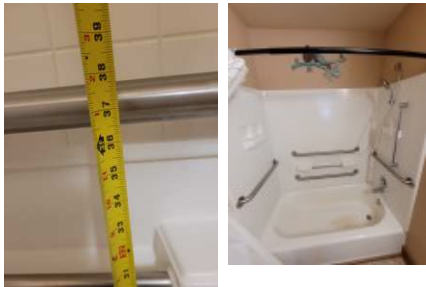
130	Cabins: Cabin - Cabin 3	[33.0091326 , -94.696461 7]	The top grab bar is not located correctly. Two grab bars shall be installed on the back wall, one installed in a horizontal position, 33 inches minimum and 36 inches maximum above the finish floor measured to the top of the gripping surface and the other located 8 inches minimum and 10 inches maximum above the rim of the bathtub. Each grab bar shall be installed 15 inches maximum from the head end wall and 12 inches maximum from the control end wall.	back wall top grab bar 37.75"	Remount top grab bar on back wall to a height min 33" and max 36" aff, mounted max 12" from control wall and max 24" from head wall	2015 ABAAS Section: 607.4.1.1 , 607.4.2.1 2012 TAS Section: 607.4.1.1, 607.4.2.1 2010 ADAS Section: 607.4.2.1, 607.4.1.1

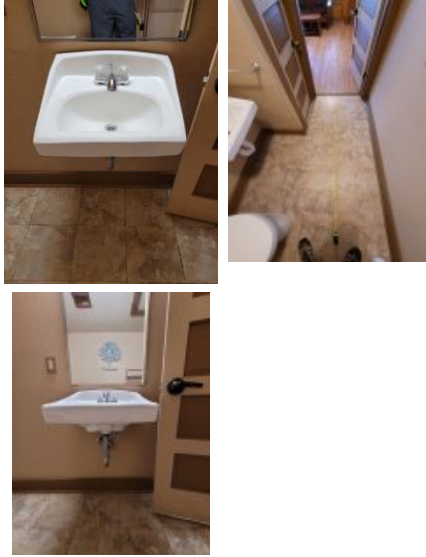
Finding Number	Area Description	Lat/Long	Finding	As Built	Recommendation	Citation	Photos	Figure
131	Cabins: Cabin - Cabin 3	[33.0091652 , -94.696479 2]	The faucet controls require twisting of the wrist. Faucet controls and operating mechanisms shall be operable with one hand and shall not require tight grasping, pinching or twisting of the wrist. The force required to activate controls shall be no greater than 5 lb. Lever-operated, push-type and electronically controlled mechanisms are examples of acceptable designs. Self-closing valves are allowed if the faucet remains open for at least 10 seconds.	Knobs on sink in restroom #2 (without tub)	Replace faucet controls with lever controls	2015 ABAAS Section: 606.4 2012 TAS Section: 606.4 2010 ADAS Section: 606.4

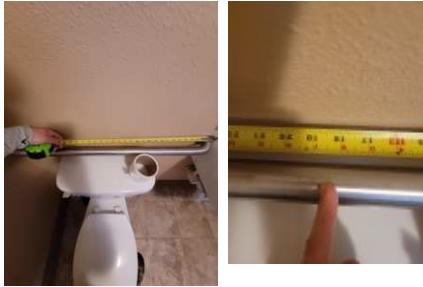
135	Cabins: Cabin - Cabin 3	[33.0091405 , -94.696485 9]	The rear grab bar is not 36" long or is not mounted in the correct location. The rear grab bar must be a minimum of 36" long and extend from the toilet centerline a minimum 12" towards the wall side and a minimum 24" towards the open side of the toilet. Grab bars shall be installed in a horizontal position, 33 inches minimum and 36 inches maximum above the finish floor measured to the top of the gripping surface and the space between the grab bar and the top of the tank shall be 1-1/2 inches minimum.	18.5" to centerline of toilet	Remount rear grab bar to behind the toilet, 12" to the wall side of center and 24" to the open side and 33" to 36" AFF	2015 ABAAS Section: 604.5.2 2012 TAS Section: 604.5.2 2010 ADAS Section: 604.5.2

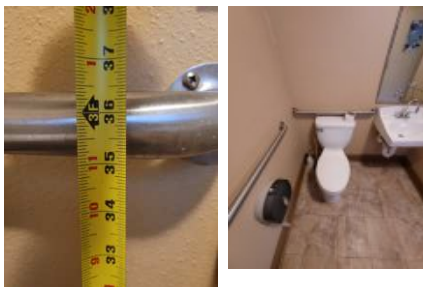
136	Cabins: Cabin - Cabin 3	[33.0091472 , -94.696488 6]	The grab bar height and/or spacing fails. Grab bars must be mounted between 33" and 36" to the top of the gripping surface. There must be 1.5" of clearance between the grab bar and the wall. There must be a minimum of 1.5" of clearance below and minimum 12" above the grab bar to any dispenser or other obstruction.	36.5" to top of bar	Remount grab bars in accessible stall to 33" to 36" above the finished floor (AFF).	2015 ABAAS Section: 609.3, 609.4 2012 TAS Section: 609.4, 609.3 2010 ADAS Section: 609.3, 609.4

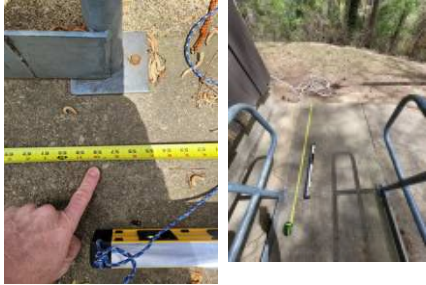
Finding Number	Area Description	Lat/Long	Finding	As Built	Recommendation	Citation	Photos	Figure
140	Cabins: Cabin - Cabin 3	[33.0091337 , -94.696473 8]	The landing is not the correct length. Landings shall have a dimension in the direction of ramp run of not less than 60 inches.	58" long landing	Enlarge landing to be 60" deep and as wide as the ramp	2015 ABAAS Section: 405.7.3 2012 TAS Section: 405.7.3 2010 ADAS Section: 405.7.3

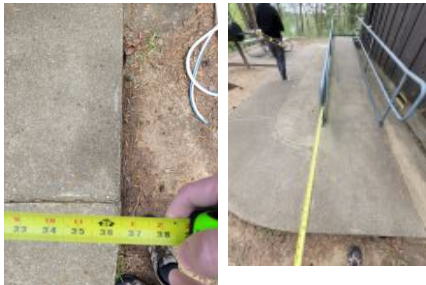
141	Cabins: Cabin - Cabin 3	[33.0091405 , -94.696457 7]	The landing at the change of direction is not the correct size. Landings at a change of direction shall have a dimension in the direction of ramp run of not less than 60 inches by 60 inches.	37" clear at turn	Enlarge landing on ramp where directions change to 60" by 60"	2015 ABAAS Section: 405.7.4 2012 TAS Section: 405.7.4 2010 ADAS Section: 405.7.4

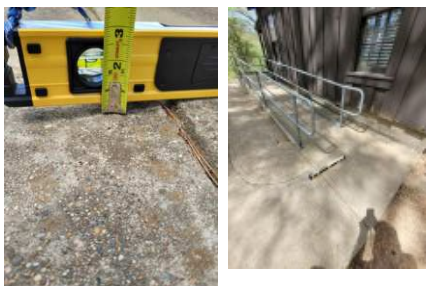
142	Cabins: Cabin - Cabin 3	[33.0091416 , -94.696479 2]	There is a change in level greater than 1/4 inch. 1/4 inch is the maximum vertical rise. Changes in level between 1/4 inch and 1/2 inch must be beveled at 1:2 or less. Changes in level greater than 1/2 inch must be by way of a ramp.	.5" CIL at bottom landing	Repair, bevel or ramp CIL along accessible route (AR) to max .25".	2015 ABAAS Section: 303.3 2012 TAS Section: 303.3 2010 ADAS Section: 303.3

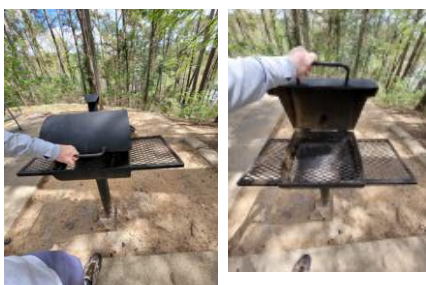
143	Cabins: Cabin - Cabin 3	[33.00907, -94.69643]	The force required to operate the element exceeds the maximum. The force required to activate operable parts is 5 pounds maximum.	Force to lift grill cover exceeds gauge reading	Adjust operating mechanism to be usable with 5 lbf or less	2015 ABAAS Section: 309.4 2012 TAS Section: 309.4 2010 ADAS Section: 309.4

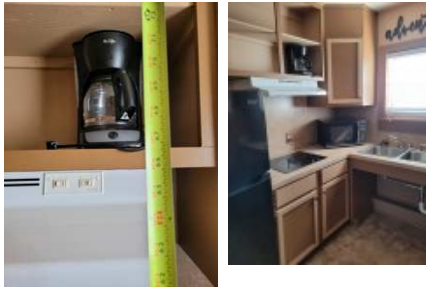
149	Cabins: Cabin - Cabin 3	[33.0091461 , -94.6964738]	The operable part is positioned too high for either a side or front approach. Where a clear floor or ground space allows a parallel approach to an element and the side reach is unobstructed, the high side reach shall be 48 inches maximum and the low side reach shall be 15 inches minimum above the finish floor or ground. Where a forward reach is unobstructed, the high forward reach shall be 48 inches maximum and the low forward reach shall be 15 inches minimum above the finish floor or ground.	Hood controls 65" AFF, coffee pot 67" AFF	Remount operable parts to be in reach range of 15" min to 48" max	2015 ABAAS Section: 308.1 2012 TAS Section: 308.1 2010 ADAS Section: 308.1

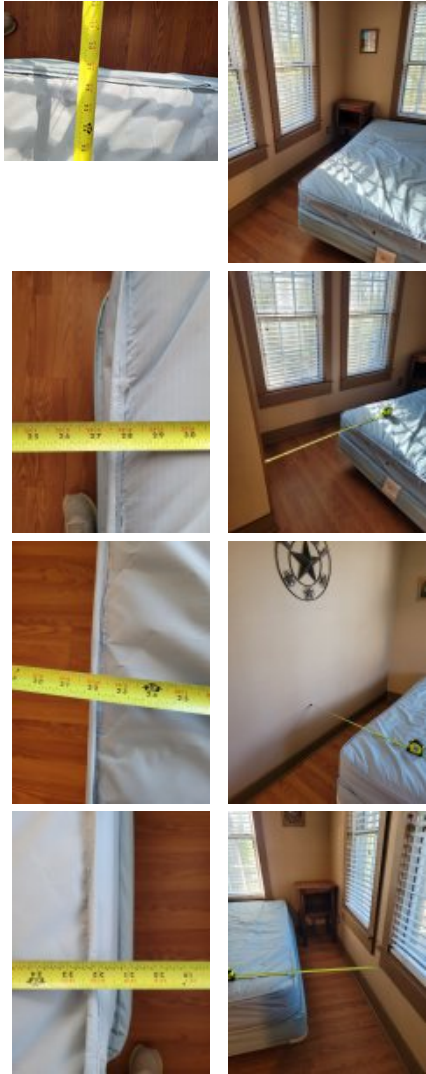
Finding Number	Area Description	Lat/Long	Finding	As Built	Recommendation	Citation	Photos	Figure
150	Cabins: Cabin - Cabin 3	[33.0091393 , -94.6964698]	The route of travel at this location does not provide a minimum width of 36 inches. The clear width shall be permitted to be reduced to 32 inches minimum for a length of 24 inches maximum provided that reduced width segments are separated by segments that are 48 inches long minimum and 36 inches wide minimum.	Kitchen bedroom - 21" to bedside table, 27" between bed and closet space, entry facing bedroom - 22" on wall side, 22" to night stand on window side	Widen AR by removing or relocating furniture to compliant 36" clear width	2015 ABAAS Section: 403.5.1 2012 TAS Section: 403.5.1 2010 ADAS Section: 403.5.1

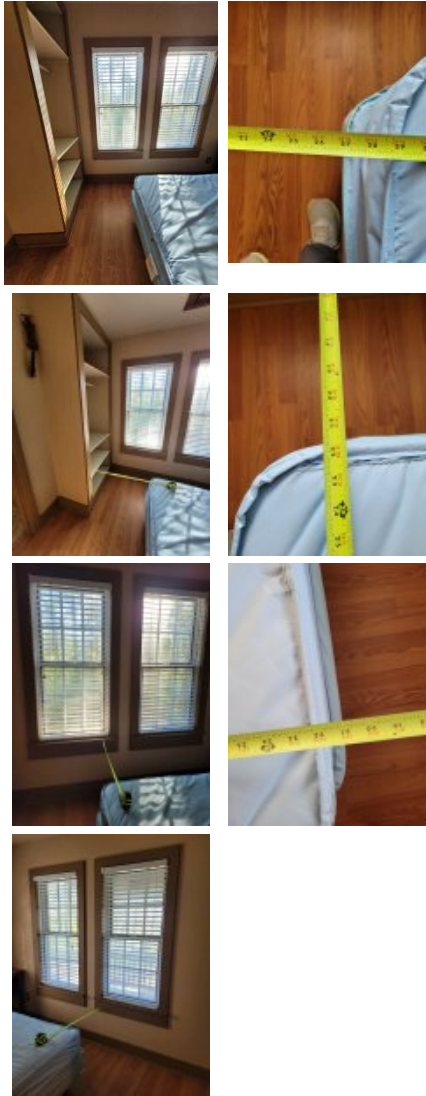
Finding Number	Area Description	Lat/Long	Finding	As Built	Recommendation	Citation	Photos	Figure
151	Cabins: Cabin - Cabin 3	[33.0091517 , -94.6964725]	The operable part is not accessible because there is not adequate clear floor space for either a forward or side approach. The clear floor or ground space shall be 30 inches minimum by 48 inches minimum.	Kitchen bedroom - CFS for closet reduced to 27" by bed, window CFS is 21.5" due to bed, entry bedroom - 21" CFS at window	Remove, or relocate furniture in CFS at fixtures and operable parts along the AR Provide required 30" by 48" CFS at operable parts	2015 ABAAS Section: 305.3 2012 TAS Section: 305.3 2010 ADAS Section: 305.3

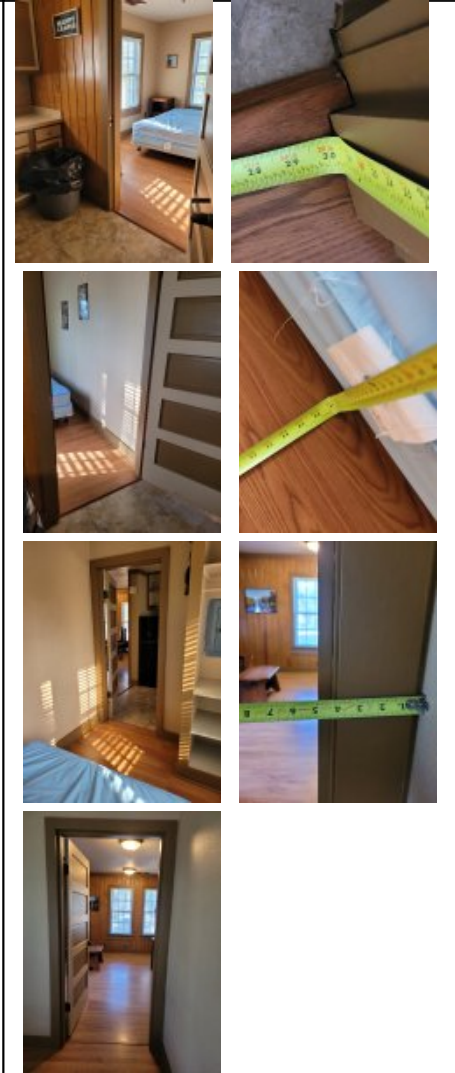
Finding Number	Area Description	Lat/Long	Finding	As Built	Recommendation	Citation	Photos	Figure
152	Cabins: Cabin - Cabin 3	[33.0091472 , -94.696473 8]	The operable part is positioned too high for either a side or front approach. Where a clear floor or ground space allows a parallel approach to an element and the side reach is unobstructed, the high side reach shall be 48 inches maximum and the low side reach shall be 15 inches minimum above the finish floor or ground. Where a forward reach is unobstructed, the high forward reach shall be 48 inches maximum and the low forward reach shall be 15 inches minimum above the finish floor or ground.	Kitchen bedroom - clothing rod is 62" AFF. entry bedroom - hanging rod 67" AFF, blind controls closest to closet space is 52" AFF	Remount operable parts to be in reach range of 15" min to 48" max	2015 ABAAS Section: 308.1 2012 TAS Section: 308.1 2010 ADAS Section: 308.1

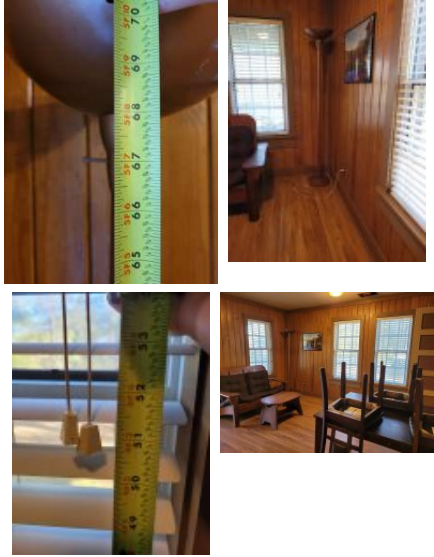
Finding Number	Area Description	Lat/Long	Finding	As Built	Recommendation	Citation	Photos	Figure
154	Cabins: Cabin - Cabin 3	[33.009145, -94.696476 5]	The operable part is positioned too high for either a side or front approach. Where a clear floor or ground space allows a parallel approach to an element and the side reach is unobstructed, the high side reach shall be 48 inches maximum and the low side reach shall be 15 inches minimum above the finish floor or ground. Where a forward reach is unobstructed, the high forward reach shall be 48 inches maximum and the low forward reach shall be 15 inches minimum above the finish floor or ground.	Light 67" AFF, window controls 51" AFF	Remount blind control to be in reach range of 15" min to 48" max Replace light to maintain 80" AFF overhead clearance	2015 ABAAS Section: 308.1 2012 TAS Section: 308.1 2010 ADAS Section: 308.1

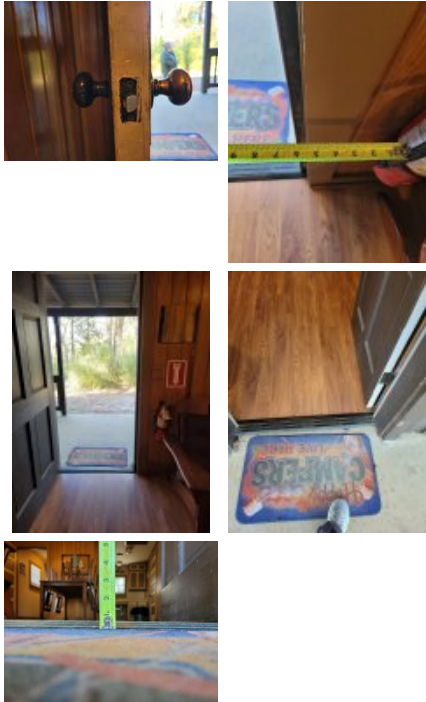
Finding Number	Area Description	Lat/Long	Finding	As Built	Recommendation	Citation	Photos	Figure																																																																																																																																																																																																										
155	Cabins: Cabin - Cabin 3	[33.009145, -94.696473 8]	Minimum maneuvering clearances at doors and gates shall comply with 404.2.4. Maneuvering clearances shall extend the full width of the doorway and the required latch side or hinge side clearance. The threshold has a vertical change greater than 1/4 inch high. The threshold at a doorway shall be no higher than 1/2 inch. Changes in level between 1/4 inch and 1/2 inch must be beveled at 1:2 or less. 1/4 inch is the maximum vertical rise. Hand-activated door opening hardware, handles, pulls, latches, locks, and other operating devices on accessible doors shall have a shape that is easy to grasp with one hand and does not require tight grasping, tight pinching or twisting of the wrist to operate. Hardware shall be 34 inches minimum and 48 inches maximum above the finish floor or ground.	Entry door - knob, 6" MC on pull due to fire extinguisher, slip rug on exterior, .5" threshold	For all doors along the public circulation route, relocate fire extinguisher to provide required maneuvering clearance on push and pull side of doors. For all doors along the public circulation route, secure rug in door clearance to prevent trip hazard. For all doors along the public circulation route, repair, bevel, or ramp CILs at door entries to max .25". For all doors along the public circulation route, repair, provide beveled threshold. For all doors along the public circulation route, replace hardware with lever hardware or hardware operable without a tight pinch or grasp.	2010 ADAS Section: 404.2.3, 404.2.7, 404.2.4, 404.2.11, 404.2.11 Exception

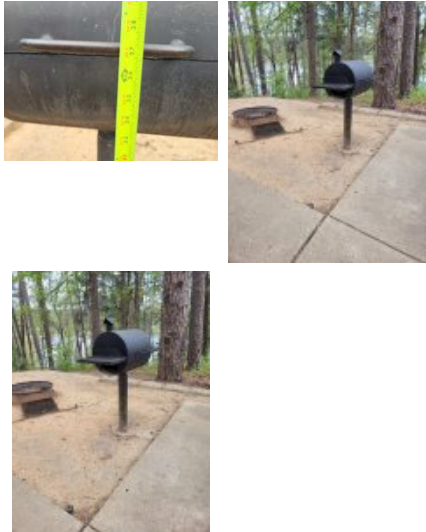
Finding Number	Area Description	Lat/Long	Finding	As Built	Recommendation	Citation	Photos	Figure
161	Cabins: Cabin - Cabin 3	[33.0090696 , -94.696437 6]	Where provided, cooking surfaces shall be 15 inches (380 mm) minimum and 34 inches (865 mm) maximum above the ground	Grill cooking surface at 37" AGL	Raise or lower cooking surface to be 15" min to 34" max above the ground; in the alternative, replace with a compliant surface as a smart practice	2015 ABAAS Section: 1011.5.2

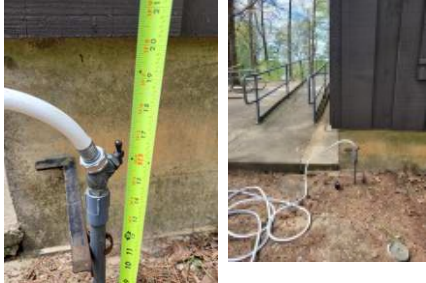
162	Cabins: Cabin - Cabin 3	[33.0090797 , -94.696452 4]	Water spouts at water hydrants and water utility hook-ups shall be 28 inches (710 mm) minimum and 36 inches (915 mm) maximum above the ground	Water spout 17" AGL	Remount water spouts to 28" min or 36" max above the ground as a smart practice	2015 ABAAS Section: 1011.6

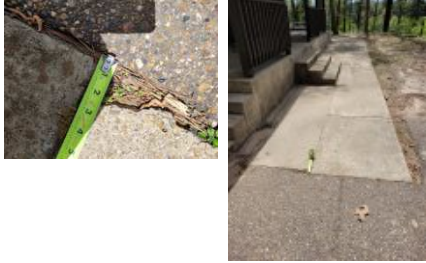
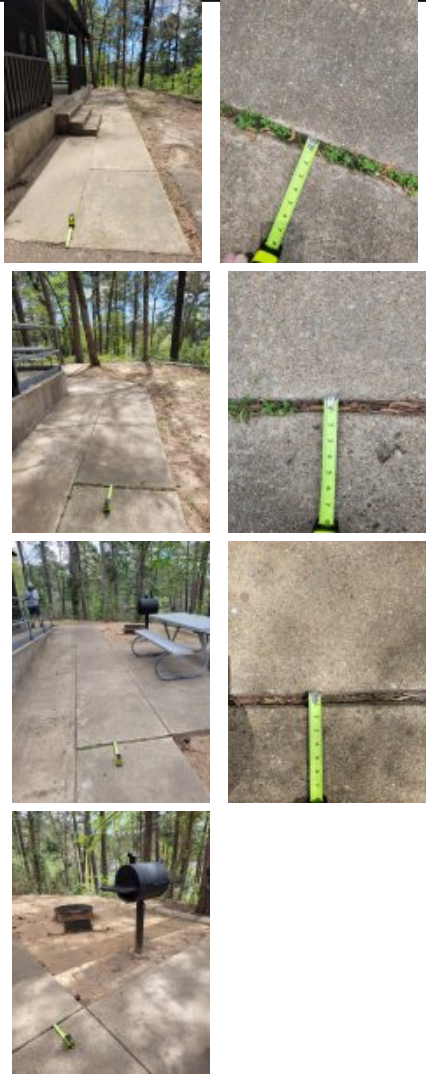
163	Cabins: Cabin - Cabin 3	[33.0091078 , -94.696518 1]	There is a gap spaced greater than a 1/2 inch. Openings in floor or ground surfaces shall not allow passage of a sphere more than 1/2 inch diameter. Elongated openings shall be placed so that the long dimension is perpendicular to the dominant direction of travel.	2.5" gap at entry, 1.5" gap before turn, 1.25" gap before table, 1.25" gap by grill	Correct or fill gaps to be max .5"	2015 ABAAS Section: 302.3 2012 TAS Section: 302.3 2010 ADAS Section: 302.3

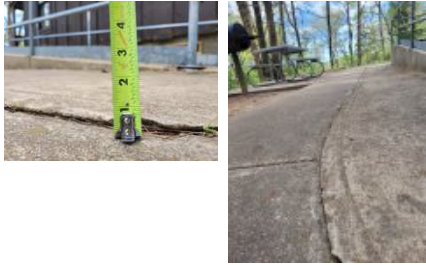
Finding Number	Area Description	Lat/Long	Finding	As Built	Recommendation	Citation	Photos	Figure
164	Cabins: Cabin - Cabin 3	[33.0091326 , -94.696538 2]	The walkway contains abrupt vertical edges and/or variations over a 1/4 inch. 1/4 inch is the maximum vertical rise. Changes in level between 1/4 inch and 1/2 inch must be beveled at 1:2 or less. Changes in level greater than 1/2 inch must be by way of a ramp.	.75" CIL by ramp	Repair, bevel or ramp CIL along AR.	2012 TAS Section: 303.2, 303.3 2010 ADAS Section: 303.2, 303.3

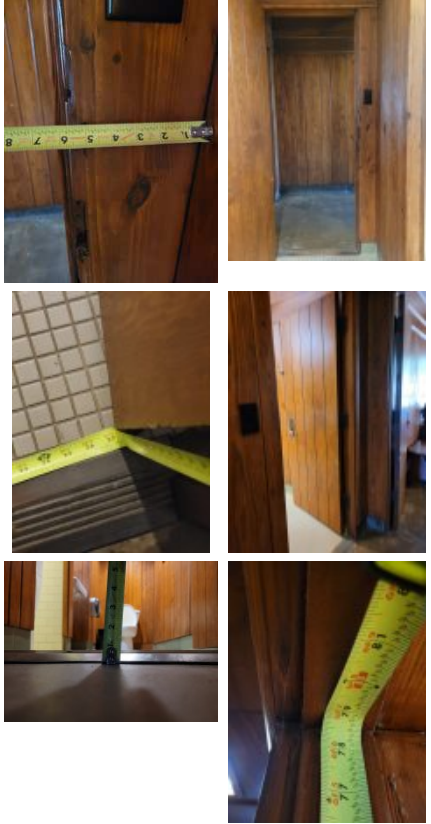
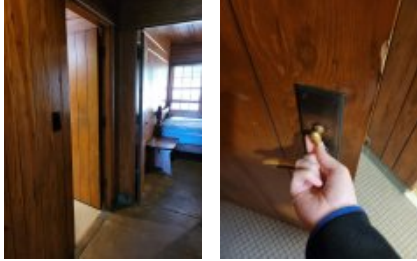
166	Group Lodge: Group Lodge Inaccessible Restroom	[33.008667, -94.696485 9]	Minimum maneuvering clearances at doors and gates shall comply with 404.2.4. Maneuvering clearances shall extend the full width of the doorway and the required latch side or hinge side clearance. Maneuvering clearances shall have a max slope of 2.08%. Door openings shall provide a clear width of 32 inches (815 mm) minimum. Clear openings of doorways with swinging doors shall be measured between the face of the door and the stop, with the door open 90 degrees. Openings more than 24 inches (610 mm) deep shall provide a clear opening of 36 inches (915 mm) minimum. There shall be no projections into the required clear opening width lower than 34 inches (865 mm) above the finish floor or ground. Projections into the clear opening width between 34 inches (865 mm) and 80 inches (2030 mm) above the finish floor or ground shall not exceed 4 inches (100 mm). The threshold has a vertical change greater than 1/4 inch high. The threshold at a doorway shall be no higher than 1/2 inch. Changes in level between 1/4 inch and 1/2 inch must be beveled at 1:2 or less. 1/4 inch is the maximum vertical rise. Hand-activated door opening hardware, handles, pulls, latches, locks, and other operating devices on accessible doors shall have a shape that is easy to grasp with one hand and does not require tight grasping, tight pinching or twisting of the wrist to operate. Hardware shall be 34 inches minimum and 48 inches maximum above the finish floor or ground.	inaccessible restroom- maneuvering clearance on pull side 6.25", 27" width, .75" CIL, 78.5" AFF overhead, hardware requires pinch	For all doors along the public circulation route, provide required maneuvering clearance on push and pull side of doors. For all doors along the public circulation route, replace doors with doors having 80" overhead clearance and 32" clear width. For all doors along the public circulation route, repair, bevel, or ramp CILs at door entries to max .25". For all doors along the public circulation route, replace hardware with lever hardware or hardware operable without a tight pinch or grasp.	2010 ADAS Section: 404.2.3, 404.2.7, 404.2.4, 404.2.11, 404.2.11 Exception

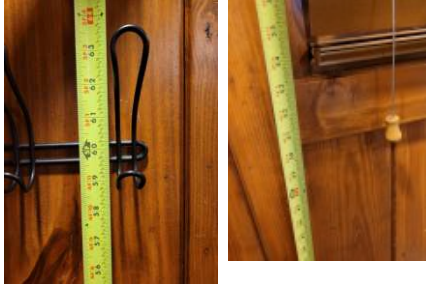
171	Group Lodge: Group Lodge Accessible Restroom	[33.0086557 , -94.69651]	The operable part is positioned too high for either a side or front approach. Where a clear floor or ground space allows a parallel approach to an element and the side reach is unobstructed, the high side reach shall be 48 inches maximum and the low side reach shall be 15 inches minimum above the finish floor or ground. Where a forward reach is unobstructed, the high forward reach shall be 48 inches maximum and the low forward reach shall be 15 inches minimum above the finish floor or ground.	Hook behind doors 59" AFF, Window 50" AFF	Remount operable parts to be in reach range of 15" min to 48" max	2015 ABAAS Section: 308.1 2012 TAS Section: 308.1 2010 ADAS Section: 308.1

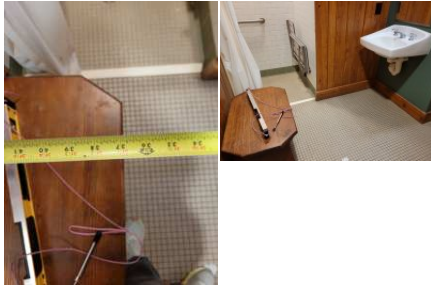
Finding Number	Area Description	Lat/Long	Finding	As Built	Recommendation	Citation	Photos	Figure
172	Group Lodge: Group Lodge Accessible Restroom	[33.0086524 , -94.696522 1]	The operable part is not accessible because there is not adequate clear floor space for either a forward or side approach. The clear floor or ground space shall be 30 inches minimum by 48 inches minimum.	Bench in back CFS 37"	Relocate furniture to provide required 30" by 48" CFS at operable parts	2015 ABAAS Section: 305.3 2012 TAS Section: 305.3 2010 ADAS Section: 305.3

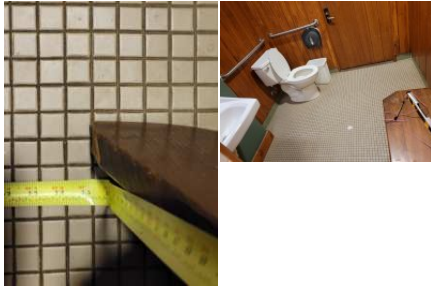
173	Group Lodge: Group Lodge Accessible Restroom	[33.0086557 , -94.696512 7]	The required 56 inches by 60 inches clear floor space for the water closet has been obstructed. The clear floor space around the water closet shall be 60 inches minimum measured perpendicular from the side wall and 56 inches minimum measured perpendicular from the rear wall.	bench in CFS 57"	Relocate bench to provide required 60" clearance around toilet	2015 ABAAS Section: 604.3. 2012 TAS Section: 604.3.1 2010 ADAS Section: 604.3.1

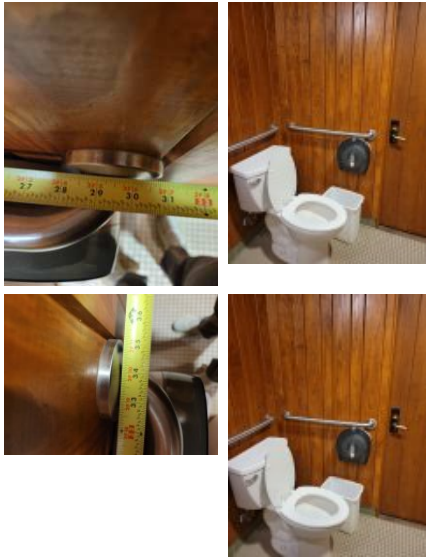
174	Group Lodge: Group Lodge Accessible Restroom	[33.0086636 , -94.696523 4]	The side grab bars are not in the correct location. Grab bars on the side wall must be installed so that the end closest to the rear wall is maximum 12" from the rear wall. The end furthest from the rear wall must be mounted minimum 54" from the rear wall.	30" grab bar, extends 33.5" from rear wall to grab bar end	Replace side grab bar with a 42" long bar mounted to max 12" from the rear wall at the close end and min 54" on the far end, and 33" to 36" AFF	2015 ABAAS Section: 604.5.1 2012 TAS Section: 604.5.1 2010 ADAS Section: 604.5.1

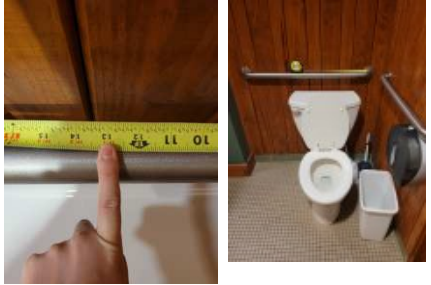
Finding Number	Area Description	Lat/Long	Finding	As Built	Recommendation	Citation	Photos	Figure
175	Group Lodge: Group Lodge Accessible Restroom	[33.0086569 , -94.696508 7]	The rear grab bar is not 36" long or is not mounted in the correct location. The rear grab bar must be a minimum of 36" long and extend from the toilet centerline a minimum 12" towards the wall side and a minimum 24" towards the open side of the toilet. Grab bars shall be installed in a horizontal position, 33 inches minimum and 36 inches maximum above the finish floor measured to the top of the gripping surface and the space between the grab bar and the top of the tank shall be 1-1/2 inches minimum.	13" centerline of toilet, lacks 24" to open side	Remount rear grab bar to behind the toilet, 12" to the wall side of center and 24" to the open side and 33" to 36" AFF	2015 ABAAS Section: 604.5.2 2012 TAS Section: 604.5.2 2010 ADAS Section: 604.5.2

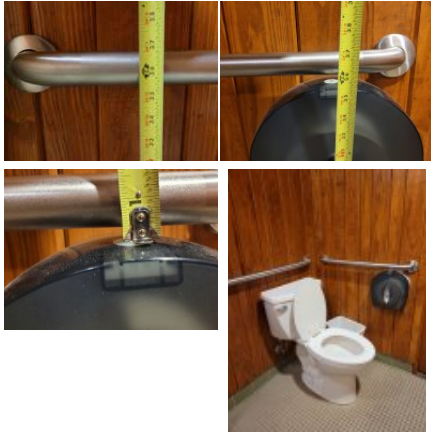
176	Group Lodge: Group Lodge Accessible Restroom	[33.0086422 , -94.696512 7]	The grab bar height and/or spacing fails. Grab bars must be mounted between 33" and 36" to the top of the gripping surface. There must be 1.5" of clearance between the grab bar and the wall. There must be a minimum of 1.5" of clearance below and minimum 12" above the grab bar to any dispenser or other obstruction.	Back grab bar 36.5" AFF, side grab bar 37" AFF. Toilet paper dispenser allows .5" clearance	Remount grab bars in accessible stall to 33" to 36" above the finished floor (AFF). Remount toilet paper dispenser max 7" to 9" from front of toilet, 15" to 48" above the finished floor (AFF) and min 12" above or 1.5" below grab bar.	2015 ABAAS Section: 609.3, 609.4 2012 TAS Section: 609.4, 609.3 2010 ADAS Section: 609.3, 609.4

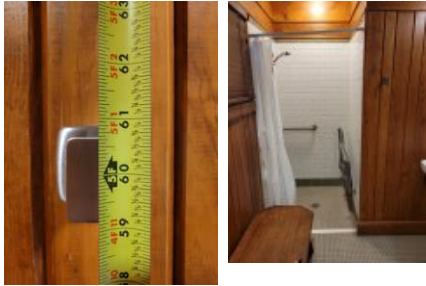
Finding Number	Area Description	Lat/Long	Finding	As Built	Recommendation	Citation	Photos	Figure
178	Group Lodge: Group Lodge Accessible Restroom	[33.0086512 , -94.696518 1]	Coat hooks provided within the room shall be located within one of the reach ranges specified in 308. Where coat hooks or shelves are provided in dressing, fitting or locker rooms without individual compartments, at least one of each type shall comply with 803.5. Where coat hooks or shelves are provided in individual compartments at least one of each type complying with 803.5 shall be provided in individual compartments in dressing, fitting, or locker rooms required to comply with 222.1.	Hook 59.25" AFF	Remount at least one hook to max 48" AFF	2015 ABAAS Section: 308.2.1, 308.1, F222.2, 803.5 2012 TAS Section: 308.2.1, 308.1, 222.2, 803.5 2010 ADAS Section: 308.2.1, 308.1, 222.2, 803.5

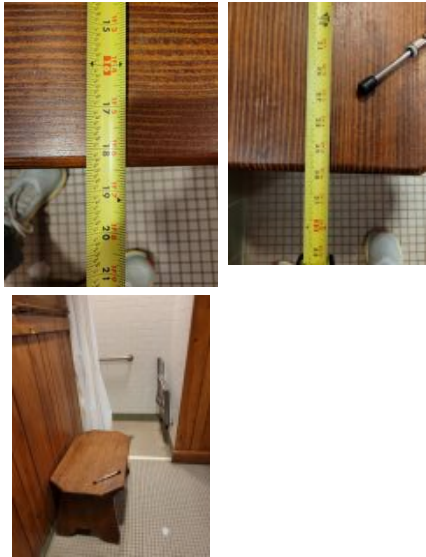
179	Group Lodge: Group Lodge Accessible Restroom	[33.0086647 , -94.696493 9]	The bench is not deep enough or long enough or is missing. Benches shall be provided having seats that are 42 inches long minimum and 20 inches deep minimum and 24 inches deep maximum. The bench shall provide for back support or shall be affixed to a wall. Back support shall be 42 inches (1065 mm) long minimum and shall extend from a point 2 inches (51 mm) maximum above the seat surface to a point 18 inches (455 mm) minimum above the seat surface. Back support shall be 2½ inches (64 mm) maximum from the rear edge of the seat measured horizontally. The top of the bench seat surface shall be 17 inches (430 mm) minimum and 19 inches (485 mm) maximum above the finish floor or ground. Clear floor or ground space complying with 305 shall be provided and shall be positioned at the end of the bench seat and parallel to the short axis of the bench	bench not fixed to wall, 18.5" x 29.75"	Replace bench in dressing area with one having a seat depth of 20" to 24" deep, 42" long, affixed to the wall or having a back and mounted 17" to 19" AFF and provide required clear floor space on the short axis of the bench.	2012 TAS Section: 903.4, 903.2, 903.3, 903.5 2010 ADAS Section: 903.4, 903.2, 903.3, 903.5

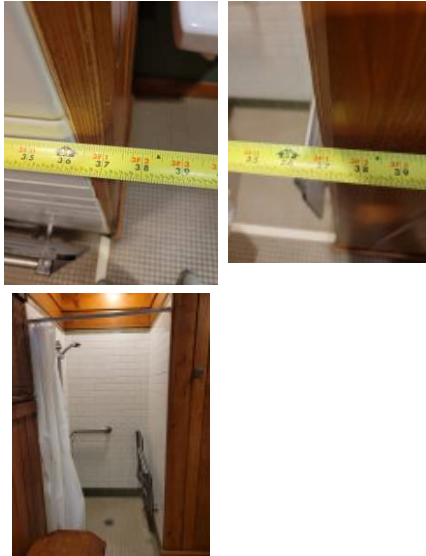
Finding Number	Area Description	Lat/Long	Finding	As Built	Recommendation	Citation	Photos	Figure
180	Group Lodge: Group Lodge Accessible Restroom	[33.008658, -94.696512 7]	Transfer type shower compartments shall be 36 inches (915 mm) by 36 inches (915 mm) clear inside dimensions measured at the center points of opposing sides and shall have a 36 inch (915 mm) wide minimum entry on the face of the shower compartment. Clearance of 36 inches (915 mm) wide minimum by 48 inches (1220 mm) long minimum measured from the control wall shall be provided.	Shower too large, 37" x 37"	Reduce transfer shower to compliant 36" by 36" clear inside dimension	2015 ABAAS Section: 608.2.1 2012 TAS Section: 608.2.1 2010 ADAS Section: 608.2.1

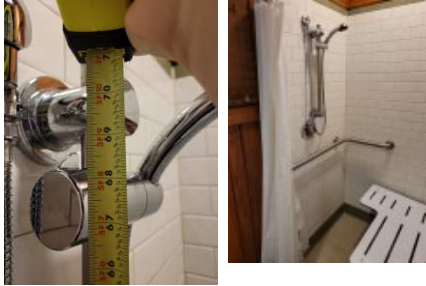
182	Group Lodge: Group Lodge Accessible Restroom	[33.0086501 , -94.696514]	Shower controls are in the incorrect location In transfer type shower compartments, the controls, faucets, and shower spray unit shall be installed on the side wall opposite the seat 38 inches (965 mm) minimum and 48 inches (1220 mm) maximum above the shower floor and shall be located on the control wall 15 inches (380 mm) maximum from the centerline of the seat toward the shower opening.	Button to lower control at 68.5" AFF	Remount shower controls to the correct location in the transfer shower	2015 ABAAS Section: 608.5.1 2012 TAS Section: 608.5.1 2010 ADAS Section: 608.5.1

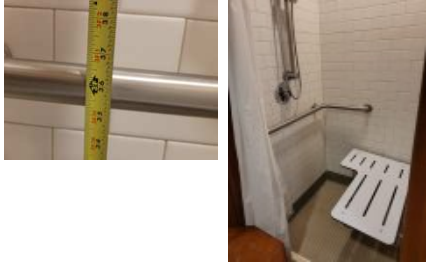
Finding Number	Area Description	Lat/Long	Finding	As Built	Recommendation	Citation	Photos	Figure
183	Group Lodge: Group Lodge Accessible Restroom	[33.0086501 , -94.696499 3]	Grab bars shall be installed in a horizontal position, 33 inches (840 mm) minimum and 36 inches (915 mm) maximum above the finish floor measured to the top of the gripping surface	Grab bar 36.75" AFF	Remount shower grab bar to 33" min. and 36" max. AFF.	2015 ABAAS Section: 609.3 Exception, 609.4 2012 TAS Section: 609.4, 609.3 Exception 2010 ADAS Section: 609.4, 609.3 Exception

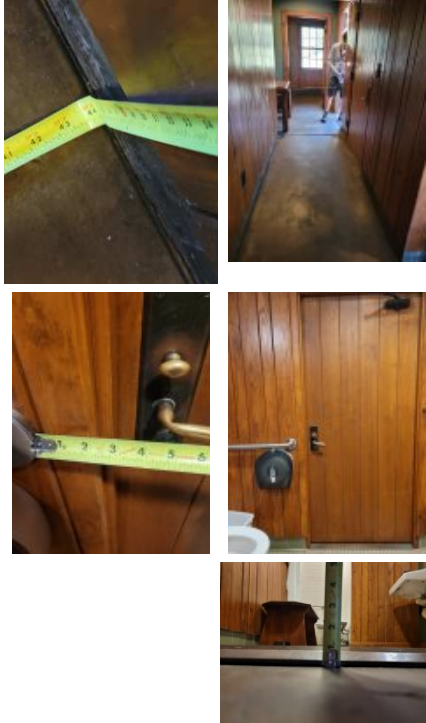
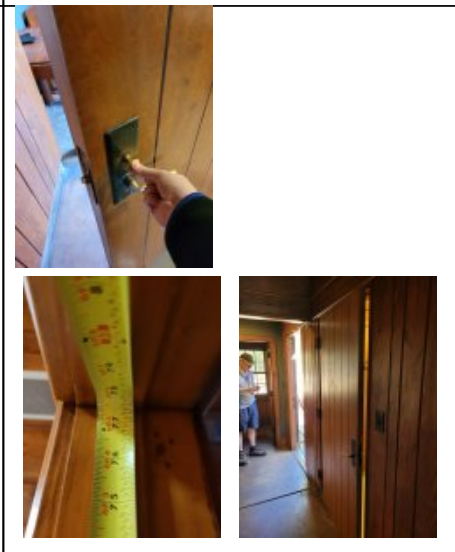
184	Group Lodge: Group Lodge Accessible Restroom	[33.0086546 , -94.696507 3]	Minimum maneuvering clearances at doors and gates shall comply with 404.2.4. Maneuvering clearances shall extend the full width of the doorway and the required latch side or hinge side clearance. Maneuvering clearances shall have a max slope of 2.08%. Door openings shall provide a clear width of 32 inches (815 mm) minimum. Clear openings of doorways with swinging doors shall be measured between the face of the door and the stop, with the door open 90 degrees. Openings more than 24 inches (610 mm) deep shall provide a clear opening of 36 inches (915 mm) minimum. There shall be no projections into the required clear opening width lower than 34 inches (865 mm) above the finish floor or ground. Projections into the clear opening width between 34 inches (865 mm) and 80 inches (2030 mm) above the finish floor or ground shall not exceed 4 inches (100 mm). The threshold at a doorway shall be no higher than 1/2 inch. Changes in level between 1/4 inch and 1/2 inch must be beveled at 1:2 or less. 1/4 inch is the maximum vertical rise. Hand-activated door opening hardware, handles, pulls, latches, locks, and other operating devices on accessible doors shall have a shape that is easy to grasp with one hand and does not	unisex restroom-latch approach on pull side is 44" back, maneuvering clearance on pull is reduced to 3" by grab bar, 1" CIL, tight pinch to lock, 77.5" overhead	For all doors along the public circulation route, provide required maneuvering clearance on push and pull side of doors. For all doors along the public circulation route, replace doors with doors having 80" overhead clearance and 32" clear width. For all doors along the public circulation route, repair, bevel, or ramp CILs at door entries to max .25". For all doors along the public circulation route, replace hardware with lever hardware or hardware operable without a tight pinch or grasp.	2010 ADAS Section: 404.2.3, 404.2.7, 404.2.4, 404.2.11, 404.2.11 Exception

Finding Number	Area Description	Lat/Long	Finding	As Built	Recommendation	Citation	Photos	Figure
			require tight grasping, tight pinching or twisting of the wrist to operate. Hardware shall be 34 inches minimum and 48 inches maximum above the finish floor or ground.

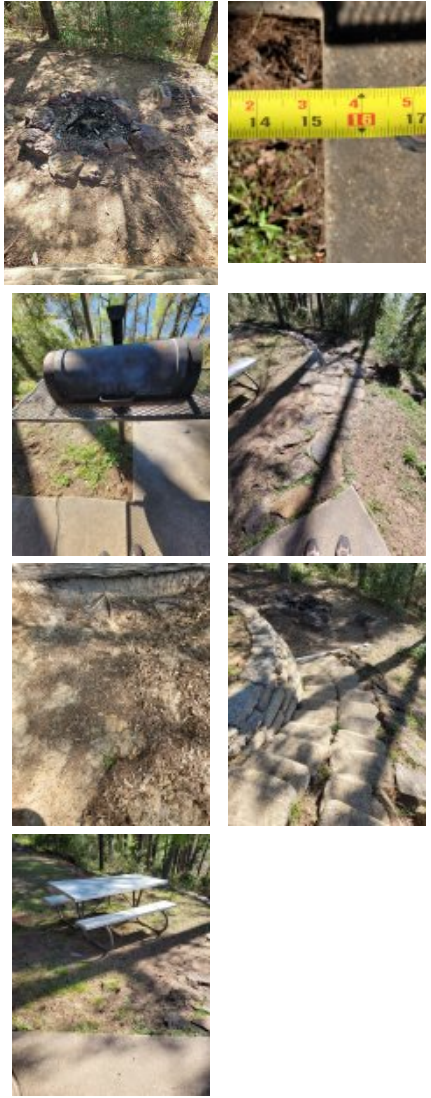
Finding Number	Area Description	Lat/Long	Finding	As Built	Recommendation	Citation	Photos	Figure
185	Group Lodge: Group Lodge Public Spaces	[33.008577, -94.696463 1]	There is no accessible route to the fire ring/grill At least one accessible route shall connect accessible buildings, accessible facilities, accessible elements, and accessible spaces that are on the same site.	No CFS at grill, no AR to picnic table, 13 risers and 25' to fire ring/grill	Create a ramp and an accessible route with crushed stone or other outdoor material with CFS from the building to the fire ring/grill	2015 ABAAS Section: F206.2.2 2012 TAS Section: 206.2.2 2010 ADAS Section: 206.2.2

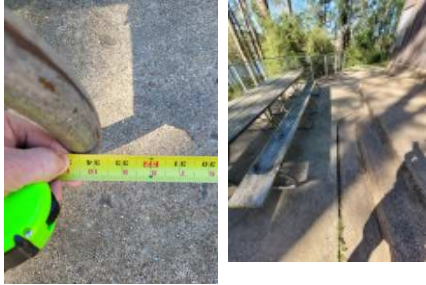
Finding Number	Area Description	Lat/Long	Finding	As Built	Recommendation	Citation	Photos	Figure
186	Group Lodge: Group Lodge Public Spaces	[33.0085793 , -94.696448 3]	The route of travel at this location does not provide the required minimum width. The minimum clear width around picnic tables is 36 inches.	33" wide at long picnic table	Widen route to min 36" clear width	2015 ABAAS Section: 403.5.1 2012 TAS Section: 403.5.1 2010 ADAS Section: 403.5.1

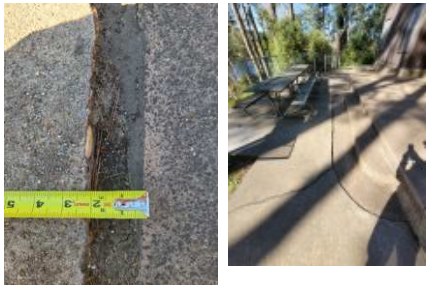
187	Group Lodge: Group Lodge Public Spaces	[33.0085883 , -94.696476 5]	There is a gap spaced greater than a 1/2 inch. Openings in floor or ground surfaces shall not allow passage of a sphere more than 1/2 inch diameter. Elongated openings shall be placed so that the long dimension is perpendicular to the dominant direction of travel.	2" opening near long side of picnic table	Correct or fill gaps to be max .5"	2015 ABAAS Section: 302.3 2012 TAS Section: 302.3 2010 ADAS Section: 302.3

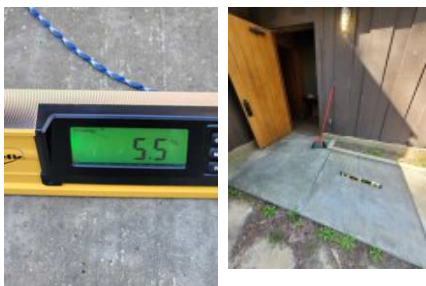
188	Group Lodge: Group Lodge Public Spaces	[33.0085995 , -94.696483 2]	The running slope of walking surfaces shall not be steeper than 1:20.	5.5% slope approaching back door	Correct running slope along the AR to max 5%	2015 ABAAS Section: 403.3 2012 TAS Section: 403.3 2010 ADAS Section: 403.3

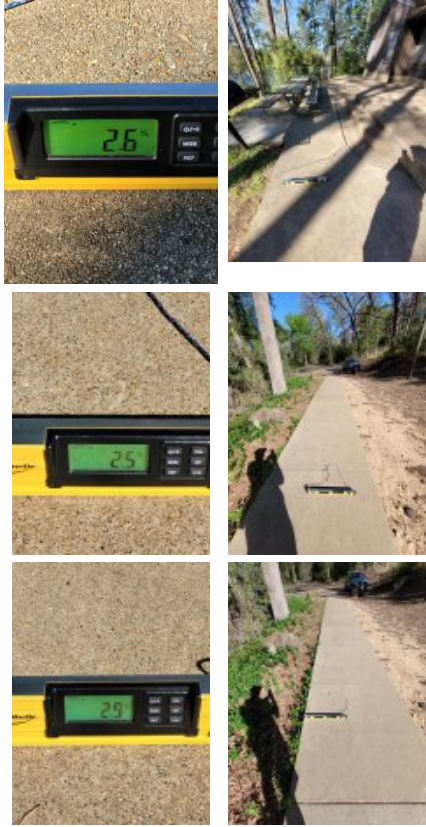
Finding Number	Area Description	Lat/Long	Finding	As Built	Recommendation	Citation	Photos	Figure
189	Group Lodge: Group Lodge Public Spaces	[33.0086006 , -94.69643 36], [33.0087468 , -94.696688 4]	The cross slope shall not be steeper than 1:48.	2.6% slope approximately 45' from parking area, 2.9% slope at cracked section, about 42' from parking, 2.6% slope at edge of lower patio toward fire ring	Correct or repair ORAR cross slope to max 2.08% as a smart practices	2015 ABAAS Section: 1016.7.2, 1016.7.2 EXCEPTION

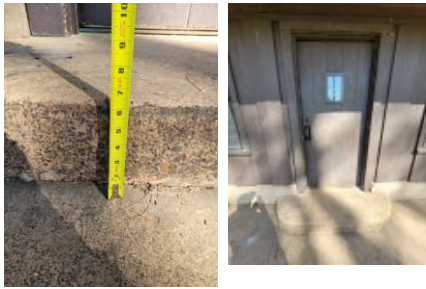
193	Group Lodge: Group Lodge Public Spaces	[33.0086287 , -94.696489 9]	Minimum maneuvering clearances at doors and gates shall comply with 404.2.4. Maneuvering clearances shall extend the full width of the doorway and the required latch side or hinge side clearance. Maneuvering clearances shall have a max slope of 2.08%. The sweep period for doors with closers shall be adjusted so that from an open position of 70 degrees, the door will take at least 3 seconds to move to a point 3 inches from the latch, measured to the leading edge of the door. Doors, gates, and side lights adjacent to doors or gates, containing one or more glazing panels that permit viewing through the panels shall have the bottom of at least one glazed panel located 43 inches (1090 mm) maximum above the finish floor. EXCEPTION: Vision lights with the lowest part more than 66 inches (1675 mm) from the finish floor or ground shall not be required to comply with 404.2.11.	back door- 6" CIL in clearance, closes fast, window 54"	For all doors along the public circulation route, provide required maneuvering clearance on push and pull side of doors. For all doors along the public circulation route, inspect, adjust, and maintain closing speed on door closers. For all doors along the public circulation route, replace doors with ones having sidelight viewing windows max 43" AFF.	2010 ADAS Section: 404.2.3, 404.2.7, 404.2.4, 404.2.11, 404.2.11 Exception

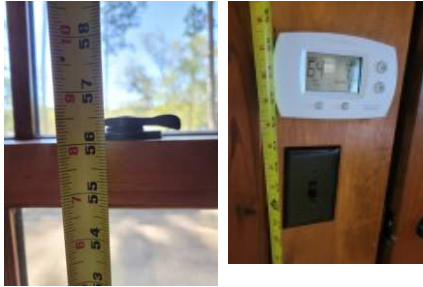
197	Group Lodge: Group Lodge Public Spaces	[33.0086602 , -94.6965006]	The operable part is positioned too high for either a side or front approach. Where a clear floor or ground space allows a parallel approach to an element and the side reach is unobstructed, the high side reach shall be 48 inches maximum and the low side reach shall be 15 inches minimum above the finish floor or ground. Where a forward reach is unobstructed, the high forward reach shall be 48 inches maximum and the low forward reach shall be 15 inches minimum above the finish floor or ground.	56.5" AFF to window hardware	Remount operable parts to be in reach range of 15" min to 48" max	2015 ABAAS Section: 308.1 2012 TAS Section: 308.1 2010 ADAS Section: 308.1

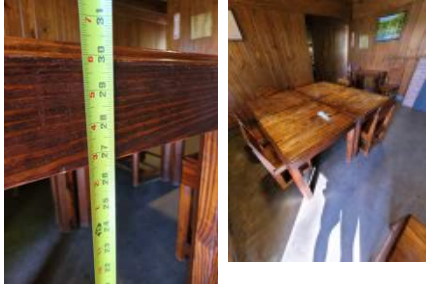
Finding Number	Area Description	Lat/Long	Finding	As Built	Recommendation	Citation	Photos	Figure
199	Group Lodge: Group Lodge Public Spaces	[33.00864, -94.696511 4]	The top of the work surface is not within a compliant height range. The tops of tables and counters shall be 28 inches to 34 inches from the floor or ground.	26.5" AFF knee space at table	Provide tables and work surfaces at 28" to 34" AFF with required knee and toe clearances	2015 ABAAS Section: 902.3 2012 TAS Section: 902.3 2010 ADAS Section: 902.3
