Access Audit Site Report

Daingerfield State Park

Accessibility Evaluation

Inspection Date: 04/07/2022

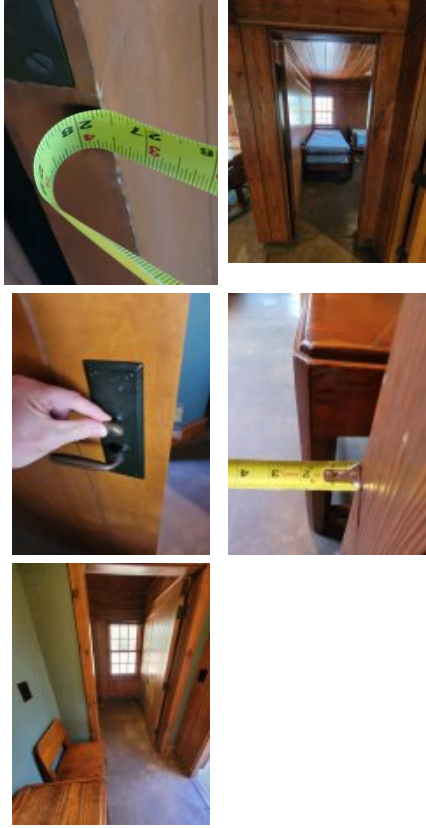
200	Group Lodge: Group Lodge Public Spaces	[33.0086692 , -94.696515 4]	Minimum maneuvering clearances at doors and gates shall comply with 404.2.4. Maneuvering clearances shall extend the full width of the doorway and the required latch side or hinge side clearance. Maneuvering clearances shall have a max slope of 2.08%. Door openings shall provide a clear width of 32 inches (815 mm) minimum. Clear openings of doorways with swinging doors shall be measured between the face of the door and the stop, with the door open 90 degrees. Openings more than 24 inches (610 mm) deep shall provide a clear opening of 36 inches (915 mm) minimum. There shall be no projections into the required clear opening width lower than 34 inches (865 mm) above the finish floor or ground. Projections into the clear opening width between 34 inches (865 mm) and 80 inches (2030 mm) above the finish floor or ground shall not exceed 4 inches (100 mm). Hand-activated door opening hardware, handles, pulls, latches, locks, and other operating devices on accessible doors shall have a shape that is easy to grasp with one hand and does not require tight grasping, tight pinching or twisting of the wrist to operate. Hardware shall be 34 inches minimum and 48 inches maximum above the finish floor or ground.	Bedroom 1- chair push side, lock hardware requires pinch; Bedroom 2- 27.5" width, lock hardware requires pinch	For all doors along the public circulation route, provide required maneuvering clearance on push and pull side of doors. For all doors along the public circulation route, replace doors with doors having 80" overhead clearance and 32" clear width. For all doors along the public circulation route, replace hardware with lever hardware or hardware operable without a tight pinch or grasp.	2010 ADAS Section: 404.2.3, 404.2.7, 404.2.4, 404.2.11, 404.2.11 Exception

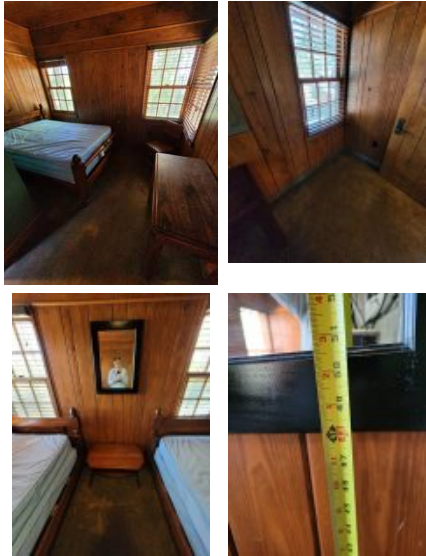
Finding Number	Area Description	Lat/Long	Finding	As Built	Recommendation	Citation	Photos	Figure
202	Group Lodge: Group Lodge Public Spaces	[33.0086524 , -94.696507 3]	The operable part is not accessible because there is not adequate clear floor space for either a forward or side approach. The clear floor or ground space shall be 30 inches minimum by 48 inches minimum.	Bedroom 1 and 2 lack CFS to mirror, both are over 35" AFF; Bedroom 1, only 1 of 4 windows has CFS	Remove, or relocate storage and furniture in CFS at fixtures and operable parts along the AR Provide required 30" by 48" CFS at operable parts Lower mirror to max 35" to bottom of reflective surface or provide a full length mirror.	2015 ABAAS Section: 305.3 2012 TAS Section: 305.3 2010 ADAS Section: 305.3

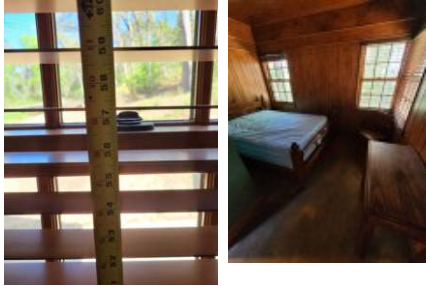
203	Group Lodge: Group Lodge Public Spaces	[33.0086524 , -94.696506]	The operable part is positioned too high for either a side or front approach. Where a clear floor or ground space allows a parallel approach to an element and the side reach is unobstructed, the high side reach shall be 48 inches maximum and the low side reach shall be 15 inches minimum above the finish floor or ground. Where a forward reach is unobstructed, the high forward reach shall be 48 inches maximum and the low forward reach shall be 15 inches minimum above the finish floor or ground.	bedrooms on kitchen side- window hardware too high	Remount operable parts to be in reach range of 15" min to 48" max	2015 ABAAS Section: 308.1 2012 TAS Section: 308.1 2010 ADAS Section: 308.1

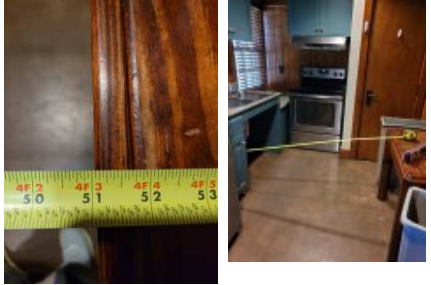
Finding Number	Area Description	Lat/Long	Finding	As Built	Recommendation	Citation	Photos	Figure
205	Group Lodge: Group Lodge Public Spaces	[33.0086535 , -94.696504 7]	The U-shaped kitchen is not wide enough. In U-shaped kitchens enclosed on three contiguous sides, clearance between all opposing base cabinets, counter tops, appliances, or walls within kitchen work areas shall be 60 inches.	51" from table to counter	Renovate U shaped kitchen to provide required 60" clearance between cabinets, counter tops and appliances	2015 ABAAS Section: 804.2.2 2012 TAS Section: 804.2.2 2010 ADAS Section: 804.2.2

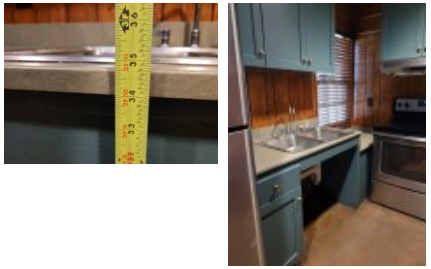
206	Group Lodge: Group Lodge Public Spaces	[33.0086546 , -94.696504 7]	The top rim of the sink is too high. All lavatories/sinks that are designated to be accessible shall be a minimum 17 inches in horizontal depth and mounted with the rim or counter edge no higher than 34 inches above the finished floor.	Sink rim 35.25" AFF	Lower sinks to max 34" above the finished floor (AFF) to front of rim.	2015 ABAAS Section: 606.3 2012 TAS Section: 606.3 2010 ADAS Section: 606.3

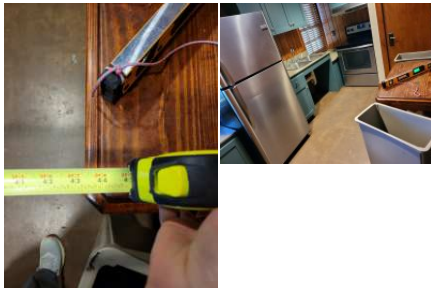
208	Group Lodge: Group Lodge Public Spaces	[33.0086467 , -94.696506]	Combination refrigerators and freezers shall have at least 50 percent of the freezer space 54 inches (1370 mm) maximum above the finish floor or ground. The clear floor or ground space shall be positioned for a parallel approach to the space dedicated to a refrigerator/freezer with the centerline of the clear floor or ground space offset 24 inches (610 mm) maximum from the centerline of the dedicated space.	Reduced clearance, 43" due to table and trash	Relocate items for required CFS at refrigerator.	2015 ABAAS Section: 804.6.6 2012 TAS Section: 804.6.6 2010 ADAS Section: 804.6.6

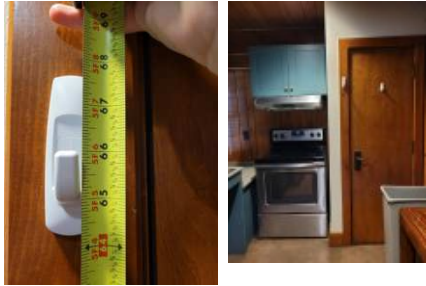
Finding Number	Area Description	Lat/Long	Finding	As Built	Recommendation	Citation	Photos	Figure
209	Group Lodge: Group Lodge Public Spaces	[33.0086512 , -94.696511 4]	The operable part is positioned too high for either a side or front approach. Where a clear floor or ground space allows a parallel approach to an element and the side reach is unobstructed, the high side reach shall be 48 inches maximum and the low side reach shall be 15 inches minimum above the finish floor or ground. Where a forward reach is unobstructed, the high forward reach shall be 48 inches maximum and the low forward reach shall be 15 inches minimum above the finish floor or ground.	Hook 65" AFF	Remount operable parts to be in reach range of 15" min to 48" max	2015 ABAAS Section: 308.1 2012 TAS Section: 308.1 2010 ADAS Section: 308.1

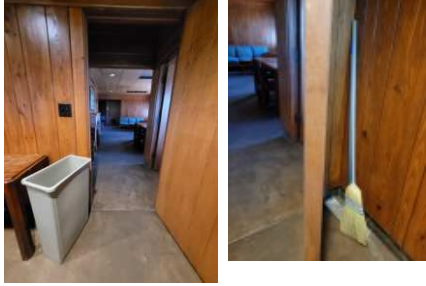
210	Group Lodge: Group Lodge Public Spaces	[33.0086535 , -94.696506]	Minimum maneuvering clearances at doors and gates shall comply with 404.2.4. Maneuvering clearances shall extend the full width of the doorway and the required latch side or hinge side clearance. Maneuvering clearances shall have a max slope of 2.08%. Hand-activated door opening hardware, handles, pulls, latches, locks, and other operating devices on accessible doors shall have a shape that is easy to grasp with one hand and does not require tight grasping, tight pinching or twisting of the wrist to operate. Hardware shall be 34 inches minimum and 48 inches maximum above the finish floor or ground.	Kitchen door - maneuvering clearance 9" pull reduced by trash, lacks hardware	For all doors along the public circulation route, provide required maneuvering clearance on push and pull side of doors. For all doors along the public circulation route, provide hardware with lever hardware or hardware operable without a tight pinch or grasp.	2010 ADAS Section: 404.2.3, 404.2.7, 404.2.4, 404.2.11, 404.2.11 Exception

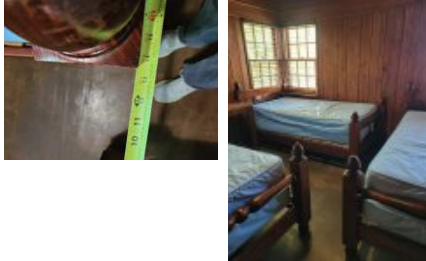
211	Group Lodge: Group Lodge Public Spaces	[33.0086602 , -94.696508 7]	The route of travel at this location does not provide a minimum width of 36 inches. The clear width shall be permitted to be reduced to 32 inches minimum for a length of 24 inches maximum provided that reduced width segments are separated by segments that are 48 inches long minimum and 36 inches wide minimum.	bedrooms opposite kitchen- beach facing bedroom - 13.5" pass through to beds, middle bedroom - 21.5" width, horizontal positioned bed offers 11.5" width, parking facing bedroom - 26" between beds	Remove or replace furniture to provide AR compliant 36" clear width	2015 ABAAS Section: 403.5.1 2012 TAS Section: 403.5.1 2010 ADAS Section: 403.5.1

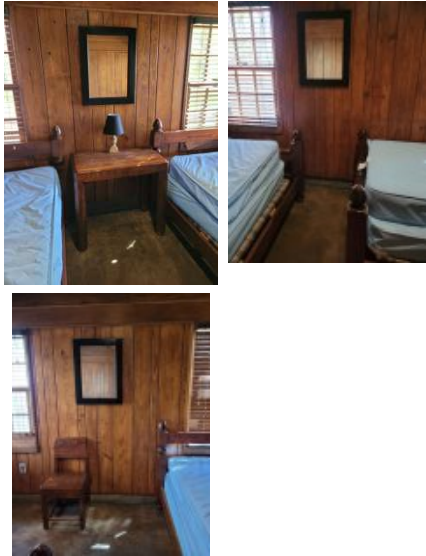
Finding Number	Area Description	Lat/Long	Finding	As Built	Recommendation	Citation	Photos	Figure
212	Group Lodge: Group Lodge Public Spaces	[33.0086501 , -94.696503 3]	The operable part is not accessible because there is not adequate clear floor space for either a forward or side approach. The clear floor or ground space shall be 30 inches minimum by 48 inches minimum.	Beach bedroom - table in CFS for mirror. middle bedroom - bed in CFS for mirror, parking bedroom - chair in CFS for mirror	Remove, or relocate storage and furniture in CFS at fixtures and operable parts along the AR	2015 ABAAS Section: 305.3 2012 TAS Section: 305.3 2010 ADAS Section: 305.3

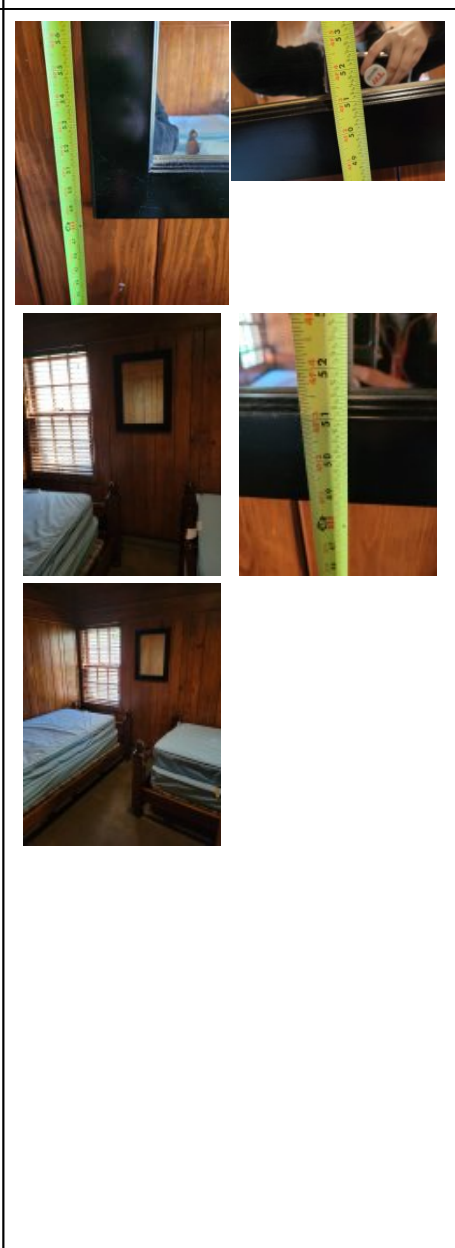
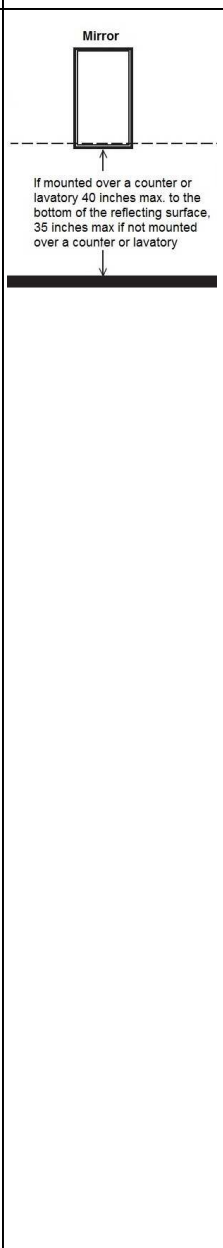
Finding Number	Area Description	Lat/Long	Finding	As Built	Recommendation	Citation	Photos	Figure
213	Group Lodge: Group Lodge Public Spaces	[33.0086591 , -94.696498]	The mirror is mounted too high. Mirrors not located above lavatories or countertops shall be installed with the bottom edge of the reflecting surface 35 inches maximum above the finish floor or ground.	Beach bedroom - mirror 51" AFF, Middle bedroom - mirror - 51.25" AFF, parking bedroom - mirror - 51.5"	Lower mirror not over a sink or counter to max 35" AFF to the bottom reflective surface and 74" to the top. Replace mirror not over a sink or counter and mount to max 35" AFF to the bottom reflective surface and 74" to the top.	2015 ABAAS Section: 603.3 2012 TAS Section: 603.3 2010 ADAS Section: 603.3

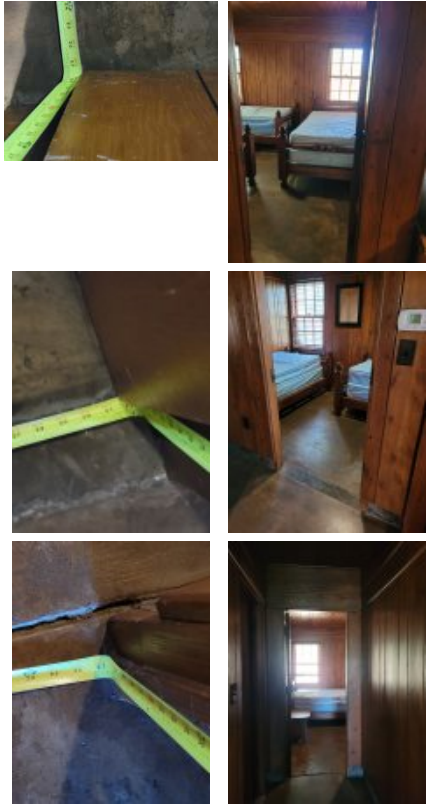
Finding Number	Area Description	Lat/Long	Finding	As Built	Recommendation	Citation	Photos	Figure
214	Group Lodge: Group Lodge Public Spaces	[33.0086501 , -94.696508 7]	The door opening does not provide at least 32 inches between the face of the door and the opposite stop. Door openings shall provide a clear width of 32 inches minimum. Clear openings of doorways with swinging doors shall be measured between the face of the door and the stop, with the door open 90 degrees. There shall be no projections into the required clear opening width lower than 34 inches above the finish floor or ground. Projections into the clear opening width between 34 inches and 80 inches above the finish floor or ground shall not exceed 4 inches.	Beach bedroom - 27.25", middle bedroom - 31.5", parking bedroom - 27.25"	Replace door with one having 32" clear width. Widen door at parking bedroom to 36" for recessed doors.	2015 ABAAS Section: 404.2.3 2012 TAS Section: 404.2.3 2010 ADAS Section: 404.2.3

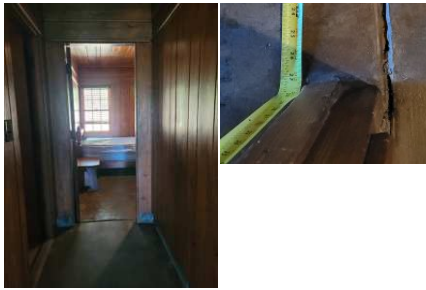
215	Group Lodge: Group Lodge Public Spaces	[33.0086546 , -94.696508 7]	Door openings shall provide a clear width of 32 inches (815 mm) minimum. Clear openings of doorways with swinging doors shall be measured between the face of the door and the stop, with the door open 90 degrees. Openings more than 24 inches (610 mm) deep shall provide a clear opening of 36 inches (915 mm) minimum. There shall be no projections into the required clear opening width lower than 34 inches (865 mm) above the finish floor or ground. Projections into the clear opening width between 34 inches (865 mm) and 80 inches (2030 mm) above the finish floor or ground shall not exceed 4 inches (100 mm).	Parking bedroom - exceeds 24" depth, only 27.25" width	Widen doors to 36" for recessed doors. Cost included in previous finding	2015 ABAAS Section: 404.2.3 2012 TAS Section: 404.2.3 2010 ADAS Section: 404.2.3

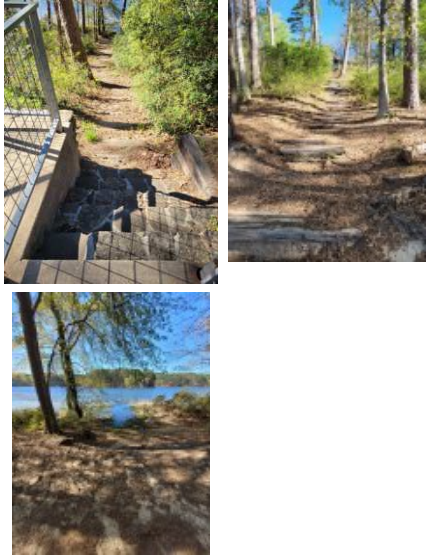
Finding Number	Area Description	Lat/Long	Finding	As Built	Recommendation	Citation	Photos	Figure
216	Group Lodge: Group Lodge Public Spaces	[33.0085388 , -94.696539 5]	The surface of trails, passing spaces, and resting intervals shall be firm and stable	To waters edge, 65 risers, height varies.	Leave trail as is and provide accessible trail elsewhere at this site.	2015 ABAAS Section: 1017.2

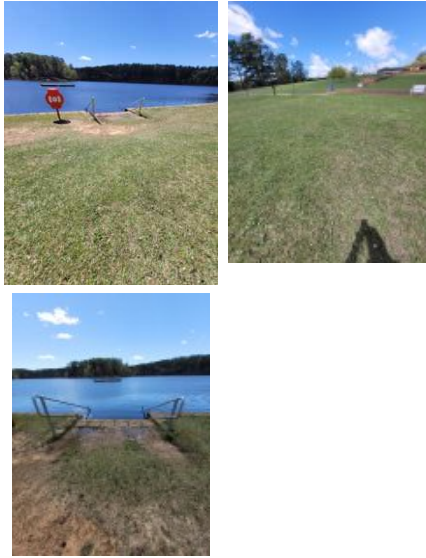
Finding Number	Area Description	Lat/Long	Finding	As Built	Recommendation	Citation	Photos	Figure
217	Day Use Area: Day Use - Swimming	[33.0080844 , -94.698317 8]	Beach access routes shall connect an entry point to the beach to the: Normal recreation water level at lake, pond, and reservoir beaches	Lacks AR to beach area, 60' to firm and stable surface	Create a beach access route to normal recreational water level of a firm and stable material as a smart practice	2015 ABAAS Section: 1018.2

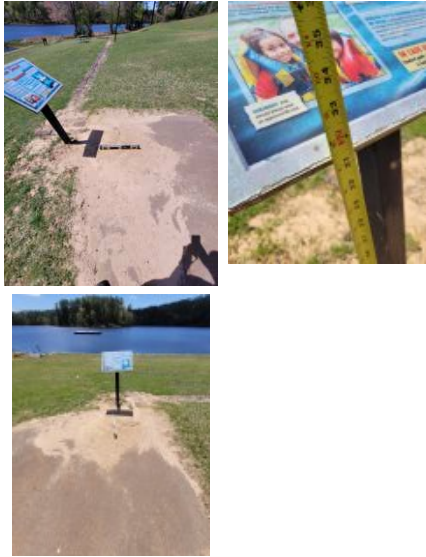
218	Day Use Area: Day Use - Swimming	[33.0081664 , -94.698486 6]	The accessible route contains loose gravel and/or surfaces that do not provide for a stable, firm slip resistant surface.	Sign CFS not firm and stable, 31.5" AFF to sign bottom	Maintain sign CFS where deterioration occurs Remount sign so visual characters are 40" min above the ground	2015 ABAAS Section: 302.1 2012 TAS Section: 302.1 2010 ADAS Section: 302.1

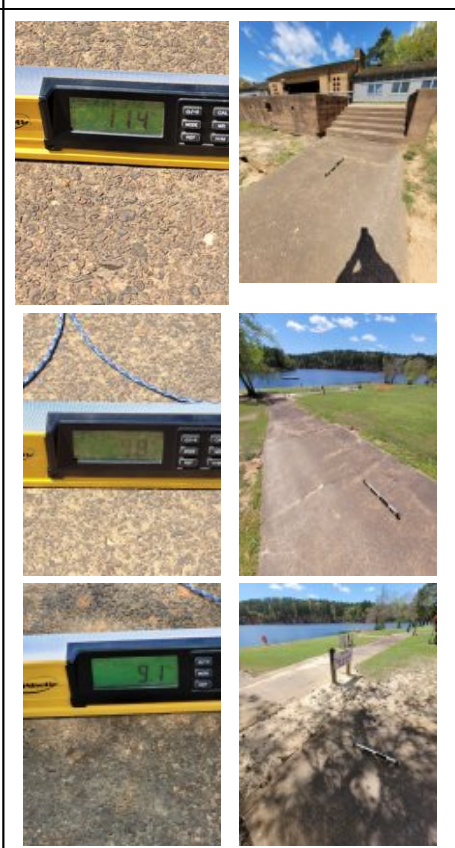
Finding Number	Area Description	Lat/Long	Finding	As Built	Recommendation	Citation	Photos	Figure
219	Day Use Area: Day Use - Swimming	[33.008371, -94.698302 8], [33.0086724 , -94.698486 6]	The running slope of walking surfaces shall not be steeper than 1:20.	2 walkways to beach access, both have excess slopes, gaps, and CILs- one side audited; 11.5% running slope at top, 9.7% running slope at mid, 9.1% slope at bottom	Remove and replace one route from the patio to the beach access with correct running slope along the AR to max 5%. Provide sign directing to accessible route	2015 ABAAS Section: 403.3 2012 TAS Section: 403.3 2010 ADAS Section: 403.3

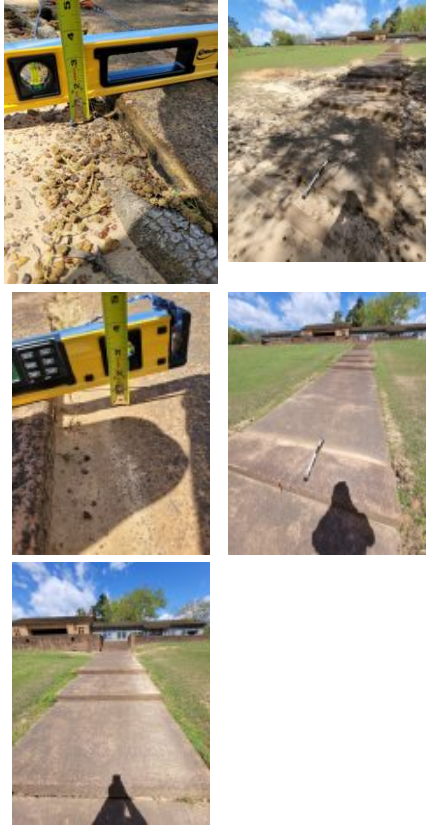
Finding Number	Area Description	Lat/Long	Finding	As Built	Recommendation	Citation	Photos	Figure
220	Day Use Area: Day Use - Swimming	[33.0083384 , -94.69828], [33.0086747 , -94.698483 9]	The walkway contains abrupt vertical edges and/or variations over a 1/4 inch. 1/4 inch is the maximum vertical rise. Changes in level between 1/4 inch and 1/2 inch must be beveled at 1:2 or less. Changes in level greater than 1/2 inch must be by way of a ramp.	2 walkways to beach access, both have excess slopes, gaps, and CILs- one side audited; 1.5" at bottom, 1.75" at mid, 17 risers each side	Provide an accessible route to access the beach	2012 TAS Section: 303.2, 303.3 2010 ADAS Section: 303.2, 303.3

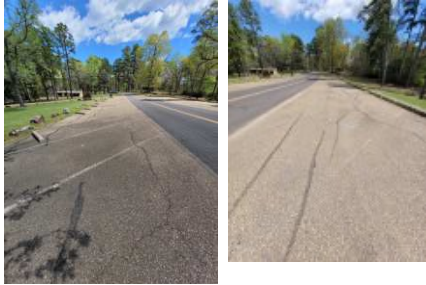
Finding Number	Area Description	Lat/Long	Finding	As Built	Recommendation	Citation	Photos	Figure
221	Day Use Area: Day Use - Parking	[33.0092957 , -94.698057 7]	There are no or not enough accessible parking stalls. Each lot where parking is provided for the public as clients, guests or employees, shall provide accessible parking and shall be located on the shortest accessible route of travel from adjacent parking to an accessible entrance. There are a total of (37) parking stalls in the parking lot that could be reasonably associated with this facility. There should be a minimum of (2) accessible stalls with a minimum of (1) being designed as van accessible.	side opposite dining hall- 0 of 37 parking spaces	Create one or more 8' accessible parking stalls, with one 5' adjacent access aisle, with proper signage and striping based on the total number of stalls.	2015 ABAAS Section: F208.2 2012 TAS Section: 208.2 2010 ADAS Section: 208.2

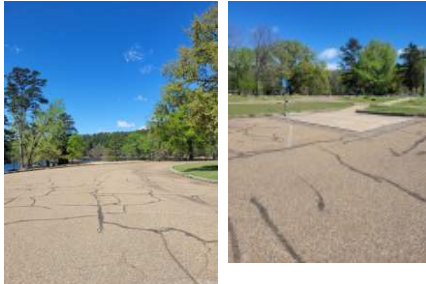
222	Day Use Area: Day Use - Parking	[33.0085433 , -94.699149 3]	There are no or not enough accessible parking stalls. Each lot where parking is provided for the public as clients, guests or employees, shall provide accessible parking and shall be located on the shortest accessible route of travel from adjacent parking to an accessible entrance. There are a total of (51) parking stalls in the parking lot that could be reasonably associated with this facility. There should be a minimum of (3) accessible stalls with a minimum of (1) being designed as van accessible.	play area/dining hall - 51 standard spaces, 1 accessible space	Create one or more 8' accessible parking stalls, with one 5' adjacent access aisle, with proper signage and striping based on the total number of stalls.	2015 ABAAS Section: F208.2 2012 TAS Section: 208.2 2010 ADAS Section: 208.2

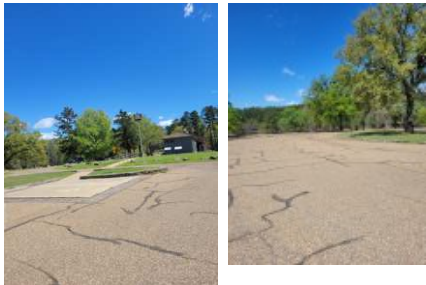
223	Day Use Area: Day Use - Parking	[33.00855, -94.699141 3]	The accessible parking is not located on the shortest accessible route to the building. Accessible parking spaces serving a particular building or facility entrance shall be located on the shortest accessible route of travel from the parking to an accessible entrance.	Route close to dining, not close to play area	Disperse new accessible stalls to be on the shortest AR to the building entry or park features	2015 ABAAS Section: F208.3.1 2012 TAS Section: 208.3.1 2010 ADAS Section: 208.3.1

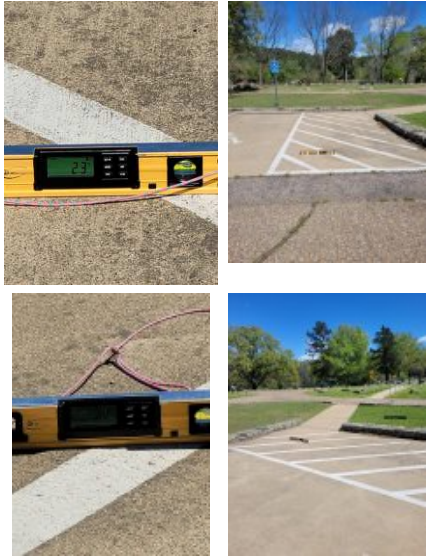
Finding Number	Area Description	Lat/Long	Finding	As Built	Recommendation	Citation	Photos	Figure
224	Day Use Area: Day Use - Parking	[33.0085545 , -94.699126 5]	The cross slopes (narrow dimension) and/or running slopes (long dimension) of the access aisle exceeds 2%. The running slope and the cross slope in an accessible parking stall and the access aisle must not exceed 2%.	Access aisle slopes- 2.3%, 2.4%	Repair or correct slope of parking space and access aisle to max 2.08% in any direction.	2015 ABAAS Section: 502.4 2012 TAS Section: 502.4 2010 ADAS Section: 502.4

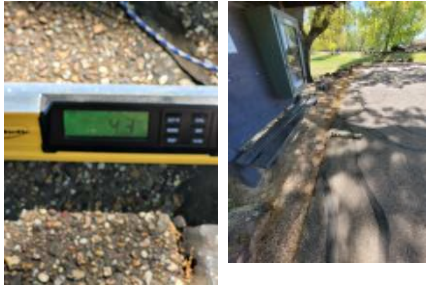
225	Day Use Area: Day Use - Picnic Area	[33.0092393 , -94.699431 1]	The 30 inches minimum by 48 inches minimum clear floor space required at the operable part is not flat (2% or 1:48 maximum slope) in all directions. Changes in level are not permitted at required clear floor or ground space except that slopes not steeper than 1:48 shall be permitted.	4.3% cross slope in CFS at little library/bench	Correct or repair slope in CFS to max 2.08%	2015 ABAAS Section: 305.2 2012 TAS Section: 305.2 2010 ADAS Section: 305.2

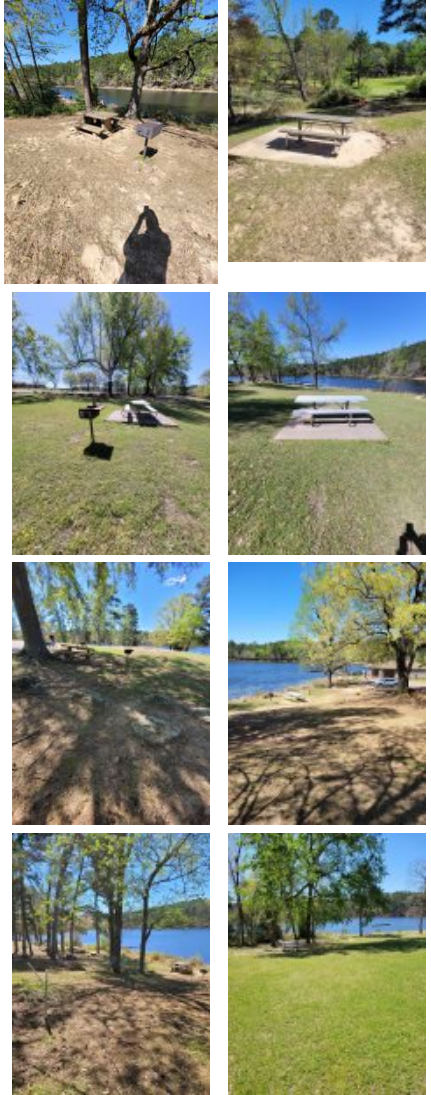
Finding Number	Area Description	Lat/Long	Finding	As Built	Recommendation	Citation	Photos	Figure
226	Day Use Area: Day Use - Picnic Area	[33.0080742 , -94.699608 2]	There is no accessible route to the site elements At least one accessible route shall connect accessible buildings, accessible facilities, accessible elements, and accessible spaces that are on the same site.	0 of 1 bench, 0 of 4 water spout, 0 of 34 grill, 0 of 52 picnic tables (6 accessible), ARs vary about 30'-45' apart	Create an accessible route with crushed stone or other outdoor material from parking or walkway to at least 20% of each type of site element	2015 ABAAS Section: F206.2.2 2012 TAS Section: 206.2.2 2010 ADAS Section: 206.2.2

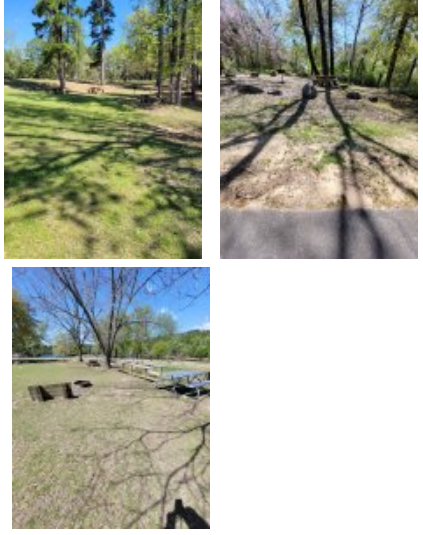
227	Day Use Area: Day Use - Picnic Area	[33.0088333 , -94.699236 7]	There is no accessible route to the site elements At least one accessible route shall connect accessible buildings, accessible facilities, accessible elements, and accessible spaces that are on the same site.	No AR to sign, no AR to two horse shoe pit areas	Create an accessible route with crushed stone or other outdoor material from parking or walkway to the site elements	2015 ABAAS Section: F206.2.2 2012 TAS Section: 206.2.2 2010 ADAS Section: 206.2.2

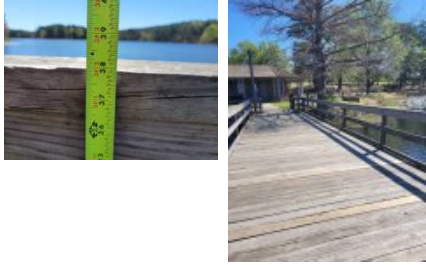
Finding Number	Area Description	Lat/Long	Finding	As Built	Recommendation	Citation	Photos	Figure
228	Day Use Area: Day Use - Fishing	[33.0082531 , -94.700847 2]	Not enough of the railings, guards, or handrails are at the allowable height. At least 25 percent of the railings, guards, or handrails shall be 34 inches maximum above the ground or deck surface.	Railing all the way around 38" AFF	Lower 25% of the railing; dispersed through pier, to max 34".	2015 ABAAS Section: 1005.2.1 2010 ADAS Section: 1005.2.1

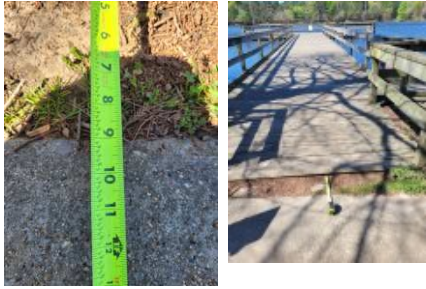
229	Day Use Area: Day Use - Fishing	[33.00836, -94.700636 6]	There is a gap spaced greater than a 1/2 inch. Openings in floor or ground surfaces shall not allow passage of a sphere more than 1/2 inch diameter. Elongated openings shall be placed so that the long dimension is perpendicular to the dominant direction of travel.	9" gap at entry to pier behind interpretive	Correct or fill gaps to be max .5".	2015 ABAAS Section: 302.3 2012 TAS Section: 302.3 2010 ADAS Section: 302.3

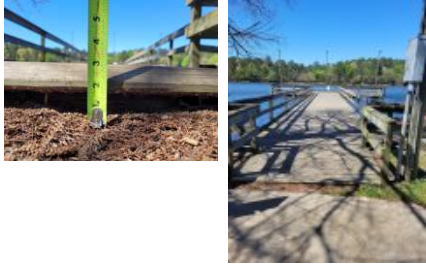
230	Day Use Area: Day Use - Fishing	[33.0083577 , -94.700639 3]	The walkway contains abrupt vertical edges and/or variations over a 1/4 inch. 1/4 inch is the maximum vertical rise. Changes in level between 1/4 inch and 1/2 inch must be beveled at 1:2 or less. Changes in level greater than 1/2 inch must be by way of a ramp.	2.75" CIL at entry to pier behind interpretive	Repair, bevel or ramp CIL along AR.	2012 TAS Section: 303.2, 303.3 2010 ADAS Section: 303.2, 303.3

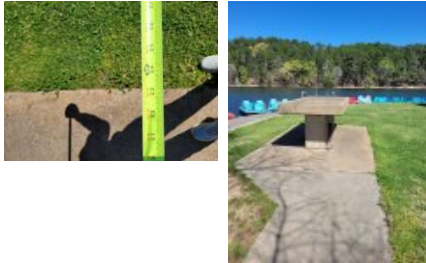
Finding Number	Area Description	Lat/Long	Finding	As Built	Recommendation	Citation	Photos	Figure
232	Day Use Area: Day Use - Fishing	[33.0084241 , -94.700646]	The route of travel at this location does not provide the required minimum width. The minimum clear width for sidewalks and walks is 36 inches.	23" around table	Widen EAR to min 36" clear width	2015 ABAAS Section: 403.5.1 2012 TAS Section: 403.5.1 2010 ADAS Section: 403.5.1

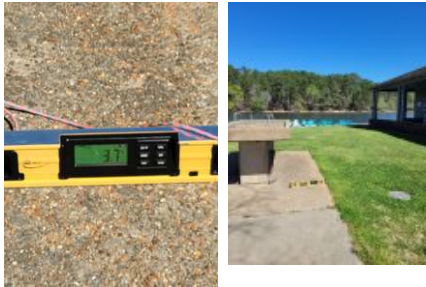
233	Day Use Area: Day Use - Fishing	[33.0084173 , -94.700632 6]	The accessible route contains running slopes greater than 5 percent and cross slopes greater than 2 percent across the width of the walk and has not been constructed as a ramp (i.e. handrails, wheel guides, etc.). When the slope in the direction of travel of any walk exceeds 1 unit vertical in 20 units horizontal (5-percent slope), it must be constructed as ramp. Surface cross slopes must not exceed one unit vertical in 48 units. Horizontal (2-percent slope).	3.7% cross slope on land side	Correct or repair slope to max 2.08% cross.	2015 ABAAS Section: 403.3 2012 TAS Section: 403.3 2010 ADAS Section: 403.3

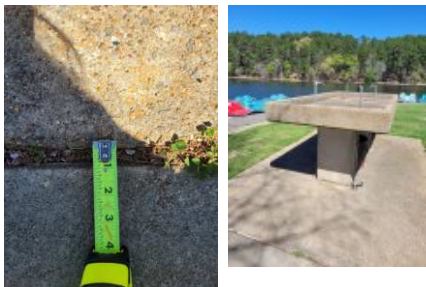
234	Day Use Area: Day Use - Fishing	[33.0083982 , -94.700633 9]	Openings in floor or ground surfaces shall not allow passage of a sphere more than 1/2 inch (13 mm) diameter except as allowed in 407.4.3, 409.4.3, 410.4, 810.5.3 and 810.10. Elongated openings shall be placed so that the long dimension is perpendicular to the dominant direction of travel.	1" gap at entry	Fill and maintain gaps to max .5"	2015 ABAAS Section: 302.3 2012 TAS Section: 302.3 2010 ADAS Section: 302.3

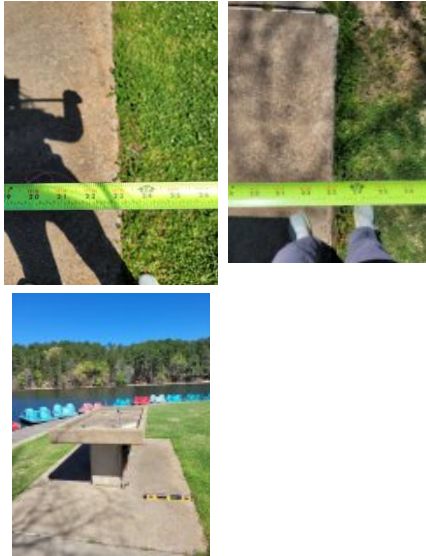
Finding Number	Area Description	Lat/Long	Finding	As Built	Recommendation	Citation	Photos	Figure
235	Day Use Area: Day Use - Fishing	[33.0084184 , -94.700643 3]	The operable part is not accessible because there is not adequate clear floor space for either a forward or side approach. The clear floor or ground space shall be 30 inches minimum by 48 inches minimum.	Table lacks CFS	Provide required 30" by 48" CFS at operable parts. Cost included in previous finding	2015 ABAAS Section: 305.3 2012 TAS Section: 305.3 2010 ADAS Section: 305.3

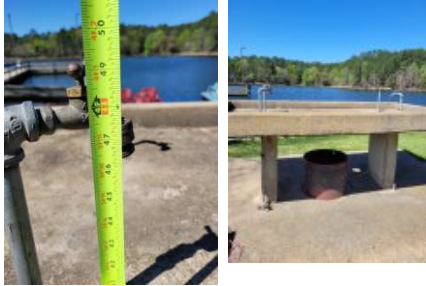
236	Day Use Area: Day Use - Fishing	[33.0084196 , -94.700648 7]	The operable part is positioned too high for either a side or front approach. Where a clear floor or ground space allows a parallel approach to an element and the side reach is unobstructed, the high side reach shall be 48 inches maximum and the low side reach shall be 15 inches minimum above the finish floor or ground. Where a forward reach is unobstructed, the high forward reach shall be 48 inches maximum and the low forward reach shall be 15 inches minimum above the finish floor or ground.	Water spigots 49" AFF	Remount operable parts to be in reach range of 15" min to 48" max	2015 ABAAS Section: 308.1 2012 TAS Section: 308.1 2010 ADAS Section: 308.1

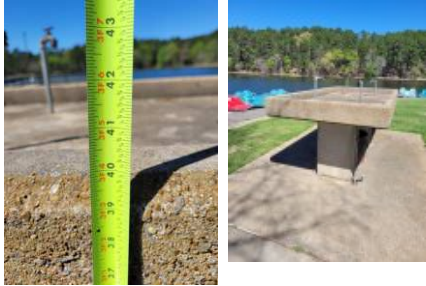
237	Day Use Area: Day Use - Fishing	[33.0084218 , -94.700643 3]	The top of the work surface is not within a compliant height range. The tops of tables and counters shall be 28 inches to 34 inches from the floor or ground.	Table 40" AFF	Provide tables and work surfaces at 28" to 34" AFF with required knee and toe clearances	2015 ABAAS Section: 902.3 2012 TAS Section: 902.3 2010 ADAS Section: 902.3

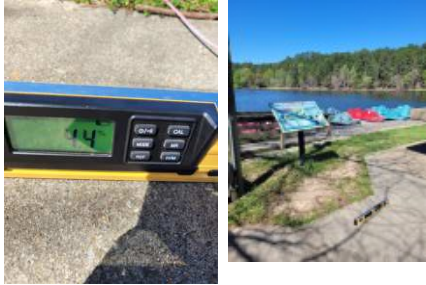
Finding Number	Area Description	Lat/Long	Finding	As Built	Recommendation	Citation	Photos	Figure
238	Day Use Area: Day Use - Fishing	[33.0083959 , -94.700643 3]	The 30 inches minimum by 48 inches minimum clear floor space required at the operable part is not flat (2% or 1:48 maximum slope) in all directions. Changes in level are not permitted at required clear floor or ground space except that slopes not steeper than 1:48 shall be permitted.	CFS for sign by fish cleaning has 4.4% cross slope	Correct or repair slope in CFS to max 2.08%	2015 ABAAS Section: 305.2 2012 TAS Section: 305.2 2010 ADAS Section: 305.2

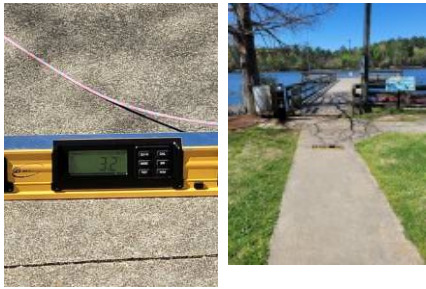
240	Day Use Area: Day Use - Fishing	[33.0083881 , -94.700616 5]	The accessible route of travel contains cross slopes greater than 2%. Cross slopes shall not exceed one unit vertical in 48 units horizontal (2-percent slope).	3.2% cross slope at turn to fish clean	Correct or repair cross slope along AR to max 2.08%.	2015 ABAAS Section: 403.3 2012 TAS Section: 403.3 2010 ADAS Section: 403.3

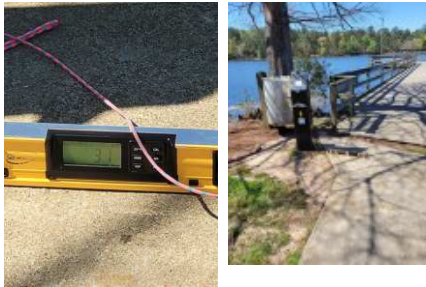
241	Day Use Area: Day Use - Fishing	[33.0083667 , -94.700615 1]	The 30 inches minimum by 48 inches minimum clear floor space required at the operable part is not flat (2% or 1:48 maximum slope) in all directions. Changes in level are not permitted at required clear floor or ground space except that slopes not steeper than 1:48 shall be permitted.	3.1% slope in CFS for donation box at fish pier	Correct or repair slope in CFS to max 2.08%	2015 ABAAS Section: 305.2 2012 TAS Section: 305.2 2010 ADAS Section: 305.2

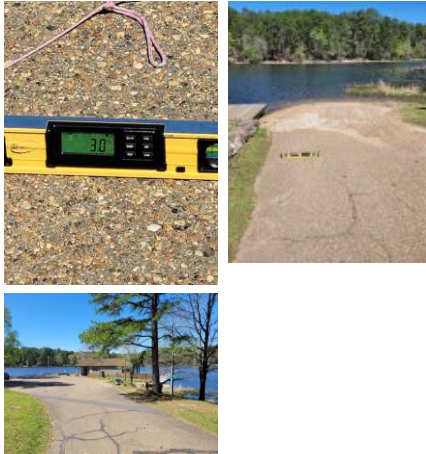
Finding Number	Area Description	Lat/Long	Finding	As Built	Recommendation	Citation	Photos	Figure
245	Day Use Area: Day Use - Boat Ramp	[33.0086265 , -94.7005038]	The 30 inches minimum by 48 inches minimum clear floor space required at the operable part is not flat (2% or 1:48 maximum slope) in all directions. Changes in level are not permitted at required clear floor or ground space except that slopes not steeper than 1:48 shall be permitted.	3% slope at boat ramp unloading by interpretive center. no level space, except parking	Correct or repair slope in CFS to max 2.08%	2015 ABAAS Section: 305.2 2012 TAS Section: 305.2 2010 ADAS Section: 305.2

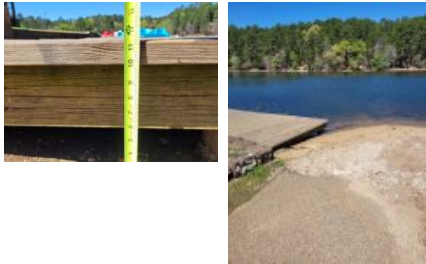
246	Day Use Area: Day Use - Boat Ramp	[33.0086108 , -94.700536]	Changes in level greater than 1/2 inch must be by way of a ramp.	11.5" CIL at boat ramp to pier	For changes in level 6" or greater, provide a ramp for access.	2012 TAS Section: 303.2, 303.3 2010 ADAS Section: 303.2, 303.3

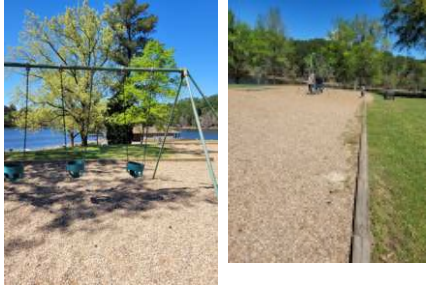
249	Day Use Area: Day Use - Playground	[33.0085523 , -94.699892 3]	Play area shall have signage listing designated ages of intended users	Play area lacks signage, assumed 2-12	Acquire and install intended user signage and mount at designated entry as a smart practice	2015 ABAAS Section: F240.1 2012 TAS Section: 240.1 2010 ADAS Section: 240.1

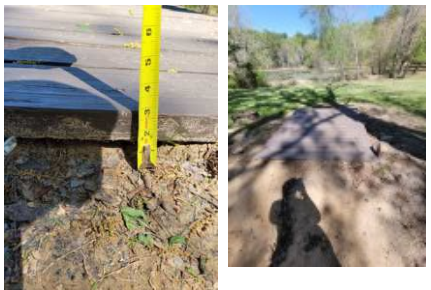
Finding Number	Area Description	Lat/Long	Finding	As Built	Recommendation	Citation	Photos	Figure
252	Day Use Area: Day Use - Amphitheater	[33.0094552 , -94.6992058]	The walkway contains abrupt vertical edges and/or variations over a 1/4 inch. 1/4 inch is the maximum vertical rise. Changes in level between 1/4 inch and 1/2 inch must be beveled at 1:2 or less. Changes in level greater than 1/2 inch must be by way of a ramp.	3" CIL to stage	Repair, bevel or ramp CIL along AR.	2012 TAS Section: 303.2, 303.3 2010 ADAS Section: 303.2, 303.3

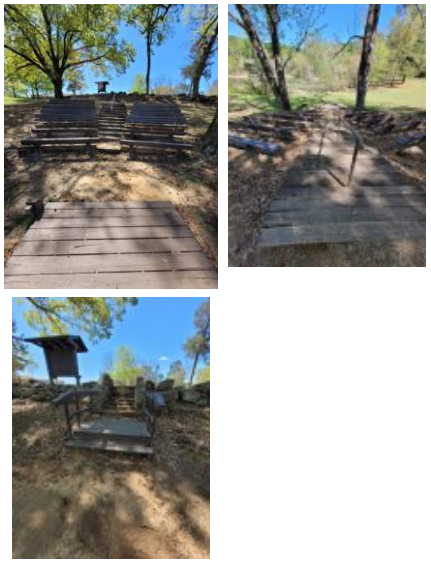
253	Day Use Area: Day Use - Amphitheater	[33.0093934 , -94.6991763]	There is no accessible route to the amphitheater. At least one accessible route shall connect accessible buildings, accessible facilities, accessible elements, and accessible spaces that are on the same site.	No AR to amphitheater	Create an accessible route with crushed stone or other outdoor material from parking or walkway to the amphitheater	2015 ABAAS Section: F206.2.2 2012 TAS Section: 206.2.2 2010 ADAS Section: 206.2.2

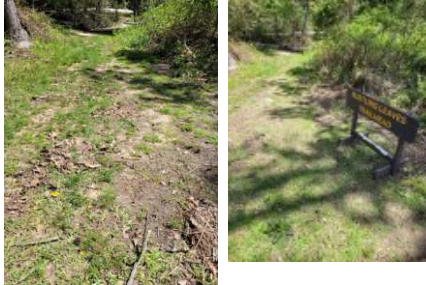
Number of Seats	Minimum Number of Required Wheelchair Spaces	4 to 25	1	26 to 50	2	51 to 100	4	101 to 200	5	201 to 500	6	501 to 1000	6, plus 1 for each 100, or fraction thereof, between 501 through 1000	1001 and over	10, plus 1 for each 100, or fraction thereof, over 1000
Number of Seats	Minimum Number of Required Wheelchair Spaces																							
4 to 25	1																							
26 to 50	2																							
51 to 100	4																							
101 to 200	5																							
201 to 500	6																							
501 to 1000	6, plus 1 for each 100, or fraction thereof, between 501 through 1000																							
1001 and over	10, plus 1 for each 100, or fraction thereof, over 1000																							
255	Day Use Area: Trails	[33.0084461 , -94.697421 8]	The surface of trails, passing spaces, and resting intervals shall be firm and stable	Trail surface not firm and stable	Leave as is and make other trails at this site as accessible	2015 ABAAS Section: 1017.2

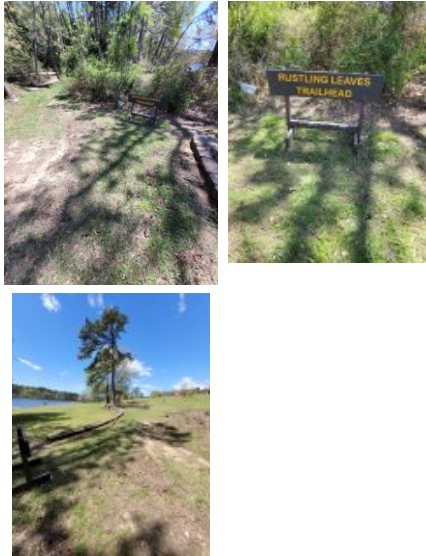
Finding Number	Area Description	Lat/Long	Finding	As Built	Recommendation	Citation	Photos	Figure
256	Day Use Area: Trails	[33.0084427 , -94.697754 4]	There is no accessible route to the trailhead At least one accessible route shall connect accessible buildings, accessible facilities, accessible elements, and accessible spaces that are on the same site.	Trailhead not accessible	Create an accessible route with crushed stone or other outdoor material from parking or walkway to the trailhead	2015 ABAAS Section: F206.2.2 2012 TAS Section: 206.2.2 2010 ADAS Section: 206.2.2

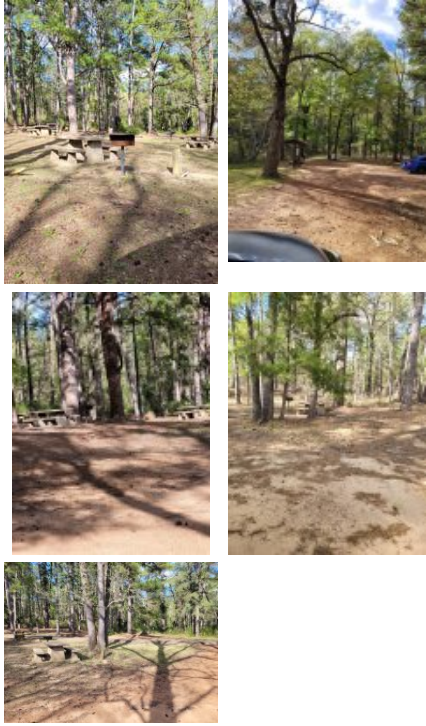
Finding Number	Area Description	Lat/Long	Finding	As Built	Recommendation	Citation	Photos	Figure																																																																																													
258	Day Use Area: Picnic Area near Camping	[33.0106378 , -94.6995373]	There is no accessible route to the site elements At least one accessible route shall connect accessible buildings, accessible facilities, accessible elements, and accessible spaces that are on the same site.	0 of 1 trash can, 0 of 2 benches, 0 of 7 grills, 0 of 7 picnic tables, 0 of 4 spigot, 0 of 2 hooks, 45' to closest picnic area	Create an accessible route with crushed stone or other outdoor material from parking or walkway to the picnic elements	2015 ABAAS Section: F206.2.2 2012 TAS Section: 206.2.2 2010 ADAS Section: 206.2.2

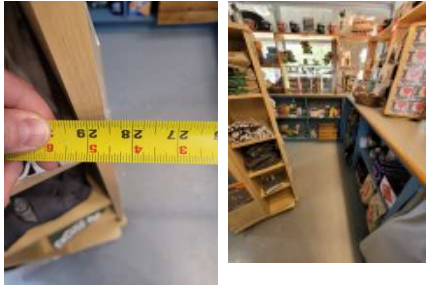
Finding Number	Area Description	Lat/Long	Finding	As Built	Recommendation	Citation	Photos	Figure
260	Day Use Area: Day Use -Store	[33.0087536 , -94.698622 3]	The route of travel at this location does not provide a minimum width of 36 inches. The clear width shall be permitted to be reduced to 32 inches minimum for a length of 24 inches maximum provided that reduced width segments are separated by segments that are 48 inches long minimum and 36 inches wide minimum.	Route reduces to 28.5" at merchandise rack	Relocate merchandise to provide AR to compliant 36" clear width	2015 ABAAS Section: 403.5.1 2012 TAS Section: 403.5.1 2010 ADAS Section: 403.5.1

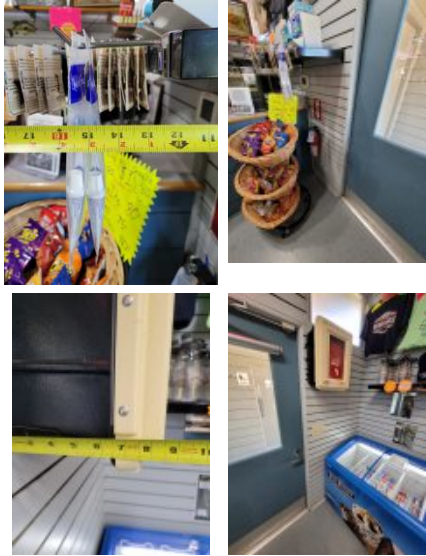
261	Day Use Area: Day Use -Store	[33.0087558 , -94.698631 6]	An item or items project more than 4 inches into the circulation path. Wall-mounted objects that have leading edges between 27 inches and 80 inches from the floor must not project more than 4 inches into the circulation path. Protruding objects that extend to the floor or within 27 inches of the floor are cane detectable and are therefore not hazardous. Where it is necessary or desirable to have objects protrude from the wall, a manner of cane detection must be provided.	Shelf with merchandise projects 16", AED projects	Relocate protruding objects or place cane detectable warning or bollard at foot of item	2015 ABAAS Section: 307.2 2012 TAS Section: 307.2 2010 ADAS Section: 307.2

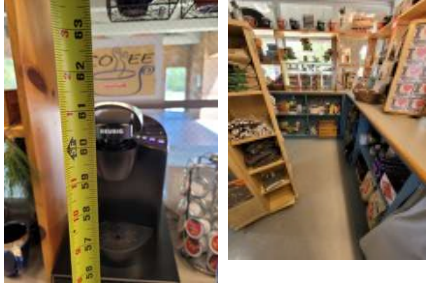
262	Day Use Area: Day Use -Store	[33.0087502 , -94.698624 9]	The operable part is positioned too high for either a side or front approach. Where a clear floor or ground space allows a parallel approach to an element and the side reach is unobstructed, the high side reach shall be 48 inches maximum and the low side reach shall be 15 inches minimum above the finish floor or ground. Where a forward reach is unobstructed, the high forward reach shall be 48 inches maximum and the low forward reach shall be 15 inches minimum above the finish floor or ground.	61" AFF to coffee	Remount operable parts to be in reach range of 15" min to 48" max	2015 ABAAS Section: 308.1 2012 TAS Section: 308.1 2010 ADAS Section: 308.1

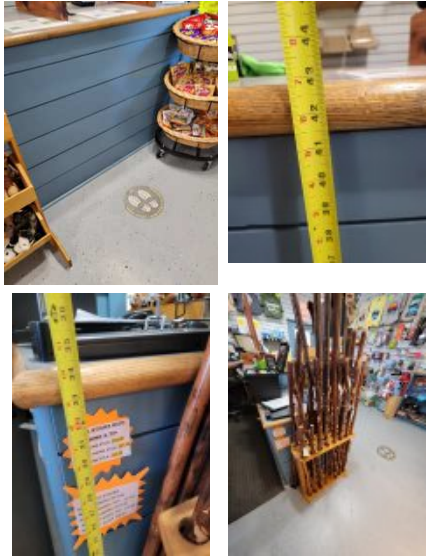
Finding Number	Area Description	Lat/Long	Finding	As Built	Recommendation	Citation	Photos	Figure
263	Day Use Area: Day Use -Store	[33.008748, -94.698634 3]	The transaction counter is too high. A portion of the counter surface that is 36 inches long minimum and 36 inches high maximum above the finish floor shall be provided. Knee and toe space must be provided for a forward approach. A 30 inch by 48 inch clear floor space on an accessible route must be provided for either a forward or parallel approach.	43" AFF to counter, lacks knee and toe clearance, lower counter blocked by merchandise	Lower 36" wide segment of service counter to max 36" AFF	2015 ABAAS Section: 904.4.2, 904.4.1 2012 TAS Section: 904.4.1, 904.4.2 2010 ADAS Section: 904.4.2, 904.4.1

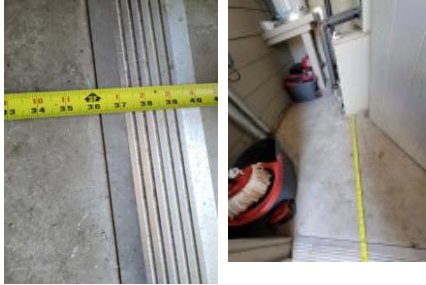
Finding Number	Area Description	Lat/Long	Finding	As Built	Recommendation	Citation	Photos	Figure
266	Day Use Area: Day Use -Store	[33.0087547 , -94.698627 6]	Spaces and elements within employee work areas shall only be required to comply with 206.2.8, 207.1, and 215.3 and shall be designed and constructed so that individuals with disabilities can approach, enter, and exit the employee work area. Employee work areas, or portions of employee work areas, other than raised courtroom stations, that are less than 300 square feet (28 m2) and elevated 7 inches (180 mm) or more above the finish floor or ground where the elevation is essential to the function of the space shall not be required to comply with these requirements or to be on an accessible route.	mechanical- equipment limits door swing clearance, 37"	For employee spaces, relocate storage, furniture, and other obstacles at doorways to provide approach, enter and exit at the employee space.	2015 ABAAS Section: F203.9 2012 TAS Section: 203.9 2010 ADAS Section: 203.9

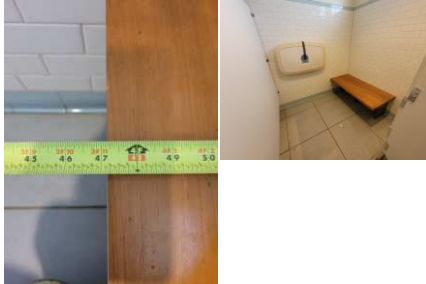
268	Day Use Area: Park Store - Women's Restroom	[33.008658, -94.698847 6]	The room does not contain compliant turning space. Dressing Rooms must contain a 60 inch circular turning space or a T-shaped turning space. Doors shall not swing into the room unless a clear floor or ground space is provided beyond the arc of the door swing.	dressing room lacks turning space, 47.25" to bench	Enlarge dressing stalls to 60" by 60" clear inside dimension	2015 ABAAS Section: 803.2 2012 TAS Section: 803.2 2010 ADAS Section: 803.2

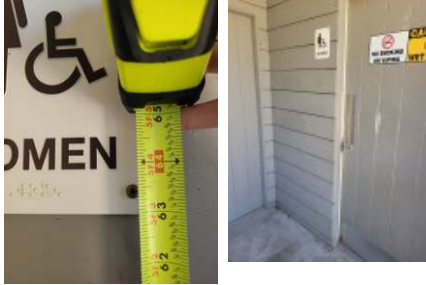
Finding Number	Area Description	Lat/Long	Finding	As Built	Recommendation	Citation	Photos	Figure
269	Day Use Area: Park Store - Women's Restroom	[33.0086524 , -94.698842 2]	The restroom sign does not comply with one or more applicable requirements for the location, height, and properties of the sign.	Compliant sign, mounted 64" AFF	Remount signage on wall, latch side of the door, 48" to baseline of lowest character and 60" to baseline of highest character	2015 ABAAS Section: F216.2, 703.1, 703.2, 703.5, 703.6 2012 TAS Section: 216.2, 703.1, 703.2, 703.5, 703.6 2010 ADAS Section: 216.2, 703.1, 703.2, 703.5, 703.6

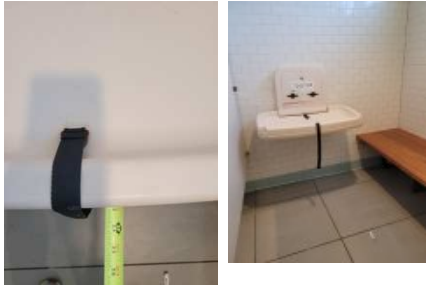
Finding Number	Area Description	Lat/Long	Finding	As Built	Recommendation	Citation	Photos	Figure
270	Day Use Area: Park Store - Women's Restroom	[33.008658, -94.698840 9]	The baby changing table is not compliant. Baby changing tables are work surfaces. If fixed or built-in baby changing tables are provided, at least 5%, but not less than one, must comply with TAS 902 based TAS 226.1. Baby changing tables cannot violate the protruding object requirements in either an open or closed position since either position is a potential hazard for persons with visual impairments. Baby changing tables are not prohibited from being located in wheelchair accessible toilet compartments; however, the minimum space required for the compartment cannot be obstructed by the baby changing table in either an open or closed position. The clear floor space required for a baby changing table may overlap the water closet clearance since baby changing tables are considered convenience "fixtures" based on Advisory 604.8.1.1. The overlap is applicable only to the clear floor space and not to actual table itself. Baby changing tables must be dispersed throughout a space, however, an additional baby changing table is not required in a common use area of a toilet or bathing room when the only baby changing table is located in a toilet compartment.	Within stall - projects 23"	Remount baby changing table so that operable parts are max 48" and the changing surface in the open position is max 34". Relocate baby changing table to eliminate protrusion when in the open position.	2012 TAS Section: 226.1, 902.3, 604.3.2, 204.1, 226.1 Advisory, 226.2, 307.1, 604.8.1.1 Advisory, 902.1, 902.1 Advisory, 902.2

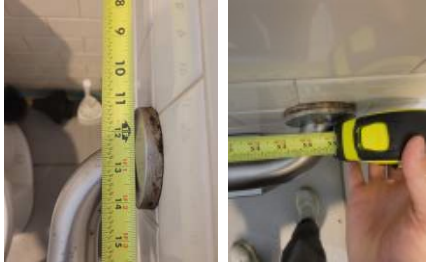
Finding Number	Area Description	Lat/Long	Finding	As Built	Recommendation	Citation	Photos	Figure
272	Day Use Area: Park Store - Women's Restroom	[33.0086816 , -94.698859 6]	The side grab bars are not in the correct location. Grab bars on the side wall must be installed so that the end closest to the rear wall is maximum 12" from the rear wall. The end furthest from the rear wall must be mounted minimum 54" from the rear wall.	Bar mounted 12.5" from rear wall	Remount side grab bar to max 12" from the rear wall at the close end and min 54" on the far end, and 33" to 36" AFF	2015 ABAAS Section: 604.5.1 2012 TAS Section: 604.5.1 2010 ADAS Section: 604.5.1

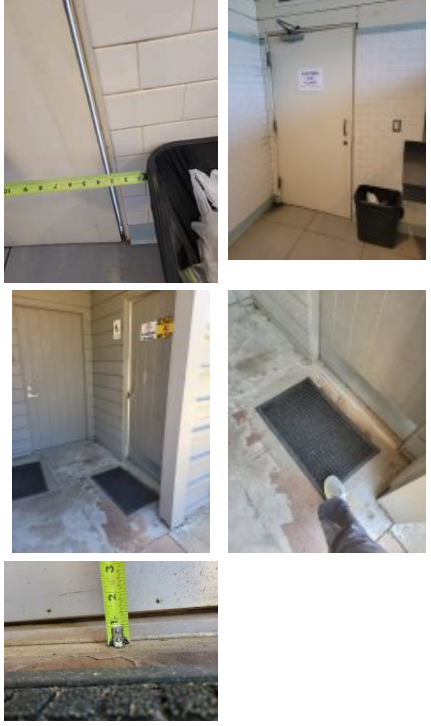
275	Day Use Area: Park Store - Women's Restroom	[33.0086569 , -94.698847 6]	Minimum maneuvering clearances at doors and gates shall comply with 404.2.4. Maneuvering clearances shall extend the full width of the doorway and the required latch side or hinge side clearance. Maneuvering clearances shall have a max slope of 2.08%. The threshold has a vertical change greater than 1/4 inch high. The threshold at a doorway shall be no higher than 1/2 inch. Changes in level between 1/4 inch and 1/2 inch must be beveled at 1:2 or less. 1/4 inch is the maximum vertical rise. The sweep period for doors with closers shall be adjusted so that from an open position of 70 degrees, the door will take at least 3 seconds to move to a point 3 inches from the latch, measured to the leading edge of the door. Exterior doors are recommended to be maintained at 8.5 LBF as a smart practice. Force is to be measured at the operating hardware or 30 inches from the hinges, whichever is greater.	women's- 3" maneuvering clearance on pull due to trash, 30#, fast close, slip rug, .75" CIL	For all doors along the public circulation route, provide required maneuvering clearance on push and pull side of doors. For all doors along the public circulation route, secure rug in door clearance to prevent trip hazard. For all doors along the public circulation route, repair, bevel, or ramp CILs at door entries to max .25". For all doors along the public circulation route, repair, provide beveled threshold. For all doors along the public circulation route, inspect, adjust, and maintain closing speed on door closers. For all doors along the public circulation route, inspect, adjust, and maintain 8.5 LBF to open exterior doors as a smart practice.	2010 ADAS Section: 404.2.3, 404.2.7, 404.2.4, 404.2.11, 404.2.11 Exception

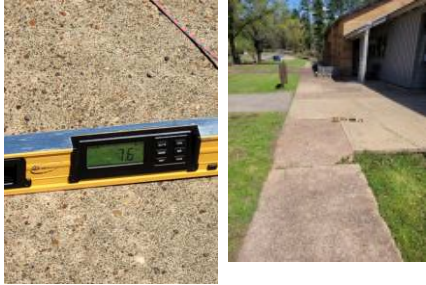
Finding Number	Area Description	Lat/Long	Finding	As Built	Recommendation	Citation	Photos	Figure
276	Day Use Area: Park Store - Women's Restroom	[33.0087187 , -94.698832 8]	The accessible route of travel contains cross slopes greater than 2%. Cross slopes shall not exceed one unit vertical in 48 units horizontal (2-percent slope).	7.6% cross slope at turn to women's from accessible parking	Correct or repair cross slope along AR to max 2.08%.	2015 ABAAS Section: 403.3 2012 TAS Section: 403.3 2010 ADAS Section: 403.3

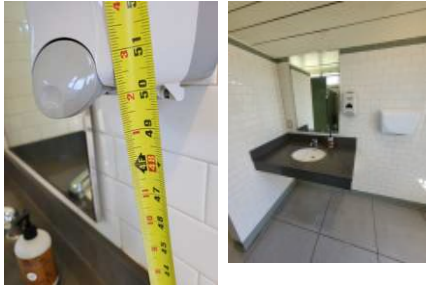
Finding Number	Area Description	Lat/Long	Finding	As Built	Recommendation	Citation	Photos	Figure
281	Day Use Area: Park Store - Mens Restroom	[33.0086524 , -94.698846 2]	Where a high forward reach is over an obstruction, the clear floor space shall extend beneath the element for a distance not less than the required reach depth over the obstruction. The high forward reach shall be 48 inches (1220 mm) maximum where the reach depth is 20 inches (510 mm) maximum. Where the reach depth exceeds 20 inches (510 mm), the high forward reach shall be 44 inches (1120 mm) maximum and the reach depth shall be 25 inches (635 mm) maximum. Where a clear floor or ground space allows a parallel approach to an element and the high side reach is over an obstruction, the height of the obstruction shall be 34 inches (865 mm) maximum and the depth of the obstruction shall be 24 inches (610 mm) maximum. The high side reach shall be 48 inches (1220 mm) maximum for a reach depth of 10 inches (255 mm) maximum. Where the reach depth exceeds 10 inches (255 mm), the high side reach shall be 46 inches (1170 mm) maximum for a reach depth of 24 inches (610 mm) maximum.	49.5" AFF to soap dispenser	Lower soap dispenser to max 44" above the finished floor (AFF) for a forward reach over counter.	2015 ABAAS Section: 308.2.1, 308.3.2 2012 TAS Section: 308.2.1, 308.3.2 2010 ADAS Section: 308.2.1, 308.3.2
