Access Audit Site Report

Daingerfield State Park

Accessibility Evaluation

Inspection Date: 04/07/2022

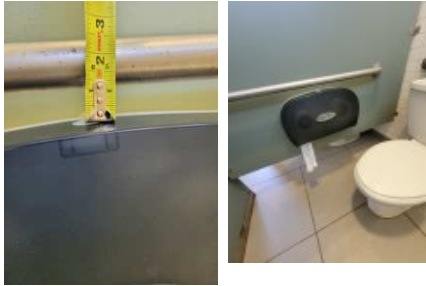
Finding Number	Area Description	Lat/Long	Finding	As Built	Recommendation	Citation	Photos	Figure
283	Day Use Area: Park Store - Mens Restroom	[33.0086524 , -94.698846 2]	The spacing fails. Grab bars must be mounted between 33" and 36" to the top of the gripping surface. There must be 1.5" of clearance between the grab bar and the wall. There must be a minimum of 1.5" of clearance below and minimum 12" above the grab bar to any dispenser or other obstruction.	1.25" between bar and dispenser	Remount toilet paper dispenser max 7" to 9" from front of toilet, 15" to 48" above the finished floor (AFF) and min 12" above or 1.5" below grab bar.	2015 ABAAS Section: 609.3, 609.4 2012 TAS Section: 609.4, 609.3 2010 ADAS Section: 609.3, 609.4

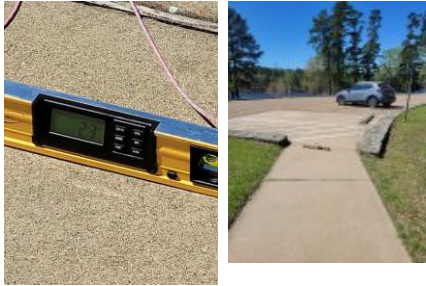
Finding Number	Area Description	Lat/Long	Finding	As Built	Recommendation	Citation	Photos	Figure
287	Group Dining Hall: Dining Hall - Public Spaces	[33.0085748, -94.6991238]	The accessible route of travel contains cross slopes greater than 2%. Cross slopes shall not exceed one unit vertical in 48 units horizontal (2-percent slope).	2.3% slope at beginning of path from accessible stall	Correct or repair cross slope along AR to max 2.08%.	2015 ABAAS Section: 403.3 2012 TAS Section: 403.3 2010 ADAS Section: 403.3

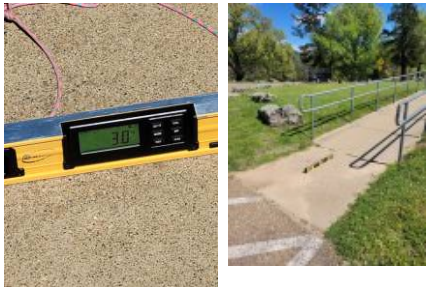
288	Group Dining Hall: Dining Hall - Public Spaces	[33.00864, -94.6990353]	The landing at the bottom of the ramp has a slope greater than 2%. Bottom landings shall have a dimension in the direction of ramp run of not less than 60 inches and have a slope of less than 2% in any direction.	3% slope at bottom	Correct ramp landing slope to max 2.08%	2015 ABAAS Section: 405.7.1, 405.7.1 EXCEPTION 2012 TAS Section: 405.7.1, 405.7.1 Exception 2010 ADAS Section: 405.7.1, 405.7.1 Exception

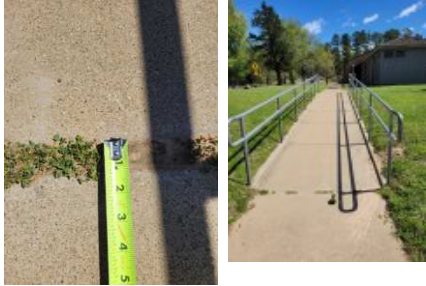
289	Group Dining Hall: Dining Hall - Public Spaces	[33.008658, -94.6989857]	Openings in floor or ground surfaces shall not allow passage of a sphere more than 1/2 inch (13 mm) diameter except as allowed in 407.4.3, 409.4.3, 410.4, 810.5.3 and 810.10. Elongated openings shall be placed so that the long dimension is perpendicular to the dominant direction of travel.	1.25" gap at bottom, .75" at top, 1" gap on two sides of level landing	Fill and maintain gaps to max .5"	2015 ABAAS Section: 302.3 2012 TAS Section: 302.3 2010 ADAS Section: 302.3

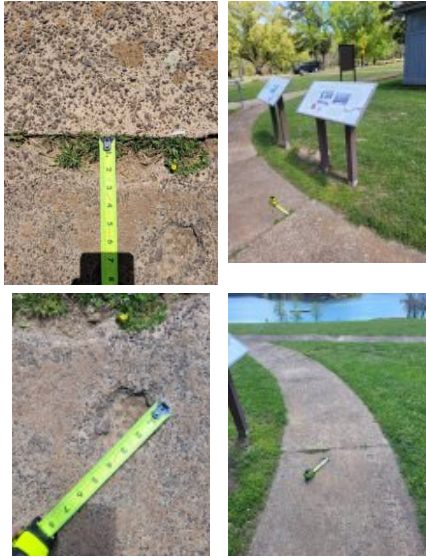
Finding Number	Area Description	Lat/Long	Finding	As Built	Recommendation	Citation	Photos	Figure
290	Group Dining Hall: Dining Hall - Public Spaces	[33.0086198 , -94.698929 4]	There is a gap spaced greater than a 1/2 inch. Openings in floor or ground surfaces shall not allow passage of a sphere more than 1/2 inch diameter. Elongated openings shall be placed so that the long dimension is perpendicular to the dominant direction of travel.	2.5" gap and 3" gap at sign to side of park store	Correct or fill gaps to be max .5"	2015 ABAAS Section: 302.3 2012 TAS Section: 302.3 2010 ADAS Section: 302.3

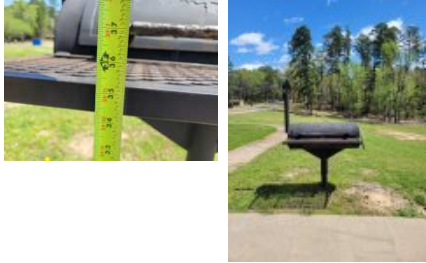
292	Group Dining Hall: Dining Hall - Public Spaces	[33.0087536 , -94.698429 1]	Where provided, cooking surfaces shall be 15 inches (380 mm) minimum and 34 inches (865 mm) maximum above the ground	Grill 35.25" AFF	Raise or lower cooking surface to be 15" min to 34" max above the ground; in the alternative, replace with a compliant surface as a smart practice	2015 ABAAS Section: 1011.5.2

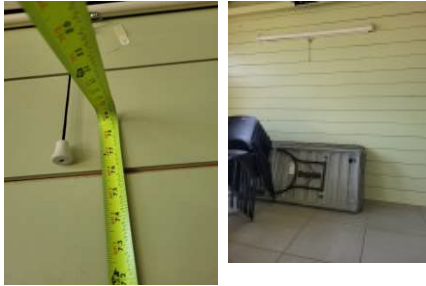
Finding Number	Area Description	Lat/Long	Finding	As Built	Recommendation	Citation	Photos	Figure
296	Group Dining Hall: Dining Hall - Public Spaces	[33.0088211 , -94.6984627]	The operable part is positioned too high for either a side or front approach. Where a clear floor or ground space allows a parallel approach to an element and the side reach is unobstructed, the high side reach shall be 48 inches maximum and the low side reach shall be 15 inches minimum above the finish floor or ground. Where a forward reach is unobstructed, the high forward reach shall be 48 inches maximum and the low forward reach shall be 15 inches minimum above the finish floor or ground.	Projector screen 77" AFF	Remount operable parts to be in reach range of 15" min to 48" max	2015 ABAAS Section: 308.1 2012 TAS Section: 308.1 2010 ADAS Section: 308.1

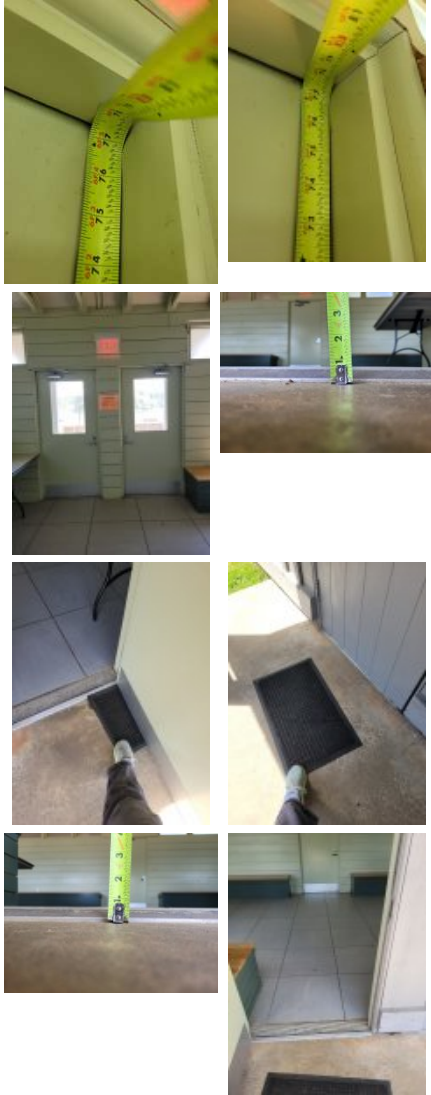
Finding Number	Area Description	Lat/Long	Finding	As Built	Recommendation	Citation	Photos	Figure
297	Group Dining Hall: Dining Hall - Public Spaces	[33.0088132 , -94.6984707]	Door openings shall provide a clear width of 32 inches (815 mm) minimum. Clear openings of doorways with swinging doors shall be measured between the face of the door and the stop, with the door open 90 degrees. Openings more than 24 inches (610 mm) deep shall provide a clear opening of 36 inches (915 mm) minimum. There shall be no projections into the required clear opening width lower than 34 inches (865 mm) above the finish floor or ground. Projections into the clear opening width between 34 inches (865 mm) and 80 inches (2030 mm) above the finish floor or ground shall not exceed 4 inches (100 mm). The threshold has a vertical change greater than 1/4 inch high. The threshold at a doorway shall be no higher than 1/2 inch. Changes in level between 1/4 inch and 1/2 inch must be beveled at 1:2 or less. 1/4 inch is the maximum vertical rise.	Window doors on backside - 77.5" AFF overhead on both, .75" CIL on both, slip mats on both	For all doors along the public circulation route, replace doors with doors having 80" overhead clearance and 32" clear width. For all doors along the public circulation route, repair, bevel, or ramp CILs at door entries to max .25". For all doors along the public circulation route, repair, provide beveled threshold. Secure edges of floor mats	2010 ADAS Section: 404.2.3, 404.2.7, 404.2.4, 404.2.11, 404.2.11 Exception

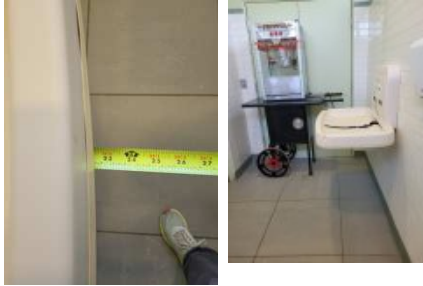
304	Group Dining Hall: Dining Hall - Unisex Restroom	[33.0088312 , -94.698438 5]	The baby changing table is not compliant. Baby changing tables are work surfaces. If fixed or built-in baby changing tables are provided, at least 5%, but not less than one, must comply with TAS 902 based TAS 226.1. Baby changing tables cannot violate the protruding object requirements in either an open or closed position since either position is a potential hazard for persons with visual impairments. Baby changing tables are not prohibited from being located in wheelchair accessible toilet compartments; however, the minimum space required for the compartment cannot be obstructed by the baby changing table in either an open or closed position. The clear floor space required for a baby changing table may overlap the water closet clearance since baby changing tables are considered convenience "fixtures" based on Advisory 604.8.1.1. The overlap is applicable only to the clear floor space and not to actual table itself. Baby changing tables must be dispersed throughout a space, however, an additional baby changing table is not required in a common use area of a toilet or bathing room when the only baby changing table is located in a toilet compartment.	Baby changing table 22.5" when open	Relocate baby changing table to eliminate protrusion when in the open position.	2012 TAS Section: 226.1, 902.3, 604.3.2, 204.1, 226.1 Advisory, 226.2, 307.1, 604.8.1.1 Advisory, 902.1, 902.1 Advisory, 902.2

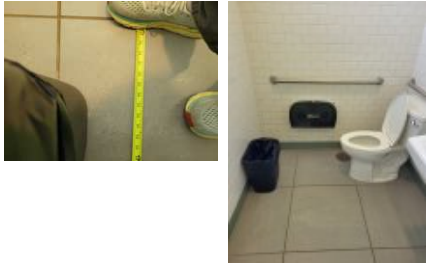
Finding Number	Area Description	Lat/Long	Finding	As Built	Recommendation	Citation	Photos	Figure
305	Group Dining Hall: Dining Hall - Unisex Restroom	[33.0088357 , -94.698441 2]	The required 56 inches by 60 inches clear floor space for the water closet has been obstructed. The clear floor space around the water closet shall be 60 inches minimum measured perpendicular from the side wall and 56 inches minimum measured perpendicular from the rear wall.	Trash 53" from wall	Relocate trash can to provide required 60" clearance around toilet	2015 ABAAS Section: 604.3. 2012 TAS Section: 604.3.1 2010 ADAS Section: 604.3.1

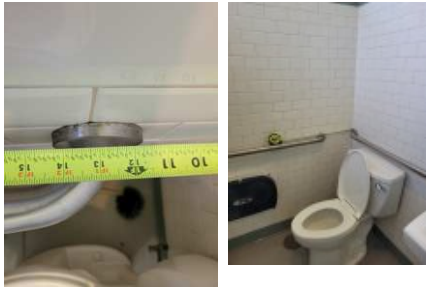
306	Group Dining Hall: Dining Hall - Unisex Restroom	[33.0088323 , -94.698434 5]	The side grab bars are not in the correct location. Grab bars on the side wall must be installed so that the end closest to the rear wall is maximum 12" from the rear wall. The end furthest from the rear wall must be mounted minimum 54" from the rear wall.	Grab bar mounted 13" from rear wall	Remount side grab bar to max 12" from the rear wall at the close end and min 54" on the far end, and 33" to 36" AFF	2015 ABAAS Section: 604.5.1 2012 TAS Section: 604.5.1 2010 ADAS Section: 604.5.1

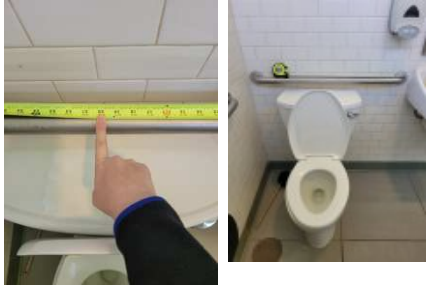
307	Group Dining Hall: Dining Hall - Unisex Restroom	[33.0088323 , -94.698435 8]	The rear grab bar is not mounted in the correct location. The rear grab bar must be a minimum of 36" long and extend from the toilet centerline a minimum 12" towards the wall side and a minimum 24" towards the open side of the toilet. Grab bars shall be installed in a horizontal position, 33 inches minimum and 36 inches maximum above the finish floor measured to the top of the gripping surface and the space between the grab bar and the top of the tank shall be 1-1/2 inches minimum.	Grab bar 20" center from open side	Remount rear grab bar to behind the toilet, 12" to the wall side of center and 24" to the open side and 33" to 36" AFF	2015 ABAAS Section: 604.5.2 2012 TAS Section: 604.5.2 2010 ADAS Section: 604.5.2

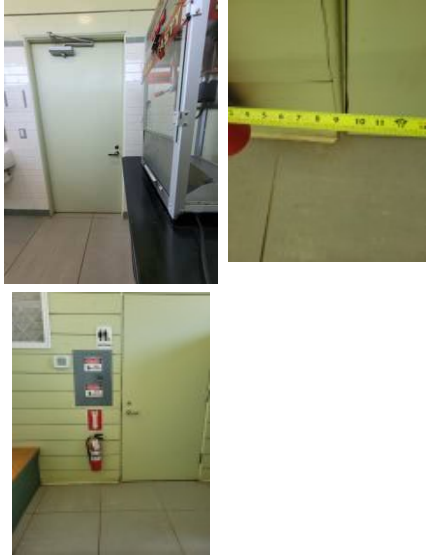
Finding Number	Area Description	Lat/Long	Finding	As Built	Recommendation	Citation	Photos	Figure
308	Group Dining Hall: Dining Hall - Unisex Restroom	[33.0088312 , -94.698438 5]	<p>Minimum maneuvering clearances at doors and gates shall comply with 404.2.4. Maneuvering clearances shall extend the full width of the doorway and the required latch side or hinge side clearance. Maneuvering clearances shall have a max slope of 2.08%. Door openings shall provide a clear width of 32 inches (815 mm) minimum. Clear openings of doorways with swinging doors shall be measured between the face of the door and the stop, with the door open 90 degrees. Openings more than 24 inches (610 mm) deep shall provide a clear opening of 36 inches (915 mm) minimum. There shall be no projections into the required clear opening width lower than 34 inches (865 mm) above the finish floor or ground. Projections into the clear opening width between 34 inches (865 mm) and 80 inches (2030 mm) above the finish floor or ground shall not exceed 4 inches (100 mm). The threshold has a vertical change greater than 1/4 inch high. The threshold has a gap greater than 1/2 inch wide. The threshold at a doorway shall be no higher than 1/2 inch. Changes in level between 1/4 inch and 1/2 inch must be beveled at 1:2 or less. 1/4 inch is the maximum vertical rise. All interior doors must be maintained so that the operating pressure does not exceed 5 lb. force to open. The sweep period for doors with closers shall be adjusted so that from an open position of 70 degrees, the door will take at least 3 seconds to move to a point 3 inches from the latch, measured to the leading edge of the door. Exterior doors are recommended to be maintained at 8.5 lbf as a smart practice. Force is to be measured at the operating hardware or 30 inches from the hinges, whichever is greater. Hand-activated door opening hardware, handles, pulls, latches, locks, and other operating devices on accessible doors shall have a shape that is easy to grasp with one hand and does not require tight grasping, tight pinching or twisting of the wrist to operate.</p>	restroom- maneuvering clearance on push reduced by popcorn machine, 13# push, maneuvering clearance on pull reduced 9" by fire extinguisher	For all doors along the public circulation route, provide required maneuvering clearance on push and pull side of doors. Relocate popcorn machine and fire extinguisher For all doors along the public circulation route, inspect, adjust, and maintain 8.5 LBF to open exterior doors as a smart practice.	2010 ADAS Section: 404.2.3, 404.2.7, 404.2.4, 404.2.11, 404.2.11 Exception

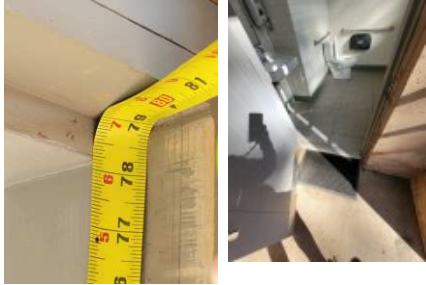
Finding Number	Area Description	Lat/Long	Finding	As Built	Recommendation	Citation	Photos	Figure
309	Little Pine Interpretive Center: Little Pine Interpretive Center - Public Spaces	[33.0084724 , -94.700537 4]	Vertical clearance shall be 80 inches (2030 mm) high minimum. Guardrails or other barriers shall be provided where the vertical clearance is less than 80 inches (2030 mm) high. The leading edge of such guardrail or barrier shall be located 27 inches (685 mm) maximum above the finish floor or ground. EXCEPTION: Door closers and door stops shall be permitted to be 78 inches (1980 mm) minimum above the finish floor or ground.	restroom- 79" AFF at door	Replace doors with doors having 80" overhead clearance Replace closer with one mounted min of 78" AFF	2015 ABAAS Section: 307.4, 307.4 EXCEPTION 2012 TAS Section: 307.4, 307.4 Exception 2010 ADAS Section: 307.4, 307.4 Exception

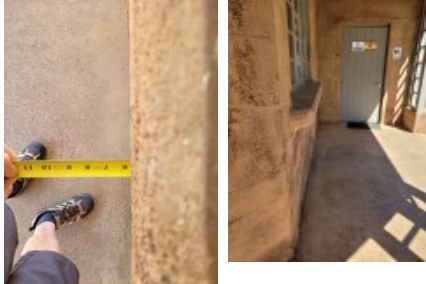
311	Little Pine Interpretive Center: Little Pine Interpretive Center - Public Spaces	[33.0084469 , -94.700570 5]	An item or items project more than 4 inches into the circulation path. Wall-mounted objects that have leading edges between 27 inches and 80 inches from the floor must not project more than 4 inches into the circulation path. Protruding objects that extend to the floor or within 27 inches of the floor are cane detectable and are therefore not hazardous. Where it is necessary or desirable to have objects protrude from the wall, a manner of cane detection must be provided.	Window sill projects 6"	Relocate protruding objects or place cane detectable warning or bollard at foot of item	2015 ABAAS Section: 307.2 2012 TAS Section: 307.2 2010 ADAS Section: 307.2

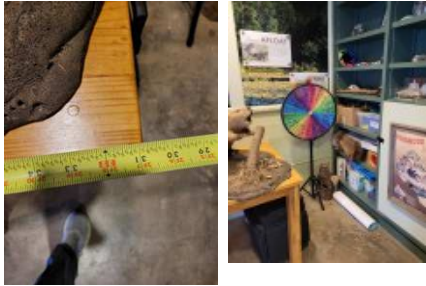
Finding Number	Area Description	Lat/Long	Finding	As Built	Recommendation	Citation	Photos	Figure
312	Little Pine Interpretive Center: Little Pine Interpretive Center - Public Spaces	[33.0084724 , -94.700537 4]	The route of travel at this location does not provide a minimum width of 36 inches. The clear width shall be permitted to be reduced to 32 inches minimum for a length of 24 inches maximum provided that reduced width segments are separated by segments that are 48 inches long minimum and 36 inches wide minimum.	31" width to "flowers afloat" signage in corner due to table	Relocate storage and furniture to widen AR to compliant 36" clear width	2015 ABAAS Section: 403.5.1 2012 TAS Section: 403.5.1 2010 ADAS Section: 403.5.1

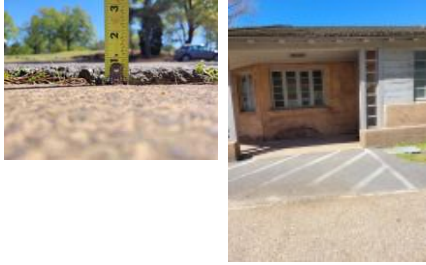
Finding Number	Area Description	Lat/Long	Finding	As Built	Recommendation	Citation	Photos	Figure
317	Little Pine Interpretive Center: Little Pine Interpretive Center - Public Spaces	[33.0084263 , -94.700482 4]	The walkway contains abrupt vertical edges and/or variations over a 1/4 inch. 1/4 inch is the maximum vertical rise. Changes in level between 1/4 inch and 1/2 inch must be beveled at 1:2 or less. Changes in level greater than 1/2 inch must be by way of a ramp.	.5" CIL at entry to interpretive center from parking lot	Repair, bevel or ramp CIL along AR.	2012 TAS Section: 303.2, 303.3 2010 ADAS Section: 303.2, 303.3

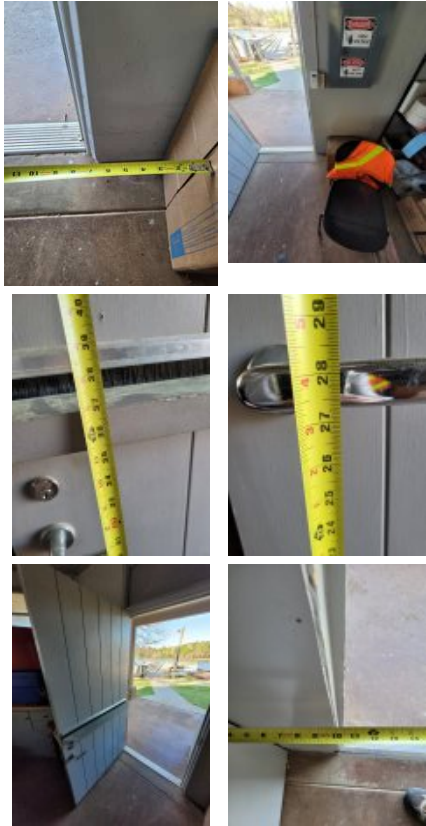
318	Little Pine Interpretive Center: Little Pine Interpretive Center - Employee Spaces	[33.0084668 , -94.700542 7]	Spaces and elements within employee work areas shall only be required to comply with 206.2.8, 207.1, and 215.3 and shall be designed and constructed so that individuals with disabilities can approach, enter, and exit the employee work area. Employee work areas, or portions of employee work areas, other than raised courtroom stations, that are less than 300 square feet (28 m2) and elevated 7 inches (180 mm) or more above the finish floor or ground where the elevation is essential to the function of the space shall not be required to comply with these requirements or to be on an accessible route.	1st office, Chair and storage block pull side, 27" AFF to lever hardware, 37" AFF to door counter; Office 2, 10" desk blocks pull side, employee door from Office 2 to Interpretive Center, 11.1% slope in doorway, 33" AFF to hardware, door does not fully open due to unsecured floor mat, 14" pull side due to storage	For employee spaces, relocate storage, furniture, and flapper obstacle at doorways to provide approach, enter and exit at the employee space. For all doors along the public circulation route, replace shelf with one that protrudes max 4" and less than 36" AFF Correct slope in door clearance to 2.08% max. Tape edges of unsecured floor mats	2015 ABAAS Section: F203.9 2012 TAS Section: 203.9 2010 ADAS Section: 203.9

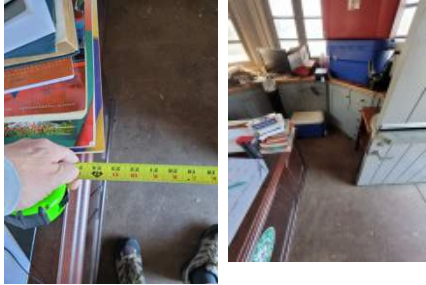
Finding Number	Area Description	Lat/Long	Finding	As Built	Recommendation	Citation	Photos	Figure
319	Little Pine Interpretive Center: Little Pine Interpretive Center - Employee Spaces	[33.0084747 , -94.7005347]	Employee Work Areas. Common use circulation paths within employee work areas shall comply with 402.	Office 1, 24.5" width due to storage	Remove storage to make corrections for compliant circulation path.	2015 ABAAS Section: F206.2.8, F206.2.8.1, F206.2.8.2 2012 TAS Section: 206.2.8, 206.2.8 Exception 1, 206.2.8 Exception 2, 206.2.8 Exception 3, 206.2.8 Advisory 1, 206.2.8 Advisory 2 2010 ADAS Section: 206.2.8, 206.2.8 Exception 1, 206.2.8 Exception 2, 206.2.8 Exception 3

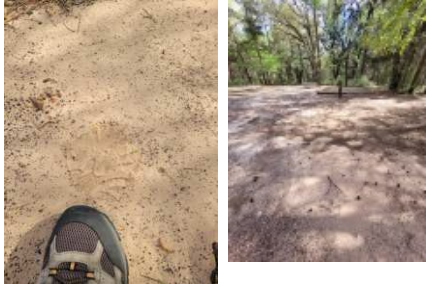
Finding Number	Area Description	Lat/Long	Finding	As Built	Recommendation	Citation	Photos	Figure
325	Cedar Ridge Camping Area: Cedar Ridge - Sample Campsite	[33.0121612 , -94.6991305]	The surface of trails, passing spaces, and resting intervals shall be firm and stable	Entire site natural surface, not firm and stable	Leave trail as is and make other trails at the site accessible	2015 ABAAS Section: 1017.2

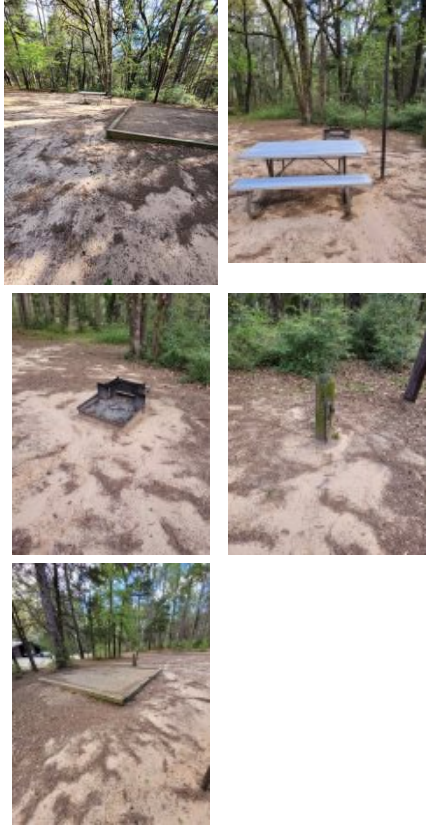
326	Cedar Ridge Camping Area: Cedar Ridge - Sample Campsite	[33.0121668 , -94.6991346]	The surface of the outdoor recreation access route, passing spaces, and/or resting intervals are not firm and stable. The surface of outdoor recreation access route, passing spaces, and resting intervals shall be firm and stable, having a width of 36", max gaps of .5" and tread obstacles of .5" or less.	Lacks AR to tent pad, picnic table, grill, water spout	Correct surface of ORAR to be firm and stable, a min 36" wide and having gaps and changes in level of max .5"	2015 ABAAS Section: 1016.2

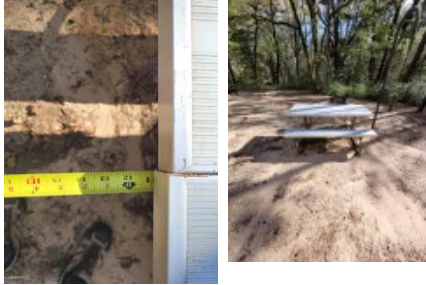
Finding Number	Area Description	Lat/Long	Finding	As Built	Recommendation	Citation	Photos	Figure
327	Cedar Ridge Camping Area: Cedar Ridge - Sample Campsite	[33.0121645 , -94.699138 6]	Picnic tables shall provide at least one wheelchair space for each 24 linear feet (7320 mm) of usable table surface perimeter. Wheelchair spaces shall be 30 inches (760 mm) minimum by 48 inches (1220 mm) minimum. Wheelchair spaces shall be positioned for a forward approach to the table and provide knee and toe clearance complying with 306 under the table	11" knee space, lacks CFS	Replace picnic table with one of an accessible design as a smart practice	2015 ABAAS Section: 1011.4.2

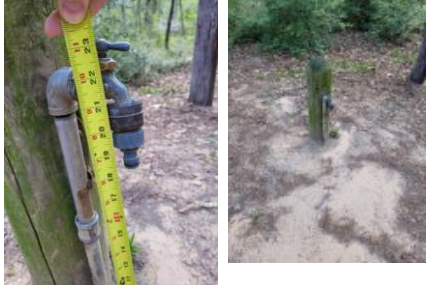
328	Cedar Ridge Camping Area: Cedar Ridge - Sample Campsite	[33.0121623 , -94.699134 6]	Water spouts at water hydrants and water utility hook-ups shall be 28 inches (710 mm) minimum and 36 inches (915 mm) maximum above the ground	21" AGL to water spout, lacks CFS	Remount water spouts to 28" min or 36" max above the ground as a smart practice	2015 ABAAS Section: 1011.6

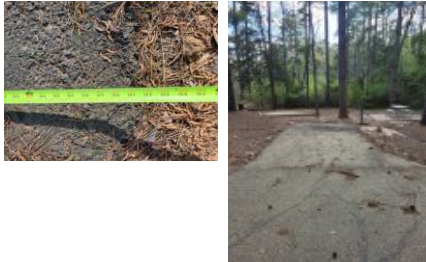
Finding Number	Area Description	Lat/Long	Finding	As Built	Recommendation	Citation	Photos	Figure
338	Mountain View Camping Area: Mountain View - Sample Campsite	[33.0126998 , -94.6995329]	Camping facilities shall provide camping units with mobility features complying with F244.2 in accordance with Table F244.2. Where a camping facility provides different types of camping units, Table F244.2 shall apply to each type of camping unit provided. Total Number of Camping Units Provided in Camping Facility Minimum Number of Camping Units with Mobility Features Required 1 1 2 to 25 2 26 to 50 3 51 to 75 4 76 to 100 5 101 to 150 7 151 to 200 8 201 and over 8, plus 2 percent of the number over 200	0 of 12 accessible camp sites, 0 of 30 total non-premium full hook up sites accessible	Create the required number of accessible camp sites per table F244.2 as a smart practice	2015 ABAAS Section: F244.2		
339	Mountain View Camping Area: Mountain View - Sample Campsite	[33.0127055 , -94.6995369]	Parking spaces and pull-up spaces for recreational vehicles shall be 20 feet (6100 mm) wide minimum. EXCEPTION: Where two adjacent parking spaces are provided for recreational vehicles, one parking space shall be permitted to be 16 feet (4880 mm) wide minimum.	12' 7" wide parking space	Correct RV parking space to be 20' wide minimum; or 16' for two adjacent spaces as a smart practice.	2015 ABAAS Section: 1012.2, 1012.2 EXCEPTION

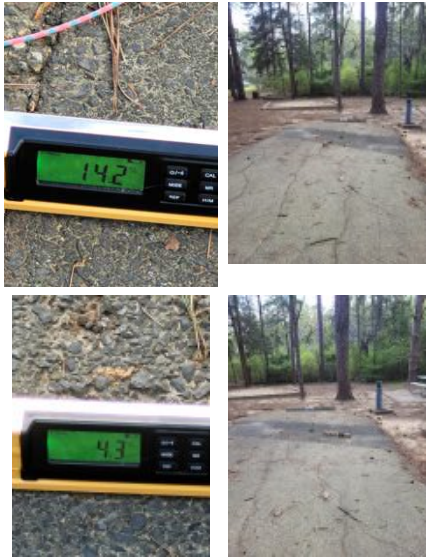
340	Mountain View Camping Area: Mountain View - Sample Campsite	[33.0126931 , -94.6995235]	The surface of parking spaces and pull-up spaces shall be firm and stable. The slope of the surface of parking spaces and pull-up spaces shall not be steeper than 1:48 in any direction. EXCEPTION: Where the surface is other than asphalt, concrete, or boards, slopes not steeper than 1:20 shall be permitted when necessary for drainage.	14.2% slope, 4.3% slope	Correct surface of parking spaces to be firm and stable with slopes max of 2.08% or 5% for surfaces other than concrete, asphalt or boards as a smart practice.	2015 ABAAS Section: 1012.4, 1012.5, 1012.5 EXCEPTION

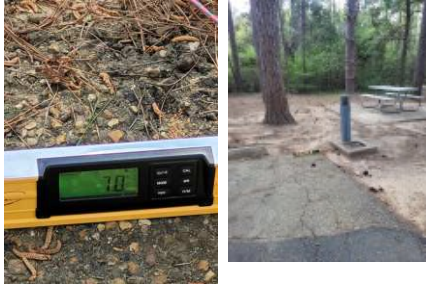
Finding Number	Area Description	Lat/Long	Finding	As Built	Recommendation	Citation	Photos	Figure
341	Mountain View Camping Area: Mountain View - Sample Campsite	[33.0126931 , -94.6995208]	30 inches (760 mm) by 60 inches (1525 mm) with the long side of the space adjoining or overlapping an accessible parking space or pull-up space for recreational vehicles. Locate the space so that the hook-ups are at the rear center of the space. Bollards or other barriers shall not obstruct the clear ground space in front of the hook-ups	7% slope in CFS	Correct slope in clear ground space to max 2.08%	2015 ABAAS Section: 1011.2

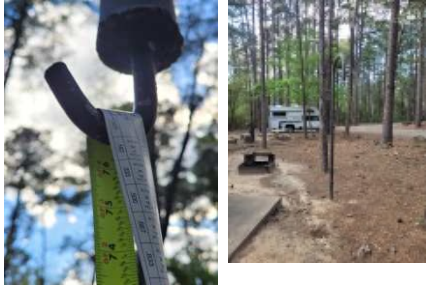
342	Mountain View Camping Area: Mountain View - Sample Campsite	[33.0126953 , -94.6995262]	The operable part is positioned too high for either a side or front approach. Where a clear floor or ground space allows a parallel approach to an element and the side reach is unobstructed, the high side reach shall be 48 inches maximum and the low side reach shall be 15 inches minimum above the finish floor or ground. Where a forward reach is unobstructed, the high forward reach shall be 48 inches maximum and the low forward reach shall be 15 inches minimum above the finish floor or ground.	77" to hook	Remount operable parts to be in reach range of 15" min to 48" max	2015 ABAAS Section: 308.1 2012 TAS Section: 308.1 2010 ADAS Section: 308.1

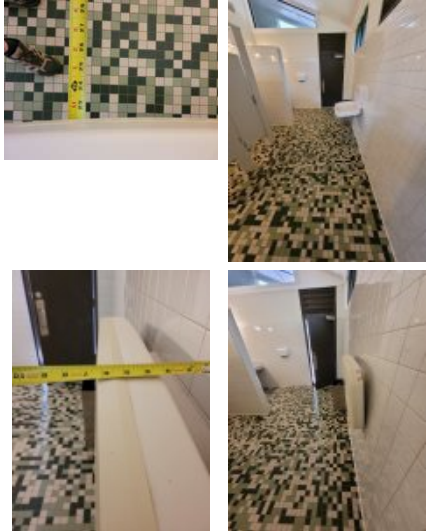
Finding Number	Area Description	Lat/Long	Finding	As Built	Recommendation	Citation	Photos	Figure
347	Mountain View Camping Area: Mountain View - Men's Restroom	[33.0123861, -94.6996039]	The baby changing table is not compliant. Baby changing tables are work surfaces. If fixed or built-in baby changing tables are provided, at least 5%, but not less than one, must comply with TAS 902 based TAS 226.1. Baby changing tables cannot violate the protruding object requirements in either an open or closed position since either position is a potential hazard for persons with visual impairments. Baby changing tables are not prohibited from being located in wheelchair accessible toilet compartments; however, the minimum space required for the compartment cannot be obstructed by the baby changing table in either an open or closed position. The clear floor space required for a baby changing table may overlap the water closet clearance since baby changing tables are considered convenience "fixtures" based on Advisory 604.8.1.1. The overlap is applicable only to the clear floor space and not to actual table itself. Baby changing tables must be dispersed throughout a space, however, an additional baby changing table is not required in a common use area of a toilet or bathing room when the only baby changing table is located in a toilet compartment.	Baby changing table protrudes 23.5"	Relocate baby changing table to eliminate protrusion when in the open position.	2012 TAS Section: 226.1, 902.3, 604.3.2, 204.1, 226.1 Advisory, 226.2, 307.1, 604.8.1.1 Advisory, 902.1, 902.1 Advisory, 902.2

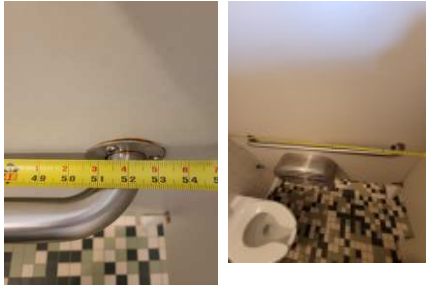
Finding Number	Area Description	Lat/Long	Finding	As Built	Recommendation	Citation	Photos	Figure
349	Mountain View Camping Area: Mountain View - Men's Restroom	[33.0123748, -94.6996039]	The side grab bars are not in the correct location. Grab bars on the side wall must be installed so that the end closest to the rear wall is maximum 12" from the rear wall. The end furthest from the rear wall must be mounted minimum 54" from the rear wall.	Grab bar does not extend far enough, 52"	Remount side grab bar to max 12" from the rear wall at the close end and min 54" on the far end, and 33" to 36" AFF	2015 ABAAS Section: 604.5.1 2012 TAS Section: 604.5.1 2010 ADAS Section: 604.5.1

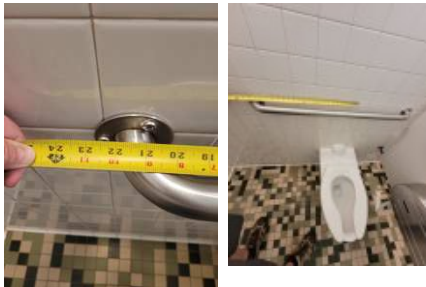
350	Mountain View Camping Area: Mountain View - Men's Restroom	[33.012376, -94.6996053]	The rear grab bar is not mounted in the correct location. Grab bars shall be installed in a horizontal position, 33 inches minimum and 36 inches maximum above the finish floor measured to the top of the gripping surface and the space between the grab bar and the top of the tank shall be 1-1/2 inches minimum.	Bar extends 22" toward open side	Remount rear grab bar to behind the toilet, 12" to the wall side of center and 24" to the open side and 33" to 36" AFF	2015 ABAAS Section: 604.5.2 2012 TAS Section: 604.5.2 2010 ADAS Section: 604.5.2

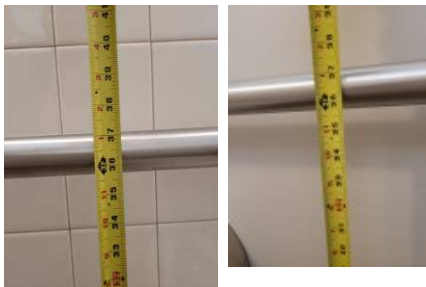
351	Mountain View Camping Area: Mountain View - Men's Restroom	[33.0124029, -94.699608]	The grab bar height and/or spacing fails. Grab bars must be mounted between 33" and 36" to the top of the gripping surface. There must be 1.5" of clearance between the grab bar and the wall. There must be a minimum of 1.5" of clearance below and minimum 12" above the grab bar to any dispenser or other obstruction.	1 bar at 37" AFF, 1 bar at 37.25" AFF	Remount grab bars in accessible stall to 33" to 36" above the finished floor (AFF)	2015 ABAAS Section: 609.3, 609.4 2012 TAS Section: 609.4, 609.3 2010 ADAS Section: 609.3, 609.4

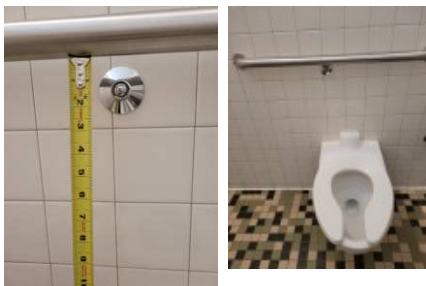
352	Mountain View Camping Area: Mountain View - Men's Restroom	[33.0123625, -94.6995919]	The flush control is located too close to grab bar Controls shall be operable with one hand and shall not require tight grasping, pinching or twisting. Controls for the flush valves shall be mounted on the wide side of toilet areas, no more than 44 inches above the floor.	Controls on open side but not 1.5" between rail	Relocate flush mechanism required distance from grab bar	2015 ABAAS Section: 604.6 2012 TAS Section: 604.6 2010 ADAS Section: 604.6

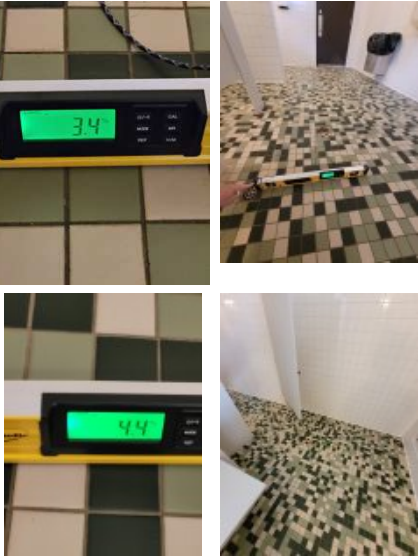
Finding Number	Area Description	Lat/Long	Finding	As Built	Recommendation	Citation	Photos	Figure
356	Mountain View Camping Area: Mountain View - Men's Restroom	[33.0123827 , -94.699613 3]	The accessible route in restroom contains slopes greater than 2 percent across the width of the walk and has not been constructed as a ramp (i.e. handrails, wheel guides, etc.). Surface slopes in restrooms must not exceed one unit vertical in 48 units. Horizontal (2-percent slope).	3.3% slope at accessible stall, 4.4% slope at bench CFS/drain	Correct or repair slope to max 2.08% in restroom.	2015 ABAAS Section: 403.3 2012 TAS Section: 403.3 2010 ADAS Section: 403.3

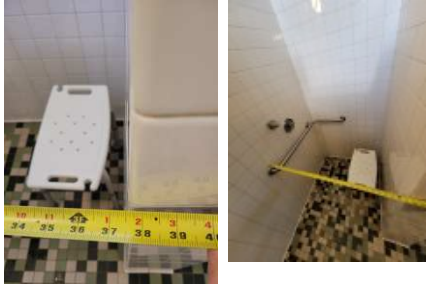
Finding Number	Area Description	Lat/Long	Finding	As Built	Recommendation	Citation	Photos	Figure
358	Mountain View Camping Area: Mountain View - Men's Restroom	[33.0123782 , -94.6996133]	Alternate roll-in type shower compartments shall be 36 inches (915 mm) wide and 60 inches (1525 mm) deep minimum clear inside dimensions measured at center points of opposing sides. A 36 inch (915 mm) wide minimum entry shall be provided at one end of the long side of the compartment.	37.5" wide shower	Reduce shower stall, if feasible, to compliant dimensions for an alternate roll in shower of 36" deep by 60" wide with a 36" opening on the long dimension	2015 ABAAS Section: 608.2.3 2012 TAS Section: 608.2.3 2010 ADAS Section: 608.2.3

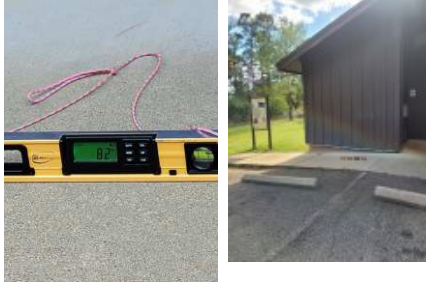
360	Mountain View Camping Area: Mountain View - Men's Restroom	[33.0123737 , -94.6995919]	The force required to operate the element exceeds the maximum. The force required to activate operable parts is 5 pounds maximum.	6 LBF to operate shower control	Adjust operating mechanism to be usable with 5 LBF or less	2015 ABAAS Section: 309.4 2012 TAS Section: 309.4 2010 ADAS Section: 309.4		
361	Mountain View Camping Area: Mountain View - Men's Restroom	[33.012322 , -94.6995329]	The running slope of walking surfaces shall not be steeper than 1:20.	8.2% slope from men's restroom to signage	Correct running slope along the AR to max 5%	2015 ABAAS Section: 403.3 2012 TAS Section: 403.3 2010 ADAS Section: 403.3

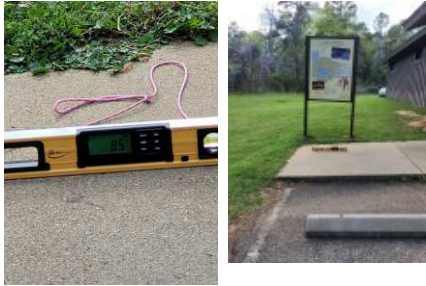
Finding Number	Area Description	Lat/Long	Finding	As Built	Recommendation	Citation	Photos	Figure
362	Mountain View Camping Area: Mountain View - Men's Restroom	[33.0123096 , -94.699530 2]	Clear floor space is not provide at the tactile door sign. Signs containing tactile Characters shall be located so that a clear floor space of 18 inches minimum by 18 inches minimum, centered on the tactile Characters, is provided beyond the arc of any door swing between the closed position and 45 degree open position.	8.5% CFS at sign by men's restroom	Correct slope in CFS at sign to max 2.08%	2015 ABAAS Section: 703.4.2 2012 TAS Section: 703.4.2 2010 ADAS Section: 703.4.2

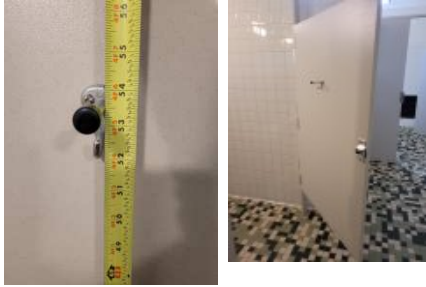
364	Mountain View Camping Area: Mountain View - Women's Restroom	[33.0123849 , -94.699599 9]	The operable part is positioned too high for either a side or front approach. Where a clear floor or ground space allows a parallel approach to an element and the side reach is unobstructed, the high side reach shall be 48 inches maximum and the low side reach shall be 15 inches minimum above the finish floor or ground. Where a forward reach is unobstructed, the high forward reach shall be 48 inches maximum and the low forward reach shall be 15 inches minimum above the finish floor or ground.	hook in accessible stall - 52" AFF	Remount operable parts to be in reach range of 15" min to 48" max	2015 ABAAS Section: 308.1 2012 TAS Section: 308.1 2010 ADAS Section: 308.1

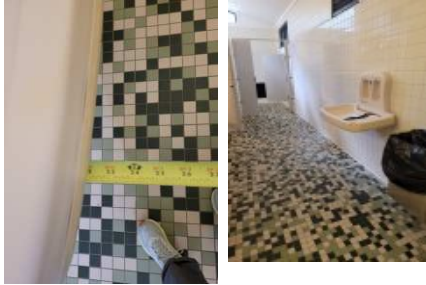
Finding Number	Area Description	Lat/Long	Finding	As Built	Recommendation	Citation	Photos	Figure
365	Mountain View Camping Area: Mountain View - Women's Restroom	[33.0123692 , -94.6996267]	The baby changing table is not compliant. Baby changing tables are work surfaces. If fixed or built-in baby changing tables are provided, at least 5%, but not less than one, must comply with TAS 902 based TAS 226.1. Baby changing tables cannot violate the protruding object requirements in either an open or closed position since either position is a potential hazard for persons with visual impairments. Baby changing tables are not prohibited from being located in wheelchair accessible toilet compartments; however, the minimum space required for the compartment cannot be obstructed by the baby changing table in either an open or closed position. The clear floor space required for a baby changing table may overlap the water closet clearance since baby changing tables are considered convenience "fixtures" based on Advisory 604.8.1.1. The overlap is applicable only to the clear floor space and not to actual table itself. Baby changing tables must be dispersed throughout a space, however, an additional baby changing table is not required in a common use area of a toilet or bathing room when the only baby changing table is located in a toilet compartment.	22" projection	Relocate baby changing table to eliminate protrusion when in the open position.	2012 TAS Section: 226.1, 902.3, 604.3.2, 204.1, 226.1 Advisory, 226.2, 307.1, 604.8.1.1 Advisory, 902.1, 902.1 Advisory, 902.2

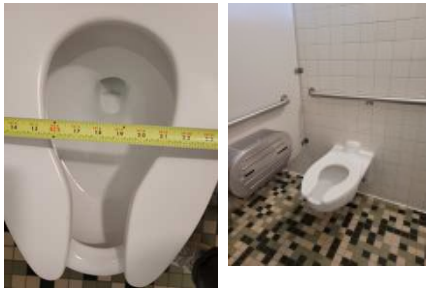
366	Mountain View Camping Area: Mountain View - Women's Restroom	[33.0123917 , -94.6995999]	The toilet is not located within the range allowed from the side wall or partition. The centerline of the toilet must be 16 to 18 inches from the side wall.	18.5" centerline of toilet	Remount toilets to 16" to 18" from the side wall to centerline	2015 ABAAS Section: 604.2 2012 TAS Section: 604.2 2010 ADAS Section: 604.2

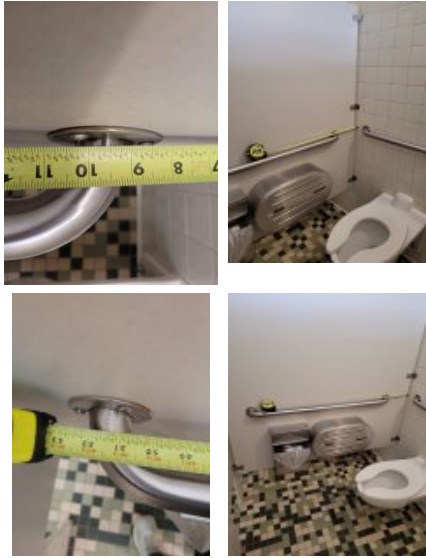
Finding Number	Area Description	Lat/Long	Finding	As Built	Recommendation	Citation	Photos	Figure
367	Mountain View Camping Area: Mountain View - Women's Restroom	[33.0123827 , -94.6995999 9]	The side grab bars are not in the correct location. Grab bars on the side wall must be installed so that the end closest to the rear wall is maximum 12" from the rear wall. The end furthest from the rear wall must be mounted minimum 54" from the rear wall.	Grab bar mounted 9.5" from rear wall, extends 51.5" to grab bar end	Remount side grab bar to max 12" from the rear wall at the close end and min 54" on the far end, and 33" to 36" AFF	2015 ABAAS Section: 604.5.1 2012 TAS Section: 604.5.1 2010 ADAS Section: 604.5.1

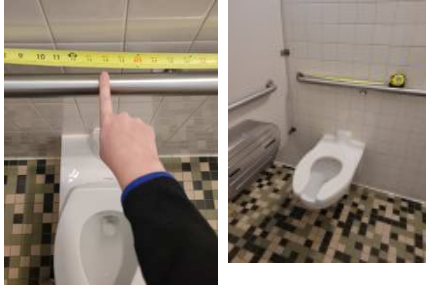
368	Mountain View Camping Area: Mountain View - Women's Restroom	[33.0123737 , -94.6996026 6]	The rear grab bar is not 36" long or is not mounted in the correct location. The rear grab bar must be a minimum of 36" long and extend from the toilet centerline a minimum 12" towards the wall side and a minimum 24" towards the open side of the toilet. Grab bars shall be installed in a horizontal position, 33 inches minimum and 36 inches maximum above the finish floor measured to the top of the gripping surface and the space between the grab bar and the top of the tank shall be 1-1/2 inches minimum.	14" centerline toilet, lacks 24" to open side	Remount rear grab bar to behind the toilet, 12" to the wall side of center and 24" to the open side and 33" to 36" AFF	2015 ABAAS Section: 604.5.2 2012 TAS Section: 604.5.2 2010 ADAS Section: 604.5.2

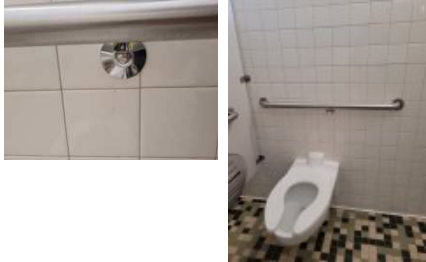
Finding Number	Area Description	Lat/Long	Finding	As Built	Recommendation	Citation	Photos	Figure
369	Mountain View Camping Area: Mountain View - Women's Restroom	[33.0123917 , -94.699586 5]	The flush control spacing fails. Grab bars must be mounted between 33" and 36" to the top of the gripping surface. There must be 1.5" of clearance between the grab bar and the wall. There must be a minimum of 1.5" of clearance below and minimum 12" above the grab bar to any dispenser or other obstruction.	Flush control button .5" below grab bar	Remount flush control 15" to 48" above the finished floor (AFF) and min 12" above or 1.5" below grab bar.	2015 ABAAS Section: 609.3, 609.4 2012 TAS Section: 609.4, 609.3 2010 ADAS Section: 609.3, 609.4

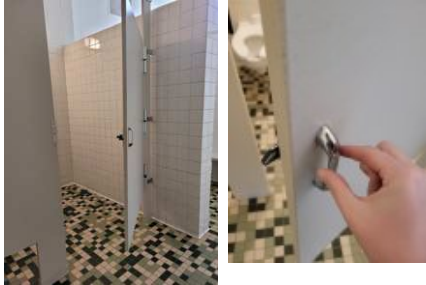
370	Mountain View Camping Area: Mountain View - Women's Restroom	[33.0123849 , -94.699591 9]	The stall door fails to comply with some of the door requirements. The stall door must have compliant hardware on both sides. The stall door must be self-closing.	stall door not self-closing	Adjust stall door to be self-closing	2015 ABAAS Section: 404.2.3, 404.2.7, 604.8.2.2 2012 TAS Section: 404.2.3, 404.2.7, 604.8.2.2 2010 ADAS Section: 404.2.3, 404.2.7, 604.8.2.2

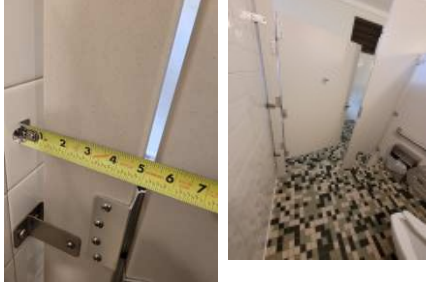
371	Mountain View Camping Area: Mountain View - Women's Restroom	[33.0123804 , -94.699586 5]	The compartment door is located too far from the partition or wall. The door shall be located in front of the clear space and diagonal to the water closet. Where located in the front partition, the door opening shall be 4 inches maximum from the side wall or partition farthest from the water closet. Where located in the side wall or partition, the door opening shall be 4 inches maximum from the front partition. Toilet compartment doors shall not swing into the minimum required compartment area.	4.75" partition	Rehang stall door to be max 4" from adjacent stall partition and on the stall wall farthest from the toilet	2015 ABAAS Section: 604.8.1.2 2012 TAS Section: 604.8.1.2 2010 ADAS Section: 604.8.1.2

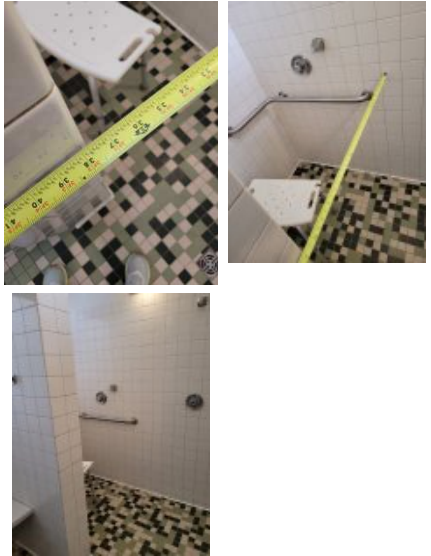
Finding Number	Area Description	Lat/Long	Finding	As Built	Recommendation	Citation	Photos	Figure
374	Mountain View Camping Area: Mountain View - Women's Restroom	[33.0123872 , -94.6995919]	Alternate roll-in type shower compartments shall be 36 inches (915 mm) wide and 60 inches (1525 mm) deep minimum clear inside dimensions measured at center points of opposing sides. A 36 inch (915 mm) wide minimum entry shall be provided at one end of the long side of the compartment.	Shower 37.75" width	Reduce shower stall, if feasible, to compliant dimensions for an alternate roll in shower of 36" deep by 60" wide with a 36" opening on the long dimension	2015 ABAAS Section: 608.2.3 2012 TAS Section: 608.2.3 2010 ADAS Section: 608.2.3

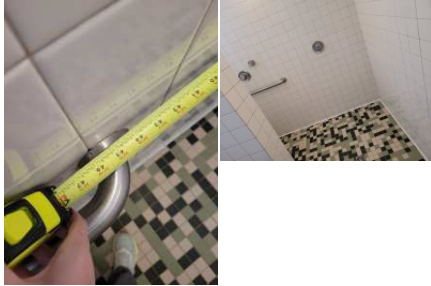
375	Mountain View Camping Area: Mountain View - Women's Restroom	[33.0123872 , -94.6995946]	The grab bar does not extend across back wall In alternate roll-in type shower compartments, grab bars shall be provided on the back wall and the side wall farthest from the compartment entry. Grab bars shall not be provided above the seat. Grab bars shall be installed 6 inches maximum from adjacent walls.	Grab bar 45.5" from open side	Provide grab bars in the shower mounted in the correct locations for the shower type	2015 ABAAS Section: 608.3.3 2012 TAS Section: 608.3.3 2010 ADAS Section: 608.3.3

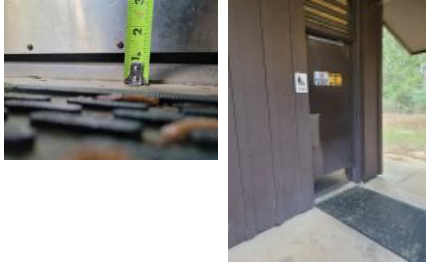
Finding Number	Area Description	Lat/Long	Finding	As Built	Recommendation	Citation	Photos	Figure
378	Mountain View Camping Area: Mountain View - Women's Restroom	[33.0123782 , -94.699594 6]	The threshold has a vertical change greater than 1/4 inch high. The threshold at a doorway shall be no higher than 1/2 inch. Changes in level between 1/4 inch and 1/2 inch must be beveled at 1:2 or less. 1/4 inch is the maximum vertical rise. Exterior doors are recommended to be maintained at 8.5 LBF as a smart practice. Force is to be measured at the operating hardware or 30 inches from the hinges, whichever is greater.	women's- 16 lbf, .75" CIL	For all doors along the public circulation route, repair, bevel, or ramp CILs at door entries to max .25". For all doors along the public circulation route, repair, provide beveled threshold. For all doors along the public circulation route, inspect, adjust, and maintain 8.5 LBF to open exterior doors as a smart practice.	2010 ADAS Section: 404.2.3, 404.2.7, 404.2.4, 404.2.11, 404.2.11 Exception

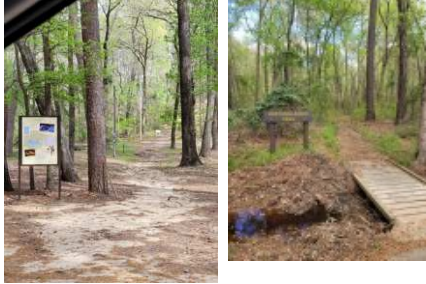
380	Trails: Trailhead	[33.0061658 , -94.691259 6]	At least one accessible route shall connect accessible buildings, accessible facilities, accessible elements, and accessible spaces that are on the same site. For areas of sport activity, an accessible route is required to connect to the boundary of each area of sport activity. The size of an area of sport activity includes only the space needed to play. Where multiple sports fields or courts are provided, an accessible route is required to each field or area of sport activity.	No AR to trailhead behind dogwood restroom, rustling leaves	Leave as is and make other trails at this site accessible	2010 ADAS Section: 206.2.2, 206.2
