Access Audit Site Report

Dinosaur Valley State Park

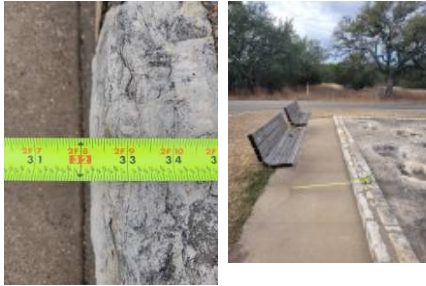
2	Headquarters Building: HQ - Parking and Exterior Accessible Route	[32.2462799, -97.813526 6]	Changes in level greater than 1/2 inch (13 mm) high shall be ramped, and shall comply with 405 or 406.	3" change in level (CIL) at parking to entry at HQ	Create a curb ramp to be max running slope 8.33%, max cross slope 2.08%, having a top landing as wide as the ramp and 36" deep and side flares with a max slope 10% along the AR where curbs are present.	2015 ABAAS Section: 303.4 2012 TAS Section: 303.4 2010 ADAS Section: 303.4

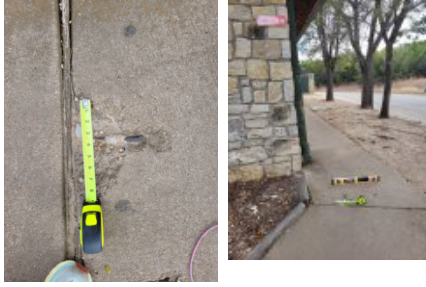
4	Headquarters Building: HQ - Parking and Exterior Accessible Route	[32.2462735, -97.813469 6]	The accessible route of travel on the accessible route contains cross slopes greater than 2%. Cross slopes shall not exceed one unit vertical in 48 units horizontal (2-percent slope).	3.3% cross slope at entry to path to HQ restroom	Correct or repair cross slope along AR to max 2.08%	2015 ABAAS Section: 403.3 2012 TAS Section: 403.3 2010 ADAS Section: 403.3

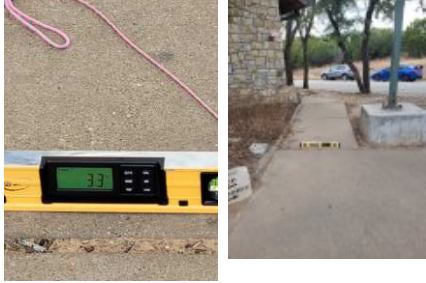
Dinosaur Valley State Park - 1629 Park Rd 59 Glen Rose, TX 76043

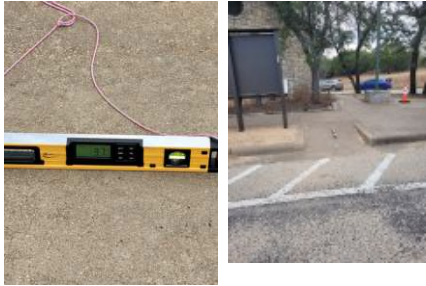
6	Headquarters Building: HQ - Parking and Exterior Accessible Route	[32.2463189 , -97.813535 3]	Element meets all standards and requirements	Parking at HQ meets scoping requirements - 11 standard, 1 accessible	None	2010 ADAS Section: N/A		
7	Headquarters Building: HQ - Parking and Exterior Accessible Route	[32.24632, -97.813539 3]	The cross slopes (narrow dimension) and/or running slopes (long dimension) of the access aisle exceeds 2%. The running slope and the cross slope in an accessible parking stall and the access aisle must not exceed 2%.	2.2% in stall at HQ	Repair or correct slope of parking space and access aisle to max 2.08% in any direction. In the alternative, leave as is citing construction tolerance.	2015 ABAAS Section: 502.4 2012 TAS Section: 502.4 2010 ADAS Section: 502.4

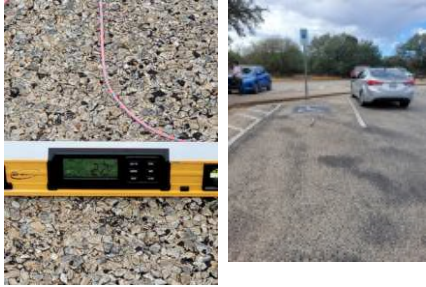
8	Headquarters Building: HQ - Parking and Exterior Accessible Route	[32.2463166 , -97.813531 3]	There are no van accessible parking stalls. 1 in every 6, minimum of one, required accessible stalls must be a van accessible stall. There are a total of 11 parking stalls in the parking lot that could be reasonably associated with this facility. There should be a minimum of 1 accessible stalls with a minimum of 1 being designed as van accessible.	no van spacing or sign at HQ	Add van parking sign to 1 accessible stall and repaint stall and access aisle to 11' and 5' or 8' and 8' per the table	2015 ABAAS Section: F208.2, F208.2.4 2012 TAS Section: 208.2, 208.2.4 2010 ADAS Section: 208.2, 208.2.4

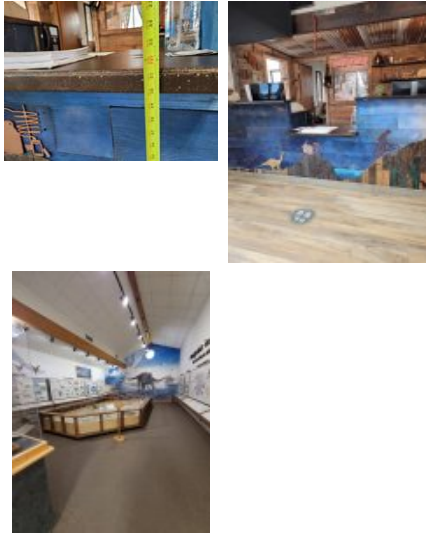
16	Headquarters Building: HQ - Public Spaces	[32.24621, -97.813383 8]	The sign does not sufficiently contrast with its background. Characters, symbols and their background shall have a non-glare finish and shall contrast with their background, either light on a dark background or dark on a light background. This includes pictograms and the symbol of access.	4 clear signs lack contrasting background	Replace sign with one having contrasting color and on a non-glare surface	2015 ABAAS Section: 703.5.1 , 703.6.2, 703.7.1 2012 TAS Section: 703.5.1 2010 ADAS Section: 703.5.1, 703.6.2, 703.7.1

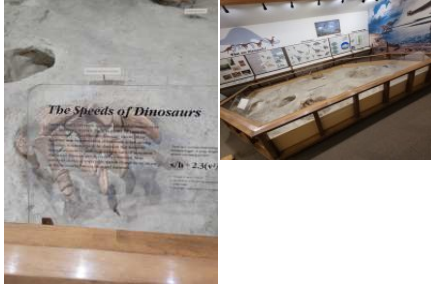
Finding Number	Area Description	Lat/Long	Finding	As Built	Recommendation	Citation	Photos	Figure
17	Headquarters Building: HQ - Public Spaces	[32.2462157 , -97.813386 5]	Thresholds, if provided at doorways, shall be 1/2 inch (13 mm) high maximum. Raised thresholds and changes in level at doorways shall comply with 302 and 303. Changes in level of 1/4 inch (6.4 mm) high maximum shall be permitted to be vertical. Changes in level between 1/4 inch (6.4 mm) high minimum and 1/2 inch (13 mm) high maximum shall be beveled with a slope not steeper than 1:2. Changes in level greater than 1/2 inch (13 mm) high shall be ramped, and shall comply with 405 or 406.	side door to restrooms at HQ - 1" change in level (CIL)	Repair, bevel or ramp CIL at doorway	2015 ABAAS Section: 303.3, 404.2.5, 303.2, 303.4 2012 TAS Section: 303.3, 404.2.5, 303.2, 303.4 2010 ADAS Section: 303.3, 404.2.5, 303.2, 303.4

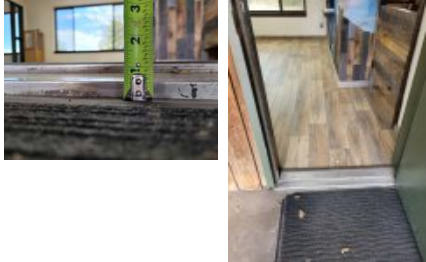
18	Headquarters Building: HQ - Womens Restroom	[32.2462089 , -97.813361]	The restroom sign does not comply with one or more applicable requirements for the location, height, and properties of the sign.	63" aff on door, no ISA	Replace sign with one of contrasting colors that includes Braille, raised characters, and the symbol of accessibility and mount on the wall, latch side of the door, 48" to the baseline of the lowest character and 60" to the baseline of the highest character	2015 ABAAS Section: F216.2, 703.1, 703.2, 703.5, 703.6 2012 TAS Section: 216.2, 703.1, 703.2, 703.5, 703.6 2010 ADAS Section: 216.2, 703.1, 703.2, 703.5, 703.6

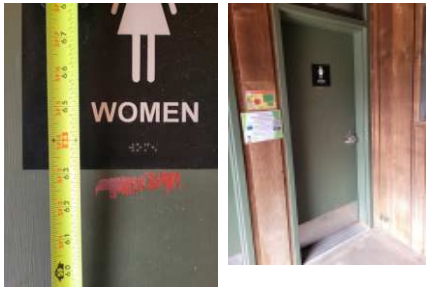
Finding Number	Area Description	Lat/Long	Finding	As Built	Recommendation	Citation	Photos	Figure
19	Headquarters Building: HQ - Womens Restroom	[32.2462145 , -97.813389 1]	The mirror is mounted too high. Mirrors must have the bottom edge of the reflecting surface a maximum of 40 inches above the floor if above a sink or counter. Mirrors not located above lavatories or countertops shall be installed with the bottom edge of the reflecting surface 35 inches maximum above the finish floor or ground.	mirror at 42" AFF	Lower mirror so reflective surface is max 40" AFF.	2015 ABAAS Section: 603.3 2012 TAS Section: 603.3 2010 ADAS Section: 603.3

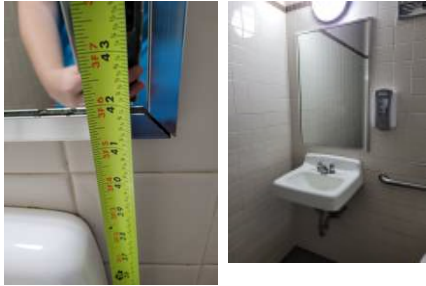
20	Headquarters Building: HQ - Womens Restroom	[32.2462179 , -97.813373]	The top rim of the sink is too high. All lavatories/sinks that are designated to be accessible shall be a minimum 17 inches in horizontal depth and mounted with the rim or counter edge no higher than 34 inches above the finished floor.	sink rim at 34.75" AFF	Lower sinks to max 34" aff to front of rim	2015 ABAAS Section: 606.3 2012 TAS Section: 606.3 2010 ADAS Section: 606.3

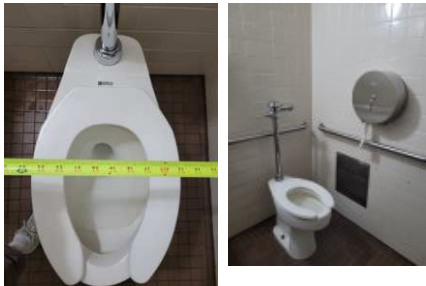
Finding Number	Area Description	Lat/Long	Finding	As Built	Recommendation	Citation	Photos	Figure
23	Headquarters Building: HQ - Womens Restroom	[32.2462213 , -97.813394 5]	The toilet seat is not located within the range allowed off the floor. The height of accessible water closets shall be a minimum of 17 inches and a maximum of 19 inches measured to the top of a maximum 2-inch high toilet seat.	seat 20" height	Replace toilet seat, or re-set or replace toilet to 17" to 19" AFF.	2015 ABAAS Section: 604.4 2012 TAS Section: 604.4 2010 ADAS Section: 604.4

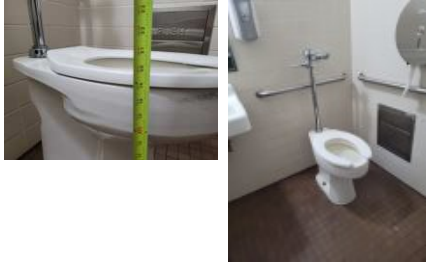
24	Headquarters Building: HQ - Womens Restroom	[32.2462066 , -97.813394 5]	The side grab bars are not in the correct location. Grab bars on the side wall must be installed so that the end closest to the rear wall is maximum 12" from the rear wall. The end furthest from the rear wall must be mounted minimum 54" from the rear wall.	side grab bar mounted 46" from rear wall	Remount side grab bar to max 12" from the rear wall at the close end and min 54" on the far end, and 33" to 36" AFF.	2015 ABAAS Section: 604.5.1 2012 TAS Section: 604.5.1 2010 ADAS Section: 604.5.1

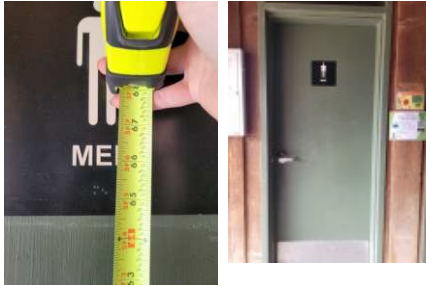
30	Headquarters Building: HQ - Mens Restroom	[32.2462157 , -97.813407 9]	The mirror is mounted too high. Mirrors must have the bottom edge of the reflecting surface a maximum of 40 inches above the floor if above a sink or counter. Mirrors not located above lavatories or countertops shall be installed with the bottom edge of the reflecting surface 35 inches maximum above the finish floor or ground.	Mirror at 43" aff	Lower mirror so reflective surface is max 40" aff	2015 ABAAS Section: 603.3 2012 TAS Section: 603.3 2010 ADAS Section: 603.3

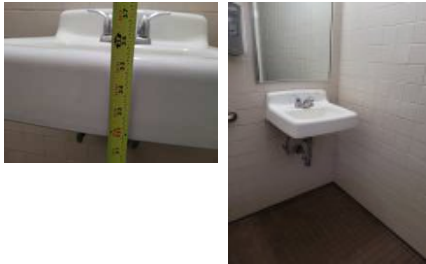
Finding Number	Area Description	Lat/Long	Finding	As Built	Recommendation	Citation	Photos	Figure
32	Headquarters Building: HQ - Mens Restroom	[32.2462111 , -97.813389 1]	The water and drain pipes under the lavatory are not adequately insulated. Water supply and drain pipes under lavatories and sinks shall be insulated or otherwise configured to protect against contact. There shall be no sharp or abrasive surfaces under lavatories and sinks.	Sink pipes not insulated	Insulate exposed pipes under one sink	2015 ABAAS Section: 606.5 2012 TAS Section: 606.5 2010 ADAS Section: 606.5

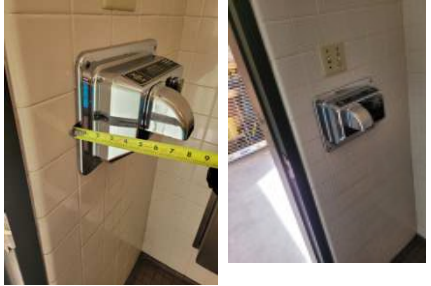
38	Headquarters Building: HQ - Mens Restroom	[32.24621, -97.8133865]	An item or items project more than 4 inches into the circulation path. Wall-mounted objects that have leading edges between 27 inches and 80 inches from the floor must not project more than 4 inches into the circulation path. Protruding objects that extend to the floor or within 27 inches of the floor are cane detectable and are therefore not hazardous. Where it is necessary or desirable to have objects protrude from the wall, a manner of cane detection must be provided.	hand dryer projects 7"	Relocate protruding objects or place cane detectable warning or bollard at foot of item.	2015 ABAAS Section: 307.2 2012 TAS Section: 307.2 2010 ADAS Section: 307.2

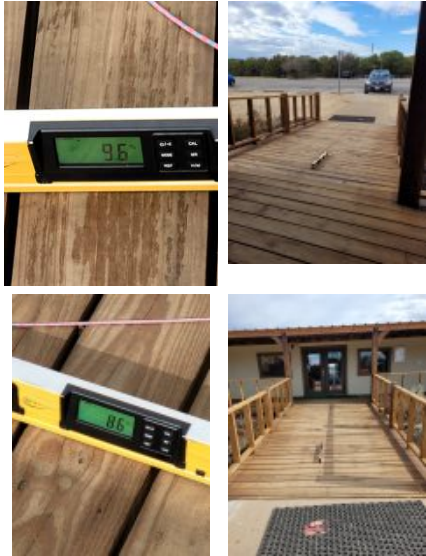
Dinosaur Valley State Park - 1629 Park Rd 59 Glen Rose, TX 76043

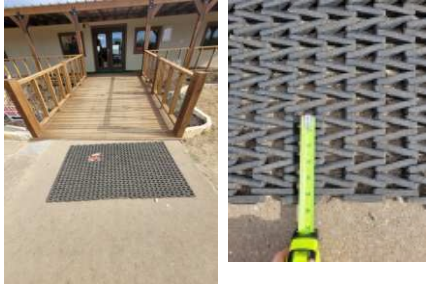
Finding Number	Area Description	Lat/Long	Finding	As Built	Recommendation	Citation	Photos	Figure
41	Park Store: Park Store - Parking and Exterior Accessible Route	[32.248128, -97.816555 5]	There is a gap spaced greater than a 1/2 inch. Openings in floor or ground surfaces shall not allow passage of a sphere more than 1/2 inch diameter. Elongated openings shall be placed so that the long dimension is perpendicular to the dominant direction of travel.	mat outside of store has gaps and no passing space around	Remove or replace with rug that is securely fastened to the ground or floor and does not have gaps less than .5".	2015 ABAAS Section: 302.3 2012 TAS Section: 302.3 2010 ADAS Section: 302.3

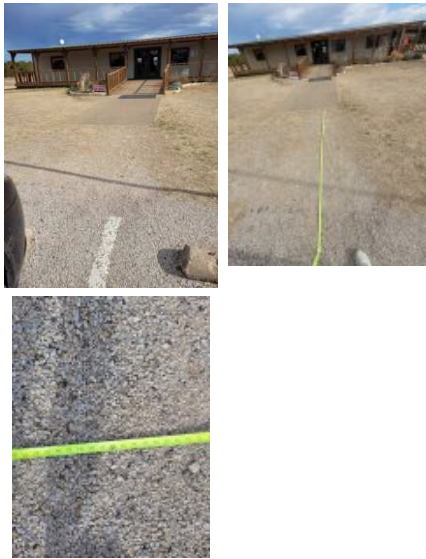
Dinosaur Valley State Park - 1629 Park Rd 59 Glen Rose, TX 76043

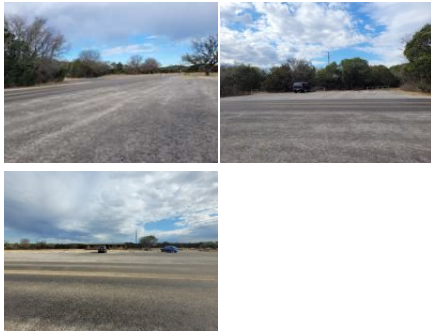
47	Park Store: Park Store - Parking and Exterior Accessible Route	[32.2480566 , -97.816618 5]	There are no accessible parking stalls. Each lot where parking is provided for the public as clients, guests or employees, shall provide accessible parking and shall be located on the shortest accessible route of travel from adjacent parking to an accessible entrance. There are a total of 41 parking stalls in the parking lot that could be reasonably associated with this facility. There should be a minimum of 2 accessible stalls with a minimum of 1 being designed as van accessible.	park store, equestrian trail, and overflow lot - 44 standard, 1 accessible	Create one or more 8' accessible parking stalls, with one 5' adjacent access aisle, with proper signage and striping based on the total number of stalls	2015 ABAAS Section: F208.2 2012 TAS Section: 208.2 2010 ADAS Section: 208.2

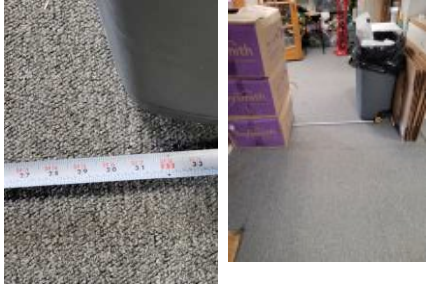
Dinosaur Valley State Park - 1629 Park Rd 59 Glen Rose, TX 76043

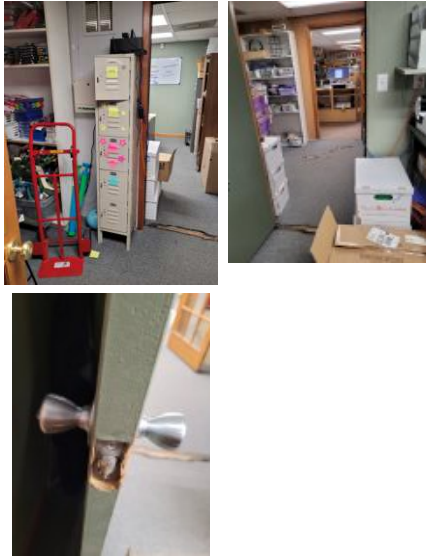
50	Park Store: Park Store - Public Space	[32.248111, -97.816379 8], [32.2476732 , -97.816053 9]	There is no accessible route to the site elements outside of park store. At least one accessible route shall connect accessible buildings, accessible facilities, accessible elements, and accessible spaces that are on the same site.	no route to dinosaur statues and signage, 3 of 3 benches, 3 of 3 grills, trash, bike rack, wood storage and ice cooler	Create an accessible route with crushed stone or other outdoor material from parking or walkway to site elements by park store.	2015 ABAAS Section: F206.2.2 2012 TAS Section: 206.2.2 2010 ADAS Section: 206.2.2

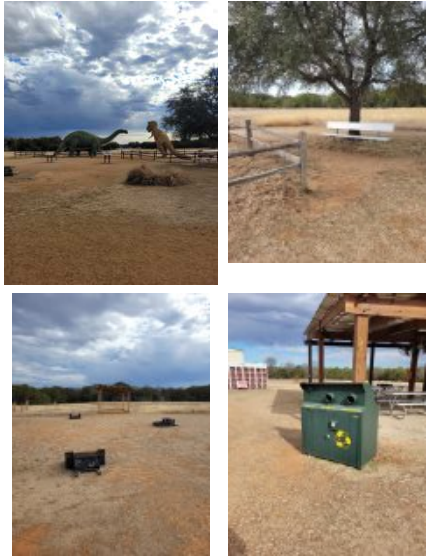
Finding Number	Area Description	Lat/Long	Finding	As Built	Recommendation	Citation	Photos	Figure

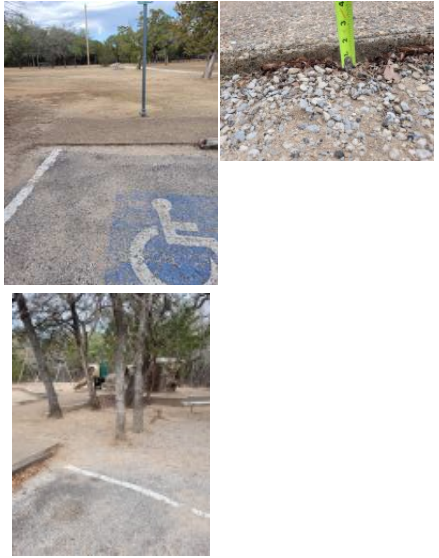
67	Day Use Area: Day Use - Parking and Exterior Accessible Route	[32.2498543 , -97.817369 5]	The parking stall contains abrupt edges and surface irregularities over a 1/4 inch vertical. Parking spaces and access aisles serving them shall be stable, firm, and slip resistant. Access aisles shall be at the same level as the parking spaces they serve. Changes in level are not permitted and shall not be sloped steeper than 2% in any direction.	loose gravel in stall at day use parking lot	Maintain stalls to be free of debris.	2015 ABAAS Section: 502.4 2012 TAS Section: 502.4 2010 ADAS Section: 502.4

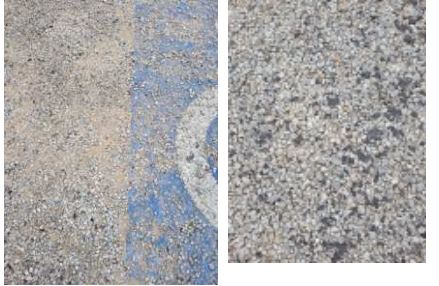
68	Day Use Area: Day Use - Parking and Exterior Accessible Route	[32.2498566 , -97.817364 2]	The cross slopes (narrow dimension) and/or running slopes (long dimension) of the access aisle exceeds 2%. The running slope and the cross slope in an accessible parking stall and the access aisle must not exceed 2%.	6.1% slope in stall at day use parking lot	Repair or correct slope of parking space and access aisle to max 2.08% in any direction	2015 ABAAS Section: 502.4 2012 TAS Section: 502.4 2010 ADAS Section: 502.4

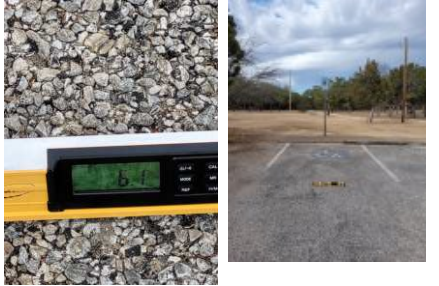
Dinosaur Valley State Park - 1629 Park Rd 59 Glen Rose, TX 76043

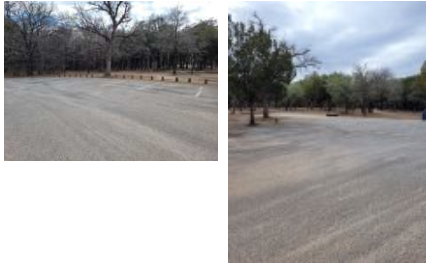
74	Day Use Area: Day Use - Men's Restroom	[32.2500136 , -97.817395 3]	The restroom sign does not comply with one or more applicable requirements for the location, height, and properties of the sign.	restroom sign is not in correct location, lacks Braille and ISA	Acquire and mount signage, including Braille, raised lettering and access symbol mounted on wall, latch side of door, 48" to baseline of lowest character and 60" to baseline of highest character	2015 ABAAS Section: F216.2, 703.1, 703.2, 703.5, 703.6 2012 TAS Section: 216.2, 703.1, 703.2, 703.5, 703.6 2010 ADAS Section: 216.2, 703.1, 703.2, 703.5, 703.6

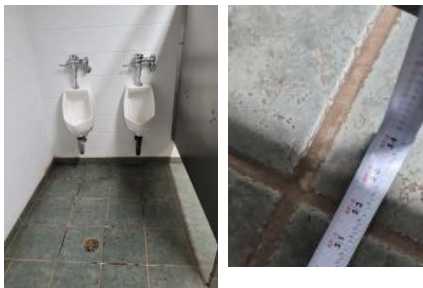
78	Day Use Area: Day Use - Men's Restroom	[32.2500193 , -97.817384 6]	The urinal is located in an area that does not provide the required clear floor space for a front approach. The surrounding elements of a urinal must provide a minimum of 30 by 48 inches of clear floor space for a front approach.	53" total width, 26.5" split evenly between both	Relocate or add a urinal in a location that provides 30" X 48" CFS for a forward approach	2015 ABAAS Section: 605.2 2012 TAS Section: 605.2 2010 ADAS Section: 605.2

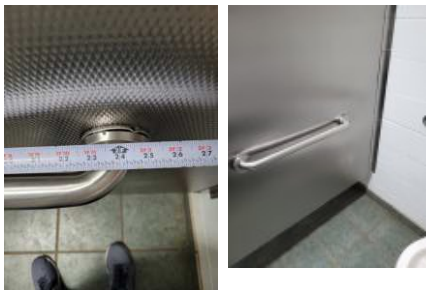
83	Day Use Area: Day Use - Men's Restroom	[32.2500215 , -97.817375 2]	The rear grab bar is not 36" long or is not mounted in the correct location. The rear grab bar must be a minimum of 36" long and extend from the toilet centerline a minimum 12" towards the wall side and a minimum 24" towards the open side of the toilet. Grab bars shall be installed in a horizontal position, 33 inches minimum and 36 inches maximum above the finish floor measured to the top of the gripping surface and the space between the grab bar and the top of the tank shall be 1-1/2 inches minimum.	24" long grab bar	Replace rear grab bar with one 36" long, mounted behind the toilet, 12" to one side of center and 24" to the other and 33" to 36" aff	2015 ABAAS Section: 604.5.2 2012 TAS Section: 604.5.2 2010 ADAS Section: 604.5.2

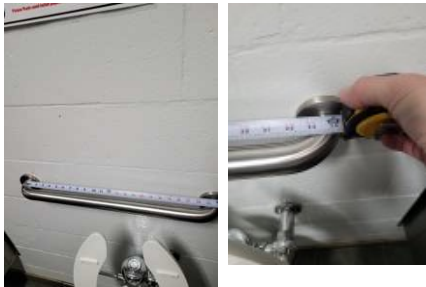
Finding Number	Area Description	Lat/Long	Finding	As Built	Recommendation	Citation	Photos	Figure
84	Day Use Area: Day Use - Men's Restroom	[32.2500295 , -97.817371 2]	The grab bar height and/or spacing fails. Grab bars must be mounted between 33" and 36" to the top of the gripping surface. There must be 1.5" of clearance between the grab bar and the wall. There must be a minimum of 1.5" of clearance below and minimum 12" above the grab bar to any dispenser or other obstruction.	both grab bars are 36.5" aff	Remount grab bars in accessible stall to 33" to 36" AFF. See previous findings for cost.	2015 ABAAS Section: 609.3, 609.4 2012 TAS Section: 609.4, 609.3 2010 ADAS Section: 609.3, 609.4

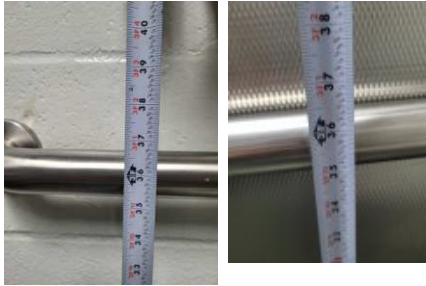
85	Day Use Area: Day Use - Men's Restroom	[32.2500147 , -97.817387 3]	An item or items project more than 4 inches into the circulation path. Wall-mounted objects that have leading edges between 27 inches and 80 inches from the floor must not project more than 4 inches into the circulation path. Protruding objects that extend to the floor or within 27 inches of the floor are cane detectable and are therefore not hazardous. Where it is necessary or desirable to have objects protrude from the wall, a manner of cane detection must be provided.	hand dryer projects 8.25"	Relocate protruding objects or place cane detectable warning or bollard at foot of item.	2015 ABAAS Section: 307.2 2012 TAS Section: 307.2 2010 ADAS Section: 307.2

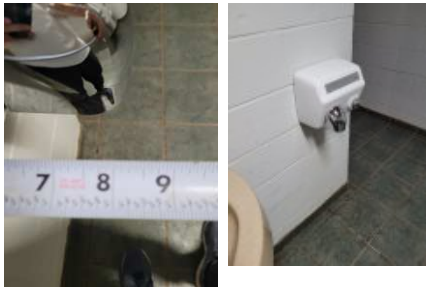
86	Day Use Area: Day Use - Men's Restroom	[32.2500147 , -97.81739]	There is a change in level greater than 1/4 inch. 1/4 inch is the maximum vertical rise. Changes in level between 1/4 inch and 1/2 inch must be beveled at 1:2 or less. Changes in level greater than 1/2 inch must be by way of a ramp.	.5" CIL at drain	Repair, bevel or ramp CIL to max .25"	2015 ABAAS Section: 303.3 2012 TAS Section: 303.3 2010 ADAS Section: 303.3

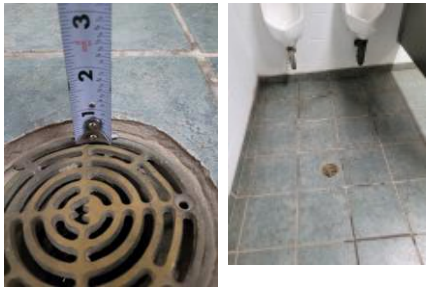
Finding Number	Area Description	Lat/Long	Finding	As Built	Recommendation	Citation	Photos	Figure
87	Day Use Area: Day Use - Men's Restroom	[32.2500204 , -97.817388 6]	The accessible route contains running slopes greater than 5 percent and cross slopes greater than 2 percent across the width of the walk and has not been constructed as a ramp (i.e. handrails, wheel guides, etc.). When the slope in the direction of travel of any walk exceeds 1 unit vertical in 20 units horizontal (5-percent slope), it must be constructed as ramp. Surface cross slopes must not exceed one unit vertical in 48 units. Horizontal (2-percent slope).	5.2% slope in urinal CFS	Correct or repair slope to max 2.08% cross.	2015 ABAAS Section: 403.3 2012 TAS Section: 403.3 2010 ADAS Section: 403.3

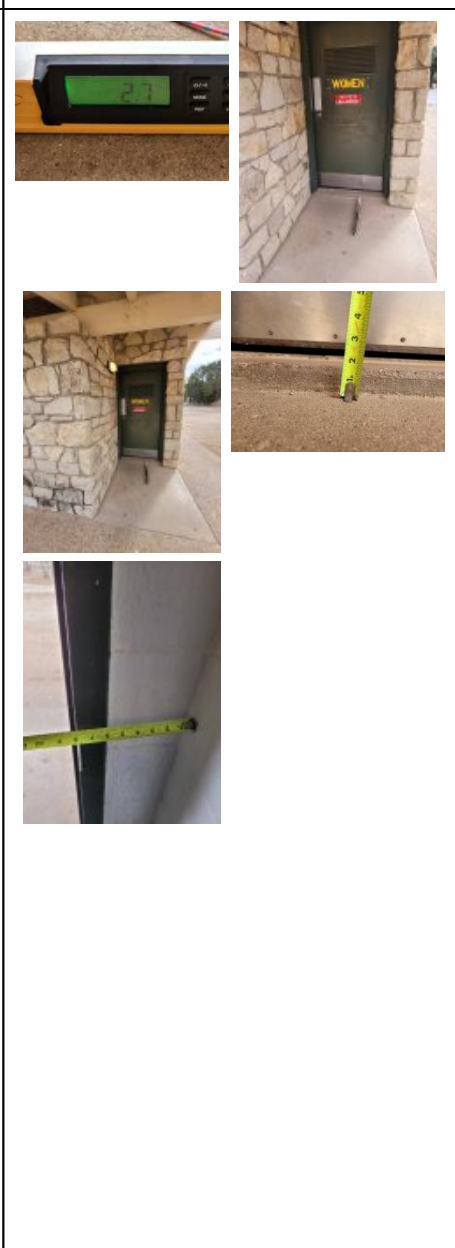
Dinosaur Valley State Park - 1629 Park Rd 59 Glen Rose, TX 76043

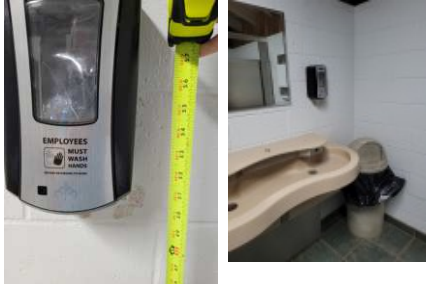
Finding Number	Area Description	Lat/Long	Finding	As Built	Recommendation	Citation	Photos	Figure
94	Day Use Area: Day Use - Women's Restroom	[32.2500089 , -97.817399 3]	The dimensions of the toilet stall do not comply. Wheelchair accessible compartments shall be 60 inches wide and 59 inches deep minimum for floor mounted water closets measured perpendicular to the rear wall. Door shall not swing into the minimum clear floor space required for the toilet.	53" width, trash bin also in clearance	Widen accessible stalls to min. 60" clear width, 59" depth. Remove garbage can for clearance around toilet.	2015 ABAAS Section: 604.8.1.1 2012 TAS Section: 604.3.2 2010 ADAS Section: 604.3.2

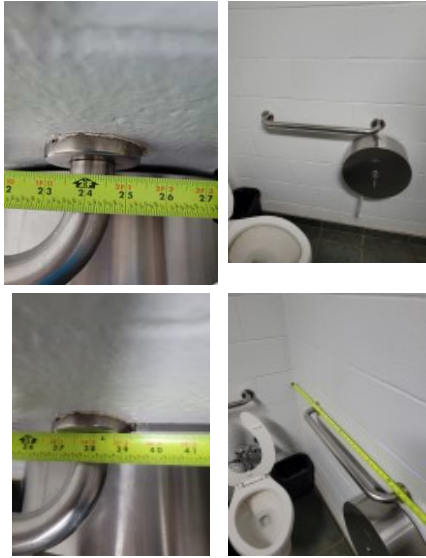
97	Day Use Area: Day Use - Women's Restroom	[32.2500146 , -97.817395 2]	The rear grab bar is not 36" long or is not mounted in the correct location. The rear grab bar must be a minimum of 36" long and extend from the toilet centerline a minimum 12" towards the wall side and a minimum 24" towards the open side of the toilet. Grab bars shall be installed in a horizontal position, 33 inches minimum and 36 inches maximum above the finish floor measured to the top of the gripping surface and the space between the grab bar and the top of the tank shall be 1-1/2 inches minimum.	24" grab bar, 18" to centerline	Replace rear grab bar with one 36" long, mounted behind the toilet, 12" to one side of center and 24" to the other and 33" to 36" aff	2015 ABAAS Section: 604.5.2 2012 TAS Section: 604.5.2 2010 ADAS Section: 604.5.2

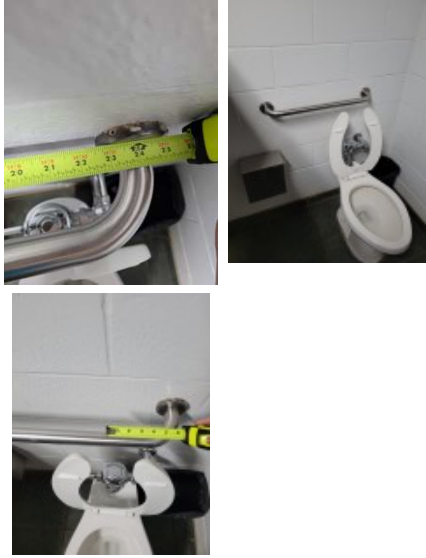
Finding Number	Area Description	Lat/Long	Finding	As Built	Recommendation	Citation	Photos	Figure
98	Day Use Area: Day Use - Women's Restroom	[32.2500089 , -97.817397 9]	The grab bar height and/or spacing fails. Grab bars must be mounted between 33" and 36" to the top of the gripping surface. There must be 1.5" of clearance between the grab bar and the wall. There must be a minimum of 1.5" of clearance below and minimum 12" above the grab bar to any dispenser or other obstruction.	3" between both grab bars and wall, both grab bars mounted 36.5" aff	Replace grab bars with ones having max gap of 1.5" between bar and wall. Cost included in previous findings.	2015 ABAAS Section: 609.3, 609.4 2012 TAS Section: 609.4, 609.3 2010 ADAS Section: 609.3, 609.4

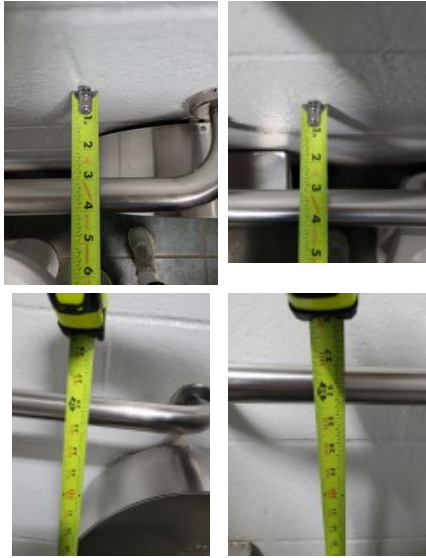
99	Day Use Area: Day Use - Women's Restroom	[32.2499964 , -97.817404 6]	The stall door fails to comply with all of the door requirements. The stall door must be a minimum of 32" wide and have compliant hardware on both sides. The stall door must be self-closing.	stall door 30" width, not self-closing	Widen stall doors to 32" when opened to 90 degrees Adjust stall door to be self-closing	2015 ABAAS Section: 404.2.3, 404.2.7, 604.8.2.2 2012 TAS Section: 404.2.3, 404.2.7, 604.8.2.2 2010 ADAS Section: 404.2.3, 404.2.7, 604.8.2.2

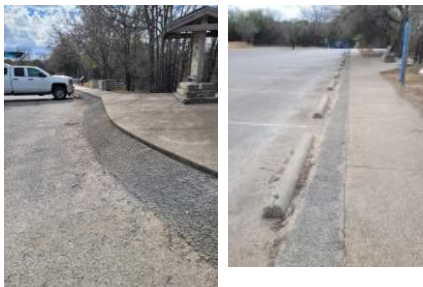
110	Park Site: Park Site - Parking and Exterior Accessible Route	[32.25347, -97.81813]	Changes in level greater than 1/2 inch (13 mm) high shall be ramped, and shall comply with 405 or 406.	Dinosaur site parking - significant CIL and slope to walkway along entire parking lot	Create a curb ramp to be max running slope 8.33%, max cross slope 2.08%, having a top landing as wide as the ramp and 36" deep and side flares with a max slope 10% along the route where curbs are present.	2015 ABAAS Section: 303.4 2012 TAS Section: 303.4 2010 ADAS Section: 303.4

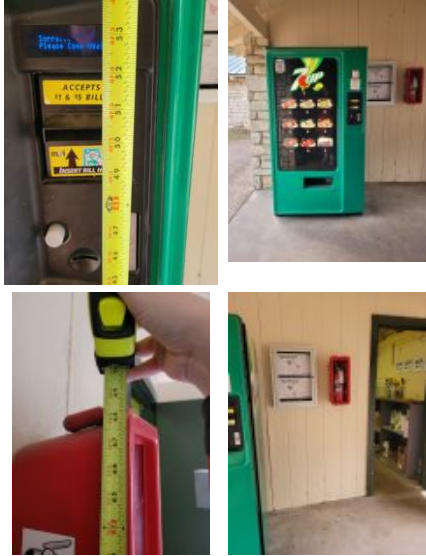
112	Park Site: Park Elements	[32.2521647 , -97.815701 2]	There is no accessible route to the amphitheater. At least one accessible route shall connect accessible buildings, accessible facilities, accessible elements, and accessible spaces that are on the same site.	no route to amphitheater due to non accessible surface	Create an accessible route with crushed stone or other outdoor material from parking or walkway to amphitheater.	2015 ABAAS Section: F206.2.2 2012 TAS Section: 206.2.2 2010 ADAS Section: 206.2.2

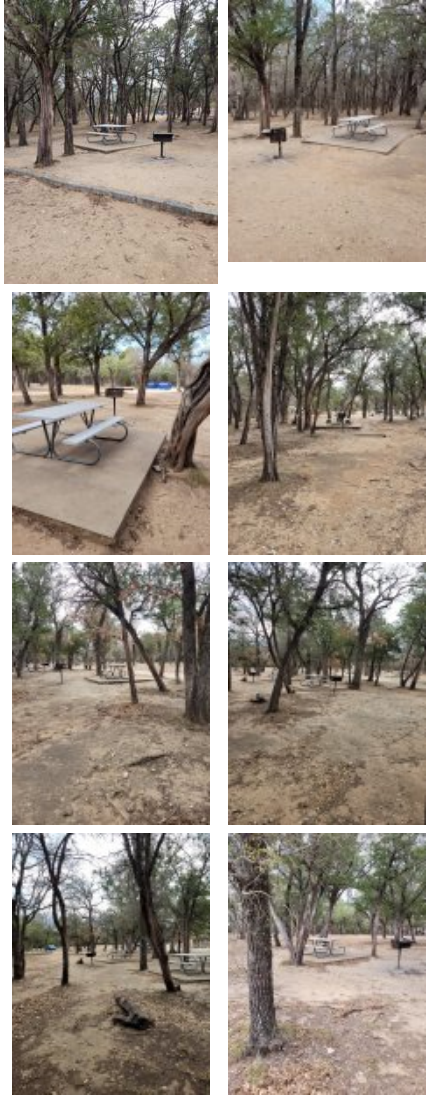
Finding Number	Area Description	Lat/Long	Finding	As Built	Recommendation	Citation	Photos	Figure

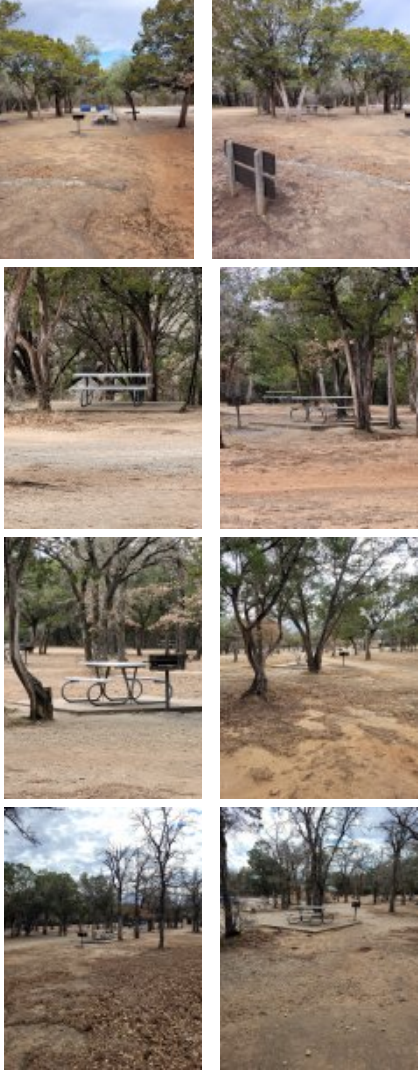
Finding Number	Area Description	Lat/Long	Finding	As Built	Recommendation	Citation	Photos	Figure

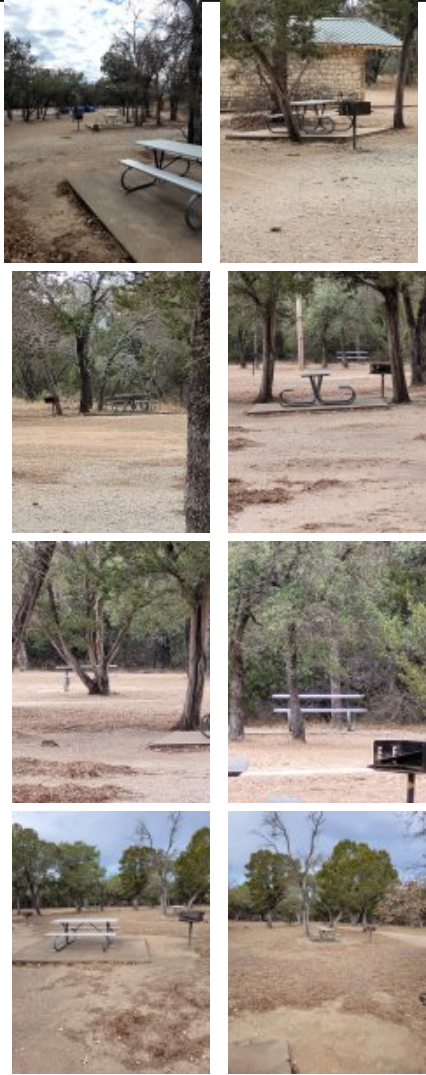
Finding Number	Area Description	Lat/Long	Finding	As Built	Recommendation	Citation	Photos	Figure

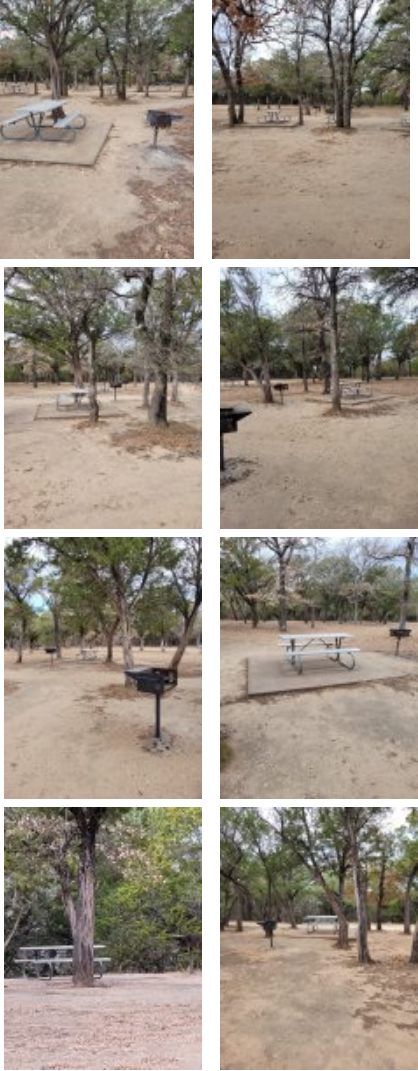
Finding Number	Area Description	Lat/Long	Finding	As Built	Recommendation	Citation	Photos	Figure

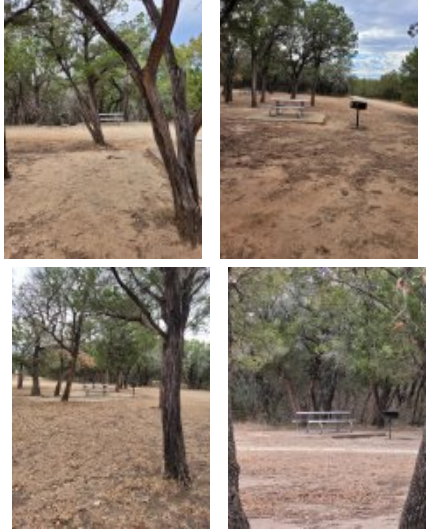
114	Park Site: Park Elements	[32.2501084, -97.8171791], [32.2500244, -97.8173829]	There is no accessible route to the garbage bins, bike rack, and fire extinguisher. At least one accessible route shall connect accessible buildings, accessible facilities, accessible elements, and accessible spaces that are on the same site.	Day use area - no route (AR) to garbage due to surface, no AR to bike rack due to surface, no AR to fire extinguisher at restroom building	Create an accessible route with crushed stone or other outdoor material from parking or walkway to garbage bin, bike rack, and fire extinguisher at day use area.	2015 ABAAS Section: F206.2.2 2012 TAS Section: 206.2.2 2010 ADAS Section: 206.2.2

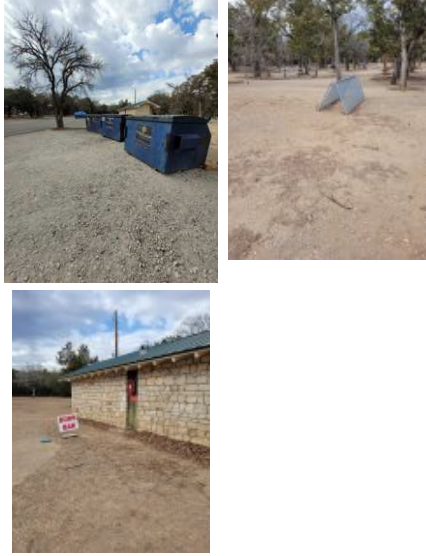
Dinosaur Valley State Park - 1629 Park Rd 59 Glen Rose, TX 76043

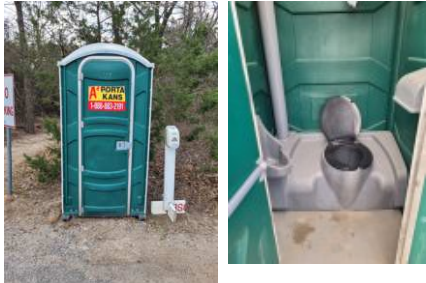
117	Park Site: Residence	[32.2474248 , -97.813507 2]	Element meets all standards and requirements	residence house complies	None	2010 ADAS Section: N/A

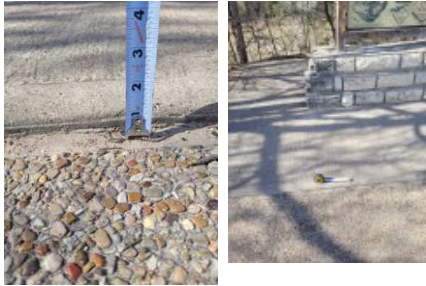
125	Park Site: Main Track Site	[32.25286, -97.81811]	The running slope of walking surfaces shall not be steeper than 1:20.	14.6% slope to site element signage and walkway	Correct running slope along the AR to max 5%	2015 ABAAS Section: 403.3 2012 TAS Section: 403.3 2010 ADAS Section: 403.3

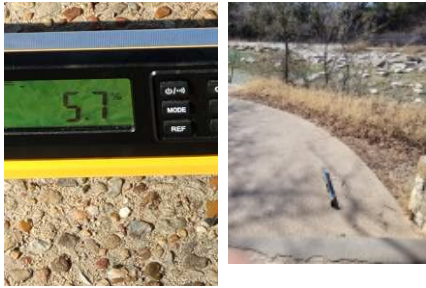
Finding Number	Area Description	Lat/Long	Finding	As Built	Recommendation	Citation	Photos	Figure
127	Park Site: Main Track Site	[32.2534383, -97.8181125]	The accessible route of travel contains cross slopes greater than 2%. Cross slopes shall not exceed one unit vertical in 48 units horizontal (2-percent slope).	AR along water overlook - 2.4% slope, 3.3% slope	Correct or repair cross slope along AR to max 2.08%	2015 ABAAS Section: 403.3 2012 TAS Section: 403.3 2010 ADAS Section: 403.3

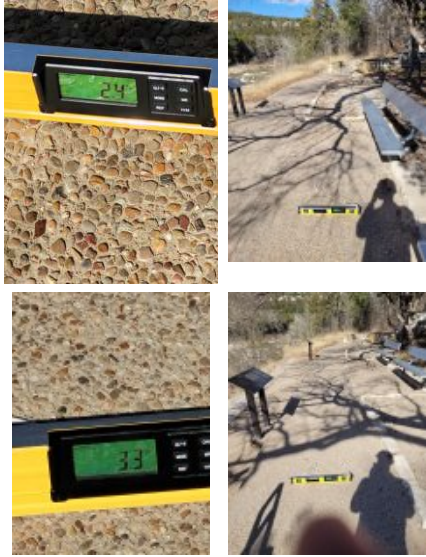
128	Park Site: Main Track Site	[32.25294, -97.81821]	The landing at the top of the ramp has a slope greater than 2%. Top landings shall have a dimension in the direction of ramp run of not less than 60 inches and have a slope of less than 2% in any direction.	11.7% running slope in resting interval on ramp	Correct ramp landing slope to max 2.08%.	2015 ABAAS Section: 405.7.1 EXCEPTION 2012 TAS Section: 405.7.1 2010 ADAS Section: 405.7.1, 405.7.1 Exception

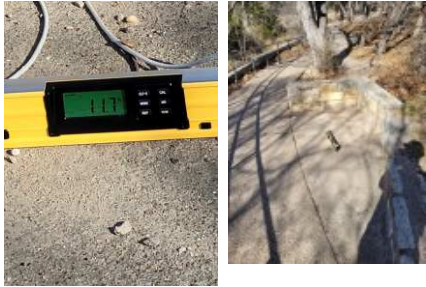
Finding Number	Area Description	Lat/Long	Finding	As Built	Recommendation	Citation	Photos	Figure
129	Park Site: Main Track Site	[32.2535109 , -97.8182627]	The ramp is too long and too high without an intermediate landing. The maximum rise for a ramp with an 8.33% slope is 30 inches. The maximum rise for any is 30 inches and the maximum length is 30 feet.	Ramp from parking - ramp rise is beyond 30" and has excessive slopes	Shorten ramp run to max 30' or a max of 30" rise	2015 ABAAS Section: 405.6 2012 TAS Section: 405.6 2010 ADAS Section: 405.6

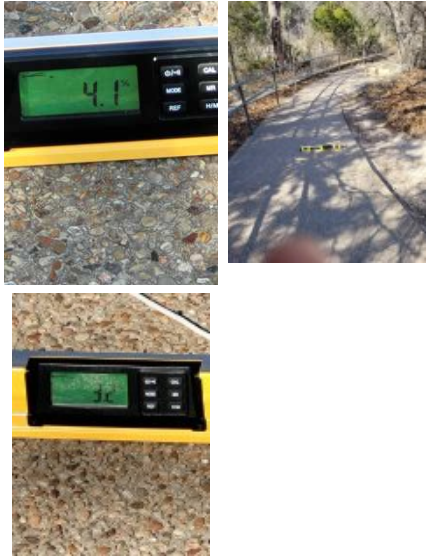
132	Park Site: Main Track Site	[32.2533657 , -97.818144 7]	The landing at the bottom of the ramp has a slope greater than 2%. Bottom landings shall have a dimension in the direction of ramp run of not less than 60 inches and have a slope of less than 2% in any direction.	Ramp from parking - 2.5% slope in bottom landing	Correct ramp landing slope to max 2.08%	2015 ABAAS Section: 405.7.1, 405.7.1 EXCEPTION 2012 TAS Section: 405.7.1, 405.7.1 Exception 2010 ADAS Section: 405.7.1, 405.7.1 Exception

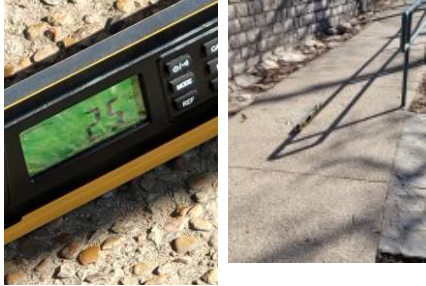
Dinosaur Valley State Park - 1629 Park Rd 59 Glen Rose, TX 76043

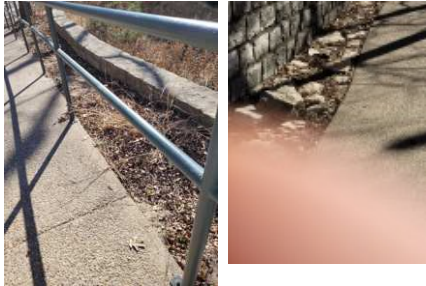
134	Park Site: Main Track Site	[32.2532115 , -97.8182198]	The ramp run has not been provided with edge protection. The floor or ground surface of the ramp run or landing shall extend 12 inches minimum beyond the inside face of a handrail or a curb or barrier shall be provided that prevents the passage of a 4 inch diameter sphere, where any portion of the sphere is within 4 inches of the finish floor or ground surface.	Ramp from parking - lacks edge protection	Install rail along bottom edge of ramp that prevents a 4" sphere from passing through.	2015 ABAAS Section: 405.9, 405.9.1, 405.9.2 2012 TAS Section: 405.9.1, 405.9.2, 405.9 2010 ADAS Section: 405.9.2, 405.9.1, 405.9

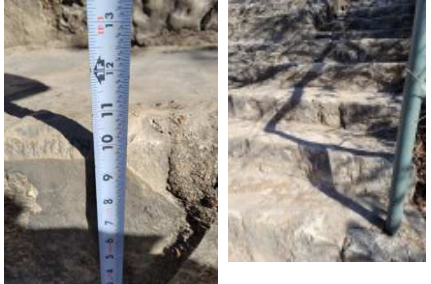
Finding Number	Area Description	Lat/Long	Finding	As Built	Recommendation	Citation	Photos	Figure
140	Park Site: Main Track Site	[32.2528667 , -97.818166 2]	Stair treads and landings subject to wet conditions shall be designed to prevent the accumulation of water.	Stairs to waters edge - surface is smooth and could be very slippery	Correct landings and treads to prevent water accumulation if feasible	2015 ABAAS Section: 504.7 2012 TAS Section: 504.7 2010 ADAS Section: 504.7

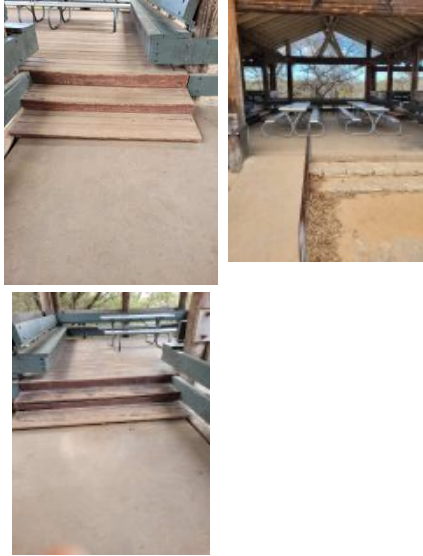
Finding Number	Area Description	Lat/Long	Finding	As Built	Recommendation	Citation	Photos	Figure
147	Park Site: Day Use Pavilion	[32.25068, -97.81837]	Openings in the surface of outdoor recreation access routes shall not allow the passage of a sphere more than 1/2 inch (13 mm) in diameter. Advisory: Spaces between the boards in a boardwalk and drainage grates are examples of openings. Where possible, drainage grates should be located outside the minimum clear width of the outdoor recreation access route. Elongated openings should be placed so that the long dimension is perpendicular, or as close to perpendicular as possible, to the dominant direction of travel	1.25" gap at top of ramp	Correct or fill gaps along the ORAR to max .5" as a smart practice.	2015 ABAAS Section: 1016.6, Advisory 1016.6

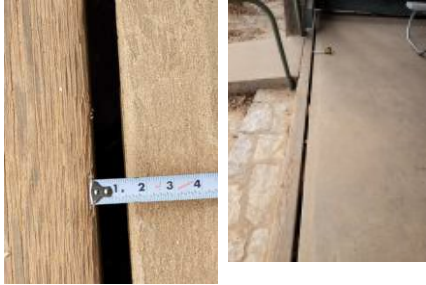
148	Park Site: Day Use Pavilion	[32.25068, -97.81837]	Picnic tables shall provide at least one wheelchair space for each 24 linear feet (7320 mm) of usable table surface perimeter. Wheelchair spaces shall be 30 inches (760 mm) minimum by 48 inches (1220 mm) minimum. Wheelchair spaces shall be positioned for a forward approach to the table and provide knee and toe clearance complying with 306 under the table	Ozark shelter - 7 of 7 tables are not accessible	Replace two picnic tables with ones of an accessible design as a smart practice	2015 ABAAS Section: 1011.4.2

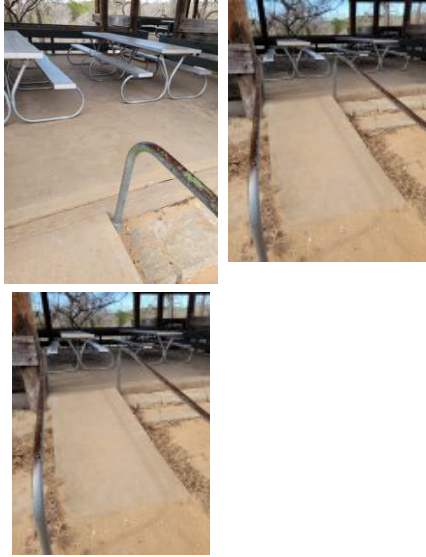
Dinosaur Valley State Park - 1629 Park Rd 59 Glen Rose, TX 76043

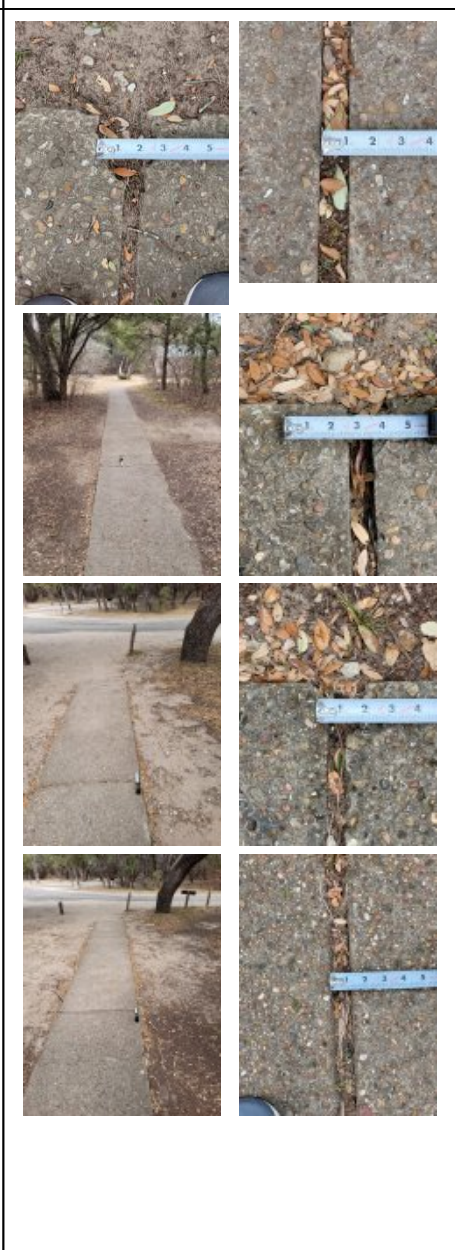
Finding Number	Area Description	Lat/Long	Finding	As Built	Recommendation	Citation	Photos	Figure

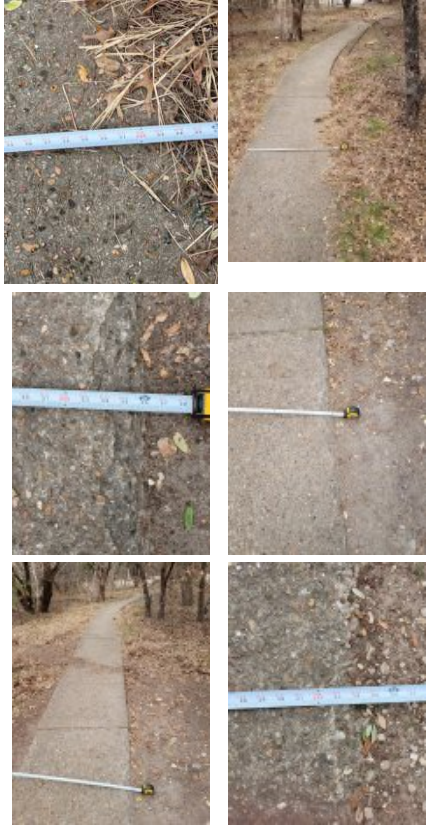
Finding Number	Area Description	Lat/Long	Finding	As Built	Recommendation	Citation	Photos	Figure

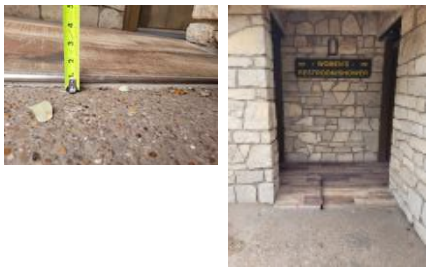
161	Campground Loop: Campground - Parking and Exterior Accessible Route	[32.2507758, -97.813699]	There are no accessible parking stalls. Each lot where parking is provided for the public as clients, guests or employees, shall provide accessible parking and shall be located on the shortest accessible route of travel from adjacent parking to an accessible entrance. There are a total of 6 parking stalls in the parking lot that could be reasonably associated with this facility. There should be a minimum of 1 accessible stalls with a minimum of 1 being designed as van accessible.	parking adjacent to campsite 41 - 6 parking stalls, no accessible parking	Create one or more 8' accessible parking stalls, with one 5' adjacent access aisle, with proper signage and striping based on the total number of stalls	2015 ABAAS Section: F208.2 2012 TAS Section: 208.2 2010 ADAS Section: 208.2

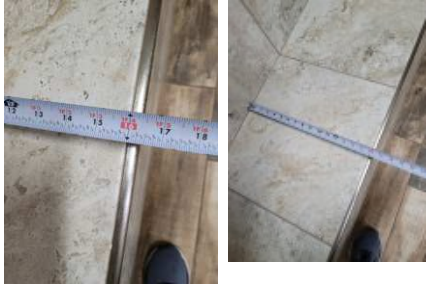
166	Campground Loop: Campground - Men's Restroom	[32.2512925 , -97.813300 6]	There are no accessible bathing or shower facilities. Where facilities for bathing are provided for the public, clients or employees, including showers or bathtubs, at least one shower or bathtub and support facilities such as lockers, and not less than 1 percent of all facilities, shall be accessible.	locker room lacks accessible shower	Create an accessible shower in locker/bathing room	2015 ABAAS Section: F213.3.6 2012 TAS Section: 213.3.6 2010 ADAS Section: 213.3.6

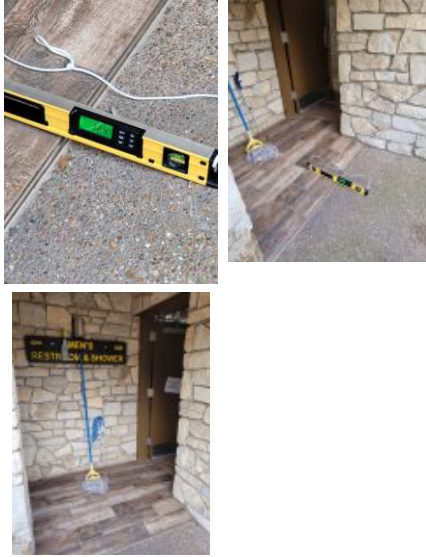
168	Campground Loop: Campground - Men's Restroom	[32.2513004 , -97.813319 4]	It is recommended that exterior doors be maintained so that the operating pressure does not exceed 8.5 lb. force to open. The sweep period for doors with closers shall be adjusted so that from an open position of 70 degrees, the door will take at least 3 seconds to move to a point 7 inches from the latch, measured to the leading edge of the door.	Restroom door - 13# push, shower - 12# push	For all doors along the public circulation route, inspect, adjust, and maintain 8.5 lbf to open exterior doors as a smart practice	2012 TAS Section: 404.2.9, 404.2.9 Advisory, 404.2.8.1 2010 ADAS Section: 404.2.9, 404.2.8.1

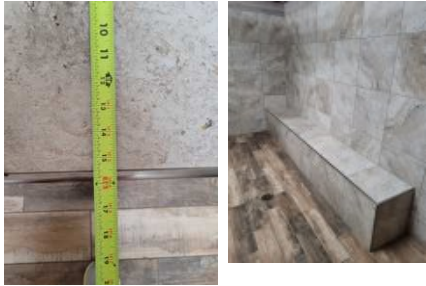
170	Campground Loop: Campground - Women's Restroom	[32.2513015 , -97.813322 1]	There are no accessible bathing or shower facilities. Where facilities for bathing are provided for the public, clients or employees, including showers or bathtubs, at least one shower or bathtub and support facilities such as lockers, and not less than 1 percent of all facilities, shall be accessible.	3 non-accessible showers provided. plans to make 1 ADA family restroom within building	Create an accessible shower in locker/bathing room.	2015 ABAAS Section: F213.3.6 2012 TAS Section: 213.3.6 2010 ADAS Section: 213.3.6

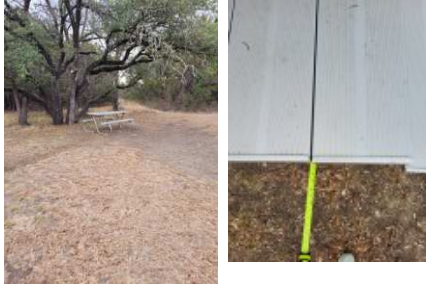
178	Campground Loop: Campground - Playground	[32.2504169 , -97.813601]	There is no accessible route to the picnic table by the play area in campground loop. At least one accessible route shall connect accessible buildings, accessible facilities, accessible elements, and accessible spaces that are on the same site.	Lacks AR to picnic table by playground in campground loop	Create an accessible route with crushed stone or other outdoor material from parking or walkway to picnic table.	2015 ABAAS Section: F206.2.2 2012 TAS Section: 206.2.2 2010 ADAS Section: 206.2.2

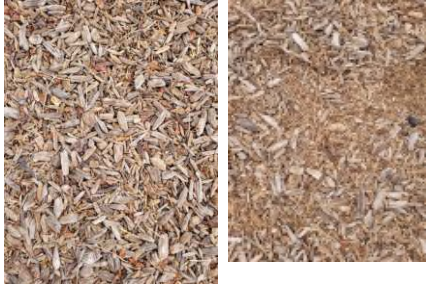
182	Campground Loop: Campground - Playground	[32.2503568 , -97.813568 8]	The walkway contains abrupt vertical edges and/or variations over a 1/4 inch. 1/4 inch is the maximum vertical rise. Changes in level between 1/4 inch and 1/2 inch must be beveled at 1:2 or less. Changes in level greater than 1/2 inch must be by way of a ramp.	swings had large CILs and slopes due to kick out	Maintain loose fill surface to be firm, stable and level.	2012 TAS Section: 303.2, 303.3 2010 ADAS Section: 303.2, 303.3

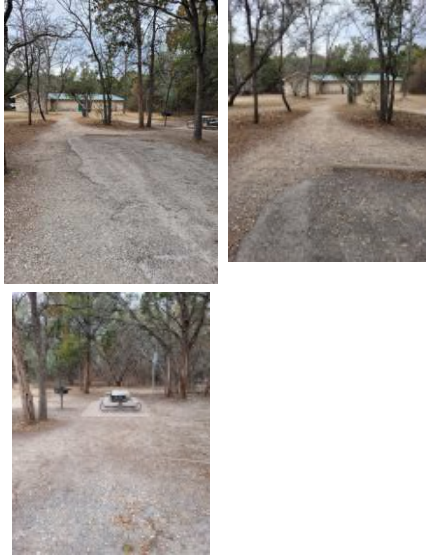
188	Campground Loop: Campsites	[32.251432, -97.8130324]	Picnic tables shall provide at least one wheelchair space for each 24 linear feet (7320 mm) of usable table surface perimeter. Wheelchair spaces shall be 30 inches (760 mm) minimum by 48 inches (1220 mm) minimum. Wheelchair spaces shall be positioned for a forward approach to the table and provide knee and toe clearance complying with 306 under the table	site 5 - 9" depth at 9" aff	Replace picnic table with one of an accessible design as a smart practice	2015 ABAAS Section: 1011.4.2

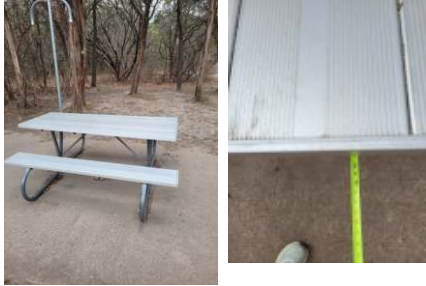
Finding Number	Area Description	Lat/Long	Finding	As Built	Recommendation	Citation	Photos	Figure
189	Campground Loop: Campsites	[32.2514342 , -97.813027]	36 inches (915 mm) on all usable sides of the table measured from the back edge of the benches	site 5 - 15" around, 23" around	Provide required 36" clear ground space around all usable portions of the table as a smart practice	2015 ABAAS Section: 1011.2.1

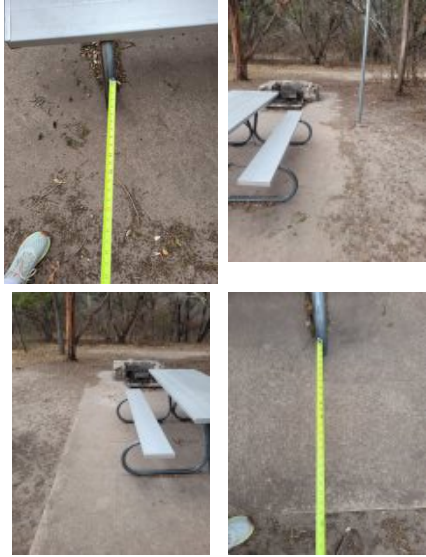
190	Campground Loop: Campsites	[32.2514331 , -97.8130177]	Fire building surfaces shall be 9 inches (230 mm) minimum above the ground	site 5 - ground level	Correct fire building surface to be 9" min above the ground as a smart practice.	2015 ABAAS Section: 1011.5.1

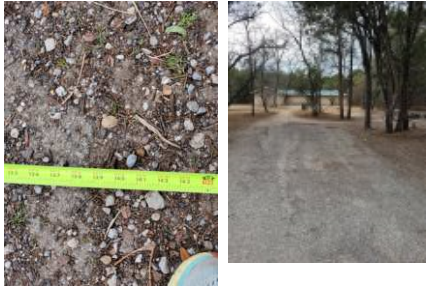
Finding Number	Area Description	Lat/Long	Finding	As Built	Recommendation	Citation	Photos	Figure
193	Campground Loop: Campsites	[32.2514184 , -97.813027]	The surface of parking spaces and pull-up spaces shall be firm and stable. The slope of the surface of parking spaces and pull-up spaces shall not be steeper than 1:48 in any direction. EXCEPTION: Where the surface is other than asphalt, concrete, or boards, slopes not steeper than 1:20 shall be permitted when necessary for drainage.	site 5 - 3.4% slope, surface needs to be paved	Correct surface of parking spaces to be firm and stable with slopes max of 2.08% or 5% for surfaces other than concrete, asphalt or boards as a smart practice.	2015 ABAAS Section: 1012.4, 1012.5, 1012.5 EXCEPTION
