Access Audit Site Report

Dinosaur Valley State Park

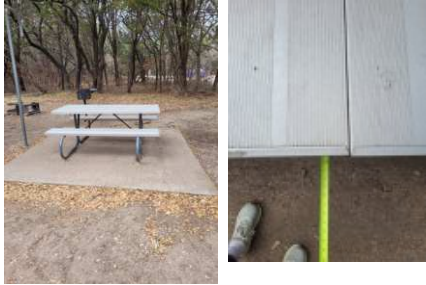
197	Campground Loop: Campsites	[32.2509511 , -97.812587 2]	36 inches (915 mm) on all usable sides of the table measured from the back edge of the benches	site 3 - 22.5", 26" around table	Provide required 36" clear ground space around all usable portions of the table as a smart practice	2015 ABAAS Section: 1011.2.1

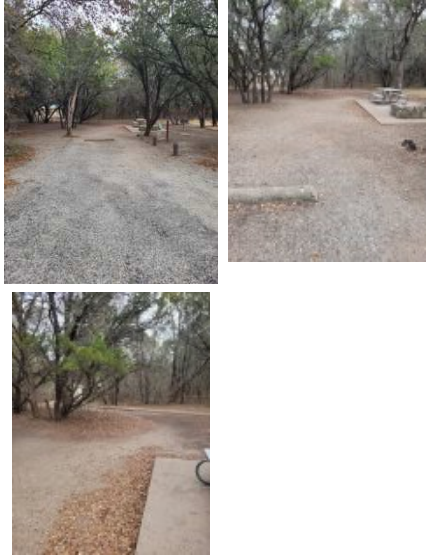
204	Campground Loop: Campsites	[32.2509148 , -97.813821]	Picnic tables shall provide at least one wheelchair space for each 24 linear feet (7320 mm) of usable table surface perimeter. Wheelchair spaces shall be 30 inches (760 mm) minimum by 48 inches (1220 mm) minimum. Wheelchair spaces shall be positioned for a forward approach to the table and provide knee and toe clearance complying with 306 under the table	site 41 - 10" toe depth	Replace picnic table with one of an accessible design as a smart practice	2015 ABAAS Section: 1011.4.2

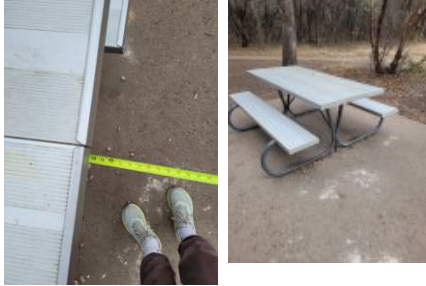
205	Campground Loop: Campsites	[32.2509159 , -97.813827 7]	36 inches (915 mm) on all usable sides of the table measured from the back edge of the benches	site 41 - 26.5" clearance around table	Provide required 36" clear ground space around all usable portions of the table as a smart practice	2015 ABAAS Section: 1011.2.1

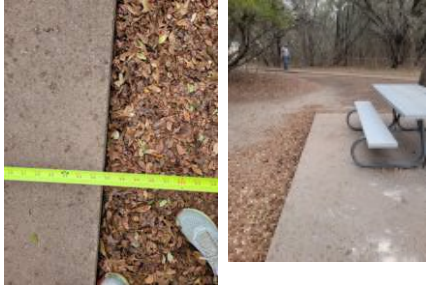
Dinosaur Valley State Park - 1629 Park Rd 59 Glen Rose, TX 76043

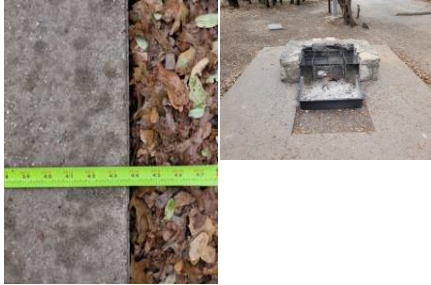
207	Campground Loop: Campsites	[32.2509205 , -97.8138223]	Fire building surfaces shall be 9 inches (230 mm) minimum above the ground	site 41 - ground level	Correct fire building surface to be 9" min above the ground as a smart practice.	2015 ABAAS Section: 1011.5.1

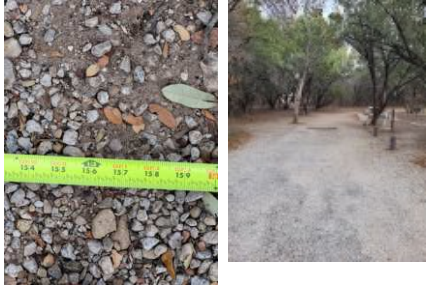
Finding Number	Area Description	Lat/Long	Finding	As Built	Recommendation	Citation	Photos	Figure
210	Campground Loop: Campsites	[32.2509205 , -97.813837 1]	The surface of parking spaces and pull-up spaces shall be firm and stable. The slope of the surface of parking spaces and pull-up spaces shall not be steeper than 1:48 in any direction. EXCEPTION: Where the surface is other than asphalt, concrete, or boards, slopes not steeper than 1:20 shall be permitted when necessary for drainage.	site 41 - 6.1% slope, surface not compliant - gravel and rock	Correct surface of parking spaces to be firm and stable with slopes max of 2.08% or 5% for surfaces other than concrete, asphalt or boards as a smart practice.	2015 ABAAS Section: 1012.4, 1012.5, 1012.5 EXCEPTION

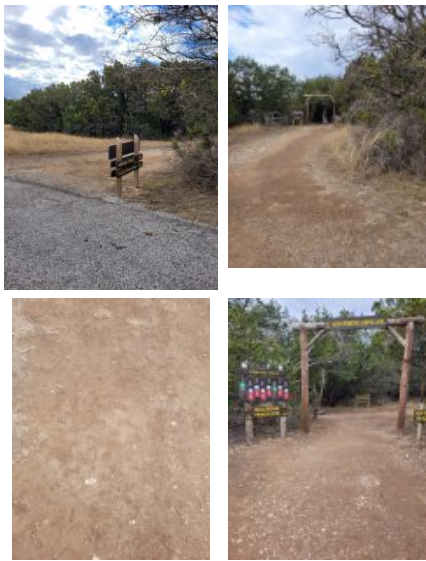
224	Trails: Trail Surface	[32.2509023 , -97.818093 7]	The surface of trails, passing spaces, and resting intervals shall be firm and stable	Children's trail has non-accessible surface - pebbles	Replace surface of trail with one that is firm and stable as a smart practice.	2015 ABAAS Section: 1017.2

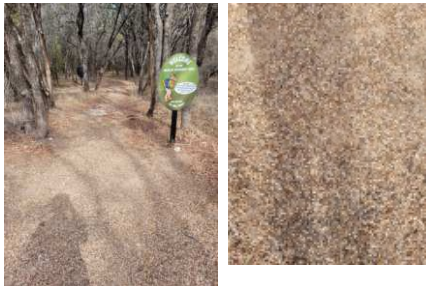
Dinosaur Valley State Park - 1629 Park Rd 59 Glen Rose, TX 76043

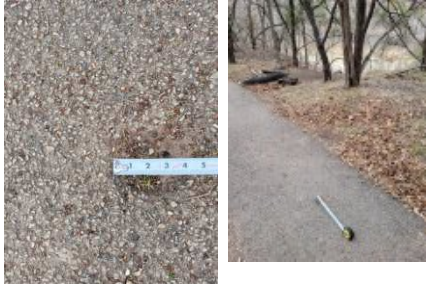
226	Trails: Trail Surface	[32.2479125, -97.817640 4]	Trails with a clear tread width less than 60 inches (1525 mm) shall provide passing spaces complying with 1017.4 at intervals of 1000 feet (300 m) maximum. Where the full length of a trail does not fully comply with 1017, a passing space shall be located at the end of the trail segment that fully complies with 1017. Passing spaces and resting intervals shall be permitted to overlap	Paluxy river trail near campsite - no passing spaces	Create 60" level turning space every 1000' along the trail	2015 ABAAS Section: 1017.4

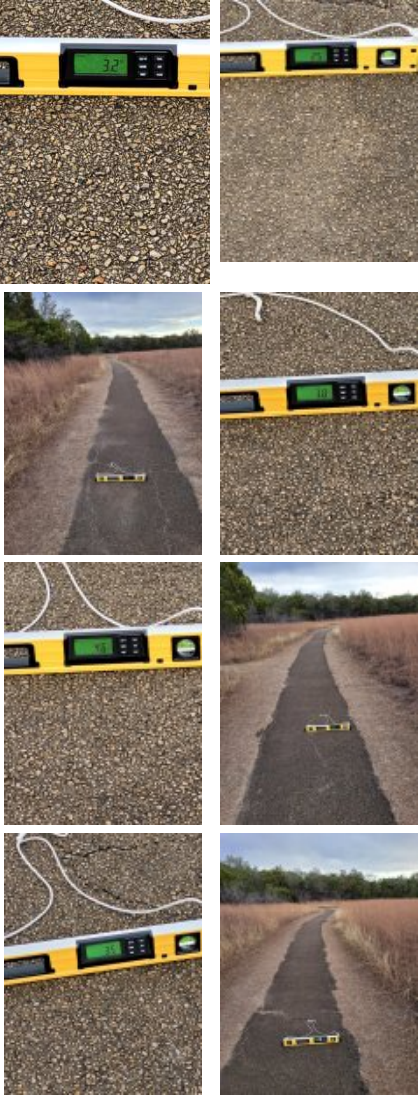
Finding Number	Area Description	Lat/Long	Finding	As Built	Recommendation	Citation	Photos	Figure

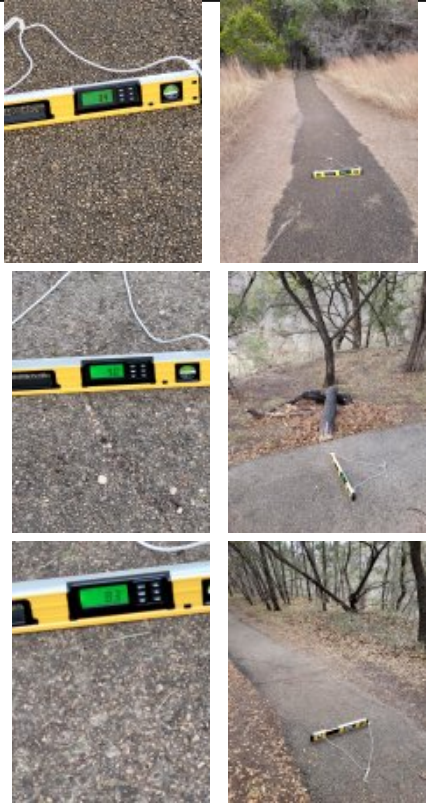
Finding Number	Area Description	Lat/Long	Finding	As Built	Recommendation	Citation	Photos	Figure
228	Trails: Trail Surface	[32.2508191 , -97.813155 9]	The clear tread width of trails shall be 36 inches (915 mm) minimum.	Monarch - reduced to 30" by debris. section of path loose surface debris	Maintain trail width to be min. 36" with 60" by 60" turning spaces every 1000'	2015 ABAAS Section: 1017.3

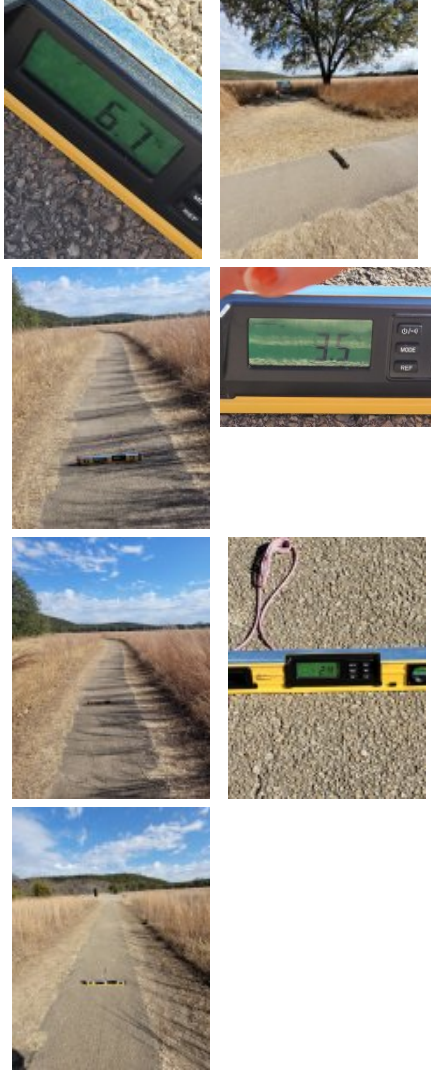
Finding Number	Area Description	Lat/Long	Finding	As Built	Recommendation	Citation	Photos	Figure
