Access Audit Site Report

Fort Richardson State Park and Historic Site

Accessibility Evaluation

Inspection Date: 05/16/2022

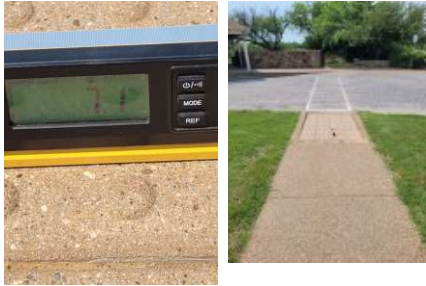
Finding Number	Area Description	Lat/Long	Finding	As Built	Recommendation	Citation	Photos	Figure
1	Headquarters Area: HQ - Exterior Accessible Route	[33.2062791 , -98.1568507]	The running slope of walking surfaces shall not be steeper than 1:20.	Running slope of 7.1% approaching crosswalk	Correct running slope along the AR to max 5%.	2015 ABAAS Section: 403.3 2012 TAS Section: 403.3 2010 ADAS Section: 403.3

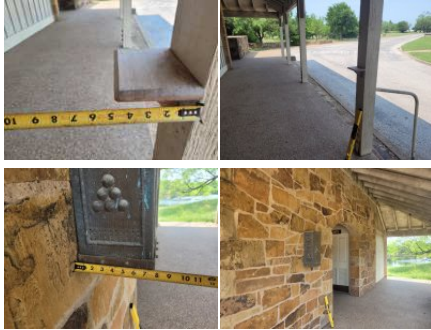
Finding Number	Area Description	Lat/Long	Finding	As Built	Recommendation	Citation	Photos	Figure
15	Headquarters Area: HQ - Exterior Accessible Route	[33.2061667, -98.1569408]	Objects project more than 4 inches into the circulation path. Wall-mounted objects that have leading edges between 27 inches and 80 inches from the floor must not project more than 4 inches into the circulation path. Protruding objects that extend to the floor or within 27 inches of the floor are cane detectable and are therefore not hazardous. Where it is necessary or desirable to have objects protrude from the wall, a manner of cane detection must be provided.	Shelf protrudes 4.5", light protrudes 7.5"	Provide cane detectable warning at base of object along the AR. Relocate object to not protrude into the circulation path.	2015 ABAAS Section: 307.2 2012 TAS Section: 307.2 2010 ADAS Section: 307.2

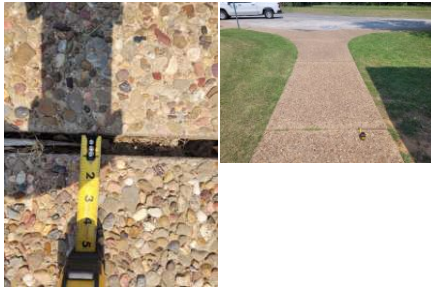
16	Headquarters Area: HQ - Exterior Accessible Route	[33.2061843, -98.1568329]	There is a gap spaced greater than a 1/2 inch. Openings in floor or ground surfaces shall not allow passage of a sphere more than 1/2 inch diameter. Elongated openings shall be placed so that the long dimension is perpendicular to the dominant direction of travel.	1" gap at ice cooler	Correct or fill gaps to be max .5".	2015 ABAAS Section: 302.3 2012 TAS Section: 302.3 2010 ADAS Section: 302.3

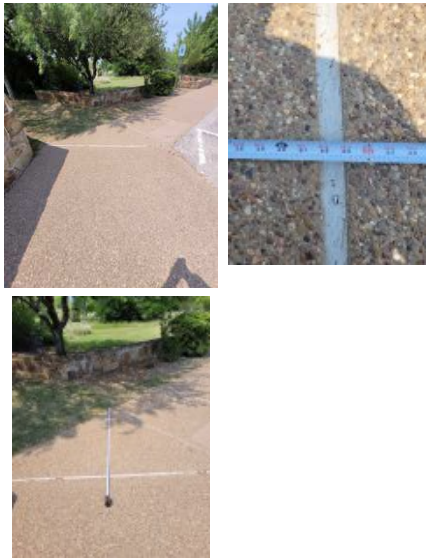
17	Headquarters Area: HQ - Exterior Accessible Route	[33.2063117, -98.1569883]	The landing is not the correct length. Landings shall have a dimension in the direction of ramp run of not less than 60 inches.	top bottom landing not as wide as the ramp for 60" length	Enlarge landing to be 60" deep and as wide as the ramp	2015 ABAAS Section: 405.7.3 2012 TAS Section: 405.7.3 2010 ADAS Section: 405.7.3

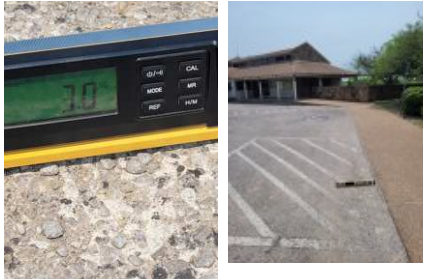
23	Headquarters Area: HQ - Parking	[33.2063768, -98.1568783]	The cross slopes (narrow dimension) and/or running slopes (long dimension) of the access aisle exceeds 2%. The running slope and the cross slope in an accessible parking stall and the access aisle must not exceed 2%.	3% slope in access aisle	Repair or correct slope of parking space and access aisle to max 2.08% in any direction.	2015 ABAAS Section: 502.4 2012 TAS Section: 502.4 2010 ADAS Section: 502.4

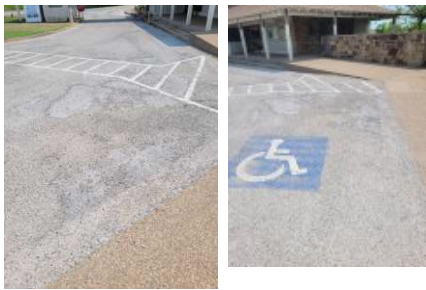
Finding Number	Area Description	Lat/Long	Finding	As Built	Recommendation	Citation	Photos	Figure
24	Headquarters Area: HQ - Parking	[33.206333, -98.156921 3]	The parking stall contains abrupt edges and surface irregularities over a 1/4 inch vertical. Parking spaces and access aisles serving them shall be stable, firm, and slip resistant. Access aisles shall be at the same level as the parking spaces they serve. Changes in level are not permitted and shall not be sloped steeper than 2% in any direction.	Loose unstable surface	Resurface accessible stalls and access aisles with a firm, stable, and slip resistant material.	2015 ABAAS Section: 502.4 2012 TAS Section: 502.4 2010 ADAS Section: 502.4

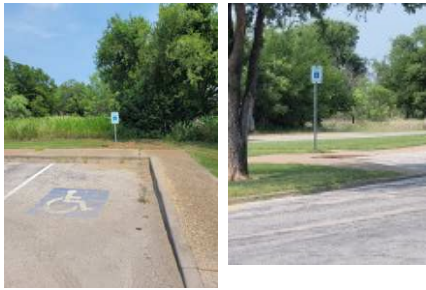
27	Headquarters Area: HQ - Parking	[33.2058595, -98.156677 2]	There are no van accessible parking stalls. 1 in every 6, minimum of one, required accessible stalls must be a van accessible stall. There are a total of 25 parking stalls in the parking lot that could be reasonably associated with this facility. There should be a minimum of 2 accessible stalls with a minimum of 1 being designed as van accessible.	exit side- lacks van signage	Add van parking sign to 1 accessible stall and repaint stall and access aisle to 11' and 5' or 8' and 8'.	2015 ABAAS Section: F208.2, F208.2.4 2012 TAS Section: 208.2, 208.2.4 2010 ADAS Section: 208.2, 208.2.4

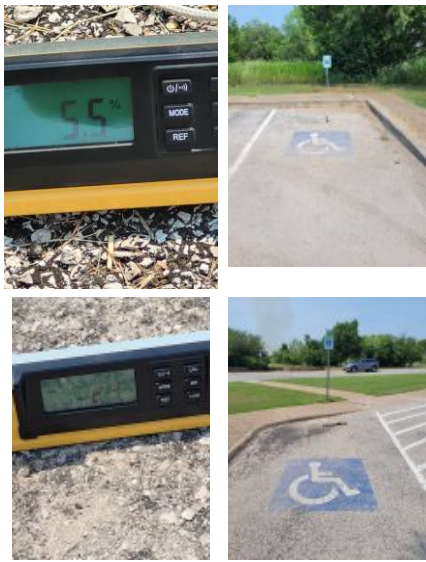
Finding Number	Area Description	Lat/Long	Finding	As Built	Recommendation	Citation	Photos	Figure
28	Headquarters Area: HQ - Parking	[33.2062017, -98.1567322], [33.2058741, -98.1567188]	The cross slopes (narrow dimension) and/or running slopes (long dimension) of the access aisle exceeds 2%. The running slope and the cross slope in an accessible parking stall and the access aisle must not exceed 2%.	exit side- slopes of 5.5% in south stall, 2.4% in north stall	Repair or correct slope of parking space and access aisle to max 2.08% in any direction.	2015 ABAAS Section: 502.4 2012 TAS Section: 502.4 2010 ADAS Section: 502.4

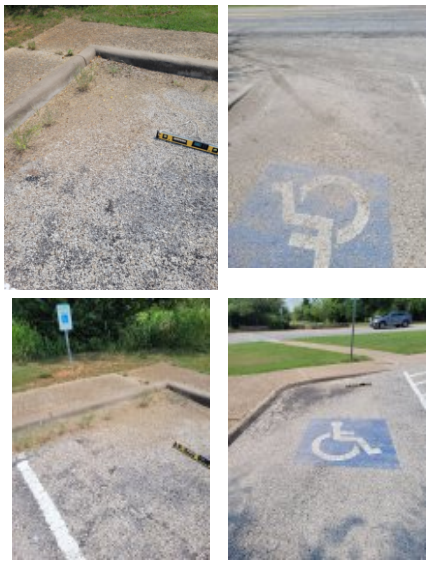
29	Headquarters Area: HQ - Parking	[33.2062006, -98.1567335], [33.2058774, -98.1567241]	The parking stall contains abrupt edges and surface irregularities over a 1/4 inch vertical. Parking spaces and access aisles serving them shall be stable, firm, and slip resistant. Access aisles shall be at the same level as the parking spaces they serve. Changes in level are not permitted and shall not be sloped steeper than 2% in any direction.	exit side- south and North stall - loose gravel, dirt and weeds	Resurface accessible stalls and access aisles with a firm, stable, and slip resistant material.	2015 ABAAS Section: 502.4 2012 TAS Section: 502.4 2010 ADAS Section: 502.4

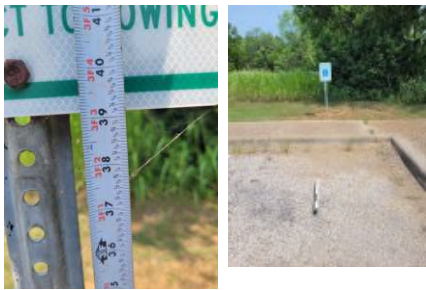
Finding Number	Area Description	Lat/Long	Finding	As Built	Recommendation	Citation	Photos	Figure
30	Headquarters Area: HQ - Parking	[33.2058561, -98.1566785]	The parking sign is mounted too low. Parking space identification signs shall include the International Symbol of Accessibility complying with. Signs identifying van parking spaces shall contain the designation "van accessible." Signs shall be 60 inches minimum above the finish floor or ground surface measured to the bottom of the sign.	exit side- south stall parking sign at 39.25" AGL	Raise existing accessible parking signs so lowest end of bottom sign is min 60" above ground level (AGL) measured from the surface of the stall.	2015 ABAAS Section: 502.6 2012 TAS Section: 502.6 2010 ADAS Section: 502.6

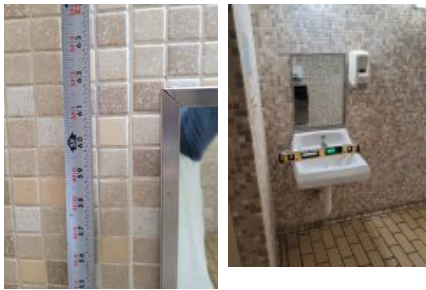
32	Headquarters Area: HQ - Men's Restroom	[33.2061613, -98.1569856]	The mirror is mounted too high. Mirrors must have the bottom edge of the reflecting surface a maximum of 40 inches above the floor if above a sink or counter. Mirrors not located above lavatories or countertops shall be installed with the bottom edge of the reflecting surface 35 inches maximum above the finish floor or ground.	Top of reflective surface at 61" AFF	Raise mirror so top reflective surface is 74" AFF.	2015 ABAAS Section: 603.3 2012 TAS Section: 603.3 2010 ADAS Section: 603.3

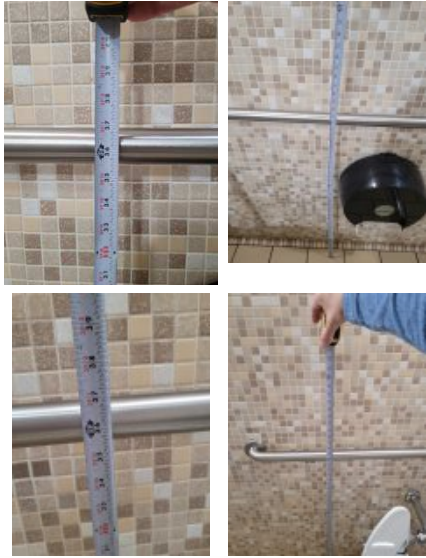
Finding Number	Area Description	Lat/Long	Finding	As Built	Recommendation	Citation	Photos	Figure
35	Headquarters Area: HQ - Men's Restroom	[33.2061647, -98.156987]	The grab bar height and/or spacing fails. Grab bars must be mounted between 33" and 36" to the top of the gripping surface. There must be 1.5" of clearance between the grab bar and the wall. There must be a minimum of 1.5" of clearance below and minimum 12" above the grab bar to any dispenser or other obstruction.	Side and rear grab bars at 37" AFF	Remount grab bars in accessible stall to 33" to 36" above the finished floor (AFF).	2015 ABAAS Section: 609.3, 609.4 2012 TAS Section: 609.4, 609.3 2010 ADAS Section: 609.3, 609.4

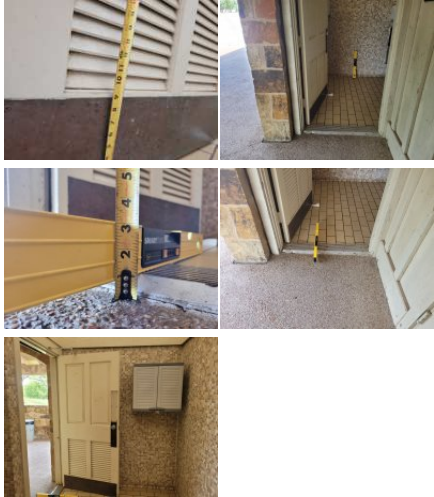
Finding Number	Area Description	Lat/Long	Finding	As Built	Recommendation	Citation	Photos	Figure
40	Headquarters Area: HQ - Women's Restroom	[33.2061588 , -98.156997 3]	Minimum maneuvering clearances at doors and gates shall comply with 404.2.4. Maneuvering clearances shall extend the full width of the doorway and the required latch side or hinge side clearance. Maneuvering clearances shall have a max slope of 2.08%. The threshold at a doorway shall be no higher than 1/2 inch. Changes in level between 1/4 inch and 1/2 inch must be beveled at 1:2 or less. 1/4 inch is the maximum vertical rise. The bottom 10 inches on the push side must be smooth and free of obstructions (hold open devices). Opening hardware must be mounted between 30 and 44 inches above the floor or ground.	HQ women's restroom door - cabinet back in pull side clearance, wall in push side clearance, 9.5" to bottom of vent, 1" threshold	For all doors along the public circulation route, provide required maneuvering clearance on push and pull side of doors. For all doors along the public circulation route, provide beveled threshold. For all doors along the public circulation route, provide kick plate on push side of door from floor to 10" AFF.	2010 ADAS Section: 404.2.3, 404.2.7, 404.2.4, 404.2.11, 404.2.11 Exception

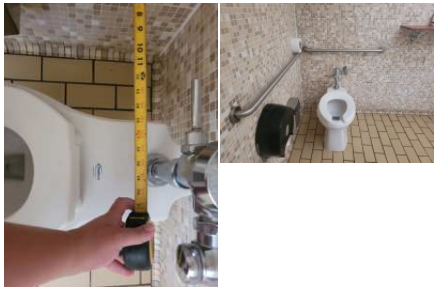
43	Headquarters Area: HQ - Women's Restroom	[33.2061512 , -98.156999]	The toilet is not located within the range allowed from the side wall or partition. The centerline of the toilet must be 16 to 18 inches from the side wall.	centerline 18.5" to wall	Remount toilets to 16" to 18" from the side wall to centerline.	2015 ABAAS Section: 604.2 2012 TAS Section: 604.2 2010 ADAS Section: 604.2

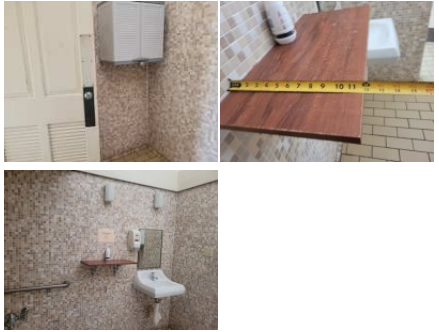
46	Headquarters Area: HQ - Women's Restroom	[33.2061591, -98.1569803]	An item or items project more than 4 inches into the circulation path. Wall-mounted objects that have leading edges between 27 inches and 80 inches from the floor must not project more than 4 inches into the circulation path. Protruding objects that extend to the floor or within 27 inches of the floor are cane detectable and are therefore not hazardous. Where it is necessary or desirable to have objects protrude from the wall, a manner of cane detection must be provided.	Cabinet protrudes more than 4", shelf protrudes 12"	Relocate protruding objects or place cane detectable warning or bollard at foot of item.	2015 ABAAS Section: 307.2 2012 TAS Section: 307.2 2010 ADAS Section: 307.2

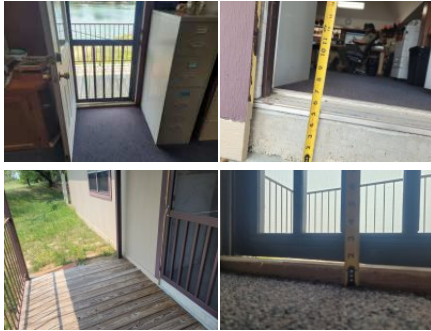
52	Headquarters Area: HQ - Employee Spaces	[33.2061496 , -98.156983 2]	Minimum maneuvering clearances at doors and gates shall comply with 404.2.4. Maneuvering clearances shall extend the full width of the doorway and the required latch side or hinge side clearance. The threshold has a vertical change greater than 1/4 inch high. The threshold at a doorway shall be no higher than 1/2 inch. Changes in level between 1/4 inch and 1/2 inch must be beveled at 1:2 or less. 1/4 inch is the maximum vertical rise. Hand-activated door opening hardware, handles, pulls, latches, locks, and other operating devices on accessible doors shall have a shape that is easy to grasp with one hand and does not require tight grasping, tight pinching or twisting of the wrist to operate. Hardware shall be 34 inches minimum and 48 inches maximum above the finish floor or ground. Egress doors shall provide a continuous and unobstructed way of egress travel from any point in a building or facility that provides an accessible route to an area of refuge, a horizontal exit, or a public way.	Exit door - knob, CIL, threshold 1", cabinet in pull side clearance, no egress, small handle screen door	For all doors along the public circulation route, provide required maneuvering clearance on push and pull side of doors. For all doors along the public circulation route, repair, bevel, or ramp CILs at door entries to max .25". For all doors along the public circulation route, repair, provide beveled threshold. For all doors along the public circulation route, replace hardware with lever hardware or hardware operable without a tight pinch or grasp. For all doors along the public circulation route, enlarge cement pad at exit to allow 18" clearance on the latch side, and extend a pathway away from the building for emergency egress.	2010 ADAS Section: 404.2.3, 404.2.7, 404.2.4, 404.2.11, 404.2.11 Exception

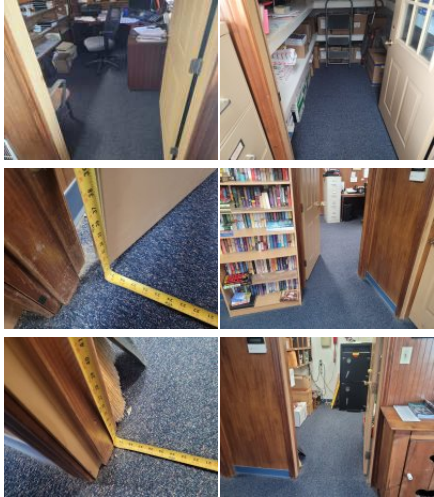
Finding Number	Area Description	Lat/Long	Finding	As Built	Recommendation	Citation	Photos	Figure
54	Headquarters Area: HQ - Employee Spaces	[33.2061647 , -98.156993 7]	Spaces and elements within employee work areas shall only be required to comply with 206.2.8, 207.1, and 215.3 and shall be designed and constructed so that individuals with disabilities can approach, enter, and exit the employee work area. Employee work areas, or portions of employee work areas, other than raised courtroom stations, that are less than 300 square feet (28 m2) and elevated 7 inches (180 mm) or more above the finish floor or ground where the elevation is essential to the function of the space shall not be required to comply with these requirements or to be on an accessible route.	Office - knob, chair in pull side clearance, desk in pull side clearance, other door has knob and is narrow 29.5" Storage - shelf in pull side clearance, knob Safe - knob, 29.5" wide	For employee spaces, relocate storage, furniture, and other obstacles at doorways to provide approach, enter and exit at the employee space. Provide required maneuvering clearance on push and pull side of doors. Replace doors with doors having 80" overhead clearance and 32" clear width. Replace hardware with lever hardware or hardware operable without a tight pinch or grasp.	2015 ABAAS Section: F203.9 2012 TAS Section: 203.9 2010 ADAS Section: 203.9

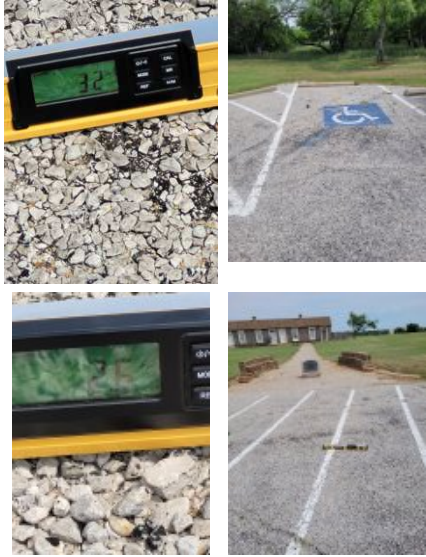
Finding Number	Area Description	Lat/Long	Finding	As Built	Recommendation	Citation	Photos	Figure
65	Parade Ground: Parade Ground - Parking	[33.2058987 , -98.1632258], [33.2059369 , -98.1633049]	The cross slopes (narrow dimension) and/or running slopes (long dimension) of the access aisle exceeds 2%. The running slope and the cross slope in an accessible parking stall and the access aisle must not exceed 2%.	parade ground- slopes of 3.2% in stall, 2.6% in access aisle	Repair or correct slope of parking space and access aisle to max 2.08% in any direction.	2015 ABAAS Section: 502.4 2012 TAS Section: 502.4 2010 ADAS Section: 502.4

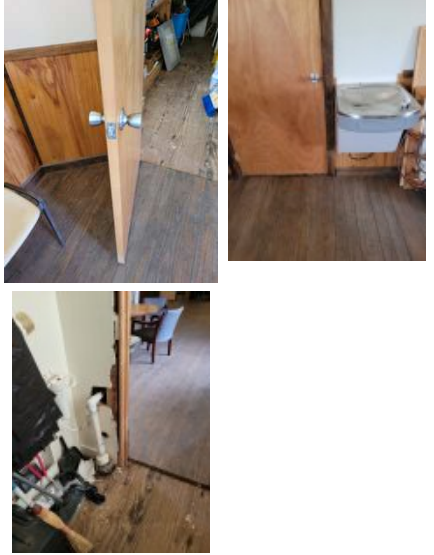
74	Parade Ground: Parade Ground - Interpretive Center	[33.2063628, -98.163411 5]	Minimum maneuvering clearances at doors and gates shall comply with 404.2.4. Maneuvering clearances shall extend the full width of the doorway and the required latch side or hinge side clearance. Hand-activated door opening hardware, handles, pulls, latches, locks, and other operating devices on accessible doors shall have a shape that is easy to grasp with one hand and does not require tight grasping, tight pinching or twisting of the wrist to operate. Hardware shall be 34 inches minimum and 48 inches maximum above the finish floor or ground.	Storage room door - knobs, lacks clearance on pull side due to drinking fountain, lacks clearance on push side due to pipe and storage	For all doors along the public circulation route, provide required maneuvering clearance on push and pull side of doors. For all doors along the public circulation route, replace hardware with lever hardware or hardware operable without a tight pinch or grasp.	2010 ADAS Section: 404.2.3, 404.2.7, 404.2.4, 404.2.11, 404.2.11 Exception

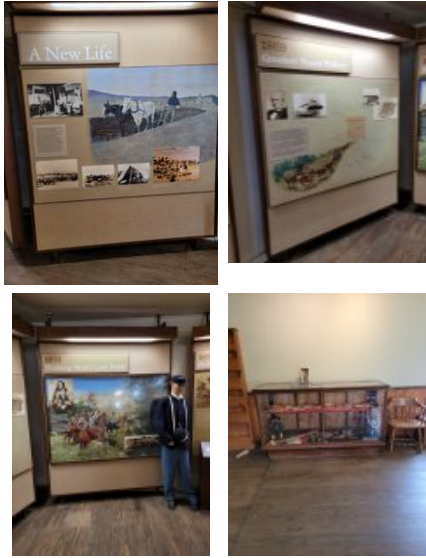
Finding Number	Area Description	Lat/Long	Finding	As Built	Recommendation	Citation	Photos	Figure
75	Parade Ground: Parade Ground - Interpretive Center	[33.2063756 , -98.163404 2]	Element meets all standards and requirements	Displays comply	None	2010 ADAS Section: N/A

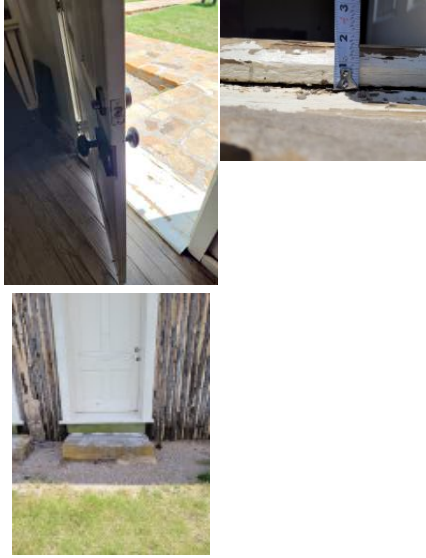
76	Parade Ground: Parade Ground - Interpretive Center	[33.2063458 , -98.163378 7]	Minimum maneuvering clearances at doors and gates shall comply with 404.2.4. Maneuvering clearances shall extend the full width of the doorway and the required latch side or hinge side clearance. Maneuvering clearances shall have a max slope of 2.08%. The threshold has a vertical change greater than 1/4 inch high. Hand-activated door opening hardware, handles, pulls, latches, locks, and other operating devices on accessible doors shall have a shape that is easy to grasp with one hand and does not require tight grasping, tight pinching or twisting of the wrist to operate. Hardware shall be 34 inches minimum and 48 inches maximum above the finish floor or ground.	Front door - knobs, 1.75" CIL Back door - large CIL/ step	For all doors along the public circulation route, provide required maneuvering clearance on push and pull side of doors. For all doors along the public circulation route, repair, bevel, or ramp CILs at door entries to max .25". For all doors along the public circulation route, replace hardware with lever hardware or hardware operable without a tight pinch or grasp.	2010 ADAS Section: 404.2.3, 404.2.7, 404.2.4, 404.2.11, 404.2.11 Exception

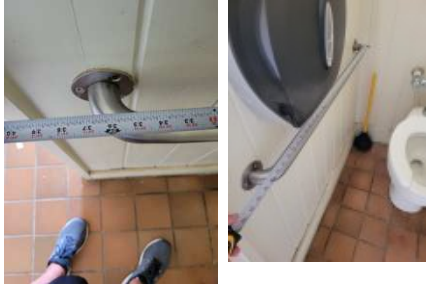
Finding Number	Area Description	Lat/Long	Finding	As Built	Recommendation	Citation	Photos	Figure
84	Parade Ground: Parade Ground - Interpretive Center	[33.2063655, -98.1633237]	Grab bars shall comply with 609. A side-wall grab bar complying with 604.5.1 shall be provided on both sides of the compartment. The space between the wall and the grab bar shall be 1½ inches (38 mm). The space between the grab bar and projecting objects below and at the ends shall be 1½ inches (38 mm) minimum. The space between the grab bar and projecting objects above shall be 12 inches (305 mm) minimum. Grab bars shall be installed in a horizontal position, 33 inches (840 mm) minimum and 36 inches (915 mm) maximum above the finish floor measured to the top of the gripping surface, except that at water closets for children's use complying with 604.9, grab bars shall be installed in a horizontal position 18 inches (455 mm) minimum and 27 inches (685 mm) max.	men's- 36" long bar on door side	Replace or add side grab bars with a 42" long grab bar, mounted max 12" from the rear wall at the close end and min 54" on the far end and 33" to 36" AFF.	2015 ABAAS Section: 604.8.2.3, 609.3, 609.4 2012 TAS Section: 609.4, 609.3, 604.8.2.3 2010 ADAS Section: 609.3, 609.4, 604.8.2.3

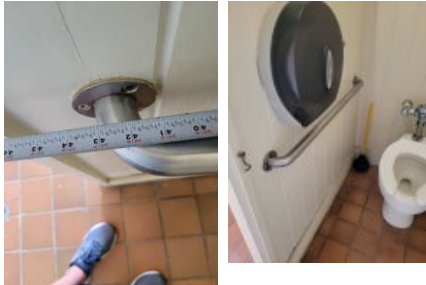
85	Parade Ground: Parade Ground - Interpretive Center	[33.2063678, -98.163325]	The side grab bars are not in the correct location. Grab bars on the side wall must be installed so that the end closest to the rear wall is maximum 12" from the rear wall. The end furthest from the rear wall must be mounted minimum 54" from the rear wall.	men's- door side grab bar extends 42.5" from rear wall	Replace side grab bar with a 42" long bar mounted to max 12" from the rear wall at the close end and min 54" on the far end, and 33" to 36" AFF.	2015 ABAAS Section: 604.5.1 2012 TAS Section: 604.5.1 2010 ADAS Section: 604.5.1

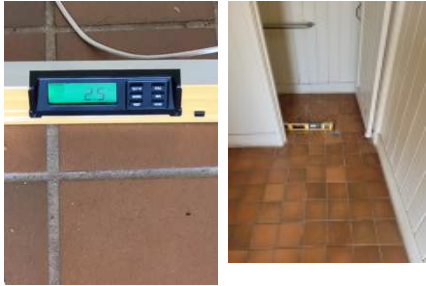
Finding Number	Area Description	Lat/Long	Finding	As Built	Recommendation	Citation	Photos	Figure
87	Parade Ground: Parade Ground - Interpretive Center	[33.2063745 , -98.163323 7]	The accessible route contains running slopes greater than 5 percent and cross slopes greater than 2 percent across the width of the walk and has not been constructed as a ramp (i.e. handrails, wheel guides, etc.). When the slope in the direction of travel of any walk exceeds 1 unit vertical in 20 units horizontal (5-percent slope), it must be constructed as ramp. Surface cross slopes must not exceed one unit vertical in 48 units. Horizontal (2-percent slope).	men's- 2.5% slope near drain	Correct or repair slope to max 2.08% in restroom.	2015 ABAAS Section: 403.3 2012 TAS Section: 403.3 2010 ADAS Section: 403.3

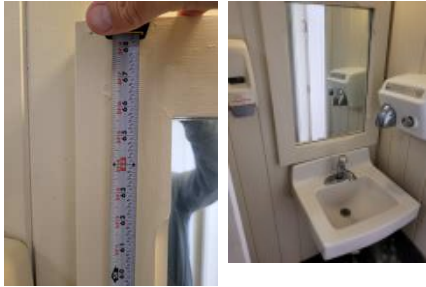
89	Parade Ground: Parade Ground - Interpretive Center	[33.2063723 , -98.163329 1]	The mirror is mounted too high. Mirrors must have the bottom edge of the reflecting surface a maximum of 40 inches above the floor if above a sink or counter. Mirrors not located above lavatories or countertops shall be installed with the bottom edge of the reflecting surface 35 inches maximum above the finish floor or ground.	women's- top edge at 65.5" AFF	Remount mirror so bottom reflective surface is max 40" AFF and top is 74" AFF.	2015 ABAAS Section: 603.3 2012 TAS Section: 603.3 2010 ADAS Section: 603.3

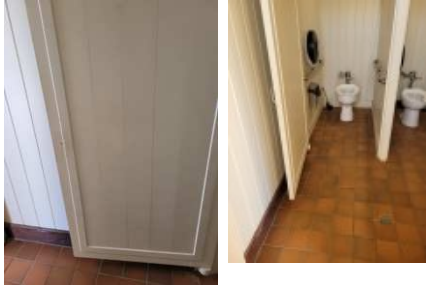
93	Parade Ground: Parade Ground - Interpretive Center	[33.2063667 , -98.1633264]	The stall door fails to comply with all of the door requirements. The stall door must be a minimum of 32" wide and have compliant hardware on both sides. The stall door must be self-closing.	women's- ambulatory stall lacks self-closing door and push side hardware	Adjust stall door to be self-closing. Replace stall hardware with hardware operable without a tight pinch or grasp on both sides of the stall door.	2015 ABAAS Section: 404.2.3, 404.2.7, 604.8.2.2 2012 TAS Section: 404.2.3, 404.2.7, 604.8.2.2 2010 ADAS Section: 404.2.3, 404.2.7, 604.8.2.2

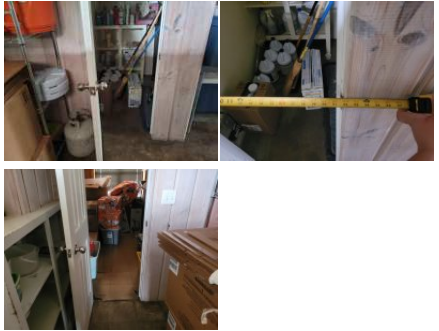
Finding Number	Area Description	Lat/Long	Finding	As Built	Recommendation	Citation	Photos	Figure
102	Parade Ground: Parade Ground - Dining Hall	[33.2096791 , -98.161730 5]	Spaces and elements within employee work areas shall only be required to comply with 206.2.8, 207.1, and 215.3 and shall be designed and constructed so that individuals with disabilities can approach, enter, and exit the employee work area. Employee work areas, or portions of employee work areas, other than raised courtroom stations, that are less than 300 square feet (28 m2) and elevated 7 inches (180 mm) or more above the finish floor or ground where the elevation is essential to the function of the space shall not be required to comply with these requirements or to be on an accessible route.	Kitchen storage - 2 doors/rooms - 21.5" wide, knob, storage in push side maneuvering clearance at both, storage in pull side maneuvering clearance at larger room	For employee spaces, relocate storage, furniture, and other obstacles at doorways to provide approach, enter and exit at the employee space. Provide required maneuvering clearance on push and pull side of doors. Replace doors with doors having 80" overhead clearance and 32" clear width. Replace hardware with lever hardware or hardware operable without a tight pinch or grasp.	2015 ABAAS Section: F203.9 2012 TAS Section: 203.9 2010 ADAS Section: 203.9

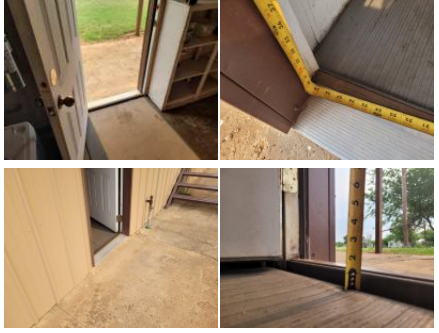
103	Parade Ground: Parade Ground - Dining Hall	[33.2096861 , -98.161728]	Minimum maneuvering clearances at doors and gates shall comply with 404.2.4. Maneuvering clearances shall extend the full width of the doorway and the required latch side or hinge side clearance. Door openings shall provide a clear width of 32 inches (815 mm) minimum. Clear openings of doorways with swinging doors shall be measured between the face of the door and the stop, with the door open 90 degrees. Openings more than 24 inches (610 mm) deep shall provide a clear opening of 36 inches (915 mm) minimum. There shall be no projections into the required clear opening width lower than 34 inches (865 mm) above the finish floor or ground. Projections into the clear opening width between 34 inches (865 mm) and 80 inches (2030 mm) above the finish floor or ground shall not exceed 4 inches (100 mm). The threshold at a doorway shall be no higher than 1/2 inch. Changes in level between 1/4 inch and 1/2 inch must be beveled at 1:2 or less. 1/4 inch is the maximum vertical rise. Hand-activated door opening hardware, handles, pulls, latches, locks, and other operating devices on accessible doors shall have a shape that is easy to grasp with one hand and does not require tight grasping, tight pinching or twisting of the wrist to	Kitchen exterior door - 29.5" wide, shelf in pull side maneuvering clearance, knob, small ramp in push side maneuvering clearance, threshold 1"	For all doors along the public circulation route, provide required maneuvering clearance on push and pull side of doors. For all doors along the public circulation route, replace doors with doors having 80" overhead clearance and 32" clear width. For all doors along the public circulation route, repair, provide beveled threshold. For all doors along the public circulation route, replace hardware with lever hardware or hardware operable without a tight pinch or grasp.	2010 ADAS Section: 404.2.3, 404.2.7, 404.2.4, 404.2.11, 404.2.11 Exception

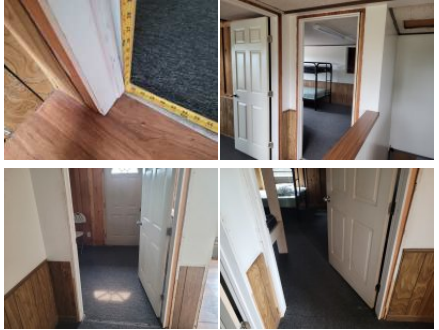
Finding Number	Area Description	Lat/Long	Finding	As Built	Recommendation	Citation	Photos	Figure
105	Parade Ground: Parade Ground - Dining Hall	[33.2096701 , -98.161709]	Minimum maneuvering clearances at doors and gates shall comply with 404.2.4. Maneuvering clearances shall extend the full width of the doorway and the required latch side or hinge side clearance. Door openings shall provide a clear width of 32 inches (815 mm) minimum. Clear openings of doorways with swinging doors shall be measured between the face of the door and the stop, with the door open 90 degrees. Openings more than 24 inches (610 mm) deep shall provide a clear opening of 36 inches (915 mm) minimum. There shall be no projections into the required clear opening width lower than 34 inches (865 mm) above the finish floor or ground. Projections into the clear opening width between 34 inches (865 mm) and 80 inches (2030 mm) above the finish floor or ground shall not exceed 4 inches (100 mm). Hand-activated door opening hardware, handles, pulls, latches, locks, and other operating devices on accessible doors shall have a shape that is easy to grasp with one hand and does not require tight grasping, tight pinching or twisting of the wrist to operate. Hardware shall be 34 inches minimum and 48 inches maximum above the finish floor or ground.	Bedroom doors (4) - all 30" wide, knob hardware, one does not open to 90 degrees and had beds in pull side clearance	For all doors along the public circulation route, provide required maneuvering clearance on push and pull side of doors. For all doors along the public circulation route, replace doors with doors having 80" overhead clearance and 32" clear width. For all doors along the public circulation route, replace hardware with lever hardware or hardware operable without a tight pinch or grasp.	2010 ADAS Section: 404.2.3, 404.2.7, 404.2.4, 404.2.11, 404.2.11 Exception

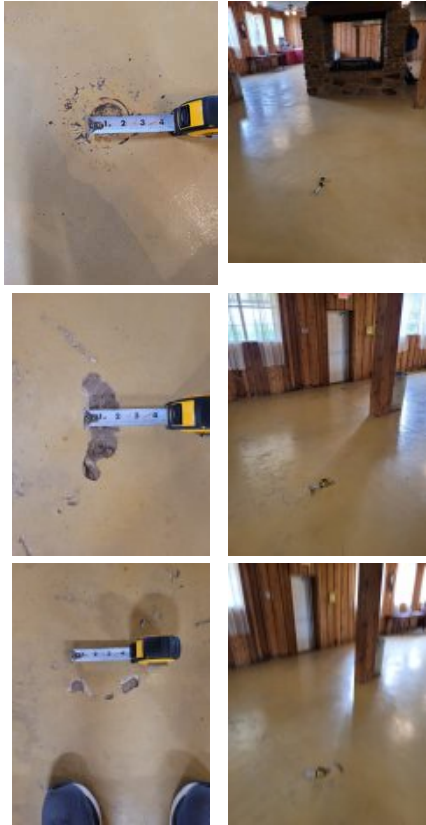
Finding Number	Area Description	Lat/Long	Finding	As Built	Recommendation	Citation	Photos	Figure
121	Parade Ground: Parade Ground - Dining Hall	[33.2096611 , -98.161741 2]	Openings in floor or ground surfaces shall not allow passage of a sphere more than 1/2 inch (13 mm) diameter except as allowed in 407.4.3, 409.4.3, 410.4, 810.5.3 and 810.10. Elongated openings shall be placed so that the long dimension is perpendicular to the dominant direction of travel.	main room- gaps of 1.75", 2", two 1"	Fill and maintain gaps to max .5".	2015 ABAAS Section: 302.3 2012 TAS Section: 302.3 2010 ADAS Section: 302.3

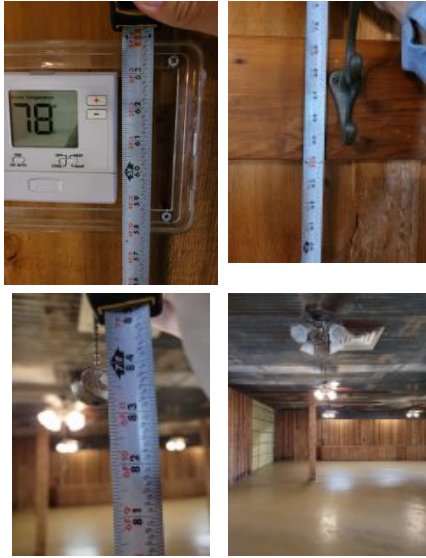
Finding Number	Area Description	Lat/Long	Finding	As Built	Recommendation	Citation	Photos	Figure
122	Parade Ground: Parade Ground - Dining Hall	[33.209688, -98.161735 8]	The operable part is positioned too high for either a side or front approach. Where a clear floor or ground space allows a parallel approach to an element and the side reach is unobstructed, the high side reach shall be 48 inches maximum and the low side reach shall be 15 inches minimum above the finish floor or ground. Where a forward reach is unobstructed, the high forward reach shall be 48 inches maximum and the low forward reach shall be 15 inches minimum above the finish floor or ground.	main room- HVAC at 62" AFF, hooks at 65" AFF, fan controls at 83.25" AFF	Remount operable parts to be in reach range of 15" min to 48" max.	2015 ABAAS Section: 308.1 2012 TAS Section: 308.1 2010 ADAS Section: 308.1

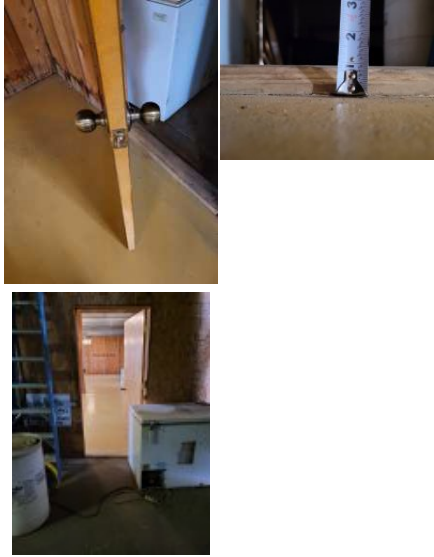
Finding Number	Area Description	Lat/Long	Finding	As Built	Recommendation	Citation	Photos	Figure
131	Parade Ground: Parade Ground - Dining Hall	[33.209697, -98.161730 5]	Minimum maneuvering clearances at doors and gates shall comply with 404.2.4. Maneuvering clearances shall extend the full width of the doorway and the required latch side or hinge side clearance. The threshold at a doorway shall be no higher than 1/2 inch. Changes in level between 1/4 inch and 1/2 inch must be beveled at 1:2 or less. 1/4 inch is the maximum vertical rise. Hand-activated door opening hardware, handles, pulls, latches, locks, and other operating devices on accessible doors shall have a shape that is easy to grasp with one hand and does not require tight grasping, tight pinching or twisting of the wrist to operate. Hardware shall be 34 inches minimum and 48 inches maximum above the finish floor or ground.	Employee storage door - knobs, 1" CIL at threshold, lacks clearance on push side due to storage	For all doors along the public circulation route, provide required maneuvering clearance on push and pull side of doors. For all doors along the public circulation route, repair, provide beveled threshold. For all doors along the public circulation route, replace hardware with lever hardware or hardware operable without a tight pinch or grasp.	2010 ADAS Section: 404.2.3, 404.2.7, 404.2.4, 404.2.11, 404.2.11 Exception

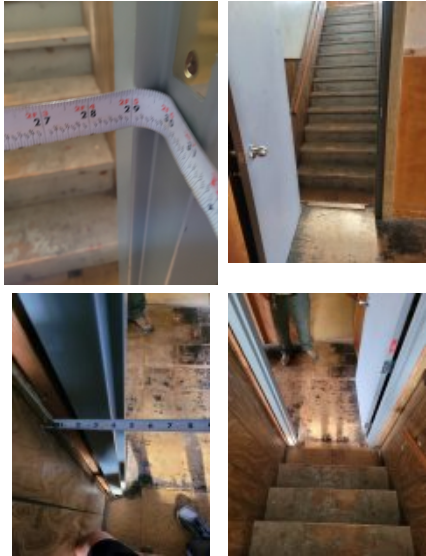
Finding Number	Area Description	Lat/Long	Finding	As Built	Recommendation	Citation	Photos	Figure
133	Parade Ground: Parade Ground - Dining Hall	[33.20966, -98.1618]	<p>Minimum maneuvering clearances at doors and gates shall comply with 404.2.4. Maneuvering clearances shall extend the full width of the doorway and the required latch side or hinge side clearance. Door openings shall provide a clear width of 32 inches (815 mm) minimum. Clear openings of doorways with swinging doors shall be measured between the face of the door and the stop, with the door open 90 degrees. Openings more than 24 inches (610 mm) deep shall provide a clear opening of 36 inches (915 mm) minimum. There shall be no projections into the required clear opening width lower than 34 inches (865 mm) above the finish floor or ground. Projections into the clear opening width between 34 inches (865 mm) and 80 inches (2030 mm) above the finish floor or ground shall not exceed 4 inches (100 mm). Hand-activated door opening hardware, handles, pulls, latches, locks, and other operating devices on accessible doors shall have a shape that is easy to grasp with one hand and does not require tight grasping, tight pinching or twisting of the wrist to operate. Hardware shall be 34 inches minimum and 48 inches maximum above the finish floor or ground.</p>	Door at stairs - knobs, 29" width, lacks clearance on push side	<p>For all doors along the public circulation route, provide required maneuvering clearance on push and pull side of doors. For all doors along the public circulation route, replace doors with doors having 80" overhead clearance and 32" clear width. For all doors along the public circulation route, replace hardware with lever hardware or hardware operable without a tight pinch or grasp.</p>	2010 ADAS Section: 404.2.3, 404.2.7, 404.2.4, 404.2.11, 404.2.11 Exception

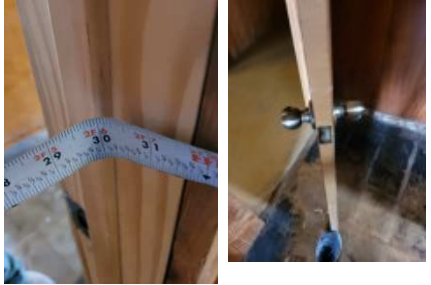
Finding Number	Area Description	Lat/Long	Finding	As Built	Recommendation	Citation	Photos	Figure
134	Parade Ground: Parade Ground - Dining Hall	[33.2097105 , -98.161725 1]	Door openings shall provide a clear width of 32 inches (815 mm) minimum. Clear openings of doorways with swinging doors shall be measured between the face of the door and the stop, with the door open 90 degrees. Openings more than 24 inches (610 mm) deep shall provide a clear opening of 36 inches (915 mm) minimum. There shall be no projections into the required clear opening width lower than 34 inches (865 mm) above the finish floor or ground. Projections into the clear opening width between 34 inches (865 mm) and 80 inches (2030 mm) above the finish floor or ground shall not exceed 4 inches (100 mm). Hand-activated door opening hardware, handles, pulls, latches, locks, and other operating devices on accessible doors shall have a shape that is easy to grasp with one hand and does not require tight grasping, tight pinching or twisting of the wrist to operate. Hardware shall be 34 inches minimum and 48 inches maximum above the finish floor or ground.	Door from room to secondary exterior entrance - knobs, 30" width	For all doors along the public circulation route, replace doors with doors having 80" overhead clearance and 32" clear width. For all doors along the public circulation route, replace hardware with lever hardware or hardware operable without a tight pinch or grasp.	2010 ADAS Section: 404.2.3, 404.2.7, 404.2.4, 404.2.11, 404.2.11 Exception

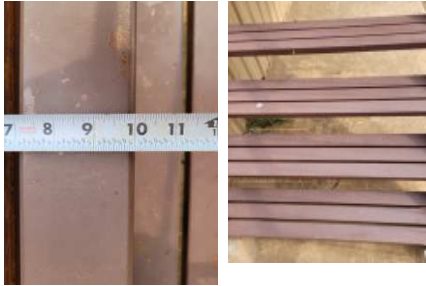
Finding Number	Area Description	Lat/Long	Finding	As Built	Recommendation	Citation	Photos	Figure
139	Parade Ground: Parade Ground - Dining Hall	[33.209706, -98.161719 7]	Treads shall be 11 inches (280 mm) deep minimum and uniform.	exterior- treads 10" depth	Correct tread depth on stairs to 11" minimum and consistent, leave as is if technically infeasible.	2015 ABAAS Section: 504.2 2012 TAS Section: 504.2 2010 ADAS Section: 504.2

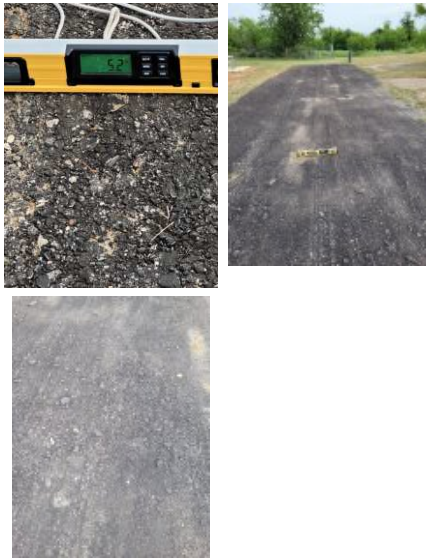
144	Parade Ground: Parade Ground - Dining Hall	[33.2096319 , -98.162427 8]	The surface of parking spaces and pull-up spaces shall be firm and stable. The slope of the surface of parking spaces and pull-up spaces shall not be steeper than 1:48 in any direction. EXCEPTION: Where the surface is other than asphalt, concrete, or boards, slopes not steeper than 1:20 shall be permitted when necessary for drainage.	5.2%, uneven surface, with CILs due to exposed larger stones	Correct surface of parking spaces to be firm and stable with slopes max of 2.08% or 5% for surfaces other than concrete, asphalt or boards as a smart practice.	2015 ABAAS Section: 1012.4, 1012.5, 1012.5 EXCEPTION

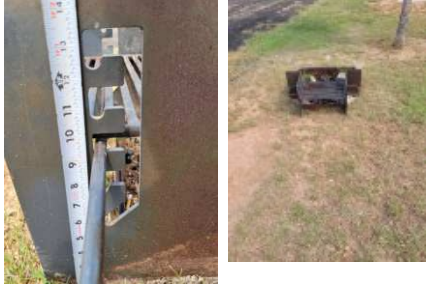
149	Parade Ground: Parade Ground - Dining Hall	[33.2096993 , -98.1624922]	Where provided, cooking surfaces shall be 15 inches (380 mm) minimum and 34 inches (865 mm) maximum above the ground.	Top setting of cooking surface at 13" AGL	Raise or lower cooking surface to be 15" min to 34" max above the ground; in the alternative, replace with a compliant surface as a smart practice.	2015 ABAAS Section: 1011.5.2

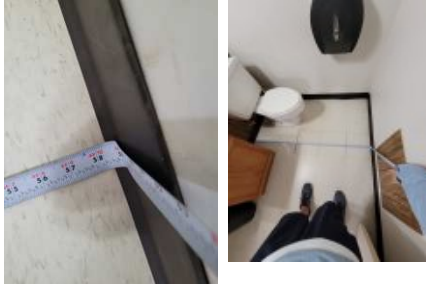
Finding Number	Area Description	Lat/Long	Finding	As Built	Recommendation	Citation	Photos	Figure
154	Parade Ground: Parade Ground - Dining Hall	[33.2096746 , -98.161698 3]	This restroom is not accessible. Where existing toilet rooms or bathing rooms do not comply, directional signs indicating the location of the nearest accessible toilet room or bathing room within the facility shall be provided. Signs shall include the International Symbol of Accessibility. Where existing toilet rooms or bathing rooms do comply), the accessible toilet rooms or bathing rooms shall be identified by the International Symbol of Where clustered single user toilet rooms or bathing facilities are permitted, accessible toilet rooms or bathing facilities shall be identified by the International Symbol of Accessibility unless all toilet rooms and bathing facilities are accessible.	Lacks directional signage to an accessible restroom	Restroom not accessible, acquire and mount signage directing patrons to accessible restroom.	2015 ABAAS Section: F216.8 2012 TAS Section: 216.8 2010 ADAS Section: 216.8

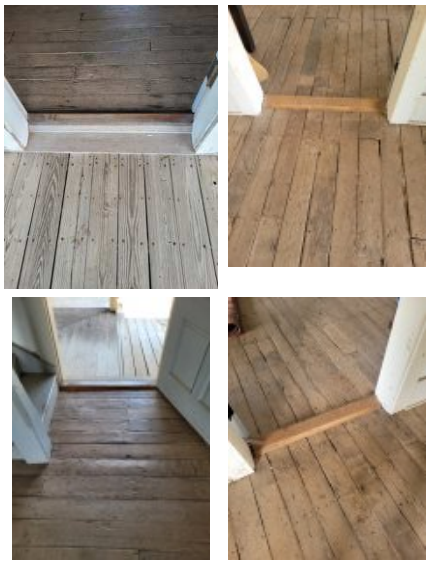
160	Parade Ground: Parade Ground - Officer's Quarters	[33.2064351 , -98.162272 3]	The threshold is greater than 1/2 inch high. The threshold at a doorway shall be no higher than 1/2 inch. Changes in level between 1/4 inch and 1/2 inch must be beveled at 1:2 or less. 1/4 inch is the maximum vertical rise.	Raised thresholds at each doorway	For all doors along the public circulation route, replace thresholds at exterior doors with ADA thresholds.	2015 ABAAS Section: 404.2.5 2012 TAS Section: 404.2.5 2010 ADAS Section: 404.2.5

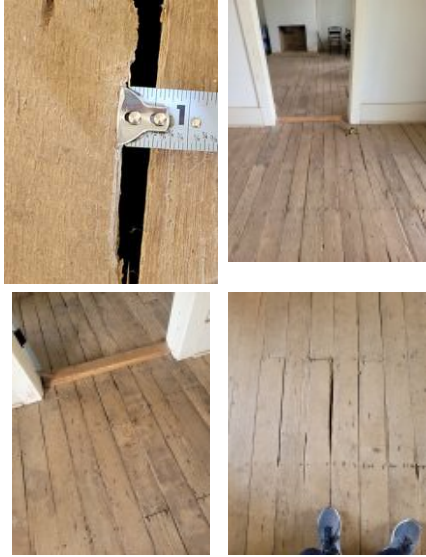
Finding Number	Area Description	Lat/Long	Finding	As Built	Recommendation	Citation	Photos	Figure
161	Parade Ground: Parade Ground - Officer's Quarters	[33.2064351 , -98.162262 9]	Openings in floor or ground surfaces shall not allow passage of a sphere more than 1/2 inch (13 mm) diameter except as allowed in 407.4.3, 409.4.3, 410.4, 810.5.3 and 810.10. Elongated openings shall be placed so that the long dimension is perpendicular to the dominant direction of travel.	Multiple .5" to .75" gaps	Fill and maintain gaps to max .5".	2015 ABAAS Section: 302.3 2012 TAS Section: 302.3 2010 ADAS Section: 302.3

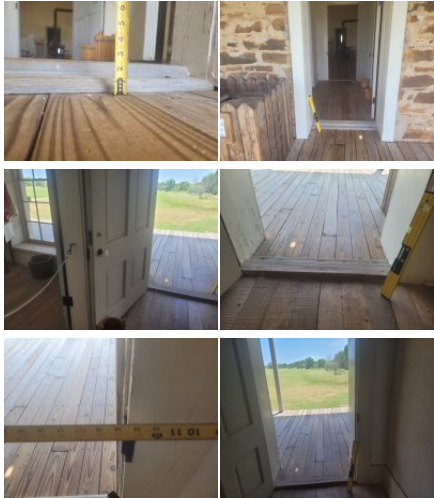
Finding Number	Area Description	Lat/Long	Finding	As Built	Recommendation	Citation	Photos	Figure
171	Parade Ground: Parade Ground - Hospital	[33.2071998 , -98.164380 2]	Minimum maneuvering clearances at doors and gates shall comply with 404.2.4. Maneuvering clearances shall extend the full width of the doorway and the required latch side or hinge side clearance. The threshold has a vertical change greater than 1/4 inch high. The threshold at a doorway shall be no higher than 1/2 inch. Changes in level between 1/4 inch and 1/2 inch must be beveled at 1:2 or less. 1/4 inch is the maximum vertical rise. Hand-activated door opening hardware, handles, pulls, latches, locks, and other operating devices on accessible doors shall have a shape that is easy to grasp with one hand and does not require tight grasping, tight pinching or twisting of the wrist to operate. Hardware shall be 34 inches minimum and 48 inches maximum above the finish floor or ground.	Entry closest to parking - 2.5" threshold, knob, small CIL at nail in clearance on push side, wall 14" in pull side clearance (doors likely kept propped open during public viewing hours)	For all doors along the public circulation route, provide required maneuvering clearance on push and pull side of doors. For all doors along the public circulation route, repair, bevel, or ramp CILs at door entries to max .25". For all doors along the public circulation route, repair, provide beveled threshold. For all doors along the public circulation route, replace hardware with lever hardware or hardware operable without a tight pinch or grasp.	2010 ADAS Section: 404.2.3, 404.2.7, 404.2.4, 404.2.11, 404.2.11 Exception

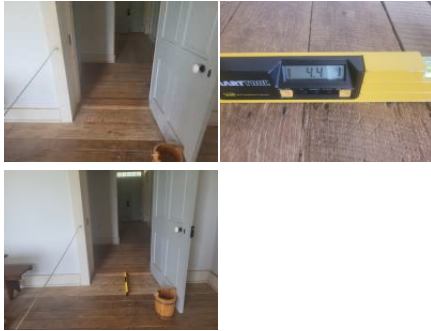
177	Parade Ground: Parade Ground - Hospital	[33.2073747 , -98.164405 4]	Minimum maneuvering clearances at doors and gates shall comply with 404.2.4. Maneuvering clearances shall extend the full width of the doorway and the required latch side or hinge side clearance. Maneuvering clearances shall have a max slope of 2.08%. The threshold at a doorway shall be no higher than 1/2 inch. Changes in level between 1/4 inch and 1/2 inch must be beveled at 1:2 or less. 1/4 inch is the maximum vertical rise. Hand-activated door opening hardware, handles, pulls, latches, locks, and other operating devices on accessible doors shall have a shape that is easy to grasp with one hand and does not require tight grasping, tight pinching or twisting of the wrist to operate. Hardware shall be 34 inches minimum and 48 inches maximum above the finish floor or ground.	Dining door - wall in pull side clearance, recessed pull side, large threshold, knob, 4.4% slope in pull side MC (doors likely kept propped open during public viewing hours)	For all doors along the public circulation route, provide required maneuvering clearance on push and pull side of doors. For all doors along the public circulation route, correct slope in door clearance to max 2.08%. For all doors along the public circulation route, repair, provide beveled threshold. For all doors along the public circulation route, replace hardware with lever hardware or hardware operable without a tight pinch or grasp.	2010 ADAS Section: 404.2.3, 404.2.7, 404.2.4, 404.2.11, 404.2.11 Exception

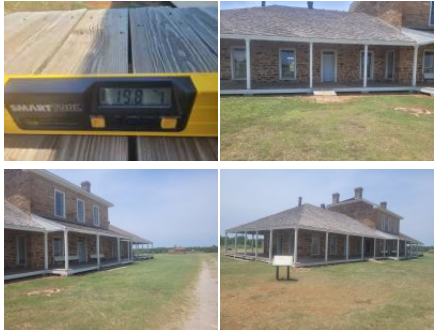
Finding Number	Area Description	Lat/Long	Finding	As Built	Recommendation	Citation	Photos	Figure
178	Parade Ground: Parade Ground - Hospital	[33.2072508 , -98.164387 6]	The building entrance is not located on an accessible route. When a building, or portion of a building, is required to be accessible, an accessible route of travel shall be provided to all portions of the building, to accessible building entrances and between the building and the public way. All walks, halls, corridors, aisles, skywalks, tunnels, and other spaces that are part of an accessible route must comply. An accessible route of travel must not pass through kitchens, storage rooms, restrooms, closets or other spaces used for similar purposes. At least one accessible route within the boundary of the site must be provided from public transportation stops, accessible parking and accessible passenger loading zones and public streets or sidewalks to the accessible building entrance they serve. The accessible route shall, to the maximum extent feasible, coincide with the route for the general public. At least one accessible route shall connect accessible buildings, facilities, elements and spaces that are on the same site. At least one accessible route shall connect accessible building or facility entrances with all accessible spaces and elements.	Currently lacks AR to building entry, ramp on existing structure 20.2%, steps to access porch in other areas, plan to add ramp on very near future	Create AR with crushed and compacted stone or similar outdoor material from parking or sidewalk to building entrance.	2015 ABAAS Section: F206.2.1 2012 TAS Section: 206.2.1 2010 ADAS Section: 206.2.1

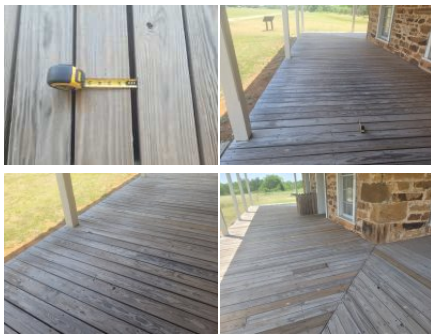
Finding Number	Area Description	Lat/Long	Finding	As Built	Recommendation	Citation	Photos	Figure
180	Parade Ground: Parade Ground - Hospital	[33.20726, -98.16446]	There is a gap spaced greater than a 1/2 inch. Openings in floor or ground surfaces shall not allow passage of a sphere more than 1/2 inch diameter. Elongated openings shall be placed so that the long dimension is perpendicular to the dominant direction of travel.	Some gaps in boards on porch due to knots, boards separating	Correct or fill gaps to be max .5".	2015 ABAAS Section: 302.3 2012 TAS Section: 302.3 2010 ADAS Section: 302.3

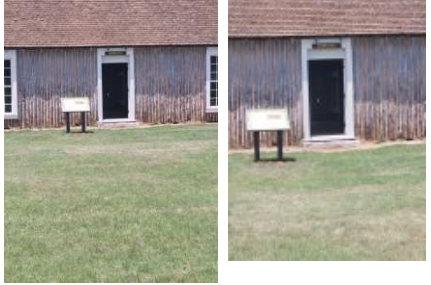
181	Parade Ground: Parade Ground - Barracks	[33.2078429, -98.1631673]	There is no accessible route to the barracks. At least one accessible route shall connect accessible buildings, accessible facilities, accessible elements, and accessible spaces that are on the same site.	Lacks AR to barracks	Create an accessible route with crushed stone or other outdoor material from parking or walkway to the barracks.	2015 ABAAS Section: F206.2.2 2012 TAS Section: 206.2.2 2010 ADAS Section: 206.2.2

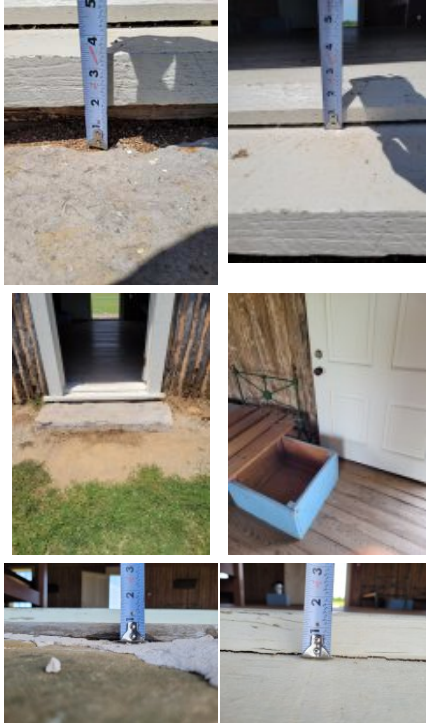
184	Parade Ground: Parade Ground - Barracks	[33.2078054 , -98.163160 6]	The threshold has a vertical change greater than 1/4 inch high. Hand-activated door opening hardware, handles, pulls, latches, locks, and other operating devices on accessible doors shall have a shape that is easy to grasp with one hand and does not require tight grasping, tight pinching or twisting of the wrist to operate. Hardware shall be 34 inches minimum and 48 inches maximum above the finish floor or ground.	Front doorway - step, 3.5" CIL, 2.5" CIL Rear doorway - knobs, two 1.5" CILs	For all doors along the public circulation route, repair, bevel, or ramp CILs at door entries to max .25". For all doors along the public circulation route, replace hardware with lever hardware or hardware operable without a tight pinch or grasp.	2010 ADAS Section: 404.2.3, 404.2.7, 404.2.4, 404.2.11, 404.2.11 Exception

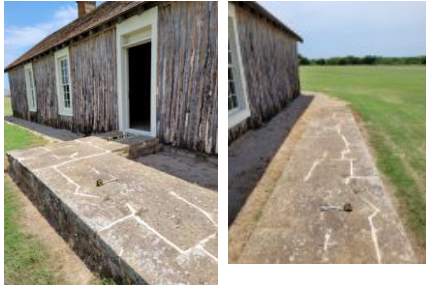
190	Parade Ground: Parade Ground - Barracks	[33.20546, -98.15981]	The ramp run has not been provided with edge protection. The floor or ground surface of the ramp run or landing shall extend 12 inches minimum beyond the inside face of a handrail or a curb or barrier shall be provided that prevents the passage of a 4 inch diameter sphere, where any portion of the sphere is within 4 inches of the finish floor or ground surface.	Lacks edge protection	Install rail along bottom edge of ramp that prevents a 4" sphere from passing through.	2015 ABAAS Section: 405.9, 405.9.1, 405.9.2 2012 TAS Section: 405.9.1, 405.9.2, 405.9 2010 ADAS Section: 405.9.2, 405.9.1, 405.9

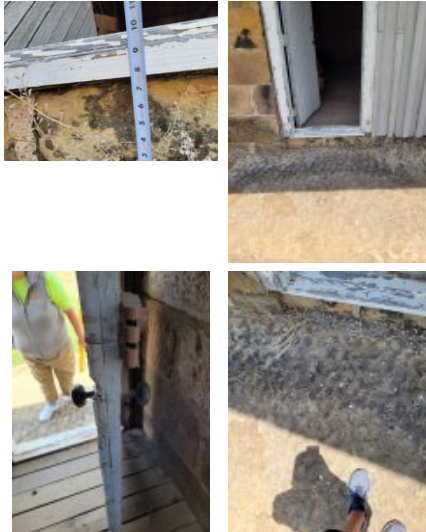
Finding Number	Area Description	Lat/Long	Finding	As Built	Recommendation	Citation	Photos	Figure
191	Parade Ground: Parade Ground - Commissary	[33.2081111 , -98.160484 7]	Minimum maneuvering clearances at doors and gates shall comply with 404.2.4. Maneuvering clearances shall extend the full width of the doorway and the required latch side or hinge side clearance. Maneuvering clearances shall have a max slope of 2.08%. The threshold has a vertical change greater than 1/4 inch high. Hand-activated door opening hardware, handles, pulls, latches, locks, and other operating devices on accessible doors shall have a shape that is easy to grasp with one hand and does not require tight grasping, tight pinching or twisting of the wrist to operate. Hardware shall be 34 inches minimum and 48 inches maximum above the finish floor or ground.	Door - 10" CIL/step, knobs, lacks clearance on push side, uneven landing in push side clearance	For all doors along the public circulation route, provide required maneuvering clearance on push and pull side of doors. For all doors along the public circulation route, correct slope in door clearance to max 2.08%. For all doors along the public circulation route, repair, bevel, or ramp CILs at door entries to max .25". For all doors along the public circulation route, replace hardware with lever hardware or hardware operable without a tight pinch or grasp.	2010 ADAS Section: 404.2.3, 404.2.7, 404.2.4, 404.2.11, 404.2.11 Exception

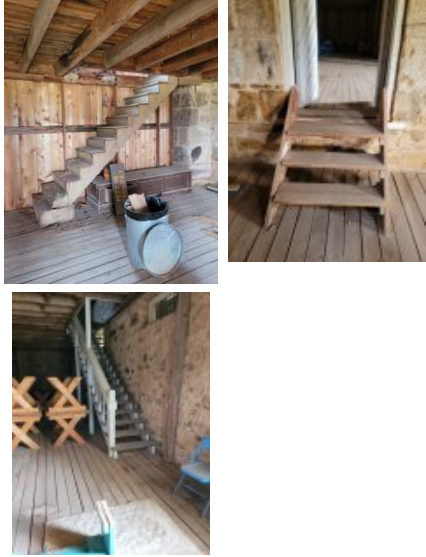
Finding Number	Area Description	Lat/Long	Finding	As Built	Recommendation	Citation	Photos	Figure
192	Parade Ground: Parade Ground - Commissary	[33.208088, -98.160475 2]	Employee Work Areas. Common use circulation paths within employee work areas shall comply with 402. EXCEPTIONS: 1. Common use circulation paths located within employee work areas that are less than 1000 square feet (93 m2) and defined by permanently installed partitions, counters, casework, or furnishings shall not be required to comply with 402. 2. Common use circulation paths located within employee work areas that are an integral component of work area equipment shall not be required to comply with 402. 3. Common use circulation paths located within exterior employee work areas that are fully exposed to the weather shall not be required to comply with 402.	stairs to enter main room and upper level, used by staff only	Make corrections for compliant circulation path.	2015 ABAAS Section: F206.2.8, F206.2.8.1, F206.2.8.2 2012 TAS Section: 206.2.8, 206.2.8 Exception 1, 206.2.8 Exception 2, 206.2.8 Exception 3, 206.2.8 Advisory 1, 206.2.8 Advisory 2 2010 ADAS Section: 206.2.8, 206.2.8 Exception 1, 206.2.8 Exception 2, 206.2.8 Exception 3
