Access Audit Site Report

Fort Richardson State Park and Historic Site

Accessibility Evaluation

Inspection Date: 05/16/2022

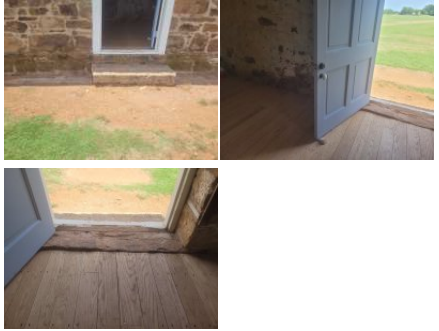
Finding Number	Area Description	Lat/Long	Finding	As Built	Recommendation	Citation	Photos	Figure
194	Parade Ground: Parade Ground - Bakery	[33.2084163 , -98.164545 1]	The threshold has a vertical change greater than 1/4 inch high. The threshold at a doorway shall be no higher than 1/2 inch. Changes in level between 1/4 inch and 1/2 inch must be beveled at 1:2 or less. 1/4 inch is the maximum vertical rise. Hand-activated door opening hardware, handles, pulls, latches, locks, and other operating devices on accessible doors shall have a shape that is easy to grasp with one hand and does not require tight grasping, tight pinching or twisting of the wrist to operate. Hardware shall be 34 inches minimum and 48 inches maximum above the finish floor or ground.	Bakery door - stone step to enter, stone threshold creates CILs and gaps, knob	For all doors along the public circulation route, repair, bevel, or ramp CILs at door entries to max .25". For all doors along the public circulation route, repair, provide beveled threshold. For all doors along the public circulation route, replace hardware with lever hardware or hardware operable without a tight pinch or grasp.	2010 ADAS Section: 404.2.3, 404.2.7, 404.2.4, 404.2.11, 404.2.11 Exception

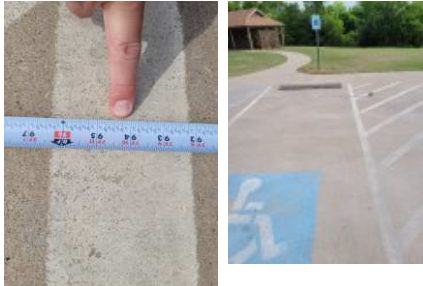
Finding Number	Area Description	Lat/Long	Finding	As Built	Recommendation	Citation	Photos	Figure																																																																																																																																																									
201	Scout Area: Scout - Parking	[33.2079825 , -98.166431]	Element meets all standards and requirements	Scout paved parking meets scoping requirements - 23 standard, 1 accessible	None	2010 ADAS Section: N/A																																																																																																																																																											
202	Scout Area: Scout - Parking	[33.2079859 , -98.1664458]	The accessible parking stall is not wide enough. Each parking space must be at least 8' feet wide and shall be marked to define the width. The measurements of parking spaces and access aisles shall be made from the centerline of the markings. Where the parking space is not adjacent to another parking space or access aisle, the measurement shall be permitted to include the full width of the line defining the parking space.	Parking stall is 94.25" wide	Repaint stalls to be 8' wide each.	2015 ABAAS Section: 502.2 2012 TAS Section: 502.2 2010 ADAS Section: 502.2

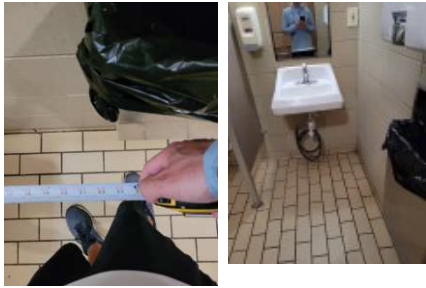
218	Scout Area: Scout - Men's Restroom	[33.2082383 , -98.166405 6]	The operable part is not accessible because there is not adequate clear floor space for either a forward or side approach. The clear floor or ground space shall be 30 inches minimum by 48 inches minimum.	Garbage in CFS at sink	Remove, or relocate storage in CFS at fixtures and operable parts along the AR.	2015 ABAAS Section: 305.3 2012 TAS Section: 305.3 2010 ADAS Section: 305.3

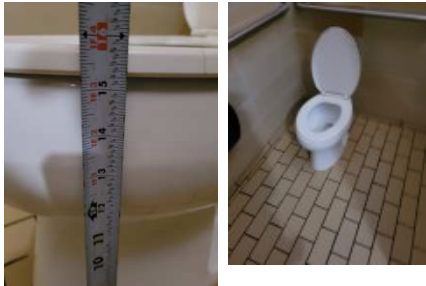
219	Scout Area: Scout - Men's Restroom	[33.2082417 , -98.166405 6]	The toilet seat is not located within the range allowed off the floor. The height of accessible water closets shall be a minimum of 17 inches and a maximum of 19 inches measured to the top of a maximum 2-inch high toilet seat.	Seat at 15.75" AFF	Replace toilet seat, or re-set or replace toilet to 17" to 19" above the finished floor (AFF).	2015 ABAAS Section: 604.4 2012 TAS Section: 604.4 2010 ADAS Section: 604.4

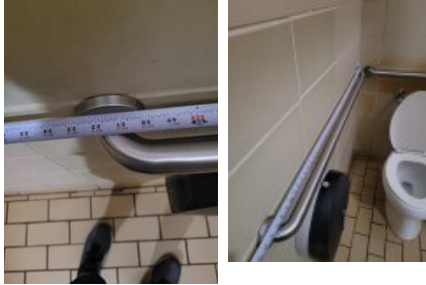
Finding Number	Area Description	Lat/Long	Finding	As Built	Recommendation	Citation	Photos	Figure
220	Scout Area: Scout - Men's Restroom	[33.2082361 , -98.166408 2]	The side grab bars are not in the correct location. Grab bars on the side wall must be installed so that the end closest to the rear wall is maximum 12" from the rear wall. The end furthest from the rear wall must be mounted minimum 54" from the rear wall.	Side grab bar ends 51.5" from rear wall	Remount side grab bar to max 12" from the rear wall at the close end and min 54" on the far end, and 33" to 36" AFF.	2015 ABAAS Section: 604.5.1 2012 TAS Section: 604.5.1 2010 ADAS Section: 604.5.1

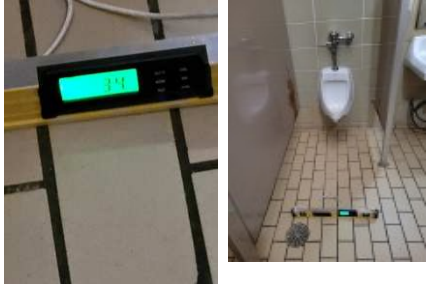
222	Scout Area: Scout - Men's Restroom	[33.2082428 , -98.166410 9]	The accessible route contains running slopes greater than 5 percent and cross slopes greater than 2 percent across the width of the walk and has not been constructed as a ramp (i.e. handrails, wheel guides, etc.). When the slope in the direction of travel of any walk exceeds 1 unit vertical in 20 units horizontal (5-percent slope), it must be constructed as ramp. Surface cross slopes must not exceed one unit vertical in 48 units. Horizontal (2-percent slope).	3.4% approaching urinal	Correct or repair slope to max 2.08% in restroom.	2015 ABAAS Section: 403.3 2012 TAS Section: 403.3 2010 ADAS Section: 403.3

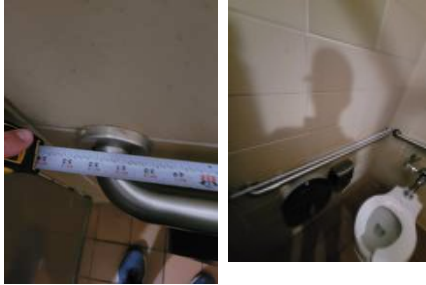
Finding Number	Area Description	Lat/Long	Finding	As Built	Recommendation	Citation	Photos	Figure
226	Scout Area: Scout - Women's Restroom	[33.2082417 , -98.166404 2]	The side grab bars are not in the correct location. Grab bars on the side wall must be installed so that the end closest to the rear wall is maximum 12" from the rear wall. The end furthest from the rear wall must be mounted minimum 54" from the rear wall.	Side grab bar ends 51.5" from rear wall	Remount side grab bar to max 12" from the rear wall at the close end and min 54" on the far end, and 33" to 36" AFF.	2015 ABAAS Section: 604.5.1 2012 TAS Section: 604.5.1 2010 ADAS Section: 604.5.1

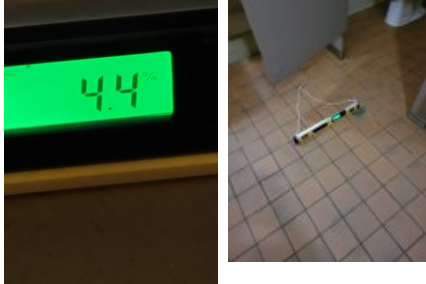
228	Scout Area: Scout - Women's Restroom	[33.2082361 , -98.166405 6]	The accessible route contains running slopes greater than 5 percent and cross slopes greater than 2 percent across the width of the walk and has not been constructed as a ramp (i.e. handrails, wheel guides, etc.). When the slope in the direction of travel of any walk exceeds 1 unit vertical in 20 units horizontal (5-percent slope), it must be constructed as ramp. Surface cross slopes must not exceed one unit vertical in 48 units. Horizontal (2-percent slope).	4.4% at drain	Correct or repair slope to max 2.08% in restroom.	2015 ABAAS Section: 403.3 2012 TAS Section: 403.3 2010 ADAS Section: 403.3

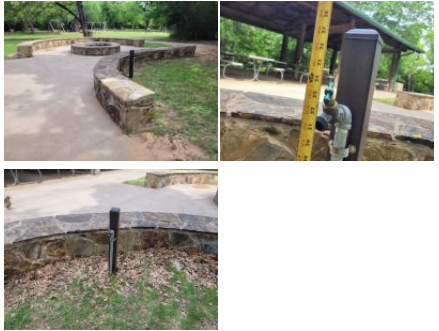
Finding Number	Area Description	Lat/Long	Finding	As Built	Recommendation	Citation	Photos	Figure
234	Scout Area: Scout - Shelter/Picnic Area	[33.2083023 , -98.166604]	Water spouts at water hydrants and water utility hook-ups shall be 28 inches (710 mm) minimum and 36 inches (915 mm) maximum above the ground.	shelter- lacks AR to water spout, spout 21"	Create ORAR to water spout and remount water spouts to 28" min or 36" max above the ground as a smart practice.	2015 ABAAS Section: 1011.6

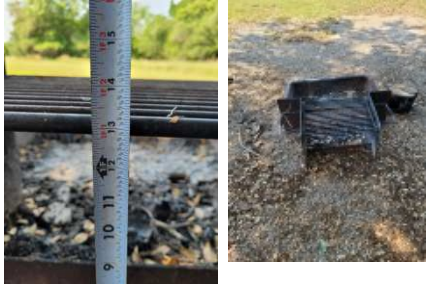
Finding Number	Area Description	Lat/Long	Finding	As Built	Recommendation	Citation	Photos	Figure
257	Campsites & Cabins: Campsites	[33.2006628 , -98.162972 3]	Where provided, cooking surfaces shall be 15 inches (380 mm) minimum and 34 inches (865 mm) maximum above the ground.	Cooking surface at 13.25" AGL	Raise or lower cooking surface to be 15" min to 34" max above the ground; in the alternative, replace with a compliant surface as a smart practice.	2015 ABAAS Section: 1011.5.2

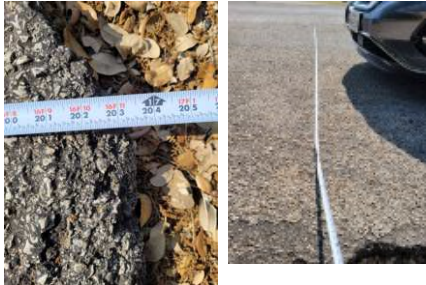
259	Campsites & Cabins: Campsites	[33.2006976 , -98.163001 8]	Parking spaces and pull-up spaces for recreational vehicles shall be 20 feet (6100 mm) wide minimum. EXCEPTION: Where two adjacent parking spaces are provided for recreational vehicles, one parking space shall be permitted to be 16 feet (4880 mm) wide minimum.	Campsite parking 16' 11" wide	Correct RV parking space to be 20' wide minimum; or 16' for two adjacent spaces as a smart practice.	2015 ABAAS Section: 1012.2, 1012.2 EXCEPTION

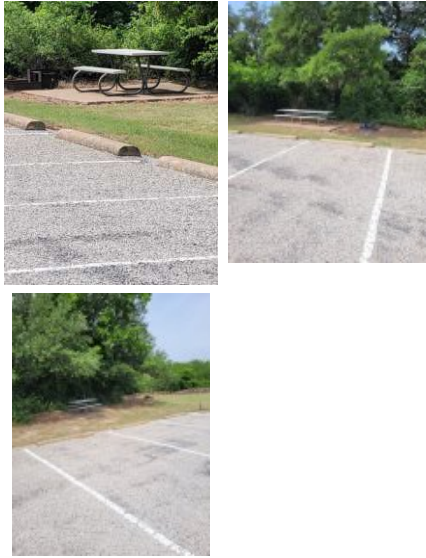
Finding Number	Area Description	Lat/Long	Finding	As Built	Recommendation	Citation	Photos	Figure																				
263	Campsites & Cabins: Overflow Camping/Picnic Area	[33.2062625 , -98.166331]	There is no accessible route to the overflow campsites/picnic areas. At least one accessible route shall connect accessible buildings, accessible facilities, accessible elements, and accessible spaces that are on the same site.	Lacks route to 12 picnic areas with grills	Create an accessible route with crushed stone or other outdoor material from parking or walkway to overflow campsites/picnic areas	2015 ABAAS Section: F206.2.2 2012 TAS Section: 206.2.2 2010 ADAS Section: 206.2.2

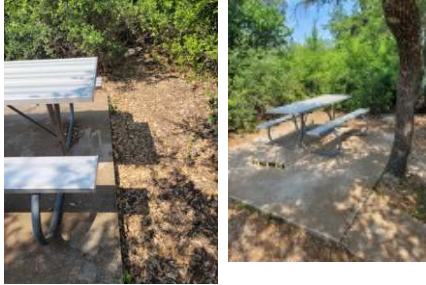
Finding Number	Area Description	Lat/Long	Finding	As Built	Recommendation	Citation	Photos	Figure
269	Campsites & Cabins: Cabins - Cabin 8	[33.2039575 , -98.164954 5]	36 inches (915 mm) on all usable sides of the table measured from the back edge of the benches	Lacks 36" clear space	Provide required 36" clear ground space around all usable portions of the table as a smart practice.	2015 ABAAS Section: 1011.2.1

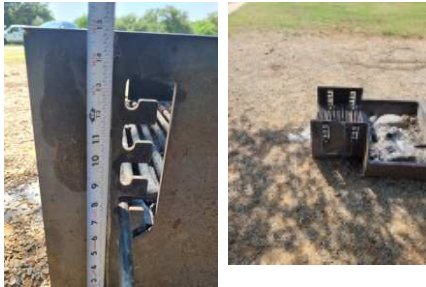
272	Campsites & Cabins: Cabins - Cabin 8	[33.2039238 , -98.164961 2]	Where provided, cooking surfaces shall be 15 inches (380 mm) minimum and 34 inches (865 mm) maximum above the ground.	Cooking surface at 13" AGL	Raise or lower cooking surface to be 15" min to 34" max above the ground; in the alternative, replace with a compliant surface as a smart practice.	2015 ABAAS Section: 1011.5.2

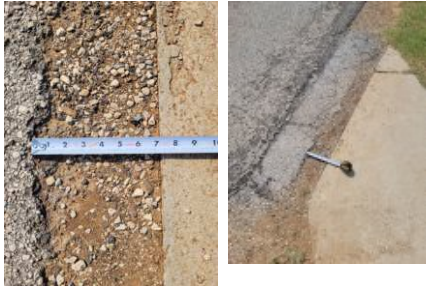
275	Campsites & Cabins: Cabins - Cabin 8	[33.2039377 , -98.165110 3]	Openings in the surface of outdoor recreation access routes shall not allow the passage of a sphere more than 1/2 inch (13 mm) in diameter. Advisory: Spaces between the boards in a boardwalk and drainage grates are examples of openings. Where possible, drainage grates should be located outside the minimum clear width of the outdoor recreation access route. Elongated openings should be placed so that the long dimension is perpendicular, or as close to perpendicular as possible, to the dominant direction of travel.	7" gap at parking connecting to route	Correct or fill gaps along the ORAR to max .5" as a smart practice.	2015 ABAAS Section: 1016.6, Advisory 1016.6

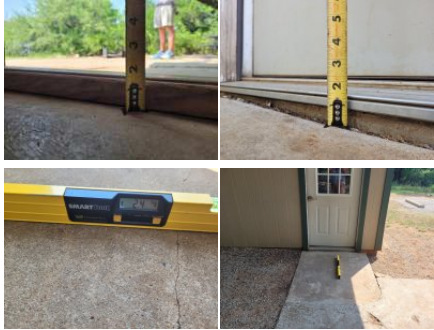
Finding Number	Area Description	Lat/Long	Finding	As Built	Recommendation	Citation	Photos	Figure
276	Campsites & Cabins: Cabins - Cabin 8	[33.2038854 , -98.165019 7]	Minimum maneuvering clearances at doors and gates shall comply with 404.2.4. Maneuvering clearances shall extend the full width of the doorway and the required latch side or hinge side clearance. Maneuvering clearances shall have a max slope of 2.08%. The threshold at a doorway shall be no higher than 1/2 inch. Changes in level between 1/4 inch and 1/2 inch must be beveled at 1:2 or less. 1/4 inch is the maximum vertical rise.	Cabin door - high threshold, slope of 2.4% in push side clearance	For all doors along the public circulation route, provide required maneuvering clearance on push and pull side of doors. For all doors along the public circulation route, correct slope in door clearance to max 2.08%. For all doors along the public circulation route, repair, provide beveled threshold.	2010 ADAS Section: 404.2.3, 404.2.7, 404.2.4, 404.2.11, 404.2.11 Exception

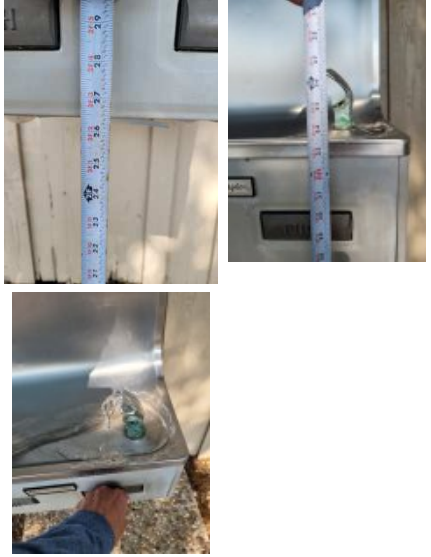
281	Campsites & Cabins: Men's Restroom	[33.20083, -98.16335]	There are not enough drinking fountains. When drinking fountains are provided, a minimum of one must be designed for wheelchair users and one must be designed for standing persons unless a single fountain meets the requirements for both.	Low bowl fountain only, lacks knee clearance, low flow	Replace drinking fountain with a hi-lo bowl fountain.	2015 ABAAS Section: F211.2 2012 TAS Section: 211.2 2010 ADAS Section: 211.2

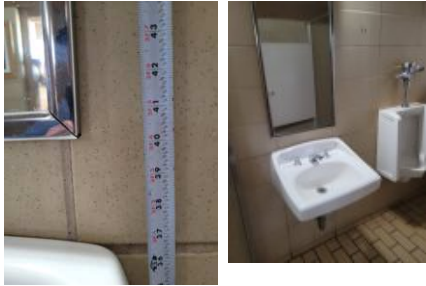
Finding Number	Area Description	Lat/Long	Finding	As Built	Recommendation	Citation	Photos	Figure
282	Campsites & Cabins: Men's Restroom	[33.2008547 , -98.1633505]	The mirror is mounted too high. Mirrors must have the bottom edge of the reflecting surface a maximum of 40 inches above the floor if above a sink or counter. Mirrors not located above lavatories or countertops shall be installed with the bottom edge of the reflecting surface 35 inches maximum above the finish floor or ground.	Bottom edge of mirror at 41" AFF	Lower mirror so bottom reflective surface is max 40" AFF and 74" at the top.	2015 ABAAS Section: 603.3 2012 TAS Section: 603.3 2010 ADAS Section: 603.3

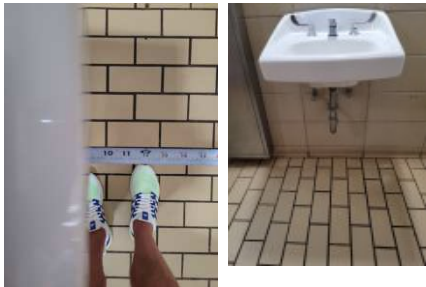
283	Campsites & Cabins: Men's Restroom	[33.2008536 , -98.1633492]	Knee clearance at 27 inches off the floor is not 8 inches minimum deep. The knee clearance, measured from the bottom of the apron or the outside bottom edge of the lavatory, must be 27 inches at a point located 8 inches back from the front edge and continuing to 11 inches minimum in depth at 9 inches above the floor. The top of the lavatory rim may be no higher than 34 inches.	Sink lacks knee clearance - 9.5"	Replace sink with one providing 27" knee clearance that is a min 8" deep.	2015 ABAAS Section: 306.3.1, 306.3.2, 306.3.3, 306.3.4 , 306.3.5 2012 TAS Section: 306.3.2, 306.3.3, 306.3.4, 306.3.5, 306.3.1 2010 ADAS Section: 306.3.3, 306.3.2, 306.3.4, 306.3.5, 306.3.1

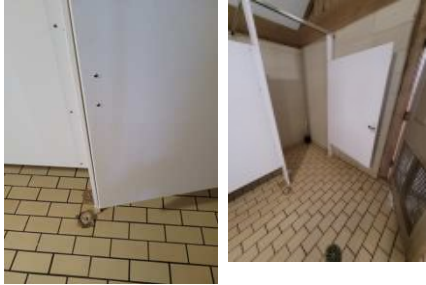
Finding Number	Area Description	Lat/Long	Finding	As Built	Recommendation	Citation	Photos	Figure
287	Campsites & Cabins: Men's Restroom	[33.2008547 , -98.1633505]	The stall door fails to comply with all of the door requirements. The stall door must be a minimum of 32" wide and have compliant hardware on both sides. The stall door must be self-closing.	Lacks hardware on pull side, not self-closing	Adjust stall door to be self-closing. Replace stall hardware with hardware operable without a tight pinch or grasp on both sides of the stall door.	2015 ABAAS Section: 404.2.3, 404.2.7, 604.8.2.2 2012 TAS Section: 404.2.3, 404.2.7, 604.8.2.2 2010 ADAS Section: 404.2.3, 404.2.7, 604.8.2.2

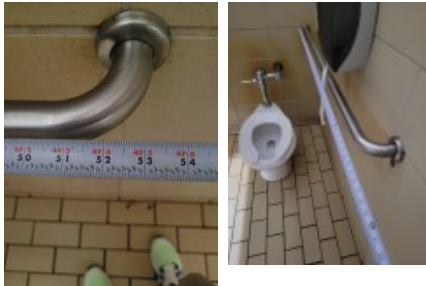
288	Campsites & Cabins: Men's Restroom	[33.2008626 , -98.1633452]	The side grab bars are not in the correct location. Grab bars on the side wall must be installed so that the end closest to the rear wall is maximum 12" from the rear wall. The end furthest from the rear wall must be mounted minimum 54" from the rear wall.	Both bars extend 53" from rear wall	Remount side grab bar to max 12" from the rear wall at the close end and min 54" on the far end, and 33" to 36" AFF.	2015 ABAAS Section: 604.5.1 2012 TAS Section: 604.5.1 2010 ADAS Section: 604.5.1

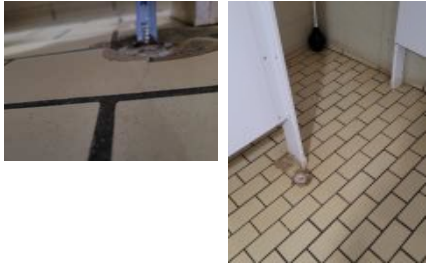
Finding Number	Area Description	Lat/Long	Finding	As Built	Recommendation	Citation	Photos	Figure
290	Campsites & Cabins: Men's Restroom	[33.2008525 , -98.163350 5]	There is a change in level greater than 1/4 inch. 1/4 inch is the maximum vertical rise. Changes in level between 1/4 inch and 1/2 inch must be beveled at 1:2 or less. Changes in level greater than 1/2 inch must be by way of a ramp.	.75" CIL at old footing	Repair, bevel or ramp CIL along accessible route (AR) to max .25".	2015 ABAAS Section: 303.3 2012 TAS Section: 303.3 2010 ADAS Section: 303.3

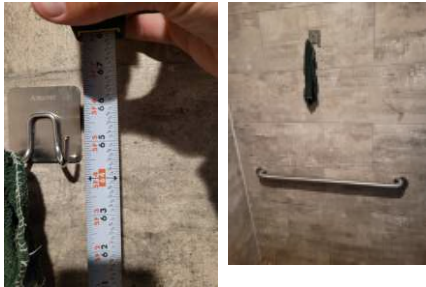
291	Campsites & Cabins: Men's Restroom	[33.2008592 , -98.163342 5]	Coat hooks provided within the room shall be located within one of the reach ranges specified in 308. Shelves shall be 40 inches (1015 mm) minimum and 48 inches (1220 mm) maximum above the finish floor or ground. Where coat hooks or shelves are provided in dressing, fitting or locker rooms without individual compartments, at least one of each type shall comply with 803.5. Where coat hooks or shelves are provided in individual compartments at least one of each type complying with 803.5 shall be provided in individual compartments in dressing, fitting, or locker rooms required to comply with 222.1.	Hook at 65" AFF	Remount at least one hook to max 48" AFF.	2015 ABAAS Section: 308.2.1, 308.1, F222.2, 803.5 2012 TAS Section: 308.2.1, 308.1, 222.2, 803.5 2010 ADAS Section: 308.2.1, 308.1, 222.2, 803.5

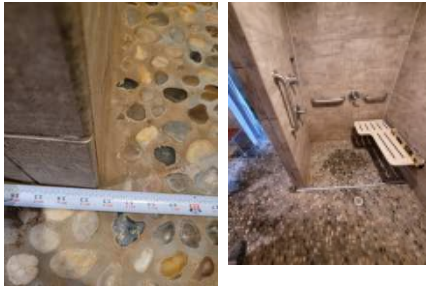
292	Campsites & Cabins: Men's Restroom	[33.2008513 , -98.163341 1]	Alternate roll-in type shower compartments shall be 36 inches (915 mm) wide and 60 inches (1525 mm) deep minimum clear inside dimensions measured at center points of opposing sides. A 36 inch (915 mm) wide minimum entry shall be provided at one end of the long side of the compartment.	Shower is 52.25" wide	Correct shower stall, if feasible, to compliant dimensions for an alternate roll in shower of 36" deep by 60" wide with a 36" opening on the long dimension.	2015 ABAAS Section: 608.2.3 2012 TAS Section: 608.2.3 2010 ADAS Section: 608.2.3

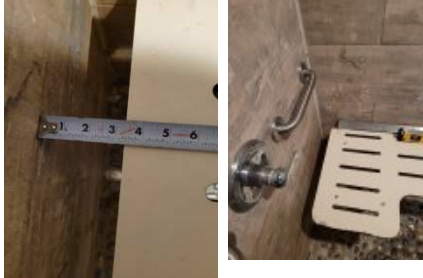
295	Campsites & Cabins: Men's Restroom	[33.2008547, -98.163347 8]	The shower seat does not have a compliant space between it and the wall. The folding seat must be mounted 17-19 inches above the floor, and have a maximum space of 1-1/2 inches between the edge of the seat and the side wall and 2-1/2 inches maximum to the seat wall.	Seat is 3.5" from wall	Remount shower seat to the correct location and height in the shower.	2015 ABAAS Section: 610.3.2 2012 TAS Section: 610.3.2 2010 ADAS Section: 610.3.2

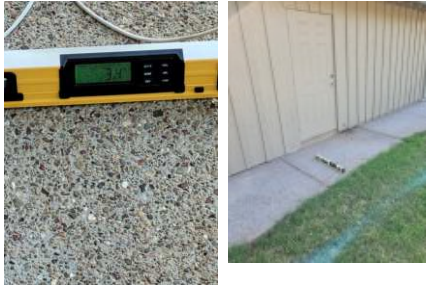
Finding Number	Area Description	Lat/Long	Finding	As Built	Recommendation	Citation	Photos	Figure
298	Campsites & Cabins: Men's Restroom	[33.2008994 , -98.163349 2]	The accessible route of travel contains cross slopes greater than 2%. Cross slopes shall not exceed one unit vertical in 48 units horizontal (2-percent slope).	3.4% cross slope near maintenance door	Correct or repair cross slope along AR to max 2.08%.	2015 ABAAS Section: 403.3 2012 TAS Section: 403.3 2010 ADAS Section: 403.3

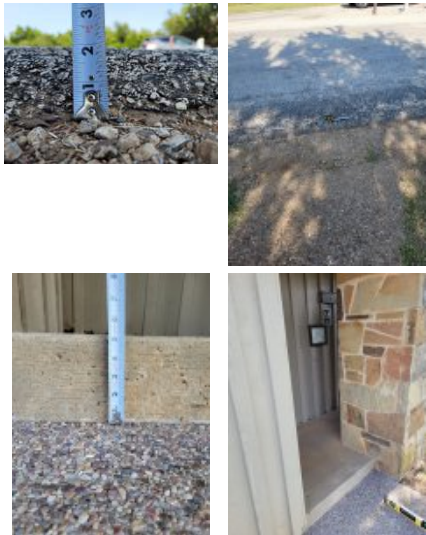
299	Campsites & Cabins: Men's Restroom	[33.2006931 , -98.16312 92], [33.2008031 , -98.163306 3]	The walkway contains abrupt vertical edges and/or variations over a 1/4 inch. 1/4 inch is the maximum vertical rise. Changes in level between 1/4 inch and 1/2 inch must be beveled at 1:2 or less. Changes in level greater than 1/2 inch must be by way of a ramp.	2" CIL at road approaching campsite 6 and 5" CIL approaching men's restroom	Repair, bevel or ramp CIL along AR.	2012 TAS Section: 303.2, 303.3 2010 ADAS Section: 303.2, 303.3

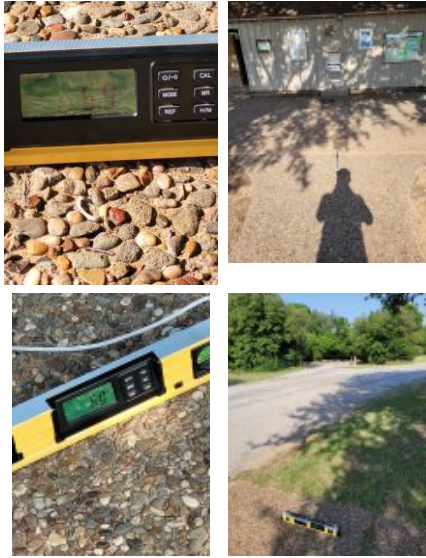
Finding Number	Area Description	Lat/Long	Finding	As Built	Recommendation	Citation	Photos	Figure
300	Campsites & Cabins: Men's Restroom	[33.2009655 , -98.1633775], [33.2008398 , -98.1634311]	The running slope of walking surfaces shall not be steeper than 1:20.	Running slopes of 5.9% approaching drinking fountain, 6% near Campsite 5	Correct running slope along the AR to max 5%.	2015 ABAAS Section: 403.3 2012 TAS Section: 403.3 2010 ADAS Section: 403.3

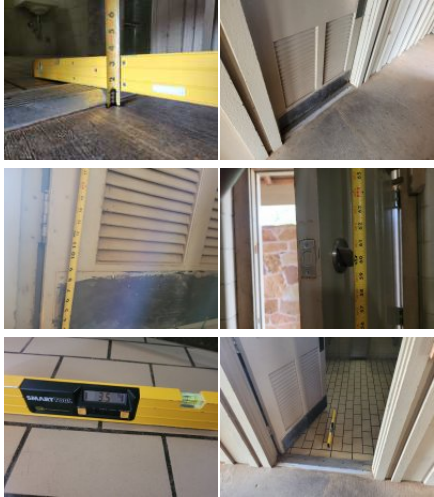
Finding Number	Area Description	Lat/Long	Finding	As Built	Recommendation	Citation	Photos	Figure
302	Campsites & Cabins: Women's Restroom	[33.2008498 , -98.163352 4]	Minimum maneuvering clearances at doors and gates shall comply with 404.2.4. Maneuvering clearances shall extend the full width of the doorway and the required latch side or hinge side clearance. Maneuvering clearances shall have a max slope of 2.08%. The threshold at a doorway shall be no higher than 1/2 inch. Changes in level between 1/4 inch and 1/2 inch must be beveled at 1:2 or less. 1/4 inch is the maximum vertical rise. The sweep period for doors with closers shall be adjusted so that from an open position of 70 degrees, the door will take at least 3 seconds to move to a point 3 inches from the latch, measured to the leading edge of the door. Exterior doors are recommended to be maintained at 8.5 lbf as a smart practice. Force is to be measured at the operating hardware or 30 inches from the hinges, whichever is greater. Hand-activated door opening hardware, handles, pulls, latches, locks, and other operating devices on accessible doors shall have a shape that is easy to grasp with one hand and does not require tight grasping, tight pinching or twisting of the wrist to operate. Hardware shall be 34 inches minimum and 48 inches maximum above the finish floor or ground. The bottom 10 inches on the push side must be smooth and free of obstructions (hold open devices). Opening hardware must be mounted between 30 and 44 inches above the floor or ground.	Women's restroom door - 1" threshold, vent starts 9.5" AFF, lock at 60" AFF, 11# push, closes fast, 3.5% slope inside	For all doors along the public circulation route, provide required maneuvering clearance on push and pull side of doors. For all doors along the public circulation route, correct slope in door clearance to max 2.08%. For all doors along the public circulation route, repair, provide beveled threshold. For all doors along the public circulation route, inspect, adjust, and maintain closing speed on door closers. For all doors along the public circulation route, inspect, adjust, and maintain 8.5 lbf to open exterior doors as a smart practice. For all doors along the public circulation route, replace hardware with lever hardware or hardware operable without a tight pinch or grasp. For all doors along the public circulation route, provide kick plate on push side of door from floor to 10" AFF.	2010 ADAS Section: 404.2.3, 404.2.7, 404.2.4, 404.2.11, 404.2.11 Exception

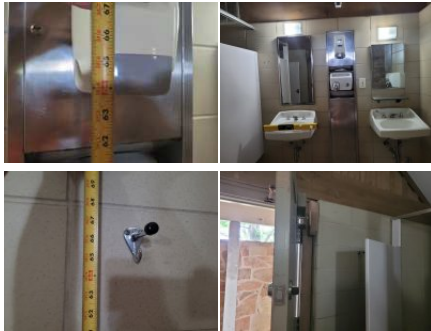
305	Campsites & Cabins: Women's Restroom	[33.2008547 , -98.1633519]	Where a high forward reach is over an obstruction, the clear floor space shall extend beneath the element for a distance not less than the required reach depth over the obstruction. The high forward reach shall be 48 inches (1220 mm) maximum where the reach depth is 20 inches (510 mm) maximum. Where the reach depth exceeds 20 inches (510 mm), the high forward reach shall be 44 inches (1120 mm) maximum and the reach depth shall be 25 inches (635 mm) maximum. Where a clear floor or ground space allows a parallel approach to an element and the high side reach is over an obstruction, the height of the obstruction shall be 34 inches (865 mm) maximum and the depth of the obstruction shall be 24 inches (610 mm) maximum. The high side reach shall be 48 inches (1220 mm) maximum for a reach depth of 10 inches (255 mm) maximum. Where the reach depth exceeds 10 inches (255 mm), the high side reach shall be 46 inches (1170 mm) maximum for a reach depth of 24 inches (610 mm) maximum.	Soap dispenser at 63.75" AFF, lowest hook at 65.5" AFF	Lower soap dispenser to max 44" above the finished floor (AFF) for a forward reach over counter.	2015 ABAAS Section: 308.2.1, 308.3.2 2012 TAS Section: 308.2.1, 308.3.2 2010 ADAS Section: 308.2.1, 308.3.2

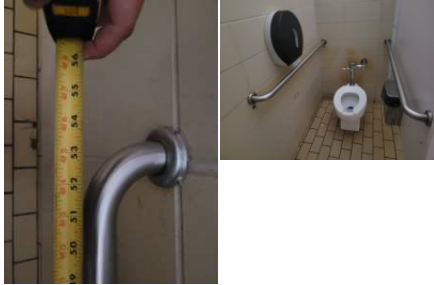
Finding Number	Area Description	Lat/Long	Finding	As Built	Recommendation	Citation	Photos	Figure
308	Campsites & Cabins: Women's Restroom	[33.200848, -98.163343 8]	The side grab bars are not in the correct location. Grab bars on the side wall must be installed so that the end closest to the rear wall is maximum 12" from the rear wall. The end furthest from the rear wall must be mounted minimum 54" from the rear wall.	Grab bars extend 53" from rear wall	Remount side grab bar to max 12" from the rear wall at the close end and min 54" on the far end, and 33" to 36" AFF.	2015 ABAAS Section: 604.5.1 2012 TAS Section: 604.5.1 2010 ADAS Section: 604.5.1

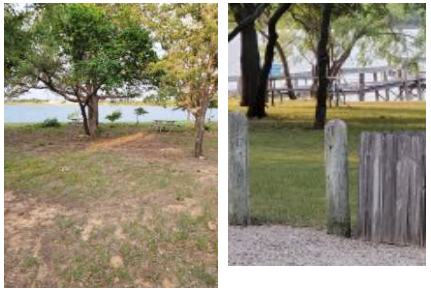
324	Lost Creek Reservoir: Parking	[33.2422, -98.14121], [33.241988, -98.140676 2]	An accessible access route is not provided between elements, spaces and the facilities provided within the accessible camping unit. At least one outdoor recreation access route shall connect accessible elements, spaces and facilities provided within camping units with mobility features.	3 of 3 non-accessible picnic tables lack AR near fishing pier	Create AR with crushed and compacted stone or similar outdoor material to camp sites and one of each type of amenity.	2015 ABAAS Section: F244.5.1

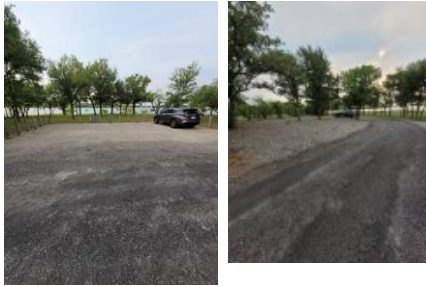
Finding Number	Area Description	Lat/Long	Finding	As Built	Recommendation	Citation	Photos	Figure
325	Lost Creek Reservoir: Parking	[33.2421815 , -98.141072 1]	There are no or not enough accessible parking stalls. Each lot where parking is provided for the public as clients, guests or employees, shall provide accessible parking and shall be located on the shortest accessible route of travel from adjacent parking to an accessible entrance. There are a total of 7 parking stalls in the parking lot that could be reasonably associated with this facility. There should be a minimum of 1 accessible stalls with a minimum of 1 being designed as van accessible.	Parking near fishing pier - lacks accessible parking spaces - approximately 7 standard, 0 accessible	Create one or more 8' accessible parking stalls, with one 5' adjacent access aisle, with proper signage and striping based on the total number of stalls.	2015 ABAAS Section: F208.2 2012 TAS Section: 208.2 2010 ADAS Section: 208.2

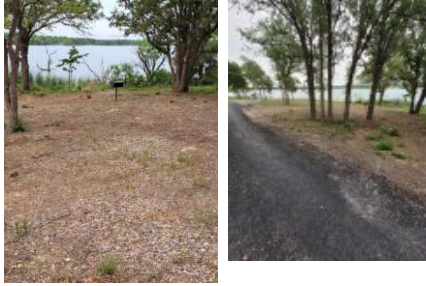
326	Lost Creek Reservoir: Parking	[33.2427573 , -98.133800 8]	There is no accessible route to the grill. At least one accessible route shall connect accessible buildings, accessible facilities, accessible elements, and accessible spaces that are on the same site.	Near canoe launch - lacks AR to grill	Create an accessible route with crushed stone or other outdoor material from parking or walkway to grill	2015 ABAAS Section: F206.2.2 2012 TAS Section: 206.2.2 2010 ADAS Section: 206.2.2

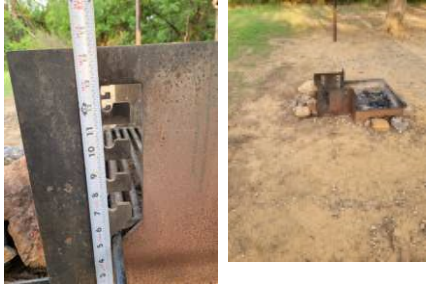
Finding Number	Area Description	Lat/Long	Finding	As Built	Recommendation	Citation	Photos	Figure
344	Lost Creek Reservoir: Campsites	[33.2426055 , -98.139828 9]	Where provided, cooking surfaces shall be 15 inches (380 mm) minimum and 34 inches (865 mm) maximum above the ground.	Highest setting of cooking surface is 12.5" AGL	Raise or lower cooking surface to be 15" min to 34" max above the ground; in the alternative, replace with a compliant surface as a smart practice.	2015 ABAAS Section: 1011.5.2

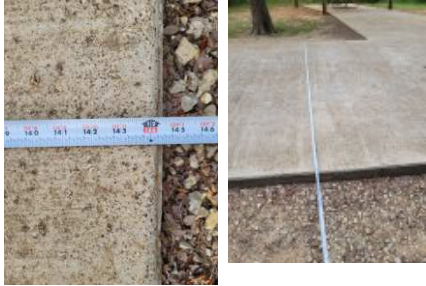
345	Lost Creek Reservoir: Campsites	[33.2427086 , -98.139865 1]	Parking spaces and pull-up spaces for recreational vehicles shall be 20 feet (6100 mm) wide minimum. EXCEPTION: Where two adjacent parking spaces are provided for recreational vehicles, one parking space shall be permitted to be 16 feet (4880 mm) wide minimum.	Campsite parking space is 12' wide	Correct RV parking space to be 20' wide minimum; or 16' for two adjacent spaces as a smart practice.	2015 ABAAS Section: 1012.2, 1012.2 EXCEPTION

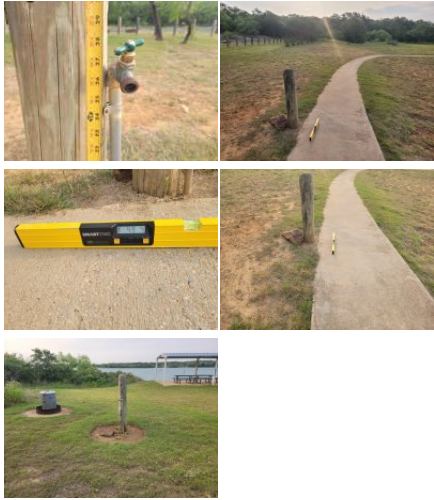
349	Lost Creek Reservoir: Swimming	[33.2433477, -98.1381527], [33.2432557, -98.1377664]	Water spouts at water hydrants and water utility hook-ups shall be 28 inches (710 mm) minimum and 36 inches (915 mm) maximum above the ground. The operable part is not accessible because there is not adequate clear floor space for either a forward or side approach. The clear floor or ground space shall be 30 inches minimum by 48 inches minimum.	Water spout along sidewalk 25", both spouts lacks CGS	Remount water spouts to 28" min or 36" max above the ground as a smart practice. Provide required 30" by 48" CFS at operable parts.	2015 ABAAS Section: 1011.6

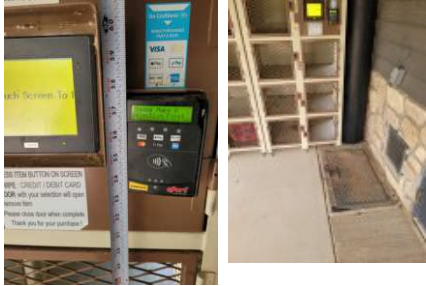
359	Lost Creek Reservoir: Men's Restroom	[33.2433475 , -98.139338]	The operable part is positioned too high for either a side or front approach. Where a clear floor or ground space allows a parallel approach to an element and the side reach is unobstructed, the high side reach shall be 48 inches maximum and the low side reach shall be 15 inches minimum above the finish floor or ground. Where a forward reach is unobstructed, the high forward reach shall be 48 inches maximum and the low forward reach shall be 15 inches minimum above the finish floor or ground. The operable part is not accessible because there is not adequate clear floor space for either a forward or side approach. The clear floor or ground space shall be 30 inches minimum by 48 inches minimum.	Credit card swipe and display screen at 57" AGL at firewood dispenser, vault door in CFS	Remount operable parts to be in reach range of 15" min to 48" max. Remove, or relocate obstacles in CFS at fixtures and operable parts along the AR. Provide required 30" by 48" CFS at operable parts.	2015 ABAAS Section: 308.1 2012 TAS Section: 308.1 2010 ADAS Section: 308.1

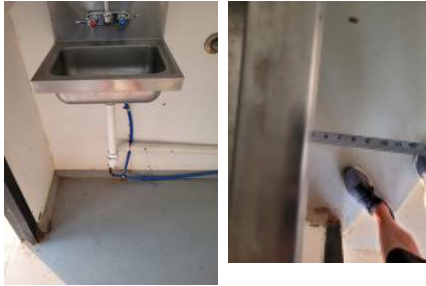
Finding Number	Area Description	Lat/Long	Finding	As Built	Recommendation	Citation	Photos	Figure
362	Lost Creek Reservoir: Men's Restroom	[33.2433502 , -98.139328 7]	Knee clearance at 27 inches off the floor is not 8 inches minimum deep. The knee clearance, measured from the bottom of the apron or the outside bottom edge of the lavatory, must be 27 inches at a point located 8 inches back from the front edge and continuing to 11 inches minimum in depth at 9 inches above the floor. The top of the lavatory rim may be no higher than 34 inches.	Sink lacks knee clearance	Replace sink with one providing 27" knee clearance that is a min 8" deep.	2015 ABAAS Section: 306.3.1, 306.3.2, 306.3.3, 306.3.4 , 306.3.5 2012 TAS Section: 306.3.2, 306.3.3, 306.3.4, 306.3.5, 306.3.1 2010 ADAS Section: 306.3.3, 306.3.2, 306.3.4, 306.3.5, 306.3.1

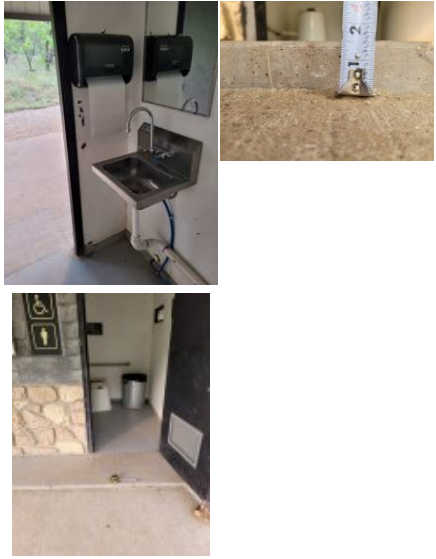
Finding Number	Area Description	Lat/Long	Finding	As Built	Recommendation	Citation	Photos	Figure
367	Lost Creek Reservoir: Men's Restroom	[33.24336, -98.13933]	Minimum maneuvering clearances at doors and gates shall comply with 404.2.4. Maneuvering clearances shall extend the full width of the doorway and the required latch side or hinge side clearance. The threshold has a vertical change greater than 1/4 inch high.	Men's restroom door - 1.5" CIL in clearance, lacks clearance on push side due to sink	For all doors along the public circulation route, provide required maneuvering clearance on push and pull side of doors. For all doors along the public circulation route, repair, bevel, or ramp CILs at door entries to max .25".	2010 ADAS Section: 404.2.3, 404.2.7, 404.2.4, 404.2.11, 404.2.11 Exception

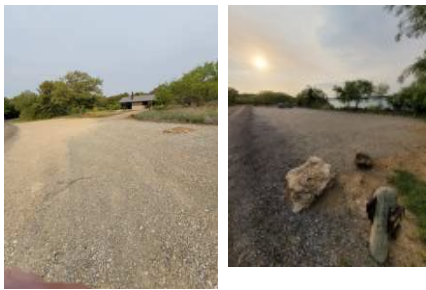
Finding Number	Area Description	Lat/Long	Finding	As Built	Recommendation	Citation	Photos	Figure
381	Trails: Trails - Parking	[33.2432672 , -98.1390524]	There are no or not enough accessible parking stalls. Each lot where parking is provided for the public as clients, guests or employees, shall provide accessible parking and shall be located on the shortest accessible route of travel from adjacent parking to an accessible entrance. There are a total of 55 parking stalls in the parking lot that could be reasonably associated with this facility. There should be a minimum of 3 accessible stalls with a minimum of 1 being designed as van accessible.	Parking lots near restrooms and Oak Ridge trail- lacks accessible parking in both gravel lots - parking spaces not identified	Create one or more 8' accessible parking stalls, with one 5' adjacent access aisle, with proper signage and striping based on the total number of stalls.	2015 ABAAS Section: F208.2 2012 TAS Section: 208.2 2010 ADAS Section: 208.2

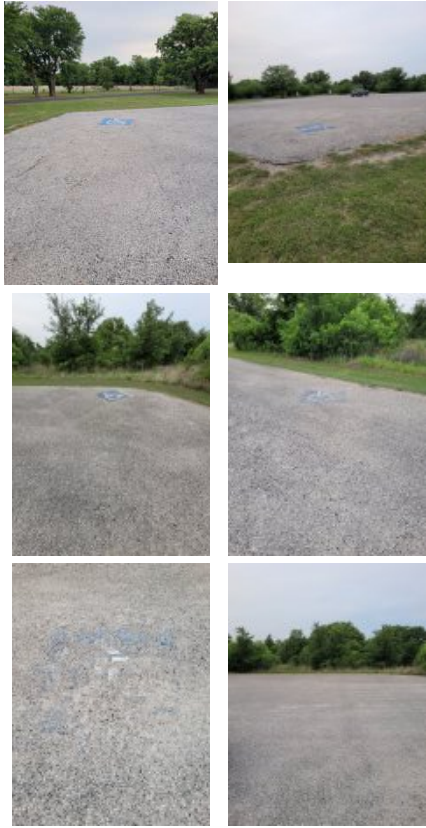
Finding Number	Area Description	Lat/Long	Finding	As Built	Recommendation	Citation	Photos	Figure																																																																																										
383	Trails: Trails - Parking	[33.2451112 , -98.1386098]	There are no or not enough accessible parking stalls. Each lot where parking is provided for the public as clients, guests or employees, shall provide accessible parking and shall be located on the shortest accessible route of travel from adjacent parking to an accessible entrance. There are a total of 40 parking stalls in the parking lot that could be reasonably associated with this facility. There should be a minimum of 2 accessible stalls with a minimum of 1 being designed as van accessible.	Unmarked lot - ISA symbol painted on 4 total areas with loose surface, no other accessible features; furthest space from site elements - approximately 40 standard, 0 accessible	Create one or more 8' accessible parking stalls, with one 5' adjacent access aisle, with proper signage and striping based on the total number of stalls.	2015 ABAAS Section: F208.2 2012 TAS Section: 208.2 2010 ADAS Section: 208.2

<table><tr> <th>Total Number of Parking Spaces</th> <th>Number of Accessible Spaces</th> <th>Minimum Number of Required Accessible Parking Spaces</th> </tr><tr><td>12</td><td>2</td><td>2</td></tr></table>

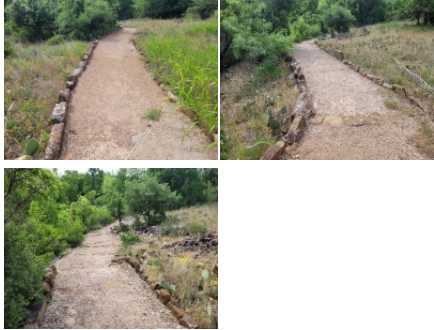
Finding Number	Area Description	Lat/Long	Finding	As Built	Recommendation	Citation	Photos	Figure
389	Trails: Lost Creek Nature Trail	[33.2076452 , -98.166039 4]	The surface of trails, passing spaces, and resting intervals shall be firm and stable	Trail surface changes about 60 ft from entry to loose surface with large tread obstacles/steps	Replace surface of trail with one that is firm and stable as a smart practice.	2015 ABAAS Section: 1017.2

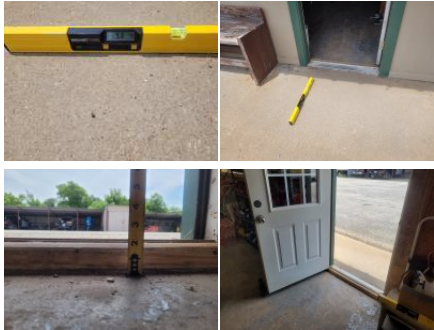
Finding Number	Area Description	Lat/Long	Finding	As Built	Recommendation	Citation	Photos	Figure
391	Employee Areas: Maintenance	[33.2065326 , -98.168680 2]	Spaces and elements within employee work areas shall only be required to comply with 206.2.8, 207.1, and 215.3 and shall be designed and constructed so that individuals with disabilities can approach, enter, and exit the employee work area. Employee work areas, or portions of employee work areas, other than raised courtroom stations, that are less than 300 square feet (28 m2) and elevated 7 inches (180 mm) or more above the finish floor or ground where the elevation is essential to the function of the space shall not be required to comply with these requirements or to be on an accessible route.	Shop entry - knob, 9.8% slope in clearance, large threshold	For employee spaces, relocate storage, furniture, and other obstacles at doorways to provide approach, enter and exit at the employee space. Provide required maneuvering clearance on push and pull side of doors. Correct slope in door clearance to max 2.08%. Repair, provide beveled threshold. Replace hardware with lever hardware or hardware operable without a tight pinch or grasp.	2015 ABAAS Section: F203.9 2012 TAS Section: 203.9 2010 ADAS Section: 203.9

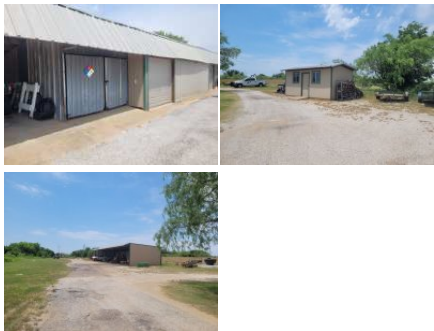
393	Employee Areas: Maintenance	[33.2058022 , -98.16877 39], [33.2062264 , -98.168773 9]	Spaces and elements within employee work areas shall only be required to comply with 206.2.8, 207.1, and 215.3 and shall be designed and constructed so that individuals with disabilities can approach, enter, and exit the employee work area. Employee work areas, or portions of employee work areas, other than raised courtroom stations, that are less than 300 square feet (28 m2) and elevated 7 inches (180 mm) or more above the finish floor or ground where the elevation is essential to the function of the space shall not be required to comply with these requirements or to be on an accessible route.	One building has gravel to enter, small building has CIL and knob	For employee spaces, relocate storage, furniture, and other obstacles at doorways to provide approach, enter and exit at the employee space. Provide required maneuvering clearance on push and pull side of doors. Repair, bevel, or ramp CILs at door entries to max .25". Replace hardware with lever hardware or hardware operable without a tight pinch or grasp. Enlarge cement pad at exit to allow 18" clearance on the latch side, and extend a pathway away from the building for emergency egress.	2015 ABAAS Section: F203.9 2012 TAS Section: 203.9 2010 ADAS Section: 203.9
