Access Audit Site Report

Inks Lake State Park

Accessibility Evaluation

Inspection Date: 08/23/2021

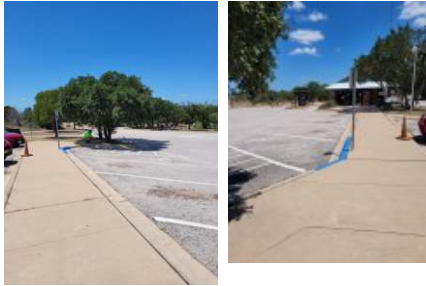
Finding Number	Area Description	Lat/Long	Finding	As Built	Recommendation	Citation	Photos	Figure
1	Headquarters: Headquarters Parking	[30.7372501 , -98.369326 4]	The accessible parking is not located on the shortest accessible route to the building. Accessible parking spaces serving a particular building or facility entrance shall be located on the shortest accessible route of travel from the parking to an accessible entrance.	accessible space is near sidewalk curb ramp, but is farthest from building entry	Consider relocation of accessible stall to be closest to the building entry and provide curb ramp serving new stall location	2015 ABAAS Section: F208.3.1 2012 TAS Section: 208.3.1 2010 ADAS Section: 208.3.1

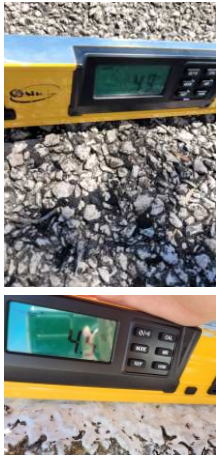
3	Headquarters: Headquarters Parking	[30.7372593 , -98.369303 6]	The cross slopes (narrow dimension) and/or running slopes (long dimension) of the access aisle exceeds 2%. The running slope and the cross slope in an accessible parking stall and the access aisle must not exceed 2%.	access aisle - 4.9% running slope and 4.5% cross slope. stall - 4.4% running slope and 6.1% cross slope	Repair or correct slope of parking space and access aisle to max 2.08% in any direction	2015 ABAAS Section: 502.4 2012 TAS Section: 502.4 2010 ADAS Section: 502.4

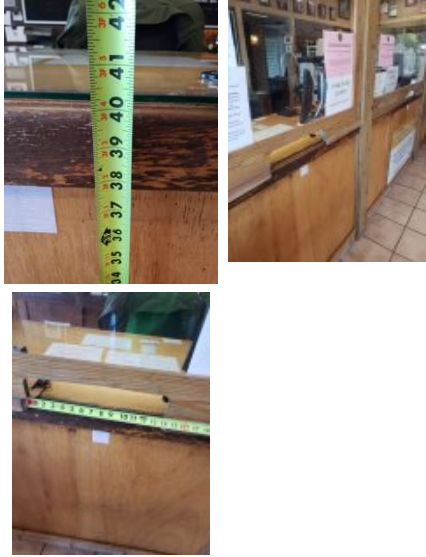
Finding Number	Area Description	Lat/Long	Finding	As Built	Recommendation	Citation	Photos	Figure
7	Headquarters: Headquarters Public Spaces	[30.73724, -98.36937]	The transaction counter is too high. A portion of the counter surface that is 36 inches long minimum and 36 inches high maximum above the finish floor shall be provided. Knee and toe space must be provided for a forward approach. A 30 inch by 48 inch clear floor space on an accessible route must be provided for either a forward or parallel approach.	Service counter 40" above finished floor (aff), 14" in length due to germ shield	Lower 36" wide segment of service counter to max 36" aff	2015 ABAAS Section: 904.4.2, 904.4.1 2012 TAS Section: 904.4.1, 904.4.2 2010 ADAS Section: 904.4.2, 904.4.1

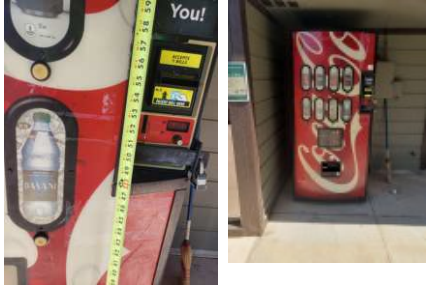
8	Headquarters: Headquarters Public Spaces	[30.73737, -98.36903]	The clear floor space only allows for a forward approach and the element is out of reach range. Where a forward reach is unobstructed, the high forward reach shall be 48 inches maximum and the low forward reach shall be 15 inches minimum above the finish floor or ground.	vending machine buttons and bill insert at 55" aff	Work with vendor to provide machine with operable parts in reach range of 15" to 48"	2015 ABAAS Section: 308.2.1 2012 TAS Section: 308.2.1 2010 ADAS Section: 308.2.1

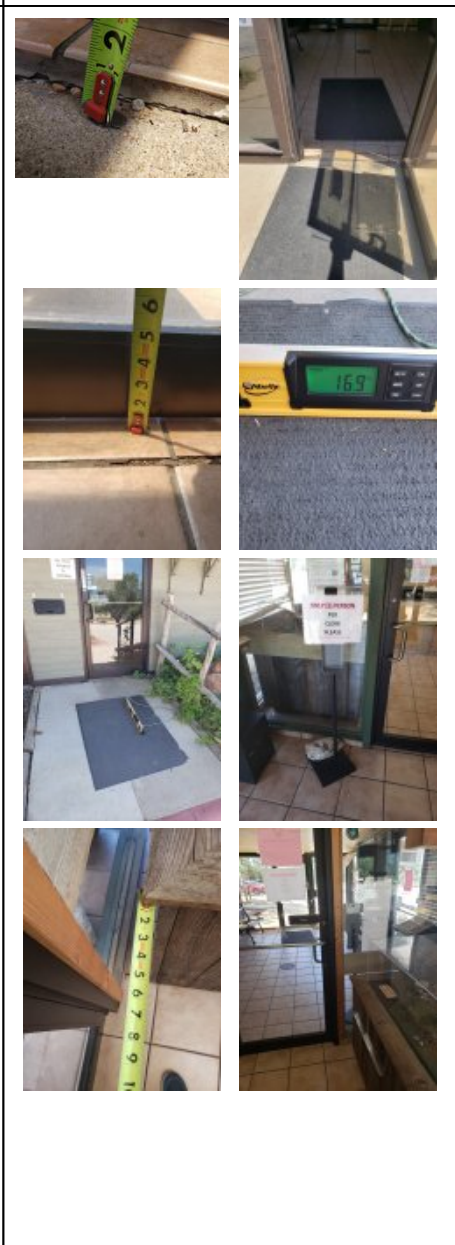
Finding Number	Area Description	Lat/Long	Finding	As Built	Recommendation	Citation	Photos	Figure
9	Headquarters: Headquarters Public Spaces	[30.73737, -98.36903]	Minimum maneuvering clearances at doors and gates shall comply with 404.2.4. Maneuvering clearances shall extend the full width of the doorway and the required latch side or hinge side clearance. The threshold has a vertical change greater than 1/4 inch high. The threshold at a doorway shall be no higher than 1/2 inch. Changes in level between 1/4 inch and 1/2 inch must be beveled at 1:2 or less. 1/4 inch is the maximum vertical rise. All interior doors must be maintained so that the operating pressure does not exceed 5 lb. force to open. Exterior doors are recommended to be maintained at 8.5 lbf as a smart practice. Force is to be measured at the operating hardware or 30 inches from the hinges, whichever is greater. The bottom 10 inches on the push side must be smooth and free of obstructions (hold open devices). Opening hardware must be mounted between 30 and 44 inches above the floor or ground.	front entry door - 15 pound force (lbf), 1" change in level (CIL), loose mats both sides, (glass window 5" from bottom). Side entry door - 15lbf, 16.9% slope to door, loose mat. Lobby door - 15lbf, items stored in push and pull MC	For all doors along the public circulation route, provide required maneuvering clearance on push and pull side of doors For all doors along the public circulation route, repair, bevel, or ramp CILs at door entries to max .25" For all doors along the public circulation route, inspect, adjust, and maintain 5 lbf to open interior doors For all doors along the public circulation route, inspect, adjust, and maintain 8.5 lbf to open exterior doors as a smart practice For all doors along the public circulation route, provide kick plate on push side of door from floor to 10" aff For all doors along the public circulation route, replace doors with ones having sidelight viewing windows max 43" aff	2010 ADAS Section: 404.2.3, 404.2.7, 404.2.4, 404.2.11, 404.2.11 Exception

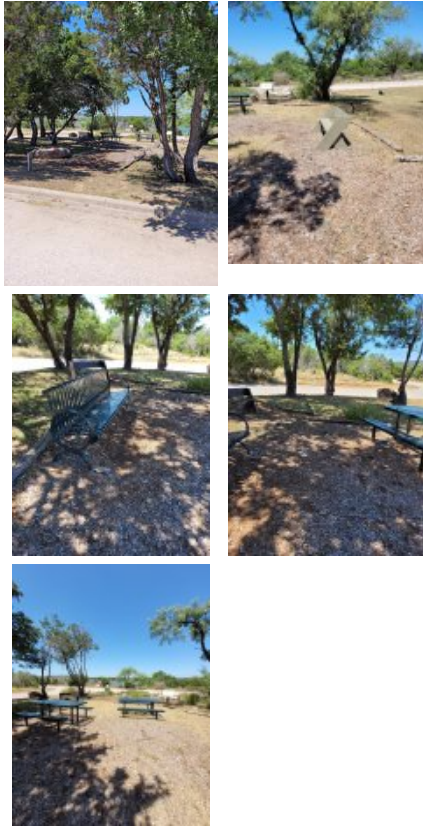
11	Headquarters: Headquarters Public Spaces	[30.73737, -98.36903]	There is no accessible route to the Gibbs Family Picnic Area. At least one accessible route shall connect accessible buildings, accessible facilities, accessible elements, and accessible spaces that are on the same site.	no AR to Gibbs Family Picnic Area (4 benches 2 picnic tables)	Create an accessible route with crushed stone or other outdoor material from parking or walkway to Gibbs Family Picnic Area.	2015 ABAAS Section: F206.2.2 2012 TAS Section: 206.2.2 2010 ADAS Section: 206.2.2

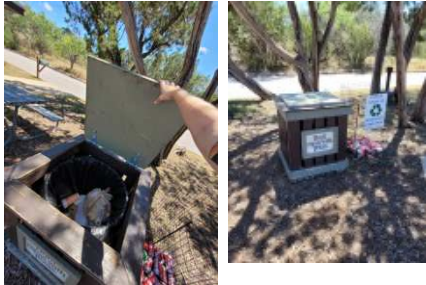
14	Headquarters: Headquarters Public Spaces	[30.73737, -98.36903]	The force required to operate the element exceeds the maximum. The force required to activate operable parts is 5 pounds maximum.	outdoor trash uses excessive force to open	Adjust operating mechanism to be usable with 5 lbf or less	2015 ABAAS Section: 309.4 2012 TAS Section: 309.4 2010 ADAS Section: 309.4

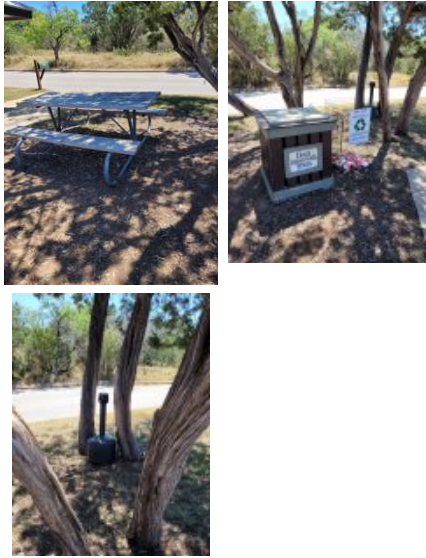
Finding Number	Area Description	Lat/Long	Finding	As Built	Recommendation	Citation	Photos	Figure
15	Headquarters: Headquarters Public Spaces	[30.73737, -98.36903]	There is no accessible route to headquarter amenities. At least one accessible route shall connect accessible buildings, accessible facilities, accessible elements, and accessible spaces that are on the same site.	picnic table, trash, cigarette trash, and recycle bin are not on AR	Create an accessible route with crushed stone or other outdoor material from parking or walkway to headquarter amenities.	2015 ABAAS Section: F206.2.2 2012 TAS Section: 206.2.2 2010 ADAS Section: 206.2.2

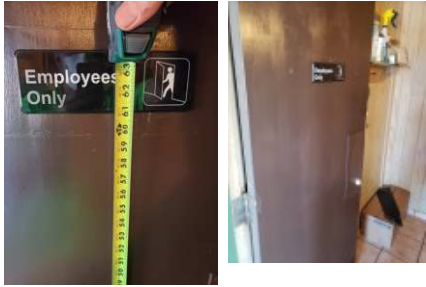
16	Headquarters: Headquarters Restrooms	[30.73737, -98.36903]	The restroom sign does not comply with one or more applicable requirements for the location, height, and properties of the sign.	employee restroom - 61" on door, non compliant sign, lacks International Symbol of Accessibility (ISA)	Acquire and mount signage, including Braille and access symbol mounted on wall, latch side of door, 48" to baseline of lowest character and 60" to baseline of highest character	2015 ABAAS Section: F216.2, 703.1, 703.2, 703.5, 703.6 2012 TAS Section: 216.2, 703.1, 703.2, 703.5, 703.6 2010 ADAS Section: 216.2, 703.1, 703.2, 703.5, 703.6

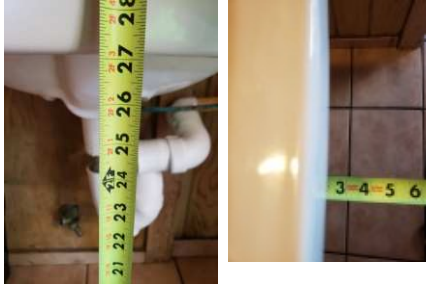
Finding Number	Area Description	Lat/Long	Finding	As Built	Recommendation	Citation	Photos	Figure
17	Headquarters: Headquarters Restrooms	[30.73737, -98.36903]	Knee clearance at 27 inches off the floor is not 8 inches minimum deep. The knee clearance, measured from the bottom of the apron or the outside bottom edge of the lavatory, must be 27 inches at a point located 8 inches back from the front edge and continuing to 11 inches minimum in depth at 9 inches above the floor. The top of the lavatory rim may be no higher than 34 inches.	employee restroom - 2.5" knee clearance at 27" aff	Raise or replace sink with to provide 27" knee clearance that is a min 8" deep	2015 ABAAS Section: 306.3.1, 306.3.2, 306.3.3, 306.3.4 , 306.3.5 2012 TAS Section: 306.3.2, 306.3.3, 306.3.4, 306.3.5, 306.3.1 2010 ADAS Section: 306.3.3, 306.3.2, 306.3.4, 306.3.5, 306.3.1

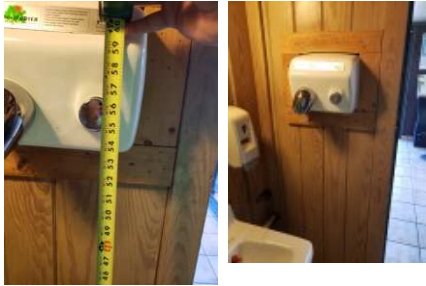
Finding Number	Area Description	Lat/Long	Finding	As Built	Recommendation	Citation	Photos	Figure
18	Headquarters: Headquarters Restrooms	[30.73737, -98.36903]	Where a high forward reach is over an obstruction, the clear floor space shall extend beneath the element for a distance not less than the required reach depth over the obstruction. The high forward reach shall be 48 inches (1220 mm) maximum where the reach depth is 20 inches (510 mm) maximum. Where the reach depth exceeds 20 inches (510 mm), the high forward reach shall be 44 inches (1120 mm) maximum and the reach depth shall be 25 inches (635 mm) maximum. Where a clear floor or ground space allows a parallel approach to an element and the high side reach is over an obstruction, the height of the obstruction shall be 34 inches (865 mm) maximum and the depth of the obstruction shall be 24 inches (610 mm) maximum. The high side reach shall be 48 inches (1220 mm) maximum for a reach depth of 10 inches (255 mm) maximum. Where the reach depth exceeds 10 inches (255 mm), the high side reach shall be 46 inches (1170 mm) maximum for a reach depth of 24 inches (610 mm) maximum.	employee restroom - hand dryer 55" aff	Lower operating mechanisms in employee restroom to max 48" aff to highest operable part	2015 ABAAS Section: 308.2.1, 308.3.2 2012 TAS Section: 308.2.1, 308.3.2 2010 ADAS Section: 308.2.1, 308.3.2

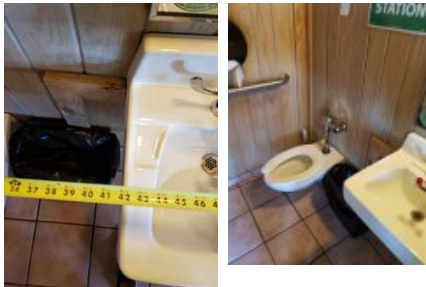
19	Headquarters: Headquarters Restrooms	[30.73737, -98.36903]	The required 56 inches by 60 inches clear floor space for the water closet has been obstructed. The clear floor space around the water closet shall be 60 inches minimum measured perpendicular from the side wall and 56 inches minimum measured perpendicular from the rear wall.	employee restroom - sink and trash in clearance	Relocate trash bin to provide required 60" clearance around toilet. Leave as is sink, meets safe harbor.	2015 ABAAS Section: 604.3. 2012 TAS Section: 604.3.1 2010 ADAS Section: 604.3.1

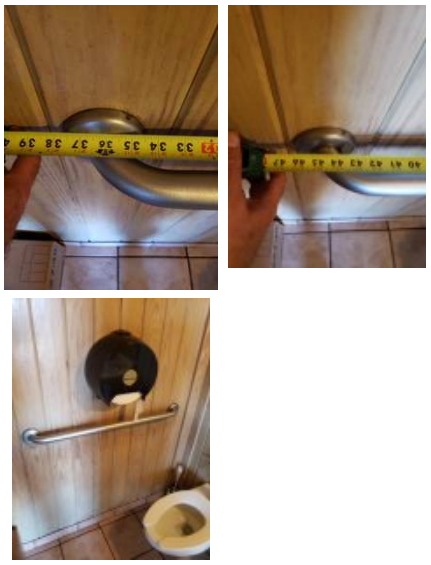
21	Headquarters: Headquarters Restrooms	[30.73737, -98.36903]	The side grab bar is not long enough. The side grab bar must extend at least 54 inches minimum beyond the rear wall and start a maximum of 12 inches from the rear wall. A 42 inch grab bar installed the maximum distance from the rear wall (12 inches) will leave the leading end 54 inches from the rear wall. Grab bars shall be installed in a horizontal position, 33 inches minimum and 36 inches maximum above the finish floor measured to the top of the gripping surface.	employee restroom - 36" bar, extends 44.5" from rear wall	Replace side grab bar with a 42" long grab bar, mounted max 12" from the rear wall at the close end and min 54" on the far end and 33" to 36" aff	2015 ABAAS Section: 604.5.1 2012 TAS Section: 604.5.1 2010 ADAS Section: 604.5.1

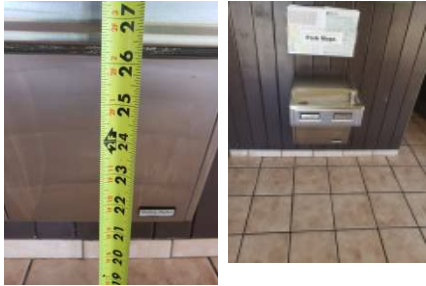
Finding Number	Area Description	Lat/Long	Finding	As Built	Recommendation	Citation	Photos	Figure
26	Headquarters: Headquarters Restrooms	[30.73737, -98.36903]	There is not enough knee clearance under the drinking fountain. The drinking fountain must have a clear knee space between the bottom of the apron and the floor not less than 27 inches in height, 30 inches in width, and 8 inches in depth.	low bowl offers 26.25" knee clearance	Raise drinking fountain to provide required 27" knee clearance	2015 ABAAS Section: 602.2 2012 TAS Section: 602.2 2010 ADAS Section: 602.2

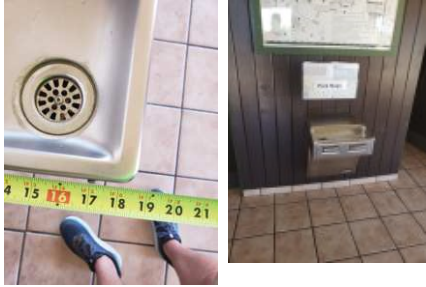
27	Headquarters: Headquarters Restrooms	[30.73737, -98.36903]	The drinking fountain projects more than 4 inches into the circulation path. Wall-mounted objects that have leading edges between 27 inches and 80 inches from the floor must not project more than 4 inches into the circulation path. Protruding objects that extend to the floor or within 27 inches of the floor are cane detectable and are therefore not hazardous. Where it is necessary or desirable to have objects protrude from the wall, a manner of cane detection must be provided.	drinking fountain projects 18.5"	Relocate protruding objects or place cane detectable warning or bollard at foot of item	2015 ABAAS Section: 307.2 2012 TAS Section: 307.2 2010 ADAS Section: 307.2

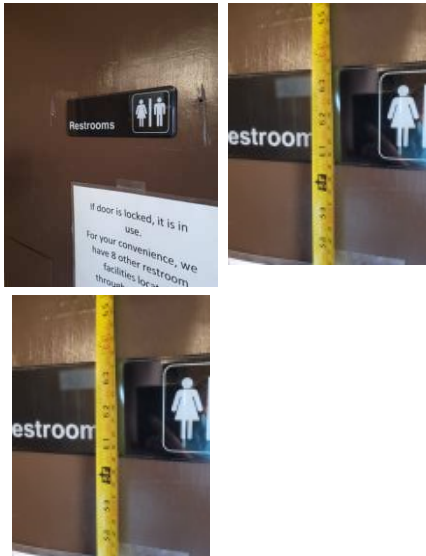
28	Headquarters: Headquarters Restrooms	[30.73737, -98.36903]	The restroom sign does not comply with one or more applicable requirements for the location, height, and properties of the sign.	public restroom - non compliant sign, missing International Symbol of Accessibility (ISA), mounted too high on door	Acquire and mount signage, including Braille and access symbol mounted on wall, latch side of door, 48" to baseline of lowest character and 60" to baseline of highest character	2015 ABAAS Section: F216.2, 703.1, 703.2, 703.5, 703.6 2012 TAS Section: 216.2, 703.1, 703.2, 703.5, 703.6 2010 ADAS Section: 216.2, 703.1, 703.2, 703.5, 703.6

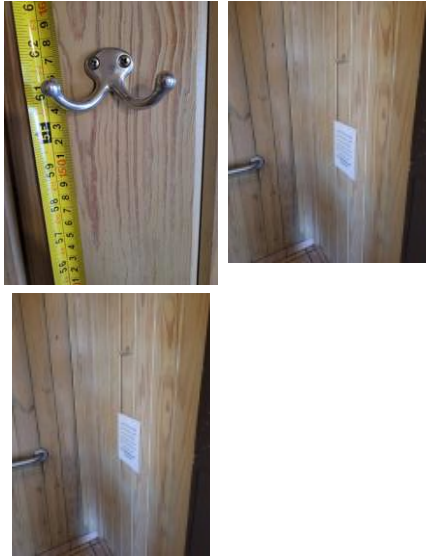
Finding Number	Area Description	Lat/Long	Finding	As Built	Recommendation	Citation	Photos	Figure
29	Headquarters: Headquarters Restrooms	[30.73737, -98.36903]	Where a high forward reach is over an obstruction, the clear floor space shall extend beneath the element for a distance not less than the required reach depth over the obstruction. The high forward reach shall be 48 inches (1220 mm) maximum where the reach depth is 20 inches (510 mm) maximum. Where the reach depth exceeds 20 inches (510 mm), the high forward reach shall be 44 inches (1120 mm) maximum and the reach depth shall be 25 inches (635 mm) maximum. Where a clear floor or ground space allows a parallel approach to an element and the high side reach is over an obstruction, the height of the obstruction shall be 34 inches (865 mm) maximum and the depth of the obstruction shall be 24 inches (610 mm) maximum. The high side reach shall be 48 inches (1220 mm) maximum for a reach depth of 10 inches (255 mm) maximum. Where the reach depth exceeds 10 inches (255 mm), the high side reach shall be 46 inches (1170 mm) maximum for a reach depth of 24 inches (610 mm) maximum.	public restroom - hook at 61"	Lower operating mechanisms in public restroom to max 48" aff to highest operable part	2015 ABAAS Section: 308.2.1, 308.3.2 2012 TAS Section: 308.2.1, 308.3.2 2010 ADAS Section: 308.2.1, 308.3.2

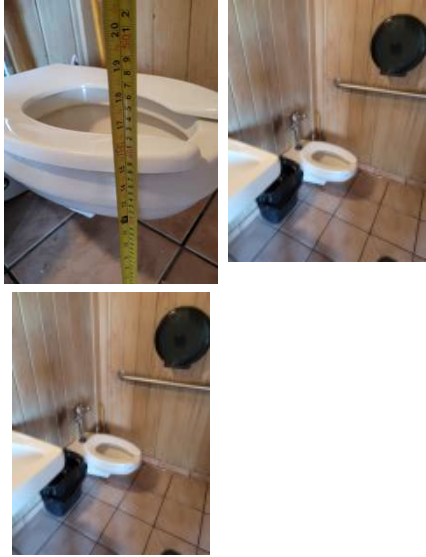
Finding Number	Area Description	Lat/Long	Finding	As Built	Recommendation	Citation	Photos	Figure
31	Headquarters: Headquarters Restrooms	[30.73737, -98.36903]	The toilet seat is not located within the range allowed off the floor. The height of accessible water closets shall be a minimum of 17 inches and a maximum of 19 inches measured to the top of a maximum 2-inch high toilet seat.	public restroom - seat at 15.5" aff	Replace toilet seat, or re-set or replace toilet to 17" to 19" aff	2015 ABAAS Section: 604.4 2012 TAS Section: 604.4 2010 ADAS Section: 604.4

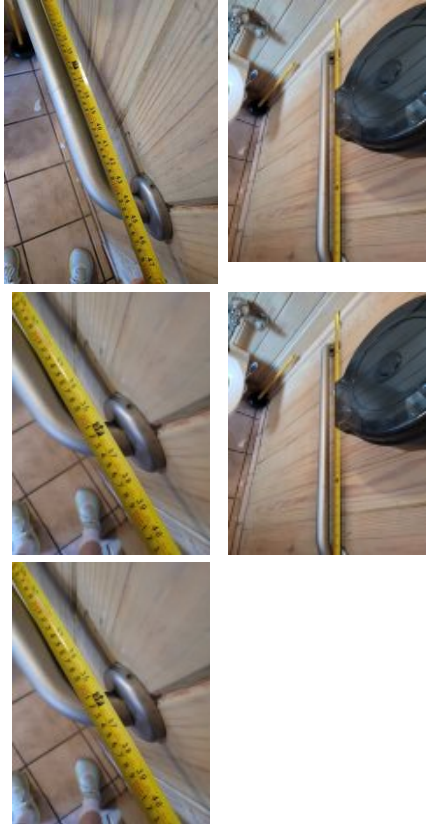
Finding Number	Area Description	Lat/Long	Finding	As Built	Recommendation	Citation	Photos	Figure
32	Headquarters: Headquarters Restrooms	[30.73737, -98.36903]	The side grab bar is not long enough. The side grab bar must extend at least 54 inches minimum beyond the rear wall and start a maximum of 12 inches from the rear wall. A 42 inch grab bar installed the maximum distance from the rear wall (12 inches) will leave the leading end 54 inches from the rear wall. Grab bars shall be installed in a horizontal position, 33 inches minimum and 36 inches maximum above the finish floor measured to the top of the gripping surface.	public restroom - 37" in length, extends 45" from wall	Replace side grab bar with a 42" long grab bar, mounted max 12" from the rear wall at the close end and min 54" on the far end and 33" to 36" aff	2015 ABAAS Section: 604.5.1 2012 TAS Section: 604.5.1 2010 ADAS Section: 604.5.1

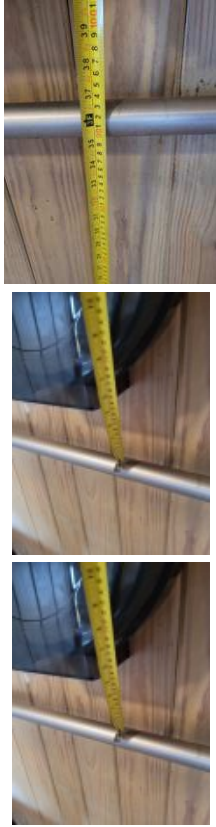
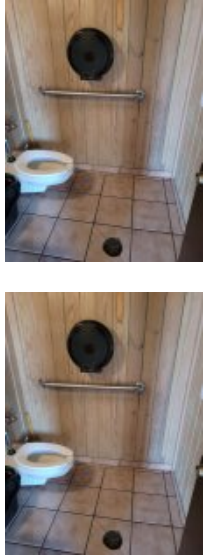
Finding Number	Area Description	Lat/Long	Finding	As Built	Recommendation	Citation	Photos	Figure
34	Headquarters: Headquarters Restrooms	[30.73737, -98.36903]	The grab bar height and/or spacing fails. Grab bars must be mounted between 33" and 36" to the top of the gripping surface. There must be 1.5" of clearance between the grab bar and the wall. There must be a minimum of 1.5" of clearance below and minimum 12" above the grab bar to any dispenser or other obstruction.	public restroom - side bar mounted 36.5" aff, toilet paper hung 5.5" above bar	Remount grab bars in accessible stall to 33" to 36" aff Remount toilet paper dispenser max 7" to 9" from front of toilet, 15" to 48" aff and min 12" above or 1.5" below grab bar	2015 ABAAS Section: 609.3, 609.4 2012 TAS Section: 609.4, 609.3 2010 ADAS Section: 609.3, 609.4

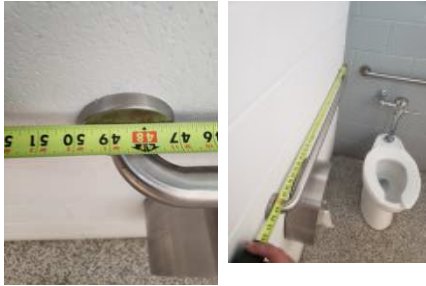
Finding Number	Area Description	Lat/Long	Finding	As Built	Recommendation	Citation	Photos	Figure
37	Restrooms For Camping: Restroom 1	[30.73737, -98.36903]	The side grab bars are not in the correct location. Grab bars on the side wall must be installed so that the end closest to the rear wall is maximum 12" from the rear wall. The end furthest from the rear wall must be mounted minimum 54" from the rear wall.	mens - 48.5" from rear wall	Remount side grab bar to max 12" from the rear wall at the close end and min 54" on the far end, and 33" to 36" aff	2015 ABAAS Section: 604.5.1 2012 TAS Section: 604.5.1 2010 ADAS Section: 604.5.1

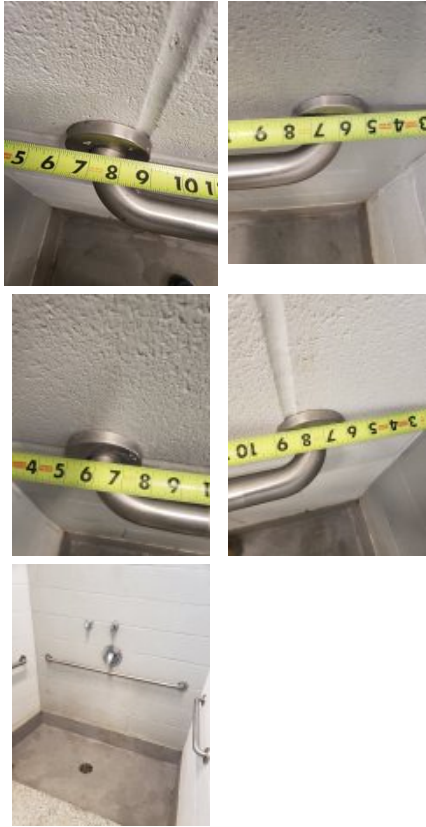
38	Restrooms For Camping: Restroom 1	[30.73737, -98.36903]	Standard Roll-In Type Shower Compartments. Where a seat is provided in standard roll-in type shower compartments, grab bars shall be provided on the back wall and the side wall opposite the seat. Grab bars shall not be provided above the seat. Where a seat is not provided in standard roll-in type shower compartments, grab bars shall be provided on three walls. Grab bars shall be installed 6 inches (150 mm) maximum from adjacent walls. Alternate Roll-In Type Shower Compartments. In alternate roll-in type shower compartments, grab bars shall be provided on the back wall and the side wall farthest from the compartment entry. Grab bars shall not be provided above the seat. Grab bars shall be installed 6 inches (150 mm) maximum from adjacent walls. Grab bars shall be installed in a horizontal position, 33 inches (840 mm) minimum and 36 inches (915 mm) maximum above the finish floor measured to the top of the gripping surface, except that at water closets for children's use complying with 604.9, grab bars shall be installed in a horizontal position 18 inches (455 mm) minimum and 27 inches (685 mm) maximum above the finish floor measured to the top of the gripping surface.	men's - side bars are mounted 7.5" from front, control wall bar 6.25" from both sides	Remount grab bars to the correct location in the shower, mounted 33" to 36" aff and max 6" from adjacent walls	2015 ABAAS Section: 608.3.2, 608.3.3, 609.4 2012 TAS Section: 609.4, 608.3.2, 608.3.3 2010 ADAS Section: 609.4, 608.3.2, 608.3.3

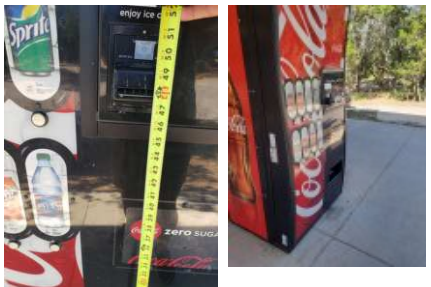
41	Restrooms For Camping: Restroom 1	[30.73443, -98.37479]	Element meets all standards and requirements	soda machine complies	None	2010 ADAS Section: N/A

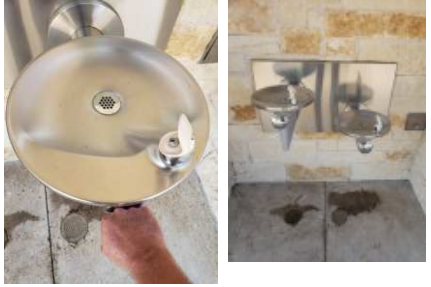
42	Restrooms For Camping: Restroom 1	[30.73737, -98.36903]	The water flow from the spout is too low. The spout shall provide a flow of water 4 inches high minimum.	water off, could not test flow height	Ensure spout flow height to min 4".	2015 ABAAS Section: 602.6 2012 TAS Section: 602.6 2010 ADAS Section: 602.6

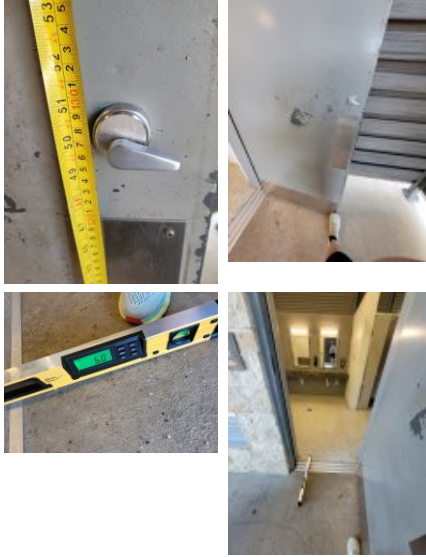
Finding Number	Area Description	Lat/Long	Finding	As Built	Recommendation	Citation	Photos	Figure
43	Restrooms For Camping: Restroom 1	[30.73737, -98.36903]	Minimum maneuvering clearances at doors and gates shall comply with 404.2.4. Maneuvering clearances shall extend the full width of the doorway and the required latch side or hinge side clearance. Exterior doors are recommended to be maintained at 8.5 lbf as a smart practice. Force is to be measured at the operating hardware or 30 inches from the hinges, whichever is greater. Hand-activated door opening hardware, handles, pulls, latches, locks, and other operating devices on accessible doors shall have a shape that is easy to grasp with one hand and does not require tight grasping, tight pinching or twisting of the wrist to operate. Hardware shall be 34 inches minimum and 48 inches maximum above the finish floor or ground.	women's - lock at 50" aff, 13 lbf, 6% running slope up	For all doors along the public circulation route, inspect, adjust, and maintain 8.5 lbf to open exterior doors as a smart practice For all doors along the public circulation route, replace hardware with lever hardware or hardware operable without a tight pinch or grasp For all doors along the public circulation route, correct or repair slope at doorway landing to max 2.08% in any direction for level CFS	2010 ADAS Section: 404.2.3, 404.2.7, 404.2.4, 404.2.11, 404.2.11 Exception

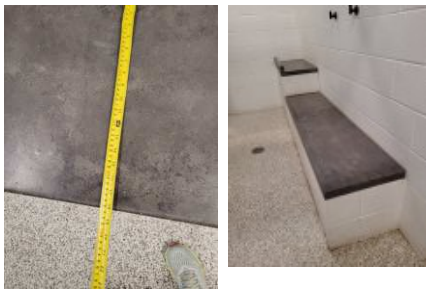
Finding Number	Area Description	Lat/Long	Finding	As Built	Recommendation	Citation	Photos	Figure
48	Restrooms For Camping: Restroom 1	[30.73737, -98.36903]	The bench is not deep enough or long enough or is missing. Benches shall be provided having seats that are 42 inches long minimum and 20 inches deep minimum and 24 inches deep maximum. The bench shall provide for back support or shall be affixed to a wall. Back support shall be 42 inches (1065 mm) long minimum and shall extend from a point 2 inches (51 mm) maximum above the seat surface to a point 18 inches (455 mm) minimum above the seat surface. Back support shall be 2½ inches (64 mm) maximum from the rear edge of the seat measured horizontally. The top of the bench seat surface shall be 17 inches (430 mm) minimum and 19 inches (485 mm) maximum above the finish floor or ground.	women's - bench 18" deep	Replace bench in dressing area with one having a seat depth of 20" to 24" deep, 42" long, affixed to the wall or having a back and mounted 17" to 19" aff	2012 TAS Section: 903.4, 903.2, 903.3, 903.5 2010 ADAS Section: 903.4, 903.2, 903.3, 903.5

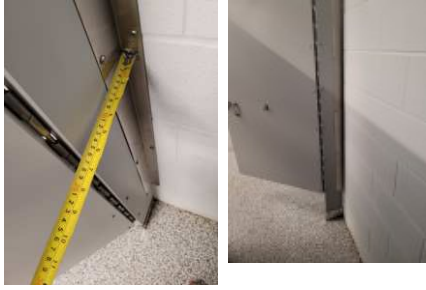
49	Restrooms For Camping: Restroom 1	[30.73737, -98.36903]	The compartment door is located too far from the partition or wall. The door shall be located in front of the clear space and diagonal to the water closet. Where located in the front partition, the door opening shall be 4 inches maximum from the side wall or partition farthest from the water closet. Where located in the side wall or partition, the door opening shall be 4 inches maximum from the front partition. Toilet compartment doors shall not swing into the minimum required compartment area.	women's - 7" partition	Rehang stall door to be max 4" from adjacent stall partition and on the stall wall farthest from the toilet	2015 ABAAS Section: 604.8.1.2 2012 TAS Section: 604.8.1.2 2010 ADAS Section: 604.8.1.2

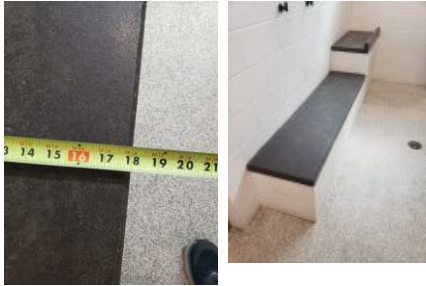
Finding Number	Area Description	Lat/Long	Finding	As Built	Recommendation	Citation	Photos	Figure
50	Restrooms For Camping: Restroom 2	[30.73737, -98.36903]	The bench is not deep enough or long enough or is missing. Benches shall be provided having seats that are 42 inches long minimum and 20 inches deep minimum and 24 inches deep maximum. The bench shall provide for back support or shall be affixed to a wall. Back support shall be 42 inches (1065 mm) long minimum and shall extend from a point 2 inches (51 mm) maximum above the seat surface to a point 18 inches (455 mm) minimum above the seat surface. Back support shall be 2½ inches (64 mm) maximum from the rear edge of the seat measured horizontally. The top of the bench seat surface shall be 17 inches (430 mm) minimum and 19 inches (485 mm) maximum above the finish floor or ground.	men's - bench 18" deep	Replace bench in dressing area with one having a seat depth of 20" to 24" deep, 42" long, affixed to the wall or having a back and mounted 17" to 19" aff	2012 TAS Section: 903.4, 903.2, 903.3, 903.5 2010 ADAS Section: 903.4, 903.2, 903.3, 903.5

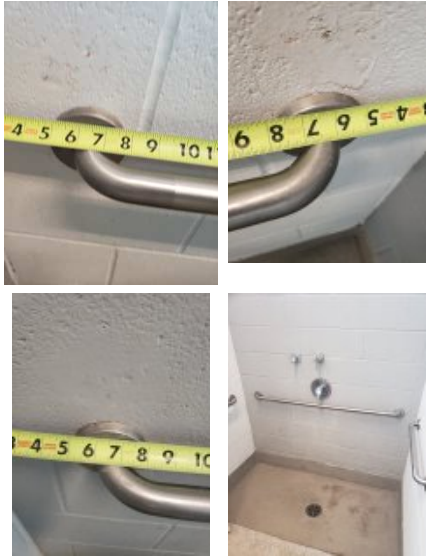
Finding Number	Area Description	Lat/Long	Finding	As Built	Recommendation	Citation	Photos	Figure
51	Restrooms For Camping: Restroom 2	[30.73737, -98.36903]	Standard Roll-In Type Shower Compartments. Where a seat is provided in standard roll-in type shower compartments, grab bars shall be provided on the back wall and the side wall opposite the seat. Grab bars shall not be provided above the seat. Where a seat is not provided in standard roll-in type shower compartments, grab bars shall be provided on three walls. Grab bars shall be installed 6 inches (150 mm) maximum from adjacent walls. Alternate Roll-In Type Shower Compartments. In alternate roll-in type shower compartments, grab bars shall be provided on the back wall and the side wall farthest from the compartment entry. Grab bars shall not be provided above the seat. Grab bars shall be installed 6 inches (150 mm) maximum from adjacent walls. Grab bars shall be installed in a horizontal position, 33 inches (840 mm) minimum and 36 inches (915 mm) maximum above the finish floor measured to the top of the gripping surface, except that at water closets for children's use complying with 604.9, grab bars shall be installed in a horizontal position 18 inches (455 mm) minimum and 27 inches (685 mm) maximum above the finish floor measured to the top of the gripping surface.	men's - side bars and one side of front bar 6.5" from wall	Remount grab bars to the correct location in the shower, mounted 33" to 36" aff and max 6" from adjacent walls	2015 ABAAS Section: 608.3.2, 608.3.3, 609.4 2012 TAS Section: 609.4, 608.3.2, 608.3.3 2010 ADAS Section: 609.4, 608.3.2, 608.3.3

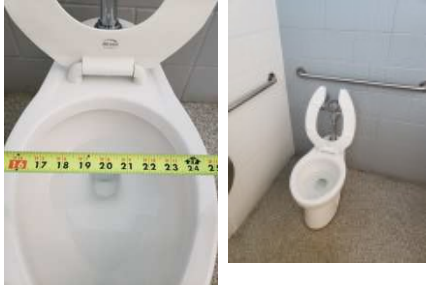
52	Restrooms For Camping: Restroom 2	[30.73737, -98.36903]	The toilet is not located within the range allowed from the side wall or partition. The centerline of the toilet must be 16 to 18 inches from the side wall.	men's - 20" centerline	Remount toilets to 16" to 18" from the side wall to centerline	2015 ABAAS Section: 604.2 2012 TAS Section: 604.2 2010 ADAS Section: 604.2

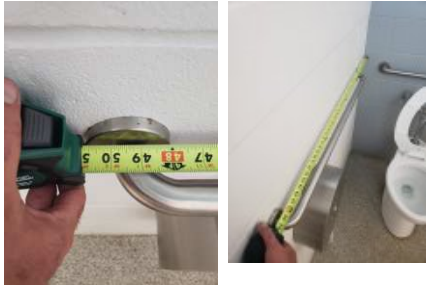
Finding Number	Area Description	Lat/Long	Finding	As Built	Recommendation	Citation	Photos	Figure
53	Restrooms For Camping: Restroom 2	[30.73737, -98.36903]	The side grab bars are not in the correct location. Grab bars on the side wall must be installed so that the end closest to the rear wall is maximum 12" from the rear wall. The end furthest from the rear wall must be mounted minimum 54" from the rear wall.	men's - side bar extends 49" from wall	Remount side grab bar to max 12" from the rear wall at the close end and min 54" on the far end, and 33" to 36" aff	2015 ABAAS Section: 604.5.1 2012 TAS Section: 604.5.1 2010 ADAS Section: 604.5.1

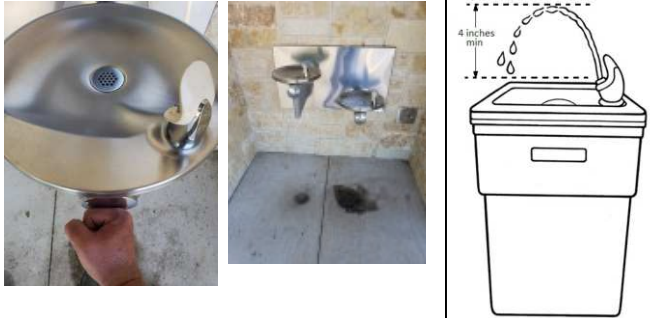
55	Restrooms For Camping: Restroom 2	[30.73737, -98.36903]	The water flow from the spout is too low. The spout shall provide a flow of water 4 inches high minimum.	water off, could not test	Ensure spout flow height to min 4".	2015 ABAAS Section: 602.6 2012 TAS Section: 602.6 2010 ADAS Section: 602.6

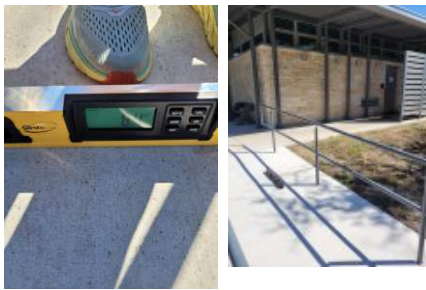
Finding Number	Area Description	Lat/Long	Finding	As Built	Recommendation	Citation	Photos	Figure
57	Restrooms For Camping: Restroom 2	[30.73737, -98.36903]	The ramps slope exceeds the maximum running slope (direction of travel) allowable of 8.33%. Ramps should have the least possible slope but in no case more than 8.3% (1:12).	8.4% running slope at top by women's restroom entry	Correct slope of ramp to max 8.33%	2015 ABAAS Section: 405.2 2012 TAS Section: 405.2 2010 ADAS Section: 405.2

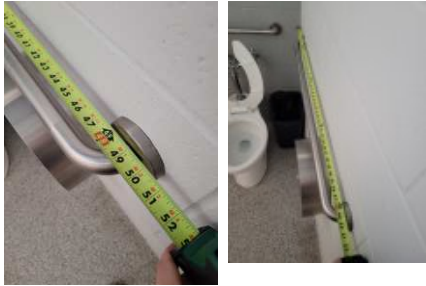
Finding Number	Area Description	Lat/Long	Finding	As Built	Recommendation	Citation	Photos	Figure
60	Restrooms For Camping: Restroom 2	[30.73737, -98.36903]	The side grab bars are not in the correct location. Grab bars on the side wall must be installed so that the end closest to the rear wall is maximum 12" from the rear wall. The end furthest from the rear wall must be mounted minimum 54" from the rear wall.	women's - bar mounted in incorrect location	Remount side grab bar to max 12" from the rear wall at the close end and min 54" on the far end, and 33" to 36" aff	2015 ABAAS Section: 604.5.1 2012 TAS Section: 604.5.1 2010 ADAS Section: 604.5.1

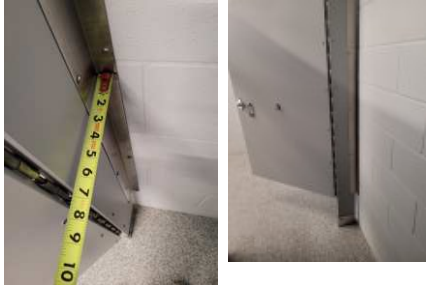
62	Restrooms For Camping: Restroom 2	[30.73737, -98.36903]	The compartment door is located too far from the partition or wall. The door shall be located in front of the clear space and diagonal to the water closet. Where located in the front partition, the door opening shall be 4 inches maximum from the side wall or partition farthest from the water closet. Where located in the side wall or partition, the door opening shall be 4 inches maximum from the front partition. Toilet compartment doors shall not swing into the minimum required compartment area.	women's - 7" from partition	Rehang stall door to be max 4" from adjacent stall partition and on the stall wall farthest from the toilet	2015 ABAAS Section: 604.8.1.2 2012 TAS Section: 604.8.1.2 2010 ADAS Section: 604.8.1.2

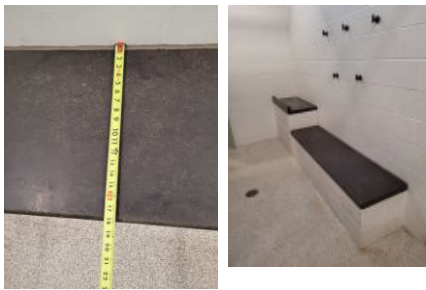
Finding Number	Area Description	Lat/Long	Finding	As Built	Recommendation	Citation	Photos	Figure
63	Restrooms For Camping: Restroom 2	[30.73737, -98.36903]	The bench is not deep enough or long enough or is missing. Benches shall be provided having seats that are 42 inches long minimum and 20 inches deep minimum and 24 inches deep maximum. The bench shall provide for back support or shall be affixed to a wall. Back support shall be 42 inches (1065 mm) long minimum and shall extend from a point 2 inches (51 mm) maximum above the seat surface to a point 18 inches (455 mm) minimum above the seat surface. Back support shall be 2½ inches (64 mm) maximum from the rear edge of the seat measured horizontally. The top of the bench seat surface shall be 17 inches (430 mm) minimum and 19 inches (485 mm) maximum above the finish floor or ground.	women's - bench 18" deep	Replace bench in dressing area with one having a seat depth of 20" to 24" deep, 42" long, affixed to the wall or having a back and mounted 17" to 19" aff	2012 TAS Section: 903.4, 903.2, 903.3, 903.5 2010 ADAS Section: 903.4, 903.2, 903.3, 903.5

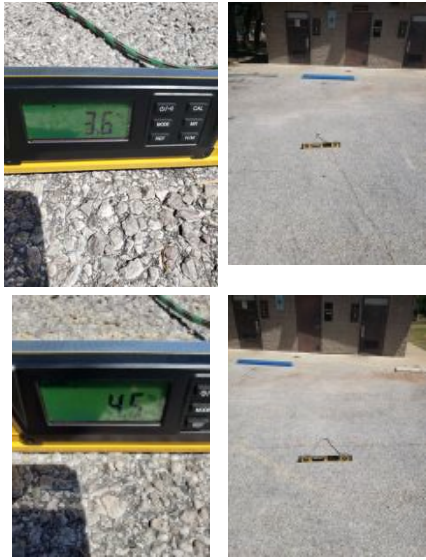
64	Restrooms For Camping: Restroom 3 (Building by Cabins)	[30.73737, -98.36903]	The cross slopes (narrow dimension) and/or running slopes (long dimension) of the access aisle exceeds 2%. The running slope and the cross slope in an accessible parking stall and the access aisle must not exceed 2%.	stall - 3.6% cross slope, access aisle - 4.5% cross slope	Repair or correct slope of parking space and access aisle to max 2.08% in any direction	2015 ABAAS Section: 502.4 2012 TAS Section: 502.4 2010 ADAS Section: 502.4

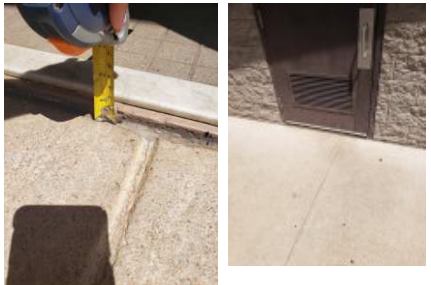
66	Restrooms For Camping: Restroom 3 (Building by Cabins)	[30.73737, -98.36903]	The threshold at a doorway shall be no higher than 1/2 inch. Changes in level between 1/4 inch and 1/2 inch must be beveled at 1:2 or less. 1/4 inch is the maximum vertical rise. The sweep period for doors with closers shall be adjusted so that from an open position of 70 degrees, the door will take at least 3 seconds to move to a point 3 inches from the latch, measured to the leading edge of the door. Exterior doors are recommended to be maintained at 8.5 lbf as a smart practice. Force is to be measured at the operating hardware or 30 inches from the hinges, whichever is greater.	womens - 20lbf, fast close, 1" CIL; mens - 25lbf, fast close	For all doors along the public circulation route, repair, bevel, or ramp CILs at door entries to max .25" For all doors along the public circulation route, inspect, adjust, and maintain closing speed on door closers For all doors along the public circulation route, inspect, adjust, and maintain 8.5 lbf to open exterior doors as a smart practice	2010 ADAS Section: 404.2.3, 404.2.7, 404.2.4, 404.2.11, 404.2.11 Exception

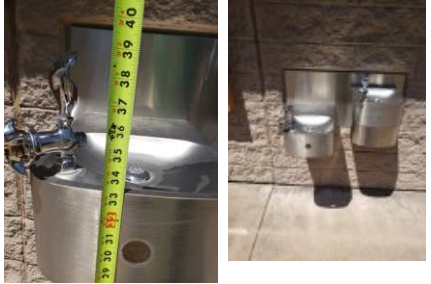
67	Restrooms For Camping: Restroom 3 (Building by Cabins)	[30.73737, -98.36903]	The spout for the drinking fountain is too high. Spout outlets shall be 36 inches maximum above the finish floor or ground.	low bowl spout height 38" aff	Remount fountain so spout outlet is max 36" aff	2015 ABAAS Section: 602.4 2012 TAS Section: 602.4 2010 ADAS Section: 602.4

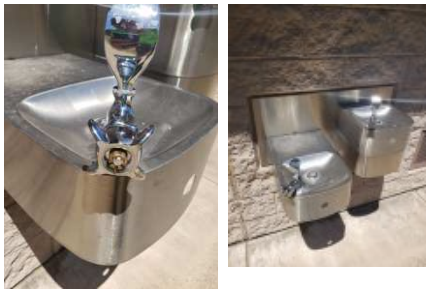
69	Restrooms For Camping: Restroom 3 (Building by Cabins)	[30.73737, -98.36903]	The fountain knob is not accessible because it requires tight grasping, pinching or twisting of the wrist.	drinking fountain knob hardware	Replace knob with an operable part usable without a tight pinch or grasp	2015 ABAAS Section: 309.4 2012 TAS Section: 309.4 2010 ADAS Section: 309.4

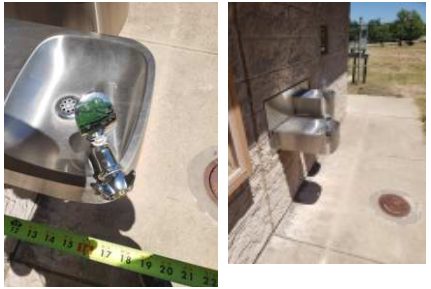
70	Restrooms For Camping: Restroom 3 (Building by Cabins)	[30.73737, -98.36903]	The fountain projects more than 4 inches into the circulation path. Wall-mounted objects that have leading edges between 27 inches and 80 inches from the floor must not project more than 4 inches into the circulation path. Protruding objects that extend to the floor or within 27 inches of the floor are cane detectable and are therefore not hazardous. Where it is necessary or desirable to have objects protrude from the wall, a manner of cane detection must be provided.	drinking fountain protrudes 18"	Relocate protruding objects or place cane detectable warning or bollard at foot of item	2015 ABAAS Section: 307.2 2012 TAS Section: 307.2 2010 ADAS Section: 307.2

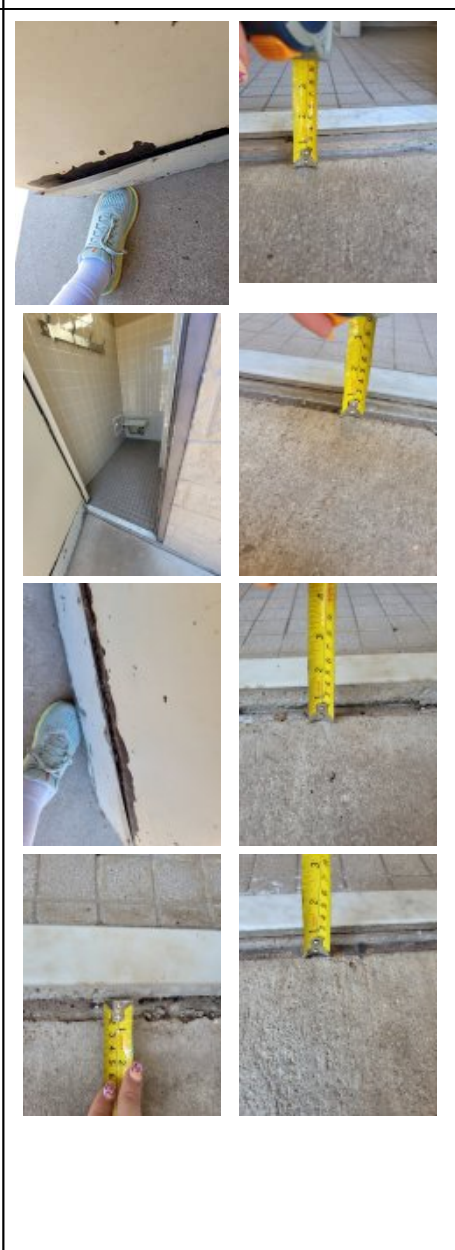
Finding Number	Area Description	Lat/Long	Finding	As Built	Recommendation	Citation	Photos	Figure
72	Restrooms For Camping: Restroom 3 (Building by Cabins)	[30.73737, -98.36903]	The threshold has a vertical change greater than 1/4 inch high. The threshold at a doorway shall be no higher than 1/2 inch. Changes in level between 1/4 inch and 1/2 inch must be beveled at 1:2 or less. 1/4 inch is the maximum vertical rise. Exterior doors are recommended to be maintained at 8.5 lbf as a smart practice. Force is to be measured at the operating hardware or 30 inches from the hinges, whichever is greater. The bottom 10 inches on the push side must be smooth and free of obstructions (hold open devices). Opening hardware must be mounted between 30 and 44 inches above the floor or ground.	shower doors in back, left to right : Left - 20 lbf, kick plate loose, 1" CIL, 2nd to Left - 14 lbf, 1" CIL. 3rd to Left - 14 lbf, loose kick plate, 1.5 CIL, .5 gap. right - 15 lbf, 1" CIL	For all doors along the public circulation route, repair, bevel, or ramp CILs at door entries to max .25" For all doors along the public circulation route, inspect, adjust, and maintain 8.5 lbf to open exterior doors as a smart practice For all doors along the public circulation route, provide kick plate on push side of door from floor to 10" aff	2010 ADAS Section: 404.2.3, 404.2.7, 404.2.4, 404.2.11, 404.2.11 Exception

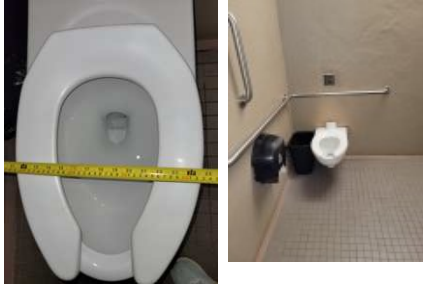
73	Restrooms For Camping: Restroom 3 (Building by Cabins)	[30.73737, -98.36903]	The toilet is not located within the range allowed from the side wall or partition. The centerline of the toilet must be 16 to 18 inches from the side wall.	women's - 18.5" centerline	Remount toilets to 16" to 18" from the side wall to centerline	2015 ABAAS Section: 604.2 2012 TAS Section: 604.2 2010 ADAS Section: 604.2

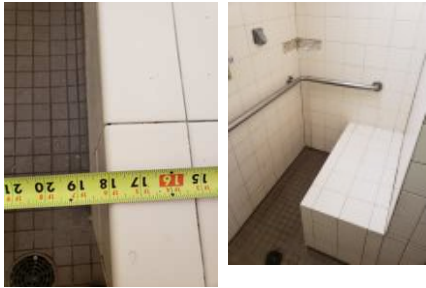
79	Restrooms For Camping: Restroom 4 (Central Park)	[30.73737, -98.36903]	The shower seat does not have a compliant space between it and the seat wall. The folding seat must be mounted 17-19 inches above the floor, and have a maximum space of 2-1/2 inches between the edge of the seat and the seat wall and 1-1/2 inches maximum to the side wall.	men's - 18" from seat wall	Remount shower seat to the correct location and height in the shower	2015 ABAAS Section: 610.3.1 2012 TAS Section: 610.3.1 2010 ADAS Section: 610.3.1

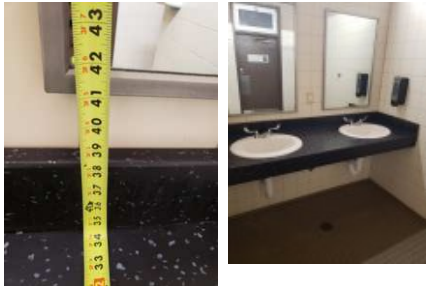
80	Restrooms For Camping: Restroom 4 (Central Park)	[30.73737, -98.36903]	The mirror is mounted too high. Mirrors must have the bottom edge of the reflecting surface a maximum of 40 inches above the floor if above a sink or counter. Mirrors not located above lavatories or countertops shall be installed with the bottom edge of the reflecting surface 35 inches maximum above the finish floor or ground.	men's - mirror mounted at 42" aff	Lower mirror so reflective surface is max 40" aff	2015 ABAAS Section: 603.3 2012 TAS Section: 603.3 2010 ADAS Section: 603.3

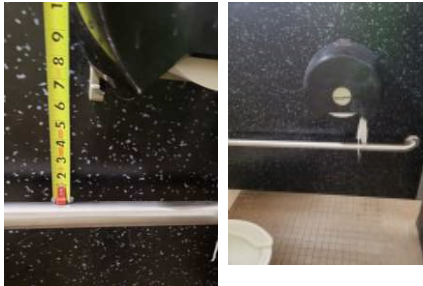
84	Restrooms For Camping: Restroom 4 (Central Park)	[30.73737, -98.36903]	The grab bar height and/or spacing fails. Grab bars must be mounted between 33" and 36" to the top of the gripping surface. There must be 1.5" of clearance between the grab bar and the wall. There must be a minimum of 1.5" of clearance below and minimum 12" above the grab bar to any dispenser or other obstruction.	men's - toilet paper 7" over bar	Remount toilet paper dispenser max 7" to 9" from front of toilet, 15" to 48" aff and min 12" above or 1.5" below grab bar	2015 ABAAS Section: 609.3, 609.4 2012 TAS Section: 609.4, 609.3 2010 ADAS Section: 609.3, 609.4

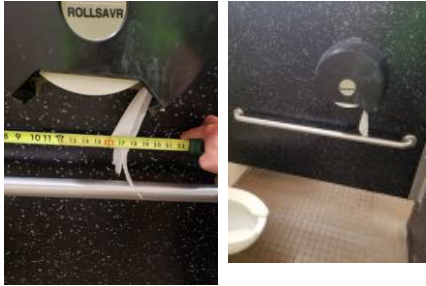
Finding Number	Area Description	Lat/Long	Finding	As Built	Recommendation	Citation	Photos	Figure
86	Restrooms For Camping: Restroom 4 (Central Park)	[30.73737, -98.36903]	The toilet paper is not installed within the compliant range in front of the toilet. Toilet paper dispensers shall be 7 inches minimum and 9 inches maximum in front of the water closet measured to the centerline of the dispenser. The outlet of the dispenser shall be 15 inches minimum and 48 inches maximum above the finish floor and shall not be located behind grab bars. Dispensers shall not be of a type that controls delivery or that does not allow continuous paper flow. There shall be a clearance of 1 1/2 inches minimum below the grab bar.	men's - tp too far, 15"	Remount toilet paper dispenser max 7" to 9" from front of toilet, 15" to 48" aff and min 12" above or 1.5" below grab bar	2015 ABAAS Section: 604.7 2012 TAS Section: 604.7 2010 ADAS Section: 604.7

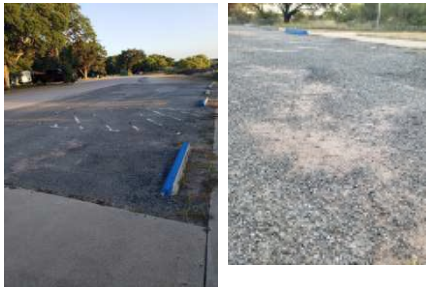
87	Restrooms For Camping: Restroom 4 (Central Park)	[30.74178, -98.36771]	Exterior doors exceed 8.5 lbs of force to open; fire doors shall have a minimum opening force allowable by the appropriate administrative authority	mens 18lbf, women's 15lbf	Inspect, adjust, and maintain 8.5 lbf to open exterior doors as a smart practice	2010 ADAS Section: 404.2.9		
88	Restrooms For Camping: Restroom 4 (Central Park)	[30.73737, -98.36903]	The parking stall contains abrupt edges and surface irregularities over a 1/4 inch vertical. Parking spaces and access aisles serving them shall be stable, firm, and slip resistant. Access aisles shall be at the same level as the parking spaces they serve. Changes in level are not permitted and shall not be sloped steeper than 2% in any direction.	broken and loose asphalt	Resurface accessible stalls and access aisles with a firm, stable, and slip resistant material	2015 ABAAS Section: 502.4 2012 TAS Section: 502.4 2010 ADAS Section: 502.4

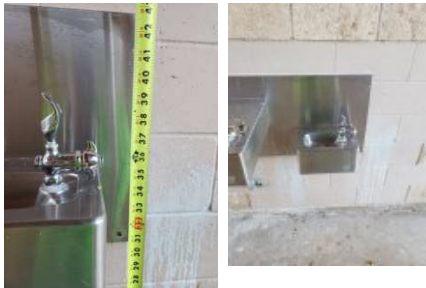
89	Restrooms For Camping: Restroom 4 (Central Park)	[30.73737, -98.36903]	The spout for the drinking fountain is too high. Spout outlets shall be 36 inches maximum above the finish floor or ground.	low bowl spout 38" aff	Remount fountain so spout outlet is max 36" aff	2015 ABAAS Section: 602.4 2012 TAS Section: 602.4 2010 ADAS Section: 602.4

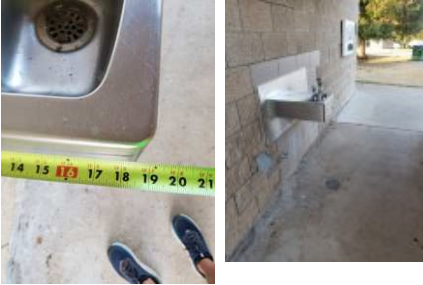
Finding Number	Area Description	Lat/Long	Finding	As Built	Recommendation	Citation	Photos	Figure
93	Restrooms For Camping: Restroom 4 (Central Park)	[30.73737, -98.36903]	The drinking fountain projects more than 4 inches into the circulation path. Wall-mounted objects that have leading edges between 27 inches and 80 inches from the floor must not project more than 4 inches into the circulation path. Protruding objects that extend to the floor or within 27 inches of the floor are cane detectable and are therefore not hazardous. Where it is necessary or desirable to have objects protrude from the wall, a manner of cane detection must be provided.	drinking fountain protrudes 19"	Relocate protruding objects or place cane detectable warning or bollard at foot of item	2015 ABAAS Section: 307.2 2012 TAS Section: 307.2 2010 ADAS Section: 307.2

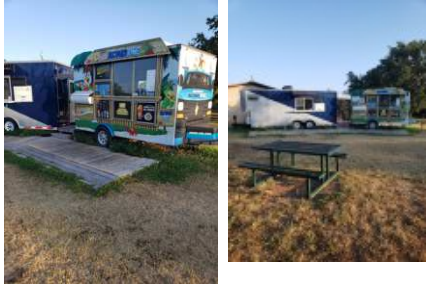
Finding Number	Area Description	Lat/Long	Finding	As Built	Recommendation	Citation	Photos	Figure
94	Restrooms For Camping: Restroom 4 (Central Park)	[30.73737, -98.36903]	Restaurants and Cafeterias. In restaurants and cafeterias, an accessible route shall be provided to all dining areas, including raised or sunken dining areas, and outdoor dining areas. EXCEPTIONS: 1. In buildings or facilities not required to provide an accessible route between stories, an accessible route shall not be required to a mezzanine dining area where the mezzanine contains less than 25 percent of the total combined area for seating and dining and where the same decor and services are provided in the accessible area. 2. In alterations, an accessible route shall not be required to existing raised or sunken dining areas, or to all parts of existing outdoor dining areas where the same services and decor are provided in an accessible space usable by the public and not restricted to use by people with disabilities. 3. In sports facilities, tiered dining areas providing seating required to comply with 221 shall be required to have accessible routes serving at least 25 percent of the dining area provided that accessible routes serve seating complying with 221 and each tier is provided with the same services. Advisory 206.2.5 Restaurants and Cafeterias Exception 2. Examples of "same services" include, but are not limited to, bar service, rooms having smoking and non-smoking sections, lotto and other table games, carry-out, and buffet service. Examples of "same decor" include, but are not limited to, seating at or near windows and railings with views, areas designed with a certain theme, party and banquet rooms, and rooms where entertainment is provided.	trailer concession and dining area lacks AR	Create accessible route to all dining areas	2015 ABAAS Section: F206.2.5, F206.2.5 EX CEPTIONS: 1, F206.2.5 E XCEPTIONS: 2, Advisory F206.2.5 2012 TAS Section: 206.2.5, 206.2.5 Exception 1, 206.2.5 Exception 2, 206.2.5 Exception 3, 206.2.5 Advisory 2010 ADAS Section: 206.2.5, 206.2.5 Exception 1, 206.2.5 Exception 2, 206.2.5 Exception 3

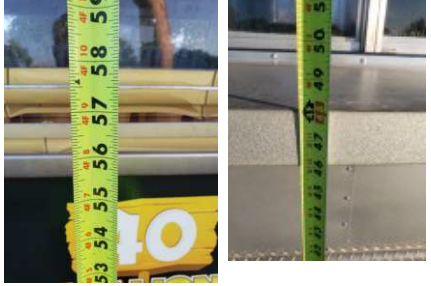
96	Restrooms For Camping: Restroom 4 (Central Park)	[30.73737, -98.36903]	The sales and service counter is not a minimum 36 inches wide. A portion of the counter surface that is 36 inches long minimum and 36 inches high maximum above the finish floor shall be provided. A 30 inch by 48 inch clear floor space on an accessible route must be provided for either a forward or parallel approach.	grill 48" aff, snow cone 56" aff	Lower 36" wide segment of service counter to max 36" aff	2012 TAS Section: 904.4 2010 ADAS Section: 904.4

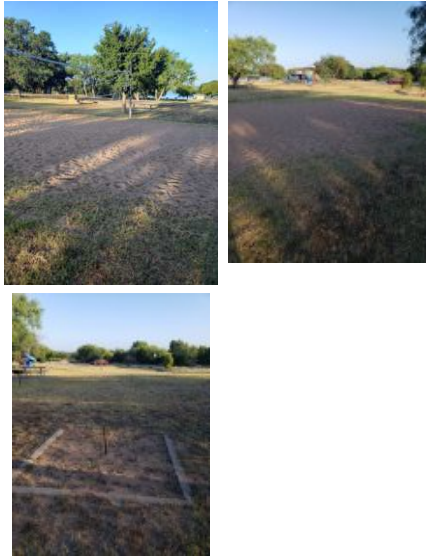
Finding Number	Area Description	Lat/Long	Finding	As Built	Recommendation	Citation	Photos	Figure
99	Restrooms For Camping: Restroom 4 (Central Park)	[30.74147, -98.36695]	There is no accessible route to the volleyball court or horse shoe game. At least one accessible route shall connect accessible buildings, accessible facilities, accessible elements, and accessible spaces that are on the same site.	no accessible route to volley ball court and horse shoes at playground near restroom 4	Create an accessible route with crushed stone or other outdoor material from parking or walkway to volleyball court and horse shoe game.	2015 ABAAS Section: F206.2.2 2012 TAS Section: 206.2.2 2010 ADAS Section: 206.2.2

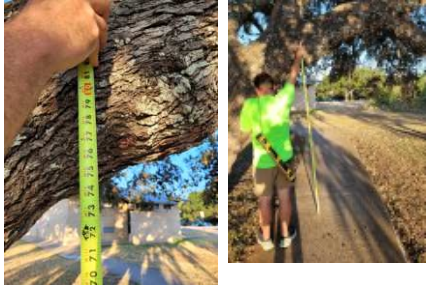
100	Restrooms For Camping: Restroom 4 (Central Park)	[30.73737, -98.36903]	The tree extends down too close to the route of travel. Any obstruction that overhangs a route of travel must be a minimum of 80 inches above the walking surface as measured from the bottom of the obstruction.	77" overhead due to tree from Bumpa's Playscape to restroom 4	Maintain overhead clearance of min. 80"	2015 ABAAS Section: 307.3 2012 TAS Section: 307.3 2010 ADAS Section: 307.3

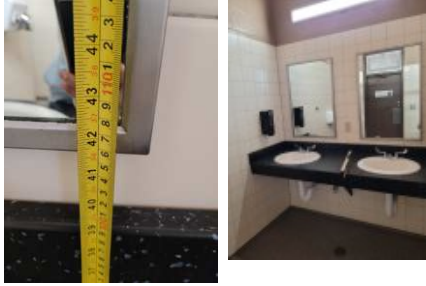
101	Restrooms For Camping: Restroom 4 (Central Park)	[30.73737, -98.36903]	The mirror is mounted too high. Mirrors must have the bottom edge of the reflecting surface a maximum of 40 inches above the floor if above a sink or counter. Mirrors not located above lavatories or countertops shall be installed with the bottom edge of the reflecting surface 35 inches maximum above the finish floor or ground.	womens - 42" aff	Lower mirror so reflective surface is max 40" aff	2015 ABAAS Section: 603.3 2012 TAS Section: 603.3 2010 ADAS Section: 603.3
