Access Audit Site Report

Inks Lake State Park

Accessibility Evaluation

Inspection Date: 08/23/2021

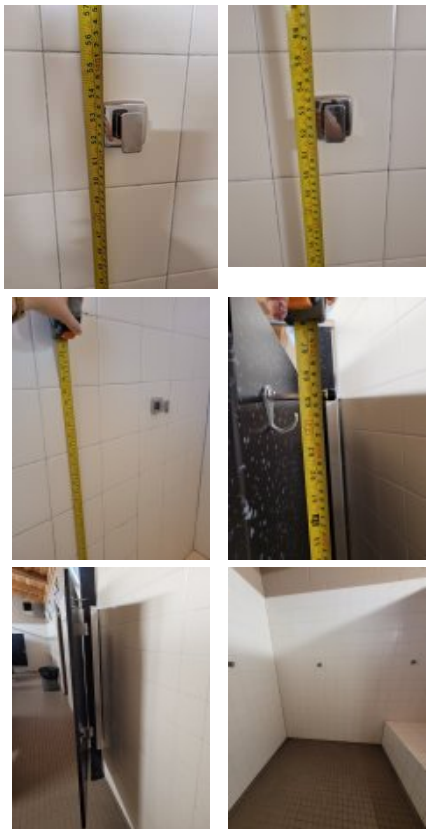
Finding Number	Area Description	Lat/Long	Finding	As Built	Recommendation	Citation	Photos	Figure
106	Restrooms For Camping: Restroom 4 (Central Park)	[30.73737, -98.36903]	Coat hooks provided within the room shall be located within one of the reach ranges specified in 308. Shelves shall be 40 inches (1015 mm) minimum and 48 inches (1220 mm) maximum above the finish floor or ground. Where coat hooks or shelves are provided in dressing, fitting or locker rooms without individual compartments, at least one of each type shall comply with 803.5. Where coat hooks or shelves are provided in individual compartments at least one of each type complying with 803.5 shall be provided in individual compartments in dressing, fitting, or locker rooms required to comply with 222.1.	women's - 53" aff to 3 hooks, 64" aff to hook on door	Remount at least one hook to max 48" aff and shelves to 40" - 48" aff	2015 ABAAS Section: 308.2.1, 308.1, F222.2, 803.5 2012 TAS Section: 308.2.1, 308.1, 222.2, 803.5 2010 ADAS Section: 308.2.1, 308.1, 222.2, 803.5

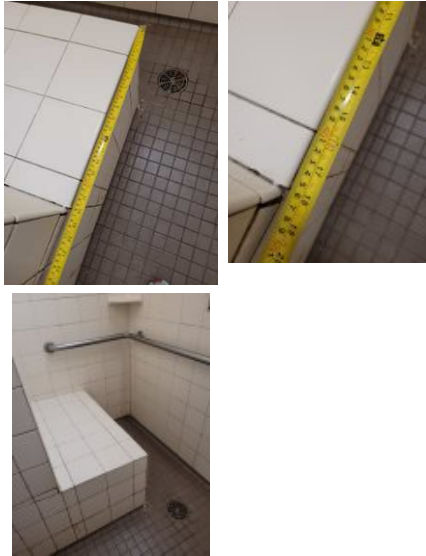
Finding Number	Area Description	Lat/Long	Finding	As Built	Recommendation	Citation	Photos	Figure
107	Restrooms For Camping: Restroom 4 (Central Park)	[30.73737, -98.36903]	The shower seat does not have a compliant space between it and the seat wall. The folding seat must be mounted 17-19 inches above the floor, and have a maximum space of 2-1/2 inches between the edge of the seat and the seat wall and 1-1/2 inches maximum to the side wall.	women's - 18" in depth	Remount shower seat to the correct location and height in the shower	2015 ABAAS Section: 610.3.1 2012 TAS Section: 610.3.1 2010 ADAS Section: 610.3.1

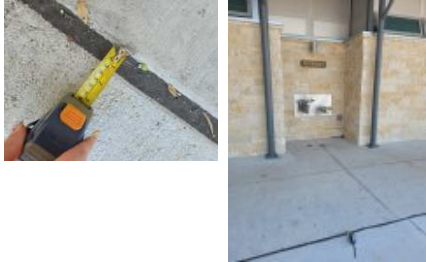
108	Restrooms For Camping: Restroom 5	[30.73737, -98.36903]	Element meets all standards and requirements	parking at restroom 5 complies	None	2010 ADAS Section: N/A		
109	Restrooms For Camping: Restroom 5	[30.73737, -98.36903]	There is a gap spaced greater than a 1/2 inch. Openings in floor or ground surfaces shall not allow passage of a sphere more than 1/2 inch diameter. Elongated openings shall be placed so that the long dimension is perpendicular to the dominant direction of travel.	1" gap by water fountain	Correct or fill gaps to be max .5"	2015 ABAAS Section: 302.3 2012 TAS Section: 302.3 2010 ADAS Section: 302.3

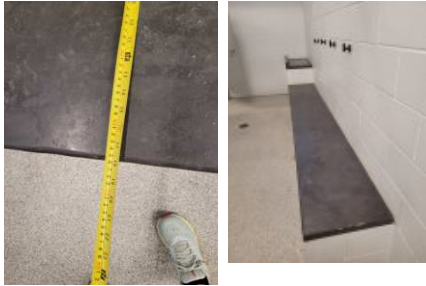
Finding Number	Area Description	Lat/Long	Finding	As Built	Recommendation	Citation	Photos	Figure
111	Restrooms For Camping: Restroom 5	[30.73737, -98.36903]	The bench is not deep enough or long enough or is missing. Benches shall be provided having seats that are 42 inches long minimum and 20 inches deep minimum and 24 inches deep maximum. The bench shall provide for back support or shall be affixed to a wall. Back support shall be 42 inches (1065 mm) long minimum and shall extend from a point 2 inches (51 mm) maximum above the seat surface to a point 18 inches (455 mm) minimum above the seat surface. Back support shall be 2½ inches (64 mm) maximum from the rear edge of the seat measured horizontally. The top of the bench seat surface shall be 17 inches (430 mm) minimum and 19 inches (485 mm) maximum above the finish floor or ground.	women's - bench 18" deep	Replace bench in dressing area with one having a seat depth of 20" to 24" deep, 42" long, affixed to the wall or having a back and mounted 17" to 19" aff	2012 TAS Section: 903.4, 903.2, 903.3, 903.5 2010 ADAS Section: 903.4, 903.2, 903.3, 903.5

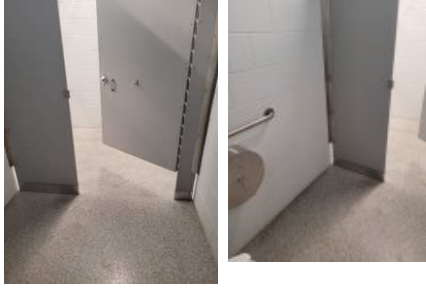
113	Restrooms For Camping: Restroom 5	[30.73737, -98.36903]	The accessible toilet compartment does not provide proper toe clearance on the front and/or side partition. The front partition and at least one side partition shall provide a toe clearance of 9 inches minimum above the finish floor and 6 inches deep minimum beyond the compartment-side face of the partition, exclusive of partition support members. Toe clearance at the side partition is not required in a compartment greater than 66 inches wide. Toe clearance at the front partition is not required where the depth is minimum 62 inches for a wall hung toilet and minimum 65 inches for a floor mounted toilet.	women - no toe clearance, 60 depth	Provide toe clearance at the front and side partitions, or enlarge stall to provide the same	2015 ABAAS Section: 604.8.1.4 2012 TAS Section: 604.8.1.4 2010 ADAS Section: 604.8.1.4

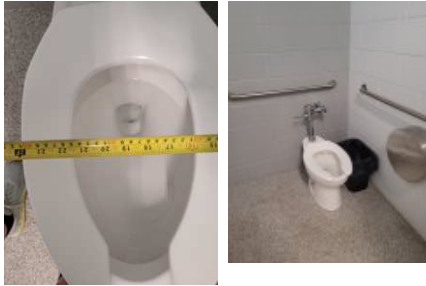
Finding Number	Area Description	Lat/Long	Finding	As Built	Recommendation	Citation	Photos	Figure
114	Restrooms For Camping: Restroom 5	[30.73737, -98.36903]	The toilet is not located within the range allowed from the side wall or partition. The centerline of the toilet must be 16 to 18 inches from the side wall.	women's - 18.5" centerline	Remount toilets to 16" to 18" from the side wall to centerline	2015 ABAAS Section: 604.2 2012 TAS Section: 604.2 2010 ADAS Section: 604.2

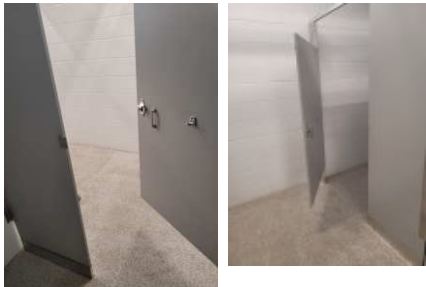
115	Restrooms For Camping: Restroom 5	[30.73737, -98.36903]	The stall door fails to comply with all of the door requirements. The stall door must be a minimum of 32" wide and have compliant hardware on both sides. The stall door must be self-closing.	women's - stall door not self closing	Adjust stall door to be self-closing	2015 ABAAS Section: 404.2.3, 404.2.7, 604.8.2.2 2012 TAS Section: 404.2.3, 404.2.7, 604.8.2.2 2010 ADAS Section: 404.2.3, 404.2.7, 604.8.2.2

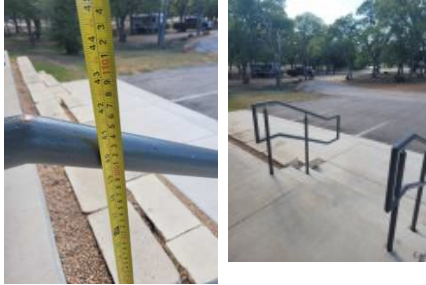
Finding Number	Area Description	Lat/Long	Finding	As Built	Recommendation	Citation	Photos	Figure
117	Restrooms For Camping: Restroom 5	[30.73737, -98.36903]	The handrails as well as the handrail extensions are not at the correct height. The tops of handrails and their extensions must be between 34 inches and 38 inches above the stair nosing or ground.	41" height	Replace or remount handrails to 34" to 38" aff	2015 ABAAS Section: 505.4 2012 TAS Section: 505.4 2010 ADAS Section: 505.4

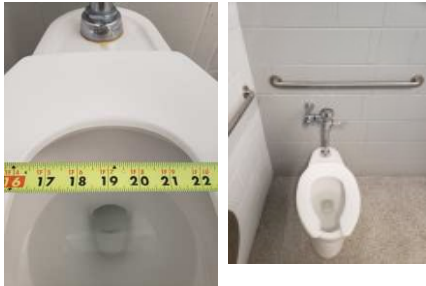
119	Restrooms For Camping: Restroom 5	[30.73737, -98.36903]	The toilet is not located within the range allowed from the side wall or partition. The centerline of the toilet must be 16 to 18 inches from the side wall.	men's - centerline is 19"	Remount toilets to 16" to 18" from the side wall to centerline	2015 ABAAS Section: 604.2 2012 TAS Section: 604.2 2010 ADAS Section: 604.2

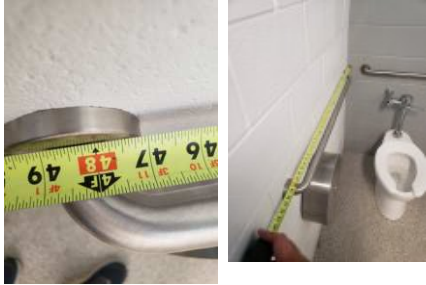
Finding Number	Area Description	Lat/Long	Finding	As Built	Recommendation	Citation	Photos	Figure
120	Restrooms For Camping: Restroom 5	[30.73737, -98.36903]	The side grab bars are not in the correct location. Grab bars on the side wall must be installed so that the end closest to the rear wall is maximum 12" from the rear wall. The end furthest from the rear wall must be mounted minimum 54" from the rear wall.	men's - extends 48" from wall	Remount side grab bar to max 12" from the rear wall at the close end and min 54" on the far end, and 33" to 36" aff	2015 ABAAS Section: 604.5.1 2012 TAS Section: 604.5.1 2010 ADAS Section: 604.5.1

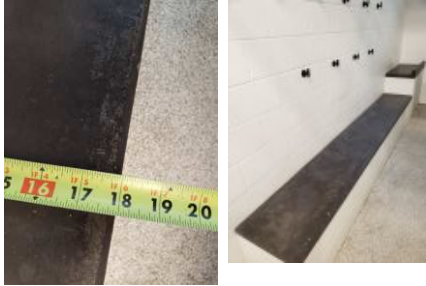
121	Restrooms For Camping: Restroom 5	[30.73737, -98.36903]	The bench is not deep enough or long enough or is missing. Benches shall be provided having seats that are 42 inches long minimum and 20 inches deep minimum and 24 inches deep maximum. The bench shall provide for back support or shall be affixed to a wall. Back support shall be 42 inches (1065 mm) long minimum and shall extend from a point 2 inches (51 mm) maximum above the seat surface to a point 18 inches (455 mm) minimum above the seat surface. Back support shall be 2 1/2 inches (64 mm) maximum from the rear edge of the seat measured horizontally. The top of the bench seat surface shall be 17 inches (430 mm) minimum and 19 inches (485 mm) maximum above the finish floor or ground.	men's - bench 18" deep	Replace bench in dressing area with one having a seat depth of 20" to 24" deep, 42" long, affixed to the wall or having a back and mounted 17" to 19" aff	2012 TAS Section: 903.4, 903.2, 903.3, 903.5 2010 ADAS Section: 903.4, 903.2, 903.3, 903.5

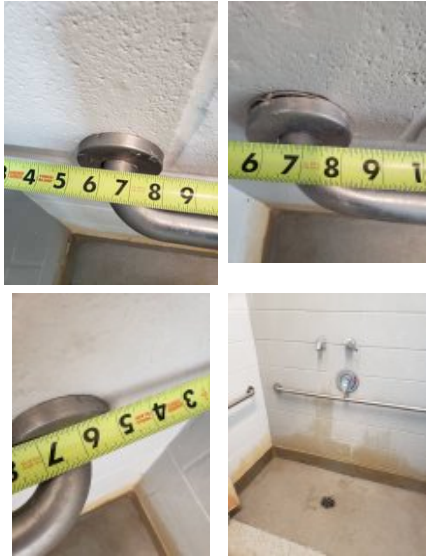
Finding Number	Area Description	Lat/Long	Finding	As Built	Recommendation	Citation	Photos	Figure
122	Restrooms For Camping: Restroom 5	[30.73737, -98.36903]	Standard Roll-In Type Shower Compartments. Where a seat is provided in standard roll-in type shower compartments, grab bars shall be provided on the back wall and the side wall opposite the seat. Grab bars shall not be provided above the seat. Where a seat is not provided in standard roll-in type shower compartments, grab bars shall be provided on three walls. Grab bars shall be installed 6 inches (150 mm) maximum from adjacent walls. Alternate Roll-In Type Shower Compartments. In alternate roll-in type shower compartments, grab bars shall be provided on the back wall and the side wall farthest from the compartment entry. Grab bars shall not be provided above the seat. Grab bars shall be installed 6 inches (150 mm) maximum from adjacent walls. Grab bars shall be installed in a horizontal position, 33 inches (840 mm) minimum and 36 inches (915 mm) maximum above the finish floor measured to the top of the gripping surface, except that at water closets for children's use complying with 604.9, grab bars shall be installed in a horizontal position 18 inches (455 mm) minimum and 27 inches (685 mm) maximum above the finish floor measured to the top of the gripping surface.	men's - grab bar 6.5" from wall	Remount grab bars to the correct location in the shower, mounted 33" to 36" aff and max 6" from adjacent walls	2015 ABAAS Section: 608.3.2, 608.3.3, 609.4 2012 TAS Section: 609.4, 608.3.2, 608.3.3 2010 ADAS Section: 609.4, 608.3.2, 608.3.3

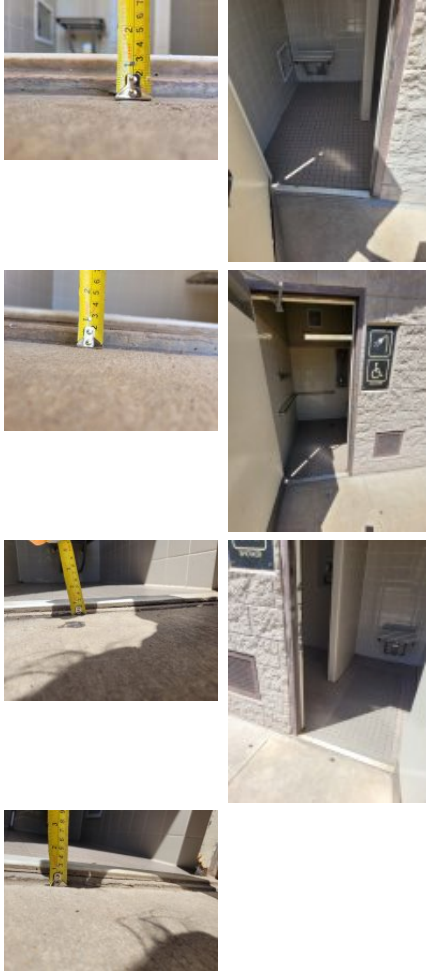
Finding Number	Area Description	Lat/Long	Finding	As Built	Recommendation	Citation	Photos	Figure
125	Restrooms For Camping: Restroom 6	[30.73737, -98.36903]	The threshold has a vertical change greater than 1/4 inch high. Exterior doors are recommended to be maintained at 8.5 lbf as a smart practice. Force is to be measured at the operating hardware or 30 inches from the hinges, whichever is greater.	back of building shower doors, left to right - 16 lbf, 11 lbf, 15 lbf, 16 lbf. left to right - 1.5 cil, .75 cil, .75 cil, 1" cil	For all doors along the public circulation route, repair, bevel, or ramp CILs at door entries to max .25" For all doors along the public circulation route, inspect, adjust, and maintain 8.5 lbf to open exterior doors as a smart practice	2010 ADAS Section: 404.2.3, 404.2.7, 404.2.4, 404.2.11, 404.2.11 Exception

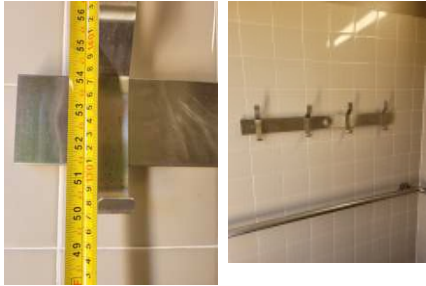
Finding Number	Area Description	Lat/Long	Finding	As Built	Recommendation	Citation	Photos	Figure
126	Restrooms For Camping: Restroom 6	[30.73737, -98.36903]	Coat hooks provided within the room shall be located within one of the reach ranges specified in 308. Shelves shall be 40 inches (1015 mm) minimum and 48 inches (1220 mm) maximum above the finish floor or ground. Where coat hooks or shelves are provided in dressing, fitting or locker rooms without individual compartments, at least one of each type shall comply with 803.5. Where coat hooks or shelves are provided in individual compartments at least one of each type complying with 803.5 shall be provided in individual compartments in dressing, fitting, or locker rooms required to comply with 222.1.	all hooks 52" aff	Remount at least one hook to max 48" aff and shelves to 40" - 48" aff	2015 ABAAS Section: 308.2.1, 308.1, F222.2, 803.5 2012 TAS Section: 308.2.1, 308.1, 222.2, 803.5 2010 ADAS Section: 308.2.1, 308.1, 222.2, 803.5

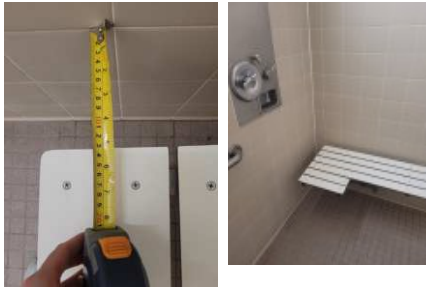
127	Restrooms For Camping: Restroom 6	[30.73737, -98.36903]	The shower seat does not have a compliant space between it and the wall. The folding seat must be mounted 17-19 inches above the floor, and have a maximum space of 1-1/2 inches between the edge of the seat and the side wall and 2-1/2 inches maximum to the seat wall.	5" gap between rear wall and bench	Remount shower seat to the correct location and height in the shower	2015 ABAAS Section: 610.3.2 2012 TAS Section: 610.3.2 2010 ADAS Section: 610.3.2

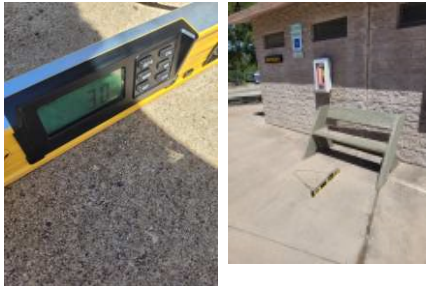
128	Restrooms For Camping: Restroom 6	[30.73737, -98.36903]	The 30 inches minimum by 48 inches minimum clear floor space required at the operable part is not flat (2% or 1:48 maximum slope) in all directions. Changes in level are not permitted at required clear floor or ground space except that slopes not steeper than 1:48 shall be permitted.	3% running slope in the CFS for bench	Correct or repair slope in CFS to max 2.08%	2015 ABAAS Section: 305.2 2012 TAS Section: 305.2 2010 ADAS Section: 305.2

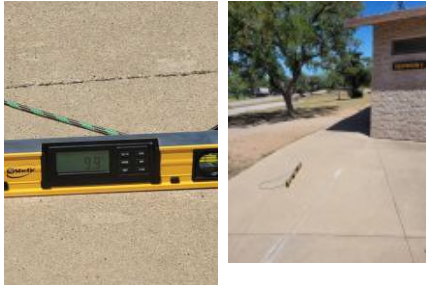
Finding Number	Area Description	Lat/Long	Finding	As Built	Recommendation	Citation	Photos	Figure
129	Restrooms For Camping: Restroom 6	[30.73737, -98.36903]	The running slope of walking surfaces shall not be steeper than 1:20.	9.9% slope towards restroom entry	Correct running slope along the AR to max 5%	2015 ABAAS Section: 403.3 2012 TAS Section: 403.3 2010 ADAS Section: 403.3

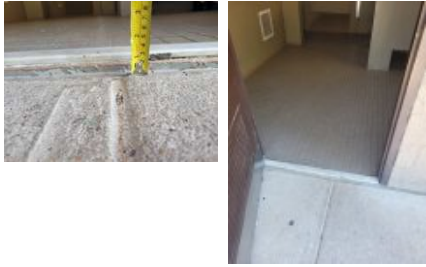
130	Restrooms For Camping: Restroom 6	[30.73737, -98.36903]	The threshold has a vertical change greater than 1/4 inch high. The threshold at a doorway shall be no higher than 1/2 inch. Changes in level between 1/4 inch and 1/2 inch must be beveled at 1:2 or less. 1/4 inch is the maximum vertical rise. Exterior doors are recommended to be maintained at 8.5 lbf as a smart practice. Force is to be measured at the operating hardware or 30 inches from the hinges, whichever is greater.	17# push, 1" CIL	For all doors along the public circulation route, repair, bevel, or ramp CILs at door entries to max .25" For all doors along the public circulation route, inspect, adjust, and maintain 8.5 lbf to open exterior doors as a smart practice	2010 ADAS Section: 404.2.3, 404.2.7, 404.2.4, 404.2.11, 404.2.11 Exception

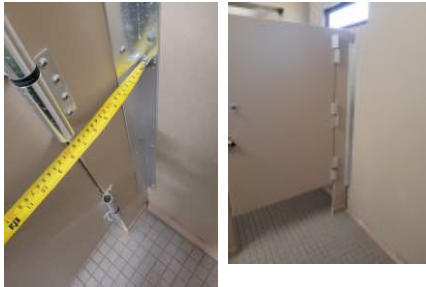
131	Restrooms For Camping: Restroom 6	[30.73737, -98.36903]	The compartment door is located too far from the partition or wall. The door shall be located in front of the clear space and diagonal to the water closet. Where located in the front partition, the door opening shall be 4 inches maximum from the side wall or partition farthest from the water closet. Where located in the side wall or partition, the door opening shall be 4 inches maximum from the front partition. Toilet compartment doors shall not swing into the minimum required compartment area.	8" partition	Rehang stall door to be max 4" from adjacent stall partition and on the stall wall farthest from the toilet	2015 ABAAS Section: 604.8.1.2 2012 TAS Section: 604.8.1.2 2010 ADAS Section: 604.8.1.2

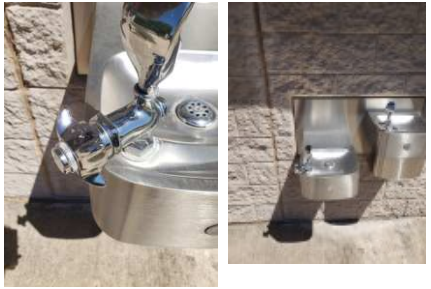
135	Restrooms For Camping: Restroom 6	[30.73737, -98.36903]	The drinking fountain is not accessible because it requires tight grasping, pinching or twisting of the wrist.	knob hardware requires force	Replace knob with an operable part usable without a tight pinch or grasp	2015 ABAAS Section: 309.4 2012 TAS Section: 309.4 2010 ADAS Section: 309.4

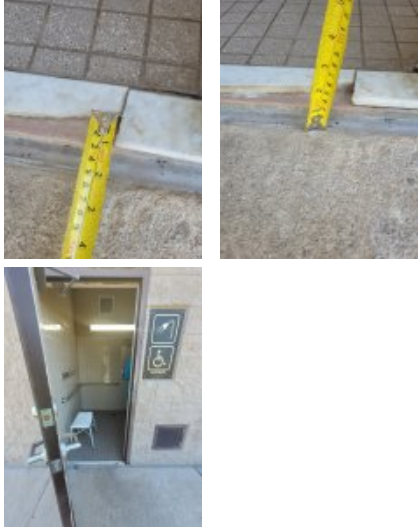
138	Restrooms For Camping: Restroom 7	[30.73737, -98.36903]	The threshold has a vertical change greater than 1/4 inch high. The threshold at a doorway shall be no higher than 1/2 inch. Changes in level between 1/4 inch and 1/2 inch must be beveled at 1:2 or less. 1/4 inch is the maximum vertical rise. Exterior doors are recommended to be maintained at 8.5 lbf as a smart practice. Force is to be measured at the operating hardware or 30 inches from the hinges, whichever is greater.	women's- 30# push, men's 27# push, women's 1.5" CIL, men's 2" CIL, men's missing threshold	For all doors along the public circulation route, repair, bevel, or ramp CILs at door entries to max .25" For all doors along the public circulation route, repair, provide beveled threshold For all doors along the public circulation route, inspect, adjust, and maintain 8.5 lbf to open exterior doors as a smart practice	2010 ADAS Section: 404.2.3, 404.2.7, 404.2.4, 404.2.11, 404.2.11 Exception

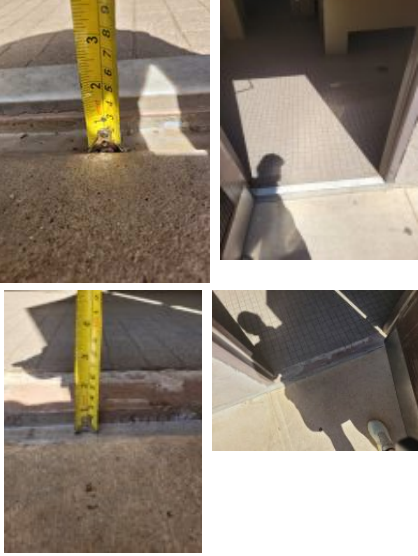
Finding Number	Area Description	Lat/Long	Finding	As Built	Recommendation	Citation	Photos	Figure
139	Restrooms For Camping: Restroom 7	[30.73737, -98.36903]	There are no or not enough accessible parking stalls. Each lot where parking is provided for the public as clients, guests or employees, shall provide accessible parking and shall be located on the shortest accessible route of travel from adjacent parking to an accessible entrance. There are a total of (XX) parking stalls in the parking lot that could be reasonably associated with this facility. There should be a minimum of (XX) accessible stalls with a minimum of (XX) being designed as van accessible.	overflow spots by restroom lack accessible stalls, 0 of 34	Create one or more 8' accessible parking stalls, with one 5' adjacent access aisle, with proper signage and striping based on the total number of stalls.	2015 ABAAS Section: F208.2 2012 TAS Section: 208.2 2010 ADAS Section: 208.2

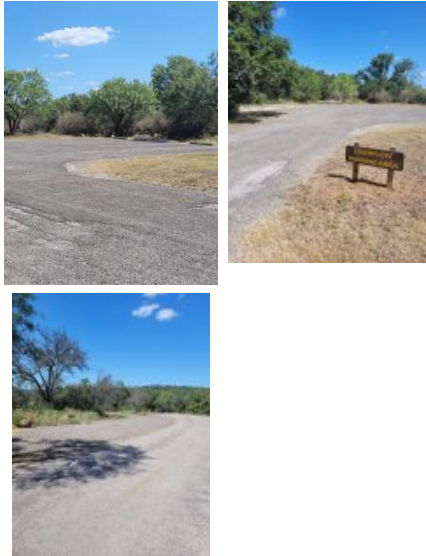
140	Restrooms For Camping: Restroom 7	[30.73737, -98.36903]	There is no accessible route to the benches. At least one accessible route shall connect accessible buildings, accessible facilities, accessible elements, and accessible spaces that are on the same site.	no AR to benches behind restroom 7	Create an accessible route with crushed stone or other outdoor material from parking or walkway to benches	2015 ABAAS Section: F206.2.2 2012 TAS Section: 206.2.2 2010 ADAS Section: 206.2.2

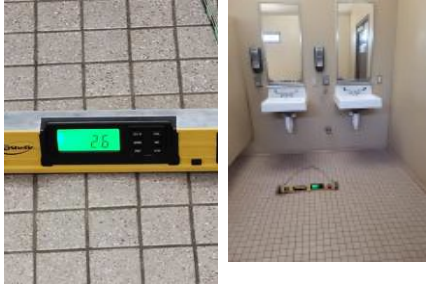
Finding Number	Area Description	Lat/Long	Finding	As Built	Recommendation	Citation	Photos	Figure
144	Restrooms For Camping: Restroom 7	[30.73737, -98.36903]	The accessible route contains running slopes greater than 5 percent and cross slopes greater than 2 percent across the width of the walk and has not been constructed as a ramp (i.e. handrails, wheel guides, etc.). When the slope in the direction of travel of any walk exceeds 1 unit vertical in 20 units horizontal (5-percent slope), it must be constructed as ramp. Surface cross slopes must not exceed one unit vertical in 48 units. Horizontal (2-percent slope).	womens 2.6% cross slope by sinks	Correct or repair slope to max 5% running and 2.08% cross	2015 ABAAS Section: 403.3 2012 TAS Section: 403.3 2010 ADAS Section: 403.3

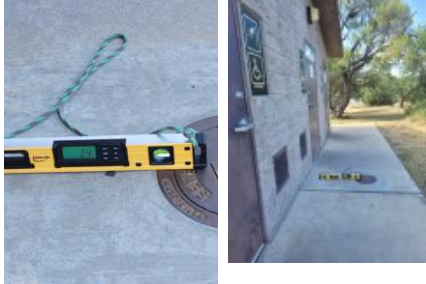
145	Restrooms For Camping: Restroom 7	[30.73737, -98.36903]	The accessible route of travel contains cross slopes greater than 2%. Cross slopes shall not exceed one unit vertical in 48 units horizontal (2-percent slope).	2.4% cross slope by shower and floor grate	Correct or repair cross slope along AR to max 2.08%.	2015 ABAAS Section: 403.3 2012 TAS Section: 403.3 2010 ADAS Section: 403.3

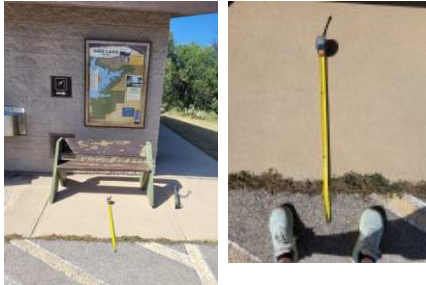
146	Restrooms For Camping: Restroom 7	[30.73737, -98.36903]	The required clear floor space is not deep enough. The clear floor or ground space shall be 30 inches minimum by 48 inches minimum.	CFS for bench by showers overlaps and can block AR	Relocate bench and provide CGS that does not overlap the AR	2015 ABAAS Section: 305.3 2012 TAS Section: 305.3 2010 ADAS Section: 305.3

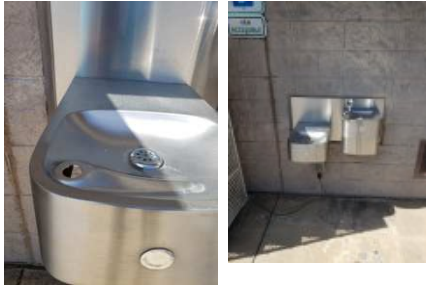
Finding Number	Area Description	Lat/Long	Finding	As Built	Recommendation	Citation	Photos	Figure
150	Restrooms For Camping: Restroom 7	[30.73737, -98.36903]	The spout for the drinking fountain is too high. Spout outlets shall be 36 inches maximum above the finish floor or ground.	low bowl spout missing	Repair fountain and ensure spout outlet is max 36" aff if intended to be used	2015 ABAAS Section: 602.4 2012 TAS Section: 602.4 2010 ADAS Section: 602.4

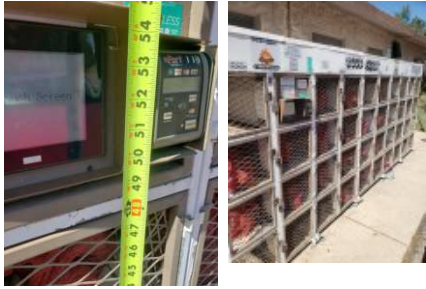
156	Restrooms For Camping: Restroom 7	[30.73737, -98.36903]	The controls are too high and are out of the maximum reach range for a side approach. Where a clear floor or ground space allows a parallel approach to an element and the side reach is unobstructed, the high side reach shall be 48 inches maximum to the finished floor.	wood vending machine controls over 50" aff	Lower operating mechanisms to max 48" aff to highest operable part	2015 ABAAS Section: 308.3.1 2012 TAS Section: 308.3.1 2010 ADAS Section: 308.3.1

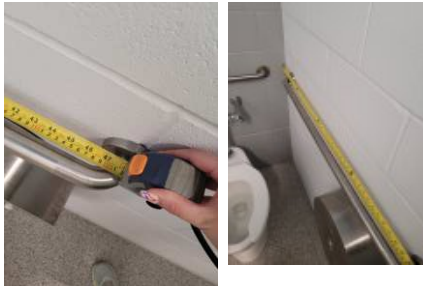
162	Restrooms For Camping: Restroom 8	[30.73737, -98.36903]	The side grab bars are not in the correct location. Grab bars on the side wall must be installed so that the end closest to the rear wall is maximum 12" from the rear wall. The end furthest from the rear wall must be mounted minimum 54" from the rear wall.	women's - extends 48" from wall	Remount side grab bar to max 12" from the rear wall at the close end and min 54" on the far end, and 33" to 36" aff	2015 ABAAS Section: 604.5.1 2012 TAS Section: 604.5.1 2010 ADAS Section: 604.5.1

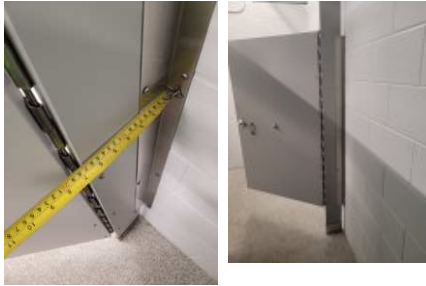
Finding Number	Area Description	Lat/Long	Finding	As Built	Recommendation	Citation	Photos	Figure
164	Restrooms For Camping: Restroom 8	[30.73737, -98.36903]	The compartment door is located too far from the partition or wall. The door shall be located in front of the clear space and diagonal to the water closet. Where located in the front partition, the door opening shall be 4 inches maximum from the side wall or partition farthest from the water closet. Where located in the side wall or partition, the door opening shall be 4 inches maximum from the front partition. Toilet compartment doors shall not swing into the minimum required compartment area.	women's - 7" partition	Rehang stall door to be max 4" from adjacent stall partition and on the stall wall farthest from the toilet	2015 ABAAS Section: 604.8.1.2 2012 TAS Section: 604.8.1.2 2010 ADAS Section: 604.8.1.2

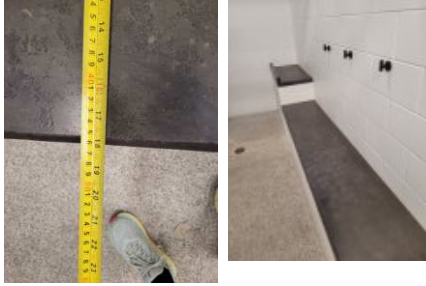
165	Restrooms For Camping: Restroom 8	[30.73737, -98.36903]	The bench is not deep enough or long enough or is missing. Benches shall be provided having seats that are 42 inches long minimum and 20 inches deep minimum and 24 inches deep maximum. The bench shall provide for back support or shall be affixed to a wall. Back support shall be 42 inches (1065 mm) long minimum and shall extend from a point 2 inches (51 mm) maximum above the seat surface to a point 18 inches (455 mm) minimum above the seat surface. Back support shall be 2½ inches (64 mm) maximum from the rear edge of the seat measured horizontally. The top of the bench seat surface shall be 17 inches (430 mm) minimum and 19 inches (485 mm) maximum above the finish floor or ground.	women's - bench 18" deep	Replace bench in dressing area with one having a seat depth of 20" to 24" deep, 42" long, affixed to the wall or having a back and mounted 17" to 19" aff	2012 TAS Section: 903.4, 903.2, 903.3, 903.5 2010 ADAS Section: 903.4, 903.2, 903.3, 903.5

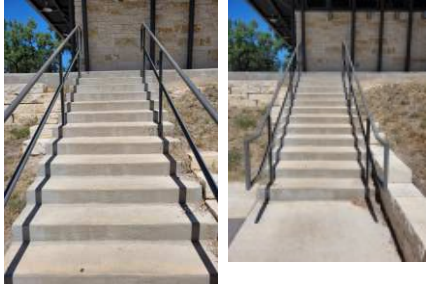
Finding Number	Area Description	Lat/Long	Finding	As Built	Recommendation	Citation	Photos	Figure
167	Restrooms For Camping: Restroom 8	[30.73737, -98.36903]	The stripe on the stair tread does not contrast adequately with the stair tread. Exterior and interior stairs are recommended to have the upper approach and lower treads marked by a stripe providing clear visual contrast.	stair treads lack contrast (12)	SMART PRACTICE Install contrasting strip along front 2" of each tread The stripe shall be a minimum of 2 inches wide to a maximum of 4 inches wide placed parallel to, and not more than 1 inch from, the nose of the step or upper approach. The stripe shall extend the full width of the step or upper approach and shall be of material that is at least as slip resistant as the other treads of the stair. A painted stripe shall be acceptable. Grooves shall not be used to satisfy this requirement.	2015 ABAAS Section: Advisory 504.4 2012 TAS Section: 504.4 Advisory 2010 ADAS Section: 504.4

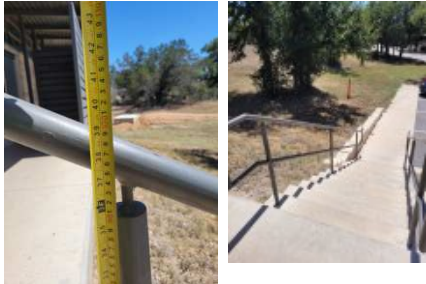
168	Restrooms For Camping: Restroom 8	[30.73737, -98.36903]	The handrails as well as the handrail extensions are not at the correct height. The tops of handrails and their extensions must be between 34 inches and 38 inches above the stair nosing or ground.	handrails 38.5" aff	Replace or remount handrails to 34" to 38" aff	2015 ABAAS Section: 505.4 2012 TAS Section: 505.4 2010 ADAS Section: 505.4

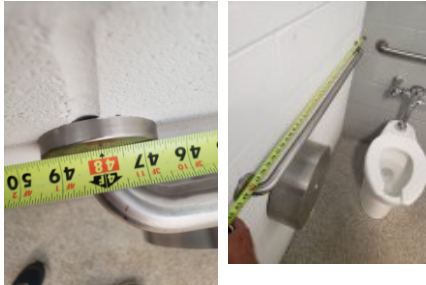
169	Restrooms For Camping: Restroom 8	[30.73737, -98.36903]	The side grab bars are not in the correct location. Grab bars on the side wall must be installed so that the end closest to the rear wall is maximum 12" from the rear wall. The end furthest from the rear wall must be mounted minimum 54" from the rear wall.	men's - extends 48" from rear wall	Remount side grab bar to max 12" from the rear wall at the close end and min 54" on the far end, and 33" to 36" aff	2015 ABAAS Section: 604.5.1 2012 TAS Section: 604.5.1 2010 ADAS Section: 604.5.1

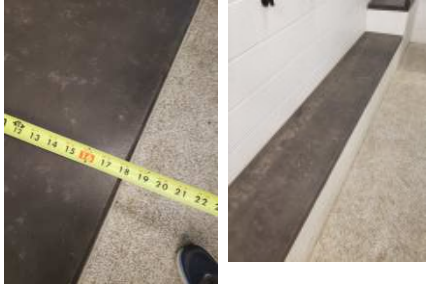
Finding Number	Area Description	Lat/Long	Finding	As Built	Recommendation	Citation	Photos	Figure
170	Restrooms For Camping: Restroom 8	[30.73737, -98.36903]	The bench is not deep enough or long enough or is missing. Benches shall be provided having seats that are 42 inches long minimum and 20 inches deep minimum and 24 inches deep maximum. The bench shall provide for back support or shall be affixed to a wall. Back support shall be 42 inches (1065 mm) long minimum and shall extend from a point 2 inches (51 mm) maximum above the seat surface to a point 18 inches (455 mm) minimum above the seat surface. Back support shall be 2½ inches (64 mm) maximum from the rear edge of the seat measured horizontally. The top of the bench seat surface shall be 17 inches (430 mm) minimum and 19 inches (485 mm) maximum above the finish floor or ground.	men's - bench 18" deep	Replace bench in dressing area with one having a seat depth of 20" to 24" deep, 42" long, affixed to the wall or having a back and mounted 17" to 19" aff	2012 TAS Section: 903.4, 903.2, 903.3, 903.5 2010 ADAS Section: 903.4, 903.2, 903.3, 903.5

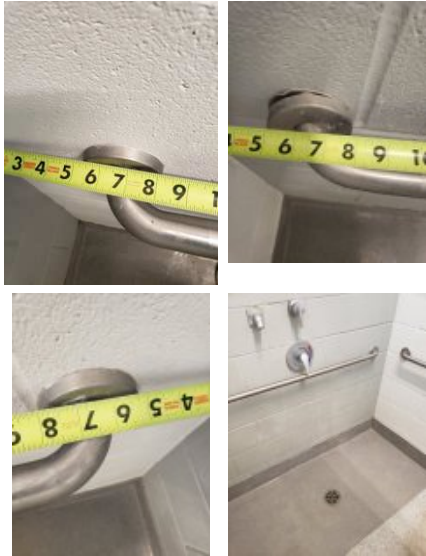
Finding Number	Area Description	Lat/Long	Finding	As Built	Recommendation	Citation	Photos	Figure
171	Restrooms For Camping: Restroom 8	[30.73737, -98.36903]	Standard Roll-In Type Shower Compartments. Where a seat is provided in standard roll-in type shower compartments, grab bars shall be provided on the back wall and the side wall opposite the seat. Grab bars shall not be provided above the seat. Where a seat is not provided in standard roll-in type shower compartments, grab bars shall be provided on three walls. Grab bars shall be installed 6 inches (150 mm) maximum from adjacent walls. Alternate Roll-In Type Shower Compartments. In alternate roll-in type shower compartments, grab bars shall be provided on the back wall and the side wall farthest from the compartment entry. Grab bars shall not be provided above the seat. Grab bars shall be installed 6 inches (150 mm) maximum from adjacent walls. Grab bars shall be installed in a horizontal position, 33 inches (840 mm) minimum and 36 inches (915 mm) maximum above the finish floor measured to the top of the gripping surface, except that at water closets for children's use complying with 604.9, grab bars shall be installed in a horizontal position 18 inches (455 mm) minimum and 27 inches (685 mm) maximum above the finish floor measured to the top of the gripping surface.	all three bars mounted 6.5" from wall	Remount grab bars to the correct location in the shower, mounted 33" to 36" aff and max 6" from adjacent walls	2015 ABAAS Section: 608.3.2, 608.3.3, 609.4 2012 TAS Section: 609.4, 608.3.2, 608.3.3 2010 ADAS Section: 609.4, 608.3.2, 608.3.3

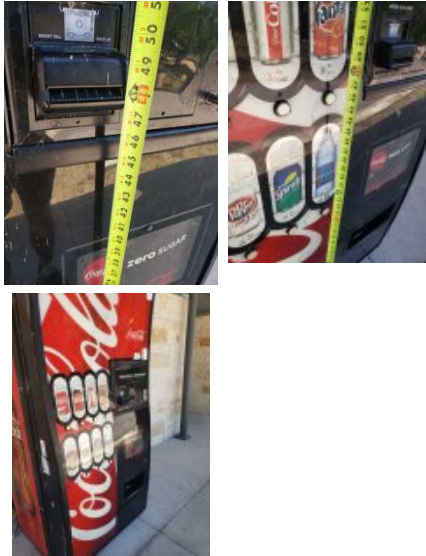
Finding Number	Area Description	Lat/Long	Finding	As Built	Recommendation	Citation	Photos	Figure
173	Restrooms For Camping: Restroom 8	[30.74539, -98.36078]	Element meets all standards and requirements	vending machine compliant	None	2010 ADAS Section: N/A

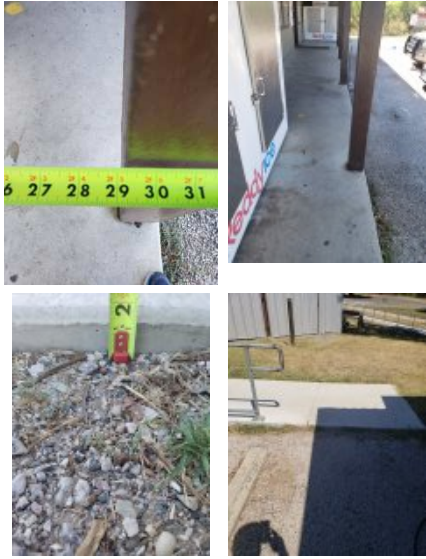
Finding Number	Area Description	Lat/Long	Finding	As Built	Recommendation	Citation	Photos	Figure
179	Park Store: Park Store Exterior Accessible Route	[30.7425029 , -98.367446 2]	The path of contains multiple issues and is not accessible. The path of travel exceeds the maximum allowable cross and running slope requirements. It also contains changes in level and/or gaps that exceed the allowable maximum requirements. The path of travel does not meet the minimum width requirements for clearances, turning spaces, and/or passing spaces. The floor or ground surface is not firm, stable, and slip resistant.	path narrows to 29" in width, 2" gap to ramp	Widen AR to compliant 36" clear width Correct or fill 1" gap along AR	2015 ABAAS Section: 403.1 2010 ADAS Section: 403.1

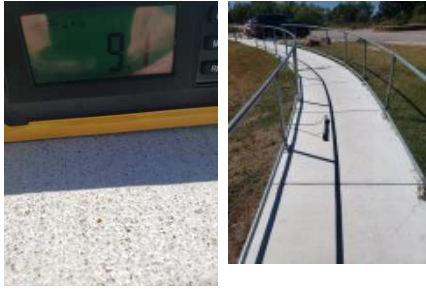
180	Park Store: Park Store Exterior Accessible Route	[30.742474, -98.367493 1]	The ramps slope exceeds the maximum running slope (direction of travel) allowable of 8.33%. Ramps should have the least possible slope but in no case more than 8.3% (1:12).	9.1% slope on ramp	Correct slope of ramp to max 8.33%	2015 ABAAS Section: 405.2 2012 TAS Section: 405.2 2010 ADAS Section: 405.2

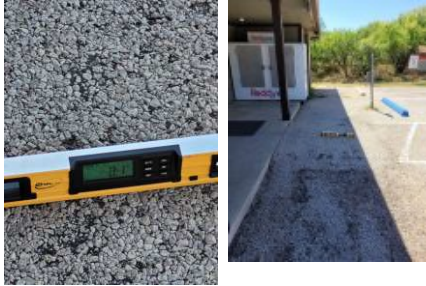
181	Park Store: Park Store Exterior Accessible Route	[30.7423853 , -98.367369 7]	The running slope of walking surfaces shall not be steeper than 1:20.	8.1% running slope up to entry from lot	Correct running slope along the AR to max 5%	2015 ABAAS Section: 403.3 2012 TAS Section: 403.3 2010 ADAS Section: 403.3

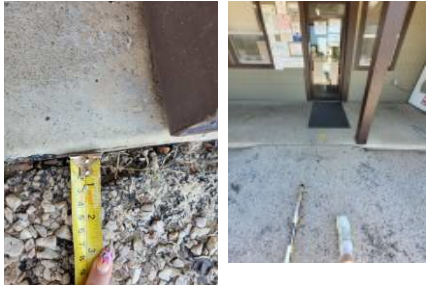
Finding Number	Area Description	Lat/Long	Finding	As Built	Recommendation	Citation	Photos	Figure
182	Park Store: Park Store Exterior Accessible Route	[30.7423853 , -98.367367]	There is a gap spaced greater than a 1/2 inch. Openings in floor or ground surfaces shall not allow passage of a sphere more than 1/2 inch diameter. Elongated openings shall be placed so that the long dimension is perpendicular to the dominant direction of travel.	1" gap from lot	Correct or fill gaps to be max .5"	2015 ABAAS Section: 302.3 2012 TAS Section: 302.3 2010 ADAS Section: 302.3

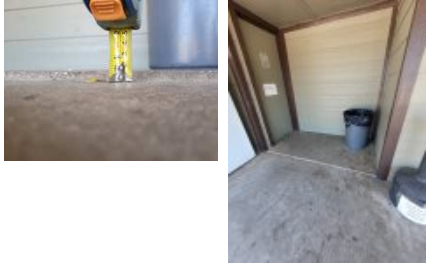
183	Park Store: Park Store Exterior Accessible Route	[30.7424014 , -98.3673737]	The walkway contains abrupt vertical edges and/or variations over a 1/4 inch. 1/4 inch is the maximum vertical rise. Changes in level between 1/4 inch and 1/2 inch must be beveled at 1:2 or less. Changes in level greater than 1/2 inch must be by way of a ramp.	.5" CIL at entry to restrooms	Repair, bevel or ramp CIL along AR	2012 TAS Section: 303.2, 303.3 2010 ADAS Section: 303.2, 303.3

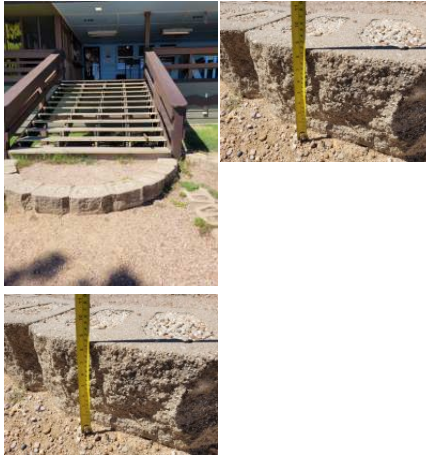
184	Park Store: Park Store Exterior Accessible Route	[30.7424833 , -98.3672276]	The stair risers are not uniform in height. Stair riser heights shall be 7 inches maximum and 4 inches minimum. On any given flight of stairs, all steps shall have uniform riser height and uniform tread widths.	cement step at bottom is 8.5" AFF	Correct riser heights on stairs to consistent height between 4" to 7", leave as is if technically infeasible	2015 ABAAS Section: 504.2 2012 TAS Section: 504.2 2010 ADAS Section: 504.2

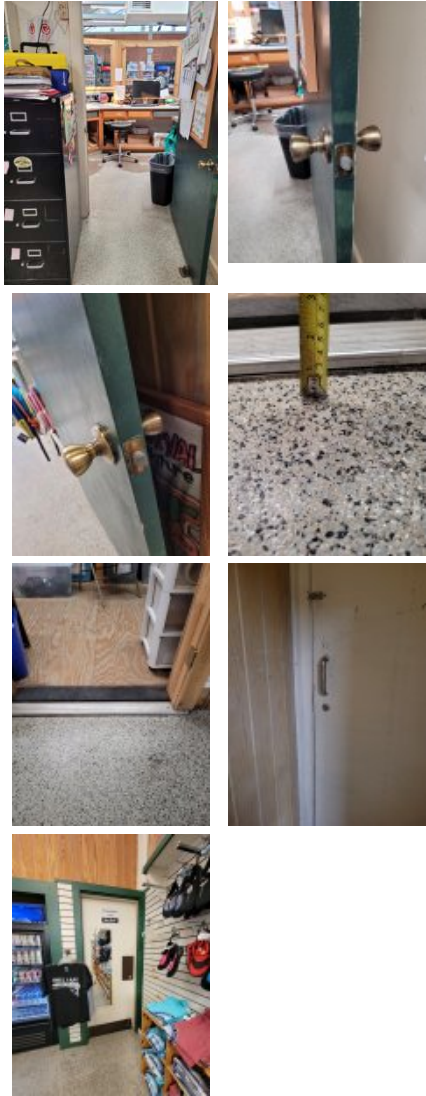
Finding Number	Area Description	Lat/Long	Finding	As Built	Recommendation	Citation	Photos	Figure
190	Park Store: Park Store Employee Spaces	[30.73737, -98.36903]	Spaces and elements within employee work areas shall only be required to comply with 206.2.8, 207.1, and 215.3 and shall be designed and constructed so that individuals with disabilities can approach, enter, and exit the employee work area. Employee work areas, or portions of employee work areas, other than raised courtroom stations, that are less than 300 square feet (28 m2) and elevated 7 inches (180 mm) or more above the finish floor or ground where the elevation is essential to the function of the space shall not be required to comply with these requirements or to be on an accessible route.	left door - clearance reduced on pull, knob hardware. right green door - knob hardware. door frame with no door, 1" step up. employee restroom door - no clearance on push or pull, 30" depth	For employee spaces, relocate storage, furniture, and other obstacles at doorways to provide approach, enter and exit at the employee space.	2015 ABAAS Section: F203.9 2012 TAS Section: 203.9 2010 ADAS Section: 203.9

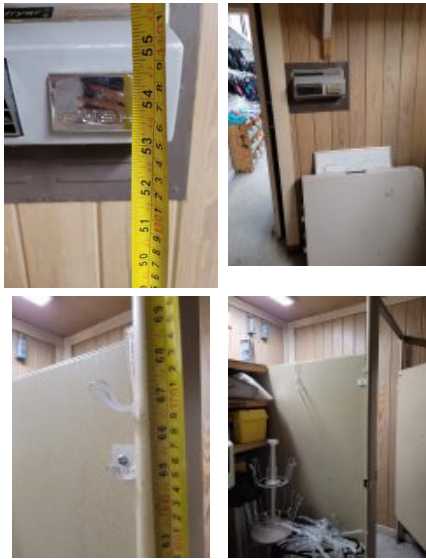
194	Park Store: Park Store Employee Spaces	[30.73737, -98.36903]	Where a high forward reach is over an obstruction, the clear floor space shall extend beneath the element for a distance not less than the required reach depth over the obstruction. The high forward reach shall be 48 inches (1220 mm) maximum where the reach depth is 20 inches (510 mm) maximum. Where the reach depth exceeds 20 inches (510 mm), the high forward reach shall be 44 inches (1120 mm) maximum and the reach depth shall be 25 inches (635 mm) maximum. Where a clear floor or ground space allows a parallel approach to an element and the high side reach is over an obstruction, the height of the obstruction shall be 34 inches (865 mm) maximum and the depth of the obstruction shall be 24 inches (610 mm) maximum. The high side reach shall be 48 inches (1220 mm) maximum for a reach depth of 10 inches (255 mm) maximum. Where the reach depth exceeds 10 inches (255 mm), the high side reach shall be 46 inches (1170 mm) maximum for a reach depth of 24 inches (610 mm) maximum.	hand dryer 53" aff, hooks 65" aff	Lower operating mechanisms in park store employee restroom to max 48" aff to highest operable part; leave as is if employee only operated	2015 ABAAS Section: 308.2.1, 308.3.2 2012 TAS Section: 308.2.1, 308.3.2 2010 ADAS Section: 308.2.1, 308.3.2

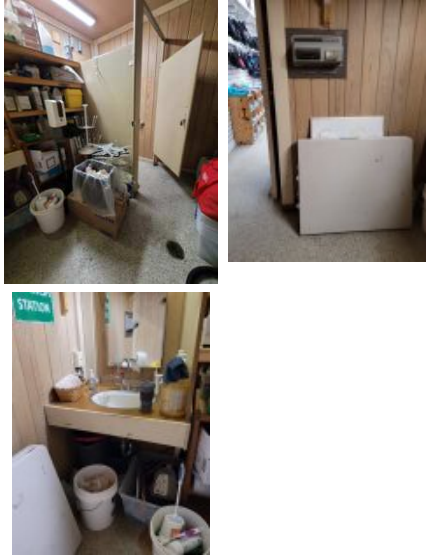
Finding Number	Area Description	Lat/Long	Finding	As Built	Recommendation	Citation	Photos	Figure
195	Park Store: Park Store Employee Spaces	[30.73737, -98.36903]	The operable part is not accessible because there is not adequate clear floor space for either a forward or side approach. The clear floor or ground space shall be 30 inches minimum by 48 inches minimum.	no CFS to hooks, hand dryers, or plug due to storage	Remove, or relocate storage in CFS at fixtures and operable parts along the AR	2015 ABAAS Section: 305.3 2012 TAS Section: 305.3 2010 ADAS Section: 305.3

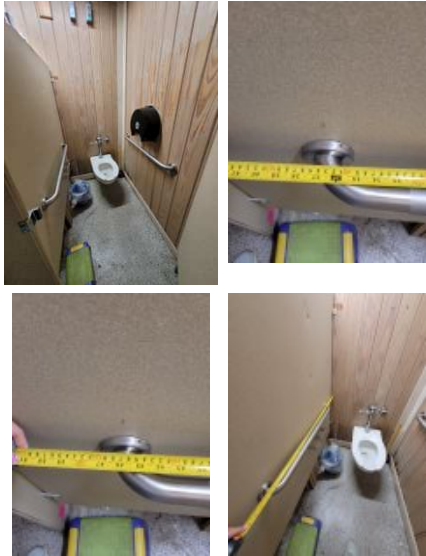
Finding Number	Area Description	Lat/Long	Finding	As Built	Recommendation	Citation	Photos	Figure
197	Park Store: Park Store Employee Spaces	[30.73737, -98.36903]	The side grab bars are not in the correct location. Grab bars on the side wall must be installed so that the end closest to the rear wall is maximum 12" from the rear wall. The end furthest from the rear wall must be mounted minimum 54" from the rear wall.	employee restroom - both grab bars extend 46" from rear wall to grab bar end and are 37" in length	Remount side grab bar to max 12" from the rear wall at the close end and min 54" on the far end, and 33" to 36" aff	2015 ABAAS Section: 604.5.1 2012 TAS Section: 604.5.1 2010 ADAS Section: 604.5.1

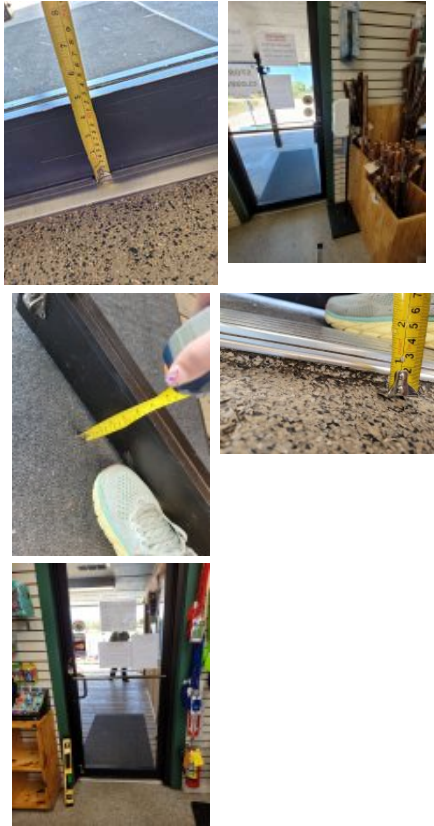
Finding Number	Area Description	Lat/Long	Finding	As Built	Recommendation	Citation	Photos	Figure
205	Park Store: Park Store Public Spaces	[30.73737, -98.36903]	Minimum maneuvering clearances at doors and gates shall comply with 404.2.4. Maneuvering clearances shall extend the full width of the doorway and the required latch side or hinge side clearance. The threshold has a vertical change greater than 1/4 inch high. The threshold at a doorway shall be no higher than 1/2 inch. Changes in level between 1/4 inch and 1/2 inch must be beveled at 1:2 or less. 1/4 inch is the maximum vertical rise. Exterior doors are recommended to be maintained at 8.5 lbf as a smart practice. Force is to be measured at the operating hardware or 30 inches from the hinges, whichever is greater. The bottom 10 inches on the push side must be smooth and free of obstructions (hold open devices). Opening hardware must be mounted between 30 and 44 inches above the floor or ground.	door to entry from lot - 5" at bottom, MC on push reduced by items. back door - 5" at bottom, 10# push, 1" CIL	For all doors along the public circulation route, provide required maneuvering clearance on push and pull side of doors For all doors along the public circulation route, repair, bevel, or ramp CILs at door entries to max .25" For all doors along the public circulation route, inspect, adjust, and maintain 8.5 lbf to open exterior doors as a smart practice For all doors along the public circulation route, provide kick plate on push side of door from floor to 10" aff	2010 ADAS Section: 404.2.3, 404.2.7, 404.2.4, 404.2.11, 404.2.11 Exception

<p>The photos show various views of door thresholds and interiors. Top-left: A yellow measuring tape is held vertically against a dark door threshold on a speckled floor. Top-right: An interior view of a doorway with a kick plate and a yellow measuring tape. Middle-left: A close-up of a hand holding a yellow measuring tape against a dark door threshold. Middle-right: A close-up of a yellow measuring tape against a door threshold. Bottom: A wider interior view of a doorway with a kick plate and a yellow measuring tape.</p>

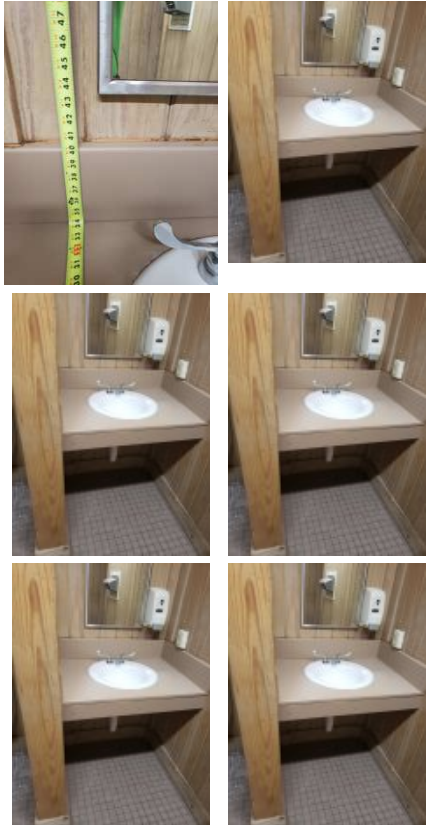
Finding Number	Area Description	Lat/Long	Finding	As Built	Recommendation	Citation	Photos	Figure
209	Park Store: Park Store Restroom	[30.73737, -98.36903]	The top rim of the sink is too high. All lavatories/sinks that are designated to be accessible shall be a minimum 17 inches in horizontal depth and mounted with the rim or counter edge no higher than 34 inches above the finished floor.	rim 34.5" AFF	Lower sinks to max 34" above the finished floor (AFF) to front of rim.	2015 ABAAS Section: 606.3 2012 TAS Section: 606.3 2010 ADAS Section: 606.3

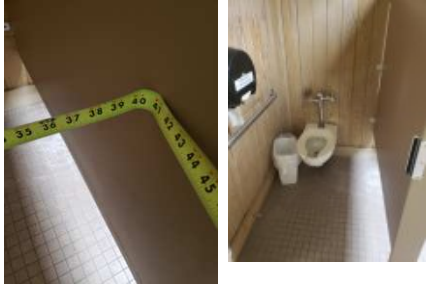
Finding Number	Area Description	Lat/Long	Finding	As Built	Recommendation	Citation	Photos	Figure
211	Park Store: Park Store Restroom	[30.73737, -98.36903]	The ambulatory stall is not between 35" to 37" wide and 60" deep.	40" wide	Correct ambulatory stall to be 35" to 37" wide and minimum 60" deep	2015 ABAAS Section: 604.8.2.1 2012 TAS Section: 604.8.2.1 2010 ADAS Section: 604.8.2.1

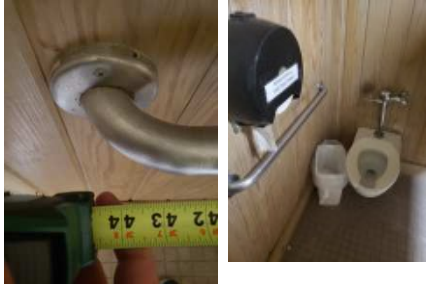
Finding Number	Area Description	Lat/Long	Finding	As Built	Recommendation	Citation	Photos	Figure
214	Park Store: Park Store Restroom	[30.73737, -98.36903]	The side grab bars are not in the correct location. Grab bars on the side wall must be installed so that the end closest to the rear wall is maximum 12" from the rear wall. The end furthest from the rear wall must be mounted minimum 54" from the rear wall.	side bar extends 44"	Replace side grab bar with a 42" long bar mounted to max 12" from the rear wall at the close end and min 54" on the far end, and 33" to 36" aff.	2015 ABAAS Section: 604.5.1 2012 TAS Section: 604.5.1 2010 ADAS Section: 604.5.1

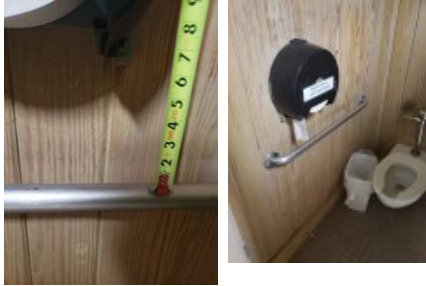
215	Park Store: Park Store Restroom	[30.73737, -98.36903]	The grab bar height and/or spacing fails. Grab bars must be mounted between 33" and 36" to the top of the gripping surface. There must be 1.5" of clearance between the grab bar and the wall. There must be a minimum of 1.5" of clearance below and minimum 12" above the grab bar to any dispenser or other obstruction.	toilet paper dispenser 7" above bar	Remount toilet paper dispenser max 7" to 9" from front of toilet, 15" to 48" above the finished floor (AFF) and min 12" above or 1.5" below grab bar.	2015 ABAAS Section: 609.3, 609.4 2012 TAS Section: 609.4, 609.3 2010 ADAS Section: 609.3, 609.4

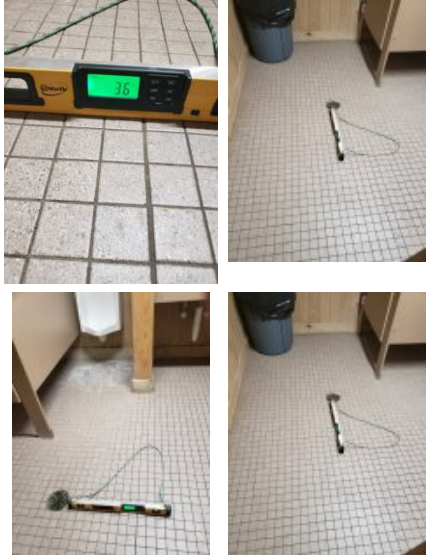
216	Park Store: Park Store Restroom	[30.73737, -98.36903]	The accessible route contains running slopes greater than 5 percent and cross slopes greater than 2 percent across the width of the walk and has not been constructed as a ramp (i.e. handrails, wheel guides, etc.). When the slope in the direction of travel of any walk exceeds 1 unit vertical in 20 units horizontal (5-percent slope), it must be constructed as ramp. Surface cross slopes must not exceed one unit vertical in 48 units. Horizontal (2-percent slope).	3.6% cross slope	Correct or repair slope to max 2.08% in restroom.	2015 ABAAS Section: 403.3 2012 TAS Section: 403.3 2010 ADAS Section: 403.3

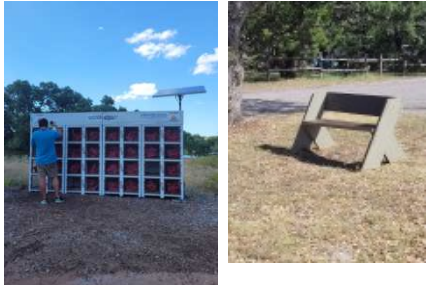
Finding Number	Area Description	Lat/Long	Finding	As Built	Recommendation	Citation	Photos	Figure
217	Park Amenities: Wood Vending near Dump Station	[30.741054, -98.3661949]	There is no accessible route to the wood storage and bench. At least one accessible route shall connect accessible buildings, accessible facilities, accessible elements, and accessible spaces that are on the same site.	no AR to wood vending or bench near dump station	Create an accessible route with crushed stone or other outdoor material from parking or walkway to wood lockers and bench	2015 ABAAS Section: F206.2.2 2012 TAS Section: 206.2.2 2010 ADAS Section: 206.2.2

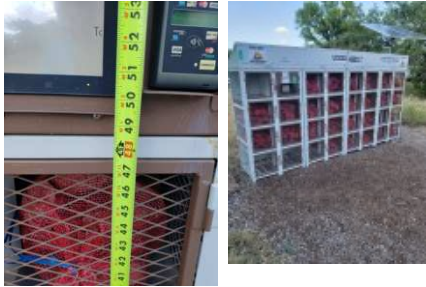
218	Park Amenities: Wood Vending near Dump Station	[30.7410551, -98.3661936]	The wood vending is too high and is out of the maximum reach range for a side approach. Where a clear floor or ground space allows a parallel approach to an element and the side reach is unobstructed, the high side reach shall be 48 inches maximum to the finished floor.	wood vending machine controls over 50" AFF	Lower operating mechanisms to max 48" aff to highest operable part; leave as is if employee only operated	2015 ABAAS Section: 308.3.1 2012 TAS Section: 308.3.1 2010 ADAS Section: 308.3.1

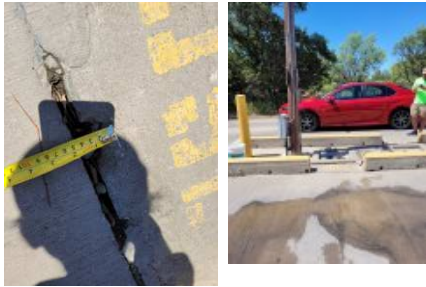
219	Park Amenities: Wood Vending near Dump Station	[30.7408661, -98.366565]	There is a gap spaced greater than a 1/2 inch. Openings in floor or ground surfaces shall not allow passage of a sphere more than 1/2 inch diameter. Elongated openings shall be placed so that the long dimension is perpendicular to the dominant direction of travel.	2" gap by hose	Correct or fill gaps to be max .5"	2015 ABAAS Section: 302.3 2012 TAS Section: 302.3 2010 ADAS Section: 302.3

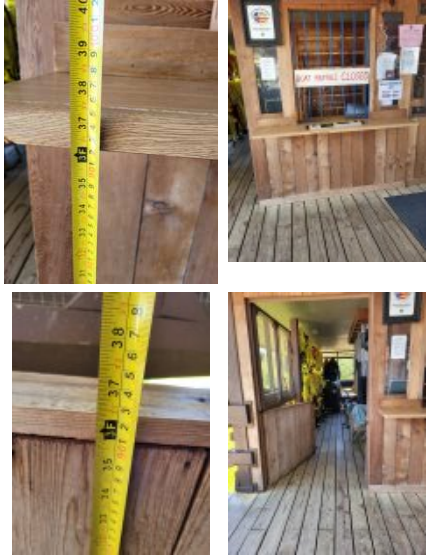
Finding Number	Area Description	Lat/Long	Finding	As Built	Recommendation	Citation	Photos	Figure
220	Park Amenities: Park Store: Watercraft Rental	[30.73737, -98.36903]	The transaction counter is too high. A portion of the counter surface that is 36 inches long minimum and 36 inches high maximum above the finish floor shall be provided. Knee and toe space must be provided for a forward approach. A 30 inch by 48 inch clear floor space on an accessible route must be provided for either a forward or parallel approach.	37" AFF, 36.5" AFF at half door	Lower 36" wide segment of service counter to max 36" aff	2015 ABAAS Section: 904.4.2, 904.4.1 2012 TAS Section: 904.4.1, 904.4.2 2010 ADAS Section: 904.4.2, 904.4.1

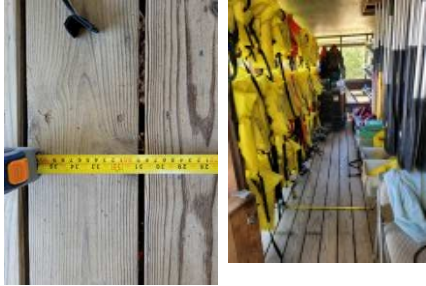
221	Park Amenities: Park Store: Watercraft Rental	[30.73737, -98.36903]	The route of travel at this location does not provide a minimum width of 36 inches. The clear width shall be permitted to be reduced to 32 inches minimum for a length of 24 inches maximum provided that reduced width segments are separated by segments that are 48 inches long minimum and 36 inches wide minimum.	34" width walking path due to PFD storage	Widen AR to compliant 36" clear width	2015 ABAAS Section: 403.5.1 2012 TAS Section: 403.5.1 2010 ADAS Section: 403.5.1
