Access Audit Site Report

Inks Lake State Park

Accessibility Evaluation

Inspection Date: 08/23/2021

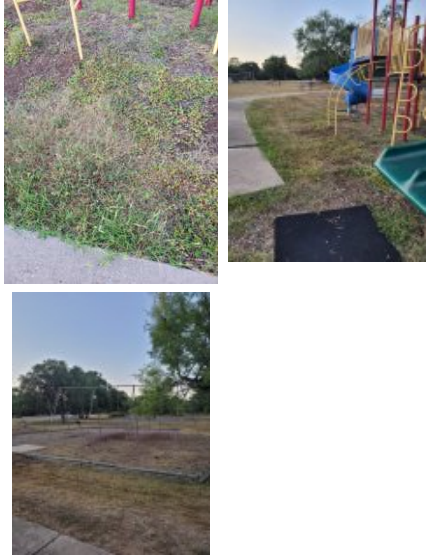
Finding Number	Area Description	Lat/Long	Finding	As Built	Recommendation	Citation	Photos	Figure
230	Park Amenities: Central Park Playground	[30.7415784 , -98.367164 5]	Compliance with ASTM F 1951 for accessibility for ground surfaces on accessible routes, clear floor or ground spaces, and turning spaces has not been determined. Ground surfaces shall comply with ASTM F 1951. Ground surfaces shall be inspected and maintained regularly and frequently to ensure continued compliance with ASTM F 1951.	central park playground - over grown and low fill	Establish protocols for regular and frequent inspection and maintenance of accessible playground surface Replace existing surface with an accessible surface such as EWF, PIP or tiles, with compliant slopes and CILs	2012 TAS Section: 1008.2.6.1 2010 ADAS Section: 1008.2.6.1

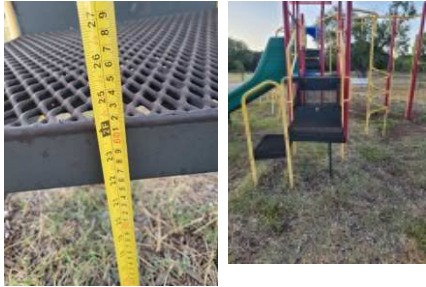
231	Park Amenities: Central Park Playground	[30.7415796 , -98.367147 1]	The transfer platform is not within the compliant range above the ground. The height of transfer platforms shall be 11 inches minimum and 18 inches maximum measured to the top of the surface from the ground or floor surface.	central park playground - 24" AFF	Lower platform on transfer system to 11" to 18" aff, in the alternative, add and maintain surface fill level to achieve the same	2012 TAS Section: 1008.3.1.2 2010 ADAS Section: 1008.3.1.2

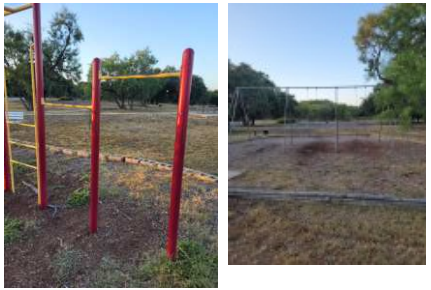
Finding Number	Area Description	Lat/Long	Finding	As Built	Recommendation	Citation	Photos	Figure																														
233	Park Amenities: Central Park Playground	[30.73737, -98.36903]	Element meets all standards and requirements	central park playground - one of each type of GLPCs complies	None	2010 ADAS Section: N/A																																
234	Park Amenities: Central Park Playground	[30.741583, -98.367156 5]	There are not enough accessible ground level play components based on the number of elevated play components. There should be a minimum of 3 accessible ground level play components of 3 types	central park playground - only two types provided, 3 swings and 2 climbers	Add one more GLPC of a type other than swings or climbers to meet incentive scoping	2012 TAS Section: 240.2.1.2 2010 ADAS Section: 240.2.1.2

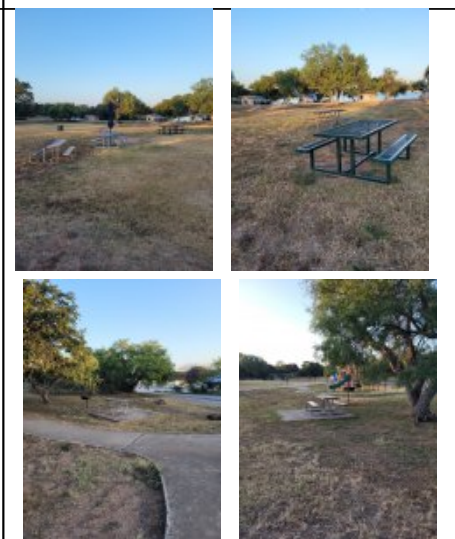
Finding Number	Area Description	Lat/Long	Finding	As Built	Recommendation	Citation	Photos	Figure
236	Park Amenities: Central Park Playground	[30.7415738 , -98.367147 1]	There is no accessible route to the park elements. At least one accessible route shall connect accessible buildings, accessible facilities, accessible elements, and accessible spaces that are on the same site.	central park playground - no AR to 2 benches, hot coal box, horse shoe game, drinking fountain	Create an accessible route with crushed stone or other outdoor material from parking or walkway to park elements.	2015 ABAAS Section: F206.2.2 2012 TAS Section: 206.2.2 2010 ADAS Section: 206.2.2

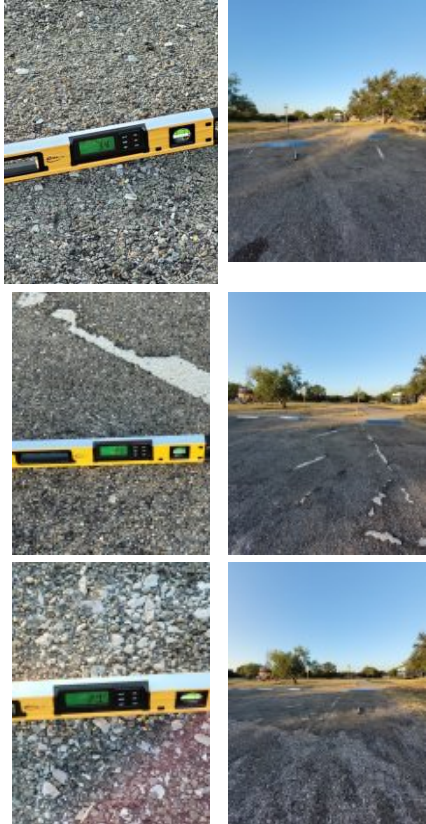
Finding Number	Area Description	Lat/Long	Finding	As Built	Recommendation	Citation	Photos	Figure
238	Park Amenities: Central Park Playground	[30.7418297 , -98.367317 4]	The parking stall contains abrupt edges and surface irregularities over a 1/4 inch vertical. Parking spaces and access aisles serving them shall be stable, firm, and slip resistant. Access aisles shall be at the same level as the parking spaces they serve. Changes in level are not permitted and shall not be sloped steeper than 2% in any direction.	central park playground parking - faded paint and loose gravel in all	Resurface accessible stalls and access aisles with a firm, stable, and slip resistant material Repaint stalls and access aisles to be 8' and 5' each	2015 ABAAS Section: 502.4 2012 TAS Section: 502.4 2010 ADAS Section: 502.4

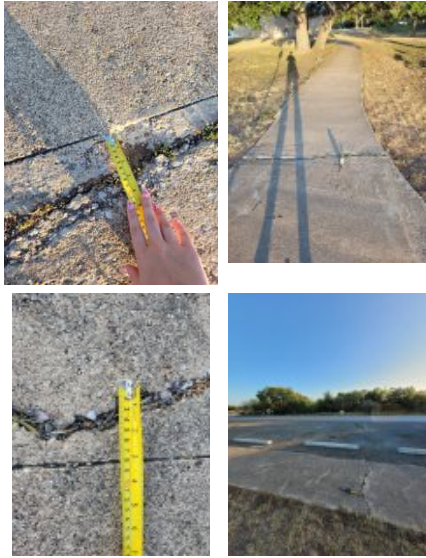
Finding Number	Area Description	Lat/Long	Finding	As Built	Recommendation	Citation	Photos	Figure
240	Park Amenities: Central Park Playground	[30.741809, -98.367376 4], [30.7417997 , -98.367794 8]	There is a gap spaced greater than a 1/2 inch. Openings in floor or ground surfaces shall not allow passage of a sphere more than 1/2 inch diameter. Elongated openings shall be placed so that the long dimension is perpendicular to the dominant direction of travel.	from central park playground parking to restroom building - 4" gap. along parking sidewalk - 1" gap	Correct or fill gaps to be max .5"	2015 ABAAS Section: 302.3 2012 TAS Section: 302.3 2010 ADAS Section: 302.3

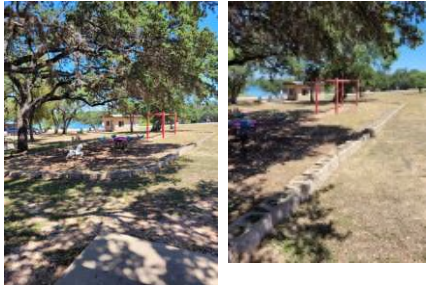
241	Park Amenities: Cabins Playground	[30.7395278 , -98.368724 2]	There is no accessible route to the play area. Accessible routes serving play areas shall comply with Chapter 4 and 1008.2 and shall be permitted to use the exceptions in 1008.2.1 through 1008.2.3. Where accessible routes serve ground level play components, the vertical clearance shall be 80 inches high (2030 mm) minimum.	cabins playground - no AR	Create an AR to the play area within the site	2015 ABAAS Section: F206.2.2 2012 TAS Section: 1008.2 2010 ADAS Section: 206.2.2

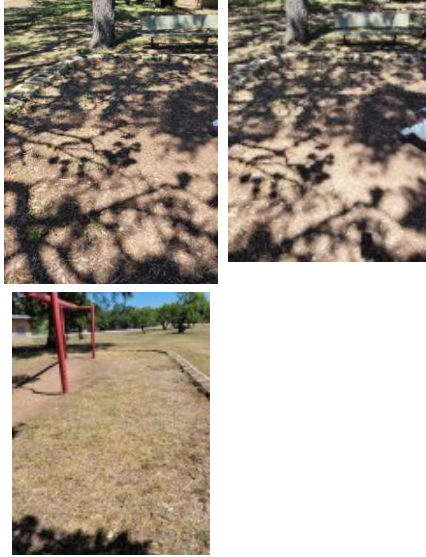
Finding Number	Area Description	Lat/Long	Finding	As Built	Recommendation	Citation	Photos	Figure
243	Park Amenities: Cabins Playground	[30.7395348 , -98.368700 1]	Compliance with ASTM F 1951 for accessibility for ground surfaces on accessible routes, clear floor or ground spaces, and turning spaces has not been determined. Ground surfaces shall comply with ASTM F 1951. Ground surfaces shall be inspected and maintained regularly and frequently to ensure continued compliance with ASTM F 1951.	cabins playground - low fill, not EWF, grass growing	Replace existing surface with an accessible surface such as EWF, PIP or tiles, with compliant slopes and CILs	2012 TAS Section: 1008.2.6.1 2010 ADAS Section: 1008.2.6.1

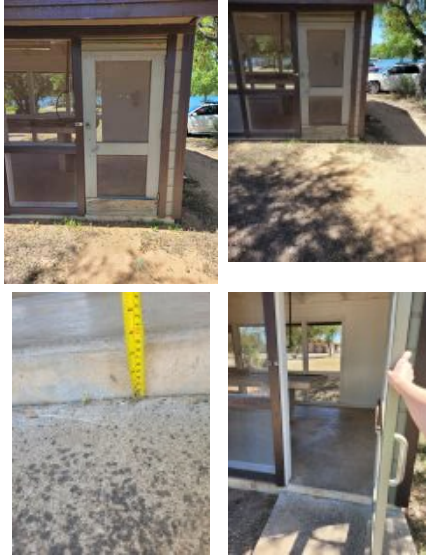
Finding Number	Area Description	Lat/Long	Finding	As Built	Recommendation	Citation	Photos	Figure
255	Park Amenities: North Fishing Pier Cleaning Station	[30.734011, -98.375278 2]	There is no accessible route to the fish cleaning building. At least one accessible route shall connect accessible buildings, accessible facilities, accessible elements, and accessible spaces that are on the same site.	north fishing pier - no AR from street facing side, parking side has 4" CIL	Create an accessible route with crushed stone or other outdoor material from parking or walkway to road facing fish cleaning entry door. For all doors along the public circulation route, fill and maintain gaps at doorways to max .5"	2015 ABAAS Section: F206.2.2 2012 TAS Section: 206.2.2 2010 ADAS Section: 206.2.2

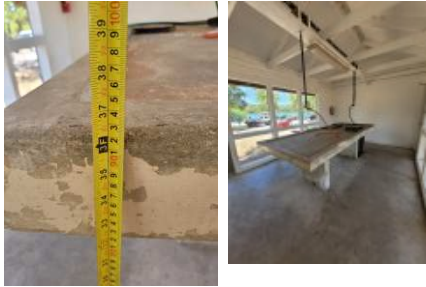
256	Park Amenities: North Fishing Pier Cleaning Station	[30.7435702 , -98.364727 7]	The top of the work surface is not within a compliant height range. The tops of tables and counters shall be 28 inches to 34 inches from the floor or ground.	north fishing pier - 36.5" AFF to fish cleaning surface	Provide tables and work surfaces at 28" to 34" aff with required knee and toe clearances	2015 ABAAS Section: 902.3 2012 TAS Section: 902.3 2010 ADAS Section: 902.3

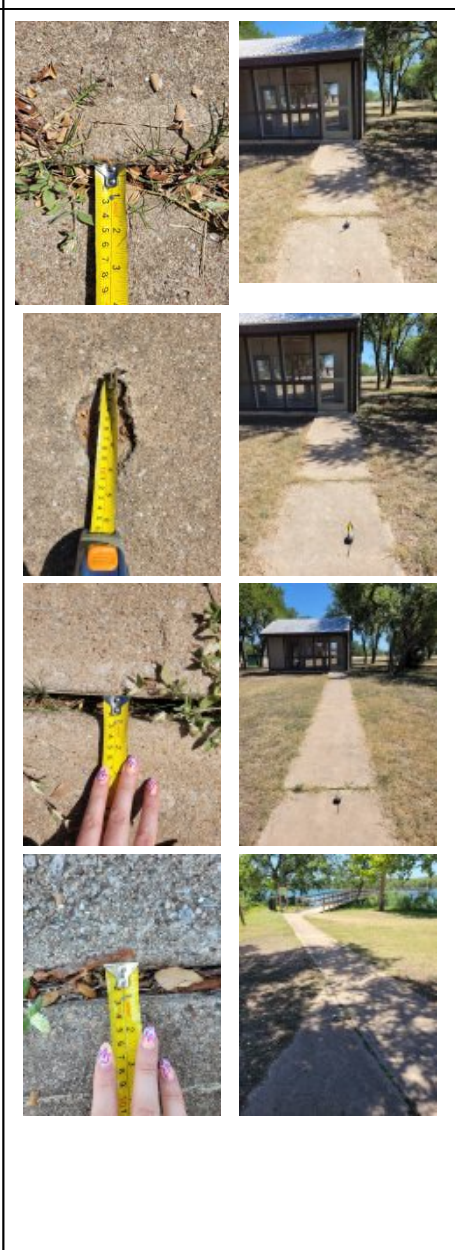
Finding Number	Area Description	Lat/Long	Finding	As Built	Recommendation	Citation	Photos	Figure
257	Park Amenities: North Fishing Pier Cleaning Station	[30.7435783 , -98.364710 3]	There is a gap spaced greater than a 1/2 inch. Openings in floor or ground surfaces shall not allow passage of a sphere more than 1/2 inch diameter. Elongated openings shall be placed so that the long dimension is perpendicular to the dominant direction of travel.	from parking to north fishing pier - 1" gap, 2 pavers down - 4" gap in cement, 3 pavers down - 1" gap, from fish clean to pier - 1" gap, pier to parking - 1" gap, to pier 1" gap	Correct or fill gaps to be max .5"	2015 ABAAS Section: 302.3 2012 TAS Section: 302.3 2010 ADAS Section: 302.3

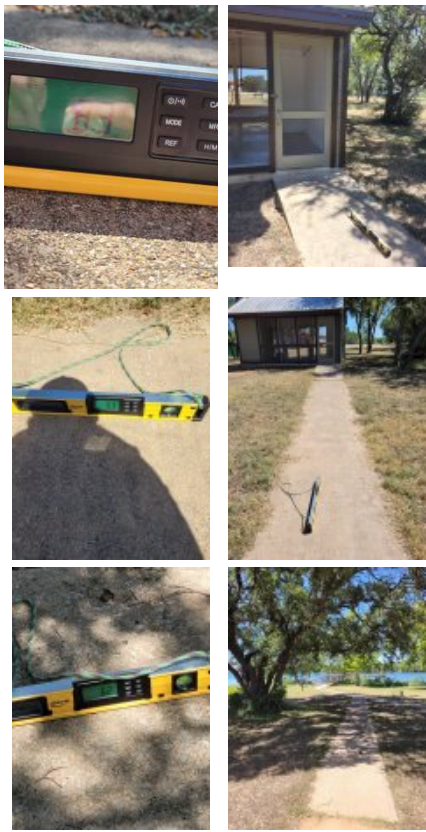
Finding Number	Area Description	Lat/Long	Finding	As Built	Recommendation	Citation	Photos	Figure
258	Park Amenities: North Fishing Pier Cleaning Station	[30.7439079 , -98.364982 5]	The running slope of walking surfaces shall not be steeper than 1:20.	north fishing pier - 8.3% slope outside of entry. 6.3% slope one paver down, 6.2% slope near trees	Correct running slope along the AR to max 5%	2015 ABAAS Section: 403.3 2012 TAS Section: 403.3 2010 ADAS Section: 403.3

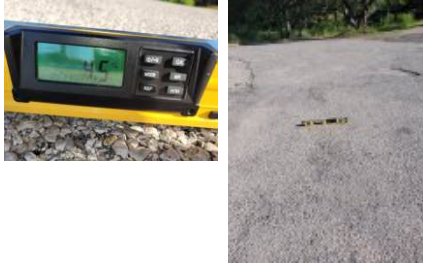
260	Park Amenities: South Fishing Pier	[30.7339833 , -98.375455 2]	The cross slopes (narrow dimension) and/or running slopes (long dimension) of the access aisle exceeds 2%. The running slope and the cross slope in an accessible parking stall and the access aisle must not exceed 2%.	south fishing pier - 4.5% slope in stall	Repair or correct slope of parking space and access aisle to max 2.08% in any direction	2015 ABAAS Section: 502.4 2012 TAS Section: 502.4 2010 ADAS Section: 502.4

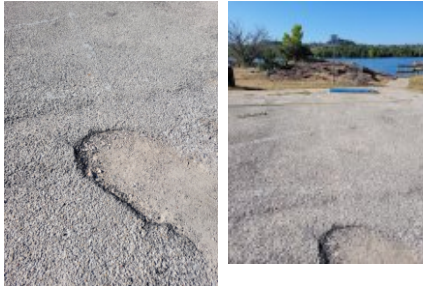
261	Park Amenities: South Fishing Pier	[30.7339868 , -98.375448 5]	The parking stall contains abrupt edges and surface irregularities over a 1/4 inch vertical. Parking spaces and access aisles serving them shall be stable, firm, and slip resistant. Access aisles shall be at the same level as the parking spaces they serve. Changes in level are not permitted and shall not be sloped steeper than 2% in any direction.	south fishing pier - faded paint, cracks in gravel, loose gravel	Resurface stalls and access aisles to eliminate gaps and cracks Repaint stalls and access aisles to be 8' and 5' each	2015 ABAAS Section: 502.4 2012 TAS Section: 502.4 2010 ADAS Section: 502.4

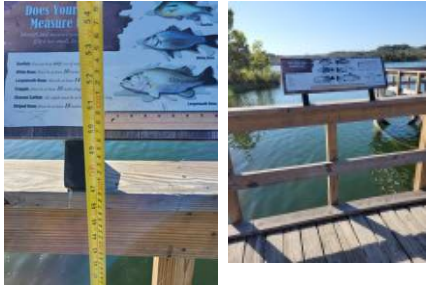
Finding Number	Area Description	Lat/Long	Finding	As Built	Recommendation	Citation	Photos	Figure
265	Park Amenities: South Fishing Pier	[30.733755, -98.375681 9]	The operable part is positioned too high for either a side or front approach. Where a clear floor or ground space allows a parallel approach to an element and the side reach is unobstructed, the high side reach shall be 48 inches maximum and the low side reach shall be 15 inches minimum above the finish floor or ground. Where a forward reach is unobstructed, the high forward reach shall be 48 inches maximum and the low forward reach shall be 15 inches minimum above the finish floor or ground.	South fishing pier - ruler to measure fish 51" AFF	Remount operable parts to be in reach range of 15" min to 48" max	2015 ABAAS Section: 308.1 2012 TAS Section: 308.1 2010 ADAS Section: 308.1

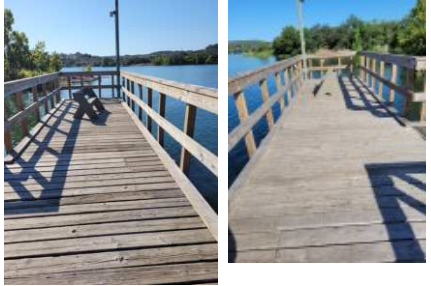
266	Park Amenities: South Fishing Pier	[30.73737, -98.36903]	Element meets all standards and requirements	CFS for benches on south pier comply	None	2010 ADAS Section: N/A

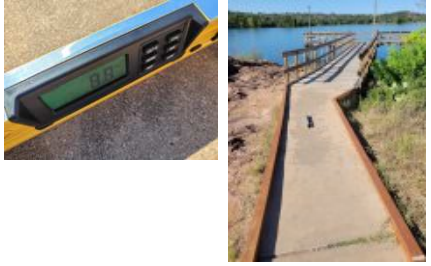
267	Park Amenities: South Fishing Pier	[30.7337666, -98.375681 9]	The running slope of walking surfaces shall not be steeper than 1:20.	South fishing pier - 8.8% slope on walkway to pier	Correct running slope along the AR to max 5%	2015 ABAAS Section: 403.3 2012 TAS Section: 403.3 2010 ADAS Section: 403.3

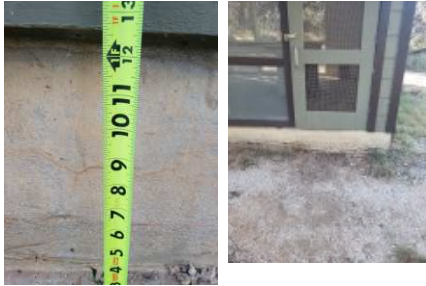
Finding Number	Area Description	Lat/Long	Finding	As Built	Recommendation	Citation	Photos	Figure
271	Park Amenities: South Fishing Pier Cleaning Station	[30.7340121 , -98.375279 5]	The threshold has a vertical change greater than 1/4 inch high. The threshold at a doorway shall be no higher than 1/2 inch. Changes in level between 1/4 inch and 1/2 inch must be beveled at 1:2 or less. 1/4 inch is the maximum vertical rise. The sweep period for doors with closers shall be adjusted so that from an open position of 70 degrees, the door will take at least 3 seconds to move to a point 3 inches from the latch, measured to the leading edge of the door.	fish cleaning hut door on left - fast close, 12.5" CIL; fish cleaning hut door on right - fast close	For all doors along the public circulation route, repair, bevel, or ramp CILs at door entries to max .25" For all doors along the public circulation route, inspect, adjust, and maintain closing speed on door closers	2010 ADAS Section: 404.2.3, 404.2.7, 404.2.4, 404.2.11, 404.2.11 Exception

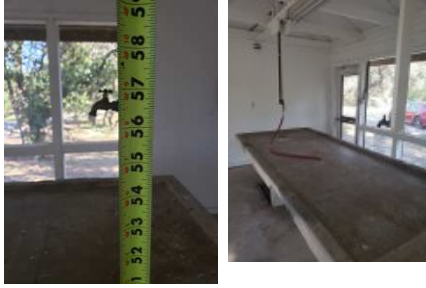
273	Park Amenities: South Fishing Pier Cleaning Station	[30.7340087 , -98.375271 5]	The water spigot is positioned too high for either a side or front approach. Where a clear floor or ground space allows a parallel approach to an element and the side reach is unobstructed, the high side reach shall be 48 inches maximum and the low side reach shall be 15 inches minimum above the finish floor or ground. Where a forward reach is unobstructed, the high forward reach shall be 48 inches maximum and the low forward reach shall be 15 inches minimum above the finish floor or ground.	south pier, fish cleaning - Water spigot is 57" AFF, over obstruction	Remount operable parts to be in reach range of 15" min to 48" max	2015 ABAAS Section: 308.1 2012 TAS Section: 308.1 2010 ADAS Section: 308.1

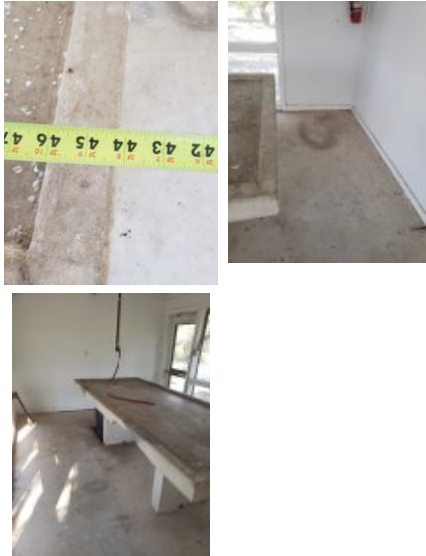
Finding Number	Area Description	Lat/Long	Finding	As Built	Recommendation	Citation	Photos	Figure
274	Park Amenities: South Fishing Pier Cleaning Station	[30.7340006 , -98.3752809]	There is insufficient turning space within this room or space. The space required for a wheelchair to make a 180-degree turn is a clear space of 60 inches in diameter or a T-shaped space.	south pier, fish cleaning - no T shaped space	Relocate obstacles to create turning space in fish cleaning	2015 ABAAS Section: 304.3.1, 304.3.2 2012 TAS Section: 304.3.1, 304.3.2 2010 ADAS Section: 304.3.1, 304.3.2

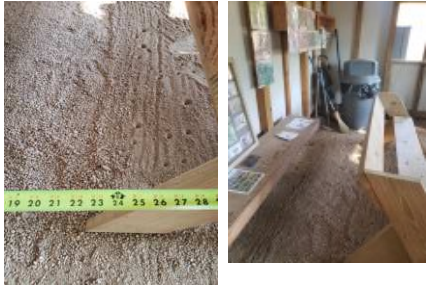
275	Park Amenities: Wildlife Viewing Station	[30.7471444 , -98.3686223]	The route of travel at this location does not provide a minimum width of 36 inches. The clear width shall be permitted to be reduced to 32 inches minimum for a length of 24 inches maximum provided that reduced width segments are separated by segments that are 48 inches long minimum and 36 inches wide minimum.	28" width within	Widen AR to compliant 36" clear width	2015 ABAAS Section: 403.5.1 2012 TAS Section: 403.5.1 2010 ADAS Section: 403.5.1

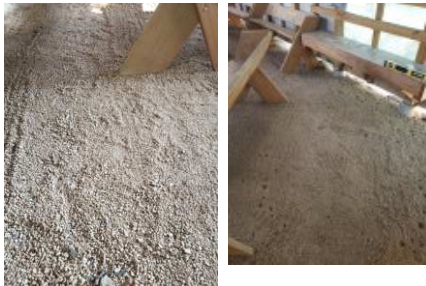
276	Park Amenities: Wildlife Viewing Station	[30.7471306 , -98.3686143]	The floor surface does not appear to be firm, stable and slip resistant. Floor and ground surfaces shall be stable, firm, and slip resistant	loose gravel surface, possible crusher fines but would need maintenance	Resurface or repair floors to be firm, stable and slip resistant.	2015 ABAAS Section: 302.1 2012 TAS Section: 302.1 2010 ADAS Section: 302.1, 302

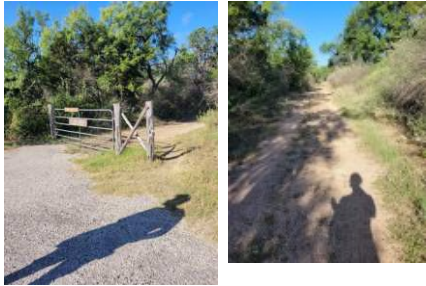
Finding Number	Area Description	Lat/Long	Finding	As Built	Recommendation	Citation	Photos	Figure
277	Park Amenities: Wildlife Viewing Station	[30.7469185 , -98.3681167]	There is no accessible route to the wildlife viewing area. At least one accessible route shall connect accessible buildings, accessible facilities, accessible elements, and accessible spaces that are on the same site.	no AR to wildlife viewing due to gravel	Create an accessible route with crushed stone or other outdoor material from parking or walkway to bird blind	2015 ABAAS Section: F206.2.2 2012 TAS Section: 206.2.2 2010 ADAS Section: 206.2.2

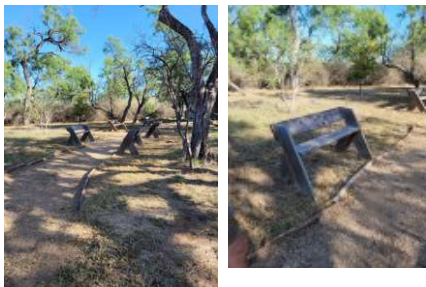
278	Park Amenities: Wildlife Viewing Station	[30.73737, -98.36903]	There is no accessible route to the bench. At least one accessible route shall connect accessible buildings, accessible facilities, accessible elements, and accessible spaces that are on the same site.	0 of 5 benches on AR	Create an accessible route with crushed stone or other outdoor material from parking or walkway to bench	2015 ABAAS Section: F206.2.2 2012 TAS Section: 206.2.2 2010 ADAS Section: 206.2.2

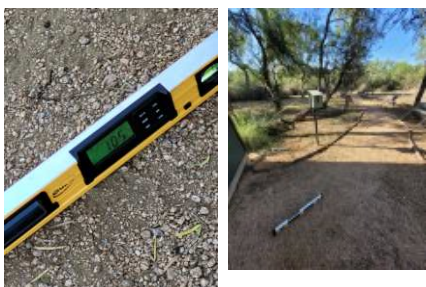
279	Park Amenities: Wildlife Viewing Station	[30.7470799 , -98.3686505]	The running slope of walking surfaces shall not be steeper than 1:20.	slope to building 10.5% slope	Correct running slope along the AR to max 5%	2015 ABAAS Section: 403.3 2012 TAS Section: 403.3 2010 ADAS Section: 403.3

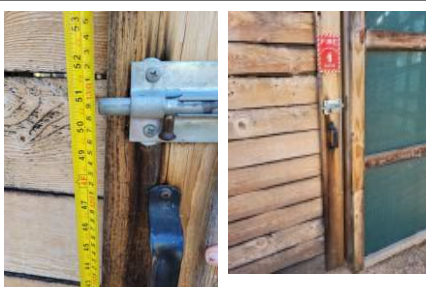
280	Park Amenities: Wildlife Viewing Station	[30.7470983 , -98.3686223]	The door operating hardware is not located within the compliant range. Hand-activated door opening hardware, handles, pulls, latches, locks, and other operating devices on accessible doors shall have a shape that is easy to grasp with one hand and does not require tight grasping, tight pinching or twisting of the wrist to operate. Hardware shall be centered between 34 inches and 48 inches above the floor.	lock height 51" AFF	For all doors along the public circulation route, replace hardware with lever hardware where indicated, mounted 34" to 48" aff	2015 ABAAS Section: 404.2.7 2012 TAS Section: 404.2.7 2010 ADAS Section: 404.2.7

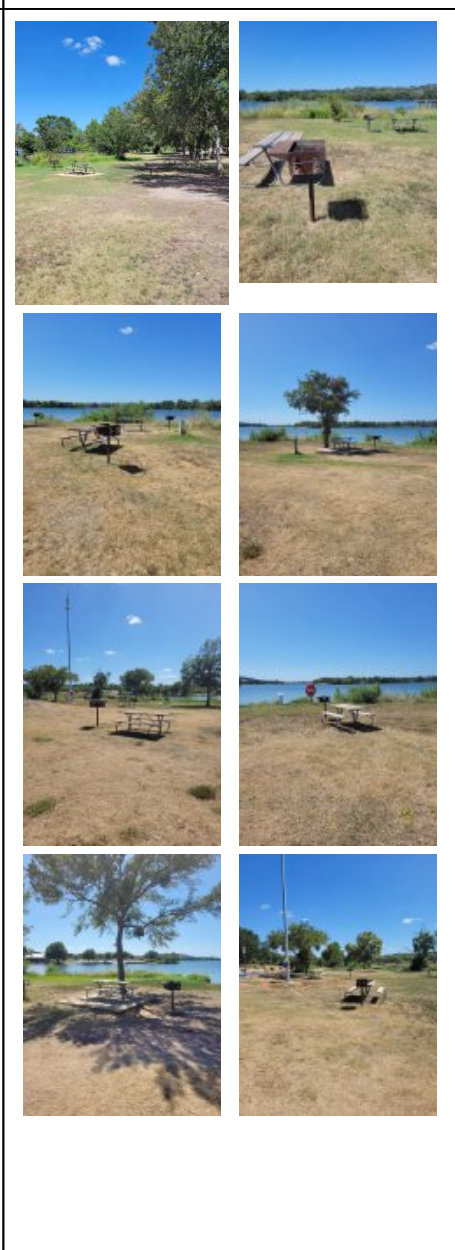
Finding Number	Area Description	Lat/Long	Finding	As Built	Recommendation	Citation	Photos	Figure
286	Park Amenities: Picnic Area	[30.7436889 , -98.365714 8]	There is no accessible route to the picnic elements. At least one accessible route shall connect accessible buildings, accessible facilities, accessible elements, and accessible spaces that are on the same site.	picnic area near 281 - 0 of 24 tables on AR, 0 of 22 grills on AR, 0 of 4 water spigot on AR	Create an accessible route with crushed stone or other outdoor material from parking or walkway to picnic elements	2015 ABAAS Section: F206.2.2 2012 TAS Section: 206.2.2 2010 ADAS Section: 206.2.2

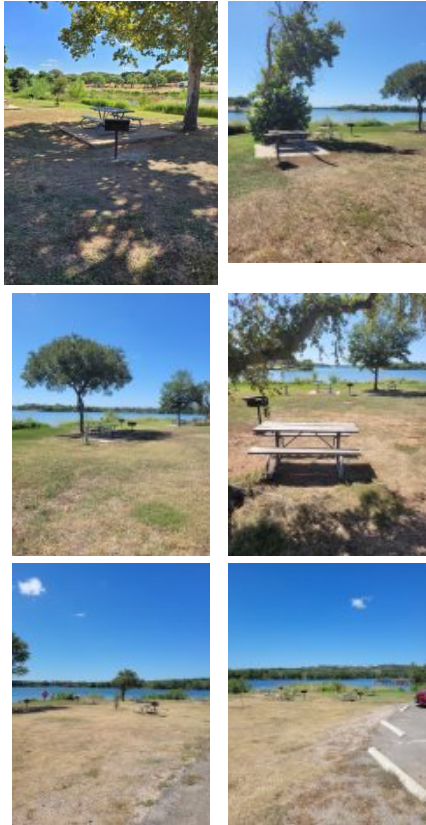
Finding Number	Area Description	Lat/Long	Finding	As Built	Recommendation	Citation	Photos	Figure
288	Park Amenities: Devils Water Hole Picnic Area	[30.7459089 , -98.360227]	There is no accessible route to the picnic area. At least one accessible route shall connect accessible buildings, accessible facilities, accessible elements, and accessible spaces that are on the same site.	Devils Water Hole Picnic Area - 0 of 3 picnic tables on AR	Create an accessible route with crushed stone or other outdoor material from parking or walkway to picnic tables	2015 ABAAS Section: F206.2.2 2012 TAS Section: 206.2.2 2010 ADAS Section: 206.2.2

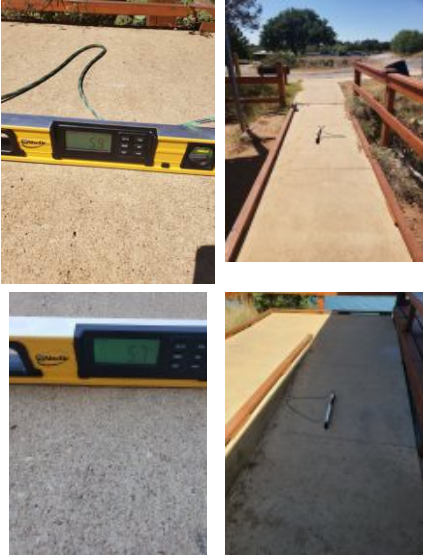
Finding Number	Area Description	Lat/Long	Finding	As Built	Recommendation	Citation	Photos	Figure
290	Park Amenities: Pavilion By Boat Ramp	[30.7433777 , -98.367941]	Picnic facilities shall provide outdoor recreation access routes complying with 1016 in accordance with F245.4 and 245.4 of IAC	5.9% running slope on AR	Correct or repair sidewalk running slope along AR to max 5%	2015 ABAAS Section: F245.4

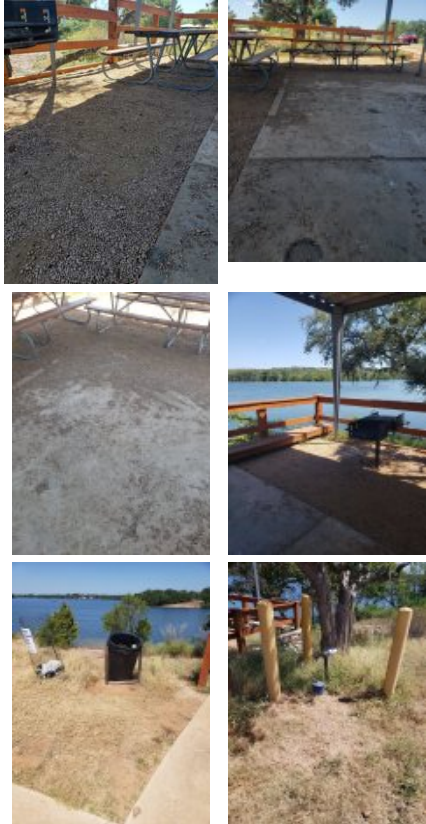
Finding Number	Area Description	Lat/Long	Finding	As Built	Recommendation	Citation	Photos	Figure
292	Park Amenities: Cabins	[30.7390414 , -98.369083 6]	The accessible route of travel contains cross slopes greater than 2%. Cross slopes shall not exceed one unit vertical in 48 units horizontal (2-percent slope).	cabin 17 - 2.4% cross slope to picnic table platform. 2.3% slope to cabin	Correct or repair cross slope along AR to max 2.08%.	2015 ABAAS Section: 403.3 2012 TAS Section: 403.3 2010 ADAS Section: 403.3

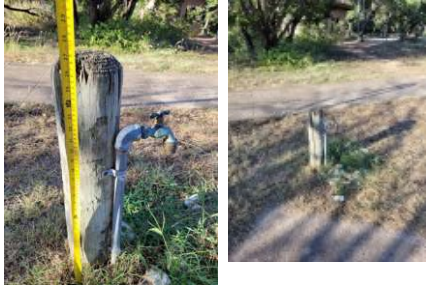
294	Park Amenities: Cabins	[30.7390898 , -98.369031 3]	Water spouts at water hydrants and water utility hook-ups shall be 28 inches (710 mm) minimum and 36 inches (915 mm) maximum above the ground	cabin 17 - water spout 21" agl, no AR	Remount water spouts to 28" min or 36" max above the ground as a smart practice	2015 ABAAS Section: 1011.6

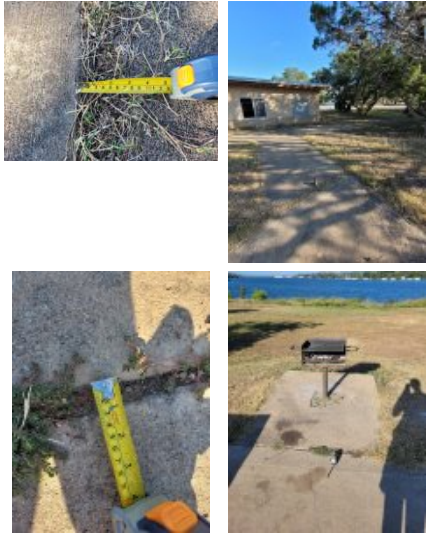
Finding Number	Area Description	Lat/Long	Finding	As Built	Recommendation	Citation	Photos	Figure
298	Park Amenities: Cabins	[30.7390714 , -98.3690729]	There is a gap spaced greater than a 1/2 inch. Openings in floor or ground surfaces shall not allow passage of a sphere more than 1/2 inch diameter. Elongated openings shall be placed so that the long dimension is perpendicular to the dominant direction of travel.	cabin 17 - 3.5" gap to picnic platform from back walkway, 1" gap to grill	Correct or fill gaps to be max .5"	2015 ABAAS Section: 302.3 2012 TAS Section: 302.3 2010 ADAS Section: 302.3

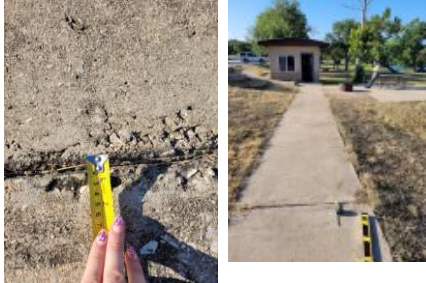
299	Park Amenities: Cabins	[30.7416119 , -98.3681543]	The surface of the outdoor recreation access route, passing spaces, and/or resting intervals are not firm and stable. The surface of outdoor recreation access route, passing spaces, and resting intervals shall be firm and stable, having a width of 36", max gaps of .5" and tread obstacles of .5" or less.	cabin 1 - 1.5" gap along entry	Correct surface of ORAR to be firm and stable, a min 36" wide and having gaps and changes in level of max .5"	2015 ABAAS Section: 1016.2

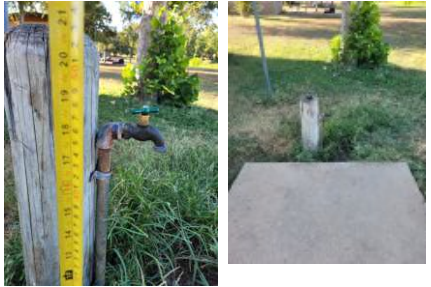
302	Park Amenities: Cabins	[30.7416061 , -98.368217 3]	Water spouts at water hydrants and water utility hook-ups shall be 28 inches (710 mm) minimum and 36 inches (915 mm) maximum above the ground	cabin 1 - spout 16" agl	Remount water spouts to 28" min or 36" max above the ground as a smart practice	2015 ABAAS Section: 1011.6

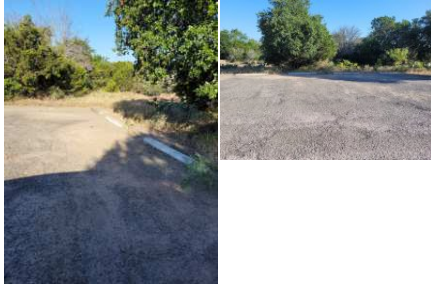
303	Park Amenities: Cabins	[30.7356121 , -98.371897 3]	There are no accessible parking stalls. Each lot where parking is provided for the public as clients, guests or employees, shall provide accessible parking and shall be located on the shortest accessible route of travel from adjacent parking to an accessible entrance. There are a total of 5 parking stalls in the parking lot that could be reasonably associated with this facility. There should be a minimum of 1 accessible stalls with a minimum of 1 being designed as van accessible.	0 of 5 accessible stalls at small lot by 300-304 camp entry	Create one or more 8' accessible parking stalls, with one 5' adjacent access aisle, with proper signage and striping based on the total number of stalls	2015 ABAAS Section: F208.2 2012 TAS Section: 208.2 2010 ADAS Section: 208.2

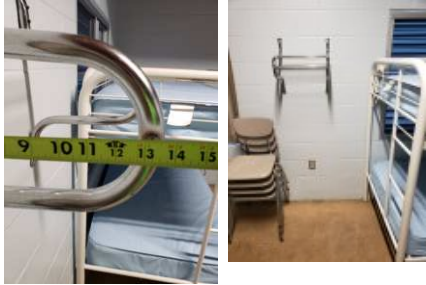
Finding Number	Area Description	Lat/Long	Finding	As Built	Recommendation	Citation	Photos	Figure
304	Park Amenities: Cabins	[30.73737, -98.36903]	The towel rack projects more than 4 inches into the circulation path. Wall-mounted objects that have leading edges between 27 inches and 80 inches from the floor must not project more than 4 inches into the circulation path. Protruding objects that extend to the floor or within 27 inches of the floor are cane detectable and are therefore not hazardous. Where it is necessary or desirable to have objects protrude from the wall, a manner of cane detection must be provided.	cabin 17 - towel rack projects 13.5"	Relocate protruding objects or place cane detectable warning or bollard at foot of item	2015 ABAAS Section: 307.2 2012 TAS Section: 307.2 2010 ADAS Section: 307.2

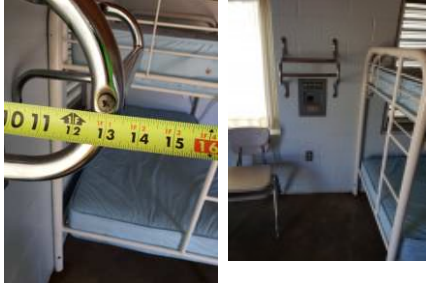
305	Park Amenities: Cabins	[30.73737, -98.36903]	The towel rack projects more than 4 inches into the circulation path. Wall-mounted objects that have leading edges between 27 inches and 80 inches from the floor must not project more than 4 inches into the circulation path. Protruding objects that extend to the floor or within 27 inches of the floor are cane detectable and are therefore not hazardous. Where it is necessary or desirable to have objects protrude from the wall, a manner of cane detection must be provided.	cabin 1 - towel rack projects 13.5"	Relocate protruding objects or place cane detectable warning or bollard at foot of item	2015 ABAAS Section: 307.2 2012 TAS Section: 307.2 2010 ADAS Section: 307.2

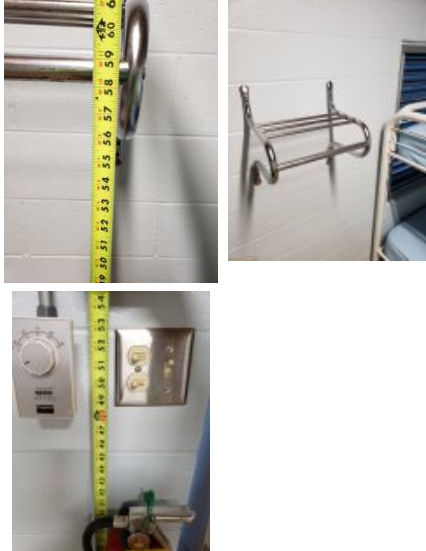
306	Park Amenities: Cabins	[30.73737, -98.36903]	The towel rack, light switch, and thermostat are positioned too high for either a side or front approach. Where a clear floor or ground space allows a parallel approach to an element and the side reach is unobstructed, the high side reach shall be 48 inches maximum and the low side reach shall be 15 inches minimum above the finish floor or ground. Where a forward reach is unobstructed, the high forward reach shall be 48 inches maximum and the low forward reach shall be 15 inches minimum above the finish floor or ground.	cabin 17 - towel rack - 58" AFF, light switch and thermostat above 50" AFF	Remount operable parts to be in reach range of 15" min to 48" max	2015 ABAAS Section: 308.1 2012 TAS Section: 308.1 2010 ADAS Section: 308.1

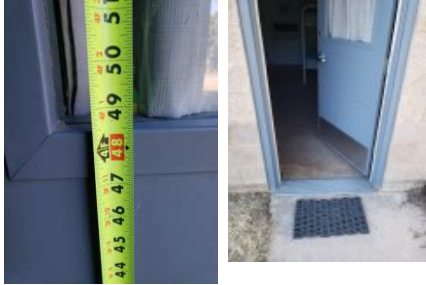
Finding Number	Area Description	Lat/Long	Finding	As Built	Recommendation	Citation	Photos	Figure
308	Park Amenities: Cabins	[30.73737, -98.36903]	<p>Door openings shall provide a clear width of 32 inches (815 mm) minimum. Clear openings of doorways with swinging doors shall be measured between the face of the door and the stop, with the door open 90 degrees. Openings more than 24 inches (610 mm) deep shall provide a clear opening of 36 inches (915 mm) minimum. There shall be no projections into the required clear opening width lower than 34 inches (865 mm) above the finish floor or ground. Projections into the clear opening width between 34 inches (865 mm) and 80 inches (2030 mm) above the finish floor or ground shall not exceed 4 inches (100 mm). Doors, gates, and side lights adjacent to doors or gates, containing one or more glazing panels that permit viewing through the panels shall have the bottom of at least one glazed panel located 43 inches (1090 mm) maximum above the finish floor. EXCEPTION: Vision lights with the lowest part more than 66 inches (1675 mm) from the finish floor or ground shall not be required to comply with 404.2.11.</p>	cabin 17 - window 48.5" AFF, unsecured mat on push side.	For all doors along the public circulation route, replace doors with ones having sidelight viewing windows max 43" aff For all doors along the public circulation route, remove or secure mat to prevent trip hazard	2010 ADAS Section: 404.2.3, 404.2.7, 404.2.4, 404.2.11, 404.2.11 Exception

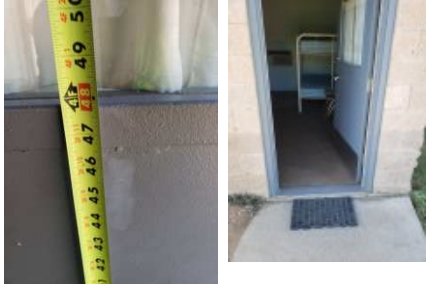
Finding Number	Area Description	Lat/Long	Finding	As Built	Recommendation	Citation	Photos	Figure
309	Park Amenities: Cabins	[30.73737, -98.36903]	Door openings shall provide a clear width of 32 inches (815 mm) minimum. Clear openings of doorways with swinging doors shall be measured between the face of the door and the stop, with the door open 90 degrees. Openings more than 24 inches (610 mm) deep shall provide a clear opening of 36 inches (915 mm) minimum. There shall be no projections into the required clear opening width lower than 34 inches (865 mm) above the finish floor or ground. Projections into the clear opening width between 34 inches (865 mm) and 80 inches (2030 mm) above the finish floor or ground shall not exceed 4 inches (100 mm). Doors, gates, and side lights adjacent to doors or gates, containing one or more glazing panels that permit viewing through the panels shall have the bottom of at least one glazed panel located 43 inches (1090 mm) maximum above the finish floor. EXCEPTION: Vision lights with the lowest part more than 66 inches (1675 mm) from the finish floor or ground shall not be required to comply with 404.2.11.	cabin 1 - window 48" AFF, unsecured mat on push side	For all doors along the public circulation route, replace doors with ones having sidelight viewing windows max 43" aff For all doors along the public circulation route, remove or secure mat to prevent trip hazard	2010 ADAS Section: 404.2.3, 404.2.7, 404.2.4, 404.2.11, 404.2.11 Exception

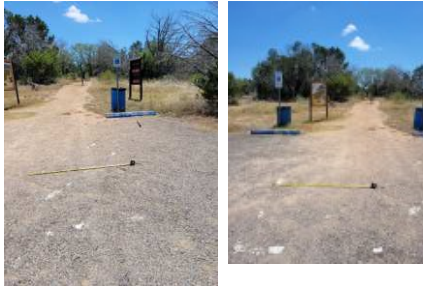
315	Park Amenities: Trailheads	[30.7368859, -98.3701431]	The access aisle is not a minimum 5 feet wide. A car accessible parking stall's access aisle must be a minimum of 5 feet wide measured from centerline to centerline. Where the access aisle is not adjacent to another parking space or access aisle, measurements shall be permitted to include the full width of the line defining the access aisle.	lot to pecan flat trail and amphitheater - lacks paint	Repaint access aisles to be 5' each	2015 ABAAS Section: 502.3.1 2012 TAS Section: 502.3.1 2010 ADAS Section: 502.3.1

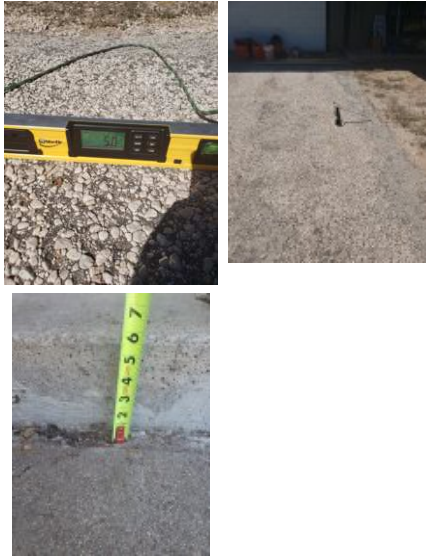
Finding Number	Area Description	Lat/Long	Finding	As Built	Recommendation	Citation	Photos	Figure
320	Employee Other: Residence	[30.7391498 , -98.3673188]	Employee residence has paved driveway with slope exceeding 2.08%. There is a change in level to enter the residence.	assistant super residence - slope on drive, step to porch	Leave as is employee residence until either renovations are made or an employee with a disability needs changes made.	Capture Section: 1

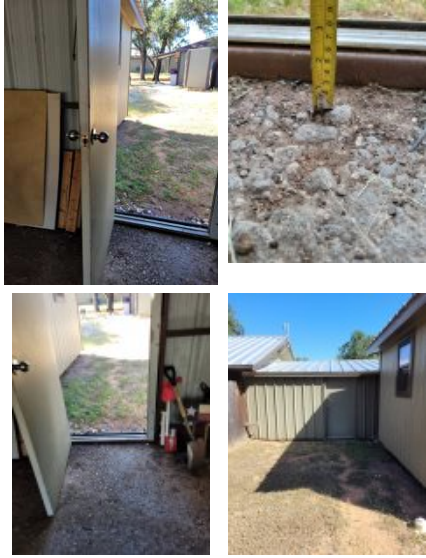
Finding Number	Area Description	Lat/Long	Finding	As Built	Recommendation	Citation	Photos	Figure
322	Employee Other: Maintenance	[30.73737, -98.36903]	Minimum maneuvering clearances at doors and gates shall comply with 404.2.4. Maneuvering clearances shall extend the full width of the doorway and the required latch side or hinge side clearance.	Maintenance screen doors: parking lot side- loose mat, no clear floor space on pull side; rear screen door- no accessible route	Provide required maneuvering clearance around pull side of door Relocate storage, furniture and other obstacles to create 60" maneuvering clearance around door	2015 ABAAS Section: 404.2.4.1, 404.2.4.4 2012 TAS Section: 404.2.4.4, 404.2.4.1 2010 ADAS Section: 404.2.4.4, 404.2.4.1

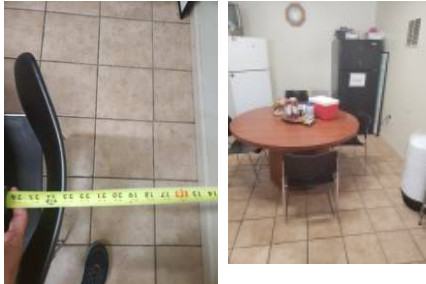
323	Employee Other: Maintenance	[30.73737, -98.36903]	The route of travel at this location does not provide a minimum width of 36 inches. The clear width shall be permitted to be reduced to 32 inches minimum for a length of 24 inches maximum provided that reduced width segments are separated by segments that are 48 inches long minimum and 36 inches wide minimum.	access to refrigerators is reduced to 23"	Widen AR to compliant 36" clear width	2015 ABAAS Section: 403.5.1 2012 TAS Section: 403.5.1 2010 ADAS Section: 403.5.1

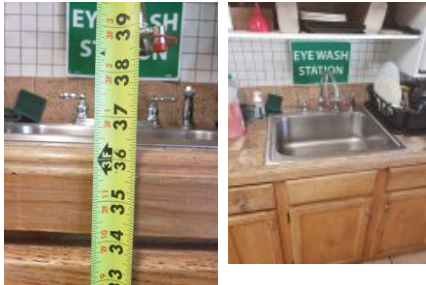
324	Employee Other: Maintenance	[30.73737, -98.36903]	The top rim of the sink is too high. All lavatories/sinks that are designated to be accessible shall be a minimum 17 inches in horizontal depth and mounted with the rim or counter edge no higher than 34 inches above the finished floor.	sink 36.5"	Lower sinks to max 34" aff to front of rim	2015 ABAAS Section: 606.3 2012 TAS Section: 606.3 2010 ADAS Section: 606.3

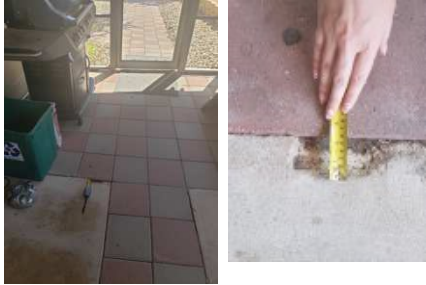
Finding Number	Area Description	Lat/Long	Finding	As Built	Recommendation	Citation	Photos	Figure
329	Employee Other: Maintenance	[30.73737, -98.36903]	Openings in floor or ground surfaces shall not allow passage of a sphere more than 1/2 inch (13 mm) diameter except as allowed in 407.4.3, 409.4.3, 410.4, 810.5.3 and 810.10. Elongated openings shall be placed so that the long dimension is perpendicular to the dominant direction of travel.	2" gap	Fill and maintain gaps to max .5"	2015 ABAAS Section: 302.3 2012 TAS Section: 302.3 2010 ADAS Section: 302.3

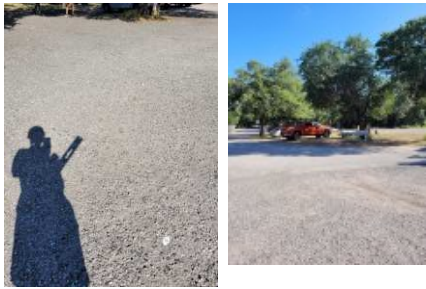
331	Employee Other: Maintenance	[30.73737, -98.36903]	There are no or not enough accessible parking stalls. Each lot where parking is provided for the public as clients, guests or employees, shall provide accessible parking and shall be located on the shortest accessible route of travel from adjacent parking to an accessible entrance. There are less than 25 parking stalls in the parking lot that could be reasonably associated with this facility. There should be a minimum of 1 accessible stalls with a minimum of 1 being designed as van accessible.	gravel lot, no marked stalls	Create one or more 8' accessible parking stalls, with one 5' adjacent access aisle, with proper signage and striping based on the total number of stalls.	2015 ABAAS Section: F208.2 2012 TAS Section: 208.2 2010 ADAS Section: 208.2

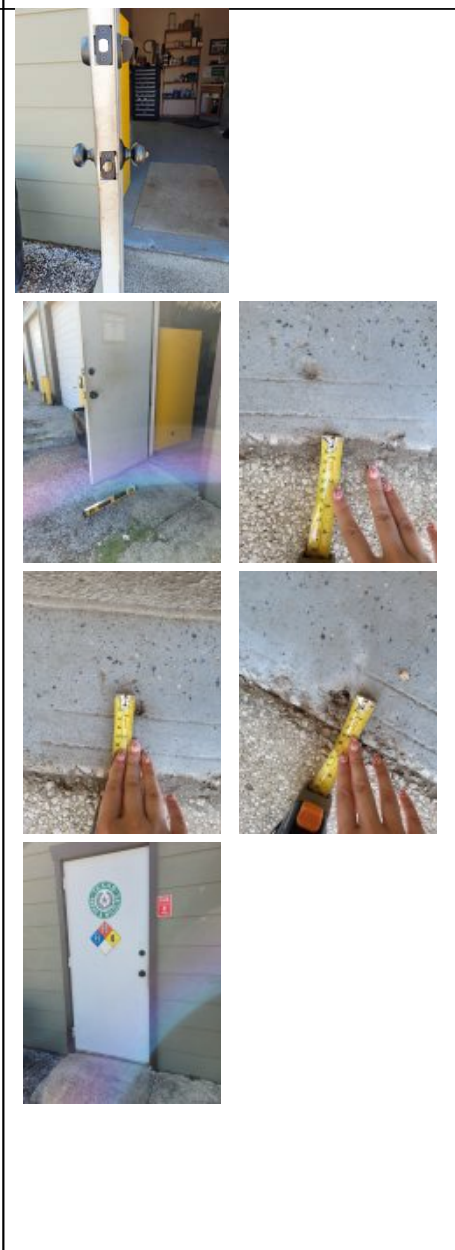
332	Employee Other: Maintenance	[30.73737, -98.36903]	Minimum maneuvering clearances at doors and gates shall comply with 404.2.4. Maneuvering clearances shall extend the full width of the doorway and the required latch side or hinge side clearance. There is a gap at the door that exceeds .5". Hand-activated door opening hardware, handles, pulls, latches, locks, and other operating devices on accessible doors shall have a shape that is easy to grasp with one hand	230 door - 14.6% slope running, knob, not on AR, 1" gap, deterioration	For all doors along the public circulation route, provide required maneuvering clearance on push and pull side of doors For all doors along the public circulation route, correct or fill gaps to max .5" For all doors along the public circulation route, replace hardware with lever hardware or hardware operable without a tight pinch or grasp	2010 ADAS Section: 404.2.3, 404.2.7, 404.2.4, 404.2.11, 404.2.11 Exception

Finding Number	Area Description	Lat/Long	Finding	As Built	Recommendation	Citation	Photos	Figure
			<p>and does not require tight grasping, tight pinching or twisting of the wrist to operate. Hardware shall be 34 inches minimum and 48 inches maximum above the finish floor or ground.</p>

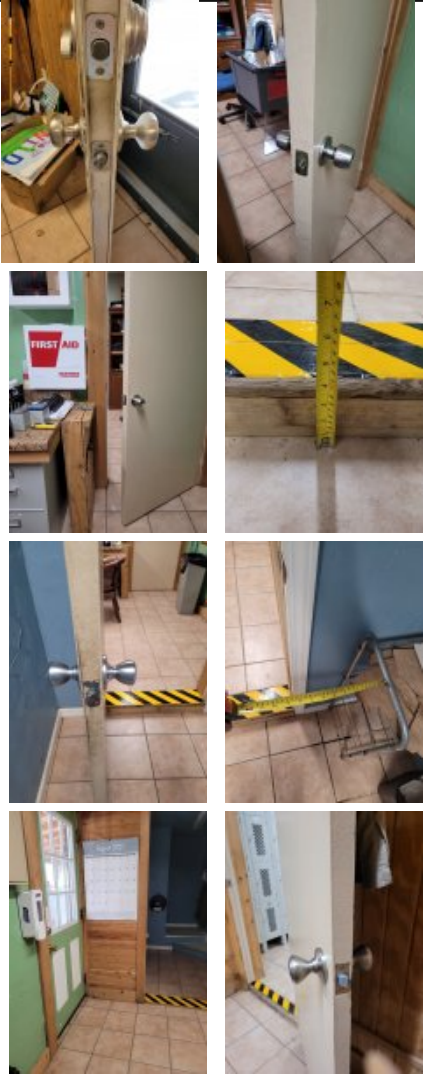
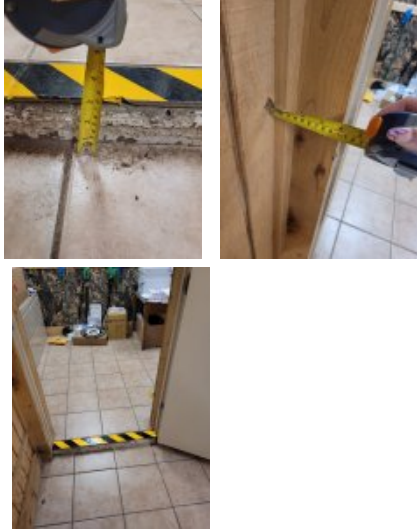
Finding Number	Area Description	Lat/Long	Finding	As Built	Recommendation	Citation	Photos	Figure
337	Employee Other: Maintenance	[30.73737, -98.36903]	<p>Minimum maneuvering clearances at doors and gates shall comply with 404.2.4. Maneuvering clearances shall extend the full width of the doorway and the required latch side or hinge side clearance. The threshold at a doorway shall be no higher than 1/2 inch. Changes in level between 1/4 inch and 1/2 inch must be beveled at 1:2 or less. 1/4 inch is the maximum vertical rise. Hand-activated door opening hardware, handles, pulls, latches, locks, and other operating devices on accessible doors shall have a shape that is easy to grasp with one hand and does not require tight grasping, tight pinching or twisting of the wrist to operate. Hardware shall be 34 inches minimum and 48 inches maximum above the finish floor or ground.</p>	<p>door into maintenance offices - knob handle, rope mat has 1" gaps, 2.75" step up, 7" maneuvering clearance on pull bc hand sanitizer. office on right- door to exit has knob, door to entry has knobs and no maneuvering clearance due to desk. door to restroom has 4" step down, knob, 8.5" maneuvering clearance on pull due to shelf, maneuvering clearance on push reduced by entry door clear floor space, maintenance supervisor office - knob hardware, 3" step down, 4" maneuvering clearance on pull</p>	<p>For all doors along the public circulation route, provide required maneuvering clearance on push and pull side of doors For all doors along the public circulation route, repair, bevel, or ramp CILs at door entries to max .25" For all doors along the public circulation route, replace hardware with lever hardware or hardware operable without a tight pinch or grasp</p>	<p>2010 ADAS Section: 404.2.3, 404.2.7, 404.2.4, 404.2.11, 404.2.11 Exception</p>

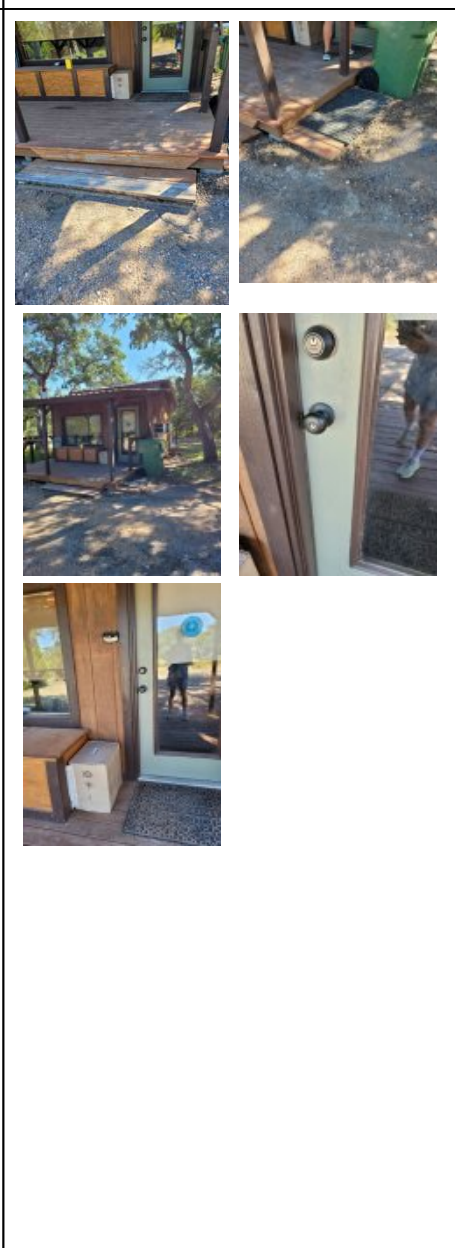
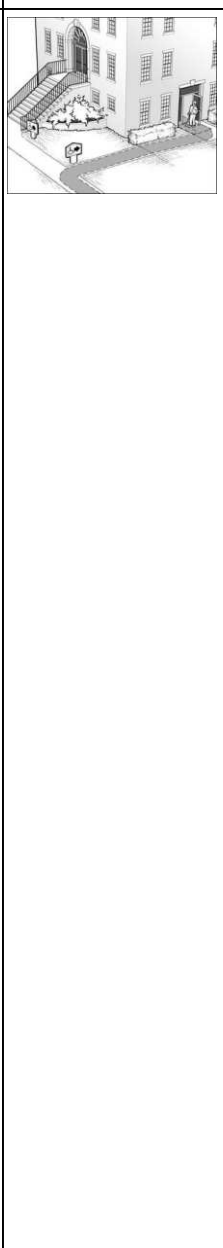
Finding Number	Area Description	Lat/Long	Finding	As Built	Recommendation	Citation	Photos	Figure
339	Employee Other: Maintenance	[30.73737, -98.36903]	<p>The building entrance is not located on an accessible route. When a building, or portion of a building, is required to be accessible, an accessible route of travel shall be provided to all portions of the building, to accessible building entrances and between the building and the public way. All walks, halls, corridors, aisles, skywalks, tunnels, and other spaces that are part of an accessible route must comply. An accessible route of travel must not pass through kitchens, storage rooms, restrooms, closets or other spaces used for similar purposes. At least one accessible route within the boundary of the site must be provided from public transportation stops, accessible parking and accessible passenger loading zones and public streets or sidewalks to the accessible building entrance they serve. The accessible route shall, to the maximum extent feasible, coincide with the route for the general public. At least one accessible route shall connect accessible buildings, facilities, elements and spaces that are on the same site. At least one accessible route shall connect accessible building or facility entrances with all accessible spaces and elements.</p>	<p>assistant super office- no AR to office shed down hill from water treatment. knob hardware and box in push maneuvering clearance</p>	<p>Create AR with crushed and compacted stone or similar outdoor material from parking or sidewalk to building entrance. For all doors along the public circulation route, relocate items to provide maneuvering clearance. For all doors along the public circulation route, replace hardware with one that is operable without a tight pinch or grasp.</p>	<p>2015 ABAAS Section: F206.2.1 2012 TAS Section: 206.2.1 2010 ADAS Section: 206.2.1</p>
