Access Audit Site Report

Inks Lake State Park

Accessibility Evaluation

Inspection Date: 08/23/2021

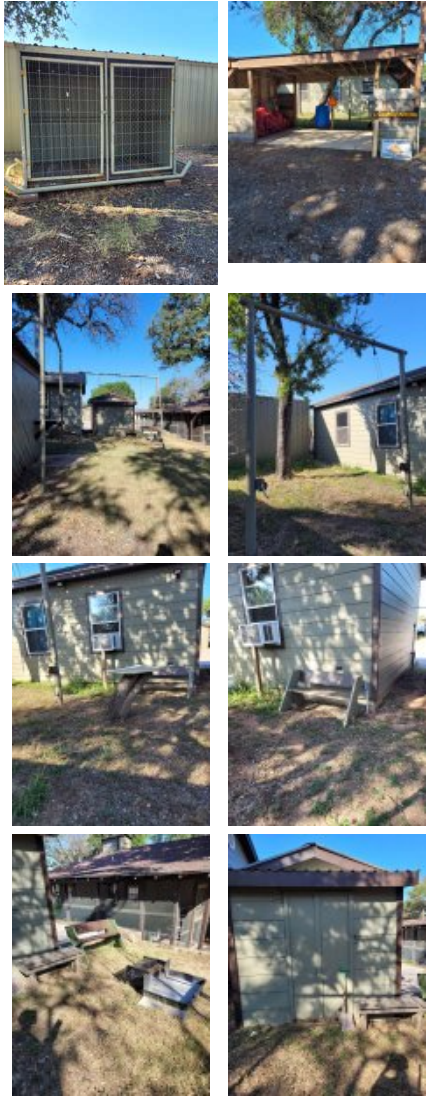
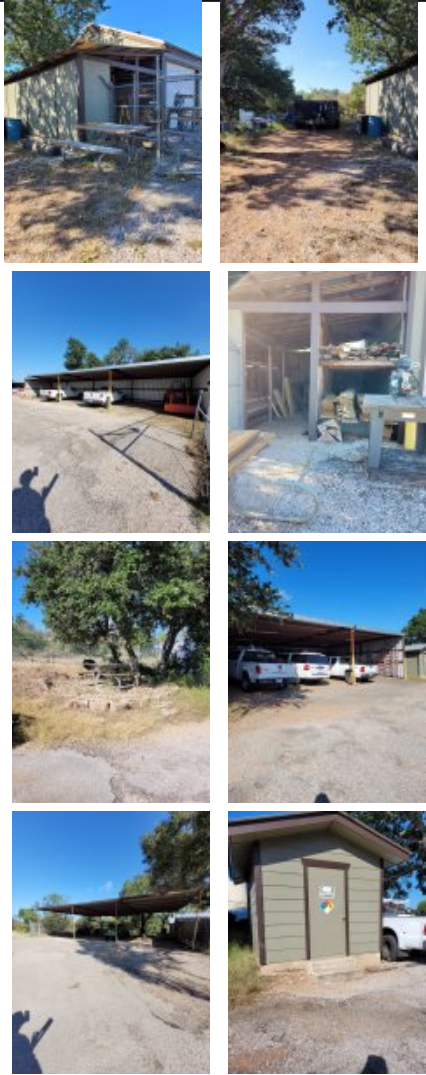
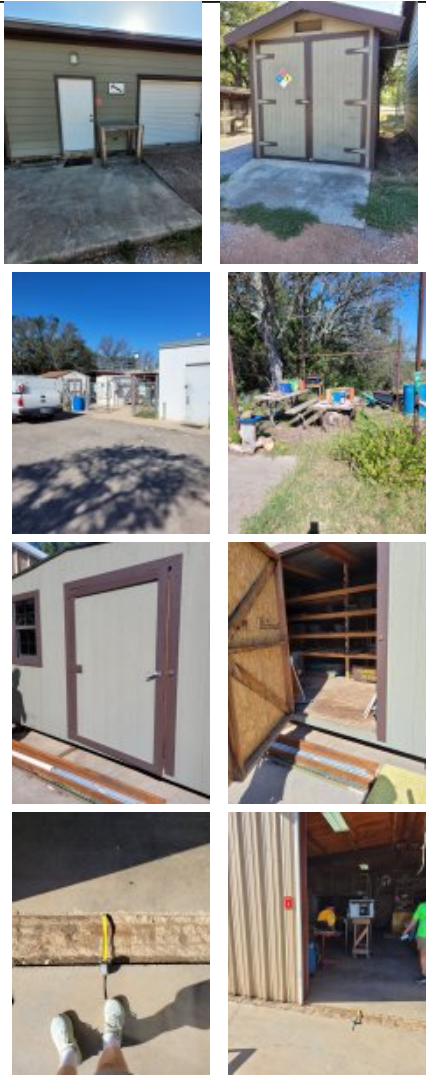
Finding Number	Area Description	Lat/Long	Finding	As Built	Recommendation	Citation	Photos	Figure
340	Employee Other: Maintenance	[30.73737, -98.36903]	There is no accessible route to the various maintenance buildings. At least one accessible route shall connect accessible buildings, accessible facilities, accessible elements, and accessible spaces that are on the same site.	no AR to wood enclosure, green shed, Shelter with wood, 2 hunting trolley system, table, 3 benches, firepit, shed, 2 picnic table, trailer, tractor/2 truck garage, plywood storage, grill, tractor shelter, flammable liquids room, building with hammer sign, Shelter by maintenance break area, treatment plant, gardening area, sign shed, tan shed by treatment plant has 12" gap, door to tan garage - 12 gap and knob. white shed behind has 6" gap and 3" gap knob hardware. 3 sheds by water treatment has have steps up. right to left - 6" CIL, middle 12" up, left 2 steps up	Create an accessible route with crushed stone or other outdoor material from parking or walkway to maintenance buildings. For all doors along the public circulation route, correct gaps to .5". For all doors along the public circulation route, replace hardware with one operable without a tight pinch or grasp. For all doors along the public circulation route, repair, bevel, or ramp CIL to max .25"	2015 ABAAS Section: F206.2.2 2012 TAS Section: 206.2.2 2010 ADAS Section: 206.2.2

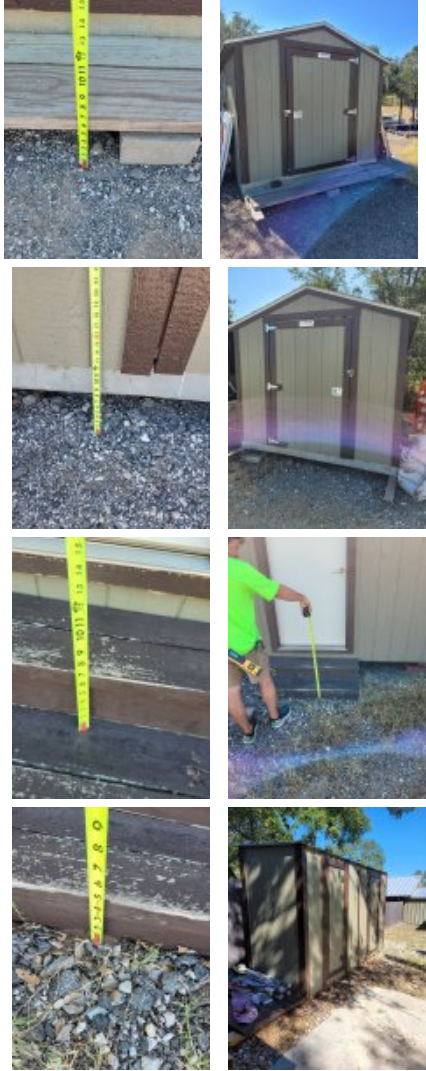
Finding Number	Area Description	Lat/Long	Finding	As Built	Recommendation	Citation	Photos	Figure
341	Employee Other: Maintenance	[30.73737, -98.36903]	There is a gap spaced greater than a 1/2 inch. Openings in floor or ground surfaces shall not allow passage of a sphere more than 1/2 inch diameter. Elongated openings shall be placed so that the long dimension is perpendicular to the dominant direction of travel.	1" gap outside of side entry to maintenance	Correct or fill gaps to be max .5"	2015 ABAAS Section: 302.3 2012 TAS Section: 302.3 2010 ADAS Section: 302.3

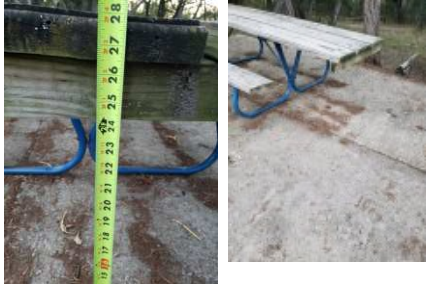
343	Campsites: Campsites	[30.7456507 , -98.360387 9]	36 inches (915 mm) on all usable sides of the table measured from the back edge of the benches	site 242 - lots of debris in picnic area	Provide required 36" clear ground space around all usable portions of the table as a smart practice	2015 ABAAS Section: 1011.2.1

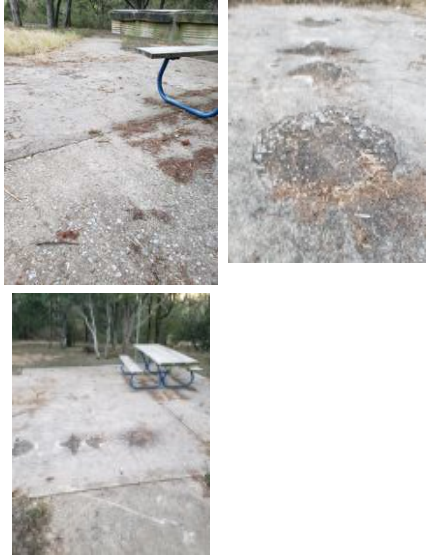
344	Campsites: Campsites	[30.7456322 , -98.360393 3]	Fire building surfaces shall be 9 inches (230 mm) minimum above the ground	site 242 - building surface level with ground	Correct fire building surface to be 9" min above the ground as a smart practice.	2015 ABAAS Section: 1011.5.1

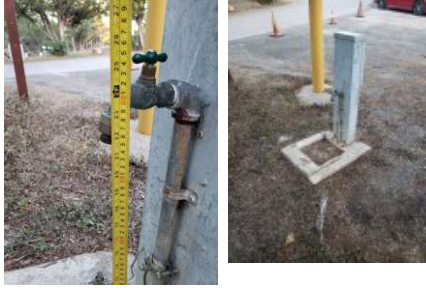
347	Campsites: Campsites	[30.7455031 , -98.360371 8]	An accessible access route is not provided between elements, spaces and the facilities provided within the accessible camping unit. At least one outdoor recreation access route shall connect accessible elements, spaces and facilities provided within camping units with mobility features.	site 261 - no accessible route to restroom	Create AR with crushed and compacted stone or similar outdoor material to camp sites and one of each type of amenity.	2015 ABAAS Section: F244.5.1

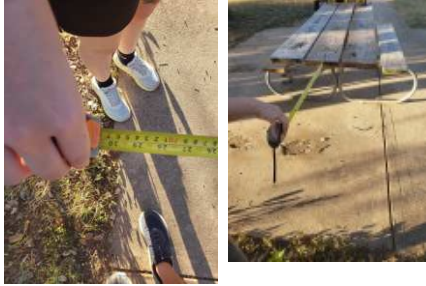
Finding Number	Area Description	Lat/Long	Finding	As Built	Recommendation	Citation	Photos	Figure
349	Campsites: Campsites	[30.743659, -98.362245 4]	48 inches (1220 mm) by 48 inches (1220 mm) on all usable sides of the fire ring, grill, fireplace, and woodstove Center the space on each usable side of the grill, fireplace, and woodstove	site 261 - no clear floor on grill side	Provide required 48" clear ground space centered along usable side of fire ring, grill, fireplace, or woodstove as a smart practice	2015 ABAAS Section: 1011.2

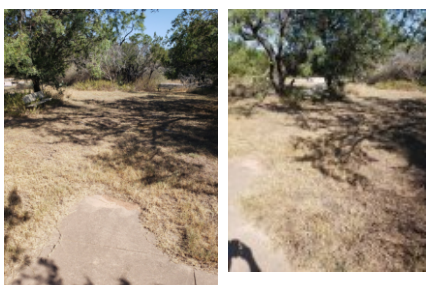
Finding Number	Area Description	Lat/Long	Finding	As Built	Recommendation	Citation	Photos	Figure
361	Campsites: Campsites	[30.7342484 , -98.373093 5]	The cross slopes (narrow dimension) and/or running slopes (long dimension) of the access aisle exceeds 2%. The running slope and the cross slope in an accessible parking stall and the access aisle must not exceed 2%.	across from campsite 322 - stall 3.8% slope, access aisle 4.8% slope	Repair or correct slope of parking space and access aisle to max 2.08% in any direction	2015 ABAAS Section: 502.4 2012 TAS Section: 502.4 2010 ADAS Section: 502.4

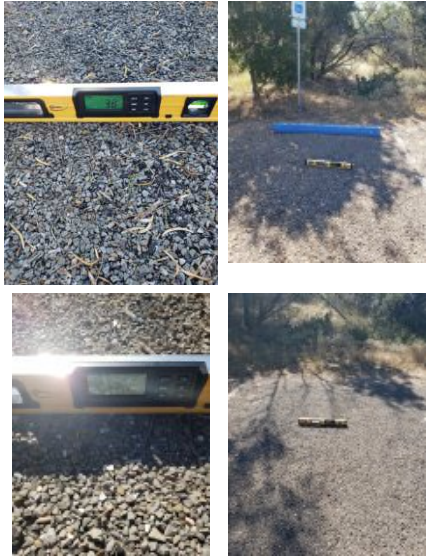
362	Campsites: Campsites	[30.7342231 , -98.373123 1]	The parking stall contains abrupt edges and surface irregularities over a 1/4 inch vertical. Parking spaces and access aisles serving them shall be stable, firm, and slip resistant. Access aisles shall be at the same level as the parking spaces they serve. Changes in level are not permitted and shall not be sloped steeper than 2% in any direction.	across from campsite 322 - loose gravel and asphalt	Resurface accessible stalls and access aisles with a firm, stable, and slip resistant material	2015 ABAAS Section: 502.4 2012 TAS Section: 502.4 2010 ADAS Section: 502.4

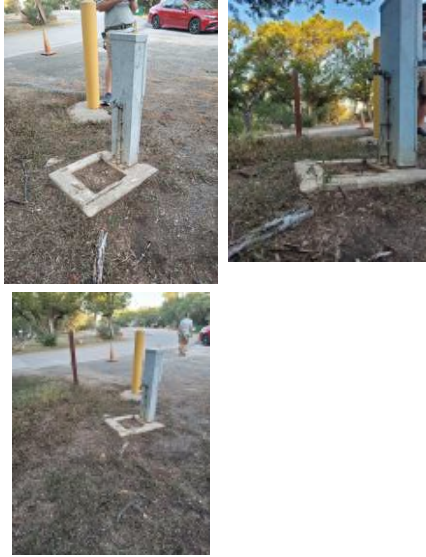
364	Campsites: Campsites	[30.7455769 , -98.360393 3]	The accessible parking stall is not wide enough. Each parking space must be at least 8' feet wide and shall be marked to define the width. The measurements of parking spaces and access aisles shall be made from the centerline of the markings. Where the parking space is not adjacent to another parking space or access aisle, the measurement shall be permitted to include the full width of the line defining the parking space.	site 242 - no paint, hard to tell sizing	Repaint stalls to be 8' wide each	2015 ABAAS Section: 502.2 2012 TAS Section: 502.2 2010 ADAS Section: 502.2

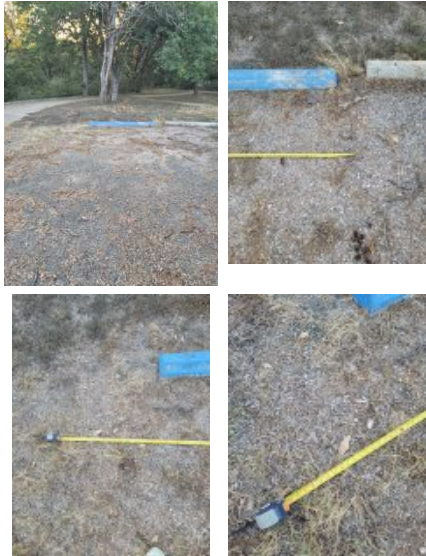
Finding Number	Area Description	Lat/Long	Finding	As Built	Recommendation	Citation	Photos	Figure
365	Campsites: Campsites	[30.7455216 , -98.360441 6]	The access aisle is missing at the accessible parking stall. Access aisles serving parking spaces shall adjoin an accessible route. Two parking spaces shall be permitted to share a common access aisle.	no access aisle marked	Create one or more 8' accessible parking stalls, with one 5' adjacent access aisle, with proper signage and striping	2015 ABAAS Section: 502.3.1 2012 TAS Section: 502.3.1 2010 ADAS Section: 502.3.1

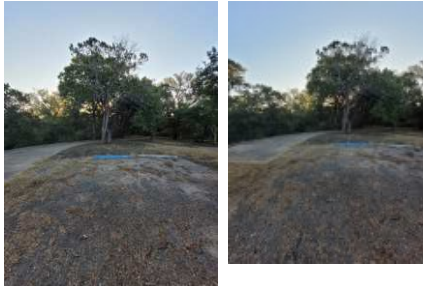
367	Campsites: Campsites	[30.7456472 , -98.360440 2]	The parking stall contains abrupt edges and surface irregularities over a 1/4 inch vertical. Parking spaces and access aisles serving them shall be stable, firm, and slip resistant. Access aisles shall be at the same level as the parking spaces they serve. Changes in level are not permitted and shall not be sloped steeper than 2% in any direction.	site 242 - surface covered in debris	Maintain stalls and access aisles to eliminate gaps, cracks, and debris	2015 ABAAS Section: 502.4 2012 TAS Section: 502.4 2010 ADAS Section: 502.4

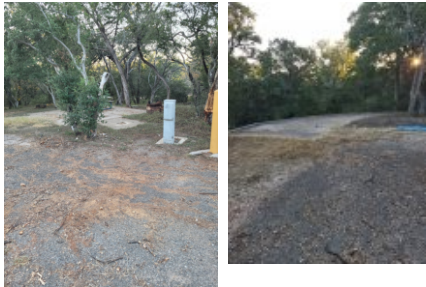
370	Campsites: Campsites	[30.7410275 , -98.364203 4]	The cross slopes (narrow dimension) and/or running slopes (long dimension) of the accessible stall exceeds 2%. The running slope and the cross slope in an accessible parking stall and the access aisle must not exceed 2%.	site 58 - 6.5% slope in stall	Correct or repair slope of stall to max 2.08% in any direction	2015 ABAAS Section: 502.4 2012 TAS Section: 502.4 2010 ADAS Section: 502.4

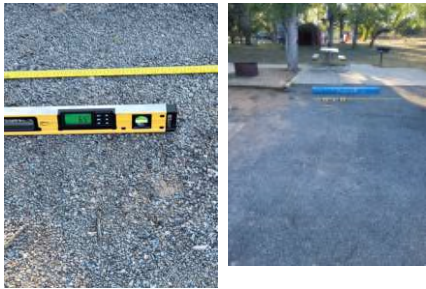
Finding Number	Area Description	Lat/Long	Finding	As Built	Recommendation	Citation	Photos	Figure
371	Campsites: Campsites	[30.7410171 , -98.364169 8]	The walkway contains abrupt vertical edges and/or variations over a 1/4 inch. 1/4 inch is the maximum vertical rise. Changes in level between 1/4 inch and 1/2 inch must be beveled at 1:2 or less. Changes in level greater than 1/2 inch must be by way of a ramp.	58 - 1.5" CIL behind parking up to platform	Repair, bevel or ramp CIL along AR	2012 TAS Section: 303.2, 303.3 2010 ADAS Section: 303.2, 303.3

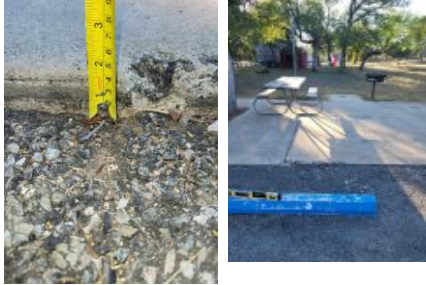
372	Campsites: Campsites	[30.7410113 , -98.364181 9]	The walkway contains abrupt vertical edges and/or variations over a 1/4 inch. 1/4 inch is the maximum vertical rise. Changes in level between 1/4 inch and 1/2 inch must be beveled at 1:2 or less. Changes in level greater than 1/2 inch must be by way of a ramp.	site 58 - .75" CIL to picnic platform	Repair or reset pavers to eliminate CIL	2012 TAS Section: 303.2, 303.3 2010 ADAS Section: 303.2, 303.3

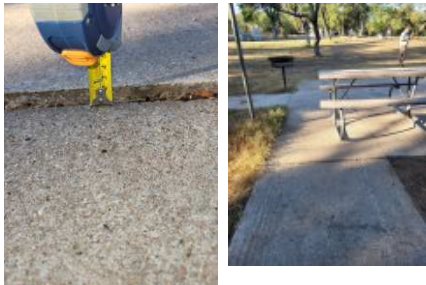
373	Campsites: Campsites	[30.7454847 , -98.360404]	There is no accessible route to the campsite amenities. At least one accessible route shall connect accessible buildings, accessible facilities, accessible elements, and accessible spaces that are on the same site.	campsite 242 - no AR to paved path	Create an accessible route with crushed stone or other outdoor material from parking or walkway to campsite amenities	2015 ABAAS Section: F206.2.2 2012 TAS Section: 206.2.2 2010 ADAS Section: 206.2.2

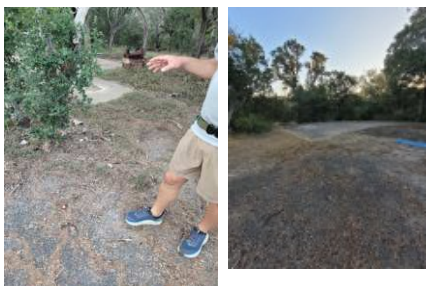
Finding Number	Area Description	Lat/Long	Finding	As Built	Recommendation	Citation	Photos	Figure
374	Campsites: Campsites	[30.7454386 , -98.360425 5]	There is no accessible route to the water spigots. At least one accessible route shall connect accessible buildings, accessible facilities, accessible elements, and accessible spaces that are on the same site.	site 242 - no AR to electric or water spigot, site 261 - no AR to water spigot or electric, site 58 - no AR to spigot. 76 - no AR to water spigot	Create an accessible route with crushed stone or other outdoor material from parking or walkway to water spigots at campsite	2015 ABAAS Section: F206.2.2 2012 TAS Section: 206.2.2 2010 ADAS Section: 206.2.2

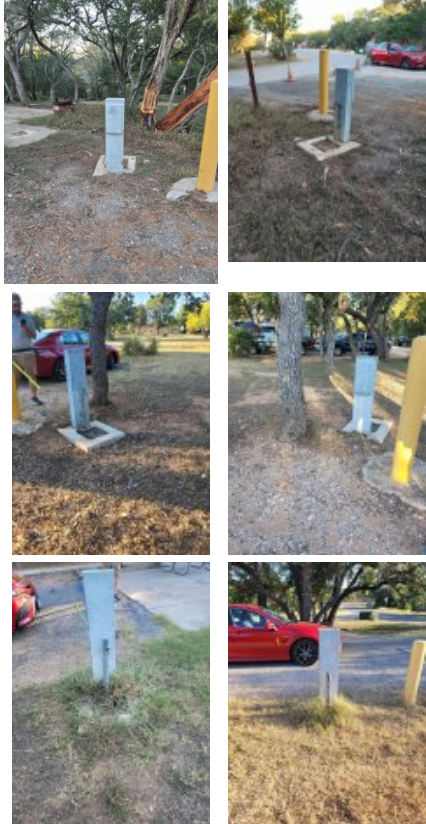
Finding Number	Area Description	Lat/Long	Finding	As Built	Recommendation	Citation	Photos	Figure
375	Campsites: Campsites	[30.7430734 , -98.362799 2]	An accessible access route is not provided between elements, spaces and the facilities provided within the accessible camping unit. At least one outdoor recreation access route shall connect accessible elements, spaces and facilities provided within camping units with mobility features.	site 212 - no AR to water spigot or electric plug in	Create AR with crushed and compacted stone or similar outdoor material to camp sites and one of each type of amenity.	2015 ABAAS Section: F244.5.1

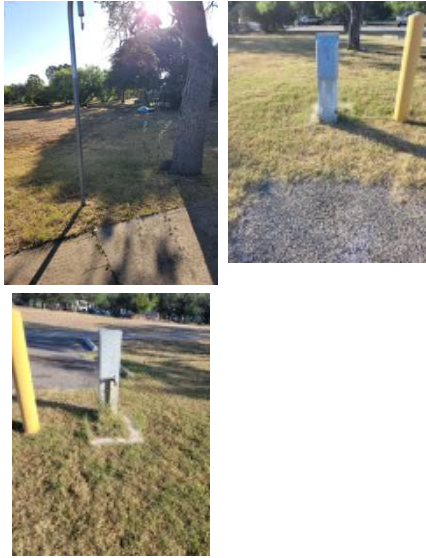
376	Campsites: Campsites	[30.7430757 , -98.36281]	36 inches (915 mm) on all usable sides of the table measured from the back edge of the benches	site 212 - no CFS for wheelchair	Provide required 36" clear ground space around all usable portions of the table as a smart practice	2015 ABAAS Section: 1011.2.1

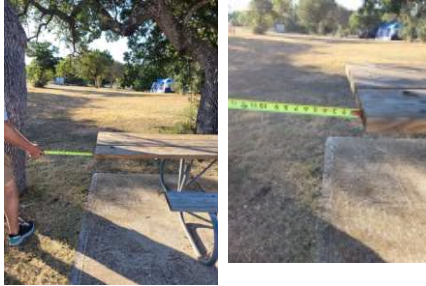
Finding Number	Area Description	Lat/Long	Finding	As Built	Recommendation	Citation	Photos	Figure
377	Campsites: Campsites	[30.7430642 , -98.362807 3]	48 inches (1220 mm) by 48 inches (1220 mm) on all usable sides of the fire ring, grill, fireplace, and woodstove Center the space on each usable side of the grill, fireplace, and woodstove	site 212 - 1" CIL, fire building side has no CGS	Provide required 48" clear ground space centered along usable side of fire ring, grill, fireplace, or woodstove as a smart practice Repair, bevel, or ramp CIL along AR	2015 ABAAS Section: 1011.2

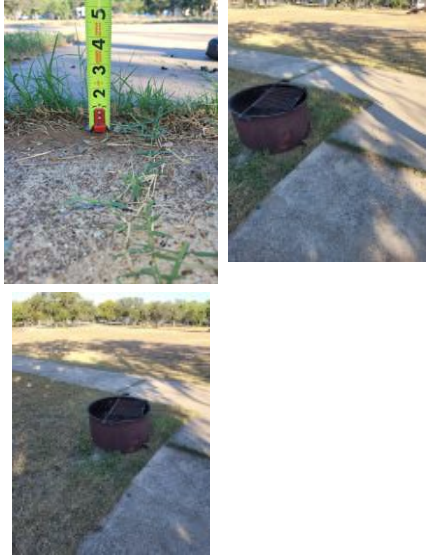
378	Campsites: Campsites	[30.7430757 , -98.362807 3]	Fire building surfaces shall be 9 inches (230 mm) minimum above the ground	site 212 - fire building surface is ground level	Correct fire building surface to be 9" min above the ground as a smart practice.	2015 ABAAS Section: 1011.5.1

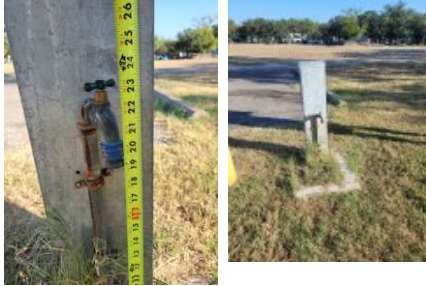
Finding Number	Area Description	Lat/Long	Finding	As Built	Recommendation	Citation	Photos	Figure
380	Campsites: Campsites	[30.7454709 , -98.360398 7]	30 inches (760 mm) by 60 inches (1525 mm) with the long side of the space adjoining or overlapping an accessible parking space or pull-up space for recreational vehicles. Locate the space so that the hook-ups are at the rear center of the space. Bollards or other barriers shall not obstruct the clear ground space in front of the hook-ups	site 242 - no AR or CGS for electric hook up	Create AR with crushed and compacted stone or similar outdoor material to water spouts, with a 30" x 60" clear space around usable area	2015 ABAAS Section: 1011.2

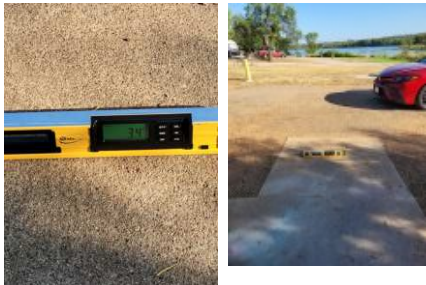
381	Campsites: Campsites	[30.7418309 , -98.365897 2]	The cross slope shall not be steeper than 1:48. EXCEPTION: Where the surface is other than concrete, asphalt, or boards, cross slopes not steeper than 1:20 shall be permitted when necessary for drainage.	site 46 - 3.4% cross slope on walkway to site	Correct or repair ORAR cross slope to max 2.08% or 5% for surfaces other than concrete, asphalt or board as a smart practices	2015 ABAAS Section: 1016.7.2, 1016.7.2 EXCEPTION

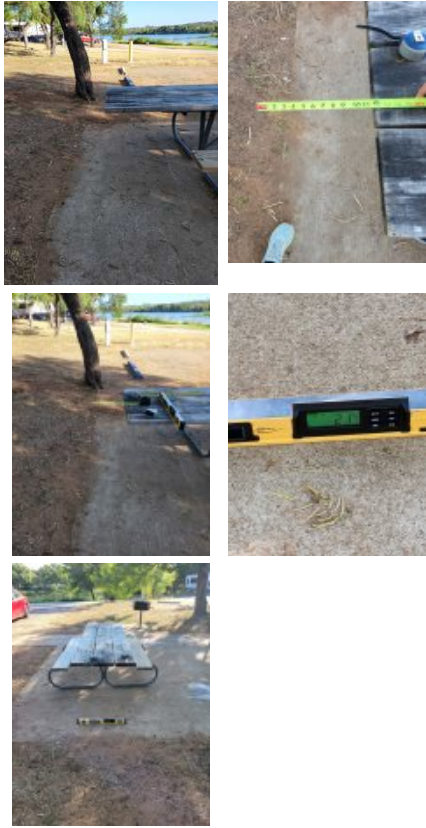
Finding Number	Area Description	Lat/Long	Finding	As Built	Recommendation	Citation	Photos	Figure
382	Campsites: Campsites	[30.7418355 , -98.365902 5]	36 inches (915 mm) on all usable sides of the table measured from the back edge of the benches	site 46 - no CFS, 2.1% cross	Provide required 36" clear ground space around all usable portions of the table as a smart practice Create a level CGS at picnic table; max 2.08% slope in any direction	2015 ABAAS Section: 1011.2.1

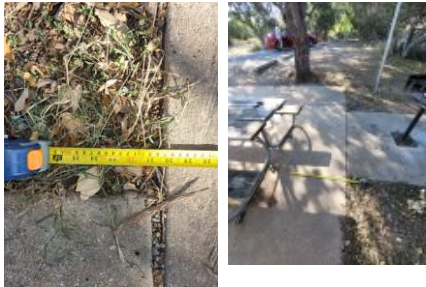
387	Campsites: Campsites	[30.7350461 , -98.3737936]	36 inches (915 mm) on all usable sides of the table measured from the back edge of the benches	site 331 - 30" CGS for picnic table	Provide required 36" clear ground space around all usable portions of the table as a smart practice	2015 ABAAS Section: 1011.2.1

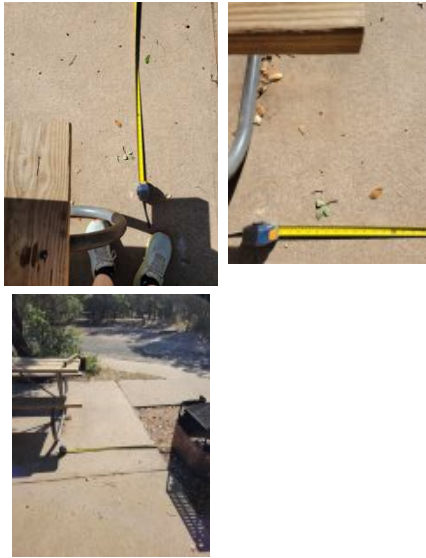
390	Campsites: Campsites	[30.7349355 , -98.373815 1]	48 inches (1220 mm) by 48 inches (1220 mm) on all usable sides of the fire ring, grill, fireplace, and woodstove Center the space on each usable side of the grill, fireplace, and woodstove	site 336 - 40" CGS around usable portion	Provide required 48" clear ground space centered along usable side of fire ring, grill, fireplace, or woodstove as a smart practice	2015 ABAAS Section: 1011.2
