Access Audit Site Report

Kickapoo Cavern State Park
20939 Ranch Rd 674
Brackettville, TX 78832
Accessibility Evaluation
Inspection Date: 07/25/2022
Inspectors: Tanya Scheibe

Prepared By
WT Group

**AMERICANS WITH DISABILITIES ACT COMPLIANCE INITIATIVE
PROGRAM AND POLICY REPORT
JULY 28, 2023**

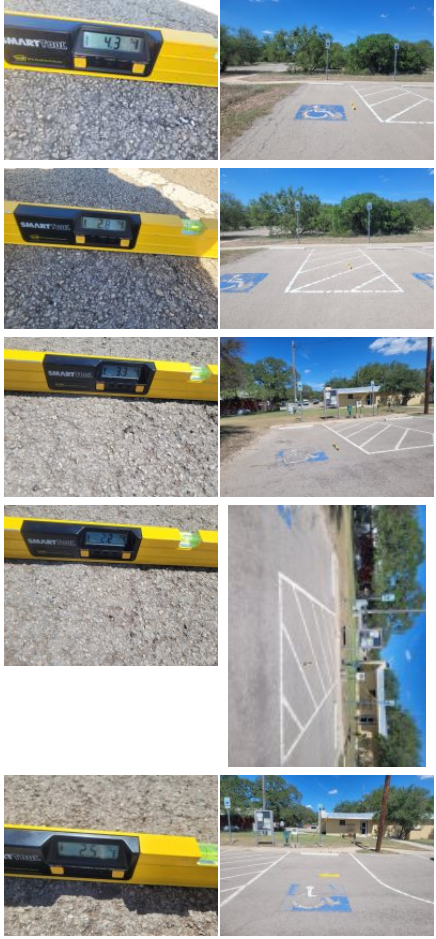
Finding Number	Area Description	Lat/Long	Finding	As Built	Recommendation	Citation	Photos	Figure
3	Headquarters Area: HQ - Parking	[29.6101035 , -100.452727]	The cross slopes (narrow dimension) and/or running slopes (long dimension) of the access aisle exceeds 2%. The running slope and the cross slope in an accessible parking stall and the access aisle must not exceed 2%.	4.3% left restroom stall, 2.8% restroom aisle, 3.3% left office stall, 2.2% office aisle, 2.5% right office stall	Repair or correct slope of parking space and access aisle to max 2.08% in any direction.	2015 ABAAS Section: 502.4 2012 TAS Section: 502.4 2010 ADAS Section: 502.4

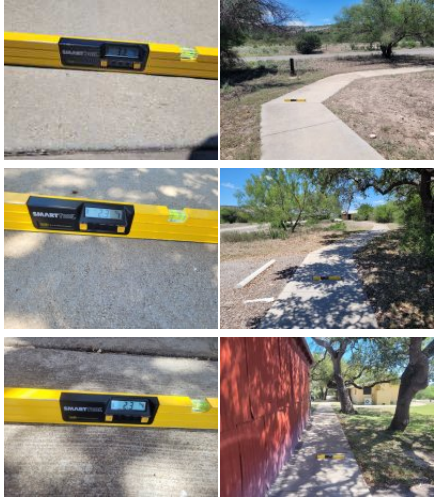
Finding Number	Area Description	Lat/Long	Finding	As Built	Recommendation	Citation	Photos	Figure
8	Headquarters Area: HQ - Exterior Accessible Route	[29.610609, -100.452708]	The accessible route of travel contains cross slopes greater than 2%. Cross slopes shall not exceed one unit vertical in 48 units horizontal (2-percent slope).	3.3% at turn to restrooms from main lot, 2.3% between road lot and restroom, 2.3% in front of maintenance	Correct or repair cross slope along AR to max 2.08%.	2015 ABAAS Section: 403.3 2012 TAS Section: 403.3 2010 ADAS Section: 403.3

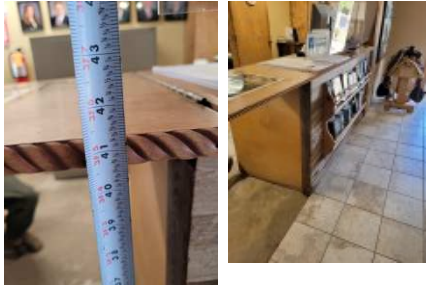
Finding Number	Area Description	Lat/Long	Finding	As Built	Recommendation	Citation	Photos	Figure
16	Headquarters Area: HQ - Public Spaces	[29.610036, -100.45248 12]	The transaction counter is too high. A portion of the counter surface that is 36 inches long minimum and 36 inches high maximum above the finish floor shall be provided. Knee and toe space must be provided for a forward approach. A 30 inch by 48 inch clear floor space on an accessible route must be provided for either a forward or parallel approach.	Service counter 41.5" AFF	Lower 36" wide segment of service counter to max 36" AFF.	2015 ABAAS Section: 904.4.2, 904.4.1 2012 TAS Section: 904.4.1, 904.4.2 2010 ADAS Section: 904.4.2, 904.4.1

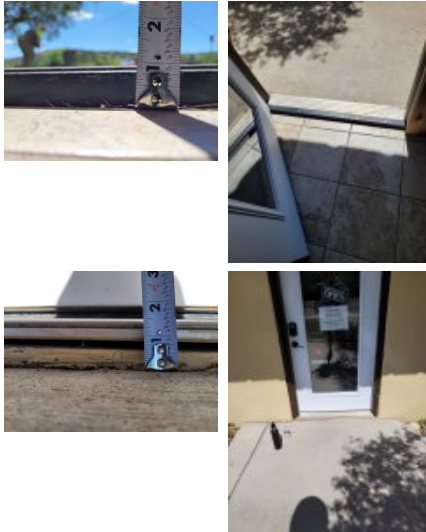
Finding Number	Area Description	Lat/Long	Finding	As Built	Recommendation	Citation	Photos	Figure
19	Headquarters Area: HQ - Public Spaces	[29.610032, -100.452495]	The threshold is greater than 1/2 inch high. The threshold at a doorway shall be no higher than 1/2 inch. Changes in level between 1/4 inch and 1/2 inch must be beveled at 1:2 or less. 1/4 inch is the maximum vertical rise.	Main entrance - 1" and 1.5" CIL at threshold	For all doors along the public circulation route, replace thresholds at exterior doors with ADA thresholds.	2015 ABAAS Section: 404.2.5 2012 TAS Section: 404.2.5 2010 ADAS Section: 404.2.5

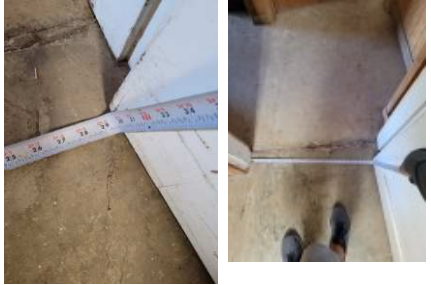
Finding Number	Area Description	Lat/Long	Finding	As Built	Recommendation	Citation	Photos	Figure
21	Headquarters Area: HQ - Employee Spaces	[29.60995, -100.4525]	Door openings shall provide a clear width of 32 inches (815 mm) minimum. Clear openings of doorways with swinging doors shall be measured between the face of the door and the stop, with the door open 90 degrees. Openings more than 24 inches (610 mm) deep shall provide a clear opening of 36 inches (915 mm) minimum. There shall be no projections into the required clear opening width lower than 34 inches (865 mm) above the finish floor or ground. Projections into the clear opening width between 34 inches (865 mm) and 80 inches (2030 mm) above the finish floor or ground shall not exceed 4 inches (100 mm). Hand-activated door opening hardware, handles, pulls, latches, locks, and other operating devices on accessible doors shall have a shape that is easy to grasp with one hand and does not require tight grasping, tight pinching or twisting of the wrist to operate. Hardware shall be 34 inches minimum and 48 inches maximum above the finish floor or ground.	Door to office area 29.5" width, knobs; office door and exterior office door - knobs	For all doors along the public circulation route, replace doors with doors having 80" overhead clearance and 32" clear width. For all doors along the public circulation route, replace hardware with lever hardware or hardware operable without a tight pinch or grasp.	2010 ADAS Section: 404.2.3, 404.2.7, 404.2.4, 404.2.11, 404.2.11 Exception

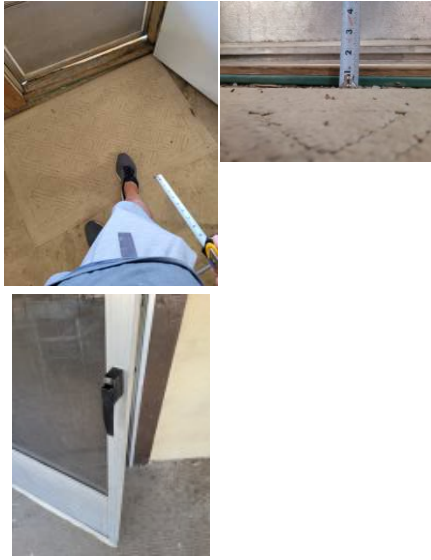
22	Headquarters Area: HQ - Employee Spaces	[29.6099892, -100.452473]	Minimum maneuvering clearances at doors and gates shall comply with 404.2.4. Maneuvering clearances shall extend the full width of the doorway and the required latch side or hinge side clearance. The threshold at a doorway shall be no higher than 1/2 inch. Changes in level between 1/4 inch and 1/2 inch must be beveled at 1:2 or less. 1/4 inch is the maximum vertical rise. Hand-activated door opening hardware, handles, pulls, latches, locks, and other operating devices on accessible doors shall have a shape that is easy to grasp with one hand and does not require tight grasping, tight pinching or twisting of the wrist to operate. Hardware shall be 34 inches minimum and 48 inches maximum above the finish floor or ground.	Exterior door from break room - loose rug, 1.5" CIL at threshold, screen door hardware requires pinch	For all doors along the public circulation route, secure rug in door clearance to prevent trip hazard. For all doors along the public circulation route, provide beveled threshold. For all doors along the public circulation route, replace hardware with lever hardware or hardware operable without a tight pinch or grasp.	2010 ADAS Section: 404.2.3, 404.2.7, 404.2.4, 404.2.11, 404.2.11 Exception

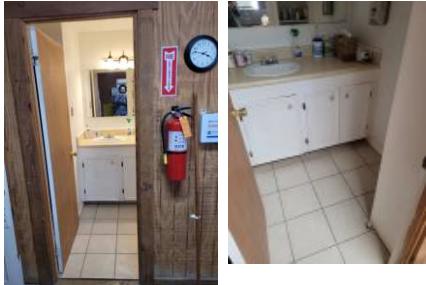
24	Headquarters Area: HQ - Restroom	[29.6100254, -100.4524736]	The restroom is not compliant. The restroom does not have the required minimum clear floor space or maneuvering clearances for the toilet. The restroom does not have the required minimum clear floor space or maneuvering clearances for the lavatory. The entry door does not contain the required minimum maneuvering spaces on the pull/push sides. The entry door encroach into the required clear floor space for fixtures. Grab bars are missing and/or incorrectly installed. Accessories, such as toilet seat covers, paper towel holders, garbage cans, hand dryers, and mirrors are either too high or without clear floor space or both.	Restroom lacks accessible features	Create a compliant wheelchair accessible restroom and correct all features to be accessible if feasible.	2015 ABAAS Section: 603.1 2012 TAS Section: 603.1 2010 ADAS Section: 603.1

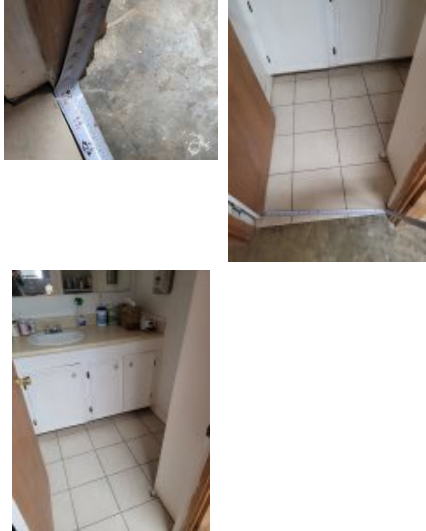
Finding Number	Area Description	Lat/Long	Finding	As Built	Recommendation	Citation	Photos	Figure
26	Headquarters Area: HQ - Restroom	[29.6100231, -100.4524642]	Minimum maneuvering clearances at doors and gates shall comply with 404.2.4. Maneuvering clearances shall extend the full width of the doorway and the required latch side or hinge side clearance. Door openings shall provide a clear width of 32 inches (815 mm) minimum. Clear openings of doorways with swinging doors shall be measured between the face of the door and the stop, with the door open 90 degrees. Openings more than 24 inches (610 mm) deep shall provide a clear opening of 36 inches (915 mm) minimum. There shall be no projections into the required clear opening width lower than 34 inches (865 mm) above the finish floor or ground. Projections into the clear opening width between 34 inches (865 mm) and 80 inches (2030 mm) above the finish floor or ground shall not exceed 4 inches (100 mm). Hand-activated door opening hardware, handles, pulls, latches, locks, and other operating devices on accessible doors shall have a shape that is easy to grasp with one hand and does not require tight grasping, tight pinching or twisting of the wrist to operate. Hardware shall be 34 inches minimum and 48 inches maximum above the finish floor or ground.	restroom- 26" width, knobs, shelving in pull clearance	For all doors along the public circulation route, provide required maneuvering clearance on push and pull side of doors. For all doors along the public circulation route, replace doors with doors having 80" overhead clearance and 32" clear width. For all doors along the public circulation route, replace hardware with lever hardware or hardware operable without a tight pinch or grasp.	2010 ADAS Section: 404.2.3, 404.2.7, 404.2.4, 404.2.11, 404.2.11 Exception

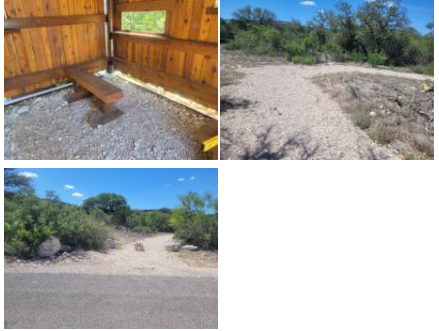
Finding Number	Area Description	Lat/Long	Finding	As Built	Recommendation	Citation	Photos	Figure
32	Headquarters Area: Bird Blind	[29.6095541, -100.4541651]	The surface of trails, passing spaces, and resting intervals shall be firm and stable	gravel trail to bird blind and gravel surface within	Replace surface of trail with one that is firm and stable as a smart practice.	2015 ABAAS Section: 1017.2

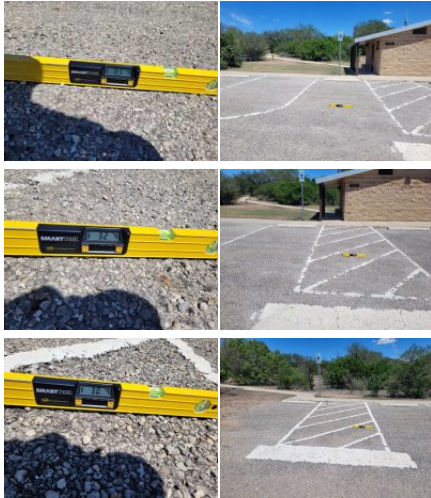
Finding Number	Area Description	Lat/Long	Finding	As Built	Recommendation	Citation	Photos	Figure
37	Campground: Campsite - Parking	[29.6115482, -100.4527136]	The cross slopes (narrow dimension) and/or running slopes (long dimension) of the access aisle exceeds 2%. The running slope and the cross slope in an accessible parking stall and the access aisle must not exceed 2%.	restroom parking- 2.7% at restroom stall, 3.2% restroom aisle, 3% camping stall	Repair or correct slope of parking space and access aisle to max 2.08% in any direction.	2015 ABAAS Section: 502.4 2012 TAS Section: 502.4 2010 ADAS Section: 502.4

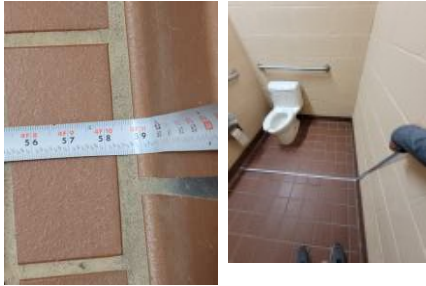
Finding Number	Area Description	Lat/Long	Finding	As Built	Recommendation	Citation	Photos	Figure
53	Campground: Campsite - Men's Restroom	[29.6115202, -100.4526653]	The dimensions of the toilet stall do not comply. Wheelchair accessible compartments shall be 60 inches wide and 59 inches deep minimum for floor mounted water closets measured perpendicular to the rear wall. Door shall not swing into the minimum clear floor space required for the toilet.	stall 59" wide	Widen accessible stalls to min. 60" clear width, 59" depth.	2015 ABAAS Section: 604.8.1.1 2012 TAS Section: 604.3.2 2010 ADAS Section: 604.3.2

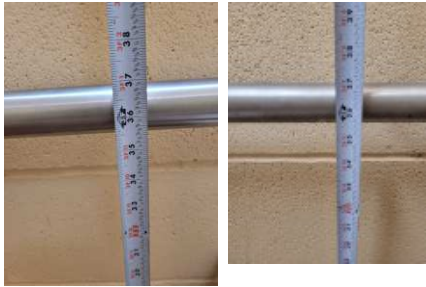
55	Campground: Campsite - Men's Restroom	[29.6115225, -100.4526694]	The grab bar height and/or spacing fails. Grab bars must be mounted between 33" and 36" to the top of the gripping surface. There must be 1.5" of clearance between the grab bar and the wall. There must be a minimum of 1.5" of clearance below and minimum 12" above the grab bar to any dispenser or other obstruction.	Both grab bars 37" AFF	Remount grab bars in accessible stall to 33" to 36" above the finished floor (AFF).	2015 ABAAS Section: 609.3, 609.4 2012 TAS Section: 609.4, 609.3 2010 ADAS Section: 609.3, 609.4

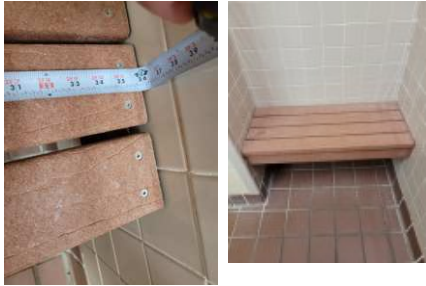
62	Campground: Campsite - Men's Restroom	[29.611519, -100.4526653]	The shower seat does not have a compliant space between it and the wall. The folding seat must be mounted 17-19 inches above the floor, and have a maximum space of 1-1/2 inches between the edge of the seat and the side wall and 2-1/2 inches maximum to the seat wall.	Seat 3.5" from back wall	Remount shower seat to the correct location and height in the shower.	2015 ABAAS Section: 610.3.2 2012 TAS Section: 610.3.2 2010 ADAS Section: 610.3.2

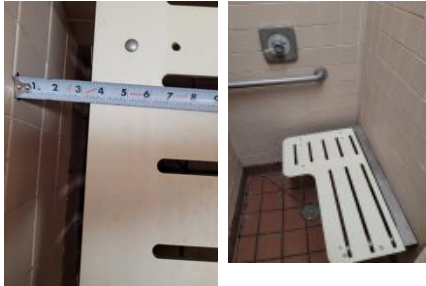
Finding Number	Area Description	Lat/Long	Finding	As Built	Recommendation	Citation	Photos	Figure
63	Campground: Campsite - Men's Restroom	[29.6115003, -100.4526598]	Minimum maneuvering clearances at doors and gates shall comply with 404.2.4. Maneuvering clearances shall extend the full width of the doorway and the required latch side or hinge side clearance. Exterior doors are recommended to be maintained at 8.5 lbf as a smart practice. Force is to be measured at the operating hardware or 30 inches from the hinges, whichever is greater. The bottom 10 inches on the push side must be smooth and free of obstructions (hold open devices). Opening hardware must be mounted between 30 and 44 inches above the floor or ground.	Men's- stopper on push side surface, sign in clearance, 13 lbf	For all doors along the public circulation route, provide required maneuvering clearance on push and pull side of doors. For all doors along the public circulation route, inspect, adjust, and maintain 8.5 lbf to open exterior doors as a smart practice. For all doors along the public circulation route, remove door holder to provide a smooth surface on the push side of door from floor to 10" AFF.	2010 ADAS Section: 404.2.3, 404.2.7, 404.2.4, 404.2.11, 404.2.11 Exception

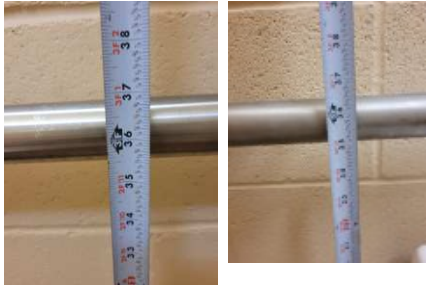
Finding Number	Area Description	Lat/Long	Finding	As Built	Recommendation	Citation	Photos	Figure
69	Campground: Campsite - Women's Restroom	[29.6114712, -100.4526814]	The grab bar height and/or spacing fails. Grab bars must be mounted between 33" and 36" to the top of the gripping surface. There must be 1.5" of clearance between the grab bar and the wall. There must be a minimum of 1.5" of clearance below and minimum 12" above the grab bar to any dispenser or other obstruction.	Side 36.75" AFF, rear 36.5" AFF	Remount grab bars in accessible stall to 33" to 36" above the finished floor (AFF).	2015 ABAAS Section: 609.3, 609.4 2012 TAS Section: 609.4, 609.3 2010 ADAS Section: 609.3, 609.4

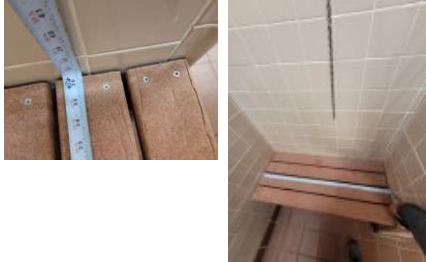
Finding Number	Area Description	Lat/Long	Finding	As Built	Recommendation	Citation	Photos	Figure
73	Campground: Campsite - Women's Restroom	[29.6114712, -100.4526814]	The bench is not deep enough or long enough or is missing. Benches shall be provided having seats that are 42 inches long minimum and 20 inches deep minimum and 24 inches deep maximum. The bench shall provide for back support or shall be affixed to a wall. Back support shall be 42 inches (1065 mm) long minimum and shall extend from a point 2 inches (51 mm) maximum above the seat surface to a point 18 inches (455 mm) minimum above the seat surface. Back support shall be 2½ inches (64 mm) maximum from the rear edge of the seat measured horizontally. The top of the bench seat surface shall be 17 inches (430 mm) minimum and 19 inches (485 mm) maximum above the finish floor or ground. Clear floor or ground space complying with 305 shall be provided and shall be positioned at the end of the bench seat and parallel to the short axis of the bench	36.25" width	Replace bench in dressing area with one having a seat depth of 20" to 24" deep, 42" long, affixed to the wall or having a back and mounted 17" to 19" aff and provide required clear floor space on the short axis of the bench.	2012 TAS Section: 903.4, 903.2, 903.3, 903.5 2010 ADAS Section: 903.4, 903.2, 903.3, 903.5

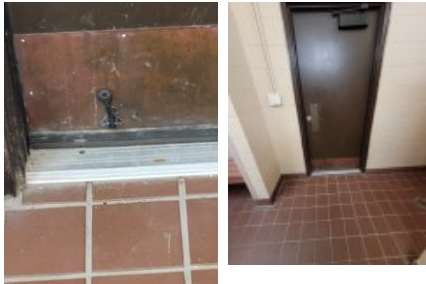
75	Campground: Campsite - Women's Restroom	[29.6114582, -100.4526766]	Exterior doors are recommended to be maintained at 8.5 lbf as a smart practice. Force is to be measured at the operating hardware or 30 inches from the hinges, whichever is greater. The bottom 10 inches on the push side must be smooth and free of obstructions (hold open devices). Opening hardware must be mounted between 30 and 44 inches above the floor or ground.	Women's - 15 lbf, stopper on push side surface	For all doors along the public circulation route, inspect, adjust, and maintain 8.5 lbf to open exterior doors as a smart practice. For all doors along the public circulation route, remove door holder to provide a smooth surface on the push side of door from floor to 10" AFF.	2010 ADAS Section: 404.2.3, 404.2.7, 404.2.4, 404.2.11, 404.2.11 Exception

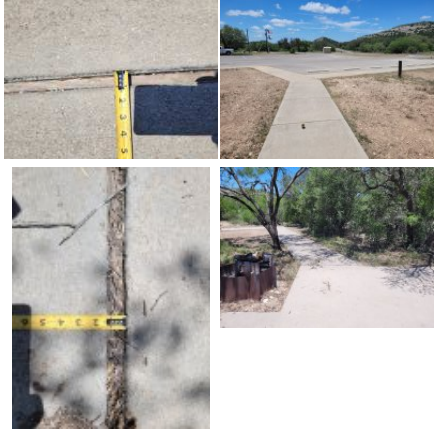
78	Campground: Campsite 1	[29.6106935 , -100.4522 402]	The cross slope shall not be steeper than 1:48. EXCEPTION: Where the surface is other than concrete, asphalt, or boards, cross slopes not steeper than 1:20 shall be permitted when necessary for drainage.	2.3% to parking	Correct or repair ORAR cross slope to max 2.08% as a smart practice.	2015 ABAAS Section: 1016.7.2, 1016.7.2 EXCEPTION

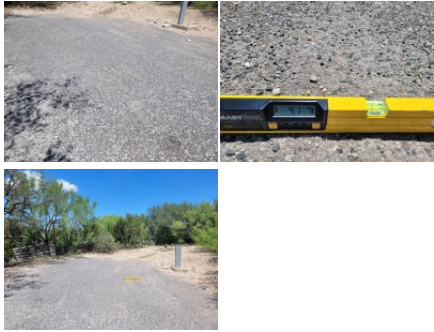
84	Campground: Campsite 1	[29.6106923, -100.4522 308]	The surface of parking spaces and pull-up spaces shall be firm and stable. The slope of the surface of parking spaces and pull-up spaces shall not be steeper than 1:48 in any direction. EXCEPTION: Where the surface is other than asphalt, concrete, or boards, slopes not steeper than 1:20 shall be permitted when necessary for drainage.	Loose debris on hard surface, 4% slope	Correct surface of parking spaces to be firm and stable with slopes max of 2.08% or 5% for surfaces other than concrete, asphalt or boards as a smart practice.	2015 ABAAS Section: 1012.4, 1012.5, 1012.5 EXCEPTION

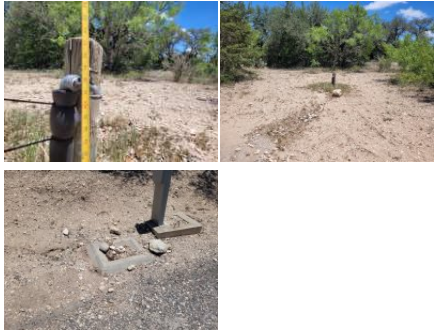
86	Campground: Campsite 1	[29.610711, -100.45223 08]	Water spouts at water hydrants and water utility hook-ups shall be 28 inches (710 mm) minimum and 36 inches (915 mm) maximum above the ground.	Spout 16.5" above ground surface	Remount water spouts to 28" min or 36" max above the ground as a smart practice.	2015 ABAAS Section: 1011.6

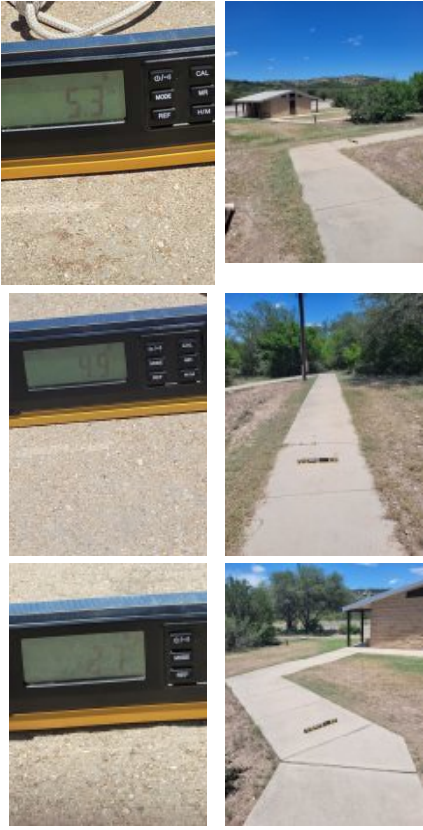
88	Campground: Campsite 3	[29.61148, -100.4525]	There is a gap spaced greater than a 1/2 inch. Openings in floor or ground surfaces shall not allow passage of a sphere more than 1/2 inch diameter. Elongated openings shall be placed so that the long dimension is perpendicular to the dominant direction of travel.	Campsite 3 to restrooms - 1", 1", .75", 1", 1.5" gaps	Correct or fill gaps to be max .5".	2015 ABAAS Section: 302.3 2012 TAS Section: 302.3 2010 ADAS Section: 302.3

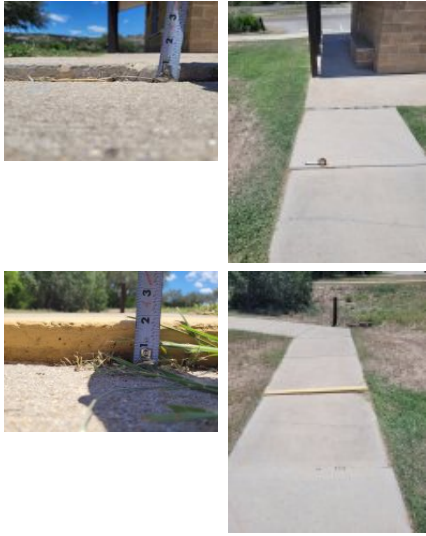
90	Campground: Campsite 3	[29.611294, -100.4523864]	Picnic tables are required to have clear ground space 36 inches (915 mm) on all usable sides of the table measured from the back edge of the benches.	Lacks 36" clearance due to shelter supports	Provide required 36" clear ground space around all usable portions of the table as a smart practice.	2015 ABAAS Section: 1011.2.1

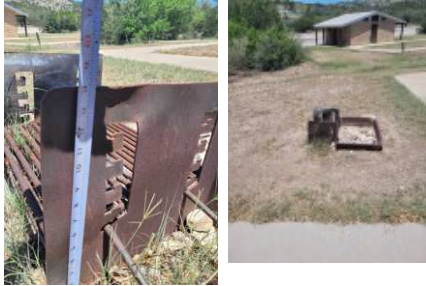
94	Campground: Campsite 3	[29.6113173 , -100.4523 864]	Water spouts at water hydrants and water utility hook-ups shall be 28 inches (710 mm) minimum and 36 inches (915 mm) maximum above the ground.	Water spigot 16.5" above ground surface	Remount water spouts to 28" min or 36" max above the ground as a smart practice.	2015 ABAAS Section: 1011.6

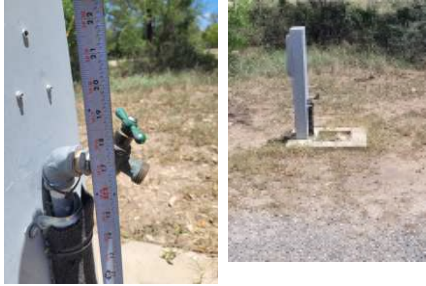
95	Campground: Campsite 3	[29.6113138 , -100.4523 408]	The surface of parking spaces and pull-up spaces shall be firm and stable.	Not firm and stable, loose gravel in parking	Maintain parking surface to be free of debris	2015 ABAAS Section: 1012.4, 1012.5, 1012.5 EXCEPTION

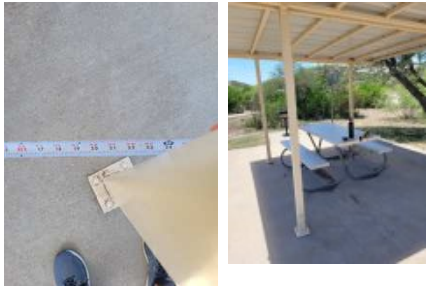
98	Campground: Campsite 5	[29.6118396, -100.4522711]	Picnic tables are required to have clear ground space 36 inches (915 mm) on all usable sides of the table measured from the back edge of the benches.	20.5" at post, lacks clearance at all posts	Provide required 36" clear ground space around all usable portions of the table as a smart practice.	2015 ABAAS Section: 1011.2.1

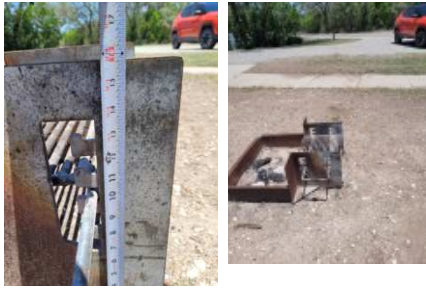
102	Campground: Campsite 5	[29.6118676 , -100.4522 281]	Water spouts at water hydrants and water utility hook-ups shall be 28 inches (710 mm) minimum and 36 inches (915 mm) maximum above the ground.	Water spout 16.5" above ground surface	Remount water spouts to 28" min or 36" max above the ground as a smart practice.	2015 ABAAS Section: 1011.6

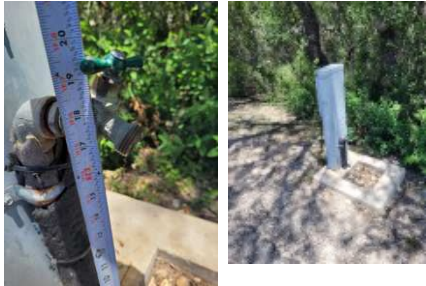
Finding Number	Area Description	Lat/Long	Finding	As Built	Recommendation	Citation	Photos	Figure
103	Campground: Campsite 5	[29.6118676 , -100.4521 906]	The surface of parking spaces and pull-up spaces shall be firm and stable. The slope of the surface of parking spaces and pull-up spaces shall not be steeper than 1:48 in any direction. EXCEPTION: Where the surface is other than asphalt, concrete, or boards, slopes not steeper than 1:20 shall be permitted when necessary for drainage.	Loose gravel in parking	Maintain parking surface to be free of debris	2015 ABAAS Section: 1012.4, 1012.5, 1012.5 EXCEPTION

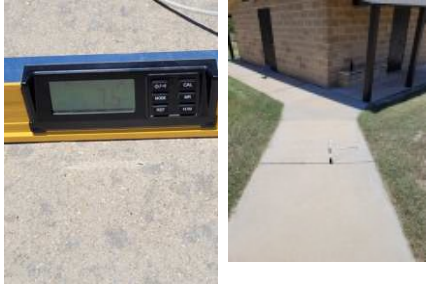
105	Campground: Campsite 5	[29.6116828 , -100.45230 8]	The running slope of walking surfaces shall not be steeper than 1:20.	Campsite 5 to restrooms - 7.5%	Correct running slope along the AR to max 5%.	2015 ABAAS Section: 403.3 2012 TAS Section: 403.3 2010 ADAS Section: 403.3

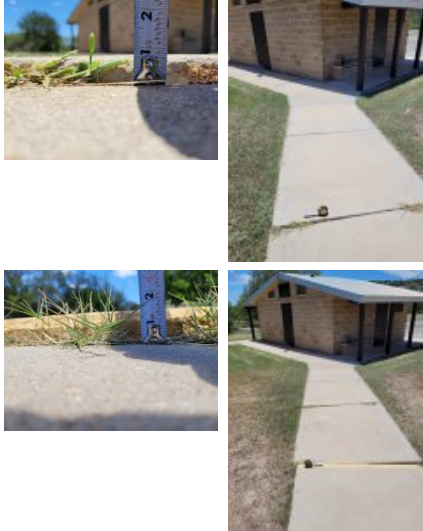
Finding Number	Area Description	Lat/Long	Finding	As Built	Recommendation	Citation	Photos	Figure
108	Campground: Campsite 5	[29.6116817 , -100.4523 027]	The accessible route of travel contains cross slopes greater than 2%. Cross slopes shall not exceed one unit vertical in 48 units horizontal (2-percent slope).	Campsite 5 to restrooms - 4.3%, 3.6%, 4.1%, 5.7%, 4.3%, 6.2%, 4.7%,	Correct or repair cross slope along AR to max 2.08%.	2015 ABAAS Section: 403.3 2012 TAS Section: 403.3 2010 ADAS Section: 403.3

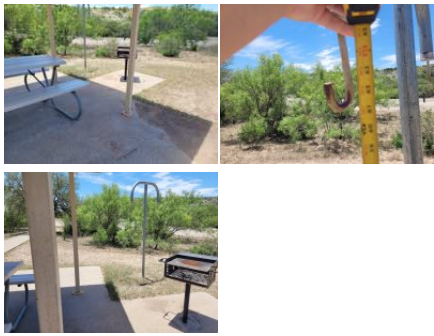
113	Campground: Campsite 7	[29.6121475, -100.4523971]	A minimum of one of each type of outdoor constructed feature does not have mobility features. Where provided, at least one of each type of outdoor constructed features with mobility features must be provided.	hooks 62" and off route	Provide accessible outdoor constructed features at the required number of camp units based on the total number provided. Lower hook to max 48".	2015 ABAAS Section: F244.2.3.1, F245.2.5.1

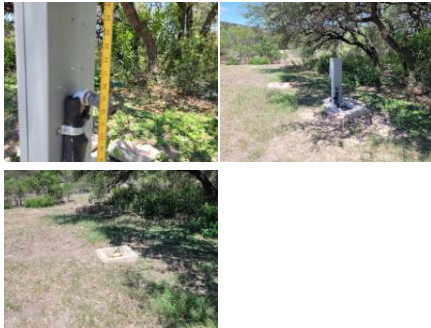
117	Campground: Campsite 7	[29.6122104 , -100.4523 113]	Water spouts at water hydrants and water utility hook-ups shall be 28 inches (710 mm) minimum and 36 inches (915 mm) maximum above the ground.	Water spout 18" above ground surface	Remount water spouts to 28" min or 36" max above the ground as a smart practice.	2015 ABAAS Section: 1011.6

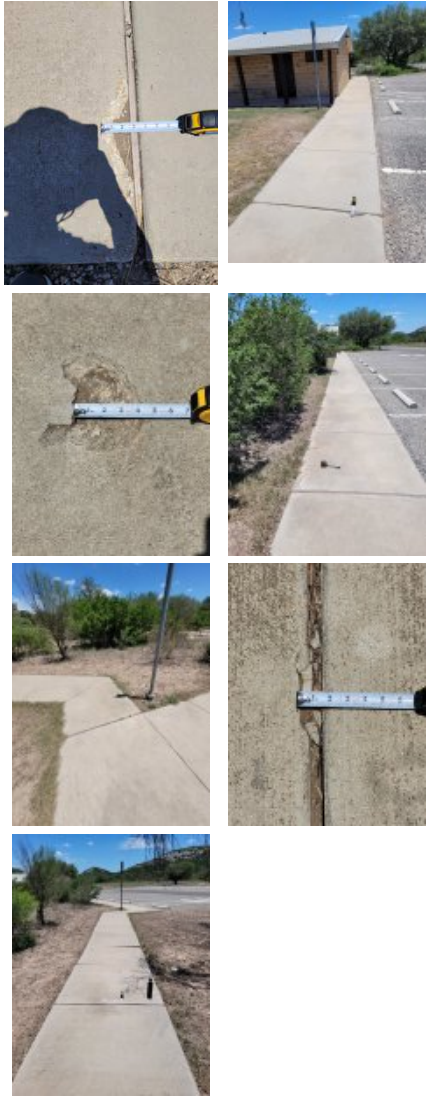
Finding Number	Area Description	Lat/Long	Finding	As Built	Recommendation	Citation	Photos	Figure
119	Campground: Campsite 7	[29.6117961, -100.4526073]	The walkway contains abrupt vertical edges and/or variations over a 1/4 inch. 1/4 inch is the maximum vertical rise. Changes in level between 1/4 inch and 1/2 inch must be beveled at 1:2 or less. Changes in level greater than 1/2 inch must be by way of a ramp.	Campsite 7 to restrooms - 1.25", 1" CIL	Repair, bevel or ramp CIL along AR.	2012 TAS Section: 303.2, 303.3 2010 ADAS Section: 303.2, 303.3

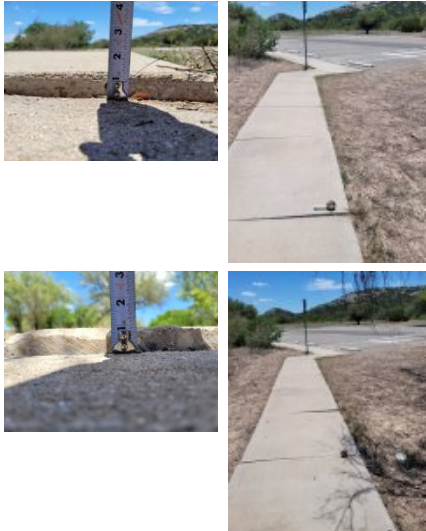
120	Campground: Campsite 7	[29.612058, -100.4523893]	The accessible route of travel contains cross slopes greater than 2%. Cross slopes shall not exceed one unit vertical in 48 units horizontal (2-percent slope).	Campsite 7 to restrooms - 5.6%, 3.3%	Correct or repair cross slope along AR to max 2.08%.	2015 ABAAS Section: 403.3 2012 TAS Section: 403.3 2010 ADAS Section: 403.3

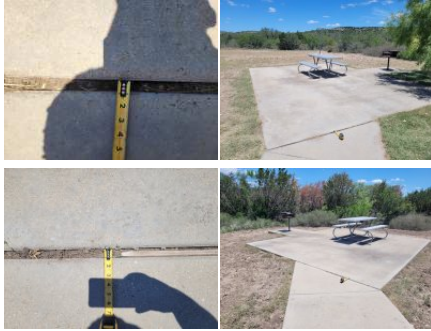
124	Group Camp Area: Group - Campsites	[29.6085656, -100.4536095]	The surface of the outdoor recreation access route, passing spaces, and/or resting intervals are not firm and stable. The surface of outdoor recreation access route, passing spaces, and resting intervals shall be firm and stable, having a width of 36", max gaps of .5" and tread obstacles of .5" or less.	.75" and 1" gap at tables	Correct surface of ORAR to be firm and stable, a min 36" wide and having gaps and changes in level of max .5"	2015 ABAAS Section: 1016.2

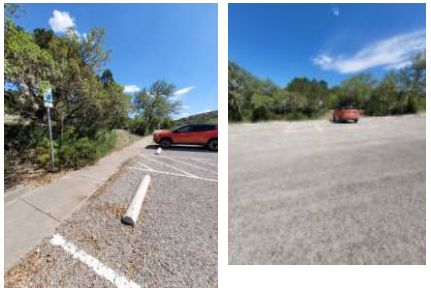
133	Stuart Bat Cave: Cave - Parking	[29.6326695 , -100.4391 041]	The cross slopes (narrow dimension) and/or running slopes (long dimension) of the access aisle exceeds 2%. The running slope and the cross slope in an accessible parking stall and the access aisle must not exceed 2%.	Left stall 3%, access aisle 3.6%	Repair or correct slope of parking space and access aisle to max 2.08% in any direction.	2015 ABAAS Section: 502.4 2012 TAS Section: 502.4 2010 ADAS Section: 502.4

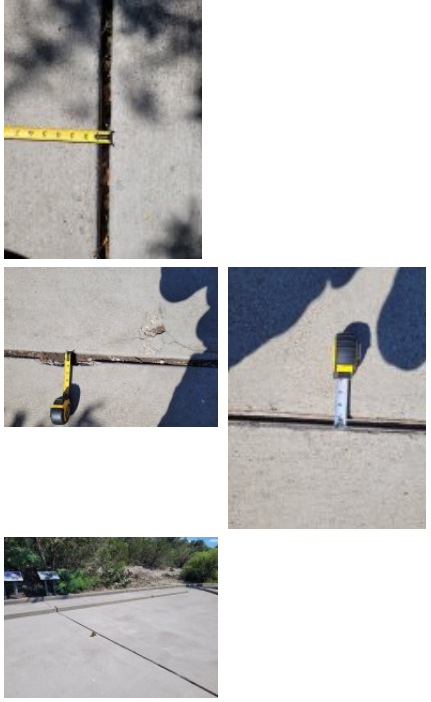
138	Stuart Bat Cave: Cave - Exterior Accessible Route	[29.63262, -100.439]	The running slope of walking surfaces shall not be steeper than 1:20.	5.7% on first run, 6.5% 2nd run	Correct running slope along the AR to max 5%.	2015 ABAAS Section: 403.3 2012 TAS Section: 403.3 2010 ADAS Section: 403.3

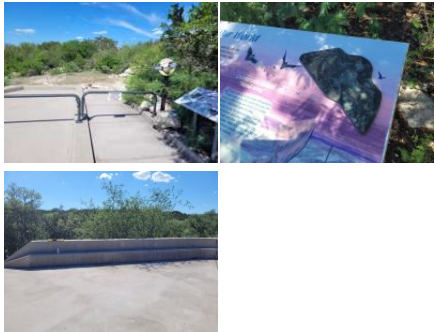
141	Stuart Bat Cave: Cave - Exterior Accessible Route	[29.6325963, -100.439104]	There is a gap spaced greater than a 1/2 inch. Openings in floor or ground surfaces shall not allow passage of a sphere more than 1/2 inch diameter. Elongated openings shall be placed so that the long dimension is perpendicular to the dominant direction of travel.	1" gap at parking approaching ramp	Correct or fill gaps to be max .5".	2015 ABAAS Section: 302.3 2012 TAS Section: 302.3 2010 ADAS Section: 302.3

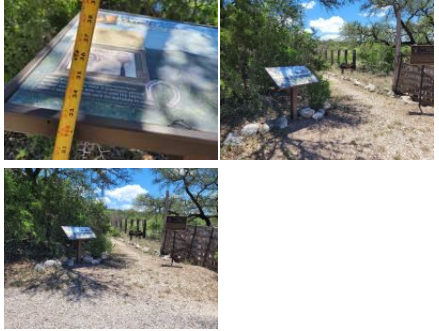
Finding Number	Area Description	Lat/Long	Finding	As Built	Recommendation	Citation	Photos	Figure
149	Trails: Trail Surface	[29.6106228, -100.4519678]	The surface of trails, passing spaces, and resting intervals shall be firm and stable	Seargeant Memorial trail surface loose stone, only 32" wide, tree branch overhang, narrows further, pipe, large rocks	Replace surface of trail with one that is firm and stable as a smart practice. Widen trail surface to min 36" wide with compliant resting intervals if trail tread is less than 60" wide. Maintain trail surface and overhead clearance.	2015 ABAAS Section: 1017.2
