Access Audit Site Report

Lake Arrowhead State Park

Accessibility Evaluation

Inspection Date: 05/18/2022

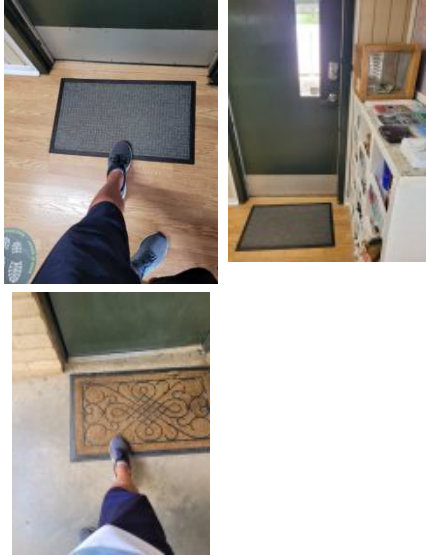
Finding Number	Area Description	Lat/Long	Finding	As Built	Recommendation	Citation	Photos	Figure																																																																																																																																																																																																																																																																														
8	Headquarters Area: HQ - Public Spaces	[33.7586, -98.3952]	Minimum maneuvering clearances at doors and gates shall comply with 404.2.4. Maneuvering clearances shall extend the full width of the doorway and the required latch side or hinge side clearance.	Main entry - lacks secured floor mats (2), lacks clearance on push side due to shelf/storage	For all doors along the public circulation route, provide required maneuvering clearance on push and pull side of doors. For all doors along the public circulation route, secure rug in door clearance to prevent trip hazard.	2010 ADAS Section: 404.2.3, 404.2.7, 404.2.4, 404.2.11, 404.2.11 Exception

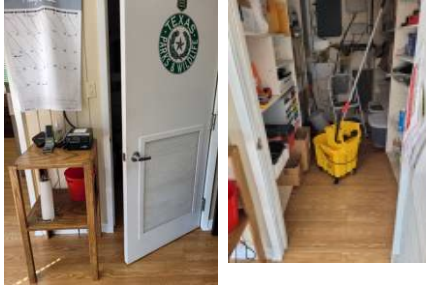
9	Headquarters Area: HQ - Public Spaces	[33.7585995, -98.3952079]	Minimum maneuvering clearances at doors and gates shall comply with 404.2.4. Maneuvering clearances shall extend the full width of the doorway and the required latch side or hinge side clearance.	storage/janitor-clearance reduced by shelf on pull side, shelves on push side	For all doors along the public circulation route, provide required maneuvering clearance on push and pull side of doors.	2010 ADAS Section: 404.2.3, 404.2.7, 404.2.4, 404.2.11, 404.2.11 Exception

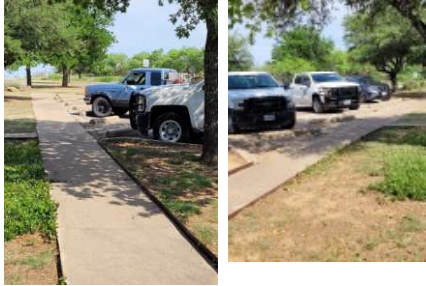
10	Headquarters Area: HQ - Public Spaces	[33.7584651, -98.3950342]	There are no or not enough accessible parking stalls. Each lot where parking is provided for the public as clients, guests or employees, shall provide accessible parking and shall be located on the shortest accessible route of travel from adjacent parking to an accessible entrance. There are a total of 13 parking stalls in the parking lot that could be reasonably associated with this facility. There should be a minimum of 1 accessible stalls with a minimum of 1 being designed as van accessible.	Lacks required number of accessible parking spaces - 13 standard, 0 accessible	Create one or more 8' accessible parking stalls, with one 5' adjacent access aisle, with proper signage and striping based on the total number of stalls.	2015 ABAAS Section: F208.2 2012 TAS Section: 208.2 2010 ADAS Section: 208.2

<table><tr> <th>Total Number of Parking Spaces</th> <th>Number of Accessible Spaces</th> <th>Minimum Number of Required Accessible Parking Spaces</th> </tr><tr> <td>12</td> <td>0</td> <td>2</td> </tr></table>

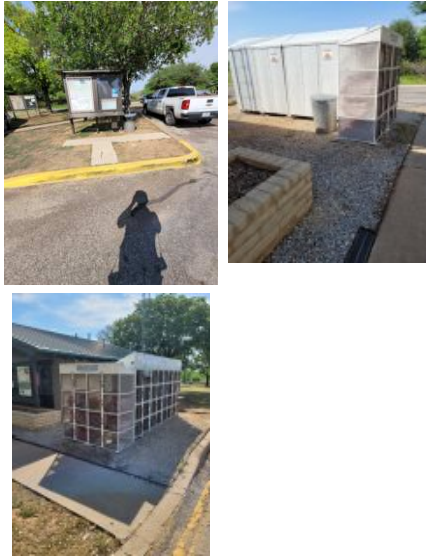
Finding Number	Area Description	Lat/Long	Finding	As Built	Recommendation	Citation	Photos	Figure
11	Headquarters Area: HQ - Public Spaces	[33.7584952, -98.3951088], [33.7586268, -98.3951423]	There is no accessible route to the garbage cans and firewood dispenser. At least one accessible route shall connect accessible buildings, accessible facilities, accessible elements, and accessible spaces that are on the same site.	Lacks route to 2 garbage, firewood	Create an accessible route with crushed stone or other outdoor material from parking or walkway to the firewood dispenser. Relocate 20% of garbage cans to be along AR.	2015 ABAAS Section: F206.2.2 2012 TAS Section: 206.2.2 2010 ADAS Section: 206.2.2

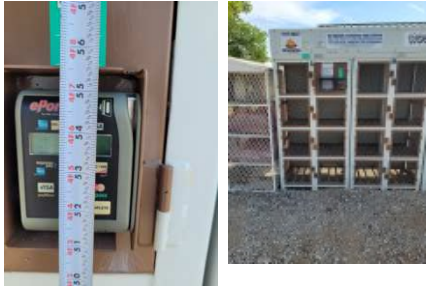
12	Headquarters Area: HQ - Public Spaces	[33.7586223, -98.3951321]	The operable part is positioned too high for either a side or front approach. Where a clear floor or ground space allows a parallel approach to an element and the side reach is unobstructed, the high side reach shall be 48 inches maximum and the low side reach shall be 15 inches minimum above the finish floor or ground. Where a forward reach is unobstructed, the high forward reach shall be 48 inches maximum and the low forward reach shall be 15 inches minimum above the finish floor or ground.	Payment controls at firewood dispenser at 55" AGL	Remount operable parts to be in reach range of 15" min to 48" max.	2015 ABAAS Section: 308.1 2012 TAS Section: 308.1 2010 ADAS Section: 308.1

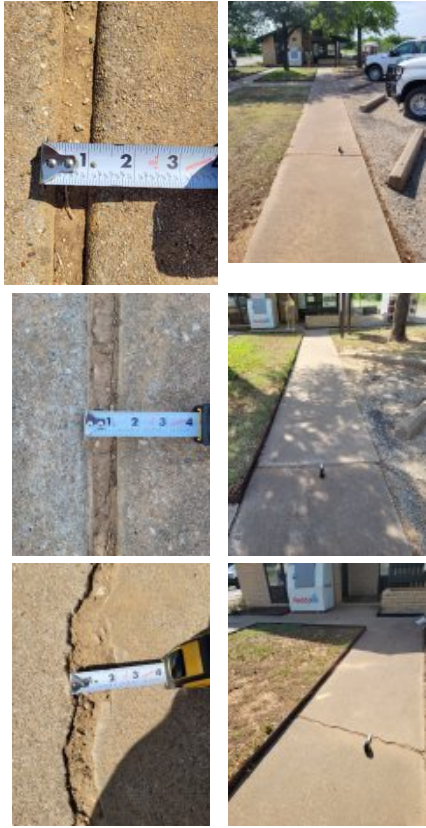
Finding Number	Area Description	Lat/Long	Finding	As Built	Recommendation	Citation	Photos	Figure
13	Headquarters Area: HQ - Public Spaces	[33.7585758, -98.3951492], [33.7584632, -98.3948984]	There is a gap spaced greater than a 1/2 inch. Openings in floor or ground surfaces shall not allow passage of a sphere more than 1/2 inch diameter. Elongated openings shall be placed so that the long dimension is perpendicular to the dominant direction of travel.	From exit parking to HQ - gaps of 1", 1.25", 2"	Correct or fill gaps to be max .5".	2015 ABAAS Section: 302.3 2012 TAS Section: 302.3 2010 ADAS Section: 302.3

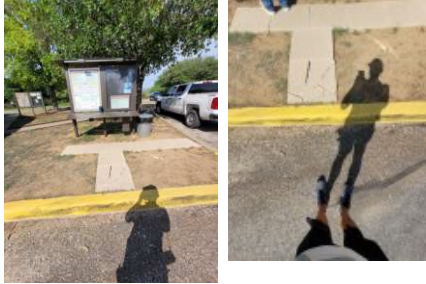
14	Headquarters Area: HQ - Public Spaces	[33.7584947, -98.3951173]	There is no accessible route to the pay station. At least one accessible route shall connect accessible buildings, accessible facilities, accessible elements, and accessible spaces that are on the same site.	Lacks route to pay station	Create an accessible route with crushed stone or other outdoor material from parking or walkway to the pay station.	2015 ABAAS Section: F206.2.2 2012 TAS Section: 206.2.2 2010 ADAS Section: 206.2.2

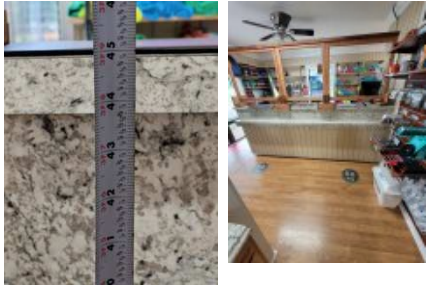
Finding Number	Area Description	Lat/Long	Finding	As Built	Recommendation	Citation	Photos	Figure
15	Headquarters Area: HQ - Public Spaces	[33.7585988 , -98.39521]	The transaction counter is too high. A portion of the counter surface that is 36 inches long minimum and 36 inches high maximum above the finish floor shall be provided. Knee and toe space must be provided for a forward approach. A 30 inch by 48 inch clear floor space on an accessible route must be provided for either a forward or parallel approach.	Service counter at 45" AFF	Lower 36" wide segment of service counter to max 36" AFF.	2015 ABAAS Section: 904.4.2, 904.4.1 2012 TAS Section: 904.4.1, 904.4.2 2010 ADAS Section: 904.4.2, 904.4.1

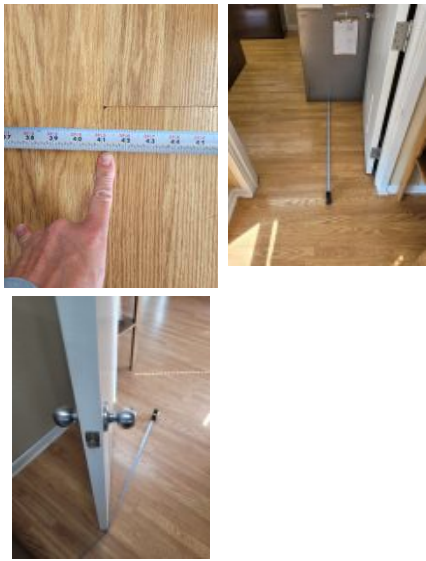
16	Headquarters Area: HQ - Employee Spaces	[33.7586044 , -98.3952497]	Minimum maneuvering clearances at doors and gates shall comply with 404.2.4. Maneuvering clearances shall extend the full width of the doorway and the required latch side or hinge side clearance. Hand-activated door opening hardware, handles, pulls, latches, locks, and other operating devices on accessible doors shall have a shape that is easy to grasp with one hand and does not require tight grasping, tight pinching or twisting of the wrist to operate. Hardware shall be 34 inches minimum and 48 inches maximum above the finish floor or ground.	Office manager office door - clearance reduced to 41" due to cabinet, knobs	For all doors along the public circulation route, provide required maneuvering clearance on push and pull side of doors. For all doors along the public circulation route, replace hardware with lever hardware or hardware operable without a tight pinch or grasp.	2010 ADAS Section: 404.2.3, 404.2.7, 404.2.4, 404.2.11, 404.2.11 Exception

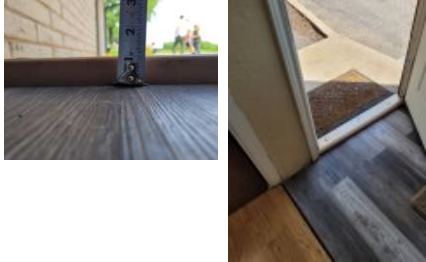
Finding Number	Area Description	Lat/Long	Finding	As Built	Recommendation	Citation	Photos	Figure
17	Headquarters Area: HQ - Employee Spaces	[33.7586041, -98.3952327]	Thresholds, if provided at doorways, shall be 1/2 inch (13 mm) high maximum. Raised thresholds and changes in level at doorways shall comply with 302 and 303. Changes in level of 1/4 inch (6.4 mm) high maximum shall be permitted to be vertical. Changes in level between 1/4 inch (6.4 mm) high minimum and 1/2 inch (13 mm) high maximum shall be beveled with a slope not steeper than 1:2. Changes in level greater than 1/2 inch (13 mm) high shall be ramped, and shall comply with 405 or 406.	1" CIL at check-in work station	Repair, bevel or ramp CIL at doorway.	2015 ABAAS Section: 303.3, 404.2.5, 303.2, 303.4 2012 TAS Section: 303.3, 404.2.5, 303.2, 303.4 2010 ADAS Section: 303.3, 404.2.5, 303.2, 303.4

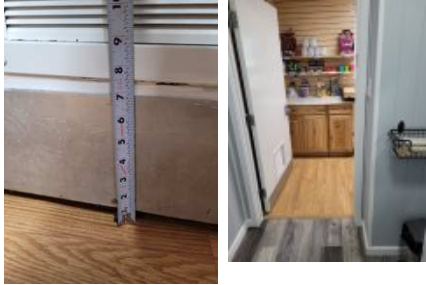
Finding Number	Area Description	Lat/Long	Finding	As Built	Recommendation	Citation	Photos	Figure
21	Headquarters Area: HQ - Employee Restroom	[33.75861, -98.39523]	Minimum maneuvering clearances at doors and gates shall comply with 404.2.4. Maneuvering clearances shall extend the full width of the doorway and the required latch side or hinge side clearance. The bottom 10 inches on the push side must be smooth and free of obstructions (hold open devices). Opening hardware must be mounted between 30 and 44 inches above the floor or ground.	Employee restroom door - lacks 10" smooth bottom, lacks clearance on push side	For all doors along the public circulation route, provide required maneuvering clearance on push and pull side of doors. For all doors along the public circulation route, provide kick plate on push side of door from floor to 10" AFF.	2010 ADAS Section: 404.2.3, 404.2.7, 404.2.4, 404.2.11, 404.2.11 Exception

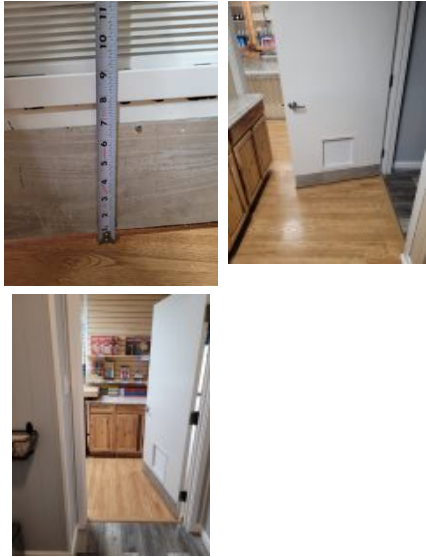
22	Headquarters Area: HQ - Public Restroom	[33.7585998, -98.3952024]	Minimum maneuvering clearances at doors and gates shall comply with 404.2.4. Maneuvering clearances shall extend the full width of the doorway and the required latch side or hinge side clearance. The bottom 10 inches on the push side must be smooth and free of obstructions (hold open devices). Opening hardware must be mounted between 30 and 44 inches above the floor or ground.	Public restroom door - lacks 10" smooth bottom, lacks clearance on push	For all doors along the public circulation route, provide required maneuvering clearance on push and pull side of doors. For all doors along the public circulation route, provide kick plate on push side of door from floor to 10" AFF.	2010 ADAS Section: 404.2.3, 404.2.7, 404.2.4, 404.2.11, 404.2.11 Exception

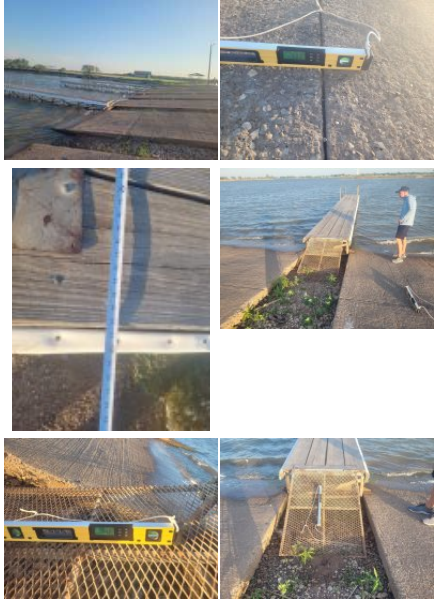
Finding Number	Area Description	Lat/Long	Finding	As Built	Recommendation	Citation	Photos	Figure
25	Public Spaces: Boat Ramp	[33.75485, -98.38753]	The minimum number of boarding piers are not accessible. Where boarding piers are provided at boat launch ramps, at least 5 percent, but no fewer than one, of the boarding piers be accessible.	Pier with ramp is 46.25" wide, access to ramp is through rocks between launches, 13.2% slope on concrete boat launches, 34.1% ramp onto pier	Provide 5%, but not less than one accessible boarding pier at boat launches.	2015 ABAAS Section: F235.3 2010 ADAS Section: 235.3

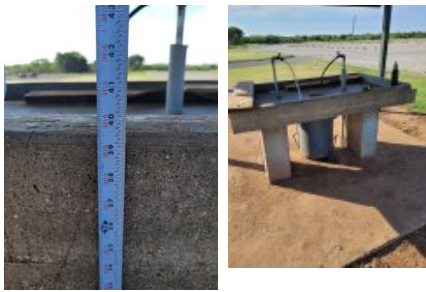
31	Public Spaces: Fish Cleaning	[33.7545648 , -98.387969 3]	The operable part is not accessible because it requires tight grasping, pinching or twisting of the wrist.	Water spout hardware requires pinch and grasp	Replace operable part with one usable without a tight pinch or grasp.	2015 ABAAS Section: 309.4 2012 TAS Section: 309.4 2010 ADAS Section: 309.4

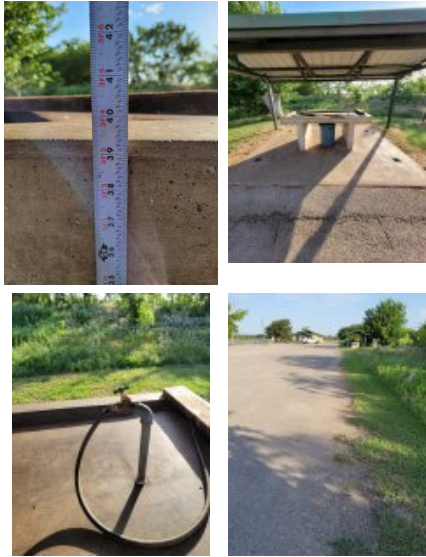
Finding Number	Area Description	Lat/Long	Finding	As Built	Recommendation	Citation	Photos	Figure
32	Public Spaces: Fish Cleaning	[33.7548699 , -98.383765 6]	The top of the work surface is not within a compliant height range. The tops of tables and counters shall be 28 inches to 34 inches from the floor or ground. The operable part is not accessible because it requires tight grasping, pinching or twisting of the wrist.	Fish cleaning station near pier - table at 39.5" above ground surface, spigot controls require grasp and twist	Provide tables and work surfaces at 28" to 34" AFF with required knee and toe clearances. Replace operable part with one usable without a tight pinch or grasp.	2015 ABAAS Section: 902.3 2012 TAS Section: 902.3 2010 ADAS Section: 902.3

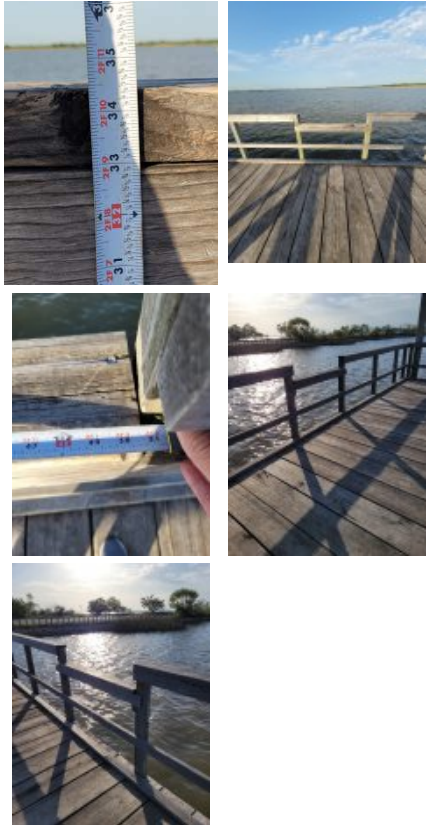
Finding Number	Area Description	Lat/Long	Finding	As Built	Recommendation	Citation	Photos	Figure
33	Public Spaces: Fishing	[33.7542749 , -98.383672 4]	Not enough of the railings, guards, or handrails are at the allowable height. At least 25 percent of the railings, guards, or handrails shall be 34 inches maximum above the ground or deck surface.	railings 34.5" AGL - 3 locations	Lower 25% of the railing; dispersed through pier, to max 34".	2015 ABAAS Section: 1005.2.1 2010 ADAS Section: 1005.2.1

<p>The 'Photos' column contains five images: 1) A close-up of a wooden railing with a blue measuring tape held against it, showing a height of approximately 34.5 inches. 2) A view of the wooden pier deck and railing extending towards the water. 3) Another close-up of the railing with the measuring tape. 4) A view of the railing from a different angle, showing its connection to the deck. 5) A wider view of the pier railing overlooking the water under a bright sky.</p>

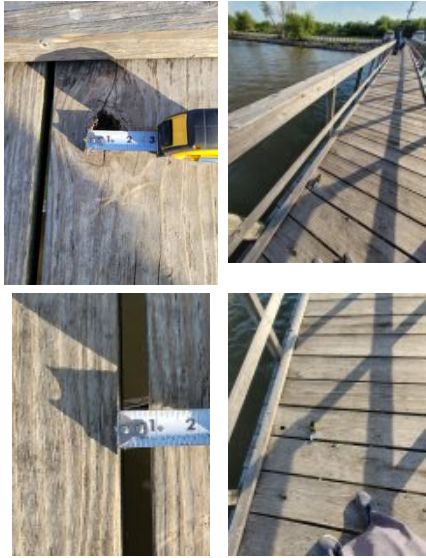
Finding Number	Area Description	Lat/Long	Finding	As Built	Recommendation	Citation	Photos	Figure																						
34	Public Spaces: Fishing	[33.75415, -98.38381]	There is a gap spaced greater than a 1/2 inch. Openings in floor or ground surfaces shall not allow passage of a sphere more than 1/2 inch diameter. Elongated openings shall be placed so that the long dimension is perpendicular to the dominant direction of travel.	1.5" gap at pier, multiple .75" - 1" gaps between boards	Correct or fill gaps to be max .5".	2015 ABAAS Section: 302.3 2012 TAS Section: 302.3 2010 ADAS Section: 302.3

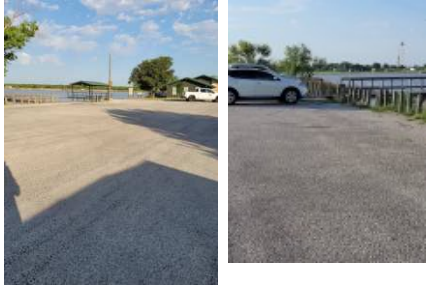
35	Public Spaces: Fishing	[33.7542972, -98.3833746]	There are no or not enough accessible parking stalls. Each lot where parking is provided for the public as clients, guests or employees, shall provide accessible parking and shall be located on the shortest accessible route of travel from adjacent parking to an accessible entrance. There are a total of 50 parking stalls in the parking lot that could be reasonably associated with this facility. There should be a minimum of 2 accessible stalls with a minimum of 1 being designed as van accessible.	Fishing area lacks accessible parking and striping - approximately 50 standard, 0 accessible	Create two or more 8' accessible parking stalls, with one 5' adjacent access aisle, with proper signage and striping based on the total number of stalls.	2015 ABAAS Section: F208.2 2012 TAS Section: 208.2 2010 ADAS Section: 208.2

<table><tr> <th>Total Number of Parking Spaces Provided in Parking Facility</th> <th>Minimum Number of Required Accessible Parking Spaces</th> </tr><tr> <td>20 or less</td> <td>2</td> </tr></table>

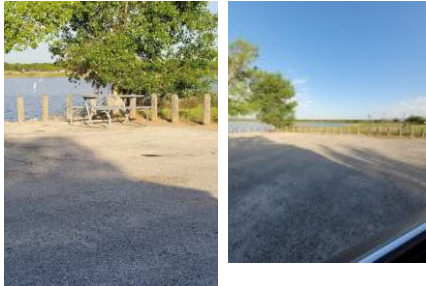
38	Public Spaces: Playground	[33.7556382 , -98.385172 1]	Picnic tables shall provide at least one wheelchair space for each 24 linear feet (7320 mm) of usable table surface perimeter. Wheelchair spaces shall be 30 inches (760 mm) minimum by 48 inches (1220 mm) minimum. Wheelchair spaces shall be positioned for a forward approach to the table and provide knee and toe clearance complying with 306 under the table	Picnic table in parking lot near playground and Admin building is not of an accessible design	Replace picnic table with one of an accessible design as a smart practice.	2015 ABAAS Section: 1011.4.2

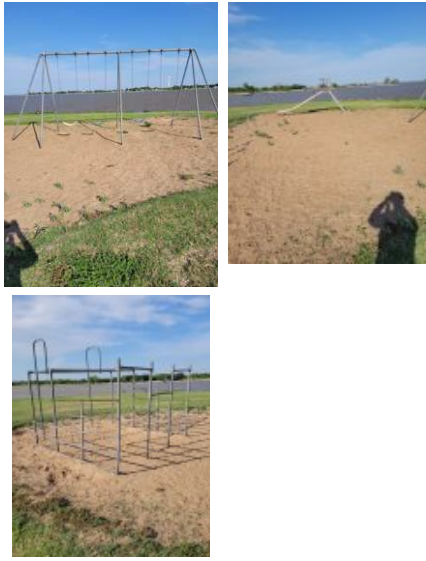
43	Public Spaces: Playground	[33.7535389 , -98.3862124]	Element meets all standards and requirements	play area by boat ramp- 4 belt swings, slide, climber comply (with surface correction)	None	2010 ADAS Section: N/A

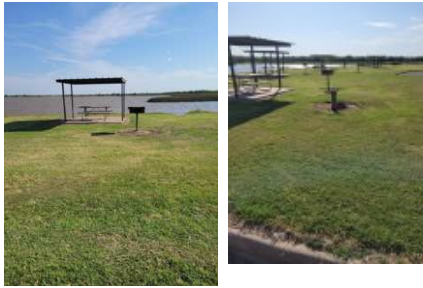
46	Public Spaces: Shelters/Picnic Areas	[33.7533628 , -98.3875803]	An accessible access route is not provided between elements, spaces and the facilities provided within the accessible camping unit. At least one outdoor recreation access route shall connect accessible elements, spaces and facilities provided within camping units with mobility features.	Day Use area - Lacks ORAR to grill and water at all sites	Create AR with crushed and compacted stone or similar outdoor material to camp sites and one of each type of amenity.	2015 ABAAS Section: F244.5.1

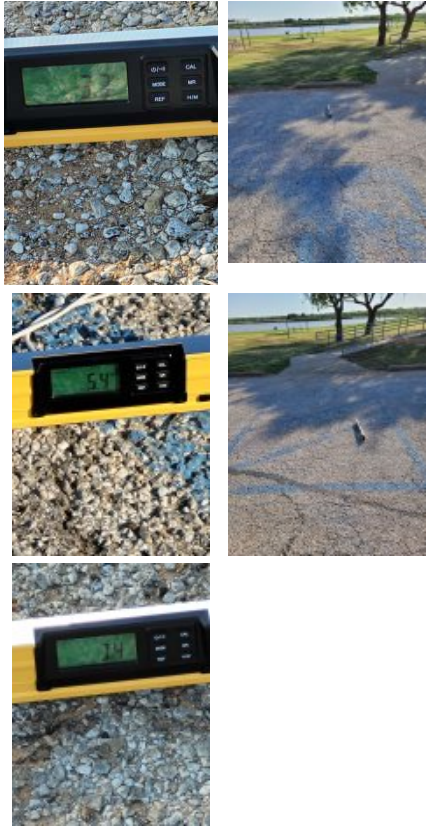
Finding Number	Area Description	Lat/Long	Finding	As Built	Recommendation	Citation	Photos	Figure
50	Public Spaces: Shelters/Picnic Areas	[33.7567625 , -98.385556 6]	The cross slopes (narrow dimension) and/or running slopes (long dimension) of the access aisle exceeds 2%. The running slope and the cross slope in an accessible parking stall and the access aisle must not exceed 2%.	Day use near campsites parking meets scoping requirements - left stall 3.3%, access aisle 5.4%, right stall 3.4%	Repair or correct slope of parking space and access aisle to max 2.08% in any direction.	2015 ABAAS Section: 502.4 2012 TAS Section: 502.4 2010 ADAS Section: 502.4

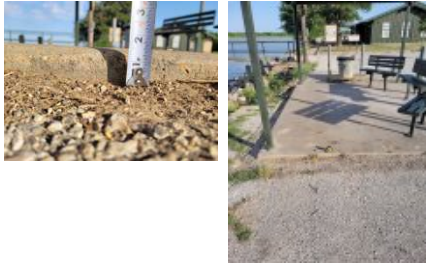
Finding Number	Area Description	Lat/Long	Finding	As Built	Recommendation	Citation	Photos	Figure
59	Public Spaces: Shelters/Picnic Areas	[33.7548926, -98.3841766]	The walkway contains abrupt vertical edges and/or variations over a 1/4 inch. 1/4 inch is the maximum vertical rise. Changes in level between 1/4 inch and 1/2 inch must be beveled at 1:2 or less. Changes in level greater than 1/2 inch must be by way of a ramp.	near swimming- 1.5" CIL at entry to covered benches	Repair, bevel or ramp CIL along AR.	2012 TAS Section: 303.2, 303.3 2010 ADAS Section: 303.2, 303.3

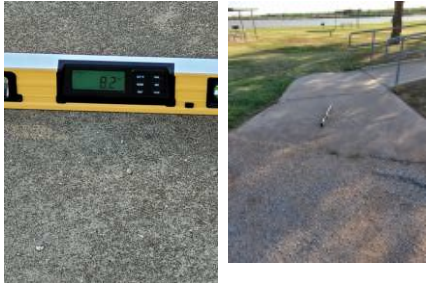
Finding Number	Area Description	Lat/Long	Finding	As Built	Recommendation	Citation	Photos	Figure
78	Public Spaces: Beach Men's Restroom	[33.7567558 , -98.385649 1]	The landing at the bottom of the ramp has a slope greater than 2%. Bottom landings shall have a dimension in the direction of ramp run of not less than 60 inches and have a slope of less than 2% in any direction.	Slope of 2.7% at top landing of ramp	Correct ramp landing slope to max 2.08%.	2015 ABAAS Section: 405.7.1, 405.7.1 EXCEPTION 2012 TAS Section: 405.7.1, 405.7.1 Exception 2010 ADAS Section: 405.7.1, 405.7.1 Exception

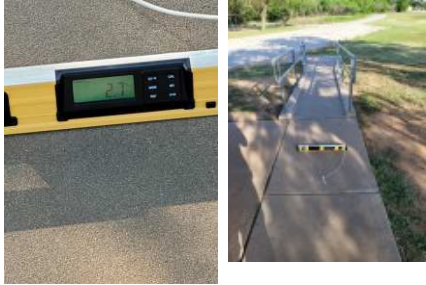
79	Public Spaces: Beach Women's Restroom	[33.7568102 , -98.385678 5]	It is recommended that exterior doors be maintained so that the operating pressure does not exceed 8.5 lb. force to open. The sweep period for doors with closers shall be adjusted so that from an open position of 70 degrees, the door will take at least 3 seconds to move to a point 7 inches from the latch, measured to the leading edge of the door.	Beach women's restroom door - 11# push, fast close	For all doors along the public circulation route, inspect, adjust, and maintain 8.5 lbf to open exterior doors as a smart practice. For all doors along the public circulation route, inspect, adjust, and maintain closing speed on door closers.	2012 TAS Section: 404.2.9, 404.2.9 Advisory, 404.2.8.1 2010 ADAS Section: 404.2.9, 404.2.8.1

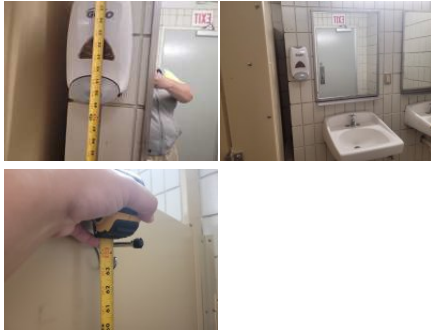
Finding Number	Area Description	Lat/Long	Finding	As Built	Recommendation	Citation	Photos	Figure
84	Public Spaces: Beach Women's Restroom	[33.7568082, -98.3856813]	Where a high forward reach is over an obstruction, the clear floor space shall extend beneath the element for a distance not less than the required reach depth over the obstruction. The high forward reach shall be 48 inches (1220 mm) maximum where the reach depth is 20 inches (510 mm) maximum. Where the reach depth exceeds 20 inches (510 mm), the high forward reach shall be 44 inches (1120 mm) maximum and the reach depth shall be 25 inches (635 mm) maximum. Where a clear floor or ground space allows a parallel approach to an element and the high side reach is over an obstruction, the height of the obstruction shall be 34 inches (865 mm) maximum and the depth of the obstruction shall be 24 inches (610 mm) maximum. The high side reach shall be 48 inches (1220 mm) maximum for a reach depth of 10 inches (255 mm) maximum. Where the reach depth exceeds 10 inches (255 mm), the high side reach shall be 46 inches (1170 mm) maximum for a reach depth of 24 inches (610 mm) maximum.	Beach women's restroom - Soap dispenser at 49" AFF and over sink, hook at 63.75"	Lower coat hook operating mechanisms to max 48" above the finished floor (AFF) to highest operable part. Lower soap dispenser to max 44" above the finished floor (AFF) for a forward reach over counter.	2015 ABAAS Section: 308.2.1, 308.3.2 2012 TAS Section: 308.2.1, 308.3.2 2010 ADAS Section: 308.2.1, 308.3.2

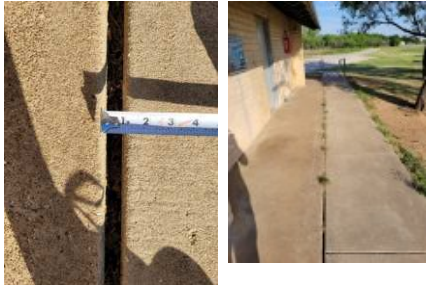
Finding Number	Area Description	Lat/Long	Finding	As Built	Recommendation	Citation	Photos	Figure
95	Public Spaces: Beach Women's Restroom	[33.7568376 , -98.385722 7]	There is a gap spaced greater than a 1/2 inch. Openings in floor or ground surfaces shall not allow passage of a sphere more than 1/2 inch diameter. Elongated openings shall be placed so that the long dimension is perpendicular to the dominant direction of travel.	Beach restrooms - 1" gap at restrooms	Correct or fill gaps to be max .5".	2015 ABAAS Section: 302.3 2012 TAS Section: 302.3 2010 ADAS Section: 302.3

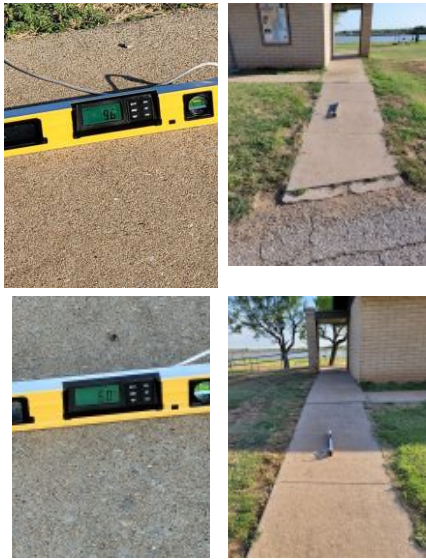
Finding Number	Area Description	Lat/Long	Finding	As Built	Recommendation	Citation	Photos	Figure
97	Public Spaces: Boat Ramp Day Use Men's Restrooms	[33.7542811, -98.3882827], [33.7542008, -98.3882062]	The walkway contains abrupt vertical edges and/or variations over a 1/4 inch. 1/4 inch is the maximum vertical rise. Changes in level between 1/4 inch and 1/2 inch must be beveled at 1:2 or less. Changes in level greater than 1/2 inch must be by way of a ramp.	Approaching day use restrooms - CILs of .75" and 1"; at women's restroom CIL of 1.25"; at men's restroom CIL of 2"	Repair, bevel or ramp CIL along AR.	2012 TAS Section: 303.2, 303.3 2010 ADAS Section: 303.2, 303.3

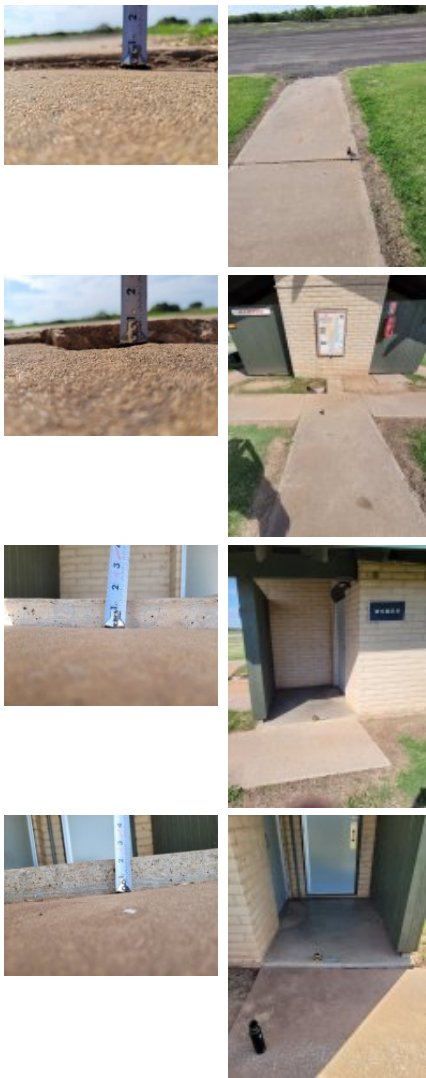
Finding Number	Area Description	Lat/Long	Finding	As Built	Recommendation	Citation	Photos	Figure
98	Public Spaces: Boat Ramp Day Use Men's Restrooms	[33.7541745 , -98.388157]	The restroom sign does not comply with one or more applicable requirements for the location, height, and properties of the sign.	Day Use Men's Restroom - Lacks compliant signage and location	Replace sign with one of contrasting colors that includes Braille, raised characters, and the symbol of accessibility and mount on the wall, latch side of the door, 48" to the baseline of the lowest character and 60" to the baseline of the highest character.	2015 ABAAS Section: F216.2, 703.1, 703.2, 703.5, 703.6 2012 TAS Section: 216.2, 703.1, 703.2, 703.5, 703.6 2010 ADAS Section: 216.2, 703.1, 703.2, 703.5, 703.6

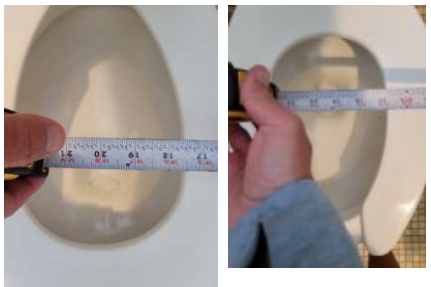
105	Public Spaces: Boat Ramp Day Use Men's Restrooms	[33.7541656 , -98.3881731]	The toilet is not located within the range to the side wall or partition. The centerline of the toilet shall be 17 inches minimum and 19 inches maximum side wall or partition in the ambulatory accessible toilet compartment.	Day Use Men's Restroom - Toilet is 20" and 19.5" from side walls	Remount toilet to 17" to 19" from the side wall to center line in ambulatory stalls.	2015 ABAAS Section: 604.9.1 2012 TAS Section: 604.9.1 2010 ADAS Section: 604.9.1

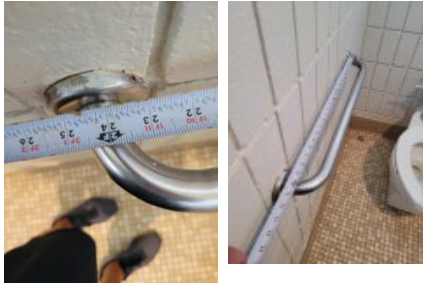
108	Public Spaces: Boat Ramp Day Use Men's Restrooms	[33.7541745 , -98.388173 1]	Grab bars shall comply with 609. A side-wall grab bar complying with 604.5.1 shall be provided on both sides of the compartment. The space between the wall and the grab bar shall be 1½ inches (38 mm). The space between the grab bar and projecting objects below and at the ends shall be 1½ inches (38 mm) minimum. The space between the grab bar and projecting objects above shall be 12 inches (305 mm) minimum. Grab bars shall be installed in a horizontal position, 33 inches (840 mm) minimum and 36 inches (915 mm) maximum above the finish floor measured to the top of the gripping surface, except that at water closets for children's use complying with 604.9, grab bars shall be installed in a horizontal position 18 inches (455 mm) minimum and 27 inches (685 mm) max	Day Use Men's Restroom - Both grab bars are 24" long	Replace or add side grab bars with a 42" long grab bar, mounted max 12" from the rear wall at the close end and min 54" on the far end and 33" to 36" AFF.	2015 ABAAS Section: 604.8.2.3, 609.3, 609.4 2012 TAS Section: 609.4, 609.3, 604.8.2.3 2010 ADAS Section: 609.3, 609.4, 604.8.2.3

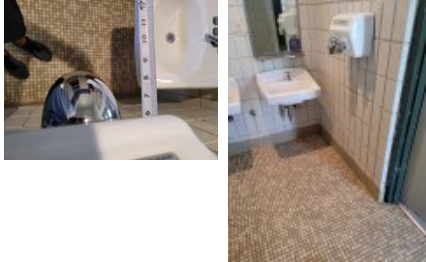
Finding Number	Area Description	Lat/Long	Finding	As Built	Recommendation	Citation	Photos	Figure
110	Public Spaces: Boat Ramp Day Use Men's Restrooms	[33.7541834 , -98.388170 4]	An item or items project more than 4 inches into the circulation path. Wall-mounted objects that have leading edges between 27 inches and 80 inches from the floor must not project more than 4 inches into the circulation path. Protruding objects that extend to the floor or within 27 inches of the floor are cane detectable and are therefore not hazardous. Where it is necessary or desirable to have objects protrude from the wall, a manner of cane detection must be provided.	Day Use Men's Restroom - Hand dryer protrudes 8.5"	Relocate protruding objects or place cane detectable warning or bollard at foot of item.	2015 ABAAS Section: 307.2 2012 TAS Section: 307.2 2010 ADAS Section: 307.2

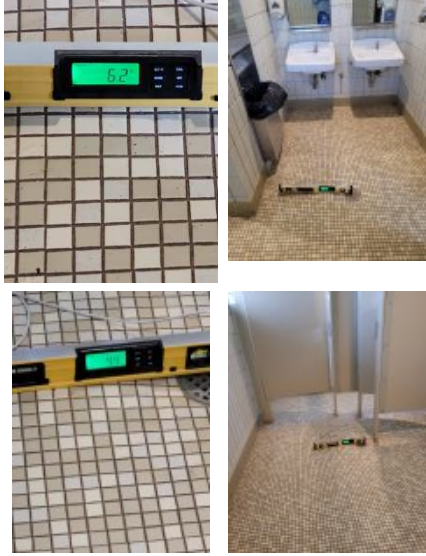
112	Public Spaces: Boat Ramp Day Use Men's Restrooms	[33.7541773 , -98.388166 1]	Minimum maneuvering clearances at doors and gates shall comply with 404.2.4. Maneuvering clearances shall extend the full width of the doorway and the required latch side or hinge side clearance. Maneuvering clearances shall have a max slope of 2.08%.	Day Use Men's Restroom - Slope of 6.9% in clearance of door	For all doors along the public circulation route, correct slope in door clearance to max 2.08%.	2010 ADAS Section: 404.2.3, 404.2.7, 404.2.4, 404.2.11, 404.2.11 Exception

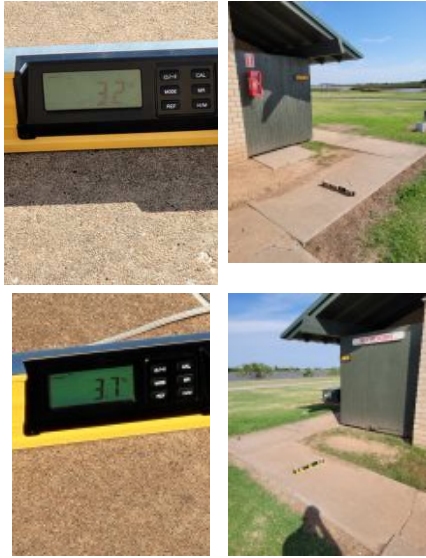
114	Public Spaces: Boat Ramp Day Use Women's Restrooms	[33.75419, -98.3881683]	Minimum maneuvering clearances at doors and gates shall comply with 404.2.4. Maneuvering clearances shall extend the full width of the doorway and the required latch side or hinge side clearance. Maneuvering clearances shall have a max slope of 2.08%.	Day Use Women's Restroom Door - 8.8% slope in clearance of restroom door	For all doors along the public circulation route, correct slope in door clearance to max 2.08%.	2010 ADAS Section: 404.2.3, 404.2.7, 404.2.4, 404.2.11, 404.2.11 Exception

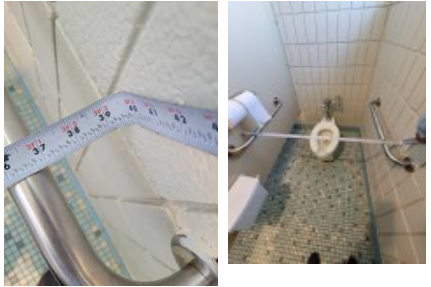
119	Public Spaces: Boat Ramp Day Use Women's Restrooms	[33.7541667 , -98.3881677]	The ambulatory stall is not between 35" to 37" wide and 60" deep.	Day Use Women's Restroom - Ambulatory stall is 39.5" wide	Correct ambulatory stall to be 35" to 37" wide and minimum 60" deep.	2015 ABAAS Section: 604.8.2.1 2012 TAS Section: 604.8.2.1 2010 ADAS Section: 604.8.2.1

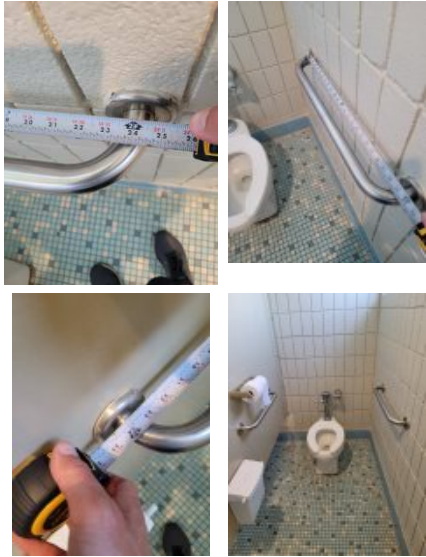
Finding Number	Area Description	Lat/Long	Finding	As Built	Recommendation	Citation	Photos	Figure
123	Public Spaces: Boat Ramp Day Use Women's Restrooms	[33.7541745 , -98.388173 1]	Grab bars shall comply with 609. A side-wall grab bar complying with 604.5.1 shall be provided on both sides of the compartment. The space between the wall and the grab bar shall be 1½ inches (38 mm). The space between the grab bar and projecting objects below and at the ends shall be 1½ inches (38 mm) minimum. The space between the grab bar and projecting objects above shall be 12 inches (305 mm) minimum. Grab bars shall be installed in a horizontal position, 33 inches (840 mm) minimum and 36 inches (915 mm) maximum above the finish floor measured to the top of the gripping surface, except that at water closets for children's use complying with 604.9, grab bars shall be installed in a horizontal position 18 inches (455 mm) minimum and 27 inches (685 mm) max	Day Use Women's Restroom - 24" long grab bars	Replace or add side grab bars with a 42" long grab bar, mounted max 12" from the rear wall at the close end and min 54" on the far end and 33" to 36" AFF.	2015 ABAAS Section: 604.8.2.3, 609.3, 609.4 2012 TAS Section: 609.4, 609.3, 604.8.2.3 2010 ADAS Section: 609.3, 609.4, 604.8.2.3

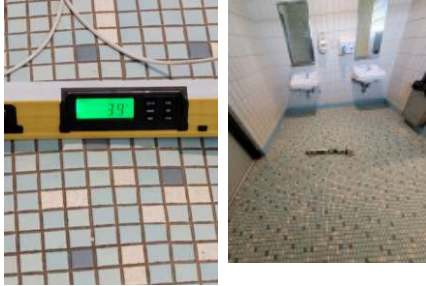
Finding Number	Area Description	Lat/Long	Finding	As Built	Recommendation	Citation	Photos	Figure
125	Public Spaces: Floating Dock	[33.7545982 , -98.384651 4]	The minimum number of boarding piers are not accessible. Where boarding piers are provided at boat launch ramps, at least 5 percent, but no fewer than one, of the boarding piers be accessible.	18 of 18 slips are not accessible - wider pier access has large gaps between boards, CILs	Provide 5%, but not less than one accessible boarding pier at boat launches.	2015 ABAAS Section: F235.3 2010 ADAS Section: 235.3

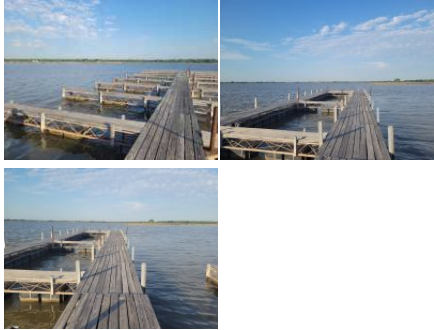
Finding Number	Area Description	Lat/Long	Finding	As Built	Recommendation	Citation	Photos	Figure
126	Public Spaces: Floating Dock	[33.7545982 , -98.384654]	There is no accessible route to/on the boating facility. Accessible routes serving recreational boating facilities, including gangways and floating piers, shall comply with accessible route requirements except as modified by section Recreational Boating Facilities - Accessible Routes.	significant CILs and gaps on gangway on both fixed and floating sections	Create an outdoor accessible route to the boat pier or make corrections for a compliant route.	2015 ABAAS Section: 1003.2 2010 ADAS Section: 1003.2

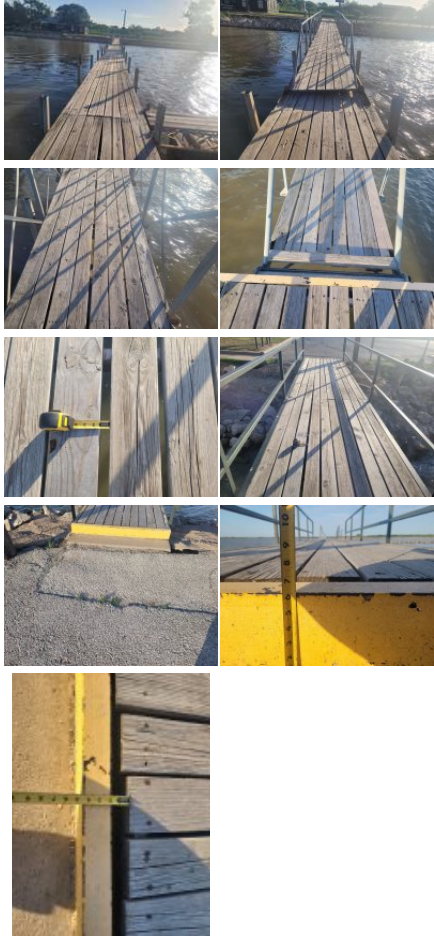
Finding Number	Area Description	Lat/Long	Finding	As Built	Recommendation	Citation	Photos	Figure
127	Public Spaces: Floating Dock	[33.7545993 , -98.384651 4]	The boat slip/pier is not wide enough. Boat slips and boarding piers shall provide clear pier space 60 inches wide minimum and at least as long as the boat slips/boarding pier. Each 10 feet maximum of linear pier edge serving boat slips and boarding piers shall contain at least one continuous clear opening 60 inches wide minimum. The clear width shall be permitted to be reduced to 36 inches minimum for a length of 24 inches maximum provided that reduced width segments are separated by segments that are 60 inches long minimum and 60 inches wide minimum.	The wider pier area is 60" wide, the boarding piers at the slips are narrow	Provide 60" wide clearance at accessible slips and a 60" wide opening every 10'.	2015 ABAAS Section: 1003.3.1 2012 TAS Section: 1003.3.1 2010 ADAS Section: 1003.3.1

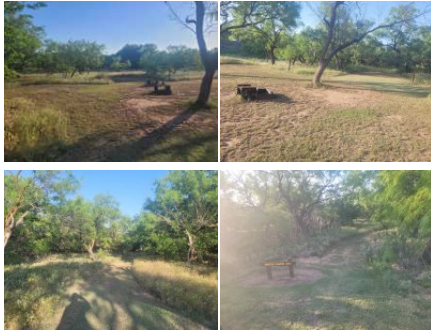
164	Camping Area: Primitive Group Area	[33.76106, -98.38763]	Camping facilities shall provide camping units with mobility features complying with F244.2 in accordance with Table F244.2. Where a camping facility provides different types of camping units, Table F244.2 shall apply to each type of camping unit provided. Total Number of Camping Units Provided in Camping Facility Minimum Number of Camping Units with Mobility Features Required 1 1 2 to 25 2 26 to 50 3 51 to 75 4 76 to 100 5 101 to 150 7 151 to 200 8 201 and over 8, plus 2 percent of the number over 200	Primitive camping - 0 of 5 sites accessible, only features are fire rings, lack high enough fire surface, lack route, lack CGS	Create the required number of accessible camp sites per table F244.2 as a smart practice.	2015 ABAAS Section: F244.2

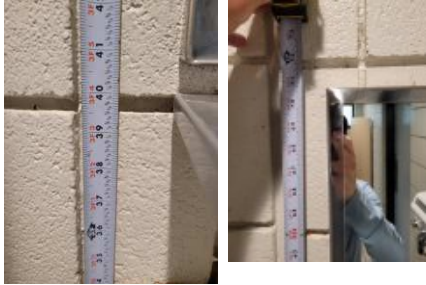
Finding Number	Area Description	Lat/Long	Finding	As Built	Recommendation	Citation	Photos	Figure
169	Camping Area: Men's Restroom	[33.7589044 , -98.386785 1]	The mirror is mounted too high. Mirrors must have the bottom edge of the reflecting surface a maximum of 40 inches above the floor if above a sink or counter. Mirrors not located above lavatories or countertops shall be installed with the bottom edge of the reflecting surface 35 inches maximum above the finish floor or ground.	Bottom edge at 41" AFF, and top edge at 70" AFF	Replace mirror so bottom reflective surface is max 40" AFF and 74" at the top.	2015 ABAAS Section: 603.3 2012 TAS Section: 603.3 2010 ADAS Section: 603.3

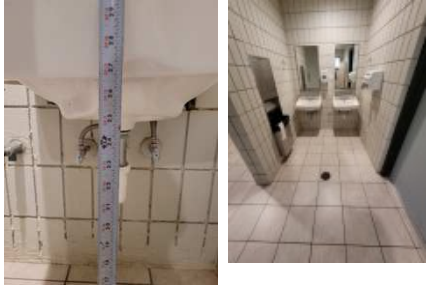
170	Camping Area: Men's Restroom	[33.7589099 , -98.386791 8]	Knee clearance at 27 inches off the floor is not 8 inches minimum deep. The knee clearance, measured from the bottom of the apron or the outside bottom edge of the lavatory, must be 27 inches at a point located 8 inches back from the front edge and continuing to 11 inches minimum in depth at 9 inches above the floor. The top of the lavatory rim may be no higher than 34 inches. The operable part is not accessible because there is not adequate clear floor space for either a forward or side approach. The clear floor or ground space shall be 30 inches minimum by 48 inches minimum.	Sink knee clearance 25" AFF, and lacks CFS due to garbage and hand dryer	Replace sink with one providing 27" knee clearance that is a min 8" deep. Remove, or relocate garbage and hand dryer in CFS at fixtures and operable parts along the AR.	2015 ABAAS Section: 306.3.1, 306.3.2, 306.3.3, 306.3.4 , 306.3.5 2012 TAS Section: 306.3.2, 306.3.3, 306.3.4, 306.3.5, 306.3.1 2010 ADAS Section: 306.3.3, 306.3.2, 306.3.4, 306.3.5, 306.3.1

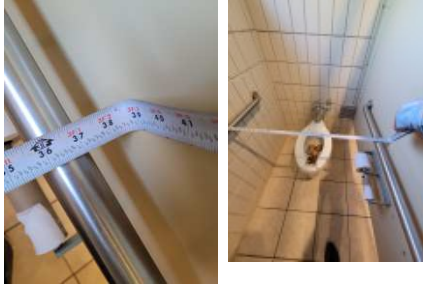
174	Camping Area: Men's Restroom	[33.7589044 , -98.3867851]	The ambulatory stall is not between 35" to 37" wide and 60" deep.	Ambulatory stall 38.5" wide	Correct ambulatory stall to be 35" to 37" wide and minimum 60" deep.	2015 ABAAS Section: 604.8.2.1 2012 TAS Section: 604.8.2.1 2010 ADAS Section: 604.8.2.1

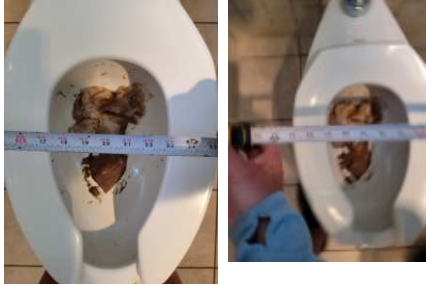
176	Camping Area: Men's Restroom	[33.7589044 , -98.386785 1]	The stall door fails to comply with all of the door requirements. The stall door must be a minimum of 32" wide and have compliant hardware on both sides. The stall door must be self-closing.	Ambulatory stall lacks self-closing door	Adjust stall door to be self-closing.	2015 ABAAS Section: 404.2.3, 404.2.7, 604.8.2.2 2012 TAS Section: 404.2.3, 404.2.7, 604.8.2.2 2010 ADAS Section: 404.2.3, 404.2.7, 604.8.2.2

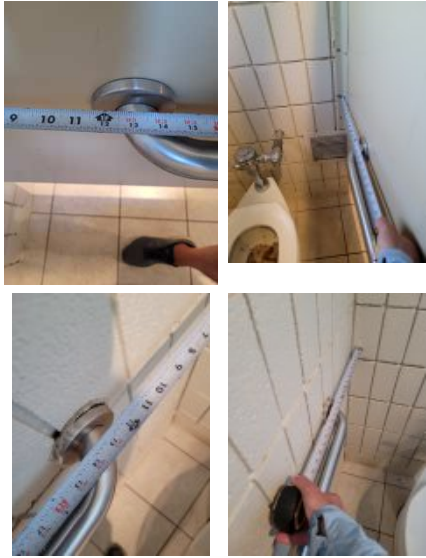
Finding Number	Area Description	Lat/Long	Finding	As Built	Recommendation	Citation	Photos	Figure
177	Camping Area: Men's Restroom	[33.75892, -98.386790 4]	The side grab bars are not in the correct location. Grab bars on the side wall must be installed so that the end closest to the rear wall is maximum 12" from the rear wall. The end furthest from the rear wall must be mounted minimum 54" from the rear wall.	Right bar starts 13" from rear wall, and left bar starts 13.5" from rear wall	Remount side grab bar to max 12" from the rear wall at the close end and min 54" on the far end, and 33" to 36" AFF.	2015 ABAAS Section: 604.5.1 2012 TAS Section: 604.5.1 2010 ADAS Section: 604.5.1

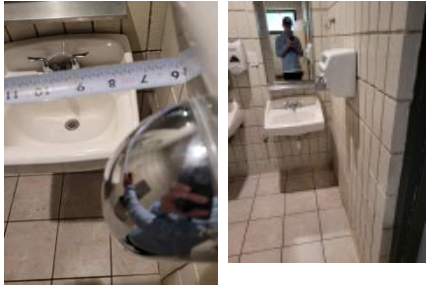
Finding Number	Area Description	Lat/Long	Finding	As Built	Recommendation	Citation	Photos	Figure
179	Camping Area: Men's Restroom	[33.758911, -98.386789 1]	An item or items project more than 4 inches into the circulation path. Wall-mounted objects that have leading edges between 27 inches and 80 inches from the floor must not project more than 4 inches into the circulation path. Protruding objects that extend to the floor or within 27 inches of the floor are cane detectable and are therefore not hazardous. Where it is necessary or desirable to have objects protrude from the wall, a manner of cane detection must be provided.	Hand dryer protrudes 8.5"	Relocate protruding objects or place cane detectable warning or bollard at foot of item.	2015 ABAAS Section: 307.2 2012 TAS Section: 307.2 2010 ADAS Section: 307.2

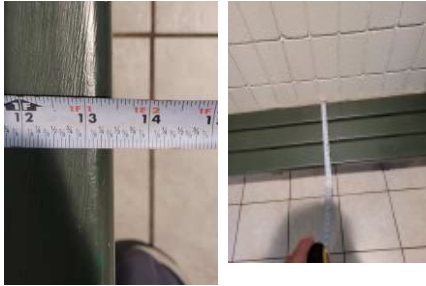
182	Camping Area: Men's Restroom	[33.7588965 , -98.386786 4]	In transfer type compartments, grab bars shall be provided across the control wall and back wall to a point 18 inches (455 mm) from the control wall.	Shower lacks grab bars	Provide grab bars in the shower mounted in the correct locations for the shower type.	2015 ABAAS Section: 608.3.1 2012 TAS Section: 608.3.1 2010 ADAS Section: 608.3.1

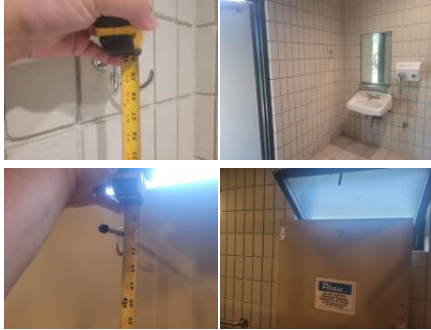
Finding Number	Area Description	Lat/Long	Finding	As Built	Recommendation	Citation	Photos	Figure
187	Camping Area: Women's Restroom	[33.7589155 , -98.386797 1]	Where a high forward reach is over an obstruction, the clear floor space shall extend beneath the element for a distance not less than the required reach depth over the obstruction. The high forward reach shall be 48 inches (1220 mm) maximum where the reach depth is 20 inches (510 mm) maximum. Where the reach depth exceeds 20 inches (510 mm), the high forward reach shall be 44 inches (1120 mm) maximum and the reach depth shall be 25 inches (635 mm) maximum. Where a clear floor or ground space allows a parallel approach to an element and the high side reach is over an obstruction, the height of the obstruction shall be 34 inches (865 mm) maximum and the depth of the obstruction shall be 24 inches (610 mm) maximum. The high side reach shall be 48 inches (1220 mm) maximum for a reach depth of 10 inches (255 mm) maximum. Where the reach depth exceeds 10 inches (255 mm), the high side reach shall be 46 inches (1170 mm) maximum for a reach depth of 24 inches (610 mm) maximum.	Hook near sink at 59.25" AFF, hook in stall at 63" AFF	Lower operating mechanisms to max 48" above the finished floor (AFF) to highest operable part.	2015 ABAAS Section: 308.2.1, 308.3.2 2012 TAS Section: 308.2.1, 308.3.2 2010 ADAS Section: 308.2.1, 308.3.2

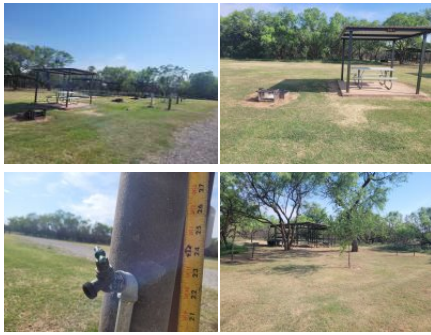
200	Camping Area: Equestrian Camping	[33.7524027 , -98.3930628]	Camping facilities shall provide camping units with mobility features complying with F244.2 in accordance with Table F244.2. Where a camping facility provides different types of camping units, Table F244.2 shall apply to each type of camping unit provided. Total Number of Camping Units Provided in Camping Facility Minimum Number of Camping Units with Mobility Features Required 1 1 2 to 25 2 26 to 50 3 51 to 75 4 76 to 100 5 101 to 150 7 151 to 200 8 201 and over 8, plus 2 percent of the number over 200	4 of 4 equestrian sites are not accessible - each has utility and water, picnic table under shelter, grill, shared horse posts and corral	Create the required number of accessible camp sites per table F244.2 as a smart practice.	2015 ABAAS Section: F244.2

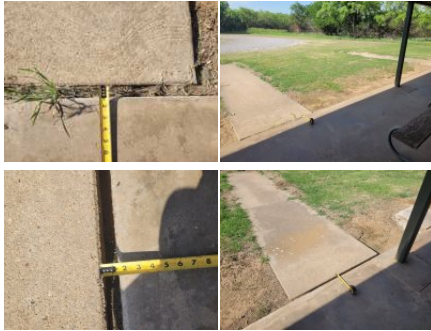
204	Camping Area: Group Pavilion	[33.7524741, -98.3926886], [33.7524941, -98.3926095]	There is a gap spaced greater than a 1/2 inch. Openings in floor or ground surfaces shall not allow passage of a sphere more than 1/2 inch diameter. Elongated openings shall be placed so that the long dimension is perpendicular to the dominant direction of travel.	1" and 1.5" gaps at sidewalk in both locations	Correct or fill gaps to be max .5".	2015 ABAAS Section: 302.3 2012 TAS Section: 302.3 2010 ADAS Section: 302.3

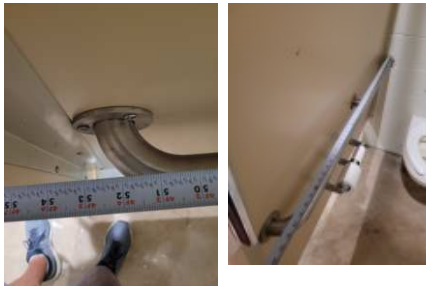
215	Camping Area: Group Pavilion Men's Restroom	[33.7524284 , -98.392716 8]	The side grab bars are not in the correct location. Grab bars on the side wall must be installed so that the end closest to the rear wall is maximum 12" from the rear wall. The end furthest from the rear wall must be mounted minimum 54" from the rear wall.	Grab bars extend 52" from rear wall	Remount side grab bar to max 12" from the rear wall at the close end and min 54" on the far end, and 33" to 36" AFF.	2015 ABAAS Section: 604.5.1 2012 TAS Section: 604.5.1 2010 ADAS Section: 604.5.1

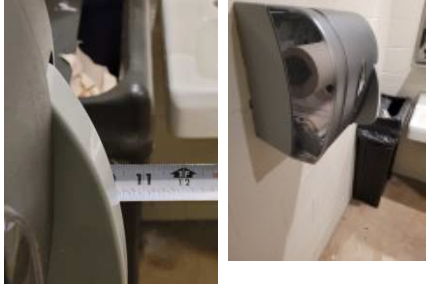
217	Camping Area: Group Pavilion Men's Restroom	[33.7524373 , -98.392703 4]	An item or items project more than 4 inches into the circulation path. Wall-mounted objects that have leading edges between 27 inches and 80 inches from the floor must not project more than 4 inches into the circulation path. Protruding objects that extend to the floor or within 27 inches of the floor are cane detectable and are therefore not hazardous. Where it is necessary or desirable to have objects protrude from the wall, a manner of cane detection must be provided.	Paper towel dispenser protrudes 10.5"	Relocate protruding objects or place cane detectable warning or bollard at foot of item.	2015 ABAAS Section: 307.2 2012 TAS Section: 307.2 2010 ADAS Section: 307.2

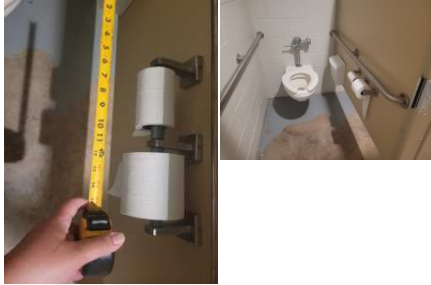
Finding Number	Area Description	Lat/Long	Finding	As Built	Recommendation	Citation	Photos	Figure
226	Camping Area: Group Pavilion Women's Restroom	[33.7524239 , -98.392708 7]	The toilet paper is not installed within the compliant range in front of the toilet. Toilet paper dispensers shall be 7 inches minimum and 9 inches maximum in front of the water closet measured to the centerline of the dispenser. The outlet of the dispenser shall be 15 inches minimum and 48 inches maximum above the finish floor and shall not be located behind grab bars. Dispensers shall not be of a type that controls delivery or that does not allow continuous paper flow. There shall be a clearance of 1 1/2 inches minimum below the grab bar.	TP too far from the front of the toilet - 11"	Remount toilet paper dispenser max 7" to 9" from front of toilet, 15" to 48" AFF and min 12" above or 1.5" below grab bar.	2015 ABAAS Section: 604.7 2012 TAS Section: 604.7 2010 ADAS Section: 604.7

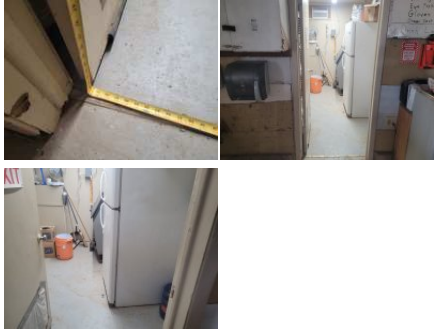
Finding Number	Area Description	Lat/Long	Finding	As Built	Recommendation	Citation	Photos	Figure
228	Employee Areas: Maintenance	[33.7618144 , -98.386738 1]	<p>Minimum maneuvering clearances at doors and gates shall comply with 404.2.4. Maneuvering clearances shall extend the full width of the doorway and the required latch side or hinge side clearance. Door openings shall provide a clear width of 32 inches (815 mm) minimum. Clear openings of doorways with swinging doors shall be measured between the face of the door and the stop, with the door open 90 degrees. Openings more than 24 inches (610 mm) deep shall provide a clear opening of 36 inches (915 mm) minimum. There shall be no projections into the required clear opening width lower than 34 inches (865 mm) above the finish floor or ground. Projections into the clear opening width between 34 inches (865 mm) and 80 inches (2030 mm) above the finish floor or ground shall not exceed 4 inches (100 mm). Hand-activated door opening hardware, handles, pulls, latches, locks, and other operating devices on accessible doors shall have a shape that is easy to grasp with one hand and does not require tight grasping, tight pinching or twisting of the wrist to operate. Hardware shall be 34 inches minimum and 48 inches maximum above the finish floor or ground.</p>	Restroom entry - 30" wide, knob, fridge in pull side clearance	<p>For all doors along the public circulation route, provide required maneuvering clearance on push and pull side of doors. For all doors along the public circulation route, replace doors with doors having 80" overhead clearance and 32" clear width. For all doors along the public circulation route, replace hardware with lever hardware or hardware operable without a tight pinch or grasp.</p>	2010 ADAS Section: 404.2.3, 404.2.7, 404.2.4, 404.2.11, 404.2.11 Exception

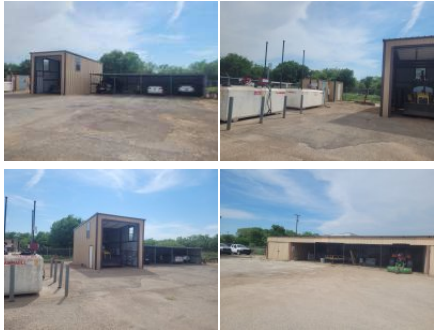
Finding Number	Area Description	Lat/Long	Finding	As Built	Recommendation	Citation	Photos	Figure
234	Employee Areas: Maintenance	[33.7614877 , -98.3868119]	Spaces and elements within employee work areas shall only be required to comply with 206.2.8, 207.1, and 215.3 and shall be designed and constructed so that individuals with disabilities can approach, enter, and exit the employee work area. Employee work areas, or portions of employee work areas, other than raised courtroom stations, that are less than 300 square feet (28 m2) and elevated 7 inches (180 mm) or more above the finish floor or ground where the elevation is essential to the function of the space shall not be required to comply with these requirements or to be on an accessible route.	gravel at several entries, CILs, knobs	For employee spaces, relocate storage, furniture, and other obstacles at doorways to provide approach, enter and exit at the employee space. Provide required maneuvering clearance on push and pull side of doors. Repair, bevel, or ramp CILs at door entries to max .25". Replace hardware with lever hardware or hardware operable without a tight pinch or grasp.	2015 ABAAS Section: F203.9 2012 TAS Section: 203.9 2010 ADAS Section: 203.9
