Access Audit Site Report

Lake Arrowhead State Park

Accessibility Evaluation

Inspection Date: 05/18/2022

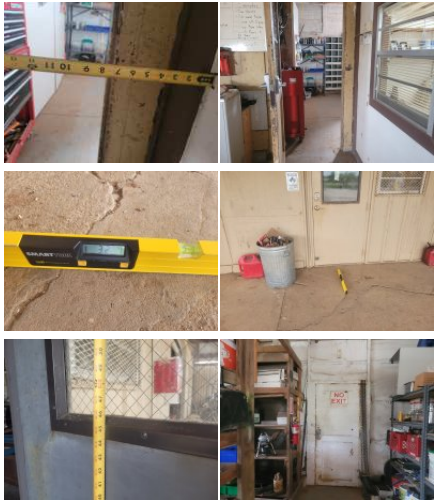
235	Employee Areas: Maintenance	[33.7616382 , -98.3866577]	Spaces and elements within employee work areas shall only be required to comply with 206.2.8, 207.1, and 215.3 and shall be designed and constructed so that individuals with disabilities can approach, enter, and exit the employee work area. Employee work areas, or portions of employee work areas, other than raised courtroom stations, that are less than 300 square feet (28 m2) and elevated 7 inches (180 mm) or more above the finish floor or ground where the elevation is essential to the function of the space shall not be required to comply with these requirements or to be on an accessible route.	Parts room - 7.5" wall reduces clearance, toolbox in push side clearance Shop entry - 3.2% slope in MC, lipped threshold, window at 46" AFF, dryer in push side MC	For employee spaces, relocate storage, furniture, and other obstacles at doorways to provide approach, enter and exit at the employee space. Provide required maneuvering clearance on push and pull side of doors. Correct slope in door clearance to max 2.08%. Repair, provide beveled threshold. Replace doors with ones having sidelight viewing windows max 43" AFF.	2015 ABAAS Section: F203.9 2012 TAS Section: 203.9 2010 ADAS Section: 203.9

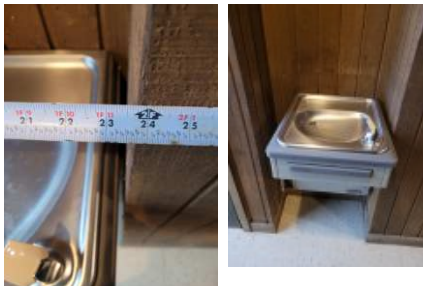
239	Employee Areas: Administration	[33.75861, -98.39523]	The required clear floor space is not wide enough. The clear floor or ground space shall be 30 inches minimum by 48 inches minimum.	administration building- lacks CGS at drinking fountain - 23.75" width	Provide 30" by 48" deep CFS for a forward approach to fountain; centered on unit.	2015 ABAAS Section: 305.3 2012 TAS Section: 305.3 2010 ADAS Section: 305.3

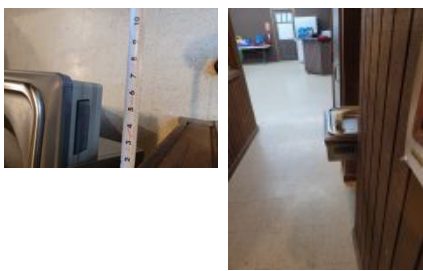
240	Employee Areas: Administration	[33.75861, -98.39523]	An item or items project more than 4 inches into the circulation path. Wall-mounted objects that have leading edges between 27 inches and 80 inches from the floor must not project more than 4 inches into the circulation path. Protruding objects that extend to the floor or within 27 inches of the floor are cane detectable and are therefore not hazardous. Where it is necessary or desirable to have objects protrude from the wall, a manner of cane detection must be provided.	administration building- drinking fountain protrudes 7"	Relocate protruding objects or place cane detectable warning or bollard at foot of item.	2015 ABAAS Section: 307.2 2012 TAS Section: 307.2 2010 ADAS Section: 307.2

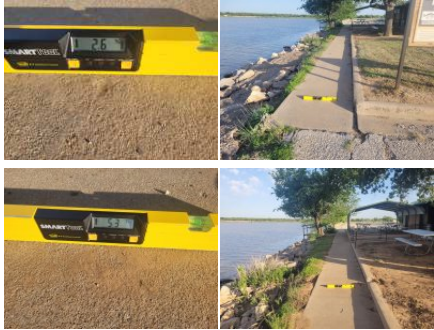
Finding Number	Area Description	Lat/Long	Finding	As Built	Recommendation	Citation	Photos	Figure
241	Employee Areas: Administration	[33.7549633, -98.3843097], [33.7550179, -98.3843928]	The accessible route of travel contains cross slopes greater than 2%. Cross slopes shall not exceed one unit vertical in 48 units horizontal (2-percent slope).	Sidewalk along lake behind admin - cross slopes of 2.6% and 5.3%	Correct or repair cross slope along AR to max 2.08%.	2015 ABAAS Section: 403.3 2012 TAS Section: 403.3 2010 ADAS Section: 403.3

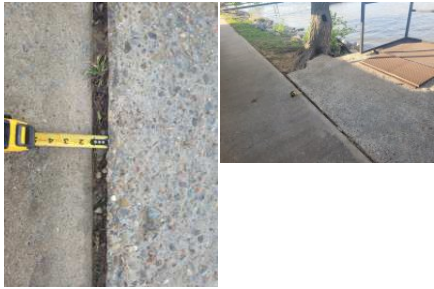
242	Employee Areas: Administration	[33.7550755, -98.3844661]	There is a gap spaced greater than a 1/2 inch. Openings in floor or ground surfaces shall not allow passage of a sphere more than 1/2 inch diameter. Elongated openings shall be placed so that the long dimension is perpendicular to the dominant direction of travel.	1.25" gap by platform	Correct or fill gaps to be max .5".	2015 ABAAS Section: 302.3 2012 TAS Section: 302.3 2010 ADAS Section: 302.3

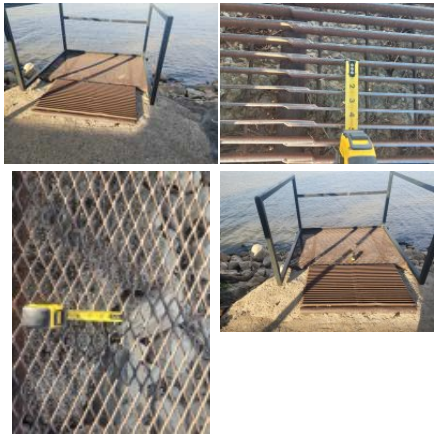
243	Employee Areas: Administration	[33.755059, -98.3844893]	The grate openings are greater than 1/2 inch and are parallel to the direction of travel. Openings in floor or ground surfaces shall not allow passage of a sphere more than 1/2 inch diameter. Elongated openings shall be placed so that the long dimension is perpendicular to the dominant direction of travel.	Grates at platform have gaps greater than .5"	Replace grates with ones having openings max .5".	2015 ABAAS Section: 302.3 2012 TAS Section: 302.3 2010 ADAS Section: 302.3

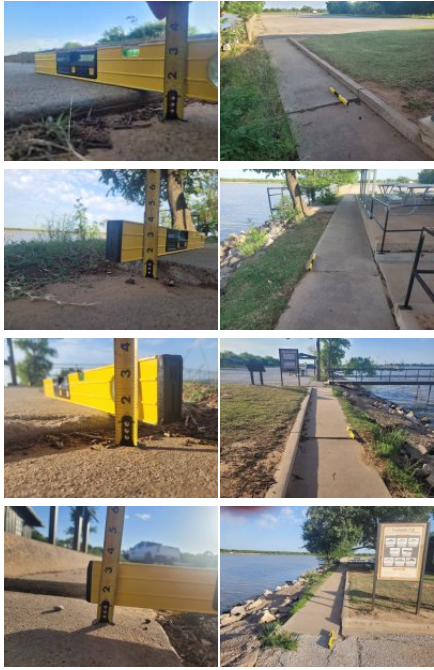
Finding Number	Area Description	Lat/Long	Finding	As Built	Recommendation	Citation	Photos	Figure
244	Employee Areas: Administration	[33.755131, -98.384538 8], [33.7549649, -98.384316 2]	The walkway contains abrupt vertical edges and/or variations over a 1/4 inch. 1/4 inch is the maximum vertical rise. Changes in level between 1/4 inch and 1/2 inch must be beveled at 1:2 or less. Changes in level greater than 1/2 inch must be by way of a ramp.	1" CIL behind admin, 1.25" CIL at ramp, 1", 1.25" at asphalt	Repair, bevel or ramp CIL along AR.	2012 TAS Section: 303.2, 303.3 2010 ADAS Section: 303.2, 303.3

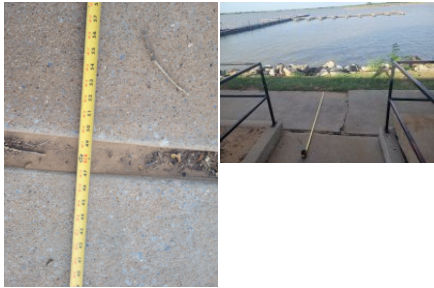
247	Employee Areas: Administration	[33.7550621 , -98.3844609]	The landing is not the correct length. Landings shall have a dimension in the direction of ramp run of not less than 60 inches.	Ramp landing is 47" long	Enlarge landing to be 60" deep and as wide as the ramp.	2015 ABAAS Section: 405.7.3 2012 TAS Section: 405.7.3 2010 ADAS Section: 405.7.3

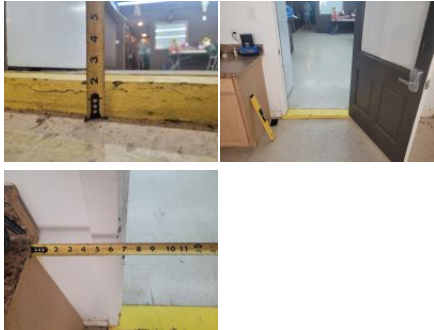
255	Employee Areas: Administration	[33.7551201 , -98.384361 2]	Minimum maneuvering clearances at doors and gates shall comply with 404.2.4. Maneuvering clearances shall extend the full width of the doorway and the required latch side or hinge side clearance. The threshold has a vertical change greater than 1/4 inch high.	Office to meeting entry - 2" CIL, counter 7" pull side clearance	For all doors along the public circulation route, provide required maneuvering clearance on push and pull side of doors. For all doors along the public circulation route, repair, bevel, or ramp CILs at door entries to max .25".	2010 ADAS Section: 404.2.3, 404.2.7, 404.2.4, 404.2.11, 404.2.11 Exception

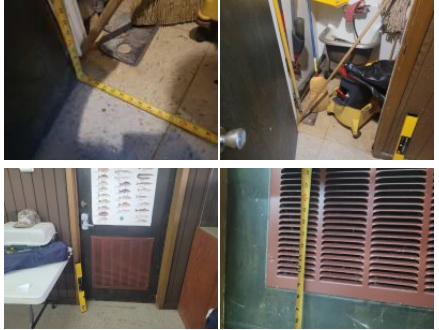
Finding Number	Area Description	Lat/Long	Finding	As Built	Recommendation	Citation	Photos	Figure
262	Employee Areas: Administration	[33.7551357 , -98.384383 1]	Spaces and elements within employee work areas shall only be required to comply with 206.2.8, 207.1, and 215.3 and shall be designed and constructed so that individuals with disabilities can approach, enter, and exit the employee work area. Employee work areas, or portions of employee work areas, other than raised courtroom stations, that are less than 300 square feet (28 m2) and elevated 7 inches (180 mm) or more above the finish floor or ground where the elevation is essential to the function of the space shall not be required to comply with these requirements or to be on an accessible route.	Janitor room - 27" wide, storage in push side clearance, knob Office at restrooms - desk in pull side MC Space at meeting room - vent starts 9.5"	For employee spaces, relocate storage, furniture, and other obstacles at doorways to provide approach, enter and exit at the employee space. Replace doors with doors having 80" overhead clearance and 32" clear width. Replace hardware with lever hardware or hardware operable without a tight pinch or grasp. Provide kick plate on push side of door from floor to 10" AFF.	2015 ABAAS Section: F203.9 2012 TAS Section: 203.9 2010 ADAS Section: 203.9

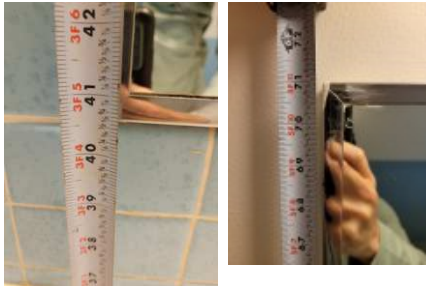
273	Employee Areas: Administration Building Women's Restroom	[33.75861, -98.39523]	The mirror is mounted too high. Mirrors must have the bottom edge of the reflecting surface a maximum of 40 inches above the floor if above a sink or counter. Mirrors not located above lavatories or countertops shall be installed with the bottom edge of the reflecting surface 35 inches maximum above the finish floor or ground.	Bottom edge at 41" AFF, top edge at 70.5" AFF	Replace mirror so bottom reflective surface is max 40" AFF and 74" at the top.	2015 ABAAS Section: 603.3 2012 TAS Section: 603.3 2010 ADAS Section: 603.3

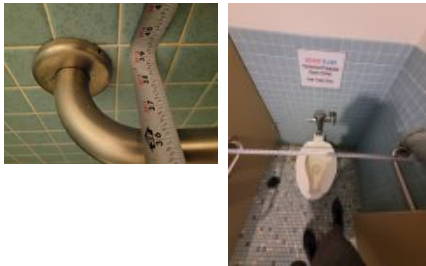
277	Employee Areas: Administration Building Women's Restroom	[33.75861, -98.39523]	The ambulatory stall is not between 35" to 37" wide and 60" deep.	Ambulatory stall is 39.5" wide	Correct ambulatory stall to be 35" to 37" wide and minimum 60" deep.	2015 ABAAS Section: 604.8.2.1 2012 TAS Section: 604.8.2.1 2010 ADAS Section: 604.8.2.1

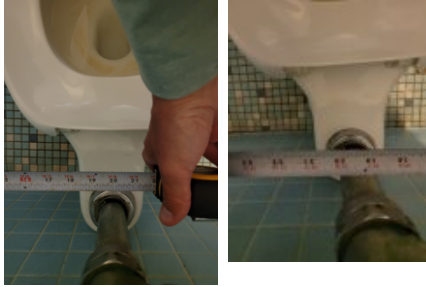
278	Employee Areas: Administration Building Women's Restroom	[33.75861, -98.39523]	The toilet is not located within the range to the side wall or partition. The centerline of the toilet shall be 17 inches minimum and 19 inches maximum side wall or partition in the ambulatory accessible toilet compartment.	20" from right wall, 19.5" from left	Remount toilet to 17" to 19" from the side wall to center line in ambulatory stalls.	2015 ABAAS Section: 604.9.1 2012 TAS Section: 604.9.1 2010 ADAS Section: 604.9.1

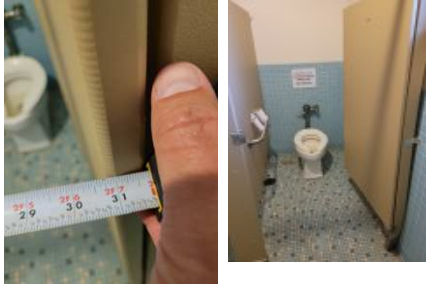
Finding Number	Area Description	Lat/Long	Finding	As Built	Recommendation	Citation	Photos	Figure
279	Employee Areas: Administration Building Women's Restroom	[33.75861, -98.39523]	The stall door fails to comply with all of the door requirements. The stall door must be a minimum of 32" wide and have compliant hardware on both sides. The stall door must be self-closing.	Ambulatory stall door is 30.5" wide, is not self-closing, and lacks push side hardware	Widen stall doors to 32" when opened to 90 degrees. Adjust stall door to be self-closing. Replace stall hardware with hardware operable without a tight pinch or grasp on both sides of the stall door.	2015 ABAAS Section: 404.2.3, 404.2.7, 604.8.2.2 2012 TAS Section: 404.2.3, 404.2.7, 604.8.2.2 2010 ADAS Section: 404.2.3, 404.2.7, 604.8.2.2

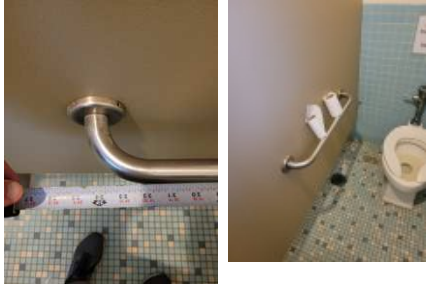
Finding Number	Area Description	Lat/Long	Finding	As Built	Recommendation	Citation	Photos	Figure
281	Employee Areas: Administration Building Women's Restroom	[33.75861, -98.39523]	Grab bars shall comply with 609. A side-wall grab bar complying with 604.5.1 shall be provided on both sides of the compartment. The space between the wall and the grab bar shall be 1½ inches (38 mm). The space between the grab bar and projecting objects below and at the ends shall be 1½ inches (38 mm) minimum. The space between the grab bar and projecting objects above shall be 12 inches (305 mm) minimum. Grab bars shall be installed in a horizontal position, 33 inches (840 mm) minimum and 36 inches (915 mm) maximum above the finish floor measured to the top of the gripping surface, except that at water closets for children's use complying with 604.9, grab bars shall be installed in a horizontal position 18 inches (455 mm) minimum and 27 inches (685 mm) max	Both bars are 24" long	Replace side grab bars with a 42" long grab bar, mounted max 12" from the rear wall at the close end and min 54" on the far end and 33" to 36" AFF.	2015 ABAAS Section: 604.8.2.3, 609.3, 609.4 2012 TAS Section: 609.4, 609.3, 604.8.2.3 2010 ADAS Section: 609.3, 609.4, 604.8.2.3
