# Access Audit Site Report

**Martin Creek Lake State Park**

**Accessibility Evaluation**

**Inspection Date: 04/08/2022**

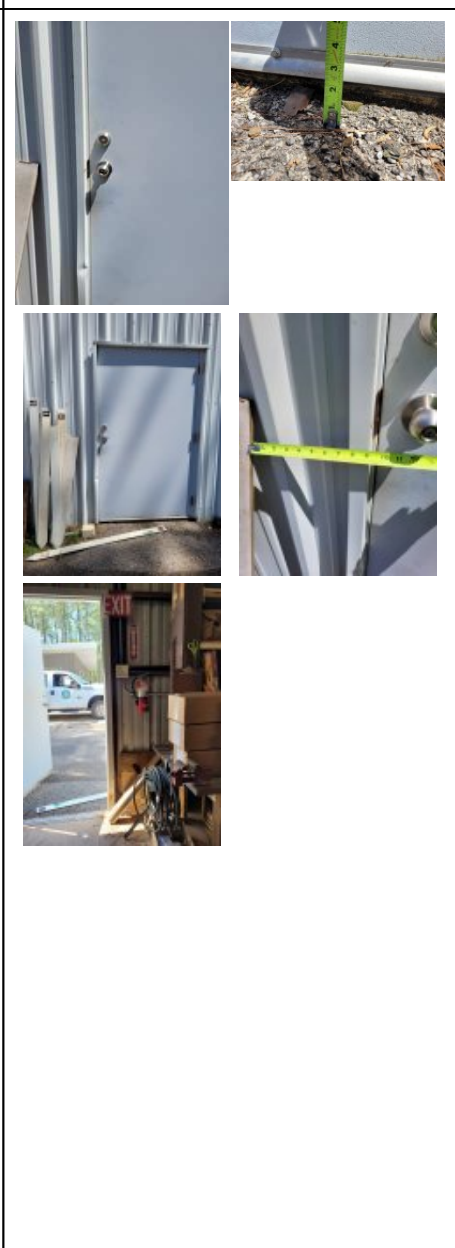
Finding Number	Area Description	Lat/Long	Finding	As Built	Recommendation	Citation	Photos	Figure
10	Employee Areas: Maintenance	[32.2768714 , -94.564645]	Spaces and elements within employee work areas shall only be required to comply with 206.2.8, 207.1, and 215.3 and shall be designed and constructed so that individuals with disabilities can approach, enter, and exit the employee work area. Employee work areas, or portions of employee work areas, other than raised courtroom stations, that are less than 300 square feet (28 m2) and elevated 7 inches (180 mm) or more above the finish floor or ground where the elevation is essential to the function of the space shall not be required to comply with these requirements or to be on an accessible route.	Grey building - White door - 9.7% slope in pull side clearance, knob, 1" CIL. Grey building - Grey door - knob, loose mat, .5" CIL due to mat, 8.2% slope in pull side clearance, pinch lock, loose mat on inside, clearance reduced on inside	For employee spaces, relocate storage, furniture, and other obstacles at doorways to provide approach, enter and exit at the employee space. Provide required maneuvering clearance on push and pull side of doors. Secure rug at door to prevent trip hazard. Provide a beveled edge to the mat to eliminate trip hazard. Correct slope in door clearance to max 2.08%. Replace doors with doors having 80" overhead clearance and 32" clear width. Repair, bevel, or ramp CILs at door entries to max .25". Replace hardware with lever hardware or hardware operable without a tight pinch or grasp.	2015 ABAAS Section: F203.9 2012 TAS Section: 203.9 2010 ADAS Section: 203.9

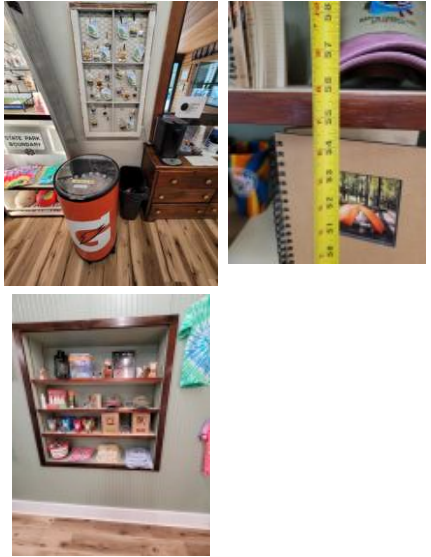
Finding Number	Area Description	Lat/Long	Finding	As Built	Recommendation	Citation	Photos	Figure
19	Headquarters Area: HQ Public Spaces	[32.2779996 , -94.566023 7]	Clear floor space has not be provided. A portion of the counter surface that is 36 inches long minimum for a parallel approach or 30 inches long minimum for a forward approach and 36 inches high maximum above the finish floor shall be provided. A 30 inch by 48 inch clear floor space on an accessible route must be provided for either a forward or parallel approach. Additionally, if a forward approach is desired, knee and toe space must be provided.	Service counter at 34.5" AFF, with its CFS obstructed by ice cream dispenser	Remove, or relocate storage in CFS at service counter.	2015 ABAAS Section: 904.4.2, 904.4.1  2012 TAS Section: 904.4.1, 904.4.2  2010 ADAS Section: 904.4.2, 904.4.1

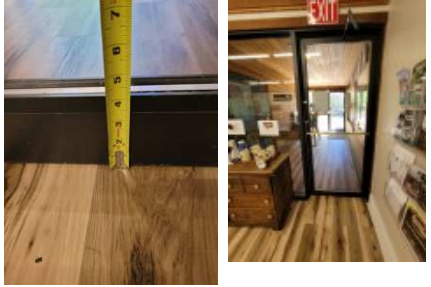
21	Headquarters Area: HQ Public Spaces	[32.2780042 , -94.566023 7]	The door must have a smooth surface within 10 inches of the floor on the push side. Swinging door surfaces within 10 inches of the finish floor or ground measured vertically must have a smooth surface on the push side extending the full width of the door. Parts creating horizontal or vertical joints in these surfaces shall be within 1/16 inch of the same plane as the other. All gates, including ticket gates, shall meet all applicable specifications for doors.	Interior vestibule door - glass surface begins 4" from bottom of push side of door	Provide kick plate on push side of door from floor to 10" AFF.	2015 ABAAS Section: 404.2.10  2012 TAS Section: 404.2.10  2010 ADAS Section: 404.2.10

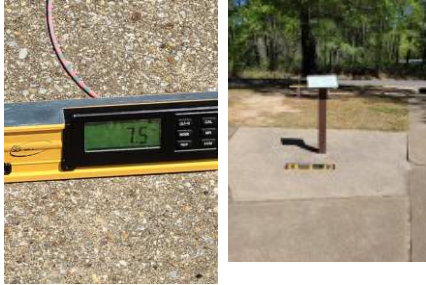
Finding Number	Area Description	Lat/Long	Finding	As Built	Recommendation	Citation	Photos	Figure
25	Headquarters Area: HQ Public Spaces	[32.2778624 , -94.5659204]	The 30 inches minimum by 48 inches minimum clear floor space required at the operable part is not flat (2% or 1:48 maximum slope) in all directions. Changes in level are not permitted at required clear floor or ground space except that slopes not steeper than 1:48 shall be permitted.	7.5% slope in CFS for sign	Correct or repair slope in CFS to max 2.08%.	2015 ABAAS Section: 305.2 2012 TAS Section: 305.2 2010 ADAS Section: 305.2

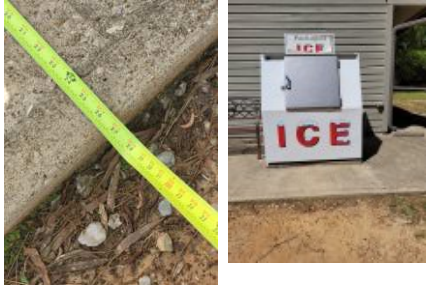
26	Headquarters Area: HQ Public Spaces	[32.2780042 , -94.5660264]	The operable part is not accessible because there is not adequate clear floor space for either a forward or side approach. The clear floor or ground space shall be 30 inches minimum by 48 inches minimum.	Ice cooler lacks CFS - 27"	Provide required 30" by 48" CFS at operable parts.	2015 ABAAS Section: 305.3 2012 TAS Section: 305.3 2010 ADAS Section: 305.3

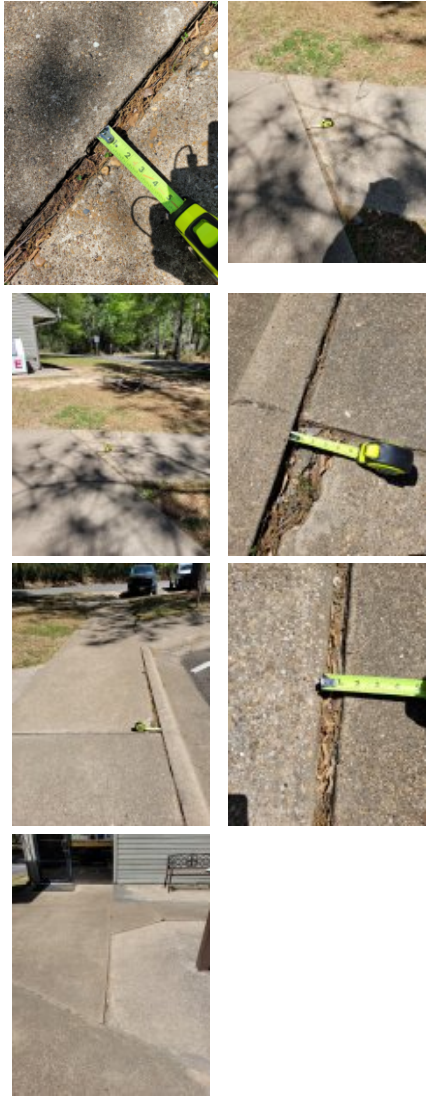
Finding Number	Area Description	Lat/Long	Finding	As Built	Recommendation	Citation	Photos	Figure
28	Headquarters Area: HQ Public Spaces	[32.2779396, -94.566021]	Minimum maneuvering clearances at doors and gates shall comply with 404.2.4. Maneuvering clearances shall extend the full width of the doorway and the required latch side or hinge side clearance. Maneuvering clearances shall have a max slope of 2.08%. The threshold at a doorway shall be no higher than 1/2 inch. Changes in level between 1/4 inch and 1/2 inch must be beveled at 1:2 or less. 1/4 inch is the maximum vertical rise. The sweep period for doors with closers shall be adjusted so that from an open position of 70 degrees, the door will take at least 3 seconds to move to a point 3 inches from the latch, measured to the leading edge of the door. Exterior doors are recommended to be maintained at 8.5 lbf as a smart practice. Force is to be measured at the operating hardware or 30 inches from the hinges, whichever is greater.	Entry door - loose mats on both sides, 19# push, fast close, 5.7% slope in clearance, 1" lipped threshold	For all doors along the public circulation route, provide required maneuvering clearance on push and pull side of doors. For all doors along the public circulation route, secure rug in door clearance to prevent trip hazard. For all doors along the public circulation route, correct slope in door clearance to max 2.08%. For all doors along the public circulation route, repair, provide beveled threshold. For all doors along the public circulation route, inspect, adjust, and maintain closing speed on door closers. For all doors along the public circulation route, inspect, adjust, and maintain 8.5 lbf to open exterior doors as a smart practice. For all doors along the public circulation route, replace hardware with lever hardware or hardware operable without a tight pinch or grasp.	2010 ADAS Section: 404.2.3, 404.2.7, 404.2.4, 404.2.11, 404.2.11 Exception

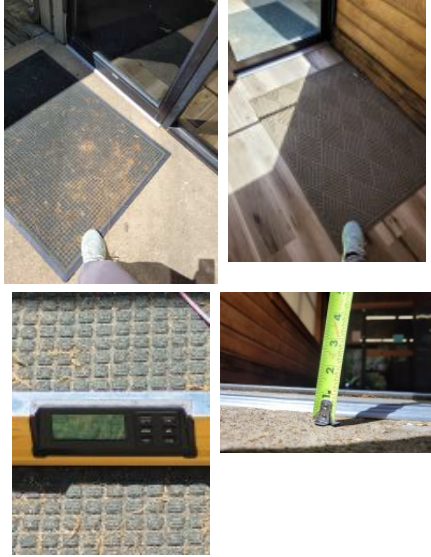
29	Headquarters Area: HQ Public Spaces	[32.2779962, -94.566017]	There is no drinking fountain for standing persons. Spout outlets of drinking fountains for standing persons shall be 38 inches minimum and 43 inches maximum above the finish floor or ground.	Lacks high bowl - spout at 32" AFF	Add second high bowl fountain for standing persons.	2015 ABAAS Section: 602.7  2012 TAS Section: 602.7  2010 ADAS Section: 602.7, 211.2

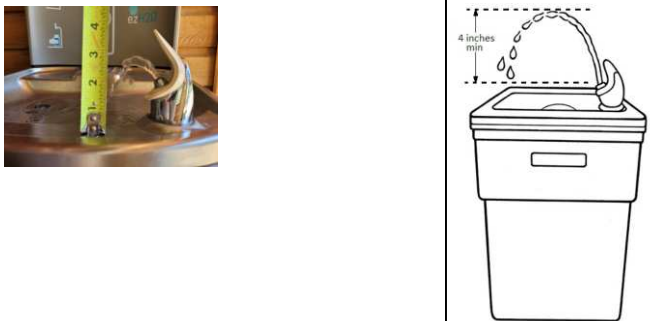
30	Headquarters Area: HQ Public Spaces	[32.2779872, -94.5660197]	The water flow from the spout is too low. The spout shall provide a flow of water 4 inches high minimum.	Water flow too low - 3"	Adjust spout flow height to min. 4".	2015 ABAAS Section: 602.6  2012 TAS Section: 602.6  2010 ADAS Section: 602.6

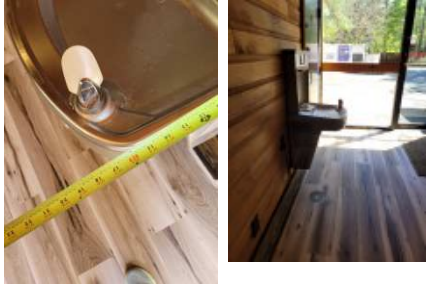
Finding Number	Area Description	Lat/Long	Finding	As Built	Recommendation	Citation	Photos	Figure
31	Headquarters Area: HQ Public Spaces	[32.2780042 , -94.566021]	An item or items project more than 4 inches into the circulation path. Wall-mounted objects that have leading edges between 27 inches and 80 inches from the floor must not project more than 4 inches into the circulation path. Protruding objects that extend to the floor or within 27 inches of the floor are cane detectable and are therefore not hazardous. Where it is necessary or desirable to have objects protrude from the wall, a manner of cane detection must be provided.	Drinking fountain projects 18"	Relocate protruding objects or place cane detectable warning or bollard at foot of item.	2015 ABAAS Section: 307.2 2012 TAS Section: 307.2 2010 ADAS Section: 307.2

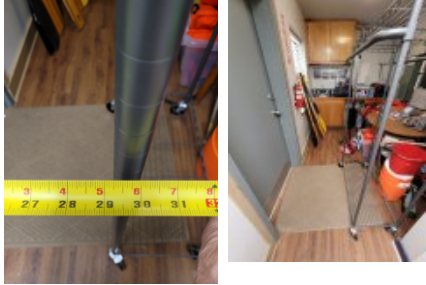
32	Headquarters Area: HQ Employee Spaces	[32.2779962 , -94.5660197]	The route of travel at this location does not provide a minimum width of 36 inches. The clear width shall be permitted to be reduced to 32 inches minimum for a length of 24 inches maximum provided that reduced width segments are separated by segments that are 48 inches long minimum and 36 inches wide minimum.	break area- 29" wide route toward break area due to storage	Relocate storage to widen AR to compliant 36" clear width.	2015 ABAAS Section: 403.5.1 2012 TAS Section: 403.5.1 2010 ADAS Section: 403.5.1

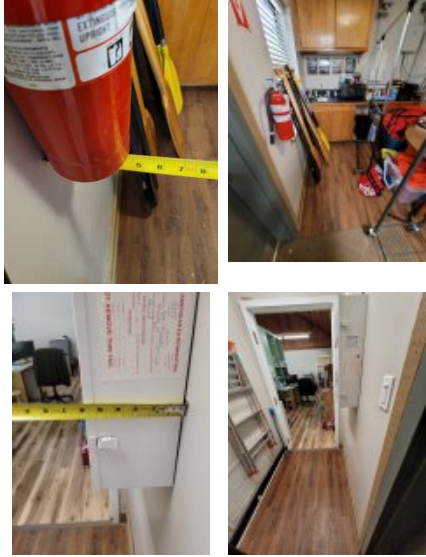
35	Headquarters Area: HQ Employee Spaces	[32.2779985, -94.5660183]	The operable part is not accessible because there is not adequate clear floor space for either a forward or side approach. The clear floor or ground space shall be 30 inches minimum by 48 inches minimum.	break area- microwave CFS obstructed by storage	Remove, or relocate storage in CFS at fixtures and operable parts along the AR.	2015 ABAAS Section: 305.3 2012 TAS Section: 305.3 2010 ADAS Section: 305.3

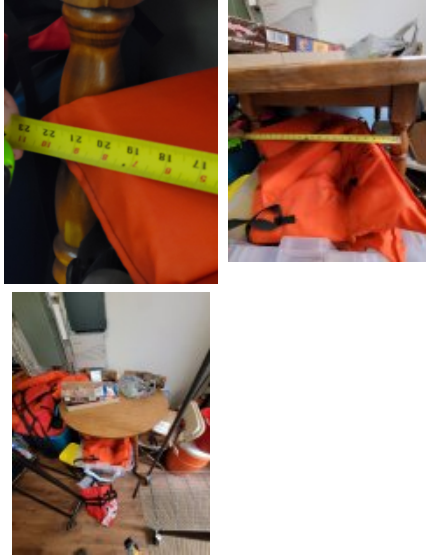
37	Headquarters Area: HQ Employee Spaces	[32.2780053 , -94.5660143]	The top rim of the sink is too high. All lavatories/sinks that are designated to be accessible shall be a minimum 17 inches in horizontal depth and mounted with the rim or counter edge no higher than 34 inches above the finished floor. The operable part is not accessible because there is not adequate clear floor space for either a forward or side approach. The clear floor or ground space shall be 30 inches minimum by 48 inches minimum.	break area- sink rim at 36" AFF, CFS obstructed by storage	Lower sinks to max 34" above the finished floor (AFF) to front of rim. Remove, or relocate storage in CFS at fixtures and operable parts along the AR.	2015 ABAAS Section: 606.3 2012 TAS Section: 606.3 2010 ADAS Section: 606.3

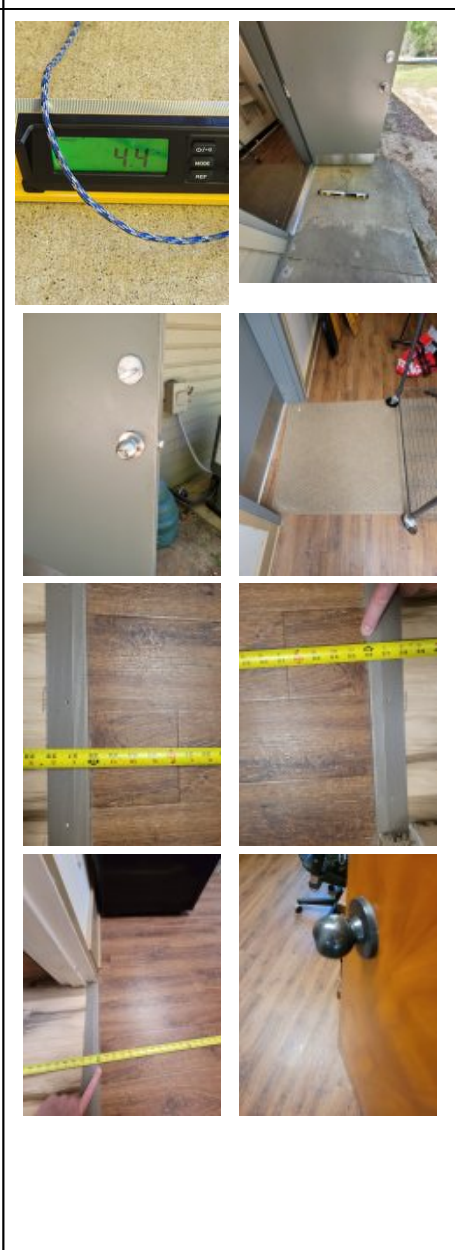
Finding Number	Area Description	Lat/Long	Finding	As Built	Recommendation	Citation	Photos	Figure
38	Headquarters Area: HQ Employee Spaces	[32.277996 , -94.566018 3]	Spaces and elements within employee work areas shall only be required to comply with 206.2.8, 207.1, and 215.3 and shall be designed and constructed so that individuals with disabilities can approach, enter, and exit the employee work area. Employee work areas, or portions of employee work areas, other than raised courtroom stations, that are less than 300 square feet (28 m2) and elevated 7 inches (180 mm) or more above the finish floor or ground where the elevation is essential to the function of the space shall not be required to comply with these requirements or to be on an accessible route.	Pay window - 32.5" wide opening Right office - knob hardware, 36" clearance Back door - 4.4% slope in clearance, knob hardware, unsecured floor mat	For employee spaces, relocate storage, furniture, and other obstacles at doorways to provide approach, enter and exit at the employee space. Provide required maneuvering clearance on push and pull side of doors. Secure rug at door to prevent trip hazard. Correct slope in door clearance to max 2.08%. Replace doors with doors having 80" overhead clearance and 32" clear width. Replace hardware with lever hardware or hardware operable without a tight pinch or grasp.	2015 ABAAS Section: F203.9 2012 TAS Section: 203.9 2010 ADAS Section: 203.9

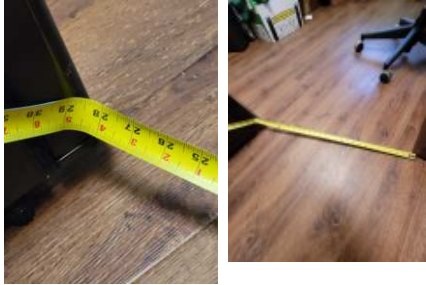
Finding Number	Area Description	Lat/Long	Finding	As Built	Recommendation	Citation	Photos	Figure
39	Headquarters Area: HQ Employee Spaces	[32.2780019 , -94.566025]	Employee Work Areas. Common use circulation paths within employee work areas shall comply with 402. EXCEPTIONS: 1. Common use circulation paths located within employee work areas that are less than 1000 square feet (93 m2) and defined by permanently installed partitions, counters, casework, or furnishings shall not be required to comply with 402. 2. Common use circulation paths located within employee work areas that are an integral component of work area equipment shall not be required to comply with 402. 3. Common use circulation paths located within exterior employee work areas that are fully exposed to the weather shall not be required to comply with 402.	Right office - 28" wide route	Make corrections for compliant circulation path.	2015 ABAAS Section: F206.2.8, F206.2.8.1, F206.2.8.2  2012 TAS Section: 206.2.8, 206.2.8 Exception 1, 206.2.8 Exception 2, 206.2.8 Exception 3, 206.2.8 Advisory 1, 206.2.8 Advisory 2  2010 ADAS Section: 206.2.8, 206.2.8 Exception 1, 206.2.8 Exception 2, 206.2.8 Exception 3

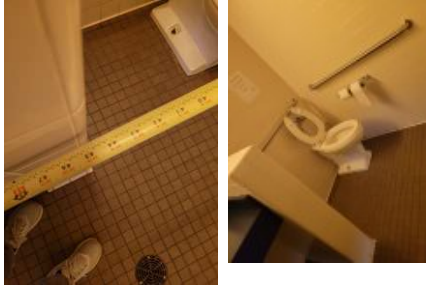
44	Headquarters Area: HQ Men's Restroom	[32.2779894 , -94.566023 7]	The required 56 inches by 60 inches clear floor space for the water closet has been obstructed. The clear floor space around the water closet shall be 60 inches minimum measured perpendicular from the side wall and 56 inches minimum measured perpendicular from the rear wall.	Lacks CFS around toilet - 45" side	Renovate restroom to provide 60" by 56" clearance around the toilet.	2015 ABAAS Section: 604.3. 2012 TAS Section: 604.3.1 2010 ADAS Section: 604.3.1

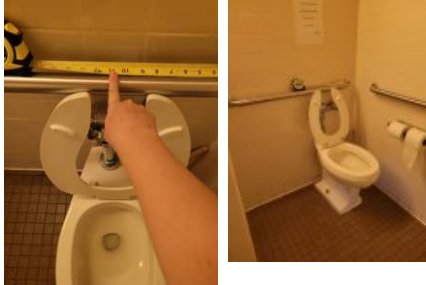
45	Headquarters Area: HQ Men's Restroom	[32.2779962 , -94.566022 3]	The rear grab bar is not 36" long or is not mounted in the correct location. The rear grab bar must be a minimum of 36" long and extend from the toilet centerline a minimum 12" towards the wall side and a minimum 24" towards the open side of the toilet. Grab bars shall be installed in a horizontal position, 33 inches minimum and 36 inches maximum above the finish floor measured to the top of the gripping surface and the space between the grab bar and the top of the tank shall be 1-1/2 inches minimum.	rear bar 11" at centerline, lacks 12" to wall side	Remount rear grab bar to behind the toilet, 12" to the wall side of center and 24" to the open side and 33" to 36" AFF.	2015 ABAAS Section: 604.5.2 2012 TAS Section: 604.5.2 2010 ADAS Section: 604.5.2

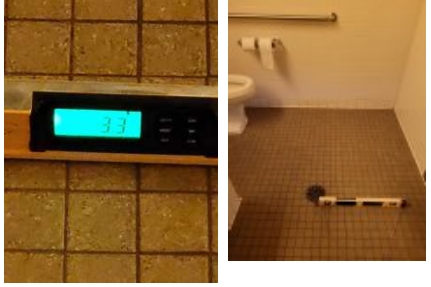
48	Headquarters Area: HQ Men's Restroom	[32.2780008, -94.566035 7]	The accessible route contains running slopes greater than 5 percent and cross slopes greater than 2 percent across the width of the walk and has not been constructed as a ramp (i.e. handrails, wheel guides, etc.). When the slope in the direction of travel of any walk exceeds 1 unit vertical in 20 units horizontal (5-percent slope), it must be constructed as ramp. Surface cross slopes must not exceed one unit vertical in 48 units. Horizontal (2-percent slope).	3.3% slope by drain	Correct or repair slope to max 2.08% in restroom.	2015 ABAAS Section: 403.3  2012 TAS Section: 403.3  2010 ADAS Section: 403.3

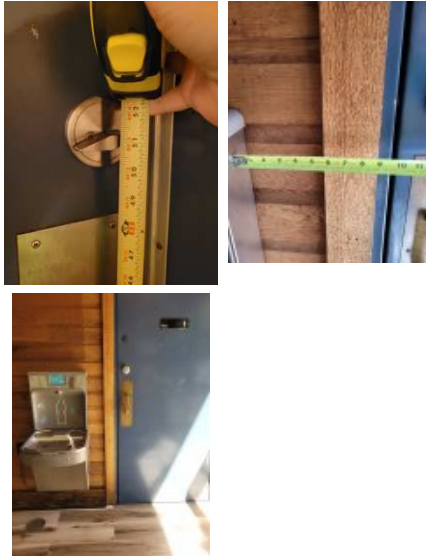
50	Headquarters Area: HQ Women's Restroom	[32.278003, -94.566017]	The restroom sign does not comply with one or more applicable requirements for the location, height, and properties of the sign.	Lacks compliant signage - on door, lacks symbol of accessibility and Braille	Replace sign with one of contrasting colors that includes Braille, raised characters, and the symbol of accessibility and mount on the wall, latch side of the door, 48" to the baseline of the lowest character and 60" to the baseline of the highest character.	2015 ABAAS Section: F216.2, 703.1, 703.2, 703.5, 703.6  2012 TAS Section: 216.2, 703.1, 703.2, 703.5, 703.6  2010 ADAS Section: 216.2, 703.1, 703.2, 703.5, 703.6

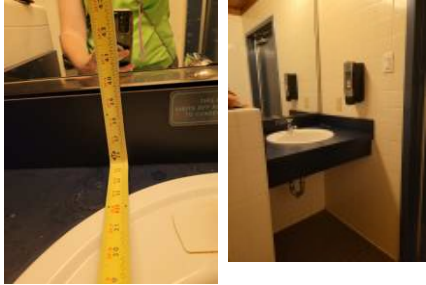
Finding Number	Area Description	Lat/Long	Finding	As Built	Recommendation	Citation	Photos	Figure
51	Headquarters Area: HQ Women's Restroom	[32.2779985 , -94.566027 7]	The mirror is mounted too high. Mirrors must have the bottom edge of the reflecting surface a maximum of 40 inches above the floor if above a sink or counter. Mirrors not located above lavatories or countertops shall be installed with the bottom edge of the reflecting surface 35 inches maximum above the finish floor or ground.	Bottom edge at 40.5" AFF	Lower mirror so bottom reflective surface is max 40" AFF and 74" at the top.	2015 ABAAS Section: 603.3  2012 TAS Section: 603.3  2010 ADAS Section: 603.3

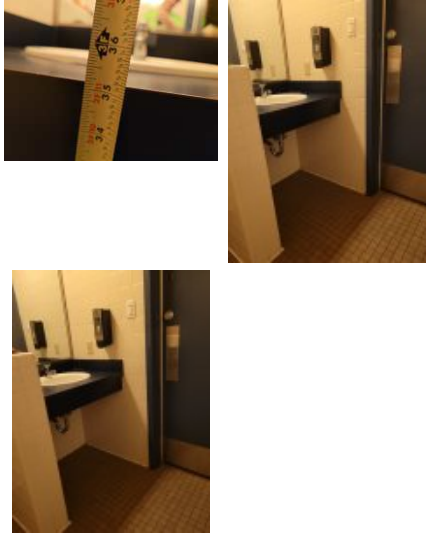
52	Headquarters Area: HQ Women's Restroom	[32.2780053 , -94.566023 7]	The top rim of the sink is too high. All lavatories/sinks that are designated to be accessible shall be a minimum 17 inches in horizontal depth and mounted with the rim or counter edge no higher than 34 inches above the finished floor.	Sink rim at 35.25" AFF	Lower sinks to max 34" above the finished floor (AFF) to front of rim.	2015 ABAAS Section: 606.3  2012 TAS Section: 606.3  2010 ADAS Section: 606.3

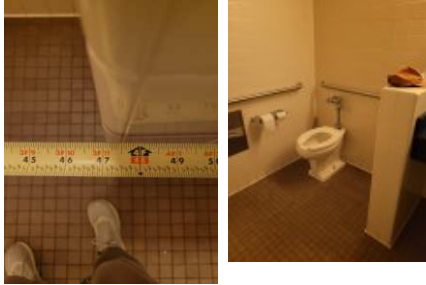
Finding Number	Area Description	Lat/Long	Finding	As Built	Recommendation	Citation	Photos	Figure
54	Headquarters Area: HQ Women's Restroom	[32.2779758, -94.566025]	The required 56 inches by 60 inches clear floor space for the water closet has been obstructed. The clear floor space around the water closet shall be 60 inches minimum measured perpendicular from the side wall and 56 inches minimum measured perpendicular from the rear wall.	Lacks clearance around toilet - 47" to tiled wall	Renovate restroom to provide 60" by 56" clearance around the toilet.	2015 ABAAS Section: 604.3. 2012 TAS Section: 604.3.1 2010 ADAS Section: 604.3.1

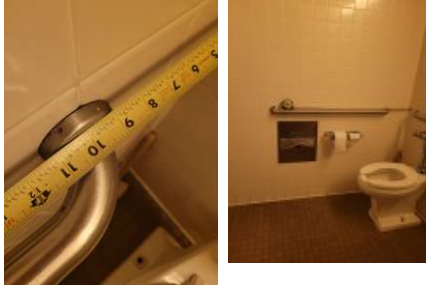
55	Headquarters Area: HQ Women's Restroom	[32.277994, -94.5660129]	The side grab bars are not in the correct location. Grab bars on the side wall must be installed so that the end closest to the rear wall is maximum 12" from the rear wall. The end furthest from the rear wall must be mounted minimum 54" from the rear wall.	Side grab bar extends 52" from rear wall	Remount side grab bar to max 12" from the rear wall at the close end and min 54" on the far end, and 33" to 36" AFF.	2015 ABAAS Section: 604.5.1 2012 TAS Section: 604.5.1 2010 ADAS Section: 604.5.1

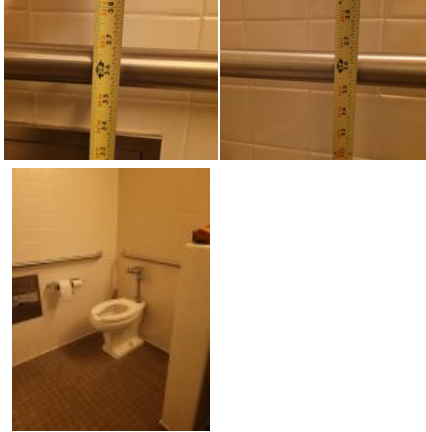
56	Headquarters Area: HQ Women's Restroom	[32.2779985, -94.5660223]	The grab bar height and/or spacing fails. Grab bars must be mounted between 33" and 36" to the top of the gripping surface. There must be 1.5" of clearance between the grab bar and the wall. There must be a minimum of 1.5" of clearance below and minimum 12" above the grab bar to any dispenser or other obstruction.	Both grab bars at 36.75" AFF	Remount grab bars in accessible stall to 33" to 36" above the finished floor (AFF).	2015 ABAAS Section: 609.3, 609.4 2012 TAS Section: 609.4, 609.3 2010 ADAS Section: 609.3, 609.4

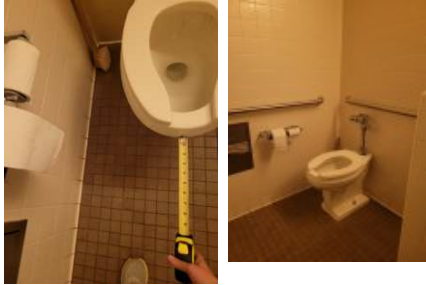
Finding Number	Area Description	Lat/Long	Finding	As Built	Recommendation	Citation	Photos	Figure
57	Headquarters Area: HQ Women's Restroom	[32.2779872 , -94.566025]	The toilet paper is not installed within the compliant range in front of the toilet. Toilet paper dispensers shall be 7 inches minimum and 9 inches maximum in front of the water closet measured to the centerline of the dispenser. The outlet of the dispenser shall be 15 inches minimum and 48 inches maximum above the finish floor and shall not be located behind grab bars. Dispensers shall not be of a type that controls delivery or that does not allow continuous paper flow. There shall be a clearance of 1 1/2 inches minimum below the grab bar.	TP dispenser too close to front of toilet	Remount toilet paper dispenser max 7" to 9" from front of toilet, 15" to 48" AFF and min 12" above or 1.5" below grab bar.	2015 ABAAS Section: 604.7  2012 TAS Section: 604.7  2010 ADAS Section: 604.7

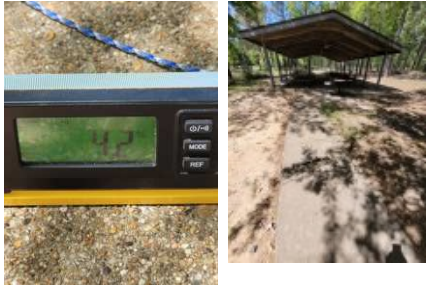
Finding Number	Area Description	Lat/Long	Finding	As Built	Recommendation	Citation	Photos	Figure
61	Group Pavilion: Group Pavilion	[32.2760433 , -94.565154 3]	The accessible route of travel contains cross slopes greater than 2%. Cross slopes shall not exceed one unit vertical in 48 units horizontal (2-percent slope).	4.2% cross slope about 21' from edge of shelter	Correct or repair cross slope along AR to max 2.08%.	2015 ABAAS Section: 403.3  2012 TAS Section: 403.3  2010 ADAS Section: 403.3

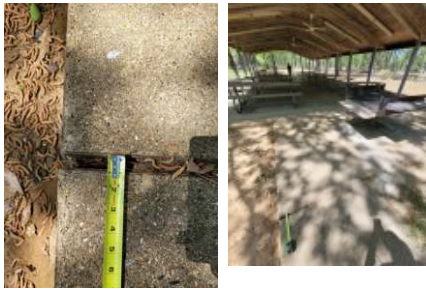
62	Group Pavilion: Group Pavilion	[32.2760297 , -94.565262 9]	There is a gap spaced greater than a 1/2 inch. Openings in floor or ground surfaces shall not allow passage of a sphere more than 1/2 inch diameter. Elongated openings shall be placed so that the long dimension is perpendicular to the dominant direction of travel.	1" gap near grill	Correct or fill gaps to be max .5".	2015 ABAAS Section: 302.3  2012 TAS Section: 302.3  2010 ADAS Section: 302.3

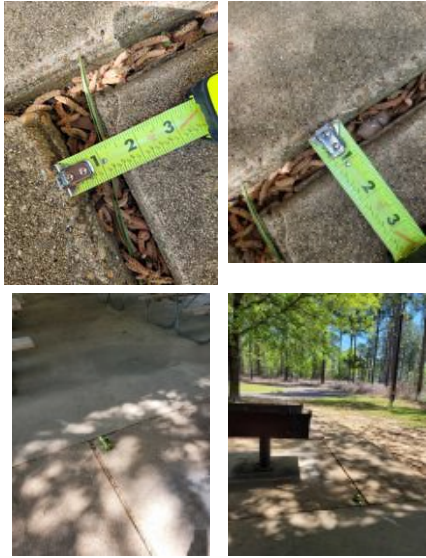
65	Group Pavilion: Group Pavilion	[32.2759711 , -94.565316 9]	An accessible access route is not provided between elements, spaces and the facilities provided within the accessible camping unit. At least one outdoor recreation access route shall connect accessible elements, spaces and facilities provided within camping units with mobility features.	Lacks ORAR to fire pit and water spout	Create AR with crushed and compacted stone or similar outdoor material to camp sites and one of each type of amenity.	2015 ABAAS Section: F244.5.1

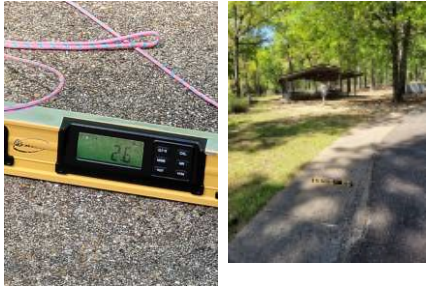
66	Group Pavilion: Group Pavilion	[32.2760086 , -94.564989 7]	The accessible route of travel contains cross slopes greater than 2%. Cross slopes shall not exceed one unit vertical in 48 units horizontal (2-percent slope).	2.6% cross on path from lot to pavilion	Correct or repair cross slope along AR to max 2.08%.	2015 ABAAS Section: 403.3  2012 TAS Section: 403.3  2010 ADAS Section: 403.3

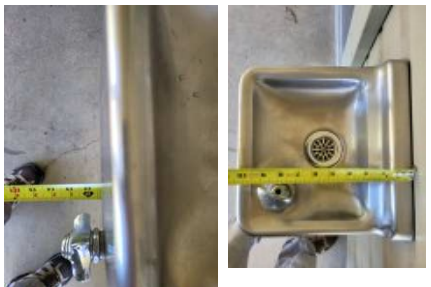
68	Day Use Area: Day Use - Swim Area Men's Restroom	[32.2752001 , -94.565907]	The spout is not positioned correctly from the vertical support. The spout shall be located 15 inches minimum from the vertical support and 5 inches maximum from the front edge of the unit, including bumpers.	Spout 8.5" from vertical support	Remount or replace fountain to provide 15" from vertical support to the spout.	2015 ABAAS Section: 602.5  2012 TAS Section: 602.5  2010 ADAS Section: 602.5

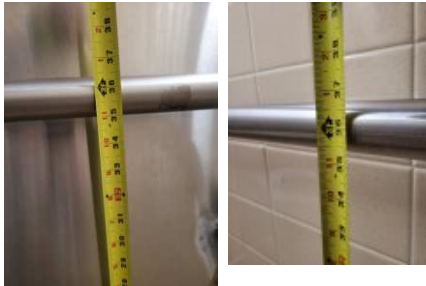
83	Day Use Area: Day Use - Swim Area Men's Restroom	[32.2751888 , -94.565903]	The grab bar height and/or spacing fails. Grab bars must be mounted between 33" and 36" to the top of the gripping surface. There must be 1.5" of clearance between the grab bar and the wall. There must be a minimum of 1.5" of clearance below and minimum 12" above the grab bar to any dispenser or other obstruction.	Left grab bar at 36.5" AFF, right grab bar at 36.75" AFF	Remount grab bars in accessible stall to 33" to 36" above the finished floor (AFF).	2015 ABAAS Section: 609.3, 609.4  2012 TAS Section: 609.4, 609.3  2010 ADAS Section: 609.3, 609.4

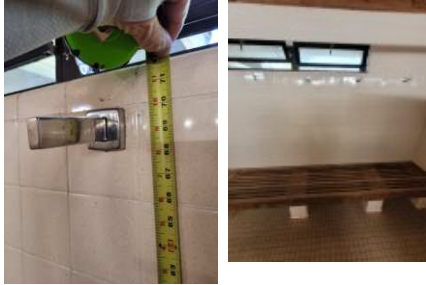
Finding Number	Area Description	Lat/Long	Finding	As Built	Recommendation	Citation	Photos	Figure
90	Day Use Area: Day Use - Swim Area Women's Restroom	[32.2752046, -94.565907]	Where a high forward reach is over an obstruction, the clear floor space shall extend beneath the element for a distance not less than the required reach depth over the obstruction. The high forward reach shall be 48 inches (1220 mm) maximum where the reach depth is 20 inches (510 mm) maximum. Where the reach depth exceeds 20 inches (510 mm), the high forward reach shall be 44 inches (1120 mm) maximum and the reach depth shall be 25 inches (635 mm) maximum. Where a clear floor or ground space allows a parallel approach to an element and the high side reach is over an obstruction, the height of the obstruction shall be 34 inches (865 mm) maximum and the depth of the obstruction shall be 24 inches (610 mm) maximum. The high side reach shall be 48 inches (1220 mm) maximum for a reach depth of 10 inches (255 mm) maximum. Where the reach depth exceeds 10 inches (255 mm), the high side reach shall be 46 inches (1170 mm) maximum for a reach depth of 24 inches (610 mm) maximum.	Hooks over bench at 69" AFF	Lower hooks to max 46" above the finished floor (AFF) for a side reach over bench.	2015 ABAAS Section: 308.2.1, 308.3.2  2012 TAS Section: 308.2.1, 308.3.2  2010 ADAS Section: 308.2.1, 308.3.2

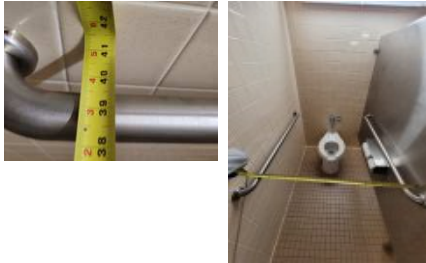
Finding Number	Area Description	Lat/Long	Finding	As Built	Recommendation	Citation	Photos	Figure
92	Day Use Area: Day Use - Swim Area Women's Restroom	[32.2751774, -94.5659124]	The ambulatory stall is not between 35" to 37" wide and 60" deep.	Ambulatory stall 41" wide	Correct ambulatory stall to be 35" to 37" wide and minimum 60" deep.	2015 ABAAS Section: 604.8.2.1  2012 TAS Section: 604.8.2.1  2010 ADAS Section: 604.8.2.1

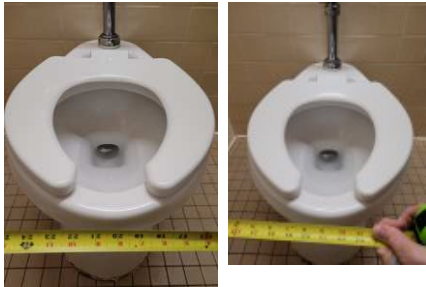
93	Day Use Area: Day Use - Swim Area Women's Restroom	[32.275191, -94.5659164]	The toilet is not located within the range to the side wall or partition. The centerline of the toilet shall be 17 inches minimum and 19 inches maximum side wall or partition in the ambulatory accessible toilet compartment.	20.5" to left and 21" to right	Remount toilet to 17" to 19" from the side wall to center line in ambulatory stalls.	2015 ABAAS Section: 604.9.1  2012 TAS Section: 604.9.1  2010 ADAS Section: 604.9.1

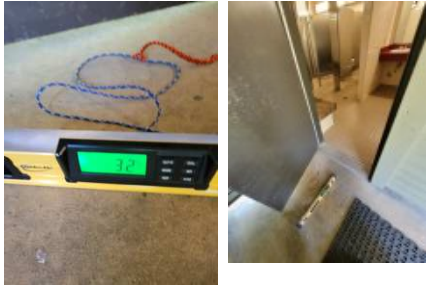
Finding Number	Area Description	Lat/Long	Finding	As Built	Recommendation	Citation	Photos	Figure
99	Day Use Area: Day Use - Swim Area Women's Restroom	[32.2752001 , -94.5659177]	The door does not have a compliant landing. Doors with an approach from the hinge side must have a landing on the pull side that is a minimum of 60 inches in depth perpendicular to the door in a close position by a minimum width dimension of 36 inches plus the door width. The additional 36 inches must extend past the door on the latch side. The entire landing must be free of obstructions and must be flat (2% max. slope is considered flat in any direction).	women's- 3.2% slope in maneuvering clearance	For all doors along the public circulation route, correct or repair slope at doorway landing to max 2.08% in any direction for level CFS.	2015 ABAAS Section: 404.2.4.1  2012 TAS Section: 404.2.4.1  2010 ADAS Section: 404.2.4.1

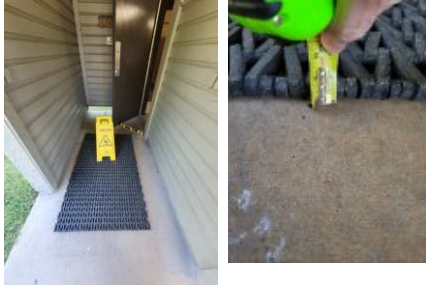
100	Day Use Area: Day Use - Swim Area Women's Restroom	[32.2751956 , -94.565915]	The floor mat or carpet pile height is too high. The doormat is not secured in place at the entry door. Carpet or carpet tile shall be securely attached and shall have a firm cushion, pad, or backing or no cushion or pad. Carpet or carpet tile shall have a level loop, textured loop, level cut pile, or level cut/uncut pile texture. Pile height shall be 1/2 inch maximum. Exposed edges of carpet shall be fastened to floor surfaces and shall have trim on the entire length of the exposed edge.	unsecured floor mat, .5" pile	Replace mat or carpet with one having max pile or edge of 1/4". Remove or secure mat at door to prevent trip hazard.	2015 ABAAS Section: 302.2  2012 TAS Section: 302.2  2010 ADAS Section: 302.2

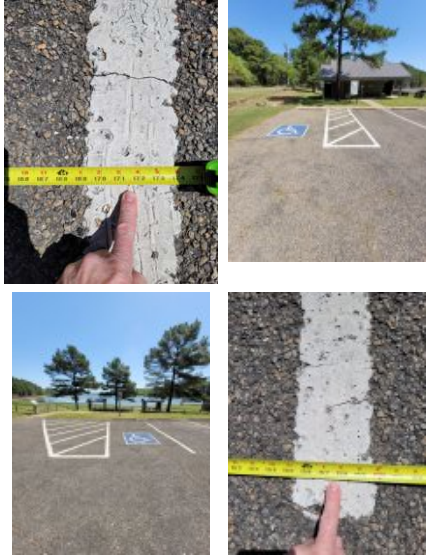
Finding Number	Area Description	Lat/Long	Finding	As Built	Recommendation	Citation	Photos	Figure																																																																																																																																																																																																																																																																																																																																																																								
102	Day Use Area: Day Use - Parking	[32.2751377 , -94.566084] [32.2749722 , -94.566081 3]	There are no van accessible parking stalls. 1 in every 6, minimum of one, required accessible stalls must be a van accessible stall. There are a total of (XX) parking stalls in the parking lot that could be reasonably associated with this facility. There should be a minimum of (XX) accessible stalls with a minimum of (XX) being designed as van accessible.	lacks van stall, left stall 14' 3.5" wide, right stall 13' 1.5"	Add van parking sign to one accessible stall and repaint stall and access aisle to 11' and 5' or 8' and 8'.	2015 ABAAS Section: F208.2, F208.2.4  2012 TAS Section: 208.2, 208.2.4  2010 ADAS Section: 208.2, 208.2.4

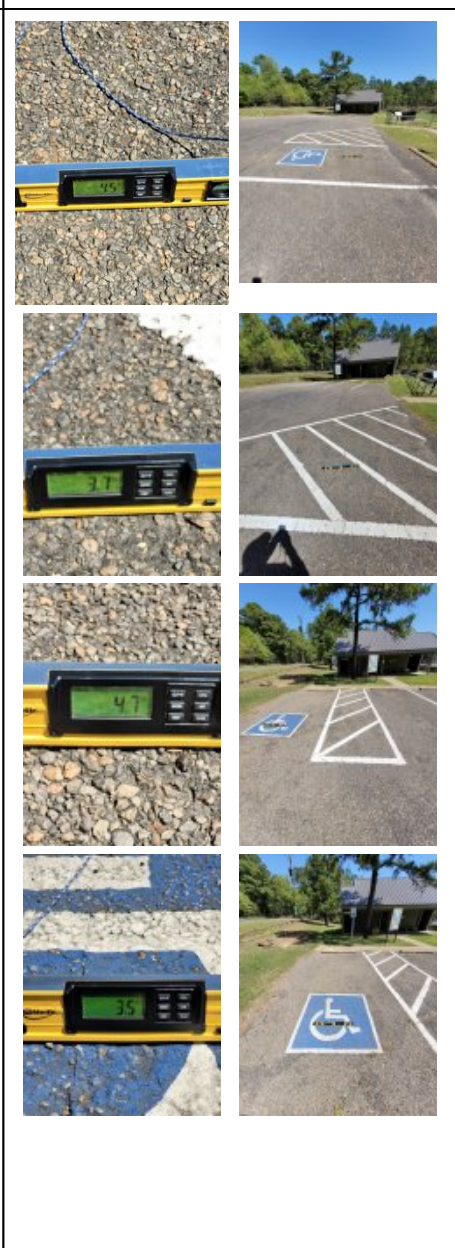
Finding Number	Area Description	Lat/Long	Finding	As Built	Recommendation	Citation	Photos	Figure
103	Day Use Area: Day Use - Parking	[32.2751355 , -94.56608 54], [32.2749835 , -94.566081 3]	The cross slopes (narrow dimension) and/or running slopes (long dimension) of the access aisle exceeds 2%. The running slope and the cross slope in an accessible parking stall and the access aisle must not exceed 2%.	Slopes of 4.7% in left AA, 3.5% in left stall, 4.5% in right stall, 3.7% in right AA	Resurface stalls and access aisles to eliminate slopes.	2015 ABAAS Section: 502.4  2012 TAS Section: 502.4  2010 ADAS Section: 502.4

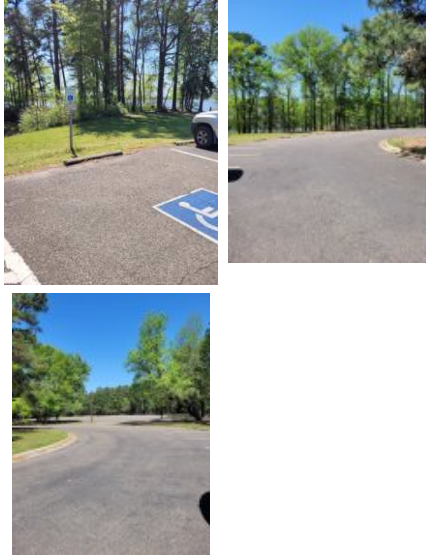
108	Day Use Area: Day Use - Parking	[32.2730411 , -94.566774 7]	The cross slopes (narrow dimension) and/or running slopes (long dimension) of the access aisle exceeds 2%. The running slope and the cross slope in an accessible parking stall and the access aisle must not exceed 2%.	Slope of 3.8% in stall	Repair or correct slope of parking space and access aisle to max 2.08% in any direction.	2015 ABAAS Section: 502.4  2012 TAS Section: 502.4  2010 ADAS Section: 502.4

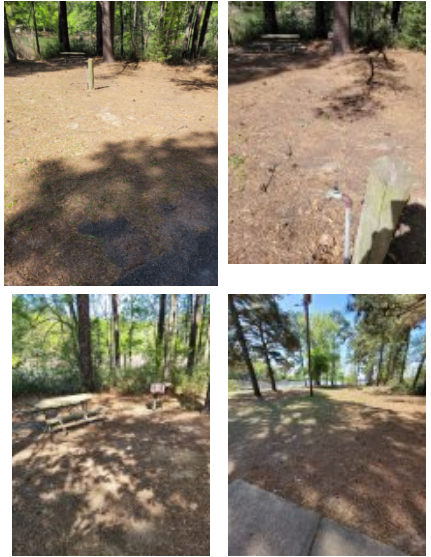
111	Day Use Area: Day Use - Picnic Area	[32.27502, -94.56599]	The 30 inches minimum by 48 inches minimum clear floor space required at the operable part is not flat (2% or 1:48 maximum slope) in all directions. Changes in level are not permitted at required clear floor or ground space except that slopes not steeper than 1:48 shall be permitted.	6.7% slope in CFS of sign	Correct or repair slope in CFS to max 2.08%.	2015 ABAAS Section: 305.2  2012 TAS Section: 305.2  2010 ADAS Section: 305.2

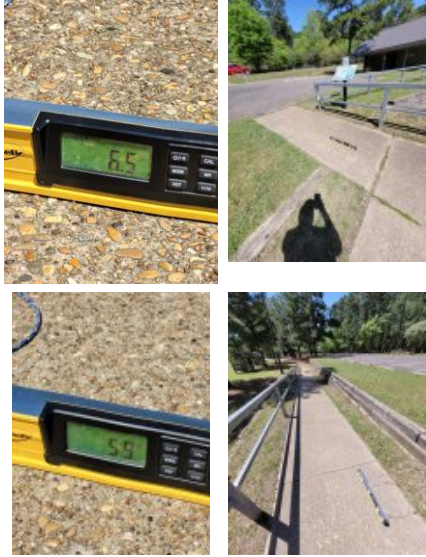
113	Day Use Area: Day Use - Playground	[32.2746218 , -94.5667801]	There is no accessible route to the play area. Accessible routes serving play areas shall comply with Chapter 4 and 1008.2 and shall be permitted to use the exceptions in 1008.2.1 through 1008.2.3. Where accessible routes serve ground level play components, the vertical clearance shall be 80 inches high (2030 mm) minimum.	Lacks AR to playground	Create an AR to the play area within the site.	2015 ABAAS Section: F206.2.2  2012 TAS Section: 1008.2  2010 ADAS Section: 206.2.2

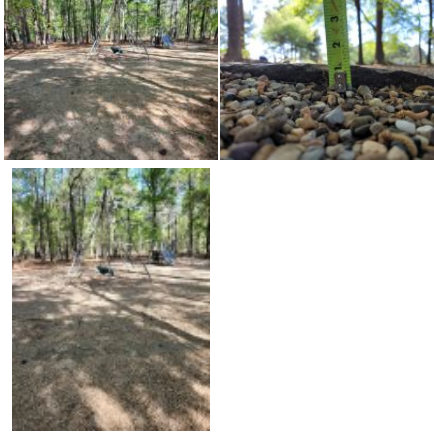
115	Day Use Area: Day Use - Playground	[32.274615, -94.566770 7]	Play area shall have signage listing designated ages of intended users.	Lacks posted ages of intended users	Acquire and install intended user signage and mount at designated entry as a smart practice.	2015 ABAAS Section: F240.1  2012 TAS Section: 240.1  2010 ADAS Section: 240.1

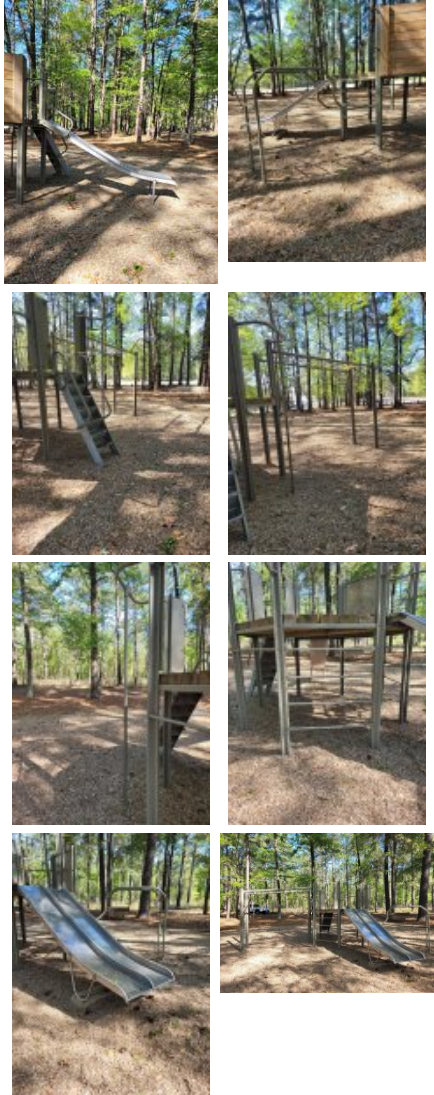
Finding Number	Area Description	Lat/Long	Finding	As Built	Recommendation	Citation	Photos	Figure
117	Day Use Area: Day Use - Playground	[32.2746173 , -94.566768]	There are not enough accessible elevated play components. Where Elevated Play Components are provided, at least 50 percent shall be on an accessible route. An accessible route may be a ramp of transfer system.	0 of 6 EPCs comply - no transfer system; slide, curved bar climber, tall monkey bars, fire pole, ladder, double slide	Add transfer system to access minimum 50% of EPCs	2012 TAS Section: 240.2.2  2010 ADAS Section: 240.2.2

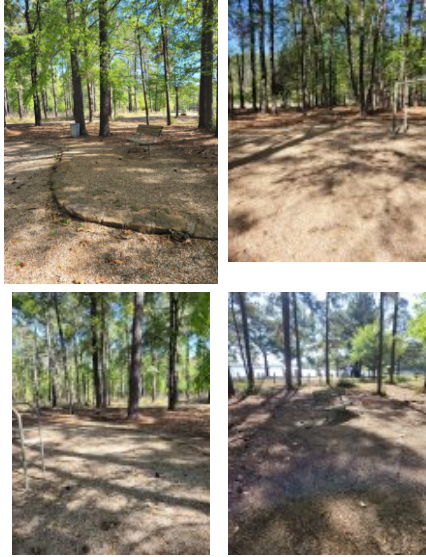
121	Day Use Area: Day Use - Swimming	[32.2741615 , -94.565877 5]	At least one accessible route shall connect accessible buildings, accessible facilities, accessible elements, and accessible spaces that are on the same site.	Lacks AR to canoe rental, from canoe to water, and to safety device	Provide an accessible route to each element within the site.	2010 ADAS Section: 206.2.2, 206.2

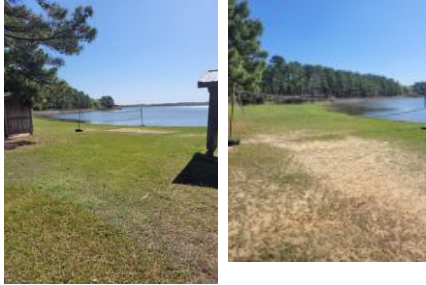
Finding Number	Area Description	Lat/Long	Finding	As Built	Recommendation	Citation	Photos	Figure
122	Day Use Area: Day Use - Swimming	[32.2747828 , -94.565825 2]	At least one accessible route shall connect accessible buildings, accessible facilities, accessible elements, and accessible spaces that are on the same site. For areas of sport activity, an accessible route is required to connect to the boundary of each area of sport activity. The size of an area of sport activity includes only the space needed to play. Where multiple sports fields or courts are provided, an accessible route is required to each field or area of sport activity.	Lacks AR to volleyball court	Provide an accessible route to each element within the site.	2010 ADAS Section: 206.2.2, 206.2

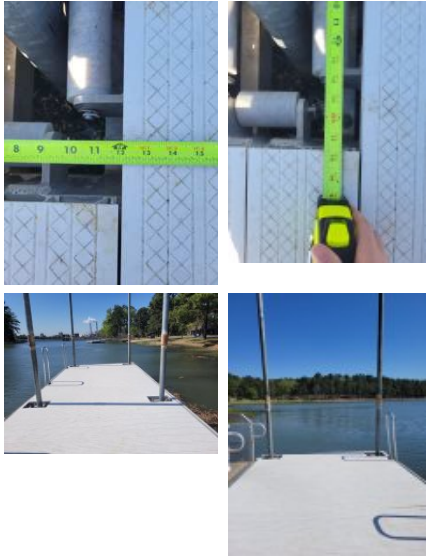
125	Day Use Area: Day Use - Boat Ramp	[32.273751, -94.565904 3]	There is a gap spaced greater than a 1/2 inch. Openings in floor or ground surfaces shall not allow passage of a sphere more than 1/2 inch diameter. Elongated openings shall be placed so that the long dimension is perpendicular to the dominant direction of travel.	Pier closer to swimming - 1" gap above curb	Correct or fill gaps to be max .5".	2015 ABAAS Section: 302.3  2012 TAS Section: 302.3  2010 ADAS Section: 302.3

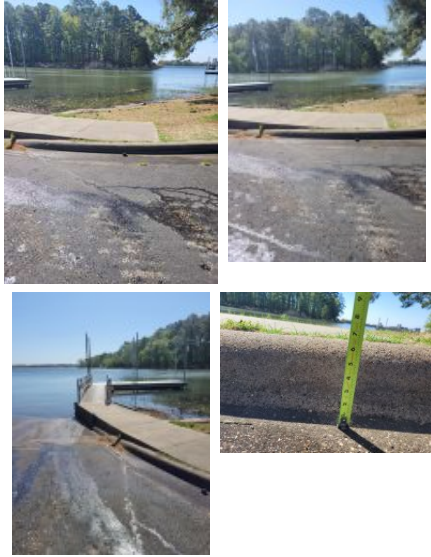
127	Day Use Area: Day Use - Fishing	[32.2731511 , -94.566413 9]	The accessible route of travel contains cross slopes greater than 2%. Cross slopes shall not exceed one unit vertical in 48 units horizontal (2-percent slope).	3.5% cross slope at path to fishing, parallel to fish clean	Correct or repair cross slope along AR to max 2.08%.	2015 ABAAS Section: 403.3  2012 TAS Section: 403.3  2010 ADAS Section: 403.3

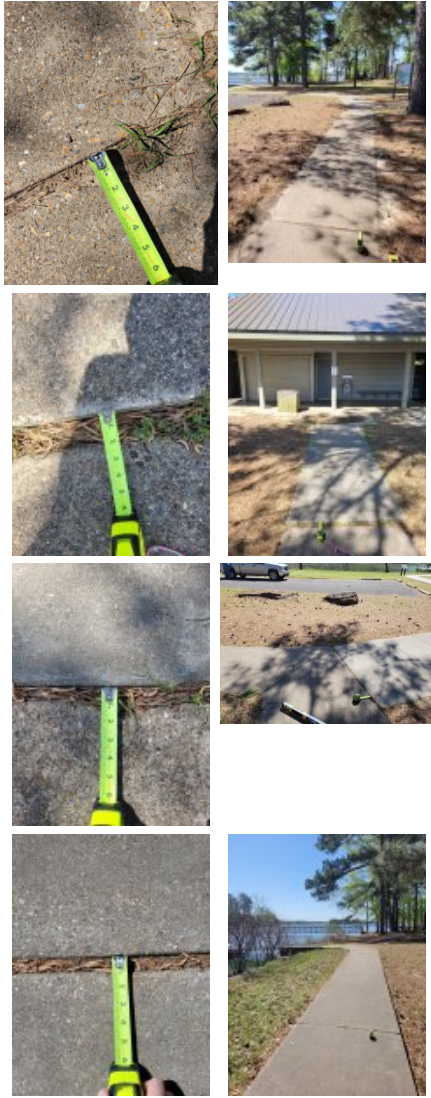
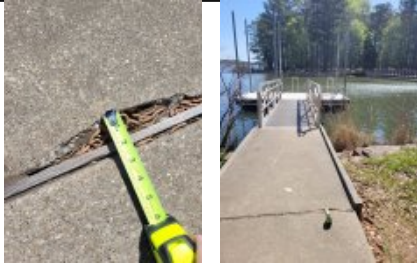
Finding Number	Area Description	Lat/Long	Finding	As Built	Recommendation	Citation	Photos	Figure
128	Day Use Area: Day Use - Fishing	[32.2731511 , -94.56644 34], [32.2728472 , -94.566220 8]	There is a gap spaced greater than a 1/2 inch. Openings in floor or ground surfaces shall not allow passage of a sphere more than 1/2 inch diameter. Elongated openings shall be placed so that the long dimension is perpendicular to the dominant direction of travel.	2.5" gap on path to bridge by restroom building, 2" gap at turn to restroom, 1.5" gap at intersection from restroom to fish pier, 1" gap before turn to pier by bridge, 1.5" gap at turn to pier by bridge	Correct or fill gaps to be max .5".	2015 ABAAS Section: 302.3  2012 TAS Section: 302.3  2010 ADAS Section: 302.3

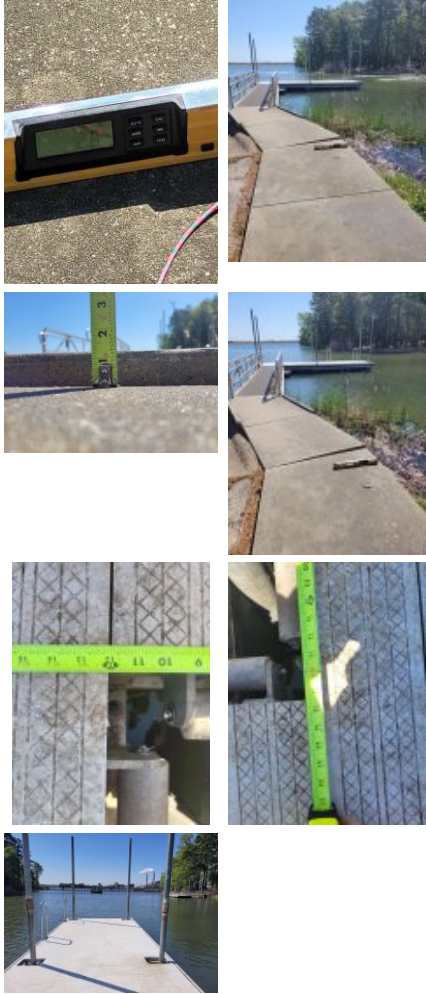
Finding Number	Area Description	Lat/Long	Finding	As Built	Recommendation	Citation	Photos	Figure
129	Day Use Area: Day Use - Fishing	[32.2732135 , -94.56604 51], [32.2731931 , -94.565911]	There is no accessible route to/on the boating facility. Accessible routes serving recreational boating facilities, including gangways and floating piers, shall comply with accessible route requirements except as modified by section Recreational Boating Facilities - Accessible Routes.	Pier at fish cleaning - 2.6% cross slope on path to where walk way turns, 1.25" CIL on approaching walkway, six 12" by 16.5" gaps at lights on pier	Correct or repair cross slope along AR to max 2.08%. Repair, bevel, or ramp CIL to max .25" along AR. Correct or fill gaps to be max .5". In the alternative, add a curb or rail to prevent a wheel from slipping into one of the holes at the posts.	2015 ABAAS Section: 1003.2  2010 ADAS Section: 1003.2

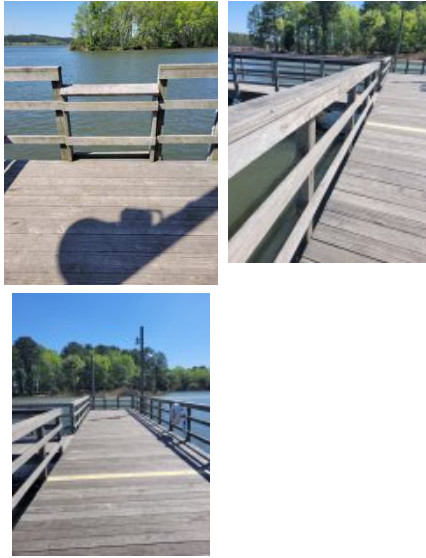
133	Day Use Area: Day Use - Fishing	[32.2723245 , -94.566360 3]	At least one accessible route shall connect accessible buildings, accessible facilities, accessible elements, and accessible spaces that are on the same site.	Lacks AR to wooden pier	Provide an accessible route to each element within the site.	2010 ADAS Section: 206.2.2, 206.2

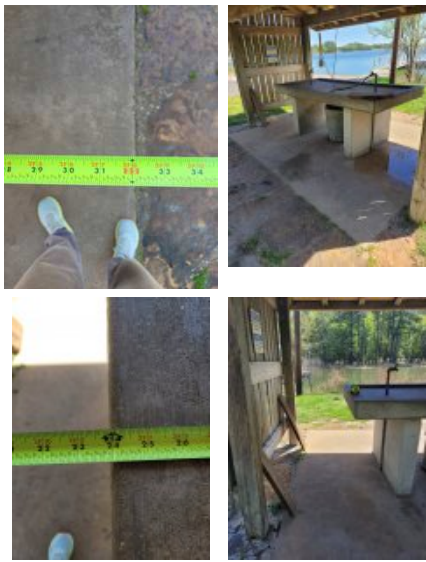
137	Day Use Area: Day Use - Picnic Area near Fishing	[32.274818, -94.565972 7]	Picnic facilities shall provide outdoor recreation access routes complying with 1016 in accordance with F245.4 and 245.4 of IAC	Lacks AR to covered picnic tables	Create ORAR with crushed and compacted stone or similar outdoor material from parking or sidewalk to shelter or picnic area.	2015 ABAAS Section: F245.4

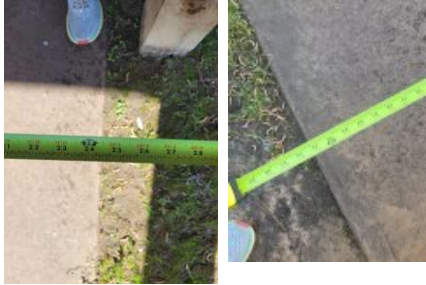
Finding Number	Area Description	Lat/Long	Finding	As Built	Recommendation	Citation	Photos	Figure
138	Day Use Area: Day Use - Picnic Area near Fishing	[32.2747284 , -94.5659928]	36 inches (915 mm) on all usable sides of the table measured from the back edge of the picnic tables.	24.5" around table	Provide required 36" clear ground space around all usable portions of the table as a smart practice.	2015 ABAAS Section: 1011.2.1

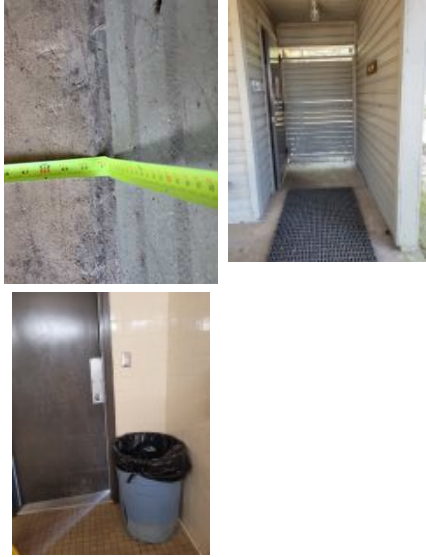
142	Day Use Area: Day Use - Boat Ramp Men's Restroom	[32.27315, -94.56654]	The restroom sign does not comply with one or more applicable requirements for the location, height, and properties of the sign.	Lacks compliant signage	Replace sign with one of contrasting colors that includes Braille, raised characters, and the symbol of accessibility and mount on the wall, latch side of the door, 48" to the baseline of the lowest character and 60" to the baseline of the highest character.	2015 ABAAS Section: F216.2, 703.1, 703.2, 703.5, 703.6  2012 TAS Section: 216.2, 703.1, 703.2, 703.5, 703.6  2010 ADAS Section: 216.2, 703.1, 703.2, 703.5, 703.6

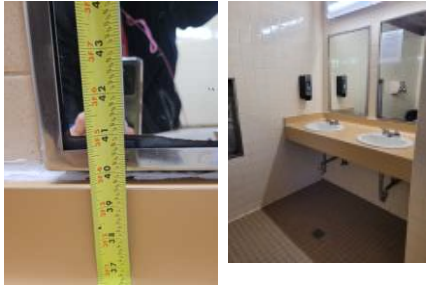
Finding Number	Area Description	Lat/Long	Finding	As Built	Recommendation	Citation	Photos	Figure
143	Day Use Area: Day Use - Boat Ramp Men's Restroom	[32.27315, -94.56654]	The mirror is mounted too high. Mirrors must have the bottom edge of the reflecting surface a maximum of 40 inches above the floor if above a sink or counter. Mirrors not located above lavatories or countertops shall be installed with the bottom edge of the reflecting surface 35 inches maximum above the finish floor or ground.	Bottom edge at 41" AFF	Lower mirror so bottom reflective surface is max 40" AFF and 74" at the top.	2015 ABAAS Section: 603.3  2012 TAS Section: 603.3  2010 ADAS Section: 603.3

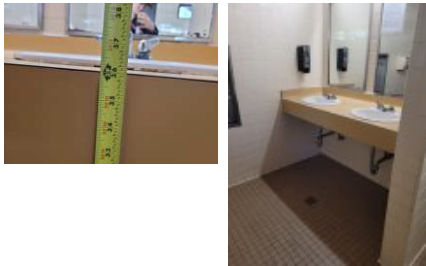
144	Day Use Area: Day Use - Boat Ramp Men's Restroom	[32.27315, -94.56654]	The top rim of the sink is too high. All lavatories/sinks that are designated to be accessible shall be a minimum 17 inches in horizontal depth and mounted with the rim or counter edge no higher than 34 inches above the finished floor.	Sink rim at 36" AFF	Lower sinks to max 34" above the finished floor (AFF) to front of rim.	2015 ABAAS Section: 606.3  2012 TAS Section: 606.3  2010 ADAS Section: 606.3

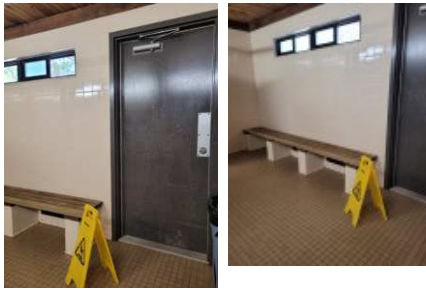
146	Day Use Area: Day Use - Boat Ramp Men's Restroom	[32.27315, -94.56654]	The operable part is not accessible because there is not adequate clear floor space for either a forward or side approach. The clear floor or ground space shall be 30 inches minimum by 48 inches minimum.	Short end of bench lacks CFS	Provide required 30" by 48" CFS at bench.	2015 ABAAS Section: 305.3  2012 TAS Section: 305.3  2010 ADAS Section: 305.3
