# Access Audit Site Report

**Martin Creek Lake State Park**

**Accessibility Evaluation**

**Inspection Date: 04/08/2022**

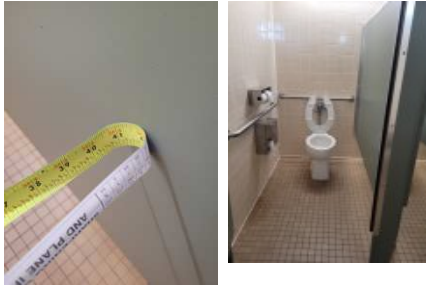
Finding Number	Area Description	Lat/Long	Finding	As Built	Recommendation	Citation	Photos	Figure
159	Day Use Area: Day Use - Boat Ramp Women's Restroom	[32.27315, -94.56654]	The ambulatory stall is not between 35" to 37" wide and 60" deep.	Ambulatory stall 41.5" wide by 64" deep	Correct ambulatory stall to be 35" to 37" wide and minimum 60" deep.	2015 ABAAS Section: 604.8.2.1  2012 TAS Section: 604.8.2.1  2010 ADAS Section: 604.8.2.1

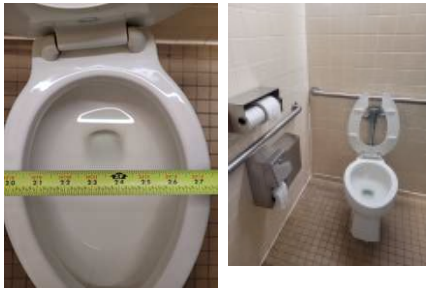
160	Day Use Area: Day Use - Boat Ramp Women's Restroom	[32.27315, -94.56654]	The toilet is not located within the range to the side wall or partition. The centerline of the toilet shall be 17 inches minimum and 19 inches maximum side wall or partition in the ambulatory accessible toilet compartment.	23" from tile side	Remount toilet to 17" to 19" from the side wall to center line in ambulatory stalls.	2015 ABAAS Section: 604.9.1  2012 TAS Section: 604.9.1  2010 ADAS Section: 604.9.1

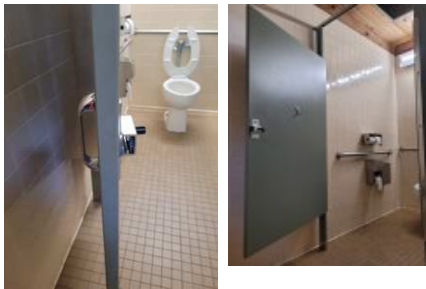
161	Day Use Area: Day Use - Boat Ramp Women's Restroom	[32.27315, -94.56654]	The stall door fails to comply with all of the door requirements. The stall door must be a minimum of 32" wide and have compliant hardware on both sides. The stall door must be self-closing.	Ambulatory stall lacks self-closing door, and hardware requires tight pinch	Adjust stall door to be self-closing. Replace stall hardware with hardware operable without a tight pinch or grasp on both sides of the stall door.	2015 ABAAS Section: 404.2.3, 404.2.7, 604.8.2.2  2012 TAS Section: 404.2.3, 404.2.7, 604.8.2.2  2010 ADAS Section: 404.2.3, 404.2.7, 604.8.2.2

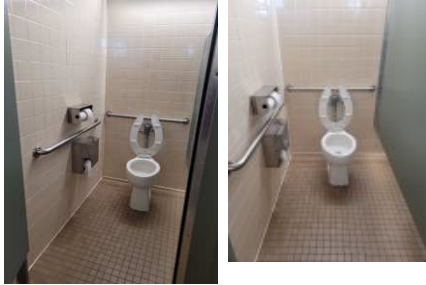
Finding Number	Area Description	Lat/Long	Finding	As Built	Recommendation	Citation	Photos	Figure
162	Day Use Area: Day Use - Boat Ramp Women's Restroom	[32.27315, -94.56654]	Grab bars shall comply with 609. A side-wall grab bar complying with 604.5.1 shall be provided on both sides of the compartment. The space between the wall and the grab bar shall be 1½ inches (38 mm). The space between the grab bar and projecting objects below and at the ends shall be 1½ inches (38 mm) minimum. The space between the grab bar and projecting objects above shall be 12 inches (305 mm) minimum. Grab bars shall be installed in a horizontal position, 33 inches (840 mm) minimum and 36 inches (915 mm) maximum above the finish floor measured to the top of the gripping surface, except that at water closets for children's use complying with 604.9, grab bars shall be installed in a horizontal position 18 inches (455 mm) minimum and 27 inches (685 mm) max	Lacks one side bar - existing bar complies	Replace or add side grab bars with a 42" long grab bar, mounted max 12" from the rear wall at the close end and min 54" on the far end and 33" to 36" AFF.	2015 ABAAS Section: 604.8.2.3, 609.3, 609.4  2012 TAS Section: 609.4, 609.3, 604.8.2.3  2010 ADAS Section: 609.3, 609.4, 604.8.2.3

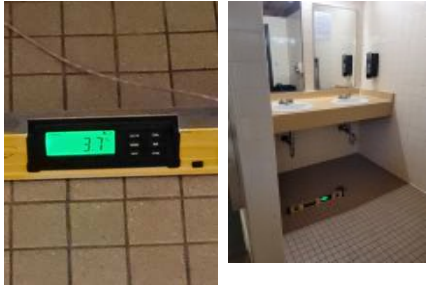
Finding Number	Area Description	Lat/Long	Finding	As Built	Recommendation	Citation	Photos	Figure
166	Day Use Area: Day Use - Boat Ramp Women's Restroom	[32.27315, -94.56654]	The accessible route contains running slopes greater than 5 percent and cross slopes greater than 2 percent across the width of the walk and has not been constructed as a ramp (i.e. handrails, wheel guides, etc.). When the slope in the direction of travel of any walk exceeds 1 unit vertical in 20 units horizontal (5-percent slope), it must be constructed as ramp. Surface cross slopes must not exceed one unit vertical in 48 units. Horizontal (2-percent slope).	Slope of 3.7% at sink	Correct or repair slope to max 2.08% in restroom.	2015 ABAAS Section: 403.3  2012 TAS Section: 403.3  2010 ADAS Section: 403.3

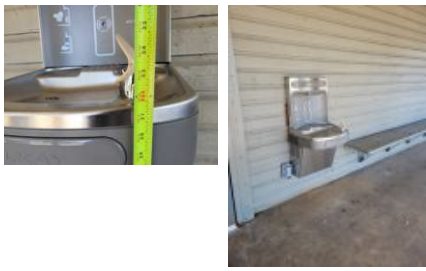
168	Day Use Area: Day Use - Boat Ramp Women's Restroom	[32.27315, -94.56654]	There is no drinking fountain for standing persons. Spout outlets of drinking fountains for standing persons shall be 38 inches minimum and 43 inches maximum above the finish floor or ground.	Lacks high bowl fountain - spout at 33.5" AFF	Add second high bowl fountain for standing persons.	2015 ABAAS Section: 602.7  2012 TAS Section: 602.7  2010 ADAS Section: 602.7, 211.2

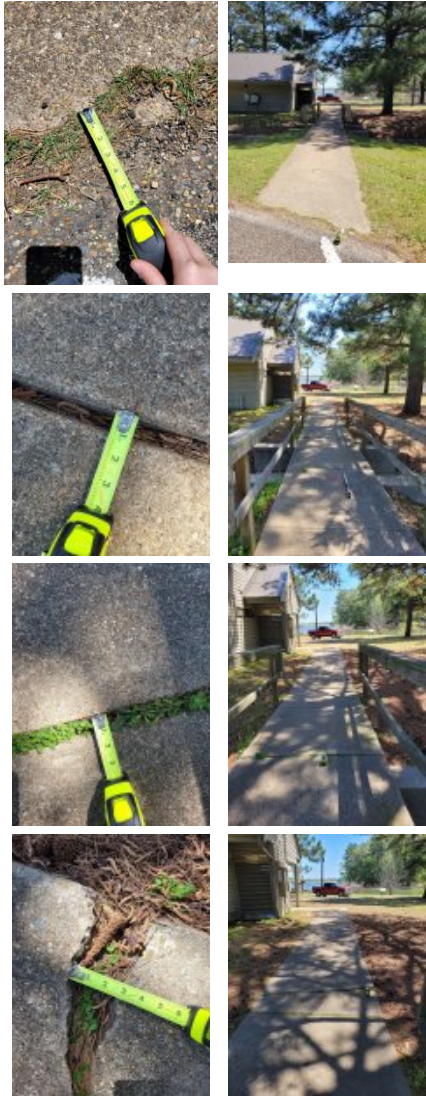
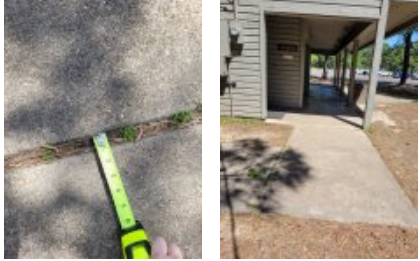
Finding Number	Area Description	Lat/Long	Finding	As Built	Recommendation	Citation	Photos	Figure
169	Day Use Area: Day Use - Boat Ramp Women's Restroom	[32.27315, -94.56654]	There is a gap spaced greater than a 1/2 inch. Openings in floor or ground surfaces shall not allow passage of a sphere more than 1/2 inch diameter. Elongated openings shall be placed so that the long dimension is perpendicular to the dominant direction of travel.	4.5" gap where access aisle meets path to restroom building, two 1" gaps in middle of walking bridge, 3" gap at end of bridge on restroom side, 1" gap at turn to women's restroom	Correct or fill gaps to be max .5".	2015 ABAAS Section: 302.3  2012 TAS Section: 302.3  2010 ADAS Section: 302.3

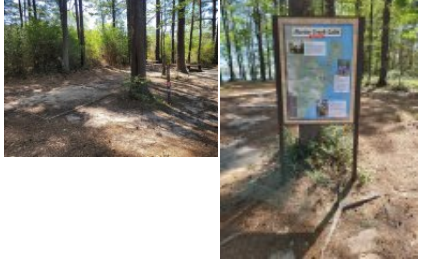
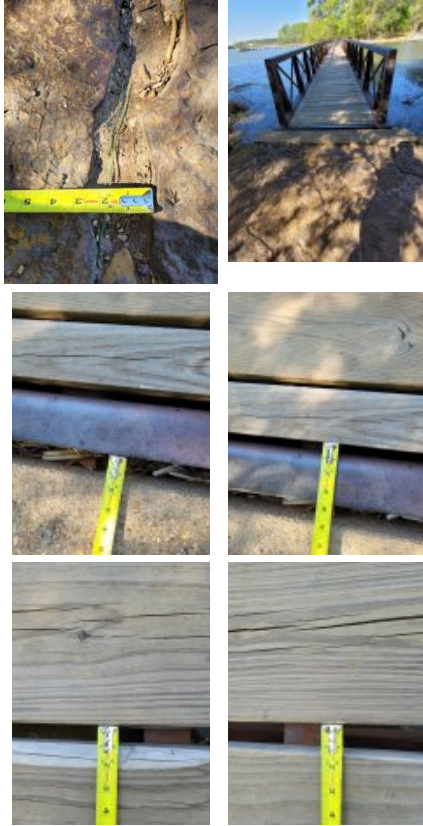
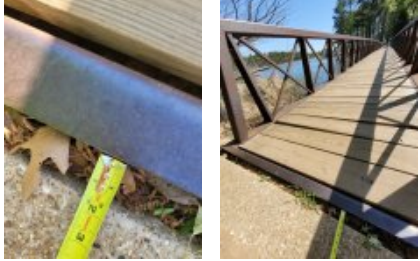
174	Island: Island - Primitive Campsites	[32.272731, -94.5655218], [32.2725655, -94.5662192]	There is a gap spaced greater than a 1/2 inch. Openings in floor or ground surfaces shall not allow passage of a sphere more than 1/2 inch diameter. Elongated openings shall be placed so that the long dimension is perpendicular to the dominant direction of travel.	2" gap to bridge on park side, 1.5" gap on island side, many gaps between boards (1" to 1.5")	Correct or fill gaps to be max .5".	2015 ABAAS Section: 302.3  2012 TAS Section: 302.3  2010 ADAS Section: 302.3

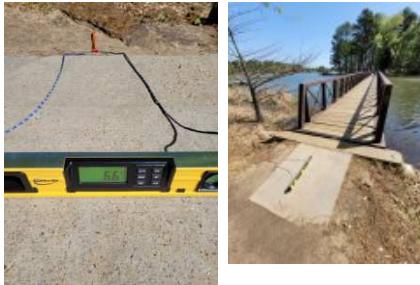
175	Island: Island - Primitive Campsites	[32.2725661, -94.5662108]	The running slope of walking surfaces shall not be steeper than 1:20.	6.6% slope at transition on park side to bridge entry	Correct running slope along the AR to max 5%.	2015 ABAAS Section: 403.3 2012 TAS Section: 403.3 2010 ADAS Section: 403.3

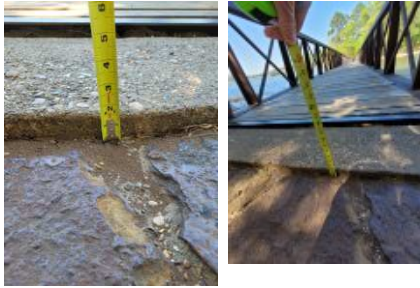
176	Island: Island - Primitive Campsites	[32.272731, -94.5655164]	The walkway contains abrupt vertical edges and/or variations over a 1/4 inch. 1/4 inch is the maximum vertical rise. Changes in level between 1/4 inch and 1/2 inch must be beveled at 1:2 or less. Changes in level greater than 1/2 inch must be by way of a ramp.	1.5" change in level to enter bridge on island side	Repair, bevel or ramp CIL along AR.	2012 TAS Section: 303.2, 303.3 2010 ADAS Section: 303.2, 303.3

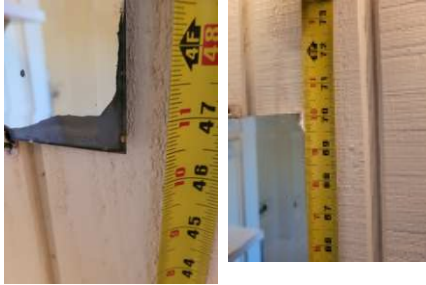
Finding Number	Area Description	Lat/Long	Finding	As Built	Recommendation	Citation	Photos	Figure
177	Cabins: Cabin 1	[32.2749461 , -94.569367]	The mirror is mounted too high. Mirrors must have the bottom edge of the reflecting surface a maximum of 40 inches above the floor if above a sink or counter. Mirrors not located above lavatories or countertops shall be installed with the bottom edge of the reflecting surface 35 inches maximum above the finish floor or ground.	Mirror bottom at 46.4" AFF, top at 70" AFF	Lower mirror so bottom reflective surface is max 40" AFF and 74" at the top.	2015 ABAAS Section: 603.3  2012 TAS Section: 603.3  2010 ADAS Section: 603.3

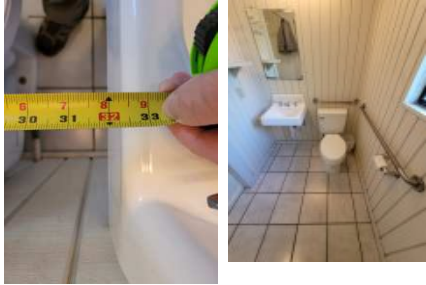
Finding Number	Area Description	Lat/Long	Finding	As Built	Recommendation	Citation	Photos	Figure
179	Cabins: Cabin 1	[32.2749359, -94.5693697]	The required 56 inches by 60 inches clear floor space for the water closet has been obstructed. The clear floor space around the water closet shall be 60 inches minimum measured perpendicular from the side wall and 56 inches minimum measured perpendicular from the rear wall.	32" between wall and sink	Renovate restroom to provide 60" by 56" clearance around the toilet.	2015 ABAAS Section: 604.3. 2012 TAS Section: 604.3.1 2010 ADAS Section: 604.3.1

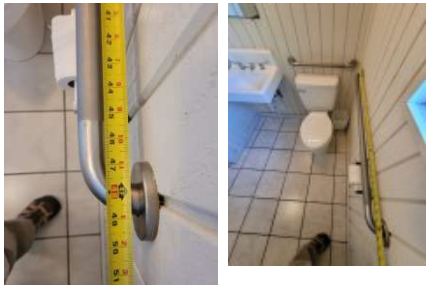
180	Cabins: Cabin 1	[32.2749427, -94.569355]	The side grab bars are not in the correct location. Grab bars on the side wall must be installed so that the end closest to the rear wall is maximum 12" from the rear wall. The end furthest from the rear wall must be mounted minimum 54" from the rear wall.	Side bar extends 48.5" from rear wall	Remount side grab bar to max 12" from the rear wall at the close end and min 54" on the far end, and 33" to 36" AFF.	2015 ABAAS Section: 604.5.1 2012 TAS Section: 604.5.1 2010 ADAS Section: 604.5.1

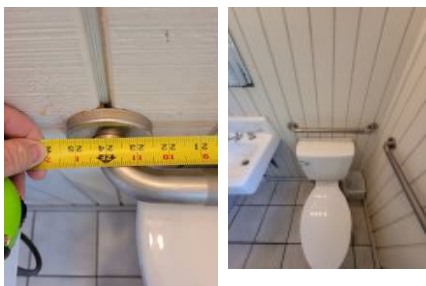
181	Cabins: Cabin 1	[32.274937, -94.569355]	The rear grab bar is not 36" long or is not mounted in the correct location. The rear grab bar must be a minimum of 36" long and extend from the toilet centerline a minimum 12" towards the wall side and a minimum 24" towards the open side of the toilet. Grab bars shall be installed in a horizontal position, 33 inches minimum and 36 inches maximum above the finish floor measured to the top of the gripping surface and the space between the grab bar and the top of the tank shall be 1-1/2 inches minimum.	Rear grab bar is 24" long - obstructed by sink	Replace rear grab bar with one 36" long, mounted behind the toilet, 12" to the wall side of center and 24" to the open side and 33" to 36" AFF.	2015 ABAAS Section: 604.5.2 2012 TAS Section: 604.5.2 2010 ADAS Section: 604.5.2

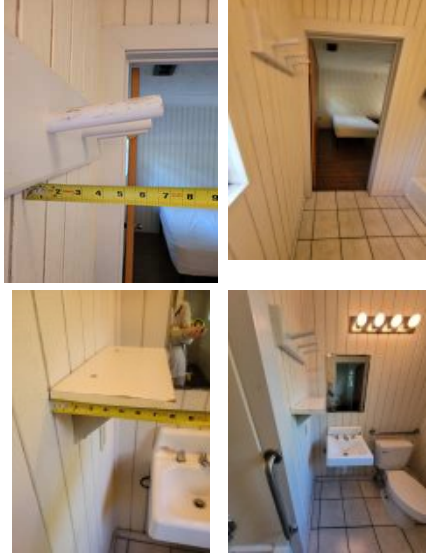
183	Cabins: Cabin 1	[32.2749404 , -94.569360 3]	An item or items project more than 4 inches into the circulation path. Wall-mounted objects that have leading edges between 27 inches and 80 inches from the floor must not project more than 4 inches into the circulation path. Protruding objects that extend to the floor or within 27 inches of the floor are cane detectable and are therefore not hazardous. Where it is necessary or desirable to have objects protrude from the wall, a manner of cane detection must be provided.	Two hooks project 6.5", and shelf projects 8"	Relocate protruding objects or place cane detectable warning or bollard at foot of item.	2015 ABAAS Section: 307.2  2012 TAS Section: 307.2  2010 ADAS Section: 307.2

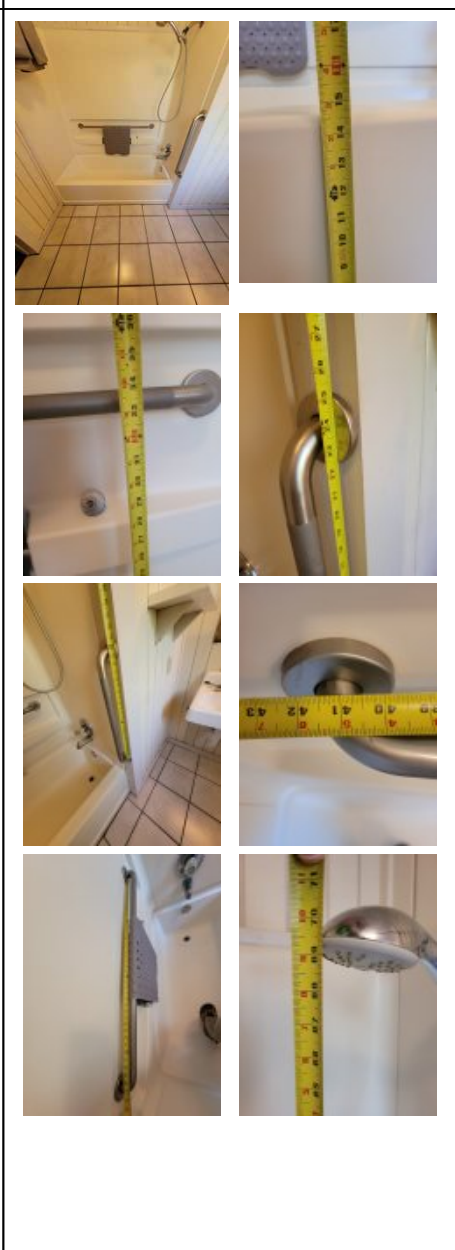
Finding Number	Area Description	Lat/Long	Finding	As Built	Recommendation	Citation	Photos	Figure
184	Cabins: Cabin 1	[32.2749223 , -94.569352 3]	There are no accessible bathing or shower facilities. Where facilities for bathing are provided for the public, clients or employees, including showers or bathtubs, at least one shower or bathtub and support facilities such as lockers, and not less than 1 percent of all facilities, shall be accessible.	tub fails to comply-lacks lower grab bar, lacks head and control wall bars, lacks seat, 69" to shower head and mount at 66"	Create a compliant tub in the cabin	2015 ABAAS Section: F213.3.6  2012 TAS Section: 213.3.6  2010 ADAS Section: 213.3.6

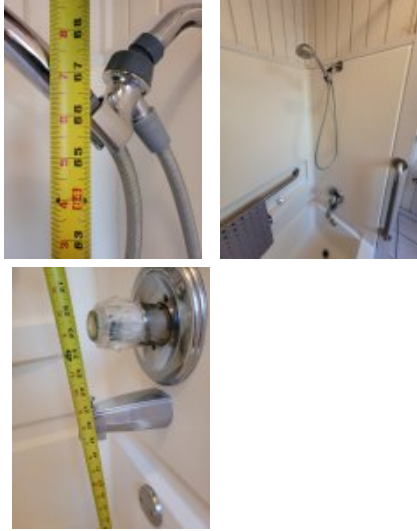
185	Cabins: Cabin 1	[32.2749348 , -94.569360 3]	The door operating hardware is not accessible. Hand-activated door opening hardware, handles, pulls, latches, locks, and other operating devices on accessible doors shall have a shape that is easy to grasp with one hand and does not require tight grasping, tight pinching or twisting of the wrist to operate. Hardware shall be 34 inches minimum and 48 inches maximum above the finish floor or ground.	restroom- knob hardware	Replace hardware with lever hardware or hardware operable without a tight pinch or grasp.	2015 ABAAS Section: 404.2.7  2012 TAS Section: 404.2.7  2010 ADAS Section: 404.2.7

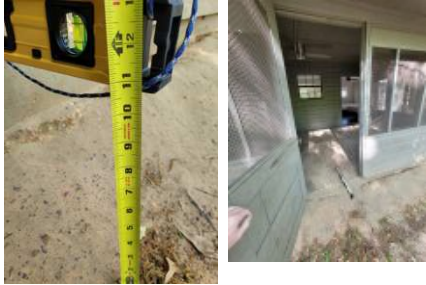
Finding Number	Area Description	Lat/Long	Finding	As Built	Recommendation	Citation	Photos	Figure
187	Cabins: Cabin 1	[32.2749484 , -94.569342 9]	Thresholds, if provided at doorways, shall be 1/2 inch (13 mm) high maximum. Raised thresholds and changes in level at doorways shall comply with 302 and 303. Changes in level of 1/4 inch (6.4 mm) high maximum shall be permitted to be vertical. Changes in level between 1/4 inch (6.4 mm) high minimum and 1/2 inch (13 mm) high maximum shall be beveled with a slope not steeper than 1:2. Changes in level greater than 1/2 inch (13 mm) high shall be ramped, and shall comply with 405 or 406.	screened porch door- 11" CIL at doorway	Repair, bevel or ramp CIL at doorway.	2015 ABAAS Section: 303.3, 404.2.5, 303.2, 303.4  2012 TAS Section: 303.3, 404.2.5, 303.2, 303.4  2010 ADAS Section: 303.3, 404.2.5, 303.2, 303.4

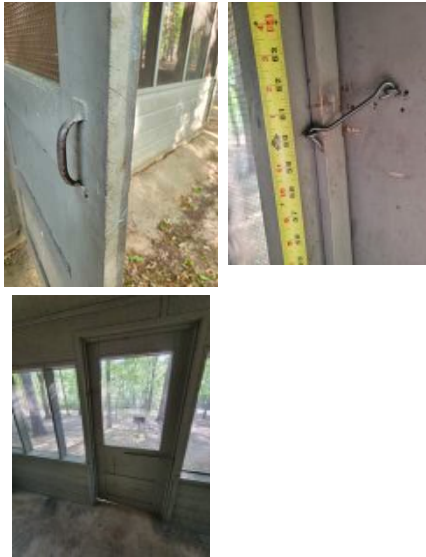
188	Cabins: Cabin 1	[32.2749382 , -94.569369 7]	The door operating hardware is not accessible. Hand-activated door opening hardware, handles, pulls, latches, locks, and other operating devices on accessible doors shall have a shape that is easy to grasp with one hand and does not require tight grasping, tight pinching or twisting of the wrist to operate. Hardware shall be 34 inches minimum and 48 inches maximum above the finish floor or ground.	screened porch- small hardware outside, latch inside requires tight pinch	Replace hardware with lever hardware or hardware operable without a tight pinch or grasp.	2015 ABAAS Section: 404.2.7  2012 TAS Section: 404.2.7  2010 ADAS Section: 404.2.7

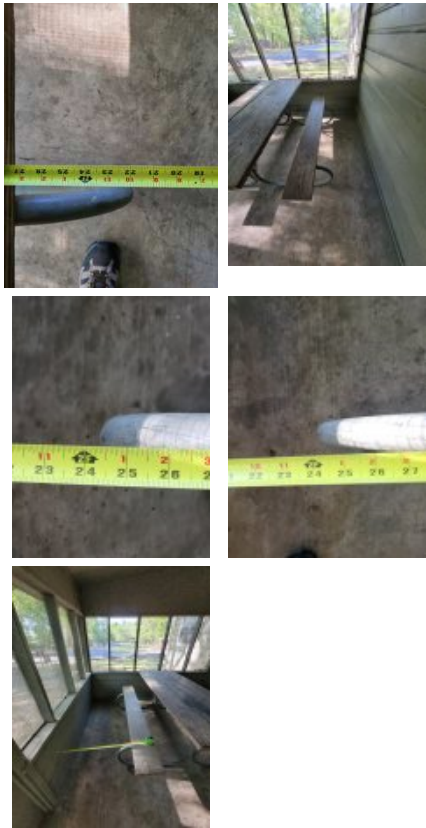
190	Cabins: Cabin 1	[32.2749325 , -94.569355]	The route of travel at this location does not provide a minimum width of 36 inches. The clear width shall be permitted to be reduced to 32 inches minimum for a length of 24 inches maximum provided that reduced width segments are separated by segments that are 48 inches long minimum and 36 inches wide minimum.	screened porch- 22" one side of picnic table, 24" other	Relocate picnic table to provide compliant 36" clear width in this space.	2015 ABAAS Section: 403.5.1  2012 TAS Section: 403.5.1  2010 ADAS Section: 403.5.1

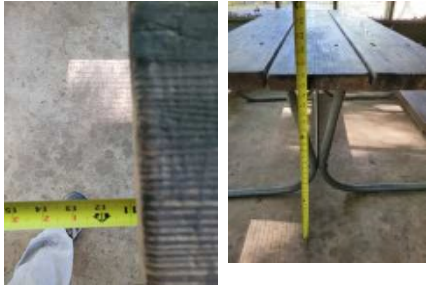
Finding Number	Area Description	Lat/Long	Finding	As Built	Recommendation	Citation	Photos	Figure
191	Cabins: Cabin 1	[32.274937, -94.569351]	The top of the work surface is not within a compliant height range. The tops of tables and counters shall be 28 inches to 34 inches from the floor or ground.	screened porch-picnic table lacks knee and toe clearance	Provide tables and work surfaces at 28" to 34" AFF with required knee and toe clearances.	2015 ABAAS Section: 902.3 2012 TAS Section: 902.3 2010 ADAS Section: 902.3

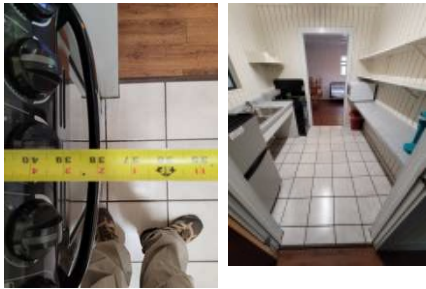
192	Cabins: Cabin 1	[32.2749506, -94.5693536]	The pass through kitchen is not wide enough. In pass through kitchens where counters, appliances or cabinets are on two opposing sides, or where counters, appliances or cabinets are opposite a parallel wall, clearance between all opposing base cabinets, counter tops, appliances, or walls within kitchen work areas shall be 40 inches minimum. Pass through kitchens shall have two entries.	kitchen- 38" between microwave and oven handle	Renovate kitchen, or remove objects to provide required 40" clearance through kitchen.	2015 ABAAS Section: 804.2.1 2012 TAS Section: 804.2.1 2010 ADAS Section: 804.2.1

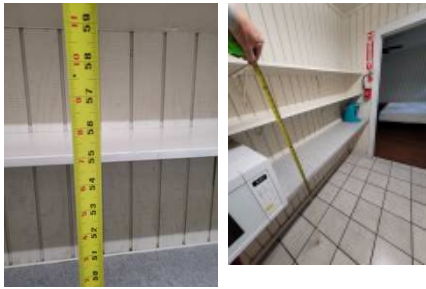
193	Cabins: Cabin 1	[32.2749325, -94.5693577]	The storage space is not within reach range. At least 50% of the storage space must be a minimum of 15 inches and a maximum of 48 inches off the floor with an unobstructed approach. For side approach, the maximum reach range is 46 inches high over an obstruction that is a maximum of 34 inches tall and 24 inches deep.	kitchen- 55" AFF to middle shelf	Lower 50% of shelving, or relocate supplies to within reach range, max 48" AFF.	2015 ABAAS Section: 804.5 2012 TAS Section: 804.5 2010 ADAS Section: 804.5

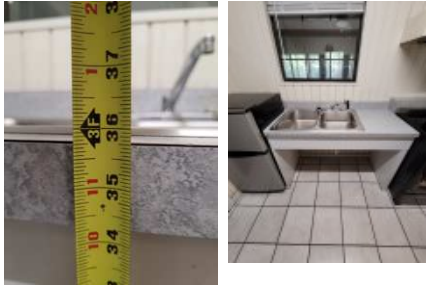
Finding Number	Area Description	Lat/Long	Finding	As Built	Recommendation	Citation	Photos	Figure
194	Cabins: Cabin 1	[32.2749325 , -94.569353 6]	The top rim of the sink is too high. All lavatories/sinks that are designated to be accessible shall be a minimum 17 inches in horizontal depth and mounted with the rim or counter edge no higher than 34 inches above the finished floor.	kitchen- sink rim at 36" AFF - knee space available	Lower sinks to max 34" above the finished floor (AFF) to front of rim.	2015 ABAAS Section: 606.3  2012 TAS Section: 606.3  2010 ADAS Section: 606.3

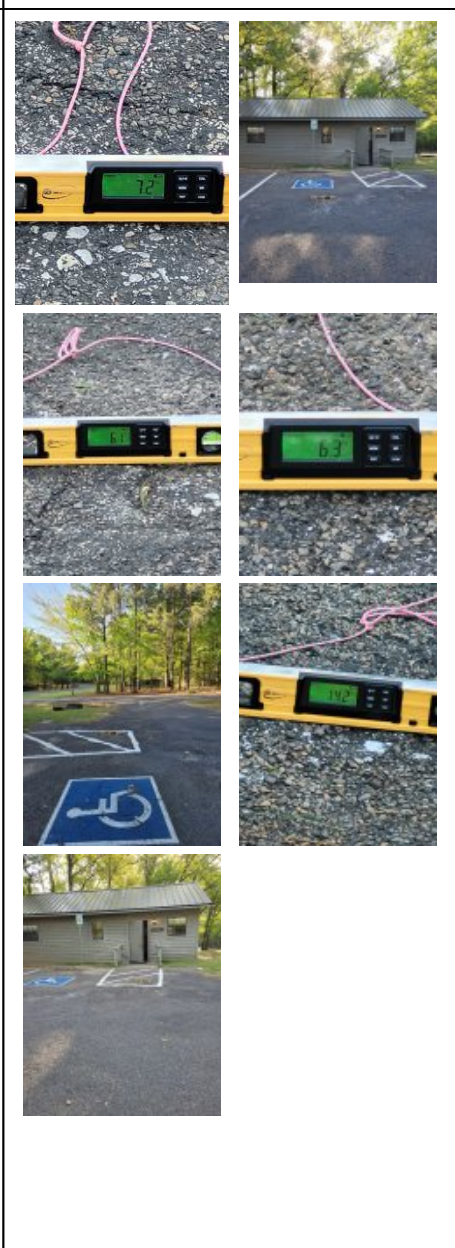
Finding Number	Area Description	Lat/Long	Finding	As Built	Recommendation	Citation	Photos	Figure
200	Cabins: Cabin 1	[32.274945, -94.569430 1]	The cross slopes (narrow dimension) and/or running slopes (long dimension) of the access aisle exceeds 2%. The running slope and the cross slope in an accessible parking stall and the access aisle must not exceed 2%.	Stall - 7.2%, 6.1% and AA - 6.3%, 14.2%	Resurface stalls and access aisles to eliminate slopes.	2015 ABAAS Section: 502.4 2012 TAS Section: 502.4 2010 ADAS Section: 502.4

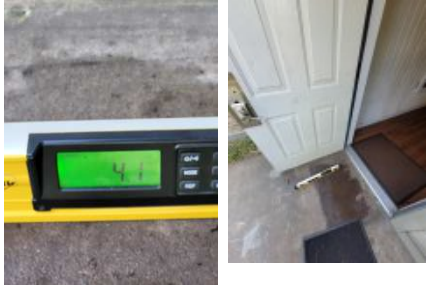
203	Cabins: Cabin 1	[32.2749325 , -94.569365 7]	Minimum maneuvering clearances at doors and gates shall comply with 404.2.4. Maneuvering clearances shall extend the full width of the doorway and the required latch side or hinge side clearance. Maneuvering clearances shall have a max slope of 2.08%.	cabin entry- 4.1% slope in clearance	For all doors along the public circulation route, provide required maneuvering clearance on push and pull side of doors. For all doors along the public circulation route, correct slope in door clearance to max 2.08%.	2010 ADAS Section: 404.2.3, 404.2.7, 404.2.4, 404.2.11, 404.2.11 Exception

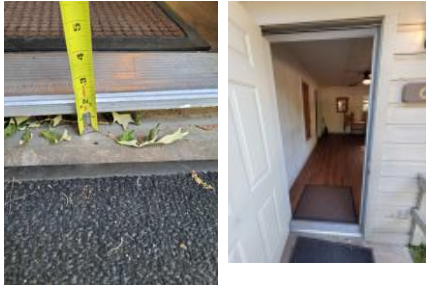
Finding Number	Area Description	Lat/Long	Finding	As Built	Recommendation	Citation	Photos	Figure
204	Cabins: Cabin 1	[32.274928, -94.569356 3]	Thresholds, if provided at doorways, shall be 1/2 inch (13 mm) high maximum. Raised thresholds and changes in level at doorways shall comply with 302 and 303. Changes in level of 1/4 inch (6.4 mm) high maximum shall be permitted to be vertical. Changes in level between 1/4 inch (6.4 mm) high minimum and 1/2 inch (13 mm) high maximum shall be beveled with a slope not steeper than 1:2. Changes in level greater than 1/2 inch (13 mm) high shall be ramped, and shall comply with 405 or 406.	cabin entry- 1.25" CIL at threshold	Repair, bevel or ramp CIL at doorway.	2015 ABAAS Section: 303.3, 404.2.5, 303.2, 303.4  2012 TAS Section: 303.3, 404.2.5, 303.2, 303.4  2010 ADAS Section: 303.3, 404.2.5, 303.2, 303.4

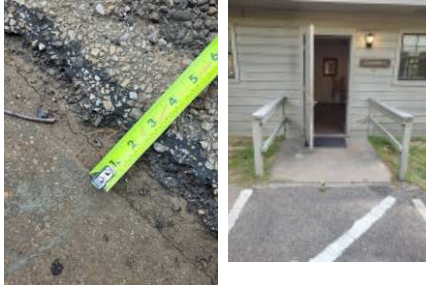
206	Cabins: Cabin 1	[32.2749336, -94.569412 6]	There is a gap spaced greater than a 1/2 inch. Openings in floor or ground surfaces shall not allow passage of a sphere more than 1/2 inch diameter. Elongated openings shall be placed so that the long dimension is perpendicular to the dominant direction of travel.	2" gap at entry to cabin from parking lot	Correct or fill gaps to be max .5".	2015 ABAAS Section: 302.3  2012 TAS Section: 302.3  2010 ADAS Section: 302.3

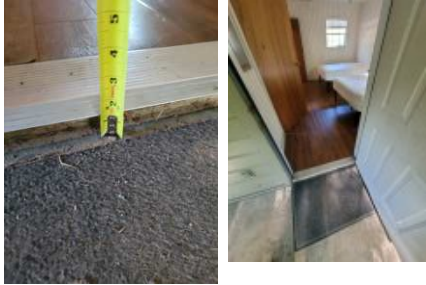
Finding Number	Area Description	Lat/Long	Finding	As Built	Recommendation	Citation	Photos	Figure
207	Cabins: Cabin 1	[32.2749325, -94.5693603]	Thresholds, if provided at doorways, shall be 1/2 inch (13 mm) high maximum. Raised thresholds and changes in level at doorways shall comply with 302 and 303. Changes in level of 1/4 inch (6.4 mm) high maximum shall be permitted to be vertical. Changes in level between 1/4 inch (6.4 mm) high minimum and 1/2 inch (13 mm) high maximum shall be beveled with a slope not steeper than 1:2. Changes in level greater than 1/2 inch (13 mm) high shall be ramped, and shall comply with 405 or 406.	cabin to screened porch- 1.5" CIL at threshold	Repair, bevel or ramp CIL at doorway.	2015 ABAAS Section: 303.3, 404.2.5, 303.2, 303.4  2012 TAS Section: 303.3, 404.2.5, 303.2, 303.4  2010 ADAS Section: 303.3, 404.2.5, 303.2, 303.4

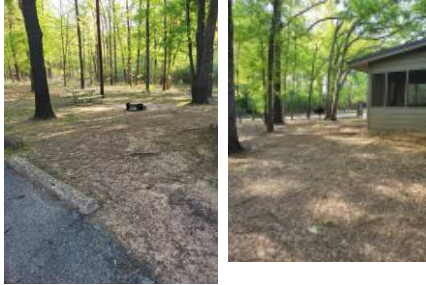
Finding Number	Area Description	Lat/Long	Finding	As Built	Recommendation	Citation	Photos	Figure
210	Cabins: Cabin 1	[32.2749824 , -94.5693577]	An accessible access route is not provided between elements, spaces and the facilities provided within the accessible camping unit. At least one outdoor recreation access route shall connect accessible elements, spaces and facilities provided within camping units with mobility features.	Lacks ORAR to campsite amenities including fire pit, picnic table, and grill	Create AR with crushed and compacted stone or similar outdoor material to camp sites and one of each type of amenity.	2015 ABAAS Section: F244.5.1

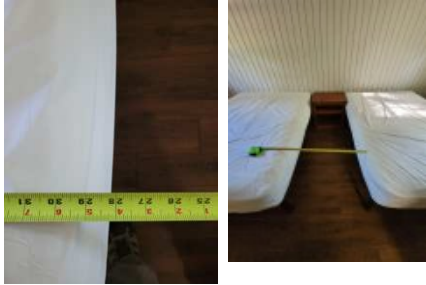
Finding Number	Area Description	Lat/Long	Finding	As Built	Recommendation	Citation	Photos	Figure
214	Cabins: Cabin 1	[32.274937, -94.569353 6]	The required clear space between the beds has not been provided. Accessible sleeping rooms shall have a 30 inch minimum by 48 inch minimum clear space located between the beds to provide a parallel approach.	Back bedroom - lacks 30" between beds	Provide 30" by 48" CFS between the two beds.	<p>2015 ABAAS Section: 806.2.3, 806.2.3 EXCEPTION</p> <p>2012 TAS Section: 806.2.3, 806.2.3 Exception</p> <p>2010 ADAS Section: 806.2.3 Exception</p>

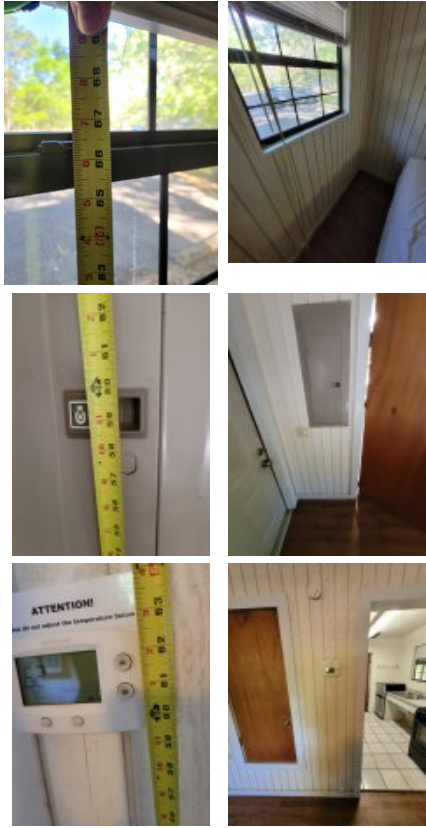
217	Cabins: Cabin 1	[32.2749359, -94.569353 6]	The operable part is not accessible because it requires tight grasping, pinching or twisting of the wrist.	Electrical panel controls require tight grasping	Replace operable part with one usable without a tight pinch or grasp.	2015 ABAAS Section: 309.4 2012 TAS Section: 309.4 2010 ADAS Section: 309.4

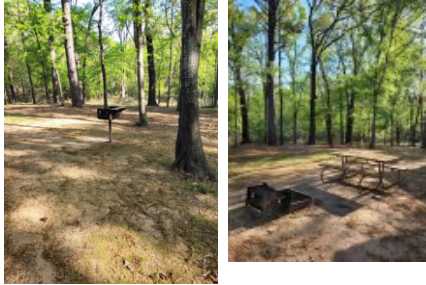
Finding Number	Area Description	Lat/Long	Finding	As Built	Recommendation	Citation	Photos	Figure
221	Cabins: Cabin 2	[32.2752647 , -94.569605 8]	An accessible access route is not provided between elements, spaces and the facilities provided within the accessible camping unit. At least one outdoor recreation access route shall connect accessible elements, spaces and facilities provided within camping units with mobility features.	Lacks ORAR to grill, fire pit, and picnic table	Create AR with crushed and compacted stone or similar outdoor material to camp sites and one of each type of amenity.	2015 ABAAS Section: F244.5.1

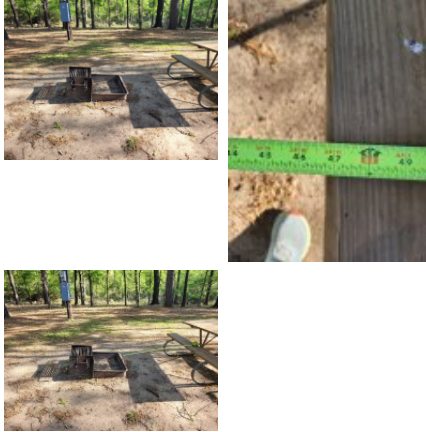
223	Cabins: Cabin 2	[32.2752477 , -94.569621 9]	48 inches (1220 mm) by 48 inches (1220 mm) on all usable sides of the fire ring, grill, fireplace, and woodstove Center the space on each usable side of the grill, fireplace, and woodstove.	Fire pit lacks CGS - surface fails and picnic table is 46.5" from fire pit	Provide required 48" clear ground space centered along usable side of fire ring, grill, fireplace, or woodstove as a smart practice. Relocate picnic table to not obstruct CFS of fire pit.	2015 ABAAS Section: 1011.2

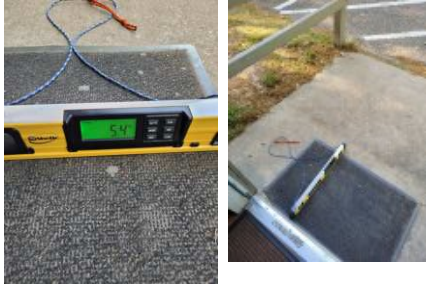
Finding Number	Area Description	Lat/Long	Finding	As Built	Recommendation	Citation	Photos	Figure
227	Cabins: Cabin 2	[32.2751547 , -94.569573 6]	Minimum maneuvering clearances at doors and gates shall comply with 404.2.4. Maneuvering clearances shall extend the full width of the doorway and the required latch side or hinge side clearance. Maneuvering clearances shall have a max slope of 2.08%.	cabin entry- 5.4% slope in MC	For all doors along the public circulation route, provide required maneuvering clearance on push and pull side of doors. For all doors along the public circulation route, correct slope in door clearance to max 2.08%.	2010 ADAS Section: 404.2.3, 404.2.7, 404.2.4, 404.2.11, 404.2.11 Exception

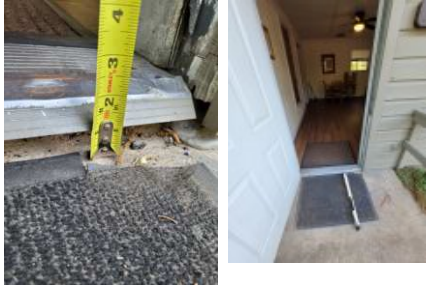
228	Cabins: Cabin 2	[32.2751797 , -94.569552 1]	Thresholds, if provided at doorways, shall be 1/2 inch (13 mm) high maximum. Raised thresholds and changes in level at doorways shall comply with 302 and 303. Changes in level of 1/4 inch (6.4 mm) high maximum shall be permitted to be vertical. Changes in level between 1/4 inch (6.4 mm) high minimum and 1/2 inch (13 mm) high maximum shall be beveled with a slope not steeper than 1:2. Changes in level greater than 1/2 inch (13 mm) high shall be ramped, and shall comply with 405 or 406.	cabin entry- 1" CIL at threshold	Repair, bevel or ramp CIL at doorway.	2015 ABAAS Section: 303.3, 404.2.5, 303.2, 303.4  2012 TAS Section: 303.3, 404.2.5, 303.2, 303.4  2010 ADAS Section: 303.3, 404.2.5, 303.2, 303.4

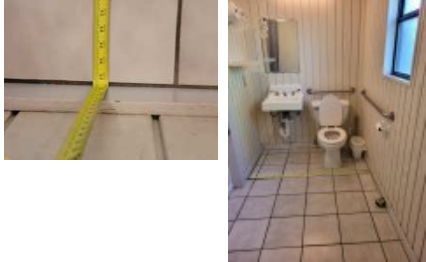
Finding Number	Area Description	Lat/Long	Finding	As Built	Recommendation	Citation	Photos	Figure
233	Cabins: Cabin 2	[32.2751616 , -94.569562 8]	The required 56 inches by 60 inches clear floor space for the water closet has been obstructed. The clear floor space around the water closet shall be 60 inches minimum measured perpendicular from the side wall and 56 inches minimum measured perpendicular from the rear wall.	Lacks clearance around the toilet - 57" width	Renovate restroom to provide 60" by 56" clearance around the toilet.	2015 ABAAS Section: 604.3.  2012 TAS Section: 604.3.1  2010 ADAS Section: 604.3.1

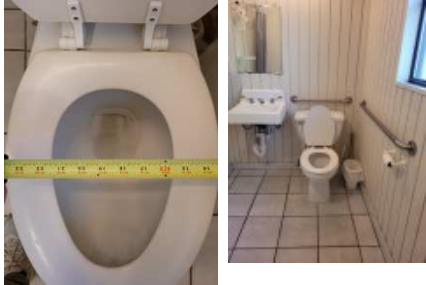
234	Cabins: Cabin 2	[32.2751695 , -94.569564 2]	The toilet is not located within the range allowed from the side wall or partition. The centerline of the toilet must be 16 to 18 inches from the side wall.	18.5" centerline	Remount toilets to 16" to 18" from the side wall to centerline.	2015 ABAAS Section: 604.2  2012 TAS Section: 604.2  2010 ADAS Section: 604.2

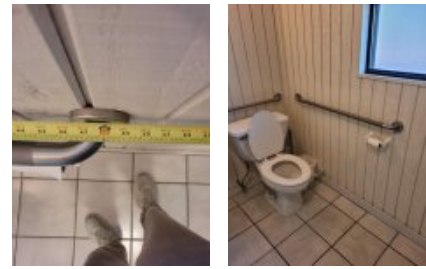
235	Cabins: Cabin 2	[32.275165, -94.569561 5]	The side grab bars are not in the correct location. Grab bars on the side wall must be installed so that the end closest to the rear wall is maximum 12" from the rear wall. The end furthest from the rear wall must be mounted minimum 54" from the rear wall.	Side grab bar extends 47.5" from rear wall	Remount side grab bar to max 12" from the rear wall at the close end and min 54" on the far end, and 33" to 36" AFF.	2015 ABAAS Section: 604.5.1  2012 TAS Section: 604.5.1  2010 ADAS Section: 604.5.1

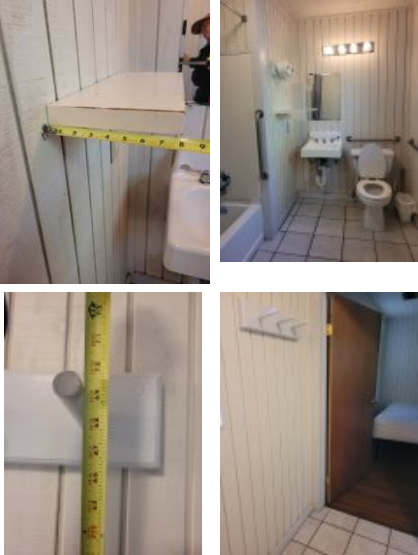
Finding Number	Area Description	Lat/Long	Finding	As Built	Recommendation	Citation	Photos	Figure
238	Cabins: Cabin 2	[32.2751672 , -94.569573 6]	An item or items project more than 4 inches into the circulation path. Wall-mounted objects that have leading edges between 27 inches and 80 inches from the floor must not project more than 4 inches into the circulation path. Protruding objects that extend to the floor or within 27 inches of the floor are cane detectable and are therefore not hazardous. Where it is necessary or desirable to have objects protrude from the wall, a manner of cane detection must be provided.	Shelf projects 8", hooks 69.5" AFF project	Relocate protruding objects or place cane detectable warning or bollard at foot of item.	2015 ABAAS Section: 307.2  2012 TAS Section: 307.2  2010 ADAS Section: 307.2

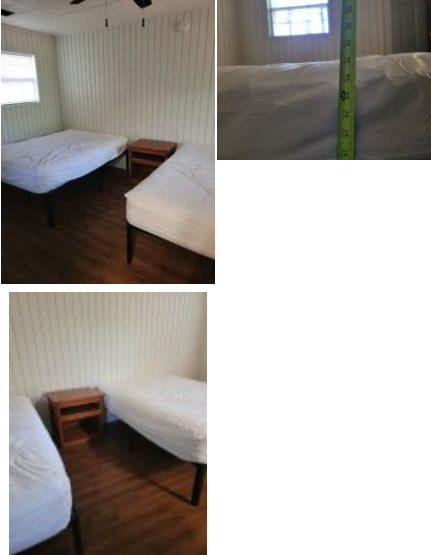
Finding Number	Area Description	Lat/Long	Finding	As Built	Recommendation	Citation	Photos	Figure
243	Cabins: Cabin 2	[32.2751672 , -94.569568 2]	Element meets all standards and requirements	bedroom- beds comply, have required clear floor space	None	2010 ADAS Section: N/A

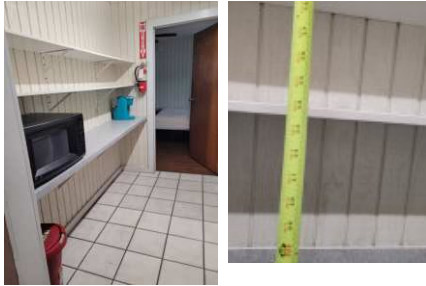
Finding Number	Area Description	Lat/Long	Finding	As Built	Recommendation	Citation	Photos	Figure
248	Cabins: Cabin 2	[32.2751559 , -94.569553 5]	The storage space is not within reach range. At least 50% of the storage space must be a minimum of 15 inches and a maximum of 48 inches off the floor with an unobstructed approach. For side approach, the maximum reach range is 46 inches high over an obstruction that is a maximum of 34 inches tall and 24 inches deep.	kitchen- 2 of 2 shelves exceed 54" AFF	Lower 50% of shelving, or relocate supplies to within reach range, max 48" AFF.	2015 ABAAS Section: 804.5  2012 TAS Section: 804.5  2010 ADAS Section: 804.5

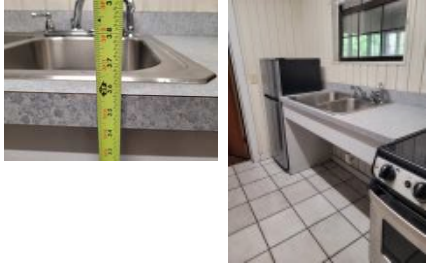
249	Cabins: Cabin 2	[32.2751638 , -94.569573 6]	The top rim of the sink is too high. All lavatories/sinks that are designated to be accessible shall be a minimum 17 inches in horizontal depth and mounted with the rim or counter edge no higher than 34 inches above the finished floor.	kitchen- sink rim at 36" AFF	Lower sinks to max 34" above the finished floor (AFF) to front of rim.	2015 ABAAS Section: 606.3  2012 TAS Section: 606.3  2010 ADAS Section: 606.3

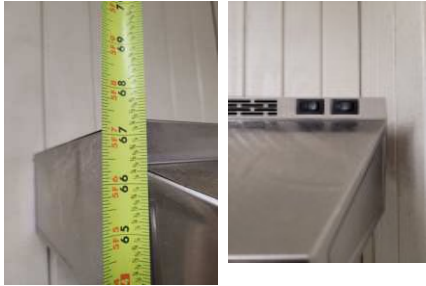
Finding Number	Area Description	Lat/Long	Finding	As Built	Recommendation	Citation	Photos	Figure
251	Cabins: Cabin 2	[32.2751638 , -94.569565 5]	The operable part is positioned too high for either a side or front approach. Where a clear floor or ground space allows a parallel approach to an element and the side reach is unobstructed, the high side reach shall be 48 inches maximum and the low side reach shall be 15 inches minimum above the finish floor or ground. Where a forward reach is unobstructed, the high forward reach shall be 48 inches maximum and the low forward reach shall be 15 inches minimum above the finish floor or ground.	kitchen- oven hood controls at 67" AFF	Remount operable parts to be in reach range of 15" min to 48" max.	2015 ABAAS Section: 308.1  2012 TAS Section: 308.1  2010 ADAS Section: 308.1

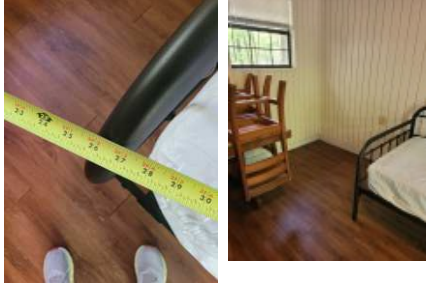
252	Cabins: Cabin 2	[32.2751638 , -94.569565 5]	The route of travel at this location does not provide a minimum width of 36 inches. The clear width shall be permitted to be reduced to 32 inches minimum for a length of 24 inches maximum provided that reduced width segments are separated by segments that are 48 inches long minimum and 36 inches wide minimum.	entry room- 26" between day bed and table	Widen AR to compliant 36" clear width	2015 ABAAS Section: 403.5.1  2012 TAS Section: 403.5.1  2010 ADAS Section: 403.5.1

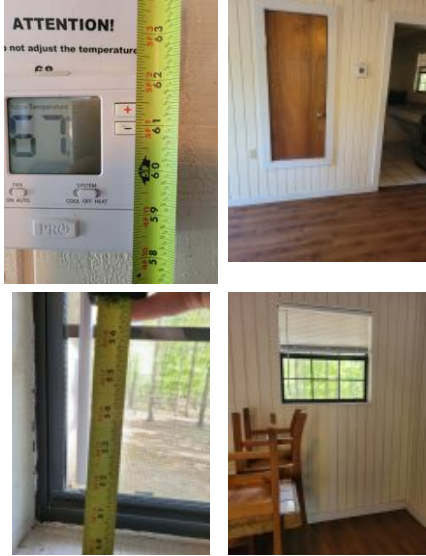
253	Cabins: Cabin 2	[32.2751616 , -94.569558 8]	The operable part is positioned too high for either a side or front approach. Where a clear floor or ground space allows a parallel approach to an element and the side reach is unobstructed, the high side reach shall be 48 inches maximum and the low side reach shall be 15 inches minimum above the finish floor or ground. Where a forward reach is unobstructed, the high forward reach shall be 48 inches maximum and the low forward reach shall be 15 inches minimum above the finish floor or ground.	entry room- thermostat at 62.5" AFF, window controls at 52" AFF	Remount operable parts to be in reach range of 15" min to 48" max.	2015 ABAAS Section: 308.1  2012 TAS Section: 308.1  2010 ADAS Section: 308.1

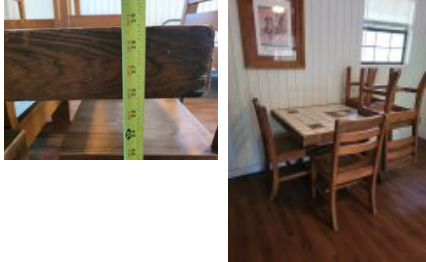
Finding Number	Area Description	Lat/Long	Finding	As Built	Recommendation	Citation	Photos	Figure
254	Cabins: Cabin 2	[32.2751616 , -94.569564 2]	The top of the work surface is not within a compliant height range. The tops of tables and counters shall be 28 inches to 34 inches from the floor or ground.	entry room- dining table lacks knee clearance - 26.5"	Provide tables and work surfaces at 28" to 34" AFF with required knee and toe clearances.	2015 ABAAS Section: 902.3  2012 TAS Section: 902.3  2010 ADAS Section: 902.3

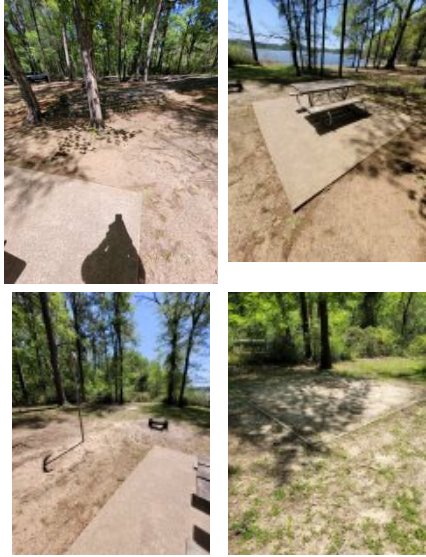
256	Shelter Camping Area: Shelter Camping - Shelter Campsite	[32.274005, -94.570545 9]	Picnic tables shall provide at least one wheelchair space for each 24 linear feet (7320 mm) of usable table surface perimeter. Wheelchair spaces shall be 30 inches (760 mm) minimum by 48 inches (1220 mm) minimum. Wheelchair spaces shall be positioned for a forward approach to the table and provide knee and toe clearance complying with 306 under the table	Picnic table lacks toe space, has knee space	Replace picnic table with one of an accessible design as a smart practice.	2015 ABAAS Section: 1011.4.2

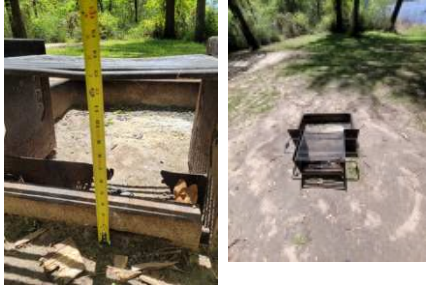
257	Shelter Camping Area: Shelter Camping - Shelter Campsite	[32.2740118 , -94.570555 3]	Where provided, cooking surfaces shall be 15 inches (380 mm) minimum and 34 inches (865 mm) maximum above the ground.	Cooking surface of fire pit at 13" AGL	Raise cooking surface to be 15" min to 34" max above the ground; in the alternative, replace with a compliant surface as a smart practice.	2015 ABAAS Section: 1011.5.2

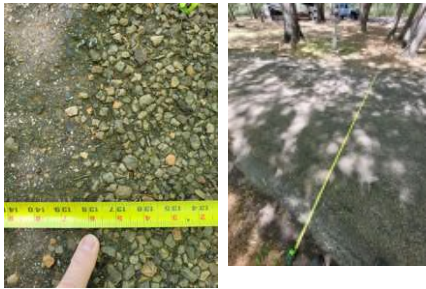
259	Shelter Camping Area: Shelter Camping - Shelter Campsite	[32.274005, -94.5705325]	Parking spaces and pull-up spaces for recreational vehicles shall be 20 feet (6100 mm) wide minimum. EXCEPTION: Where two adjacent parking spaces are provided for recreational vehicles, one parking space shall be permitted to be 16 feet (4880 mm) wide minimum.	11.5' wide	Correct RV parking space to be 20' wide minimum; or 16' for two adjacent spaces as a smart practice.	2015 ABAAS Section: 1012.2, 1012.2 EXCEPTION

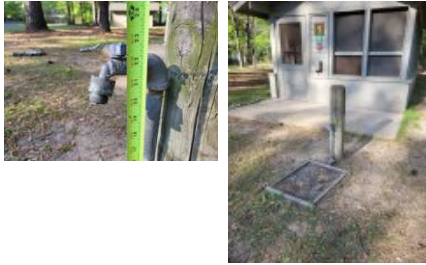
Finding Number	Area Description	Lat/Long	Finding	As Built	Recommendation	Citation	Photos	Figure																						
269	Shelter Camping Area: Shelter Camping - Cottage	[32.2746468 , -94.569528]	Water spouts at water hydrants and water utility hook-ups shall be 28 inches (710 mm) minimum and 36 inches (915 mm) maximum above the ground.	Shelter 1 - water spout at 20" AGL	Remount water spouts to 28" min or 36" max above the ground as a smart practice.	2015 ABAAS Section: 1011.6

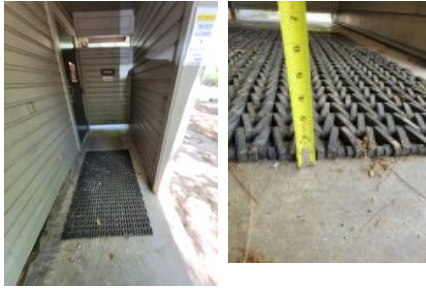
276	Shelter Camping Area: Shelter Camping - Men's Restroom	[32.2735242, -94.569540 1]	The floor mat or carpet pile height is too high. Carpet or carpet tile shall be securely attached and shall have a firm cushion, pad, or backing or no cushion or pad. Carpet or carpet tile shall have a level loop, textured loop, level cut pile, or level cut/uncut pile texture. Pile height shall be 1/2 inch maximum. Exposed edges of carpet shall be fastened to floor surfaces and shall have trim on the entire length of the exposed edge.	.5" high unsecured floor mat	Replace mat or carpet with one having max pile or edge of 1/4". Secure edges of carpeting or mats to prevent trip hazard.	2015 ABAAS Section: 302.2 2012 TAS Section: 302.2 2010 ADAS Section: 302.2

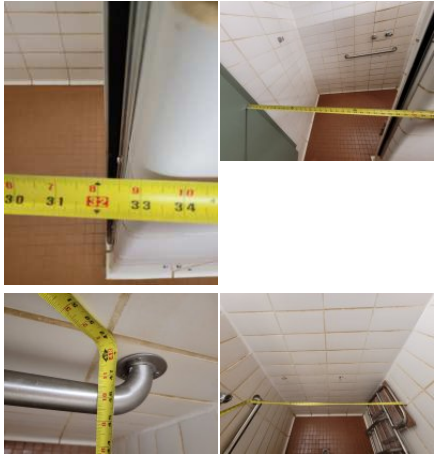
280	Shelter Camping Area: Shelter Camping - Men's Restroom	[32.2735219 , -94.569534 7]	The grab bar is located above the seat In alternate roll-in type shower compartments, grab bars shall be provided on the back wall and the side wall farthest from the compartment entry. Grab bars shall not be provided above the seat. Grab bars shall be installed 6 inches maximum from adjacent walls.	Side bar missing, back bar does not extend	Provide grab bars in the shower mounted in the correct locations for the shower type.	2015 ABAAS Section: 608.3.3  2012 TAS Section: 608.3.3  2010 ADAS Section: 608.3.3

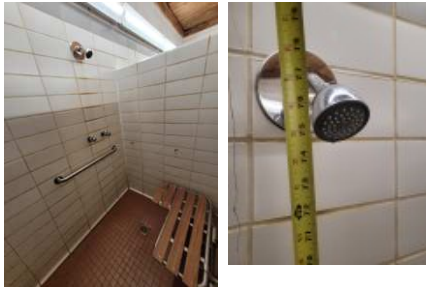
282	Shelter Camping Area: Shelter Camping - Men's Restroom	[32.2735265 , -94.5695414]	There is no hand held sprayer unit. The sprayer unit must have a 59 inches hose and be mounted 48 inches maximum to the top of mounting bracket off the floor. The shower spray unit shall have an on/off control with a non-positive shutoff. If an adjustable-height shower head on a vertical bar is used, the bar shall be installed so as not to obstruct the use of grab bars.	75" AFF to shower head	Replace shower control with a compliant lever control with a shower head on a 59" hose and usable as hand held.	2015 ABAAS Section: 608.6  2012 TAS Section: 608.6  2010 ADAS Section: 608.6

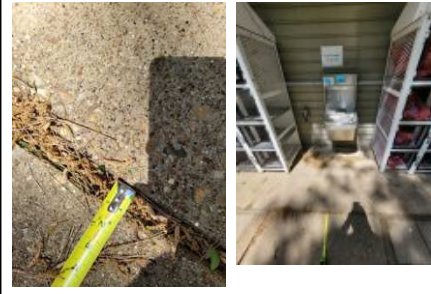
289	Shelter Camping Area: Shelter Camping - Men's Restroom	[32.2735015 , -94.5695494]	There is a gap spaced greater than a 1/2 inch. Openings in floor or ground surfaces shall not allow passage of a sphere more than 1/2 inch diameter. Elongated openings shall be placed so that the long dimension is perpendicular to the dominant direction of travel.	1" gap near drinking fountain CFS	Correct or fill gaps to be max .5".	2015 ABAAS Section: 302.3  2012 TAS Section: 302.3  2010 ADAS Section: 302.3

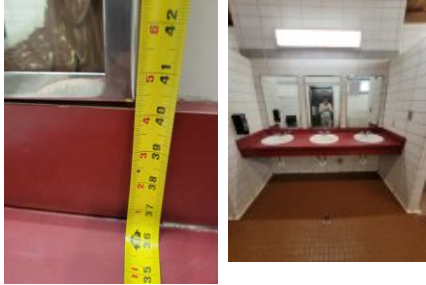
Finding Number	Area Description	Lat/Long	Finding	As Built	Recommendation	Citation	Photos	Figure
291	Shelter Camping Area: Shelter Camping - Men's Restroom	[32.2735129 , -94.569549 4]	The mirror is mounted too high. Mirrors must have the bottom edge of the reflecting surface a maximum of 40 inches above the floor if above a sink or counter. Mirrors not located above lavatories or countertops shall be installed with the bottom edge of the reflecting surface 35 inches maximum above the finish floor or ground.	Bottom edge at 41" AFF	Lower mirror so bottom reflective surface is max 40" AFF and 74" at the top.	2015 ABAAS Section: 603.3  2012 TAS Section: 603.3  2010 ADAS Section: 603.3

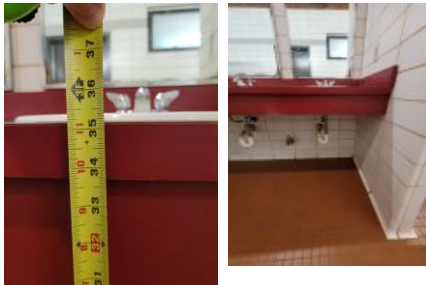
292	Shelter Camping Area: Shelter Camping - Men's Restroom	[32.2735117 , -94.569548 1]	The top rim of the sink is too high. All lavatories/sinks that are designated to be accessible shall be a minimum 17 inches in horizontal depth and mounted with the rim or counter edge no higher than 34 inches above the finished floor.	Sink rim at 35.25" AFF	Lower sinks to max 34" above the finished floor (AFF) to front of rim.	2015 ABAAS Section: 606.3  2012 TAS Section: 606.3  2010 ADAS Section: 606.3

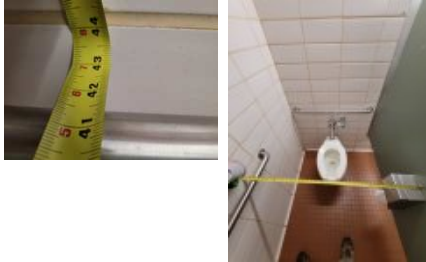
Finding Number	Area Description	Lat/Long	Finding	As Built	Recommendation	Citation	Photos	Figure
295	Shelter Camping Area: Shelter Camping - Men's Restroom	[32.2735163 , -94.569538 7]	The ambulatory stall is not between 35" to 37" wide and 60" deep.	Ambulatory stall 43.5" wide	Correct ambulatory stall to be 35" to 37" wide and minimum 60" deep.	2015 ABAAS Section: 604.8.2.1  2012 TAS Section: 604.8.2.1  2010 ADAS Section: 604.8.2.1

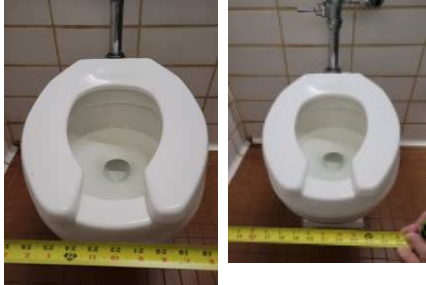
296	Shelter Camping Area: Shelter Camping - Men's Restroom	[32.2735129 , -94.569546 8]	The toilet is not located within the range to the side wall or partition. The centerline of the toilet shall be 17 inches minimum and 19 inches maximum side wall or partition in the ambulatory accessible toilet compartment.	22" to the left, 21.5" to the right	Remount toilet to 17" to 19" from the side wall to center line in ambulatory stalls.	2015 ABAAS Section: 604.9.1  2012 TAS Section: 604.9.1  2010 ADAS Section: 604.9.1

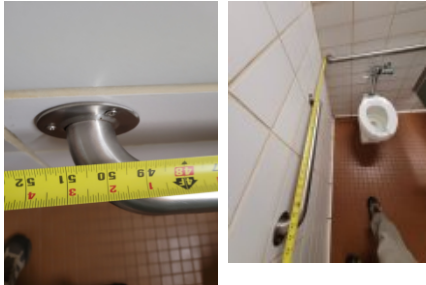
299	Shelter Camping Area: Shelter Camping - Men's Restroom	[32.2735299 , -94.5695454]	The side grab bars are not in the correct location. Grab bars on the side wall must be installed so that the end closest to the rear wall is maximum 12" from the rear wall. The end furthest from the rear wall must be mounted minimum 54" from the rear wall.	Existing 25" long grab bar extends 50" from rear wall	Replace side grab bar with a 42" long bar mounted to max 12" from the rear wall at the close end and min 54" on the far end, and 33" to 36" AFF.	2015 ABAAS Section: 604.5.1  2012 TAS Section: 604.5.1  2010 ADAS Section: 604.5.1

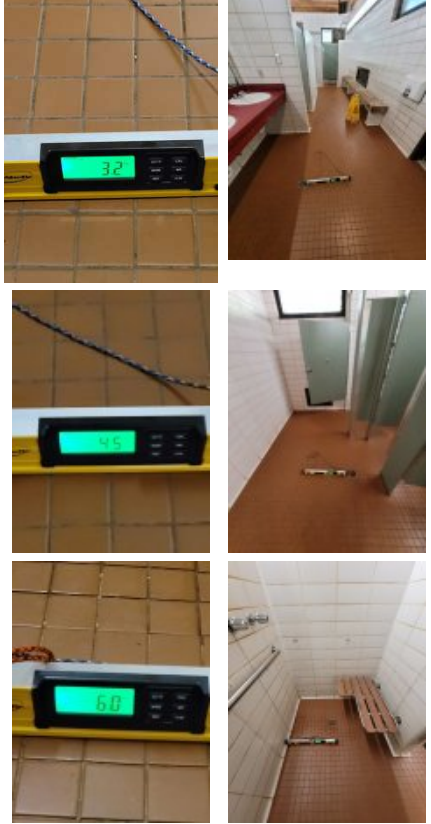
302	Shelter Camping Area: Shelter Camping - Men's Restroom	[32.2735117, -94.569552 1]	The accessible route contains running slopes greater than 5 percent and cross slopes greater than 2 percent across the width of the walk and has not been constructed as a ramp (i.e. handrails, wheel guides, etc.). When the slope in the direction of travel of any walk exceeds 1 unit vertical in 20 units horizontal (5-percent slope), it must be constructed as ramp. Surface cross slopes must not exceed one unit vertical in 48 units. Horizontal (2-percent slope).	3.2% slope at sink floor drain, 4.5% slope toward ambulatory stall, 6% at accessible shower	Correct or repair slope to max 2.08% in restroom.	2015 ABAAS Section: 403.3 2012 TAS Section: 403.3 2010 ADAS Section: 403.3

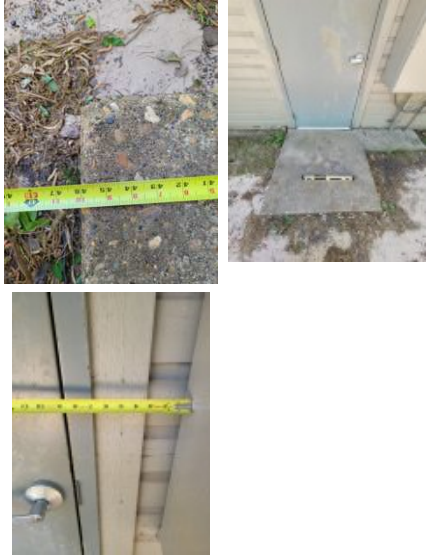
304	Shelter Camping Area: Shelter Camping - Women's Restroom	[32.2735503 , -94.569528]	The restroom sign does not comply with one or more applicable requirements for the location, height, and properties of the sign.	Lacks compliant signage	Replace sign with one of contrasting colors that includes Braille, raised characters, and the symbol of accessibility and mount on the wall, latch side of the door, 48" to the baseline of the lowest character and 60" to the baseline of the highest character.	2015 ABAAS Section: F216.2, 703.1, 703.2, 703.5, 703.6 2012 TAS Section: 216.2, 703.1, 703.2, 703.5, 703.6 2010 ADAS Section: 216.2, 703.1, 703.2, 703.5, 703.6

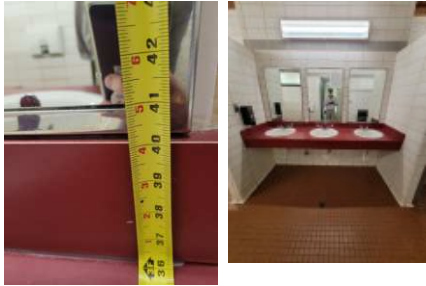
Finding Number	Area Description	Lat/Long	Finding	As Built	Recommendation	Citation	Photos	Figure
305	Shelter Camping Area: Shelter Camping - Women's Restroom	[32.2735605, -94.569532]	The mirror is mounted too high. Mirrors must have the bottom edge of the reflecting surface a maximum of 40 inches above the floor if above a sink or counter. Mirrors not located above lavatories or countertops shall be installed with the bottom edge of the reflecting surface 35 inches maximum above the finish floor or ground.	Bottom edge at 41" AFF	Lower mirror so bottom reflective surface is max 40" AFF and 74" at the top.	2015 ABAAS Section: 603.3 2012 TAS Section: 603.3 2010 ADAS Section: 603.3
