# Access Audit Site Report

**Martin Creek Lake State Park**

**Accessibility Evaluation**

**Inspection Date: 04/08/2022**

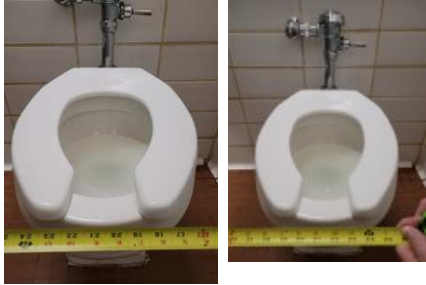
Finding Number	Area Description	Lat/Long	Finding	As Built	Recommendation	Citation	Photos	Figure
309	Shelter Camping Area: Shelter Camping - Women's Restroom	[32.2735299 , -94.569549 4]	The toilet is not located within the range to the side wall or partition. The centerline of the toilet shall be 17 inches minimum and 19 inches maximum side wall or partition in the ambulatory accessible toilet compartment.	21.5" to left, 20.5" to right	Remount toilet to 17" to 19" from the side wall to center line in ambulatory stalls.	2015 ABAAS Section: 604.9.1  2012 TAS Section: 604.9.1  2010 ADAS Section: 604.9.1

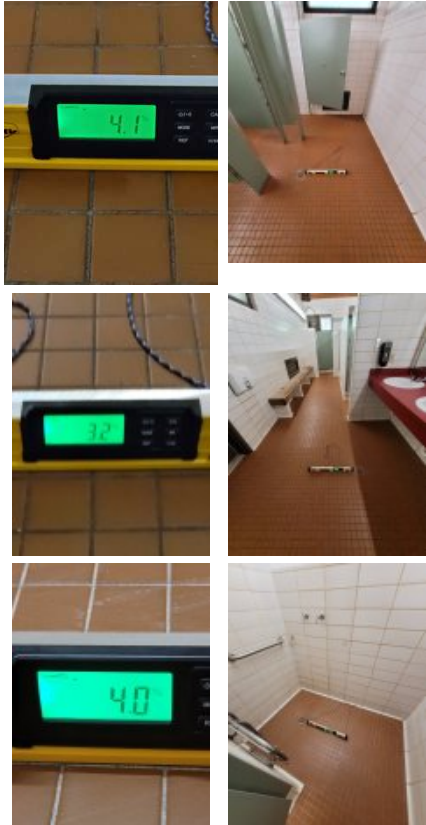
Finding Number	Area Description	Lat/Long	Finding	As Built	Recommendation	Citation	Photos	Figure
314	Shelter Camping Area: Shelter Camping - Women's Restroom	[32.2735219 , -94.569548 1]	The accessible route contains running slopes greater than 5 percent and cross slopes greater than 2 percent across the width of the walk and has not been constructed as a ramp (i.e. handrails, wheel guides, etc.). When the slope in the direction of travel of any walk exceeds 1 unit vertical in 20 units horizontal (5-percent slope), it must be constructed as ramp. Surface cross slopes must not exceed one unit vertical in 48 units. Horizontal (2-percent slope).	4.1% slope near ambulatory stall floor drain, 3.2% slope near sink, 4.2% slope at accessible shower	Correct or repair slope to max 2.08% in restroom.	2015 ABAAS Section: 403.3  2012 TAS Section: 403.3  2010 ADAS Section: 403.3

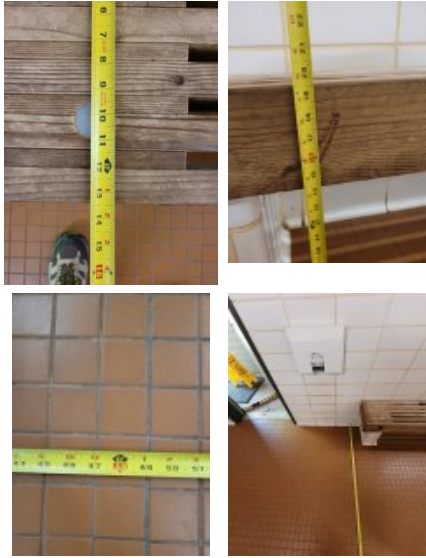
Finding Number	Area Description	Lat/Long	Finding	As Built	Recommendation	Citation	Photos	Figure
315	Shelter Camping Area: Shelter Camping - Women's Restroom	[32.2735299 , -94.5695374]	The bench is not deep enough or long enough or is missing. Benches shall be provided having seats that are 42 inches long minimum and 20 inches deep minimum and 24 inches deep maximum. The bench shall provide for back support or shall be affixed to a wall. Back support shall be 42 inches (1065 mm) long minimum and shall extend from a point 2 inches (51 mm) maximum above the seat surface to a point 18 inches (455 mm) minimum above the seat surface. Back support shall be 2½ inches (64 mm) maximum from the rear edge of the seat measured horizontally. The top of the bench seat surface shall be 17 inches (430 mm) minimum and 19 inches (485 mm) maximum above the finish floor or ground. Clear floor or ground space complying with 305 shall be provided and shall be positioned at the end of the bench seat and parallel to the short axis of the bench	Bench lacks CFS (blocks route and dryer in CFS), 13.5" deep, 19.5" high	Replace bench in dressing area with one having a seat depth of 20" to 24" deep, 42" long, affixed to the wall or having a back and mounted 17" to 19" AFF and provide required clear floor space on the short axis of the bench.	2012 TAS Section: 903.4, 903.2, 903.3, 903.5  2010 ADAS Section: 903.4, 903.2, 903.3, 903.5

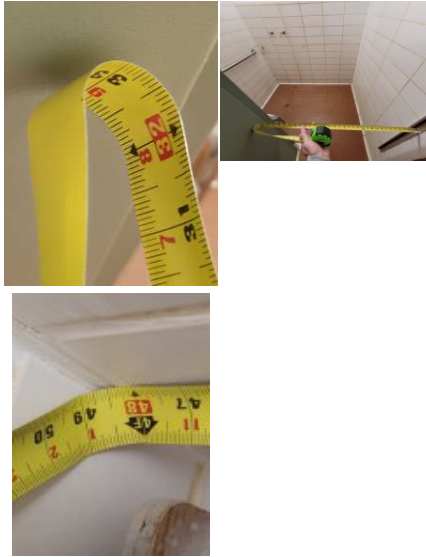
316	Shelter Camping Area: Shelter Camping - Women's Restroom	[32.2735208 , -94.5695226]	Alternate roll-in type shower compartments shall be 36 inches (915 mm) wide and 60 inches (1525 mm) deep minimum clear inside dimensions measured at center points of opposing sides. A 36 inch (915 mm) wide minimum entry shall be provided at one end of the long side of the compartment.	alternate roll-in shower 32" wide opening, 48.5" wide	Renovate shower stall, if feasible, to compliant dimensions for an alternate roll in shower of 36" deep by 60" wide with a 36" opening on the long dimension.	2015 ABAAS Section: 608.2.3  2012 TAS Section: 608.2.3  2010 ADAS Section: 608.2.3

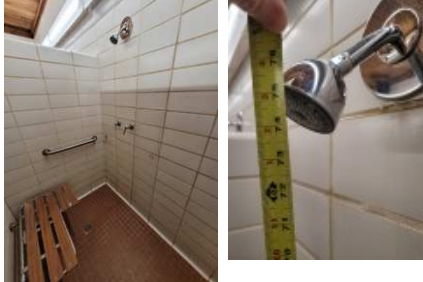
319	Shelter Camping Area: Shelter Camping - Women's Restroom	[32.2735367 , -94.569530 7]	There is no hand held sprayer unit. The sprayer unit must have a 59 inches hose and be mounted 48 inches maximum to the top of mounting bracket off the floor. The shower spray unit shall have an on/off control with a non-positive shutoff. If an adjustable-height shower head on a vertical bar is used, the bar shall be installed so as not to obstruct the use of grab bars.	Shower head at 74" AFF	Replace shower control with a compliant lever control with a shower head on a 59" hose and usable as hand held.	2015 ABAAS Section: 608.6  2012 TAS Section: 608.6  2010 ADAS Section: 608.6

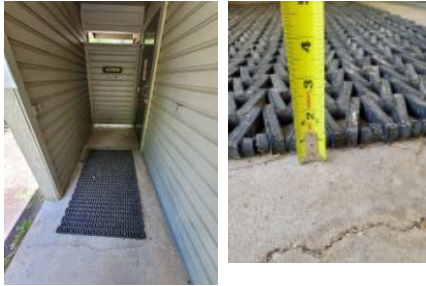
Finding Number	Area Description	Lat/Long	Finding	As Built	Recommendation	Citation	Photos	Figure
322	Shelter Camping Area: Shelter Camping - Women's Restroom	[32.2735321 , -94.5695427]	The floor mat or carpet pile height is too high. Carpet or carpet tile shall be securely attached and shall have a firm cushion, pad, or backing or no cushion or pad. Carpet or carpet tile shall have a level loop, textured loop, level cut pile, or level cut/uncut pile texture. Pile height shall be 1/2 inch maximum. Exposed edges of carpet shall be fastened to floor surfaces and shall have trim on the entire length of the exposed edge.	.5" high, unsecured floor mat	Replace mat or carpet with one having max pile or edge of 1/4". Secure edges of carpeting or mats to prevent trip hazard.	2015 ABAAS Section: 302.2 2012 TAS Section: 302.2 2010 ADAS Section: 302.2

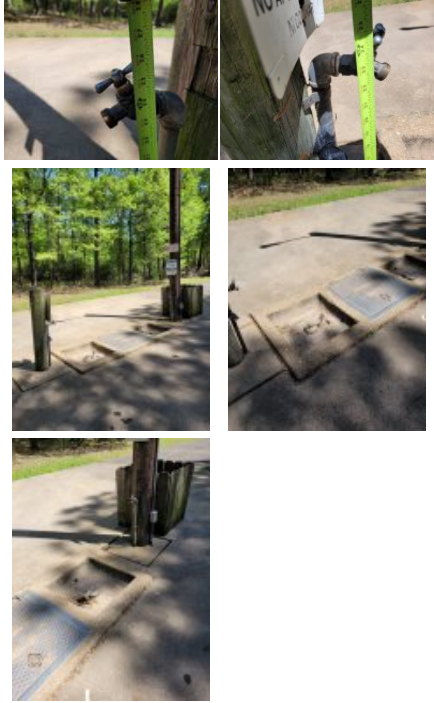
Finding Number	Area Description	Lat/Long	Finding	As Built	Recommendation	Citation	Photos	Figure
323	Bee Tree Camping Area: Bee Tree - RV Dump Station	[32.2755471, -94.57011]	Operable parts shall comply with 309.3 and 309.4. EXCEPTIONS: 1. Fire rings, grills, fireplaces, wood stoves, water hydrants, and water utility hookups shall comply with 309.4 to the extent practicable. 2. Trash and recycling receptacles with hinged lids and controls to keep out large animals shall comply with 309.4 to the extent practicable. 3. Dumpster type trash and recycling receptacles shall not be required to comply with 309.3 and 309.4. 4. Sewage hatches shall not be required to comply with 309.3 and 309.4.	Water spouts at 23" AFF	Replace operable parts with ones usable without a tight pinch or grasp, mounted within reach range of 15" to 48" above the ground as a smart practice.	2015 ABAAS Section: 1011.3, 1011.3 EXCEPTIONS: 1, 1011.3 EXCEPTIONS: 2, 1011.3 EXCEPTIONS: 3, 1011.3 EXCEPTIONS: 4

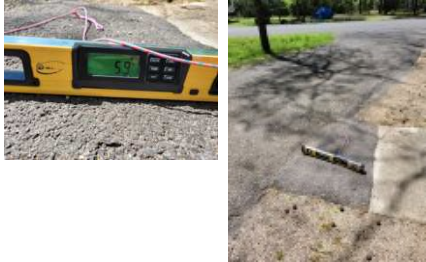
Finding Number	Area Description	Lat/Long	Finding	As Built	Recommendation	Citation	Photos	Figure
326	Bee Tree Camping Area: Bee Tree - Campsite 36	[32.2763896 , -94.572678 2]	The cross slope shall not be steeper than 1:48. EXCEPTION: Where the surface is other than concrete, asphalt, or boards, cross slopes not steeper than 1:20 shall be permitted when necessary for drainage.	5.9% slope at entry	Correct or repair ORAR cross slope to max 2.08% or 5% for surfaces other than concrete, asphalt or board as a smart practices.	2015 ABAAS Section: 1016.7.2, 1016.7.2 EXCEPTION

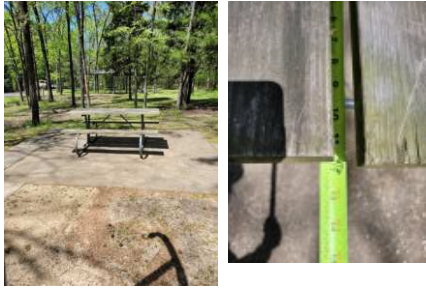
327	Bee Tree Camping Area: Bee Tree - Campsite 36	[32.2763896 , -94.572676 9]	Picnic tables shall provide at least one wheelchair space for each 24 linear feet (7320 mm) of usable table surface perimeter. Wheelchair spaces shall be 30 inches (760 mm) minimum by 48 inches (1220 mm) minimum. Wheelchair spaces shall be positioned for a forward approach to the table and provide knee and toe clearance complying with 306 under the table	Lacks knee clearance - 11" depth	Replace picnic table with one of an accessible design as a smart practice.	2015 ABAAS Section: 1011.4.2

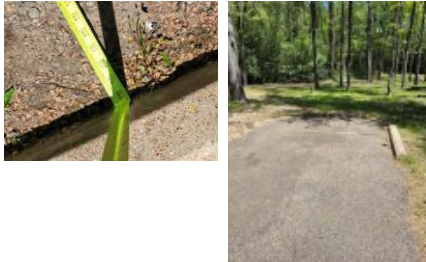
Finding Number	Area Description	Lat/Long	Finding	As Built	Recommendation	Citation	Photos	Figure
329	Bee Tree Camping Area: Bee Tree - Campsite 36	[32.2763941 , -94.572684 9]	Camping facilities shall provide camping units with mobility features complying with F244.2 in accordance with Table F244.2. Where a camping facility provides different types of camping units, Table F244.2 shall apply to each type of camping unit provided. Total Number of Camping Units Provided in Camping Facility Minimum Number of Camping Units with Mobility Features Required 1 1 2 to 25 2 26 to 50 3 51 to 75 4 76 to 100 5 101 to 150 7 151 to 200 8 201 and over 8, plus 2 percent of the number over 200	Lacks required number of accessible campsites - 1 of 58 are accessible	Create the required number of accessible camp sites per table F244.2 as a smart practice.	2015 ABAAS Section: F244.2		
330	Bee Tree Camping Area: Bee Tree - Campsite 36	[32.2763907 , -94.572679 6]	Parking spaces and pull-up spaces for recreational vehicles shall be 20 feet (6100 mm) wide minimum. EXCEPTION: Where two adjacent parking spaces are provided for recreational vehicles, one parking space shall be permitted to be 16 feet (4880 mm) wide minimum.	13.4" width	Correct RV parking space to be 20' wide minimum; or 16' for two adjacent spaces as a smart practice.	2015 ABAAS Section: 1012.2, 1012.2 EXCEPTION

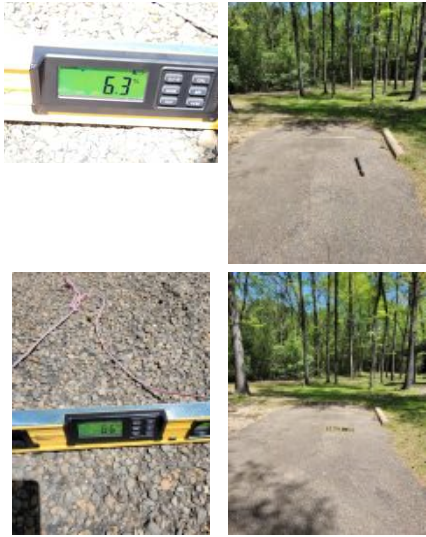
331	Bee Tree Camping Area: Bee Tree - Campsite 36	[32.2763873 , -94.572676 9]	The surface of parking spaces and pull-up spaces shall be firm and stable. The slope of the surface of parking spaces and pull-up spaces shall not be steeper than 1:48 in any direction. EXCEPTION: Where the surface is other than asphalt, concrete, or boards, slopes not steeper than 1:20 shall be permitted when necessary for drainage.	Slopes of 6.3% and 6.6%	Correct surface of parking spaces to be firm and stable with slopes max of 2.08% or 5% for surfaces other than concrete, asphalt or boards as a smart practice.	2015 ABAAS Section: 1012.4, 1012.5, 1012.5 EXCEPTION

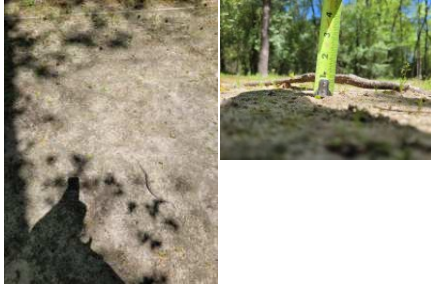
Finding Number	Area Description	Lat/Long	Finding	As Built	Recommendation	Citation	Photos	Figure
332	Bee Tree Camping Area: Bee Tree - Campsite 36	[32.2763839 , -94.572684 9]	A clear floor space at the tent pad and/or tent platform is not provided. Clear ground space shall be provided on all usable sides of tent pads and tent platforms. The clear ground space shall be 48 inches wide minimum. The surface of the clear ground space shall be firm and stable. The surface shall allow use of tent stakes and other tent securement devices. The slope of the surface of tent pads, tent platforms, and clear ground spaces shall not be steeper than 1:48 in any direction. Where the surface is other than asphalt, concrete, or boards, slopes not steeper than 1:20 shall be permitted where necessary for drainage.	CIL of 1" on tent pad due to exposed root	Repair, bevel or ramp CIL to max .5".	2015 ABAAS Section: 1013.2

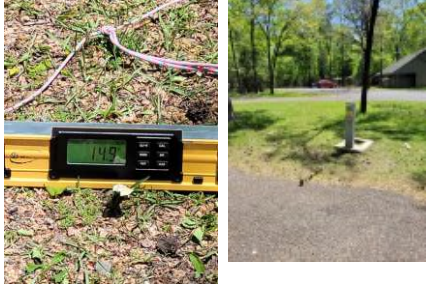
333	Bee Tree Camping Area: Bee Tree - Campsite 36	[32.276393, -94.572682 3]	An accessible access route is not provided between elements, spaces and the facilities provided within the accessible camping unit. At least one outdoor recreation access route shall connect accessible elements, spaces and facilities provided within camping units with mobility features.	Lacks ORAR to utility hook up - 14.9% slope in existing CGS (natural surface) and too far of a reach from stall	Create AR with crushed and compacted stone or similar outdoor material to camp sites and one of each type of amenity.	2015 ABAAS Section: F244.5.1

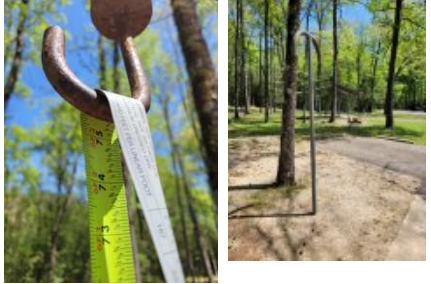
334	Bee Tree Camping Area: Bee Tree - Campsite 36	[32.2763952 , -94.572675 6]	The operable part is positioned too high for either a side or front approach. Where a clear floor or ground space allows a parallel approach to an element and the side reach is unobstructed, the high side reach shall be 48 inches maximum and the low side reach shall be 15 inches minimum above the finish floor or ground. Where a forward reach is unobstructed, the high forward reach shall be 48 inches maximum and the low forward reach shall be 15 inches minimum above the finish floor or ground.	Camp hook at 76" AGL	Remount operable parts to be in reach range of 15" min to 48" max.	2015 ABAAS Section: 308.1  2012 TAS Section: 308.1  2010 ADAS Section: 308.1

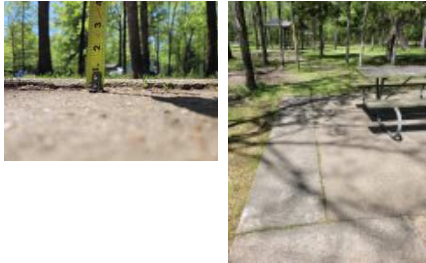
Finding Number	Area Description	Lat/Long	Finding	As Built	Recommendation	Citation	Photos	Figure
335	Bee Tree Camping Area: Bee Tree - Campsite 36	[32.2763896, -94.5726782]	The walkway contains abrupt vertical edges and/or variations over a 1/4 inch. 1/4 inch is the maximum vertical rise. Changes in level between 1/4 inch and 1/2 inch must be beveled at 1:2 or less. Changes in level greater than 1/2 inch must be by way of a ramp.	.5" CIL at campsite	Repair, bevel or ramp CIL along AR.	2012 TAS Section: 303.2, 303.3  2010 ADAS Section: 303.2, 303.3

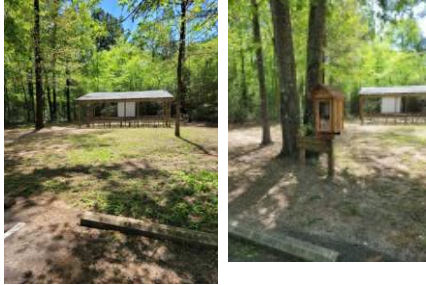
Finding Number	Area Description	Lat/Long	Finding	As Built	Recommendation	Citation	Photos	Figure
338	Bee Tree Camping Area: Bee Tree - Amphitheater	[32.2756605 , -94.5720358]	At least one accessible route shall connect accessible buildings, accessible facilities, accessible elements, and accessible spaces that are on the same site. For areas of sport activity, an accessible route is required to connect to the boundary of each area of sport activity. The size of an area of sport activity includes only the space needed to play. Where multiple sports fields or courts are provided, an accessible route is required to each field or area of sport activity.	Lacks AR to amphitheater and Little Free Library at amphitheater	Provide an accessible route to each element within the site.	2010 ADAS Section: 206.2.2, 206.2

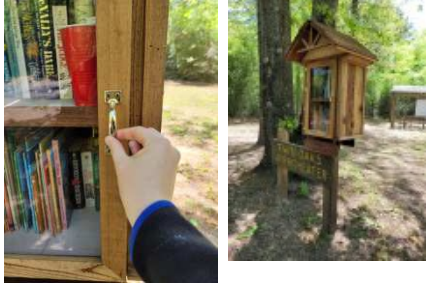
339	Bee Tree Camping Area: Bee Tree - Amphitheater	[32.2756639 , -94.5720399]	The operable part is not accessible because it requires tight grasping, pinching or twisting of the wrist.	Little Free Library door handle requires pinch	Replace operable part with one usable without a tight pinch or grasp.	2015 ABAAS Section: 309.4  2012 TAS Section: 309.4  2010 ADAS Section: 309.4

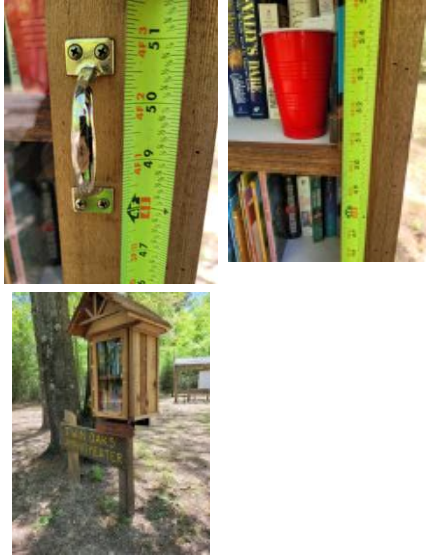
340	Bee Tree Camping Area: Bee Tree - Amphitheater	[32.2756537 , -94.5720385]	The operable part is positioned too high for either a side or front approach. Where a clear floor or ground space allows a parallel approach to an element and the side reach is unobstructed, the high side reach shall be 48 inches maximum and the low side reach shall be 15 inches minimum above the finish floor or ground. Where a forward reach is unobstructed, the high forward reach shall be 48 inches maximum and the low forward reach shall be 15 inches minimum above the finish floor or ground.	Little Free Library - handle at 49.5" AGL and shelf inside at 50.5" AGL	Remount operable parts to be in reach range of 15" min to 48" max.	2015 ABAAS Section: 308.1  2012 TAS Section: 308.1  2010 ADAS Section: 308.1

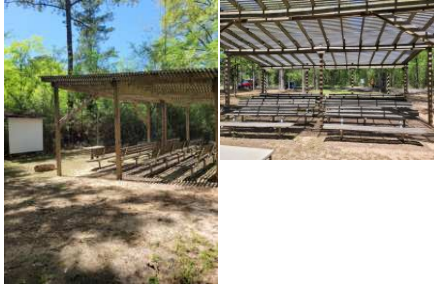
Finding Number	Area Description	Lat/Long	Finding	As Built	Recommendation	Citation	Photos	Figure																
341	Bee Tree Camping Area: Bee Tree - Amphitheater	[32.2756605 , -94.5720318]	The floor surface at the wheelchair seating spaces contain abrupt edges and/or variation over a 1/2", In addition the floor area is sloped greater than 2% and is not slip resistant. Floor and ground surfaces shall not be sloped steeper than 1:48 (2%) and shall be stable, firm, and slip resistant Changes in level are not permitted.	Lacks wheelchair space due to surface	Repair landing at accessible seating to be level or no more than 2.08% slope in any direction and free of gaps and CIL.	2015 ABAAS Section: 802.1.1 , 802.1.1 EXCEPTION  2012 TAS Section: 802.1.1, 802.1.1 Exception  2010 ADAS Section: 802.1.1 Exception

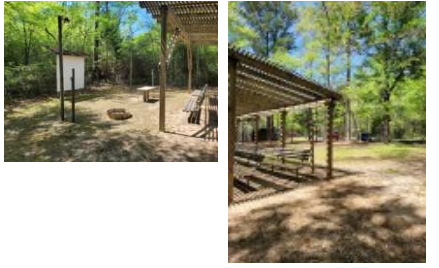
Number of Seats	Minimum Number of Required Wheelchair Spaces	4 to 25	1	26 to 50	2	51 to 100	4	101 to 200	6	201 to 500	8	501 to 1000	10, plus 1 for each 100, or fraction thereof, between 100 through 1000	1000 and over	16, plus 1 for each 200, or fraction thereof, over 1000
Number of Seats	Minimum Number of Required Wheelchair Spaces																							
4 to 25	1																							
26 to 50	2																							
51 to 100	4																							
101 to 200	6																							
201 to 500	8																							
501 to 1000	10, plus 1 for each 100, or fraction thereof, between 100 through 1000																							
1000 and over	16, plus 1 for each 200, or fraction thereof, over 1000																							
343	Bee Tree Camping Area: Bee Tree - Amphitheater	[32.2756582 , -94.5720358]	There is no accessible route between the performance areas to ancillary areas used by the performers. An accessible route shall be provided from performance areas to ancillary areas or facilities used by performers unless specifically exempted.	Lacks AR to any elements at the amphitheater	Create an accessible route connecting ancillary elements of amphitheater.	2015 ABAAS Section: F206.2.6  2012 TAS Section: 206.2.6  2010 ADAS Section: 206.2.6

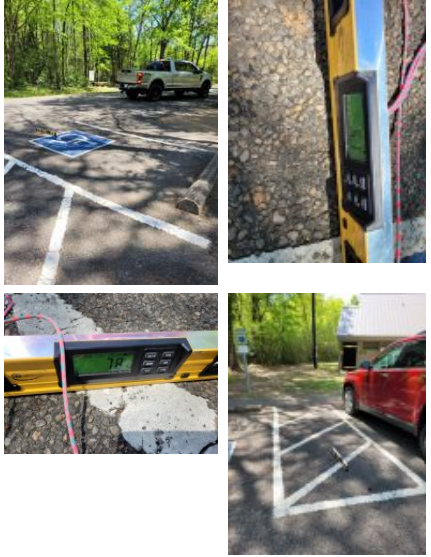
345	Bee Tree Camping Area: Bee Tree - Parking	[32.2759099 , -94.572212 9]	The cross slopes (narrow dimension) and/or running slopes (long dimension) of the access aisle exceeds 2%. The running slope and the cross slope in an accessible parking stall and the access aisle must not exceed 2%.	Slopes of 5.7% in stall, 8.1% in access aisle	Repair or correct slope of parking space and access aisle to max 2.08% in any direction.	2015 ABAAS Section: 502.4  2012 TAS Section: 502.4  2010 ADAS Section: 502.4

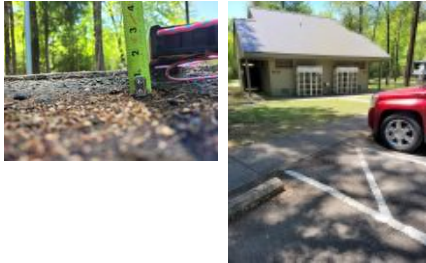
Finding Number	Area Description	Lat/Long	Finding	As Built	Recommendation	Citation	Photos	Figure
346	Bee Tree Camping Area: Bee Tree - Parking	[32.2758986 , -94.572229]	The walkway contains abrupt vertical edges and/or variations over a 1/4 inch. 1/4 inch is the maximum vertical rise. Changes in level between 1/4 inch and 1/2 inch must be beveled at 1:2 or less. Changes in level greater than 1/2 inch must be by way of a ramp.	1.25" CIL at access aisle to path to restrooms	Repair, bevel or ramp CIL along AR.	2012 TAS Section: 303.2, 303.3  2010 ADAS Section: 303.2, 303.3

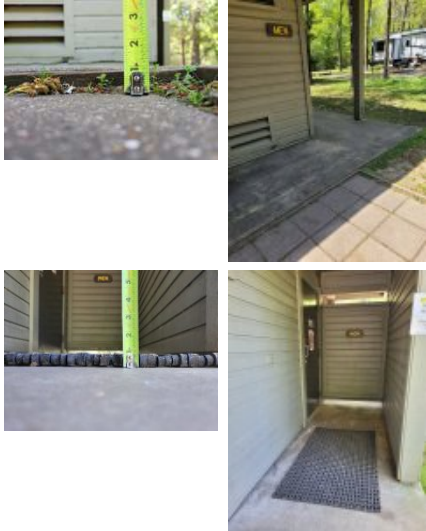
Finding Number	Area Description	Lat/Long	Finding	As Built	Recommendation	Citation	Photos	Figure
350	Bee Tree Camping Area: Bee Tree - Men's Restroom	[32.2758906, -94.5723577], [32.2758374, -94.5722893]	The walkway contains abrupt vertical edges and/or variations over a 1/4 inch. 1/4 inch is the maximum vertical rise. Changes in level between 1/4 inch and 1/2 inch must be beveled at 1:2 or less. Changes in level greater than 1/2 inch must be by way of a ramp. The floor mat or carpet pile height is too high. Carpet or carpet tile shall be securely attached and shall have a firm cushion, pad, or backing or no cushion or pad. Carpet or carpet tile shall have a level loop, textured loop, level cut pile, or level cut/uncut pile texture. Pile height shall be 1/2 inch maximum. Exposed edges of carpet shall be fastened to floor surfaces and shall have trim on the entire length of the exposed edge.	CIL of .75" at turn to men's restroom, .75" due to mat outside of entry	Repair, bevel or ramp CIL along AR. Replace mat or carpet with one having max pile or edge of 1/4". Secure rug to prevent trip hazard.	2012 TAS Section: 303.2, 303.3  2010 ADAS Section: 303.2, 303.3

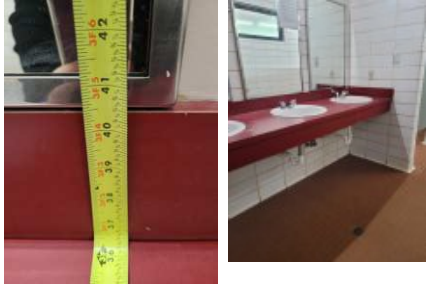
Finding Number	Area Description	Lat/Long	Finding	As Built	Recommendation	Citation	Photos	Figure
352	Bee Tree Camping Area: Bee Tree - Men's Restroom	[32.2758283 , -94.5723658]	The mirror is mounted too high. Mirrors must have the bottom edge of the reflecting surface a maximum of 40 inches above the floor if above a sink or counter. Mirrors not located above lavatories or countertops shall be installed with the bottom edge of the reflecting surface 35 inches maximum above the finish floor or ground.	Bottom edge at 41.25" AFF	Lower mirror so bottom reflective surface is max 40" AFF and 74" at the top.	2015 ABAAS Section: 603.3  2012 TAS Section: 603.3  2010 ADAS Section: 603.3

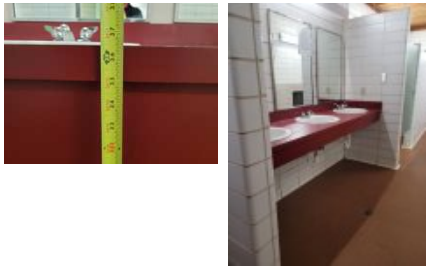
353	Bee Tree Camping Area: Bee Tree - Men's Restroom	[32.2758079 , -94.5723872]	The top rim of the sink is too high. All lavatories/sinks that are designated to be accessible shall be a minimum 17 inches in horizontal depth and mounted with the rim or counter edge no higher than 34 inches above the finished floor.	Sink rim at 36.5" AFF.	Lower sinks to max 34" above the finished floor (AFF) to front of rim.	2015 ABAAS Section: 606.3  2012 TAS Section: 606.3  2010 ADAS Section: 606.3

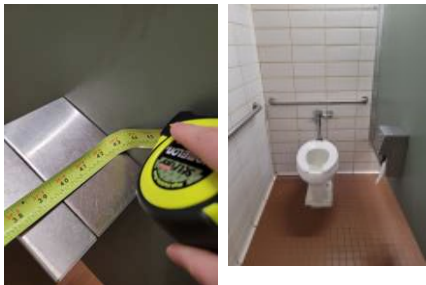
355	Bee Tree Camping Area: Bee Tree - Men's Restroom	[32.2758215 , -94.5723845]	The ambulatory stall is not between 35" to 37" wide and 60" deep.	Ambulatory stall 43" wide	Correct ambulatory stall to be 35" to 37" wide and minimum 60" deep.	2015 ABAAS Section: 604.8.2.1  2012 TAS Section: 604.8.2.1  2010 ADAS Section: 604.8.2.1

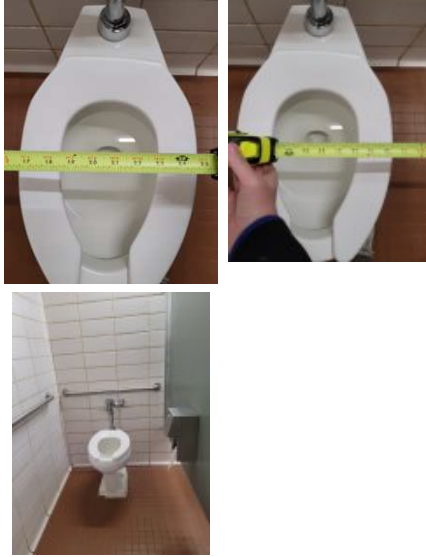
Finding Number	Area Description	Lat/Long	Finding	As Built	Recommendation	Citation	Photos	Figure
356	Bee Tree Camping Area: Bee Tree - Men's Restroom	[32.2758203, -94.5723819]	The toilet is not located within the range to the side wall or partition. The centerline of the toilet shall be 17 inches minimum and 19 inches maximum side wall or partition in the ambulatory accessible toilet compartment.	20.5" from tile, 22.5" other side	Remount toilet to 17" to 19" from the side wall to center line in ambulatory stalls.	2015 ABAAS Section: 604.9.1  2012 TAS Section: 604.9.1  2010 ADAS Section: 604.9.1

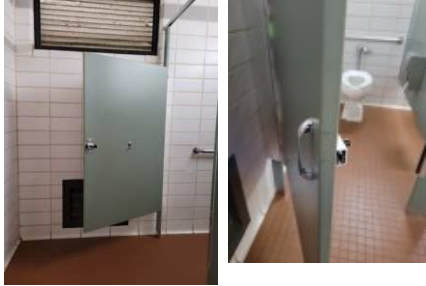
357	Bee Tree Camping Area: Bee Tree - Men's Restroom	[32.275826, -94.5723738]	The stall door fails to comply with all of the door requirements. The stall door must be a minimum of 32" wide and have compliant hardware on both sides. The stall door must be self-closing.	Ambulatory stall lacks self-closing door, hardware requires tight pinch	Adjust stall door to be self-closing. Replace stall hardware with hardware operable without a tight pinch or grasp on both sides of the stall door.	2015 ABAAS Section: 404.2.3, 404.2.7, 604.8.2.2  2012 TAS Section: 404.2.3, 404.2.7, 604.8.2.2  2010 ADAS Section: 404.2.3, 404.2.7, 604.8.2.2

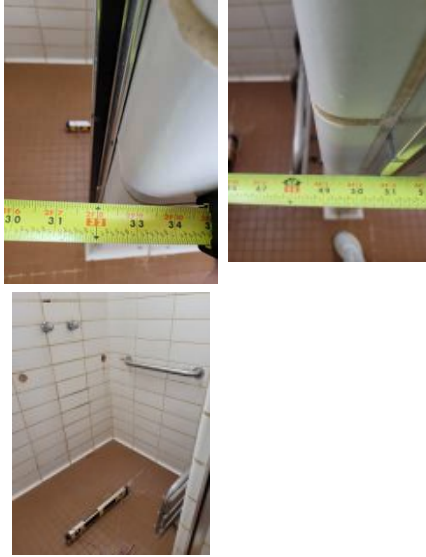
Finding Number	Area Description	Lat/Long	Finding	As Built	Recommendation	Citation	Photos	Figure
360	Bee Tree Camping Area: Bee Tree - Men's Restroom	[32.2758101 , -94.572376 5]	Alternate roll-in type shower compartments shall be 36 inches (915 mm) wide and 60 inches (1525 mm) deep minimum clear inside dimensions measured at center points of opposing sides. A 36 inch (915 mm) wide minimum entry shall be provided at one end of the long side of the compartment.	alternate roll in shower 32" entry, 49" width	Renovate shower stall, if feasible, to compliant dimensions for an alternate roll in shower of 36" deep by 60" wide with a 36" opening on the long dimension.	2015 ABAAS Section: 608.2.3  2012 TAS Section: 608.2.3  2010 ADAS Section: 608.2.3

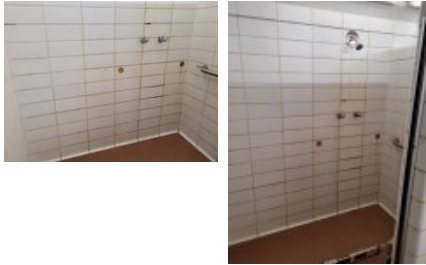
361	Bee Tree Camping Area: Bee Tree - Men's Restroom	[32.2758101 , -94.572371 1]	The grab bar is located above the seat In alternate roll-in type shower compartments, grab bars shall be provided on the back wall and the side wall farthest from the compartment entry. Grab bars shall not be provided above the seat. Grab bars shall be installed 6 inches maximum from adjacent walls.	Lacks grab bar	Provide grab bars in the shower mounted in the correct locations for the shower type.	2015 ABAAS Section: 608.3.3  2012 TAS Section: 608.3.3  2010 ADAS Section: 608.3.3

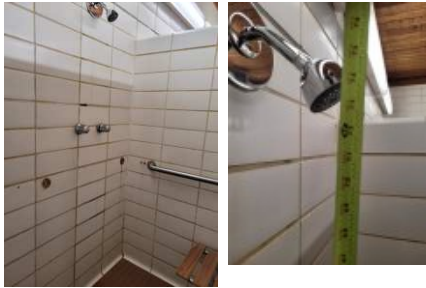
<b>SHOWER SPRAY UNIT</b>

363	Bee Tree Camping Area: Bee Tree - Men's Restroom	[32.2758249 , -94.572385 9]	There is no hand held sprayer unit. The sprayer unit must have a 59 inches hose and be mounted 48 inches maximum to the top of mounting bracket off the floor. The shower spray unit shall have an on/off control with a non-positive shutoff. If an adjustable-height shower head on a vertical bar is used, the bar shall be installed so as not to obstruct the use of grab bars.	Shower head at 73" AFF	Replace shower control with a compliant lever control with a shower head on a 59" hose and usable as hand held.	2015 ABAAS Section: 608.6  2012 TAS Section: 608.6  2010 ADAS Section: 608.6

59" Long Flexible Hose Water Temperature: 120° F Max. Top of mounting bracket: 48" Max. above the shower floor. ©Builder's Book, Inc.

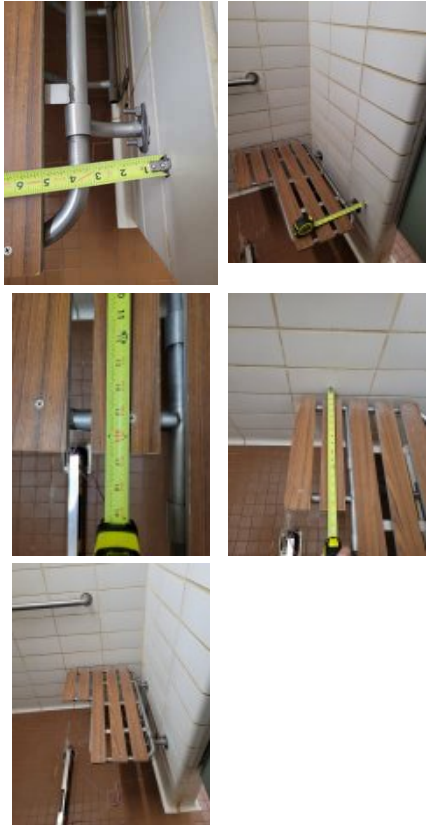
Finding Number	Area Description	Lat/Long	Finding	As Built	Recommendation	Citation	Photos	Figure
364	Bee Tree Camping Area: Bee Tree - Men's Restroom	[32.2758226 , -94.572375 1]	The shower seat does not have a compliant space between it and the wall. The folding seat must be mounted 17-19 inches above the floor, and have a maximum space of 1-1/2 inches between the edge of the seat and the side wall and 2-1/2 inches maximum to the seat wall.	Mounted 3" from back wall, wide part of L is 17.5" from wall	Remount shower seat to the correct location and height in the shower.	2015 ABAAS Section: 610.3.2  2012 TAS Section: 610.3.2  2010 ADAS Section: 610.3.2

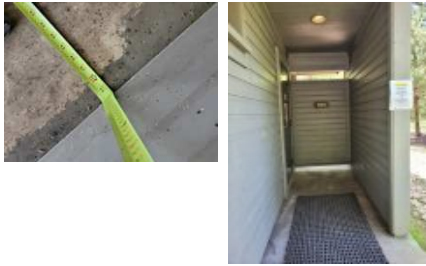
365	Bee Tree Camping Area: Bee Tree - Men's Restroom	[32.2758237 , -94.572377 8]	Minimum maneuvering clearances at doors and gates shall comply with 404.2.4. Maneuvering clearances shall extend the full width of the doorway and the required latch side or hinge side clearance.	49.5" back maneuvering clearance on pull, latch approach	Provide required maneuvering clearance around pull side of door.	2015 ABAAS Section: 404.2.4.1 , 404.2.4.4  2012 TAS Section: 404.2.4.4, 404.2.4.1  2010 ADAS Section: 404.2.4.4, 404.2.4.1

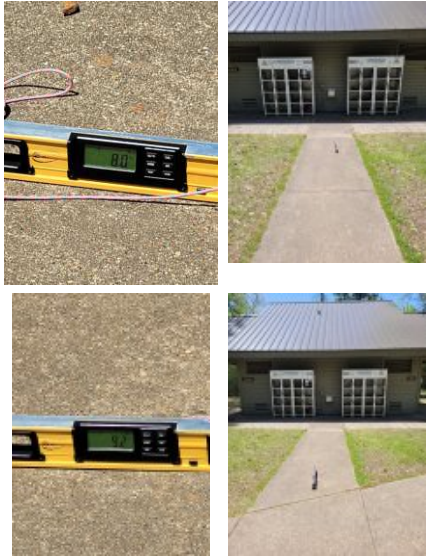
Finding Number	Area Description	Lat/Long	Finding	As Built	Recommendation	Citation	Photos	Figure
366	Bee Tree Camping Area: Bee Tree - Men's Restroom	[32.2758203 , -94.5723805]	The running slope of walking surfaces shall not be steeper than 1:20.	8% at bottom of path to restroom building, 9.2% at top	Correct running slope along the AR to max 5%.	2015 ABAAS Section: 403.3  2012 TAS Section: 403.3  2010 ADAS Section: 403.3

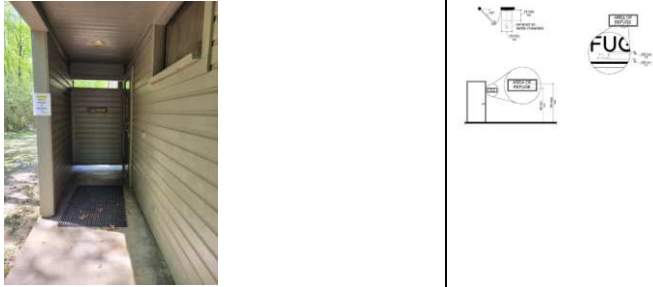
367	Bee Tree Camping Area: Bee Tree - Women's Restroom	[32.2758203 , -94.5723805]	The restroom sign does not comply with one or more applicable requirements for the location, height, and properties of the sign.	Lacks compliant signage	Replace sign with one of contrasting colors that includes Braille, raised characters, and the symbol of accessibility and mount on the wall, latch side of the door, 48" to the baseline of the lowest character and 60" to the baseline of the highest character.	2015 ABAAS Section: F216.2, 703.1, 703.2, 703.5, 703.6  2012 TAS Section: 216.2, 703.1, 703.2, 703.5, 703.6  2010 ADAS Section: 216.2, 703.1, 703.2, 703.5, 703.6

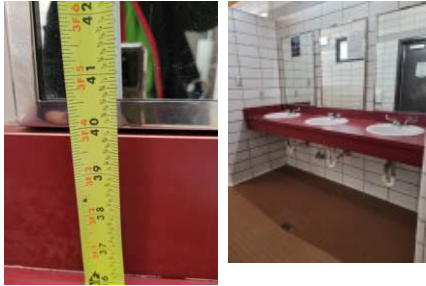
Finding Number	Area Description	Lat/Long	Finding	As Built	Recommendation	Citation	Photos	Figure
368	Bee Tree Camping Area: Bee Tree - Women's Restroom	[32.2758192 , -94.572383 2]	The mirror is mounted too high. Mirrors must have the bottom edge of the reflecting surface a maximum of 40 inches above the floor if above a sink or counter. Mirrors not located above lavatories or countertops shall be installed with the bottom edge of the reflecting surface 35 inches maximum above the finish floor or ground.	Bottom edge at 40.5" AFF	Lower mirror so bottom reflective surface is max 40" AFF and 74" at the top.	2015 ABAAS Section: 603.3  2012 TAS Section: 603.3  2010 ADAS Section: 603.3

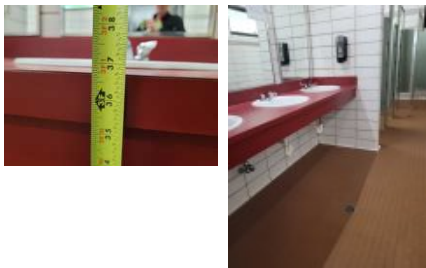
369	Bee Tree Camping Area: Bee Tree - Women's Restroom	[32.2758237 , -94.572380 5]	The top rim of the sink is too high. All lavatories/sinks that are designated to be accessible shall be a minimum 17 inches in horizontal depth and mounted with the rim or counter edge no higher than 34 inches above the finished floor.	Sink rim at 37.75" AFF	Lower sinks to max 34" above the finished floor (AFF) to front of rim.	2015 ABAAS Section: 606.3  2012 TAS Section: 606.3  2010 ADAS Section: 606.3

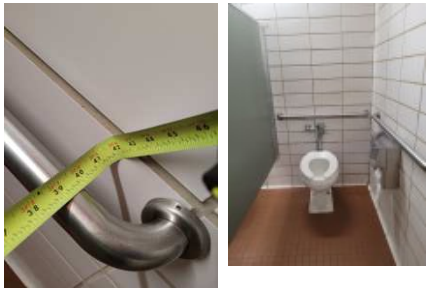
371	Bee Tree Camping Area: Bee Tree - Women's Restroom	[32.2758215 , -94.572379 2]	The ambulatory stall is not between 35" to 37" wide and 60" deep.	Ambulatory stall 42" wide	Correct ambulatory stall to be 35" to 37" wide and minimum 60" deep.	2015 ABAAS Section: 604.8.2.1  2012 TAS Section: 604.8.2.1  2010 ADAS Section: 604.8.2.1

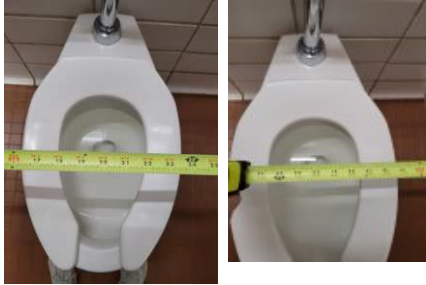
Finding Number	Area Description	Lat/Long	Finding	As Built	Recommendation	Citation	Photos	Figure
372	Bee Tree Camping Area: Bee Tree - Women's Restroom	[32.2758169 , -94.572383 2]	The toilet is not located within the range to the side wall or partition. The centerline of the toilet shall be 17 inches minimum and 19 inches maximum side wall or partition in the ambulatory accessible toilet compartment.	20" to green side, 22" to tile side	Remount toilet to 17" to 19" from the side wall to center line in ambulatory stalls.	2015 ABAAS Section: 604.9.1  2012 TAS Section: 604.9.1  2010 ADAS Section: 604.9.1

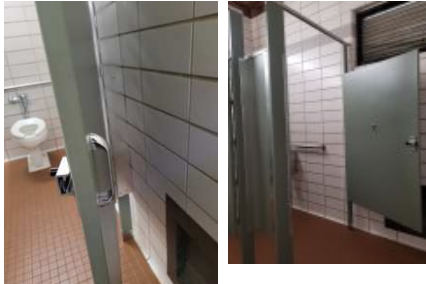
373	Bee Tree Camping Area: Bee Tree - Women's Restroom	[32.2758237 , -94.572381 9]	The stall door fails to comply with all of the door requirements. The stall door must be a minimum of 32" wide and have compliant hardware on both sides. The stall door must be self-closing.	Stall lacks self-closing door, small hardware	Adjust stall door to be self-closing. Replace stall hardware with hardware operable without a tight pinch or grasp on both sides of the stall door.	2015 ABAAS Section: 404.2.3, 404.2.7, 604.8.2.2  2012 TAS Section: 404.2.3, 404.2.7, 604.8.2.2  2010 ADAS Section: 404.2.3, 404.2.7, 604.8.2.2

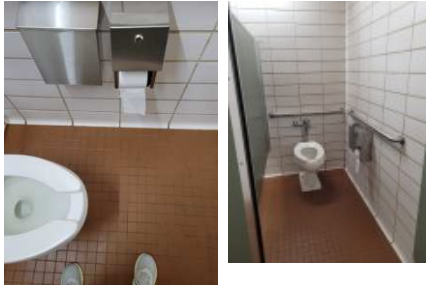
375	Bee Tree Camping Area: Bee Tree - Women's Restroom	[32.2758237 , -94.5723819]	The toilet paper is not installed within the compliant range in front of the toilet. Toilet paper dispensers shall be 7 inches minimum and 9 inches maximum in front of the water closet measured to the centerline of the dispenser. The outlet of the dispenser shall be 15 inches minimum and 48 inches maximum above the finish floor and shall not be located behind grab bars. Dispensers shall not be of a type that controls delivery or that does not allow continuous paper flow. There shall be a clearance of 1 1/2 inches minimum below the grab bar.	TP too close to front of toilet	Remount toilet paper dispenser max 7" to 9" from front of toilet, 15" to 48" AFF and min 12" above or 1.5" below grab bar.	2015 ABAAS Section: 604.7  2012 TAS Section: 604.7  2010 ADAS Section: 604.7

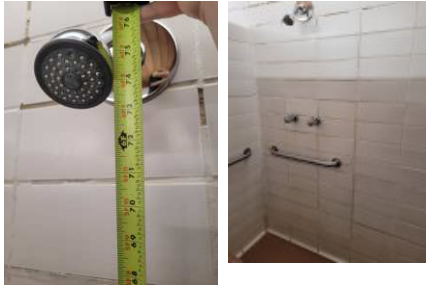
<p><b>SHOWER SPRAY UNIT</b></p>

Finding Number	Area Description	Lat/Long	Finding	As Built	Recommendation	Citation	Photos	Figure
378	Bee Tree Camping Area: Bee Tree - Women's Restroom	[32.2758249 , -94.5723819]	There is no hand held sprayer unit. The sprayer unit must have a 59 inches hose and be mounted 48 inches maximum to the top of mounting bracket off the floor. The shower spray unit shall have an on/off control with a non-positive shutoff. If an adjustable-height shower head on a vertical bar is used, the bar shall be installed so as not to obstruct the use of grab bars.	Shower head at 73" AFF	Replace shower control with a compliant lever control with a shower head on a 59" hose and usable as hand held.	2015 ABAAS Section: 608.6  2012 TAS Section: 608.6  2010 ADAS Section: 608.6

<p>Water Temperature: 120° F Max.</p> <p>Top of mounting bracket: 48" Max. above the shower floor.</p> <p>©Builder's Book, Inc.</p>

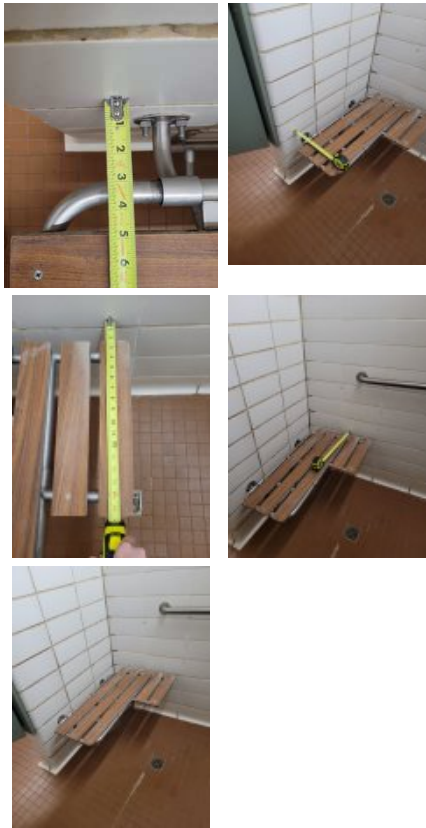
379	Bee Tree Camping Area: Bee Tree - Women's Restroom	[32.2758192 , -94.5723698]	The shower seat does not have a compliant space between it and the wall. The folding seat must be mounted 17-19 inches above the floor, and have a maximum space of 1-1/2 inches between the edge of the seat and the side wall and 2-1/2 inches maximum to the seat wall.	Mounted 3" in back, wide part of L is 17.5" from side wall	Remount shower seat to the correct location and height in the shower.	2015 ABAAS Section: 610.3.2  2012 TAS Section: 610.3.2  2010 ADAS Section: 610.3.2

<p>(a) size (b) distance from wall</p>

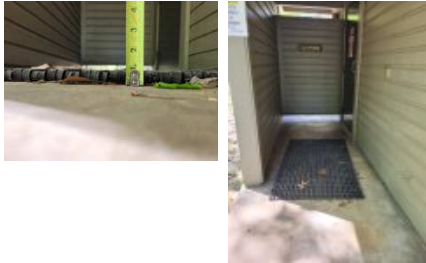
Finding Number	Area Description	Lat/Long	Finding	As Built	Recommendation	Citation	Photos	Figure
381	Bee Tree Camping Area: Bee Tree - Women's Restroom	[32.2758169 , -94.572376 5]	The floor mat or carpet pile height is too high. Carpet or carpet tile shall be securely attached and shall have a firm cushion, pad, or backing or no cushion or pad. Carpet or carpet tile shall have a level loop, textured loop, level cut pile, or level cut/uncut pile texture. Pile height shall be 1/2 inch maximum. Exposed edges of carpet shall be fastened to floor surfaces and shall have trim on the entire length of the exposed edge.	CIL of .75" due to floor mat height, unsecured	Replace mat or carpet with one having max pile or edge of 1/4". Secure rug to prevent trip hazard.	2015 ABAAS Section: 302.2  2012 TAS Section: 302.2  2010 ADAS Section: 302.2

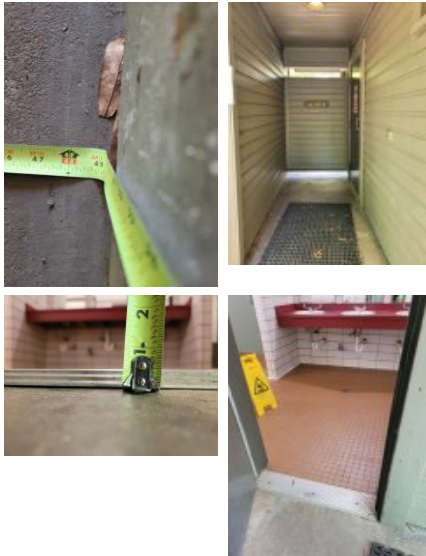
382	Bee Tree Camping Area: Bee Tree - Women's Restroom	[32.2758203 , -94.572376 5]	Minimum maneuvering clearances at doors and gates shall comply with 404.2.4. Maneuvering clearances shall extend the full width of the doorway and the required latch side or hinge side clearance. The threshold at a doorway shall be no higher than 1/2 inch. Changes in level between 1/4 inch and 1/2 inch must be beveled at 1:2 or less. 1/4 inch is the maximum vertical rise.	49" back maneuvering clearance on pull side - latch approach, threshold CIL of .5"	For all doors along the public circulation route, provide required maneuvering clearance on push and pull side of doors. For all doors along the public circulation route, repair, provide beveled threshold.	2010 ADAS Section: 404.2.3, 404.2.7, 404.2.4, 404.2.11, 404.2.11 Exception

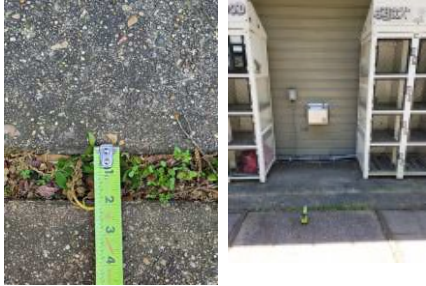
383	Bee Tree Camping Area: Bee Tree - Women's Restroom	[32.2758169 , -94.572397 9]	There is a gap spaced greater than a 1/2 inch. Openings in floor or ground surfaces shall not allow passage of a sphere more than 1/2 inch diameter. Elongated openings shall be placed so that the long dimension is perpendicular to the dominant direction of travel.	2" gap near drinking fountain	Correct or fill gaps to be max .5".	2015 ABAAS Section: 302.3  2012 TAS Section: 302.3  2010 ADAS Section: 302.3

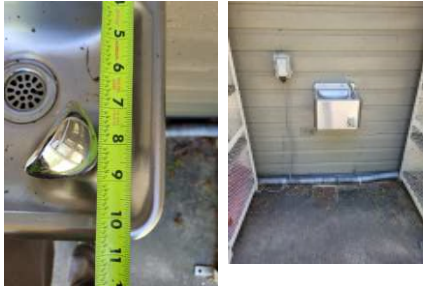
385	Bee Tree Camping Area: Bee Tree - Women's Restroom	[32.275826, -94.5723832]	The spout is not positioned correctly from the vertical support. The spout shall be located 15 inches minimum from the vertical support and 5 inches maximum from the front edge of the unit, including bumpers.	Spout is 8" from vertical support	Remount or replace fountain to provide 15" from vertical support to the spout.	2015 ABAAS Section: 602.5  2012 TAS Section: 602.5  2010 ADAS Section: 602.5

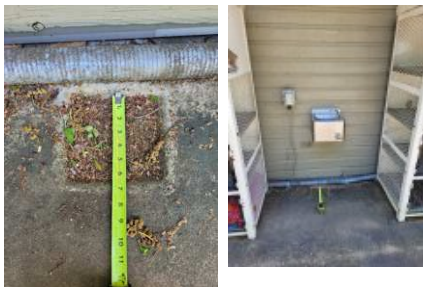
386	Bee Tree Camping Area: Bee Tree - Women's Restroom	[32.275826, -94.5723845]	There is a gap spaced greater than a 1/2 inch. Openings in floor or ground surfaces shall not allow passage of a sphere more than 1/2 inch diameter. Elongated openings shall be placed so that the long dimension is perpendicular to the dominant direction of travel.	6.5" gap in CFS of drinking fountain	Correct or fill gaps to be max .5".	2015 ABAAS Section: 302.3  2012 TAS Section: 302.3  2010 ADAS Section: 302.3

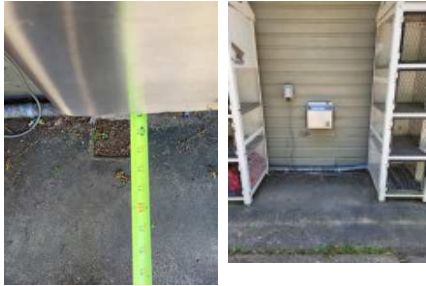
Finding Number	Area Description	Lat/Long	Finding	As Built	Recommendation	Citation	Photos	Figure
387	Bee Tree Camping Area: Bee Tree - Women's Restroom	[32.2758192 , -94.572373 8]	There is not enough toe space clearance under the drinking fountain. Space under an element between the finish floor or ground and 9 inches above the finish floor or ground shall be considered toe clearance. Space extending greater than 6 inches beyond the available knee clearance at 9 inches above the finish floor or ground shall not be considered toe clearance. Where toe clearance is required at an element as part of a clear floor space, the toe clearance shall extend 17 inches minimum under the element.	Lacks toe clearance - 11"	Remount or replace fountain with one provided 17" min and 25" max deep toe clearance.	2015 ABAAS Section: 306.2.3  2012 TAS Section: 306.2.3  2010 ADAS Section: 306.2.3

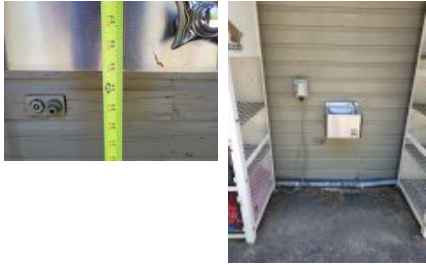
388	Bee Tree Camping Area: Bee Tree - Women's Restroom	[32.2758215 , -94.572375 1]	There is not enough knee clearance under the drinking fountain. The drinking fountain must have a clear knee space between the bottom of the apron and the floor not less than 27 inches in height, 30 inches in width, and 8 inches in depth.	Lacks knee clearance - 24.75"	Replace drinking fountain with a hi-lo bowl fountain.	2015 ABAAS Section: 602.2  2012 TAS Section: 602.2  2010 ADAS Section: 602.2

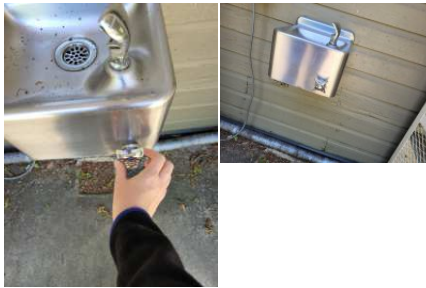
389	Bee Tree Camping Area: Bee Tree - Women's Restroom	[32.2758169 , -94.572379 2]	The operable part is not accessible because it requires tight grasping, pinching or twisting of the wrist.	Drinking fountain knob control requires tight pinch	Replace operable part with one usable without a tight pinch or grasp.	2015 ABAAS Section: 309.4  2012 TAS Section: 309.4  2010 ADAS Section: 309.4
