NUECES RIVER COLLECTION REPORT

Dr. Gary Garrett

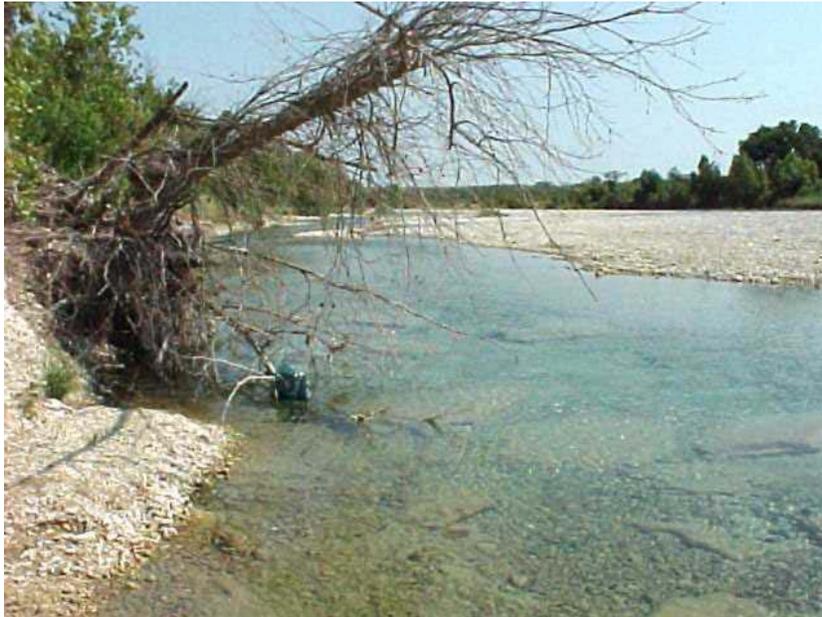
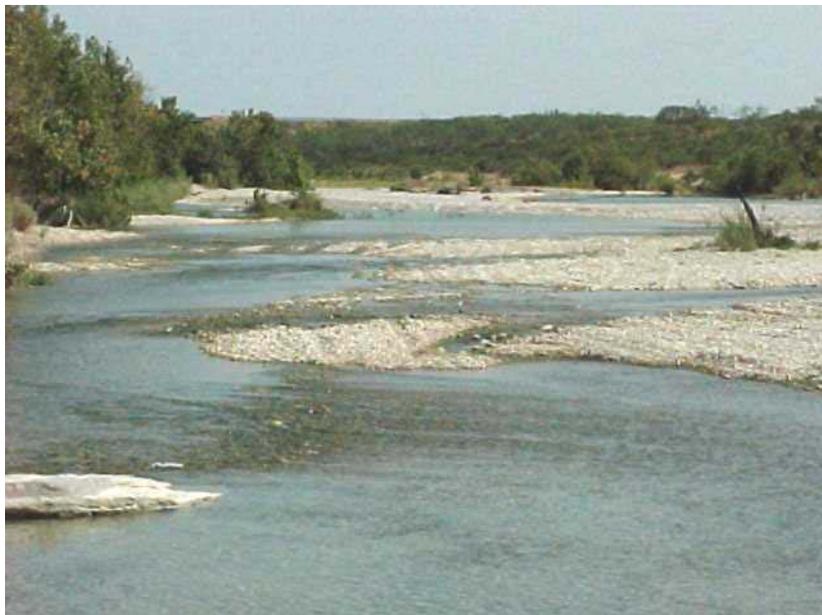
IMPACTED SITE

The first site (Lyles Ranch) is near state highway 83 and has been heavily used by off-road vehicles. Their impact was dramatically evident. There was little to no aquatic vegetation, virtually no riparian vegetation and the substrate had the appearance of heavy scouring (mostly cobble and bedrock). I have enclosed photos of each site.

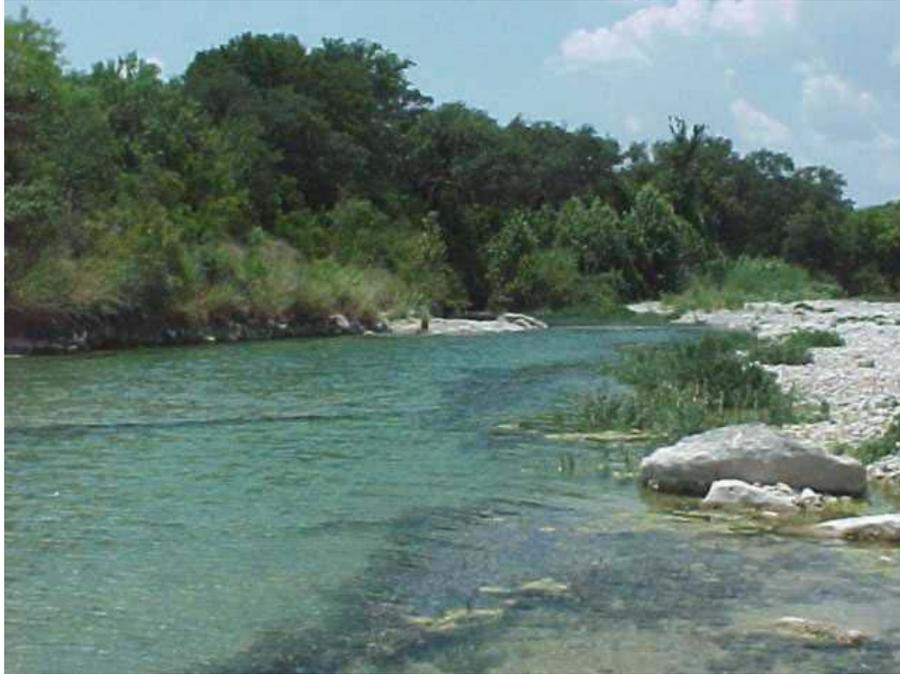
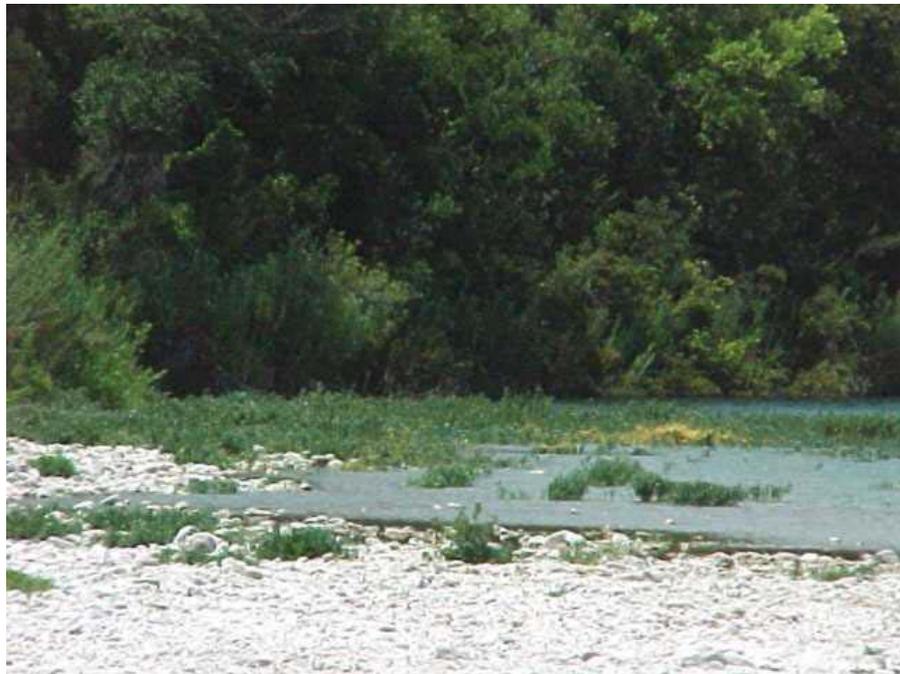
UN-IMPACTED SITE

The second site (Mirasol Ranch) was used for comparison. It is relatively near the first site and has similar topography. The sites differ in that there is no public access adjacent to the site and thus, no vehicular traffic in the river. This location was more typical of what I would expect of normal conditions for this stream (e.g., aquatic and riparian vegetation, gravels and sand as well as cobble and bedrock).
