Self-Guided Tour

Fort Leaton

State Historic Site

WELCOME TO FORT LEATON STATE HISTORIC SITE

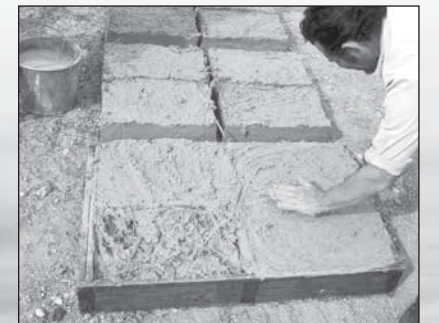
Adobe brick being made during restoration work.

Fort Leaton was constructed of the native materials on hand: earth, rock and wood. Large, sun-dried adobes laid on rubble stone foundations comprise its walls, which range in thickness from 18 to 44 inches, nearly four feet at maximum. The adobe—a mixture of straw, water and clay—were pre-cast in wooden forms. After setting and hardening somewhat, the adobe were removed from the forms and allowed to dry thoroughly in the hot desert sun.
